# Preliminary Report of Saco River Submerged Debris Investigation

By Kerby Dobbs

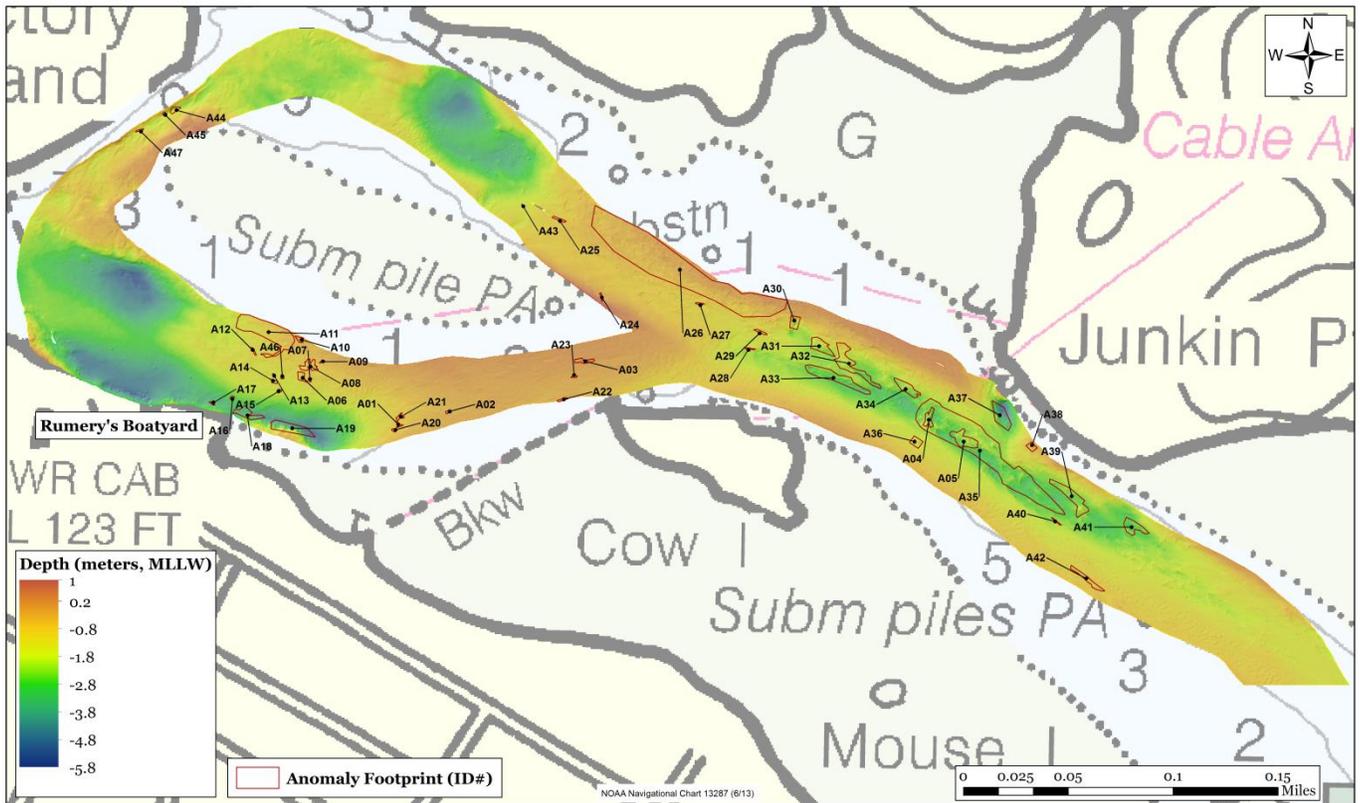
Figure 3. Bathymetric (MLLW, meters) and anomaly (outlined in red with corresponding ID) footprint map. See Appendix A for anomaly attributes.

The combination of video and MBES data analysis resulted in the delineation of 47 anomaly areas suspected or confirmed to contain submerged debris (Figure 3). These areas ranged in size from 1 m<sup>2</sup> to approximately 3150 m<sup>2</sup>, with a total combined area of 8146 m<sup>2</sup>. The footprints delineated for anomalies A04 and A05 fall within anomaly A35 and were subtracted from the total combined area. These anomalies (A04 and A05) were delineated separately from the surrounding zone because they represent key anomalies visualized in video recordings, served as calibration to improve interpretations of data, and/or may present a distinct hazard to those operating (e.g. dredging, mariners, recreational use) in their vicinity. The attributes (e.g. ID, footprint area, coordinates, and brief description) of anomalies shown in Figure 3 are located in Appendix A.

As an effort to guide any subsequent investigation of anomalies outlined in this report, each anomaly was given a value to correspond with a recommended investigation priority (RIP) (column X in Appendix A). A value of 1 indicates an area or discrete object with the highest investigation priority and a value of 3 represents the lowest priority. An anomaly with an RIP value of 1 had attributes consistent with one or several of the following criteria: (a) may pose an existing hazard to mariners due to size, depth, and proximity to surface during low tide, (b) may pose a hazard to those engaging in recreational activity (e.g. fishing, scuba diving, swimming), (c) may pose a hazard to dredging, or (d) has characteristics consistent with hazards shown on nautical charts (e.g. cable area). An anomaly with an RIP equal to 3 met one or several of the following criteria: (a) not suspected to present an immediate hazard to mariners, (b) suspected to be mostly comprised of coarse, woody debris, or (c) was not located in areas previously suspected to contain significant hazards. An RIP equal to 2 was chosen as an intermediate value for anomalies that did not fit neatly into either category. Using the RIP index for the 47 anomalies, 9 anomalies were assigned a value of 1, 7 anomalies a value of 2, and 31 anomalies a value of 3. It is important to note that the RIP index was developed as logistical aid for interpreting the findings included in this report and that all anomalies may present unique hazards to different types of activity within the Saco River. Thus, it is recommended that further investigation be performed in all anomaly locations to evaluate hazard potential.

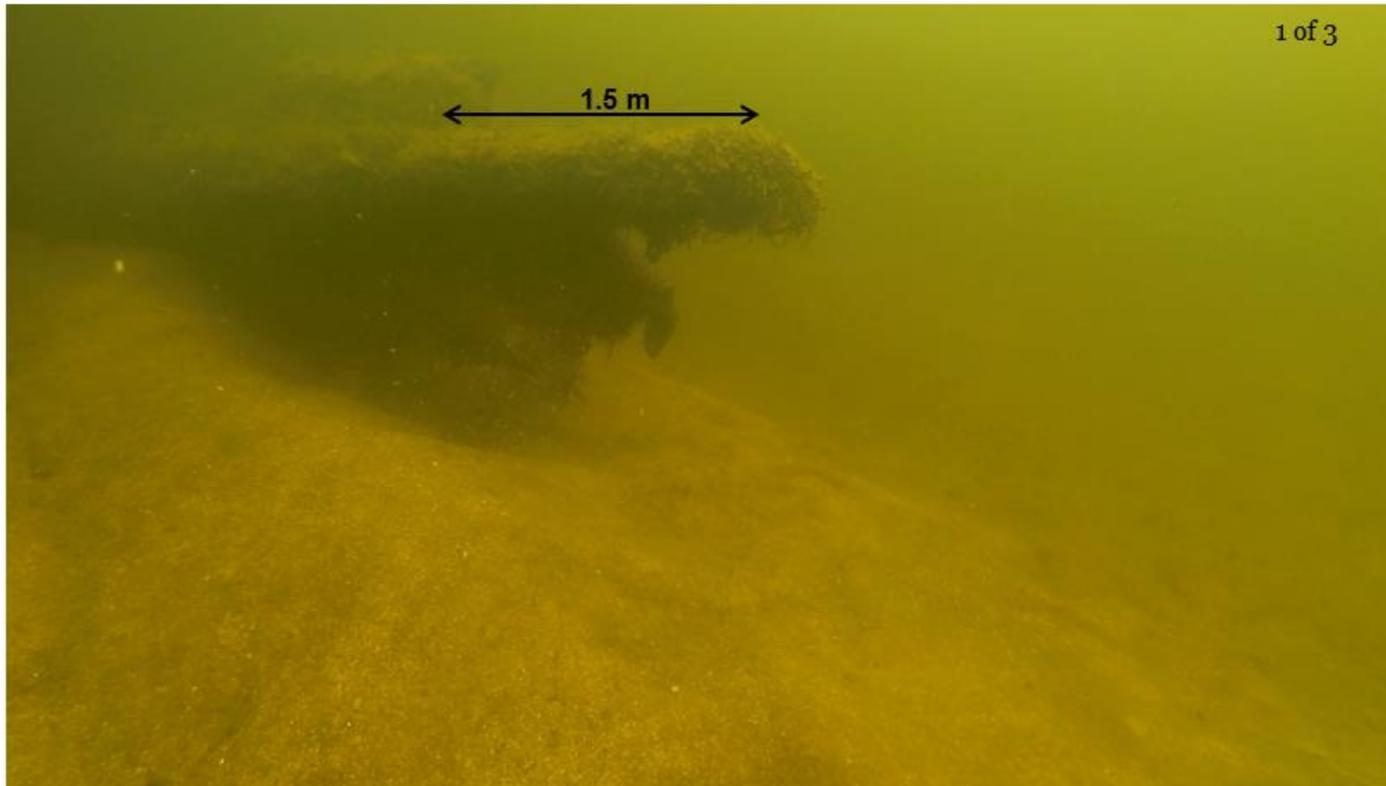
00:00:00 – large, elongated object and adjacent large, irregular object that extend above seafloor; further investigation recommended

Project Location:	Saco River, ME	Anomaly ID:	A1
	Method:	camera drop/tow	Easting (m):	383314
	Date/Time (EST):	5-25-16 / 10:23	Northing (m):	4816416
	Camera Bearing:	285 °	Shape:	elongate/irregular
	Depth (m):	2.2	File name:	gopr0337.mp4

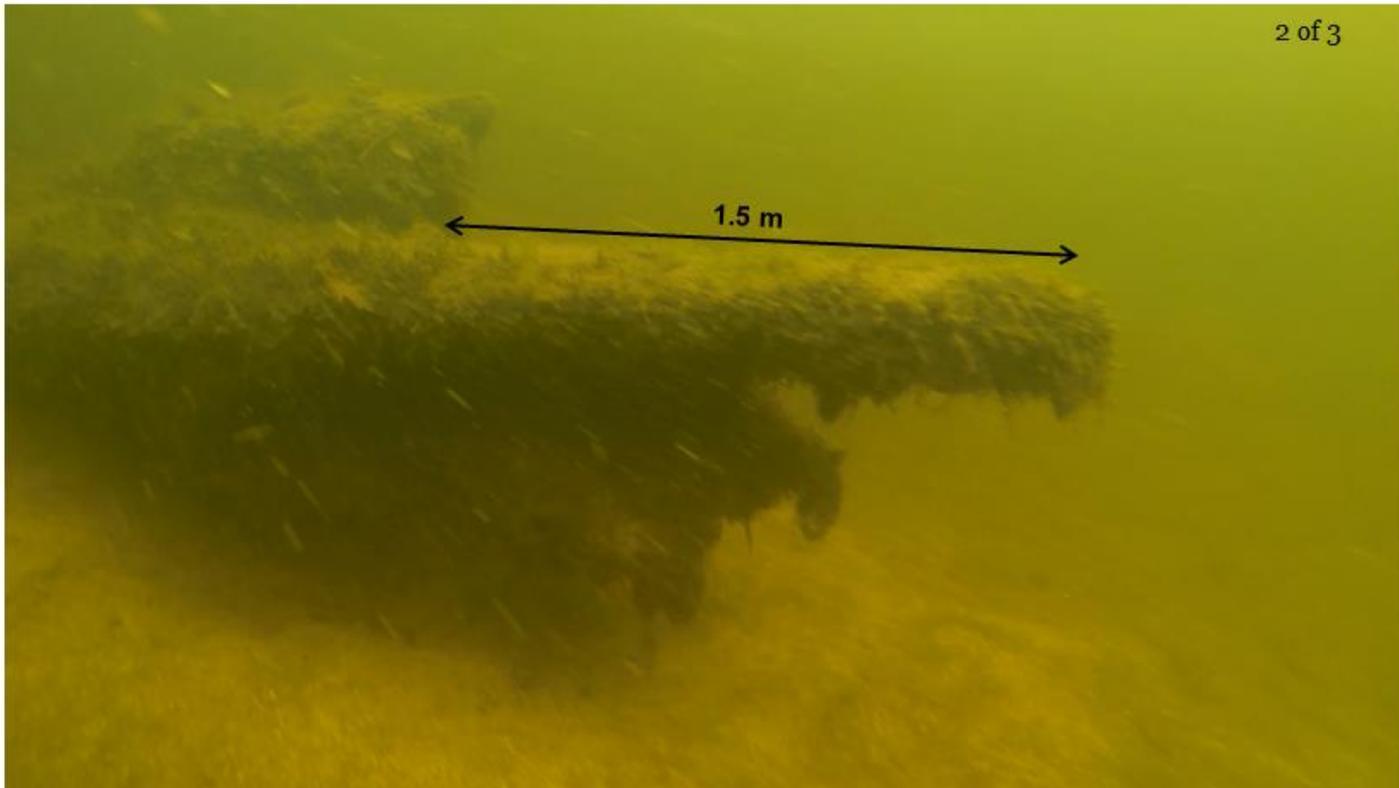
Project Location:	Saco River, ME	Anomaly ID:	A1
	Method:	camera drop/tow	Easting (m):	383314
	Date/Time (EST):	5-25-16 / 10:23	Northing (m):	4816416
	Camera Bearing:	340° (approx.)	Shape:	elongate/irregular
	Depth (m):	2.2	File name:	gopr0337.mp4

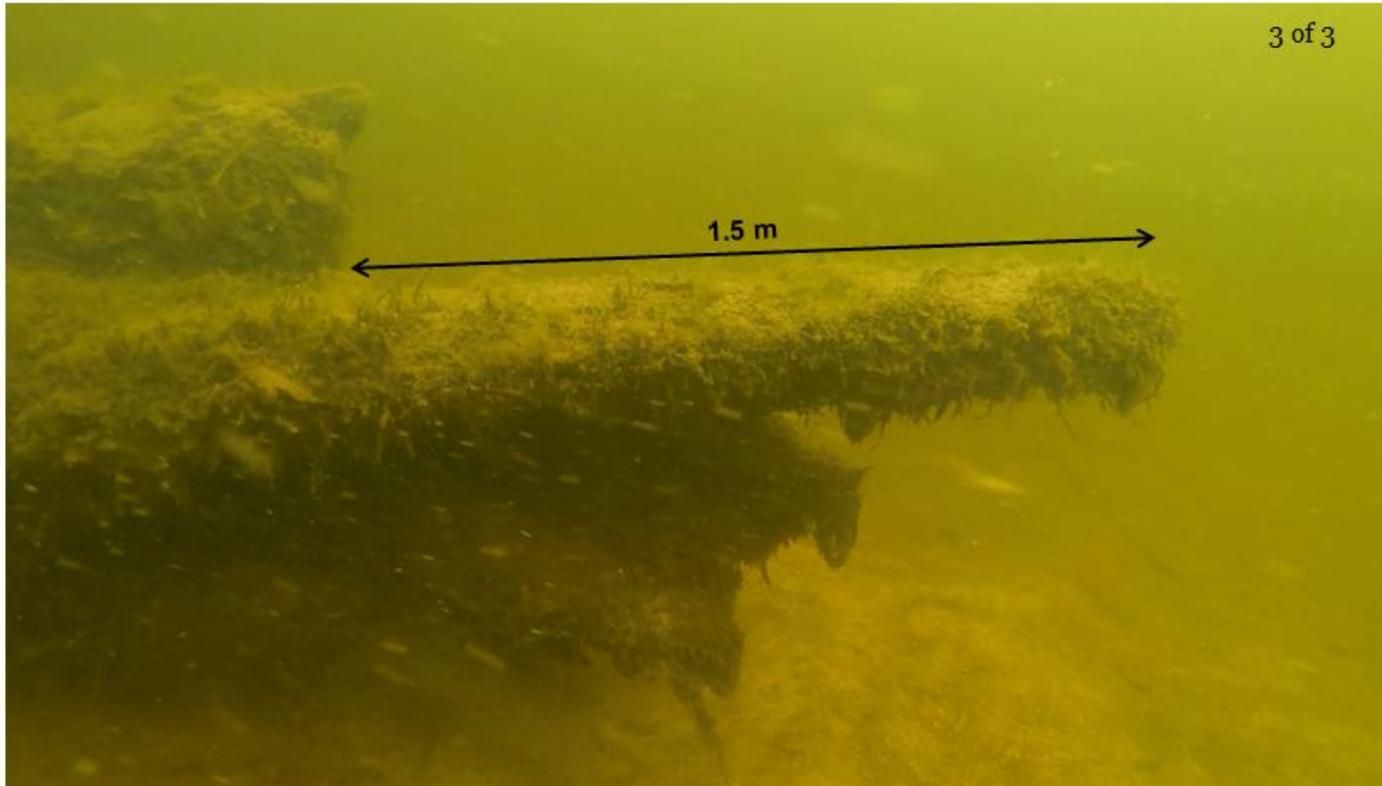
Project Location:	Saco River, ME	Anomaly ID:	A1
	Method:	camera drop/tow	Easting (m):	383314
	Date/Time (EST):	5-25-16 / 10:23	Northing (m):	4816416
	Camera Bearing:	350 ° (approx.)	Shape:	elongate/irregular
	Depth (m):	2.2	File name:	gopr0337.mp4

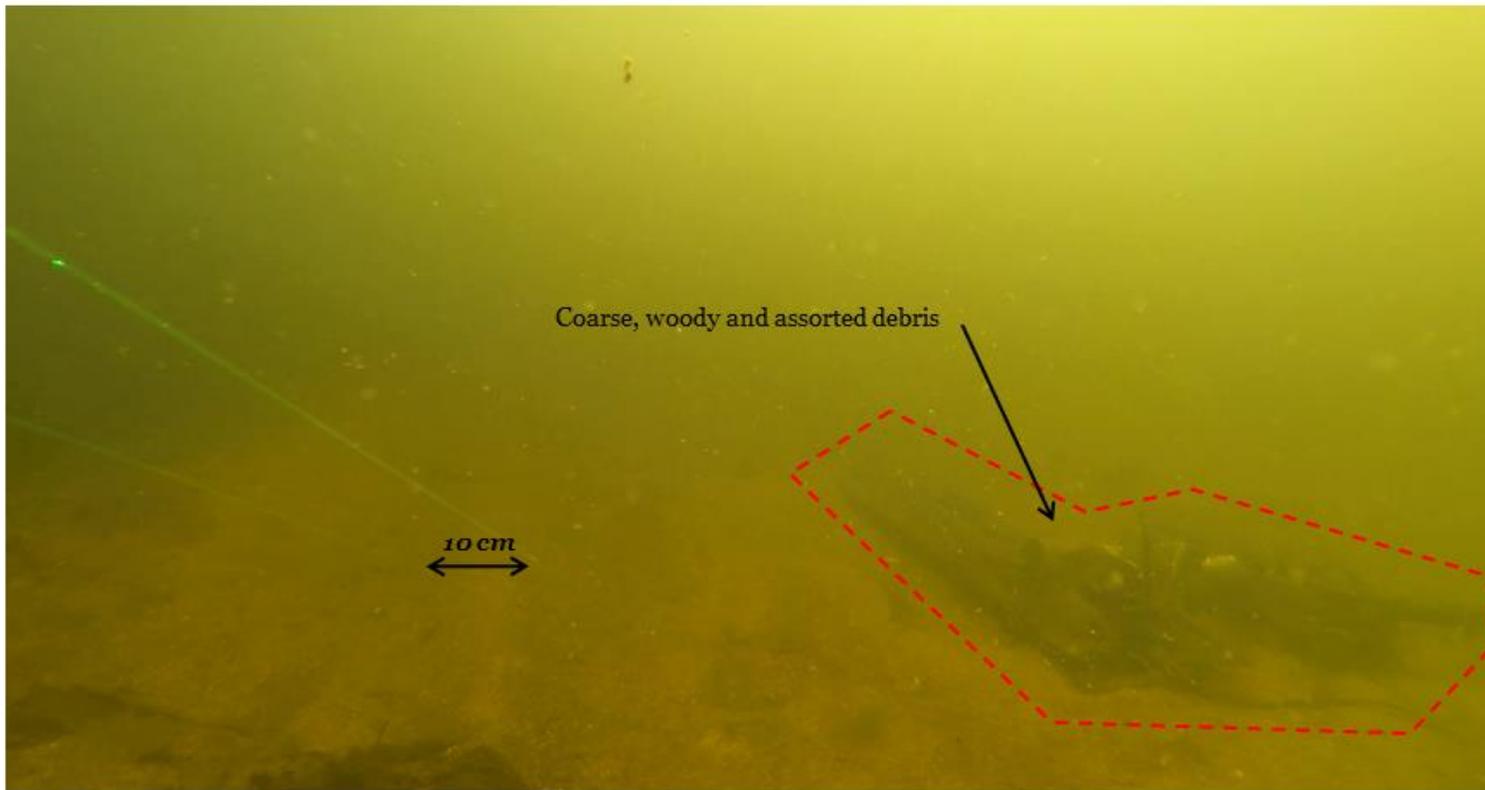
**Video notes:** video shows suspected coarse, woody and metal debris

Project Location:	Saco River, ME	Anomaly ID:	A2
	Method:	camera drop	Easting (m):	383347
	Date/Time (EST):	5-25-16 / 10:52	Northing (m):	4816427
	Camera Bearing:	63°	Shape:	linear/irregular
	Depth (m):	2.0	File name:	gopr0338.mp4

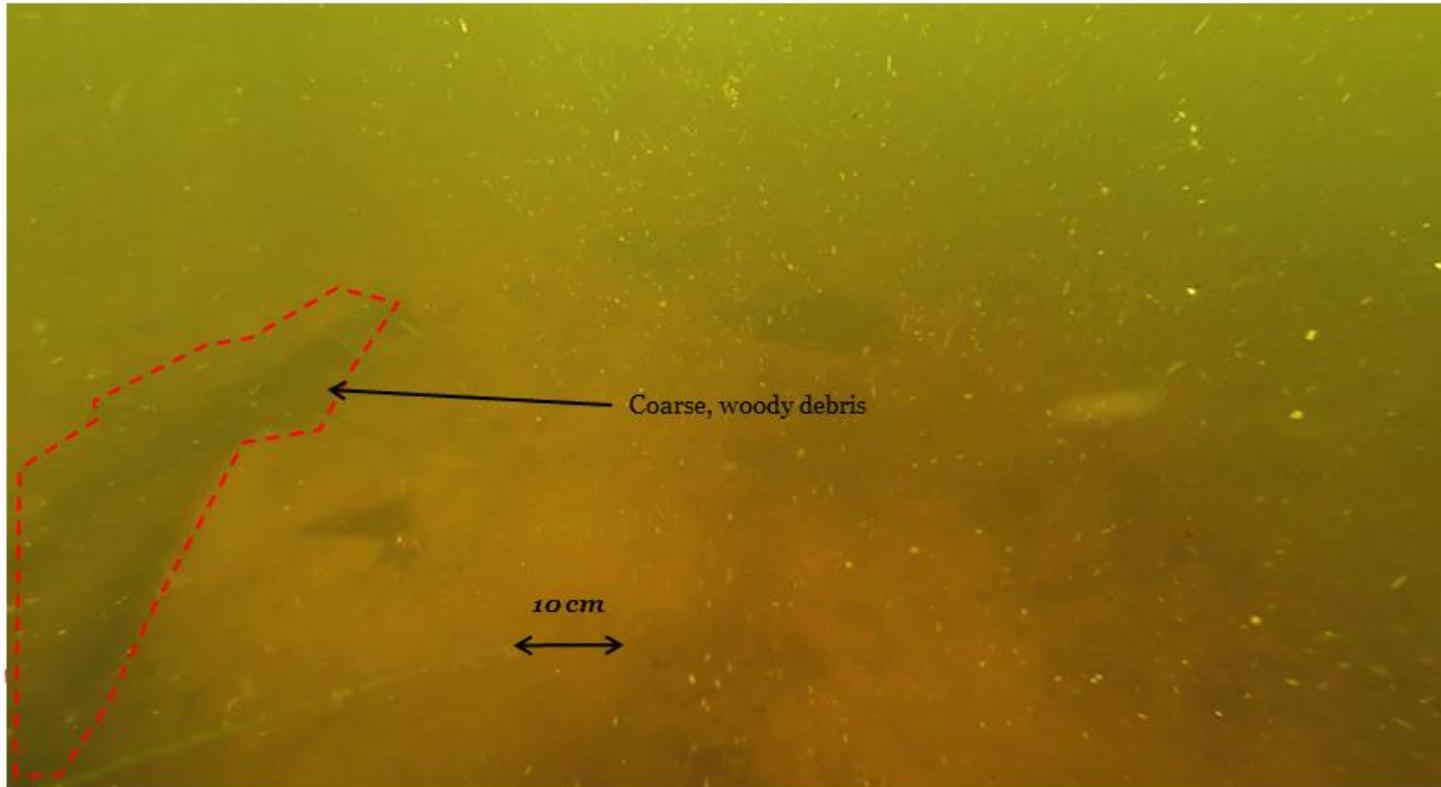
Project Location:	Saco River, ME	Anomaly ID:	A3
	Method:	camera tow	Easting (m):	383456
	Date/Time (EST):	5-25-16 / 11:57	Northing (m):	4816465
	Camera Bearing:	88°	Shape:	linear/irregular
	Depth (m):	~2.0	File name:	gopr000341.mp4

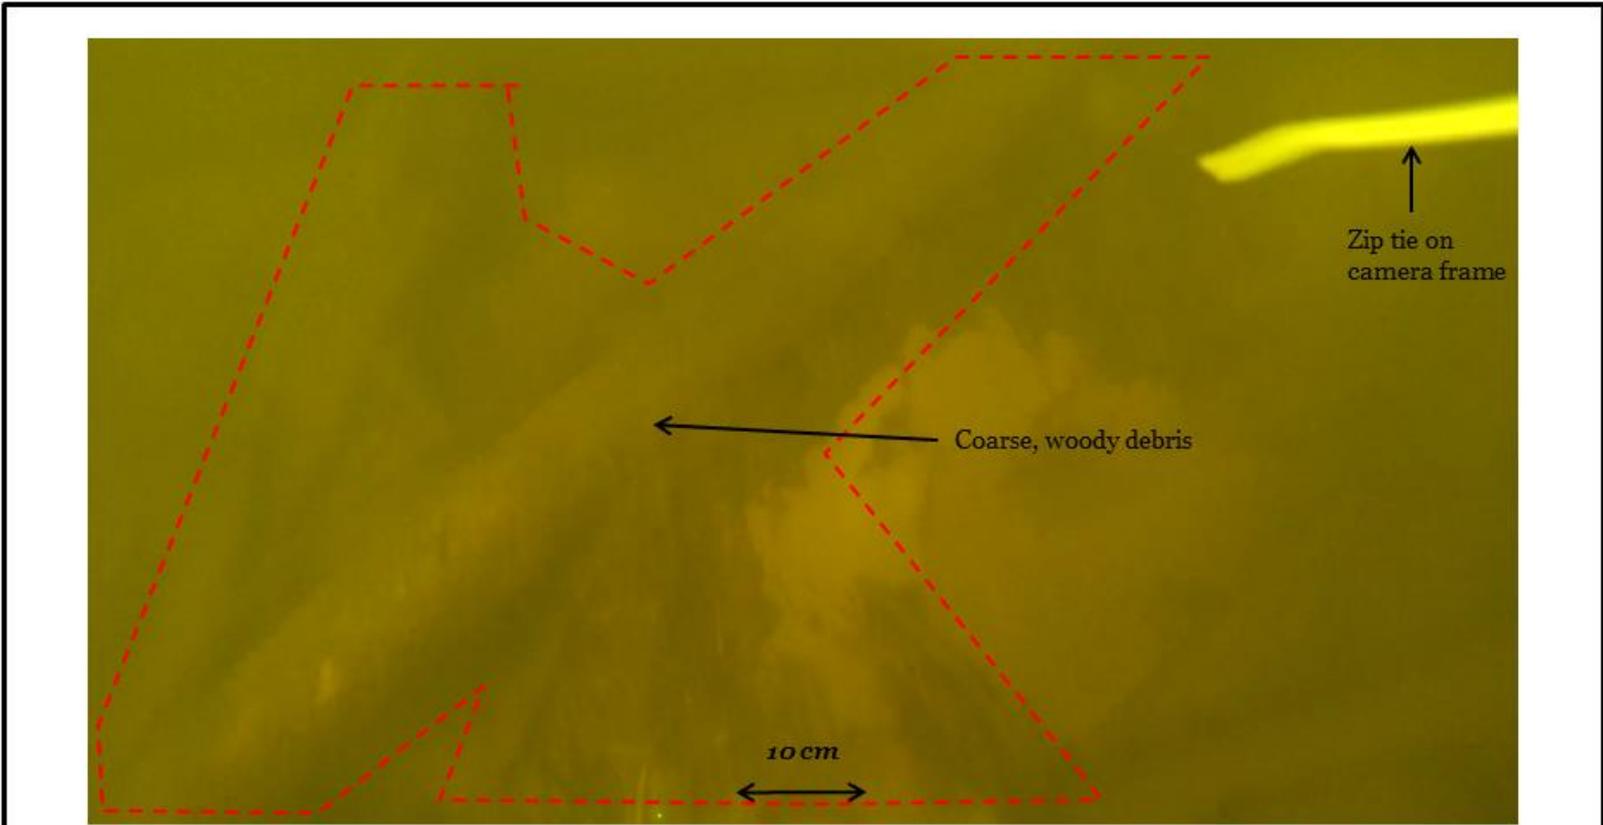
Project Location:	Saco River, ME	Anomaly ID:	A4
	Method:	camera tow	Easting (m):	383720
	Date/Time (EST):	5-25-16 / 13:06	Northing (m):	4816422
	Camera Bearing:	303°	Shape:	Irregular/elongate
	Depth (m):	~4.0	File name:	gopr00346.mp4

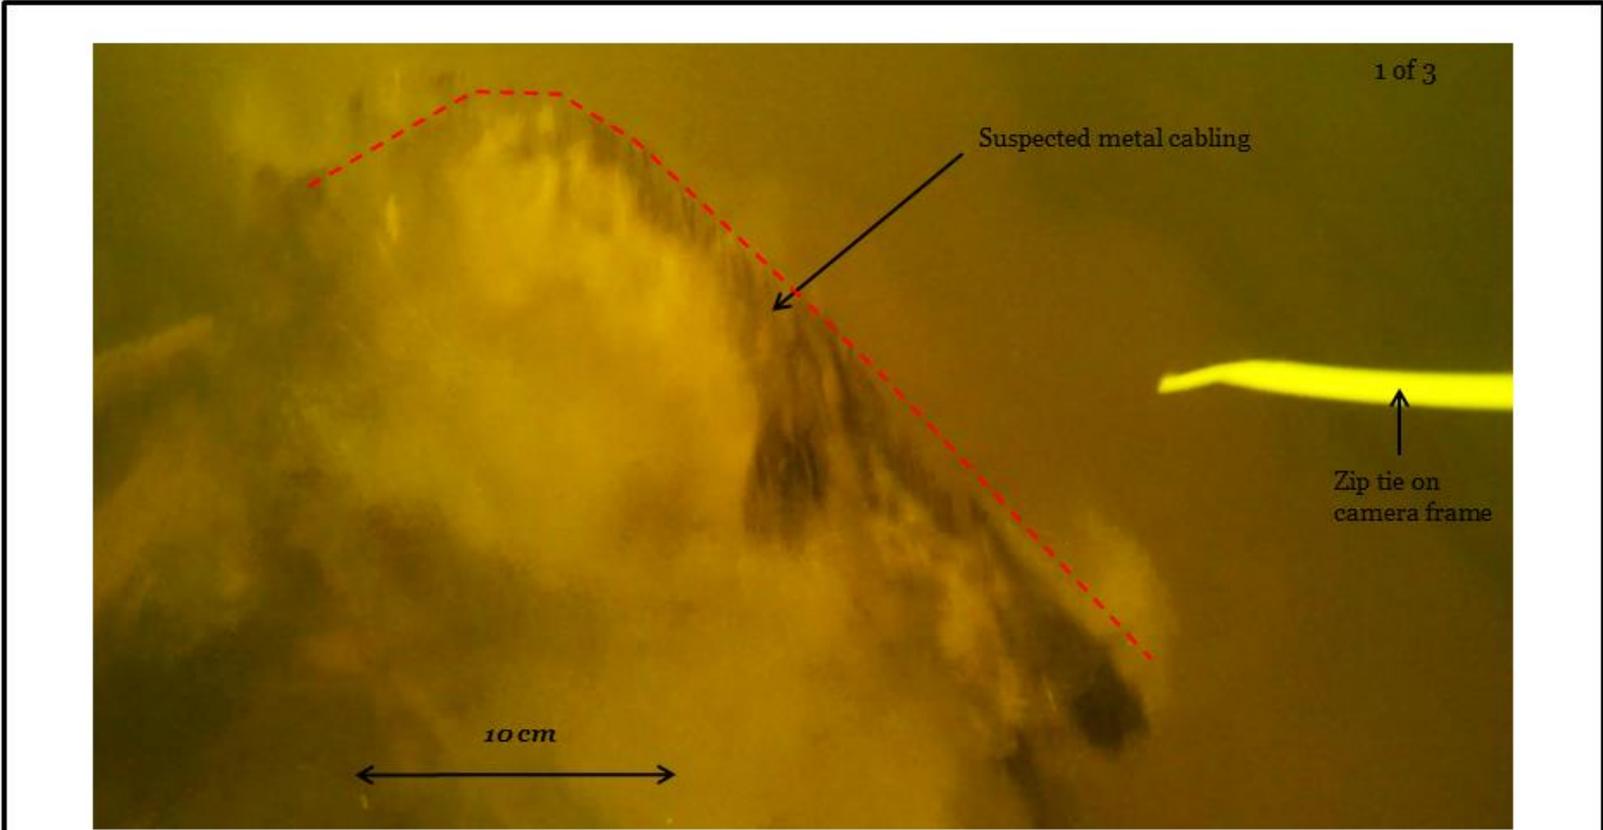
Project Location:	Saco River, ME	Anomaly ID:	A5
	Method:	camera tow	Easting (m):	383742
	Date/Time (EST):	5-25-16 / 13:07	Northing (m):	4816408
	Camera Bearing:	303°	Shape:	irregular
	Depth (m):	~4.0	File name:	gopr00346.mp4

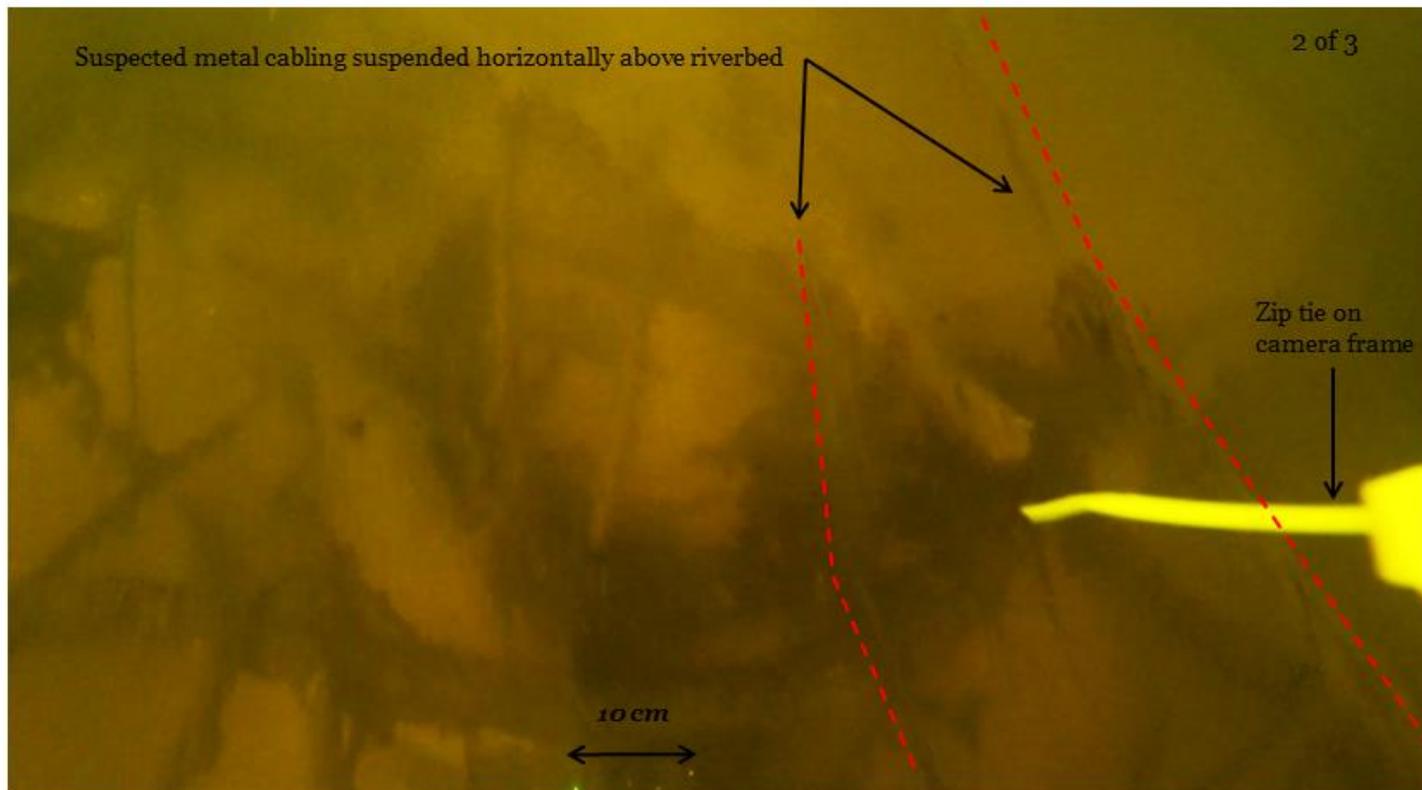
Project Location:	Saco River, ME	Anomaly ID:	A5
	Method:	camera tow	Easting (m):	383742
	Date/Time (EST):	5-25-16 / 13:07	Northing (m):	4816408
	Camera Bearing:	303°	Shape:	linear/irregular
	Depth (m):	~4.0	File name:	gopro00346.mp4

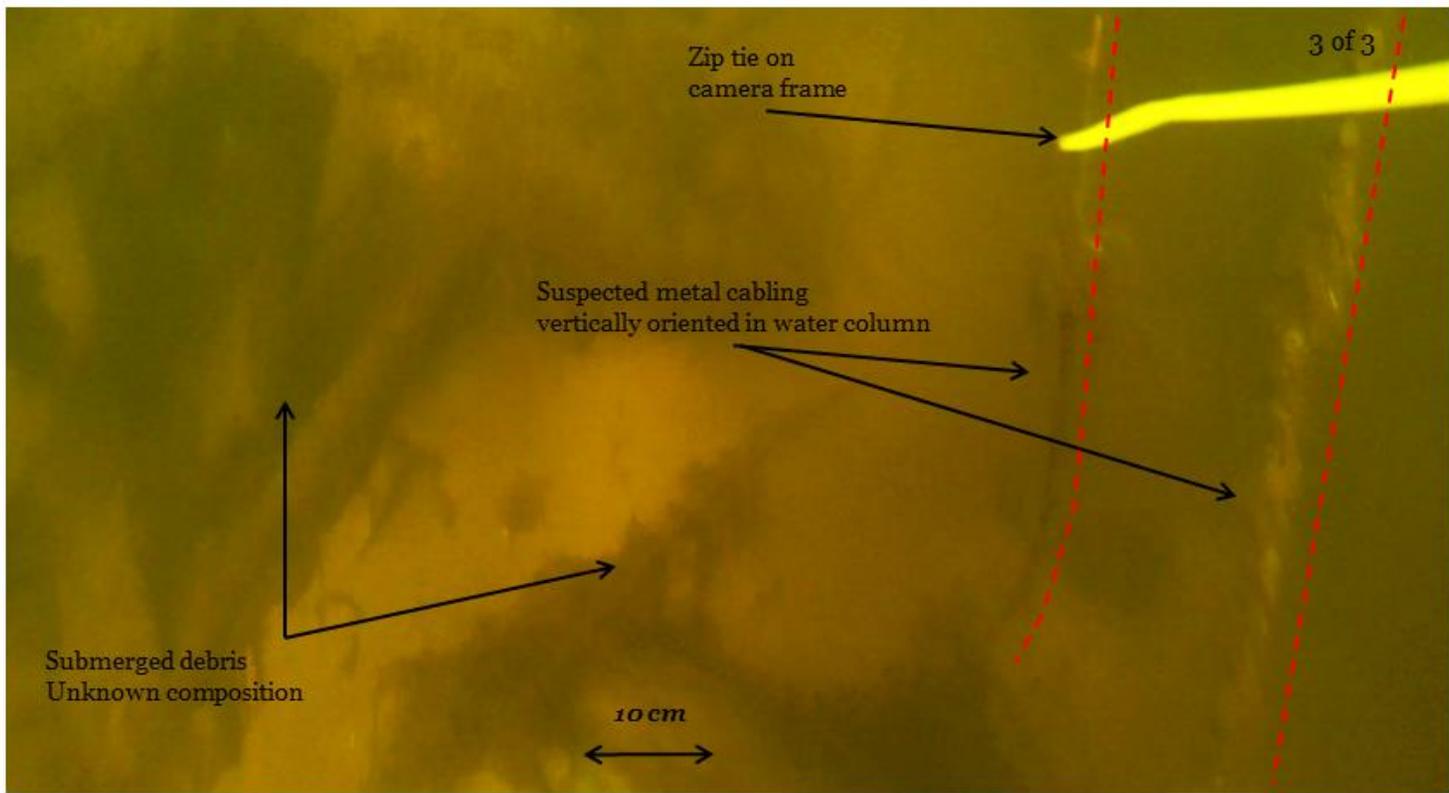
Project Location:	Saco River, ME	Anomaly ID:	A5
	Method:	camera tow	Easting (m):	383742
	Date/Time (EST):	5-25-16 / 13:07	Northing (m):	4816408
	Camera Bearing:	303°	Shape:	linear/irregular
	Depth (m):	~4.0	File name:	gopro00346.mp4

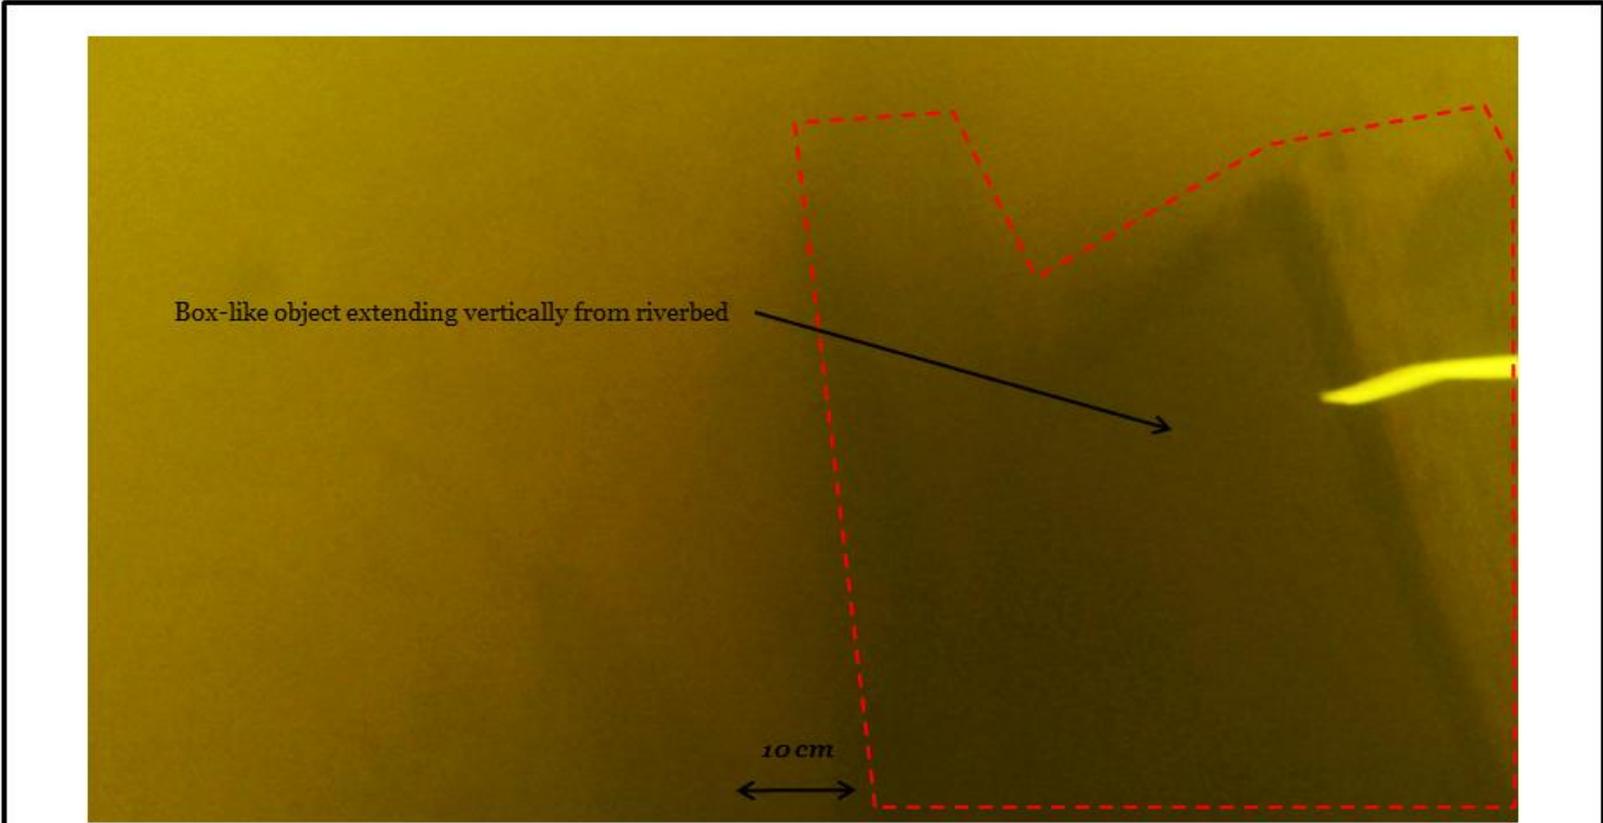
Project Location:	Saco River, ME	Anomaly ID:	A6
	Method:	camera tow	Easting (m):	383238
	Date/Time (EST):	5-25-16 / 13:41	Northing (m):	4816454
	Camera Bearing:	93°	Shape:	polygonal/irregular
	Depth (m):	~2.0	File name:	gopr00347.mp4

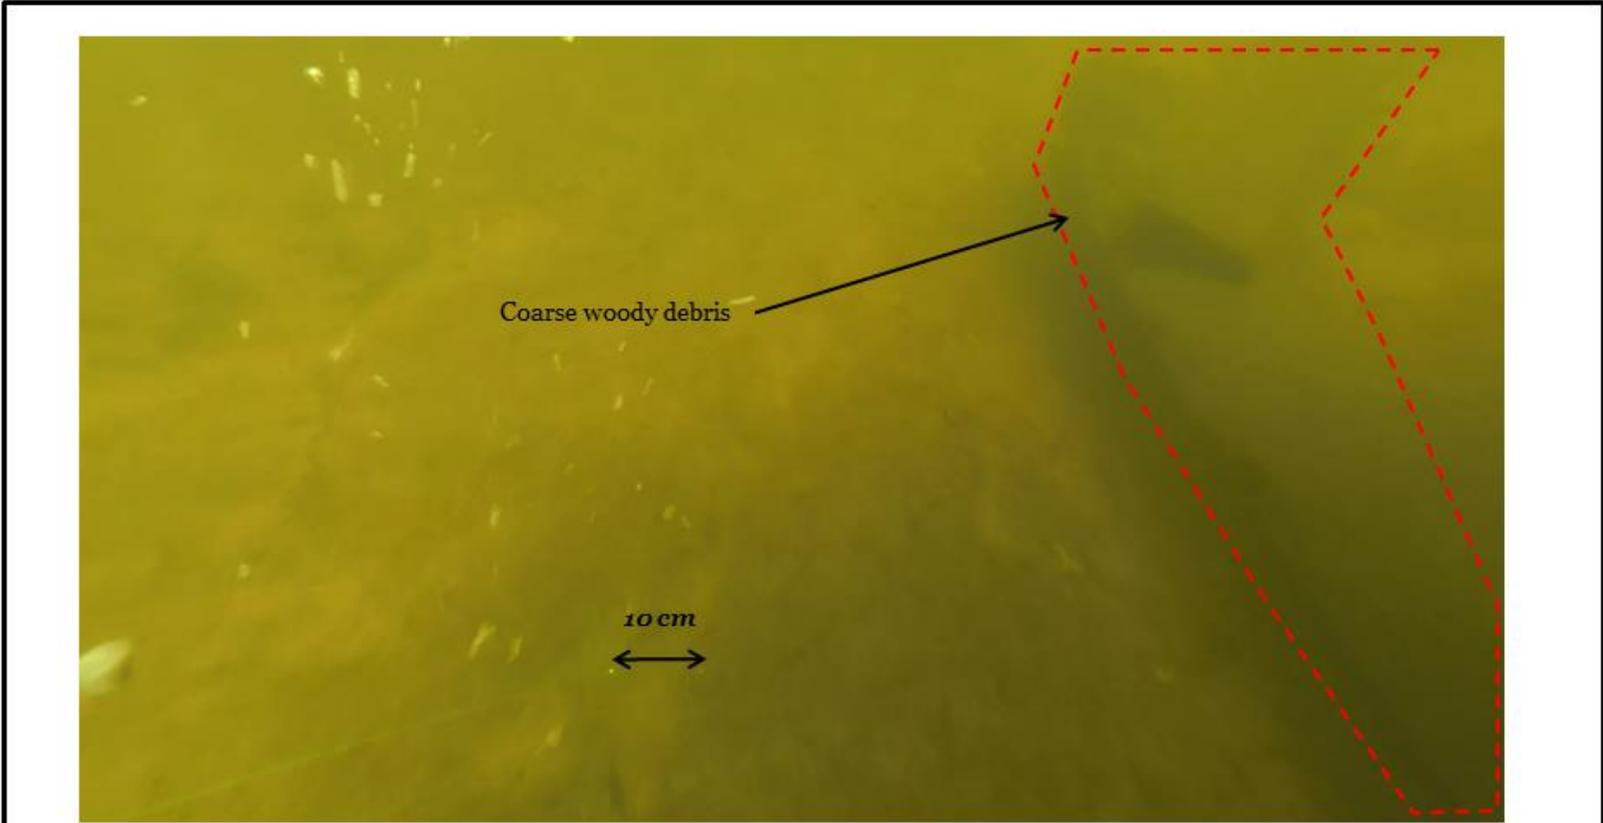
Project Location:	Saco River, ME	Camera Tow ID:	4
	Method:	camera tow	Easting (m):	See tow coords.
	Date/Time (EST):	5-25-16 / 11:57	Northing (m):	See tow coords
	Camera Bearing:	88°	Shape:	linear/irregular
	Depth (m):	~2.0	File name:	gopro00341.mp4

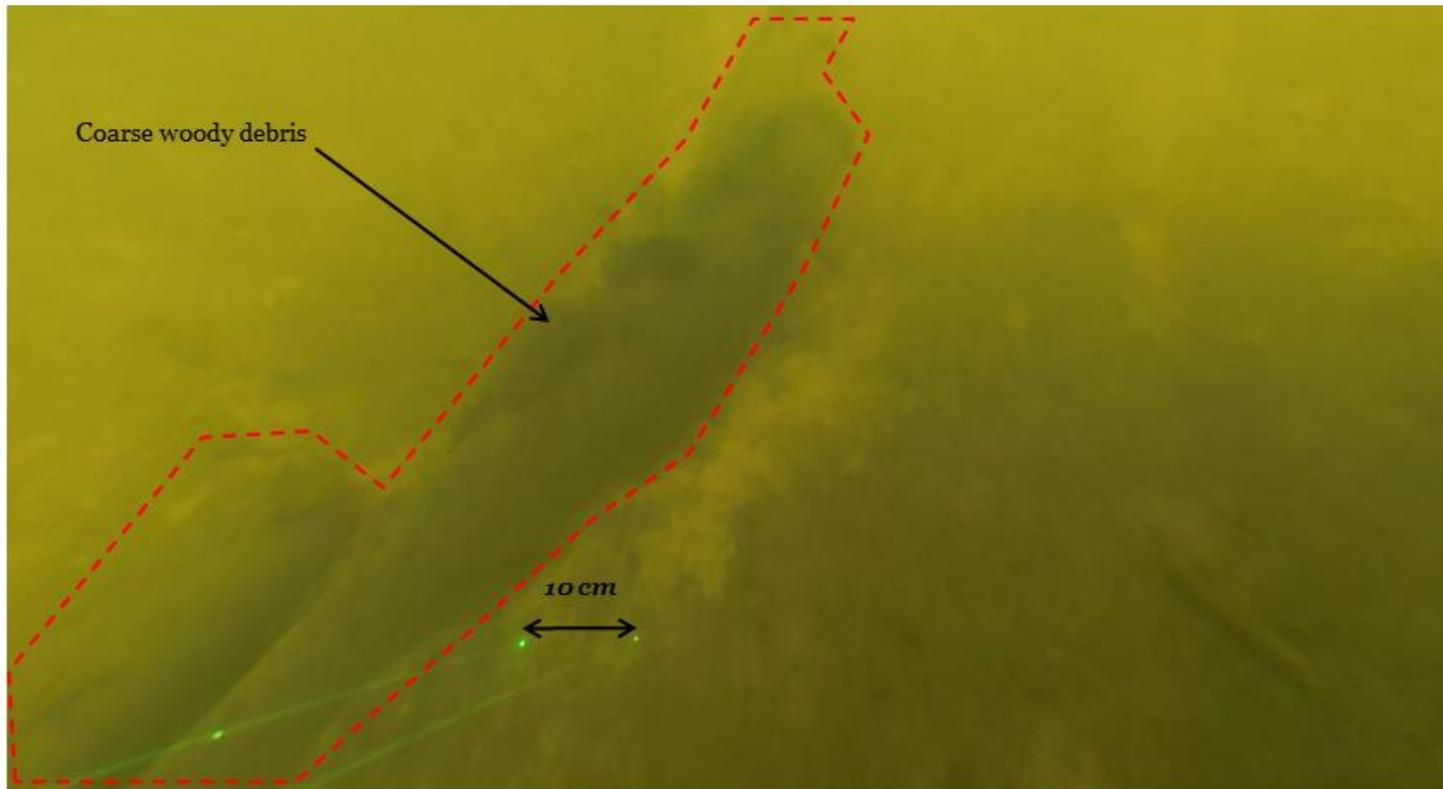
Project Location:	Saco River, ME	Camera Tow ID:	4
	Method:	camera tow	Easting (m):	See tow coords.
	Date/Time (EST):	5-25-16 / 11:57	Northing (m):	See tow coords.
	Camera Bearing:	88°	Shape:	linear/irregular
	Depth (m):	~2.0	File name:	gopr000341.mp4
