20 December 2019

Project Number: 3611191238

**Subject: Vulnerability Assessment and Resilience Planning, Public Landing, Belfast, Maine  
Penobscot Bay Working Waterfront Resiliency Analysis  
State of Maine, Department of Marine Resources**

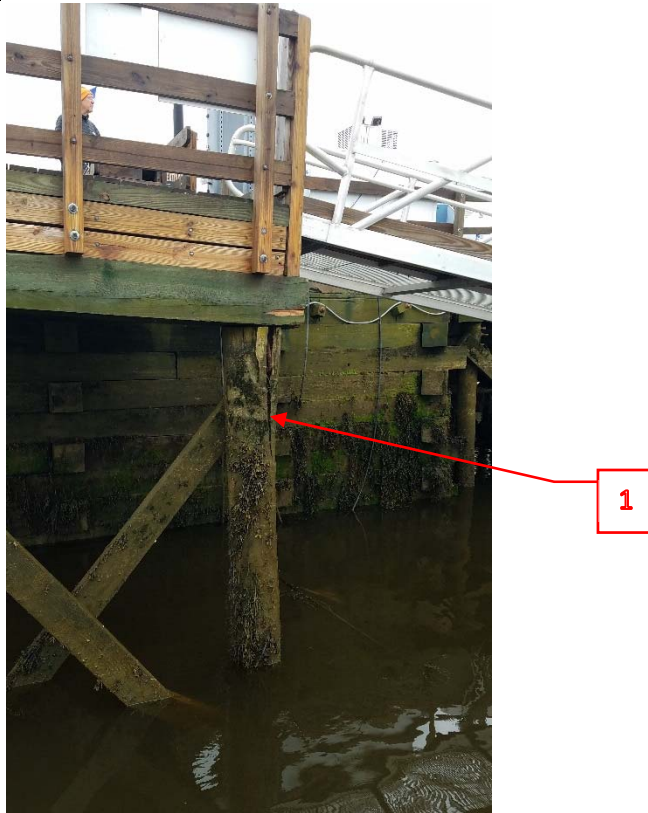
**Photograph No. 11:**

The wharf was viewed from above, the shoreline below, or from the floating docks. Timber members stacked at the face of wharf appear to be in serviceable condition. We noted weathered timber members throughout which exhibited signs of checking, splitting and shakes. Severity of these observed conditions ranged from minor to moderate in nature. Timber piles and pile caps appear to be in serviceable condition; however, connecting elements for these members could not be assessed due to limited access. Connecting elements such as fasteners appear to experience minor to moderate condition of corrosion. Similar conditions were noted at the pier, with the exception of the cross bracing which are, for the most part, within the tidal zone.

**Splitting noted at timber pile supporting the small landing in previous photo.**

1. Splitting

- Confirm positive attachment of all structural members to their substrate or load-bearing elements. We recommend a detailed analysis to verify the structures are designed according to current standards and design loading. Incorporate redundancies in design as needed based on a detailed structural analysis.
- Utilities and equipment should be properly secured to resist design wind and water loading or relocated above the flood elevation as specified in ASCE 24. Watertight enclosures should be incorporated for electrical equipment and conduits. Fuel supply fixtures should be confirmed for watertight and corrosion resistant fixtures and appurtenances or otherwise raise exposed elements above the DFE per design specifications when not unpractical for use.

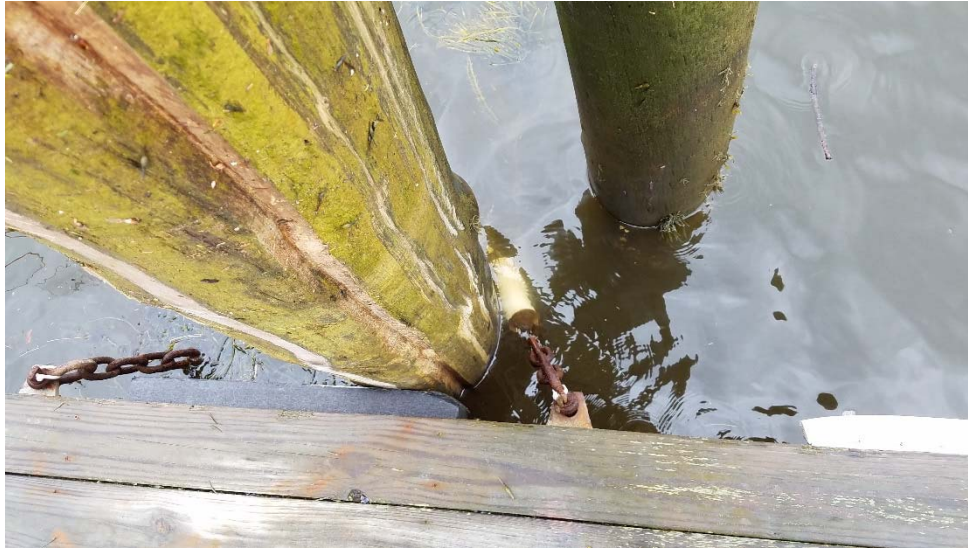
**Photograph No. 17:**

The floating docks appear to be in good condition with some decking exhibiting minor weathering. The pontoons appear to function as intended. Mooring chains and clamps show signs of corrosion (**Photographs 17 & 26**). Mooring structures exhibit signs of moderate to major corrosion at many locations throughout, such as delamination and cracking (**Photograph 27**).

**Typical attachment of floating dock with buoy chains at mooring piles.**

- Clean and coat all corroded steel framing members and replace severely corroded hardware. Confirm that all members are positively connected, and the substrate is reasonable condition to resist the intended design loading.
- Confirm the gangway attachments are sufficient to resist the design loading and repair or replace as needed.

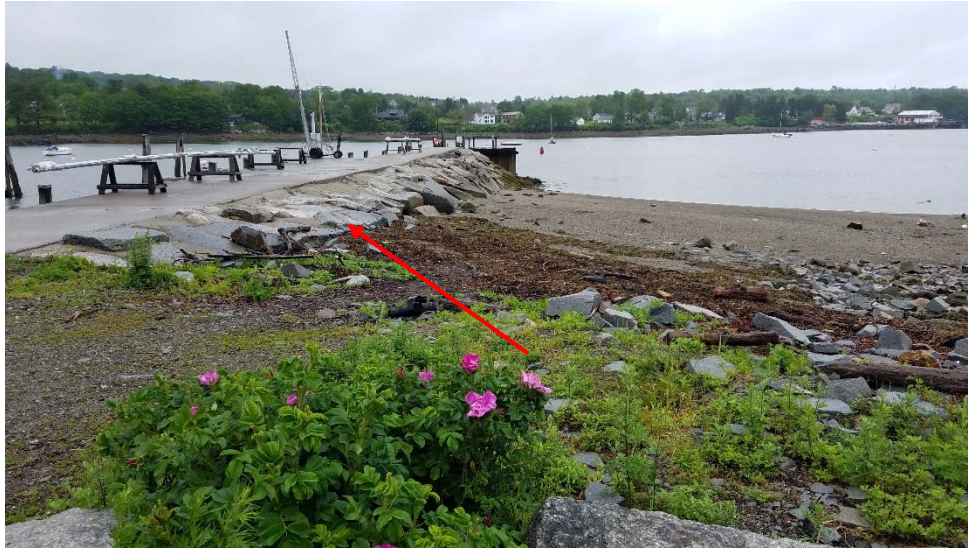
**Photograph No. 21:**

**Overview of breakwater.**

**Remediated area visible from south side of structure.**

- The breakwater appears to experience continued erosion of interior material. A detailed analysis for the current breakwater should be performed given the level of inundation already expected at the Present Day scenario. In addition to repair, recommendations for raising or retrofitting the breakwater will be based on this analysis and performance of the breakwater in protecting harbor assets.

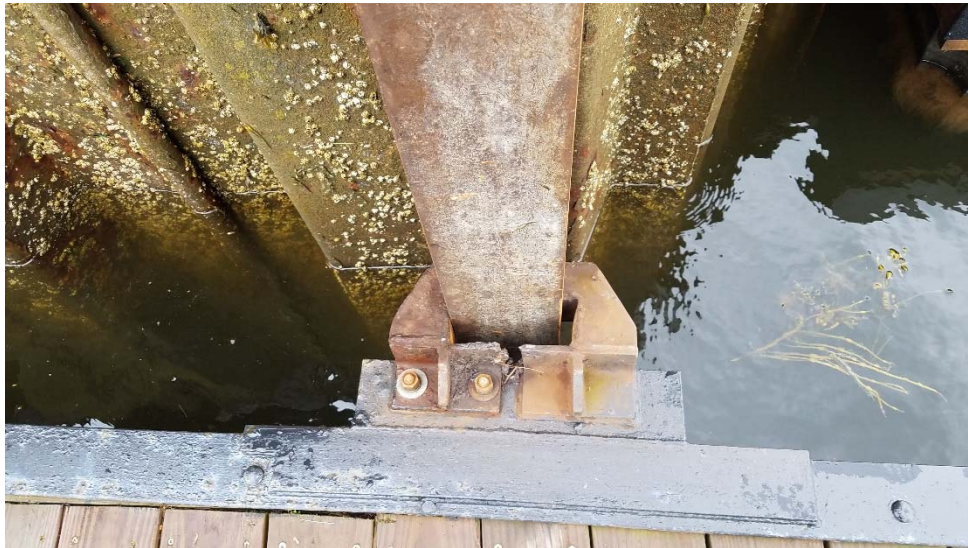
**Photograph No. 26:**

**View of attachment of floating dock to structure via mooring clamp.**

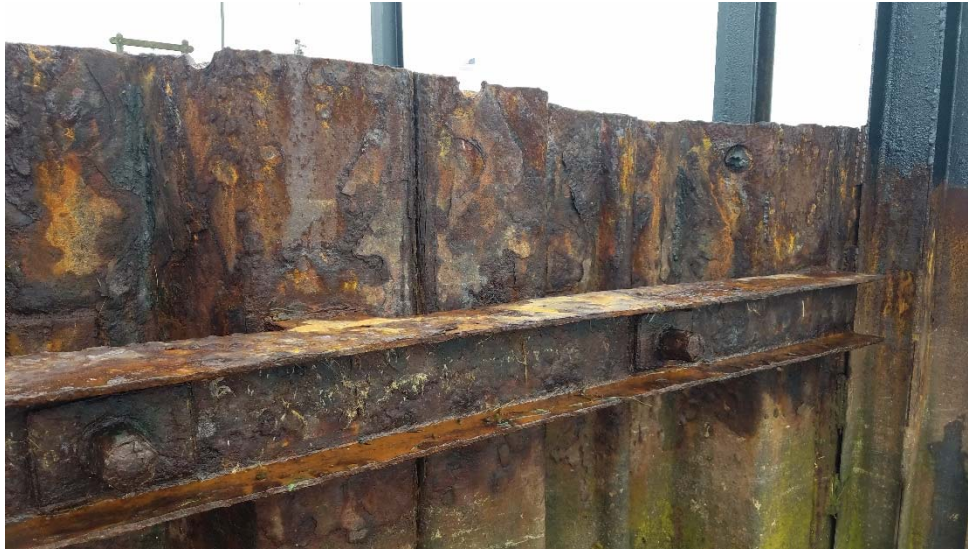
**Photograph No. 27:**

Condition of steel at mooring structure noted. Moderate to major corrosion noted.

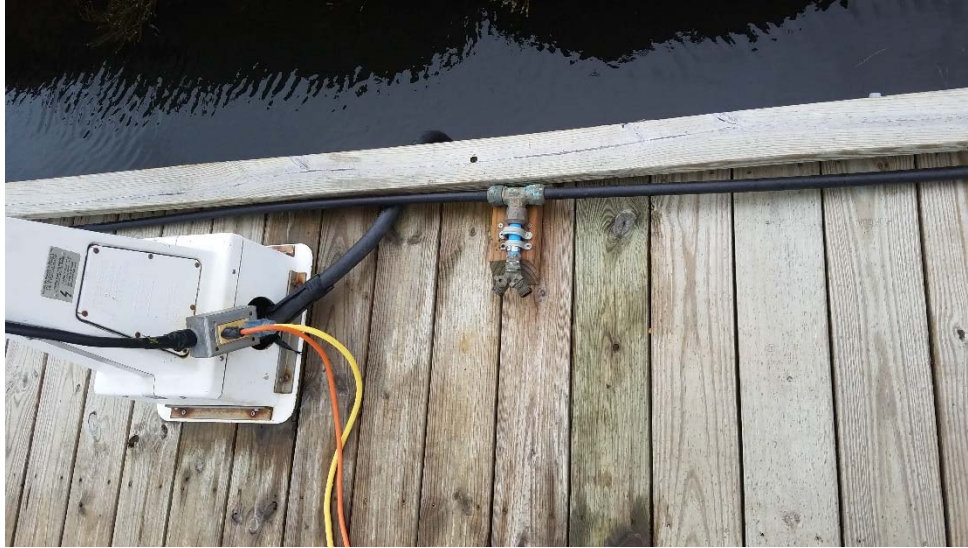
**Photograph No. 31:**

As previously mentioned, the site is equipped with water and electrical services. Electrical fixtures do not appear to have moisture resistant covers and connections. Waterline fixtures show signs of corrosion (**Photograph 31**).

**View of water and electrical conduits.**

**Moisture proof electrical fixtures do not appear to be used.**

- Consider either flood proof construction at lower portion of building such as a minimum 5-foot stem wall, sealed openings, or relocation at or above Mid Term DFE. Confirm waterproof conduits and fixture/receptacles for electrical, water and sewer or other utilities/equipment to prevent intrusion and/or backflow.
- In addition, we recommend weatherproof openings against wind-driven rain. For the vender offices to accommodate the Mid Term scenario, we recommend raising or relocation of the structures due to a rising 1% Stillwater flood elevation.

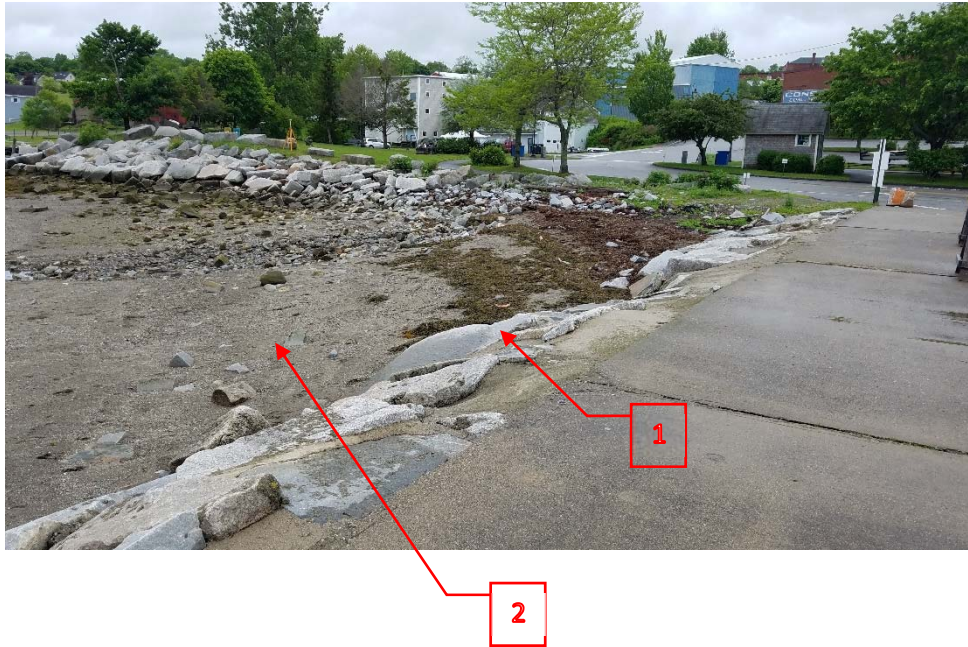
**Photograph No. 35:**

Historical site information indicates that previous repairs to the breakwater in the form of pressure grouting were performed to reduce erosion of the interior loose fill material and undermining of the structure. A later remediation to re-secure the south face by means of stone and grouting was also performed (**Photograph 35**). Some voids were noted at the north side of the structure with loose material deposited on the adjacent pavement (**Photographs 41 & 42**). Given the type of construction and the conditions observed, conclusive signs of settlement would be expected but could not be confirmed. This may be due to the frequency of construction joints on the slab above. In addition, small rock material appears to be washing out (**Photograph 35**) at the south side of breakwater where no large riprap is present as shoreline protection.

**View looking south at breakwater.**

- 1. Location of previous remedial work to stabilize breakwater deterioration.**
- 2. Washed out smaller rock and bare area with no large riprap adjacent to breakwater as shoreline protection.**

- Design and provide additional shoreline protection at the south side of the existing breakwater where protection is missing. Consider continuing shoreline protection up the slope if allowed by local and federal regulations/authorities.

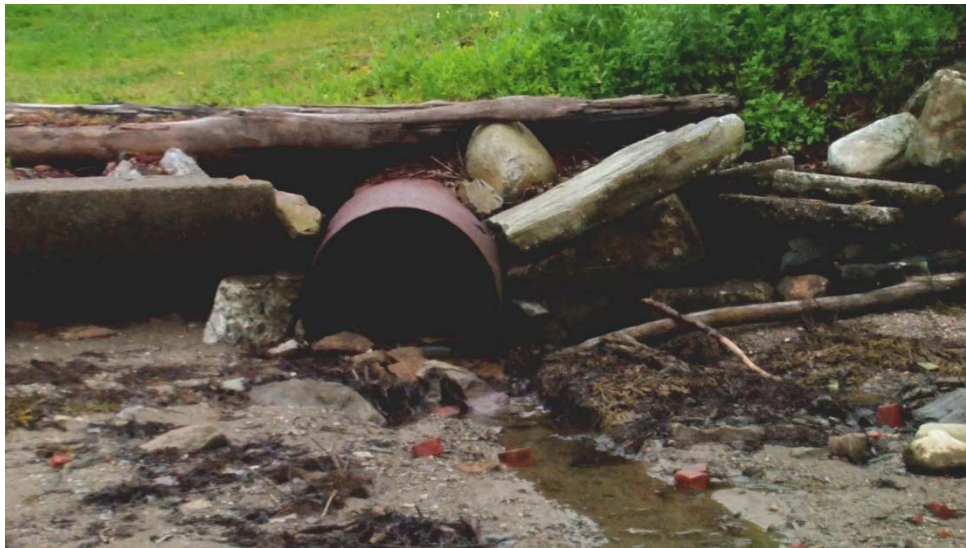
**Photograph No. 38:**

We noted a drainage pipe which discharged to the beach area to the south of the breakwater. Signs of channel erosions were noted along the path of discharge to the bay. There was minimal riprap to protect surrounding soils from water discharge and associated erosion (**Photographs 38 & 39**).

**View of drain pipe which drains into shoreline.**

**An unprotected channel is noted with signs of erosion.**

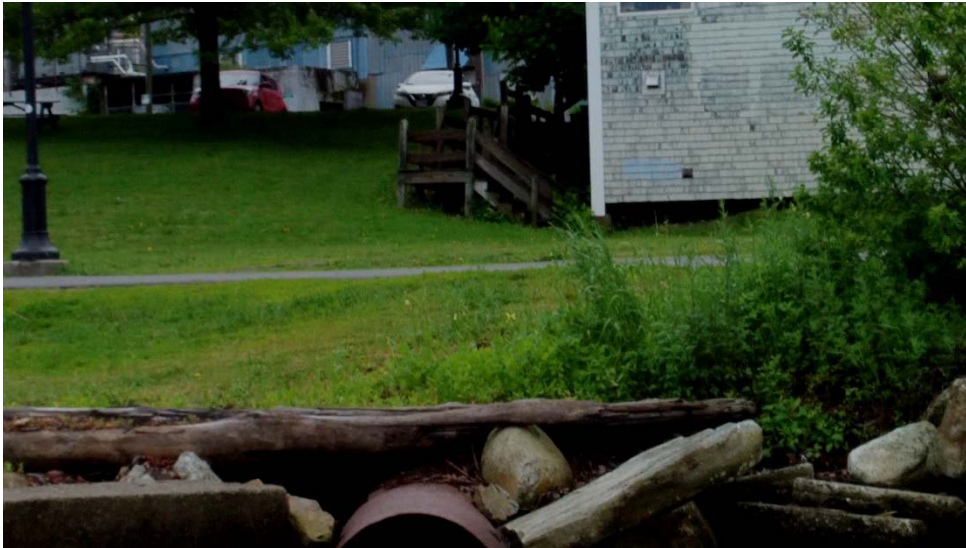
**Photograph No. 39:**

**Overview of location of storm pipe.**

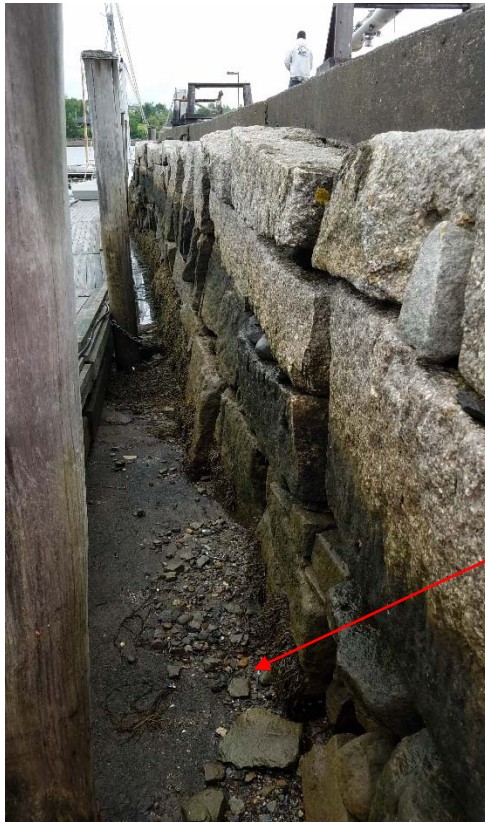
**Photograph No. 41:**

**View at north side of breakwater.**

- 1. Material at north side which appears to have eroded from breakwater interior.**
