Wood Environment & Infrastructure Solutions, Inc.
511 Congress Street, Suite 200
Portland, ME 04101, USA
T: +1 (207) 775-5401
www.woodplc.com

20 December 2019

**Subject: Vulnerability Assessment and Resilience Planning, Municipal Fishing Pier, Lincolnville, Maine
Penobscot Bay Working Waterfront Resiliency Analysis
State of Maine, Department of Marine Resources**

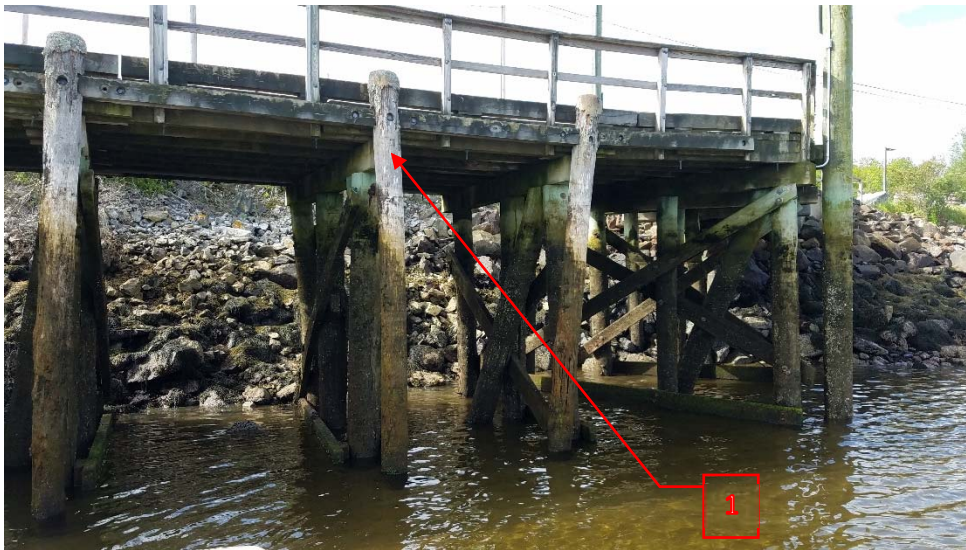
Photograph No. 11:

some conditions appearing moderate to major in severity of damage due to loss of cross-sectional area at the tips. A synthetic pile wrap was provided on some piles as protection (**Photographs 11 - 16**). This may be attributed to bacterial infestations such as marine borers, weathering, or combination of both. In contrast, some members such as the deck timbers, appear to have extensive deterioration at the surface but minimal weathering is noted from the underside (**Photographs 17 – 19**). This variation can be explained by the surface wear from ploughing activities as opposed to the underside of the same timber (See **Photograph 14**). These members, being almost 4 inches in thickness, may be able to sustain extensive wear prior to a need for replacement. Nonetheless, a destructive investigation of the worst case would reveal the integrity of the wood fibers to determine their behaviour under the design loading.

View of north elevation of pier access.

1. View of weathered and delaminated piles (typ.).

- Confirm positive attachment of all structural members to their substrate or load-bearing elements. Incorporate redundancies in design as needed based on a detailed structural analysis. Recommend a destructive investigation to confirm the presence of shipworms / marine borers and determine the need for any corrective action per a Structural Engineer Licensed in the State of Maine.
- Utilities and equipment should be properly secured to resist design wind and water loading or relocated above the flood elevation as specified in ASCE 24. Watertight enclosures should be incorporated for electrical equipment and

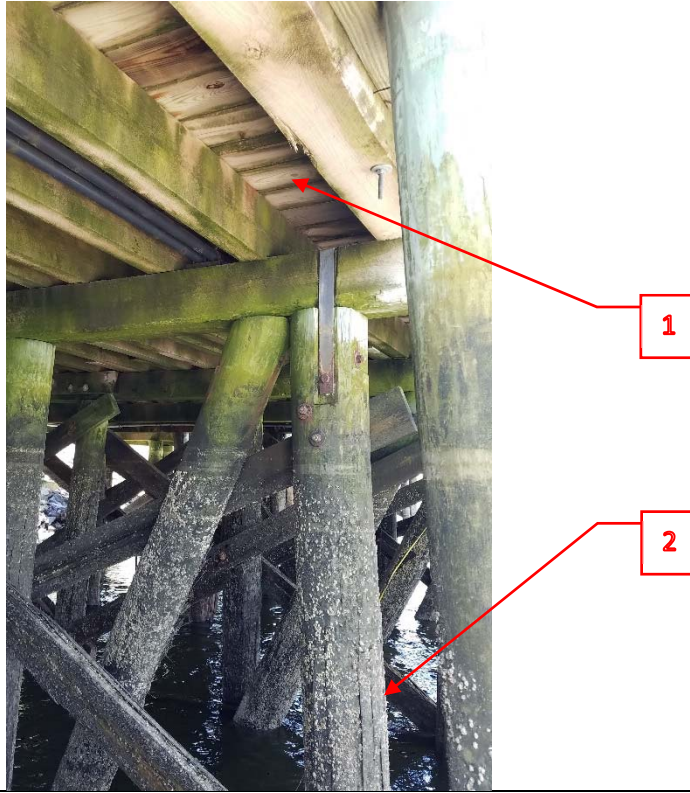
Photograph No. 13:

View at underside of pier.

1. Deck noted in decent condition from below.
2. Piles possibly affected by bacterial infestation and/or weathering. Integrity of wood fiber should be verified.

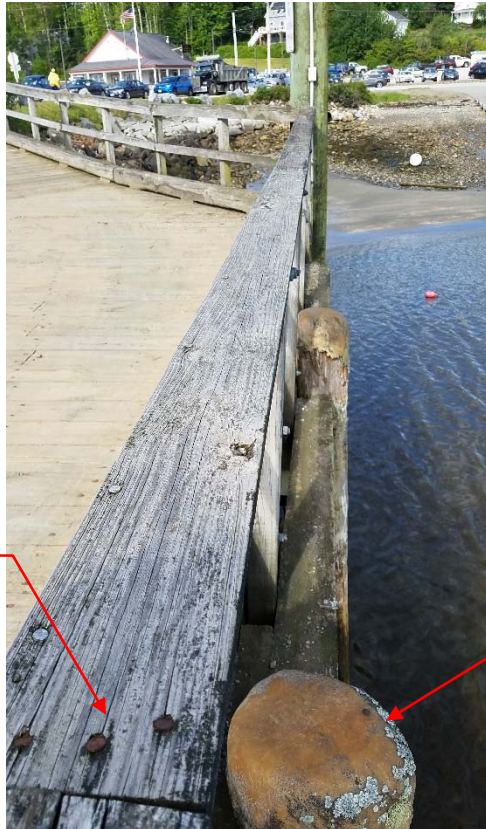
Photograph No. 15:

View from top of pier.

1. Pile covers at weathered timber
2. View of weathered railing and corroded fasteners.

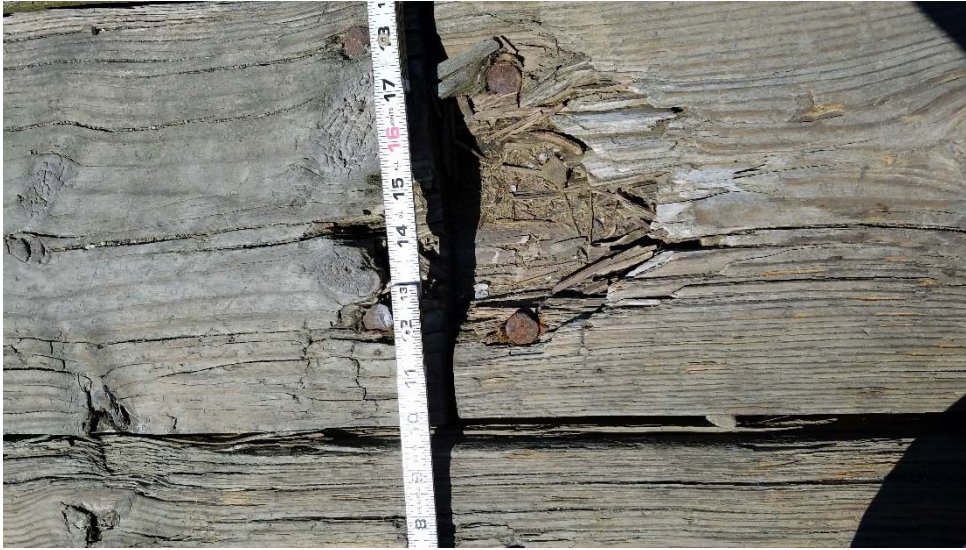
Photograph No. 19:

**Close-up of deck timbers.
View of a 5-inch diameter
gouge in surface of decking.**

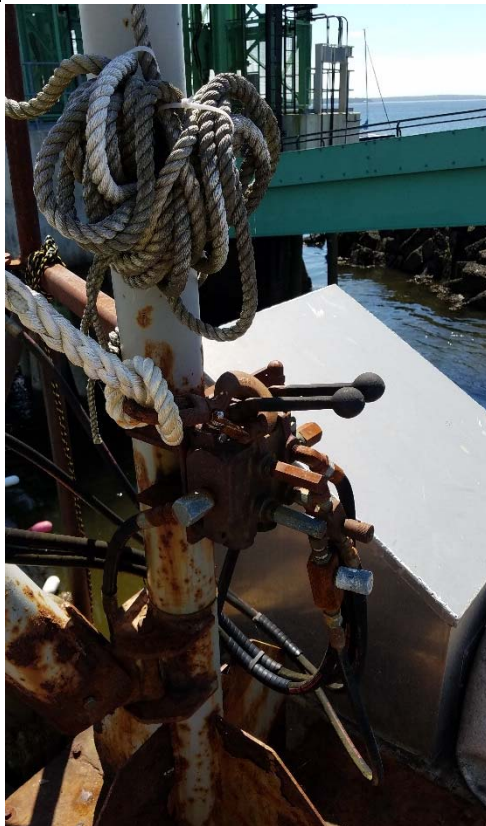
Photograph No. 22:

Close-up of equipment. Framing and fittings exhibit signs of moderate to major corrosion.

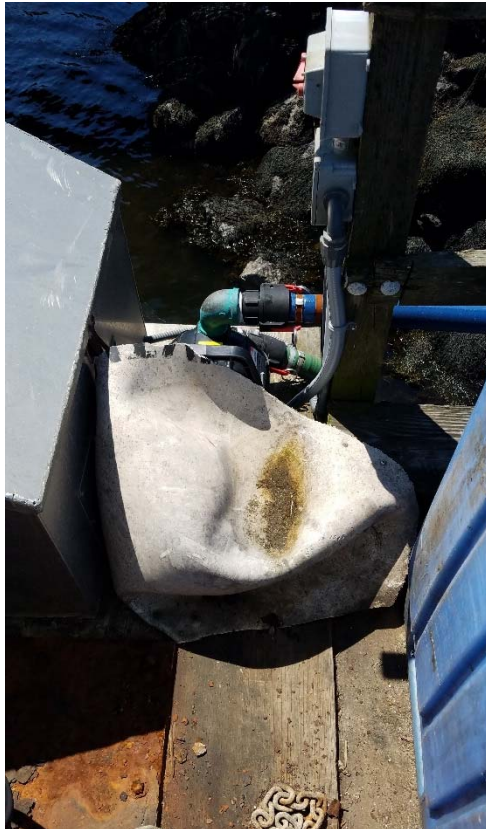
Photograph No. 23:

View of water pump at surface of deck. Equipment is not secured from moisture or inundation.

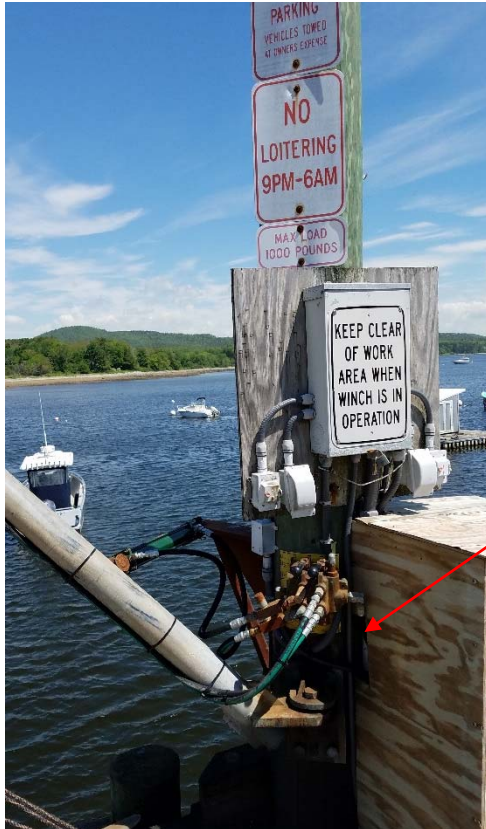
Photograph No. 25:

Closer view of hoist and operation panel.

1. View of opening in equipment housing. Elevation is well below the Present Day BFE of 6 ft above top of deck.

conduits. This would include the hoist motor and electrical appurtenances being encased in moisture resistant enclosures and elevated above the Mid Term 1% Stillwater with at least 1 foot of freeboard.

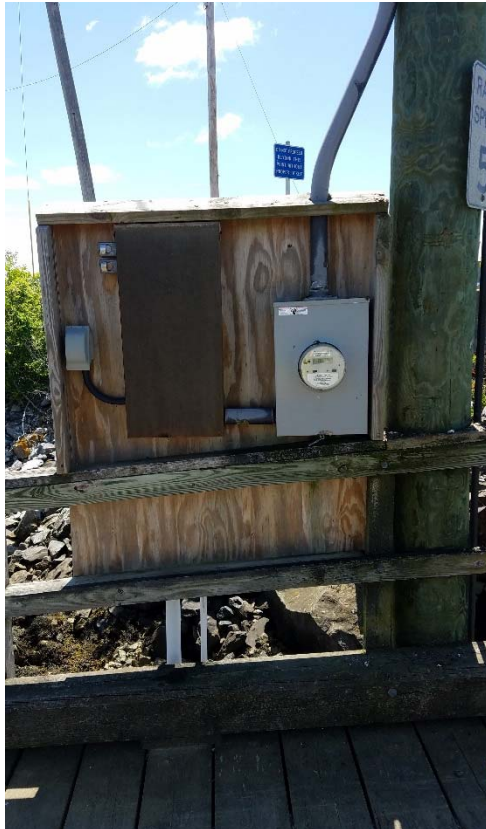
Photograph No. 27:

Site utilities which include water and electricity (**Photographs 20 - 27**) are exposed to wave action and inundation at the pier for the Present Day. As mentioned earlier, many electrical items appear to be protected from exposure to moisture, however some items were noted, such as the hoists motor, which will be submerged by the 1% Stillwater of the Present Day (**Photograph 25**). The risk also includes the electrical panel noted near the pier entrance (**Photograph 26 & 27**) already for the Present Day with regard to the BFE.

Close up of electrical panel in previous photo. The current BFE lies just barely below the panel.

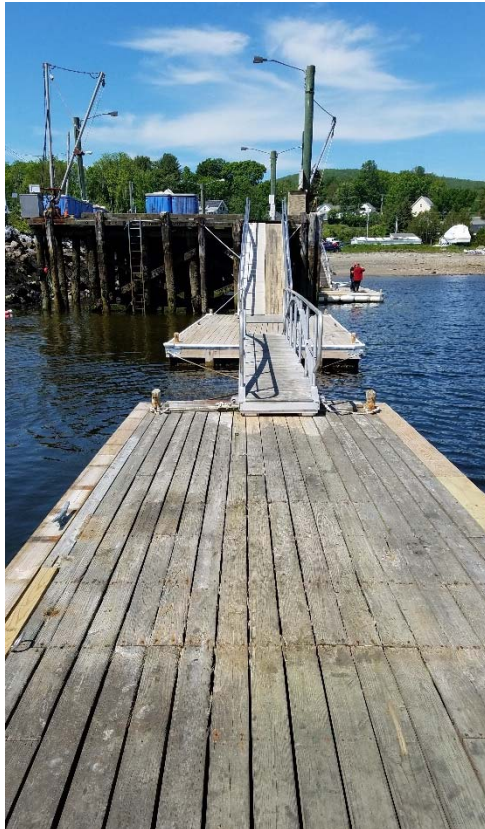
Photograph No. 33:

View of the condition exterior panel of Floating dock No. 1

Deck exhibits signs of mild weathering.

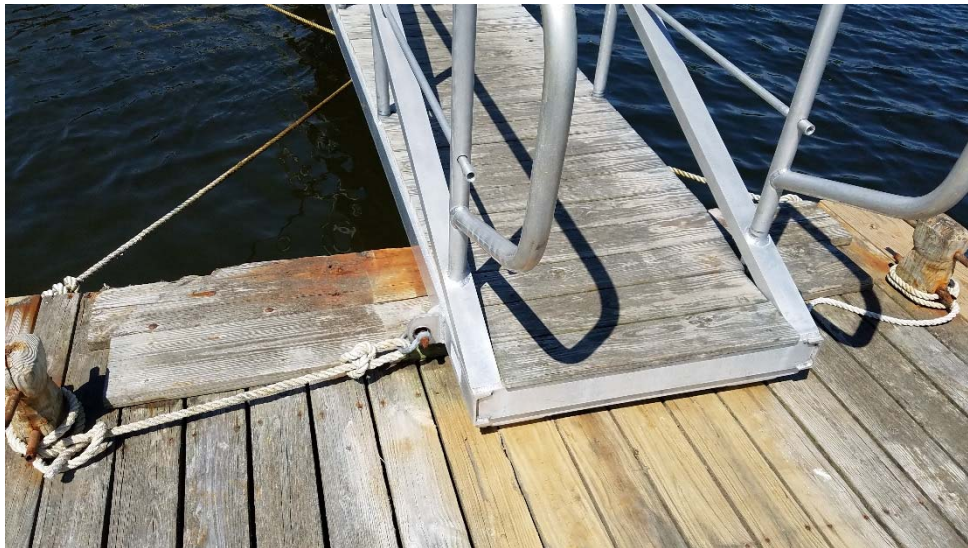
Photograph No. 34:

The general condition of the floating dock appears to be good, however the floats seem to be for temporary use only based on the attachment to the pier using ropes. In addition, the gangway attachment for Floating Dock 1 exhibits mild corrosion at the header. The docks are secured by ropes instead of another more stable means, such as isolated timber piles

Close-up of bridge attachment to float. Ropes visible as means to secure floats to each other and the pier.

- Moor all floats to independent float piles or using mooring chains/ropes anchored to the seabed. Design and Construction **\$250,000.**
- Clean, coat or replace all corroded steel. Confirm gangway condition to resist the intended design loading. Design and Construction **\$285,000.**

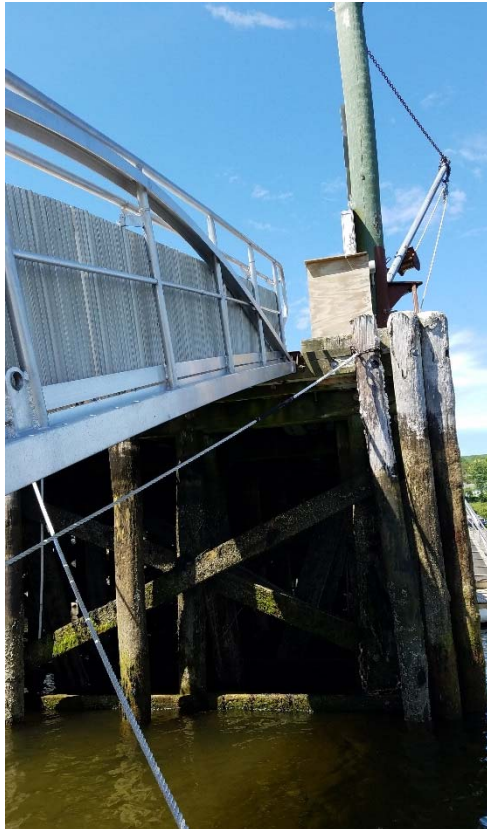
Photograph No. 35:

Close-up at gangway attachment to pier.

View of ropes used to secure floats and gangway to pier.

- Clean and coat all corroded steel framing members and replace corroded hardware. Confirm that all members are positively connected and the substrate is in decent condition to resist the intended design loading
- Confirm the gangway attachments ability to resist the design loading and repair or replace as needed.

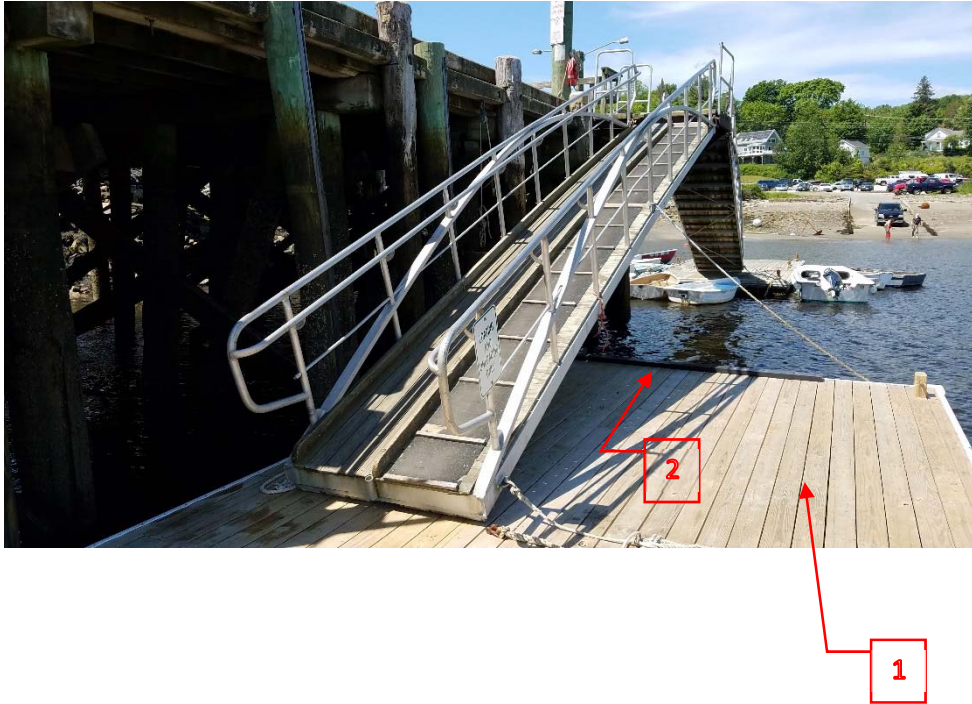
Photograph No. 39:

View of typical condition of a float at Floating Dock 2.

1. Deck wood appears in decent condition.
2. The pontoons appear to function as intended.

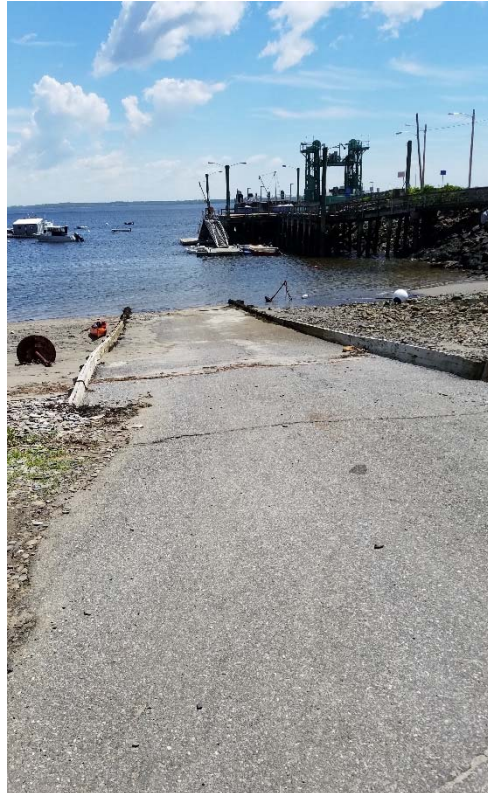
Photograph No. 45:

Although the current condition of the ramp is not ideal for its intended use, it is our opinion that the Present Day and Short Term scenarios present minimal risk for inundation which compromises the function of this feature. For the Mid and Long Term scenario, the combination of limited approach space near the main road and the rising MHHW create conditions which impair the functionality of the ramp, at a minimum.

Close up of boat ramp.

Paved ramp with timber border.

- Recommend regrading ramp to provide a slope between 12% and 15% for optimal boat unloading conditions. A structural means of maintaining slope stability, such as modular reinforced concrete units or paving, for the intended use and design life should be incorporated.
