# WIN 27710.00 Bucksport ADA Pedestrian Ramp Report

# WIN 27710.00 Seal Harbor ADA Pedestrian Ramp Report

# WIN 27710.00 Bar Harbor Pedestrian Ramp Report

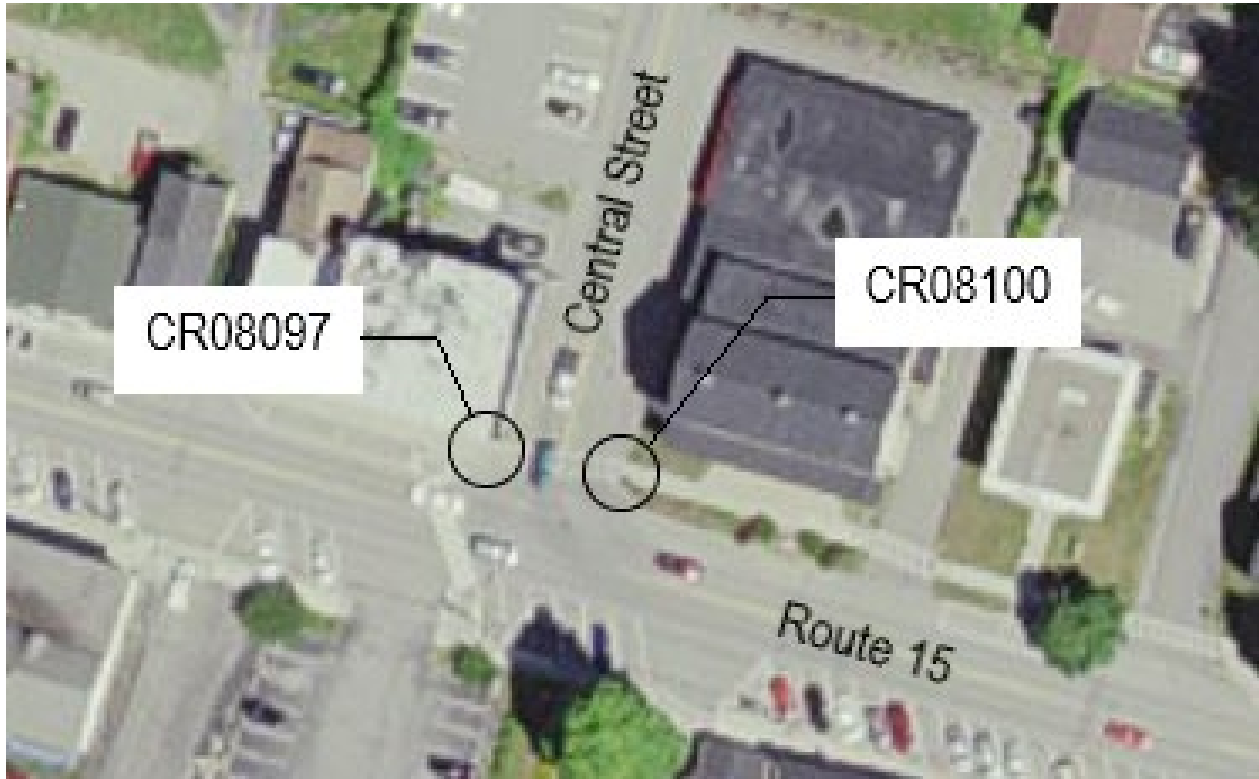
## **Central Street westerly side @ Route 15 (CR08097)**

Install Detectable Warning Fields in existing concrete sidewalk

## **Central Street easterly side @ Route 15 (CR08100)**

- Saw cut and remove 7'-8" x 2'-8" of existing concrete sidewalk
- Regrade removal area as needed to accept 4" of new concrete
- Install 7' x 2' Detectable Warning Fields matching existing sidewalk slopes
- Remove existing painted crosswalk across Central Street between Asset ID's CR08097 & CR08100
- Paint new crosswalk across Central Street between Asset ID's CR08097 & CR08100

- Saw cut (full width) and remove 6'-0" x 2'-8" of existing concrete sidewalk
- Regrade removal area as needed to accept 4" of new concrete
- Install 5'-4" x 2' Detectable Warning Fields matching existing sidewalk slopes
- Place loam, seed, & mulch as needed on both sides of sidewalk

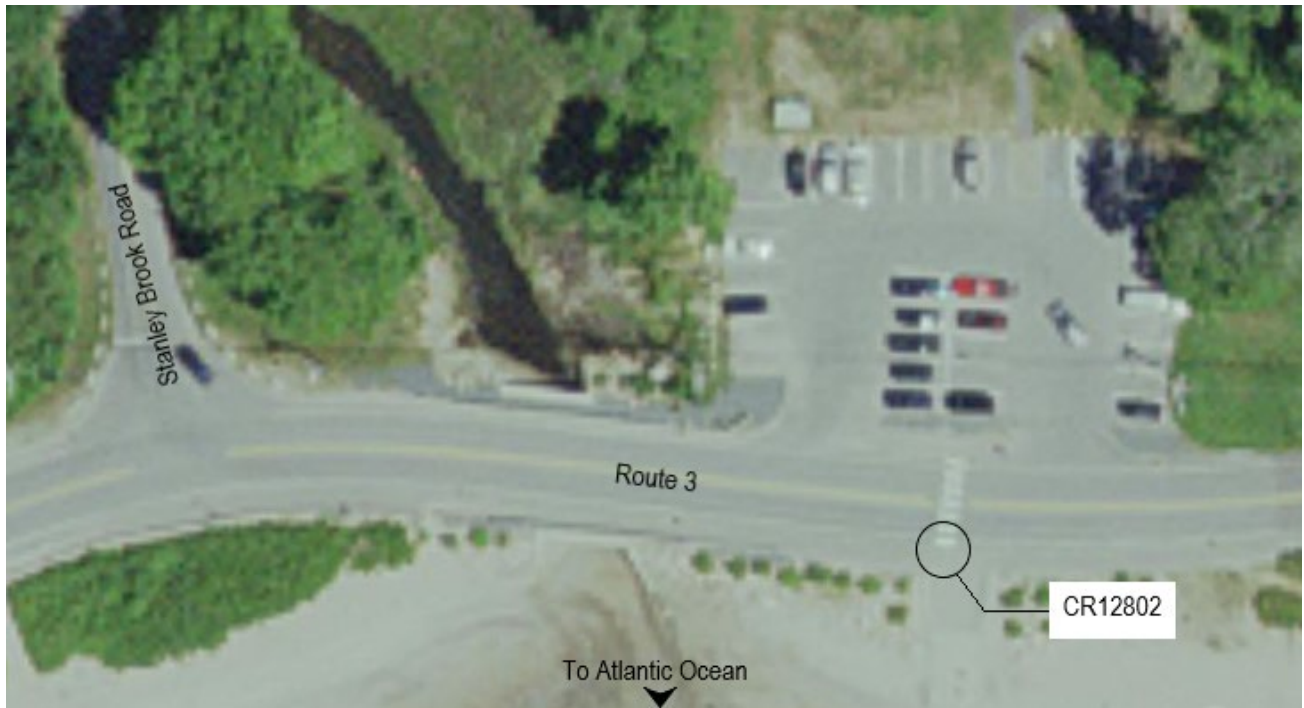
## **Route 3 southerly side (CR12802)**

### Construct Pedestrian Ramp

- Construct per SD 801(27)
- Coordinate with Mount Desert Water District for lowering the existing water shut-off located in the existing sidewalk ramp
- Remove existing pavement on sidewalk approx. 21' x 5' and on shoulder approx.. 23' x 2'
- Remove 21' existing Curb Type 1
- Reset existing 7' tip-down and approximately 3'- 4" existing Curb Type 1
- Regrade existing sidewalk approx. 21' x 5' & shoulder approximately 23' x 2'
- Repave sidewalk (2") & shoulder (4") along face of curb
- Install 5' x 2' Detectable Warning Fields
- Remove existing perpendicular painted crosswalk across Route 3
- Paint new skewed crosswalk across Route 3
- Install regulatory pedestrian signs on both sides of Route 3 near ends of new crosswalk

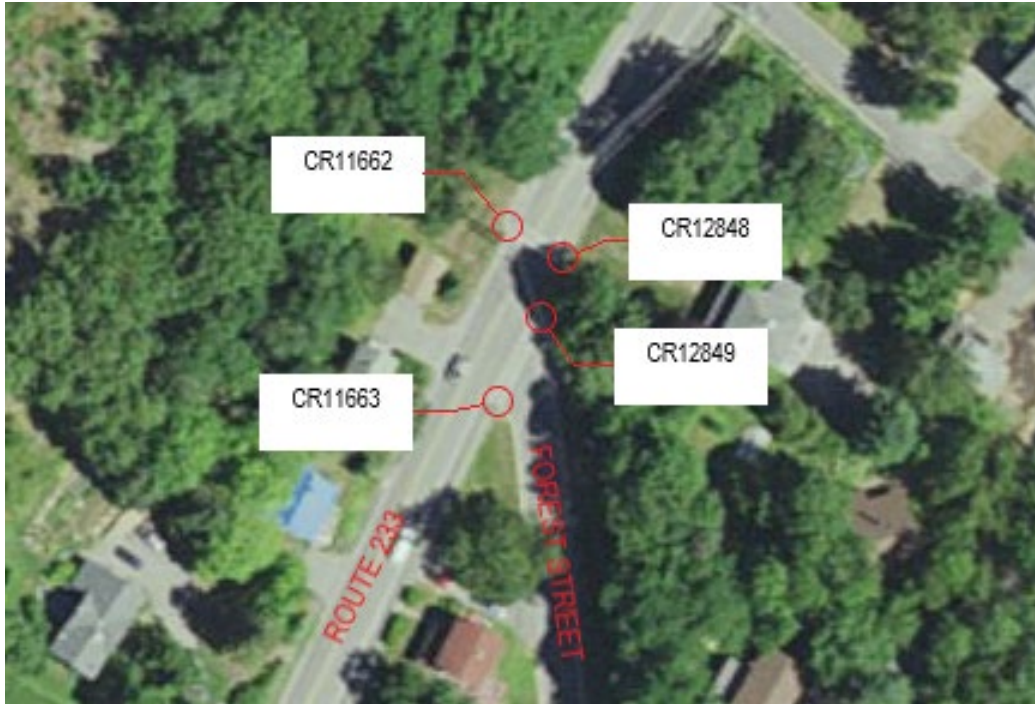
## **Route 233 (Eagle Lake Road) westerly side (CR11662)**

Construct pedestrian ramp approx. 20' northerly of existing crossing

## **Route 233 (Eagle Lake Road) easterly side (CR12848)**

- Construct similar to SD 801(27)
- Remove existing sidewalk pavement approx. 21' x 5'
- Remove approx. 21' Curb Type 3
- Place new 15' Curb Type 3 tip-down
- Regrade sidewalk approx. 21' x 5'
- Repave sidewalk approx. 21' x 5'
- Install 5' x 2' Detectable Warning Fields
- Grade behind existing lawn entrance apron to shed water away from road
- Loam, seed, & mulch as needed behind sidewalk and lawn entrance apron
- Remove existing perpendicular crosswalk
- Paint new perpendicular crosswalk approx. 20' northerly of existing
- Install regulatory pedestrian signs
- Install advance warning pedestrian signs approx. 200' northerly of new crosswalk

- Construct per SD 801(14)
- Remove existing sidewalk pavement approx. 44' x 5'
- Remove 35' ± existing Curb Type 1
- Reset 30' ± Curb Type 1 to create (2) 15' tip-downs
- Install new 8' Curb Type 1 Term. End
- Regrade sidewalk approx. 44' x 5'
- Repave sidewalk (2") and shoulder (4") along face of curb
- Loam, seed, & mulch as needed behind sidewalk
- Install regulatory pedestrian signs
