# Highway Bridge Inspection Report

BR# 3542

RTE 16

**Inspection Type(s):** Underwater

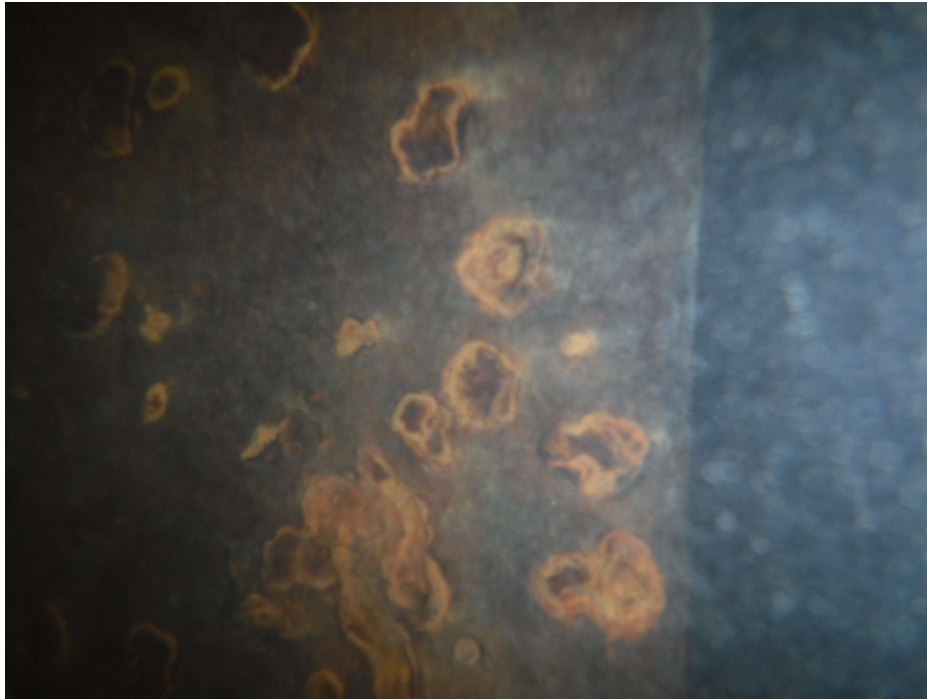
PHOTO 1

2019: Even layer of rust. Rust nodules 1/8"-1/4" now. Worst of pitting is 2' below waterline.

Piles are sound but have minor section loss

Description pitted piles

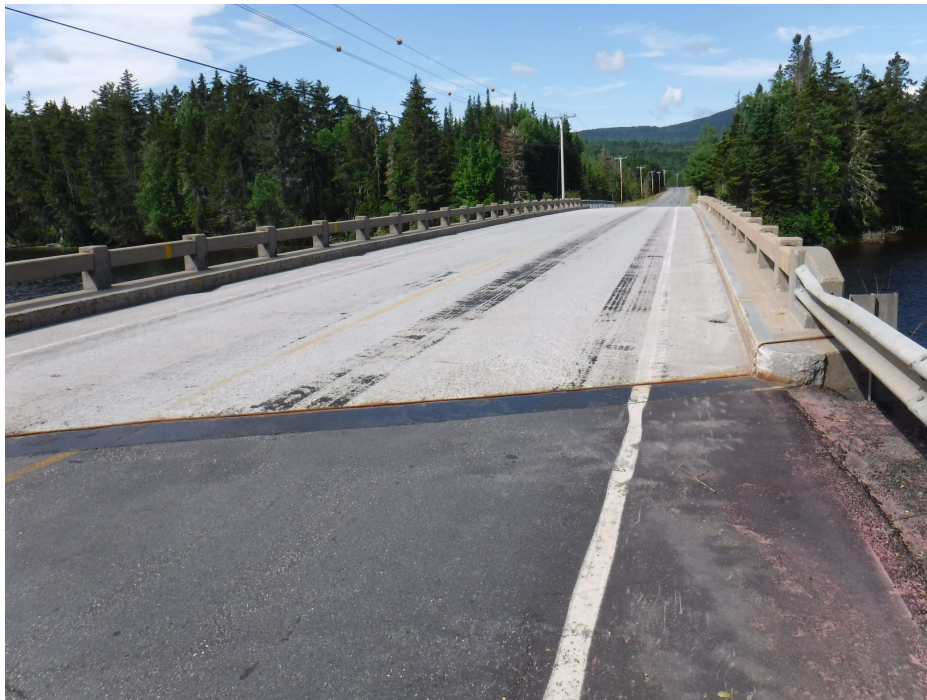
PHOTO 2

Description deck

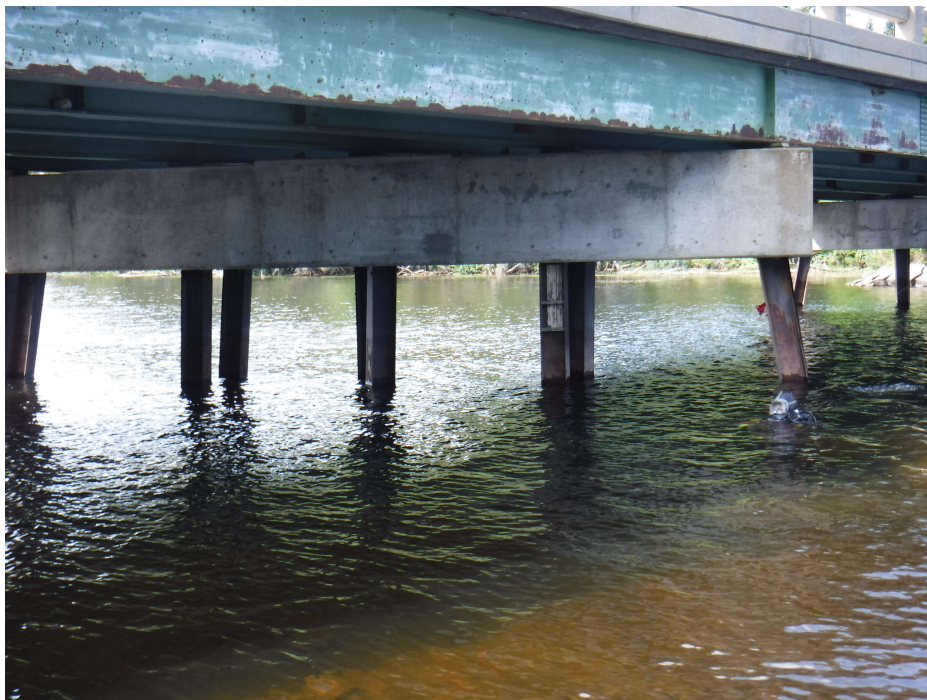
PHOTO 4

Description piers

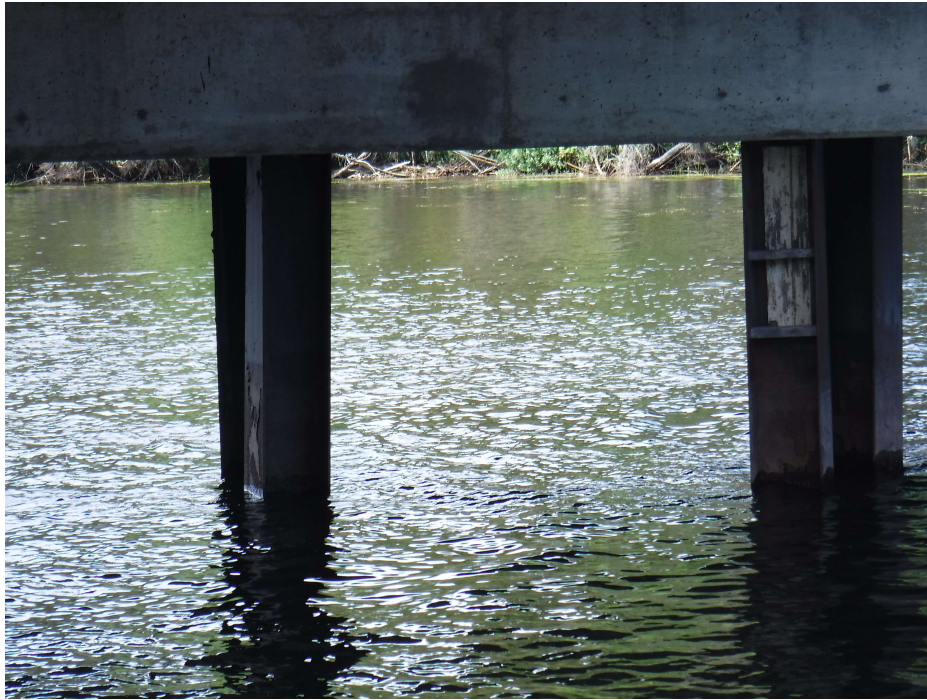
PHOTO 5

Description piles

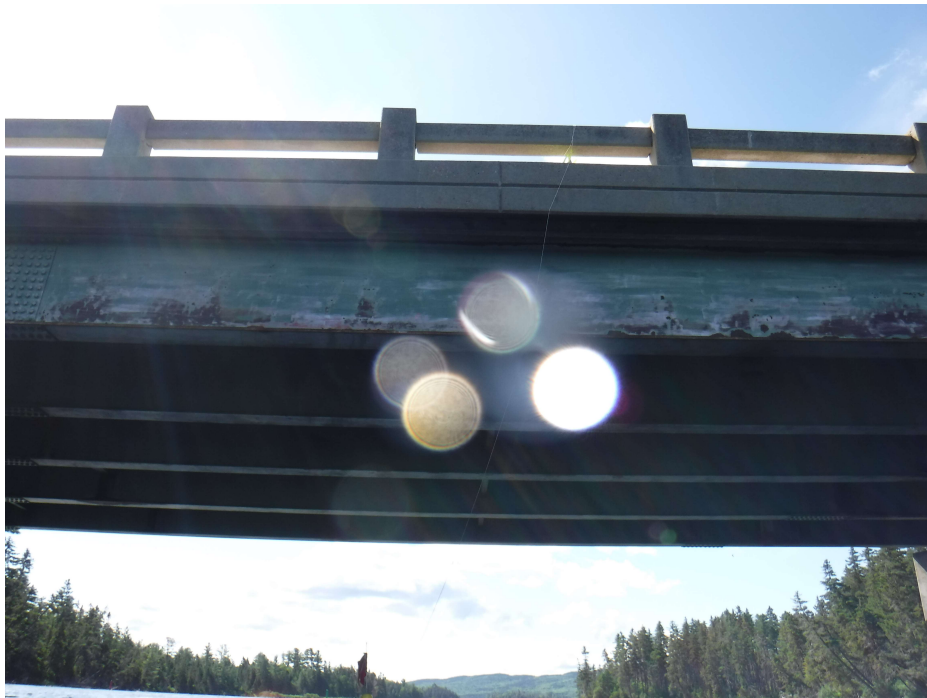
PHOTO 6

Description girders

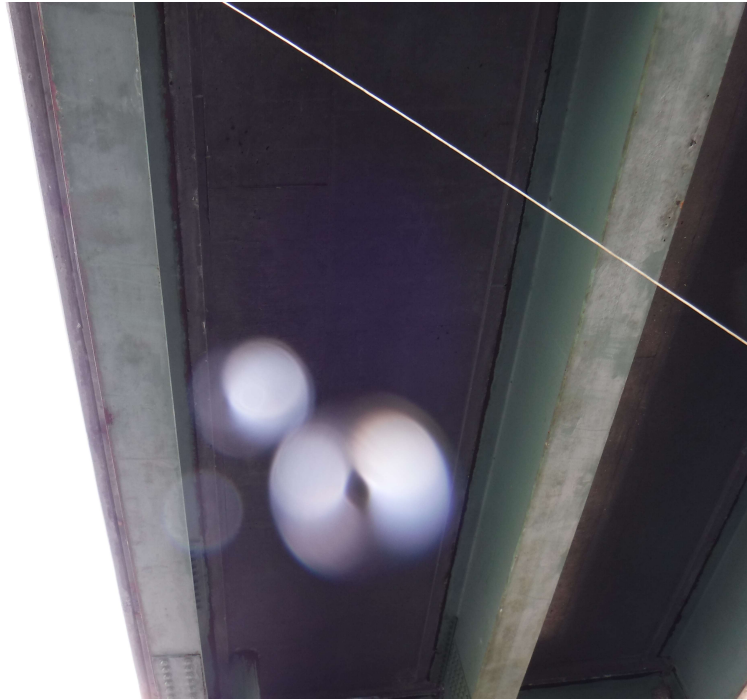
PHOTO 7

Description soffit

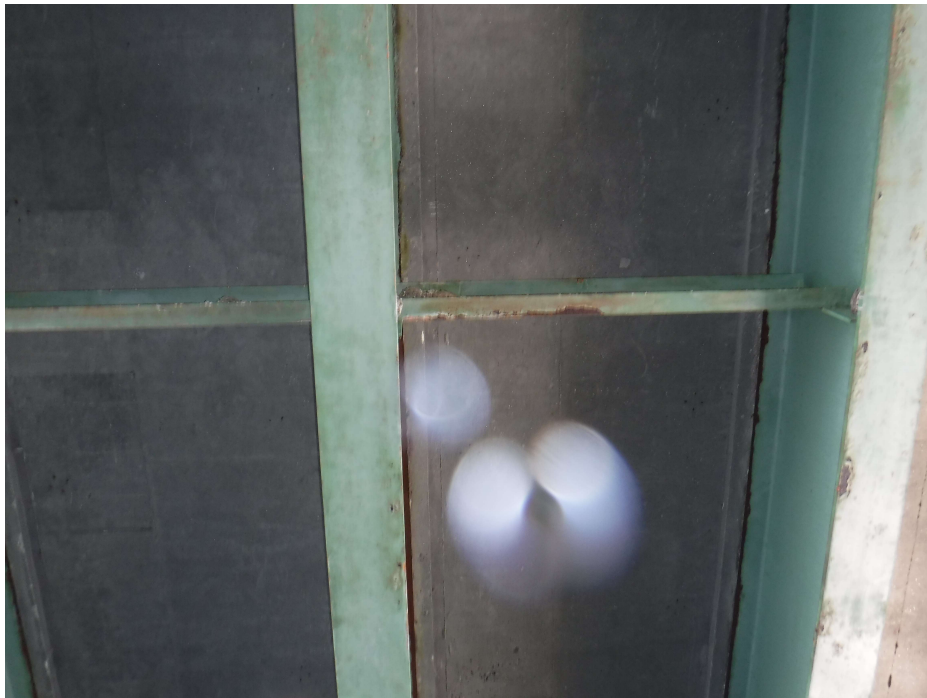
PHOTO 8

Description soffit

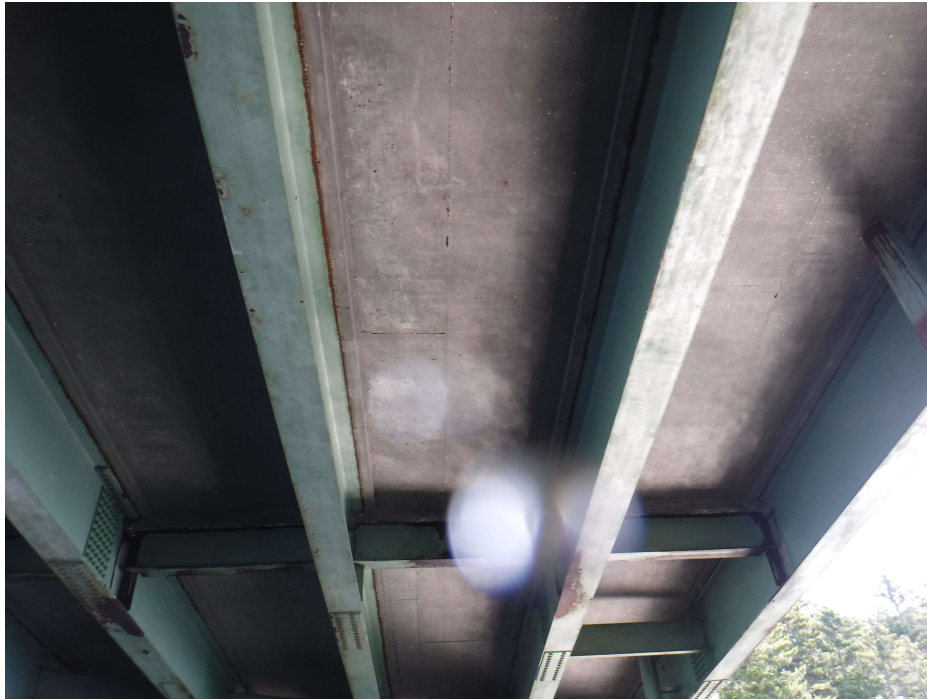
PHOTO 9

Description soffit

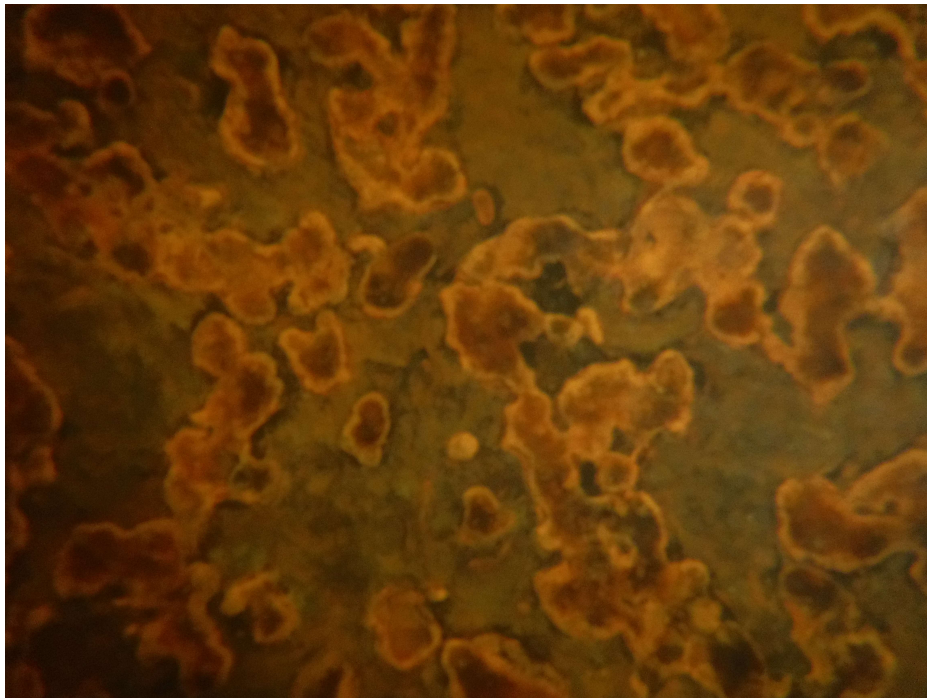
PHOTO 10

Description pitted piles
