Highway Bridge Inspection Report

JAMES ANDREW GRIFFITH

Structure Number: 2786

Underwater Dive Inspection Report

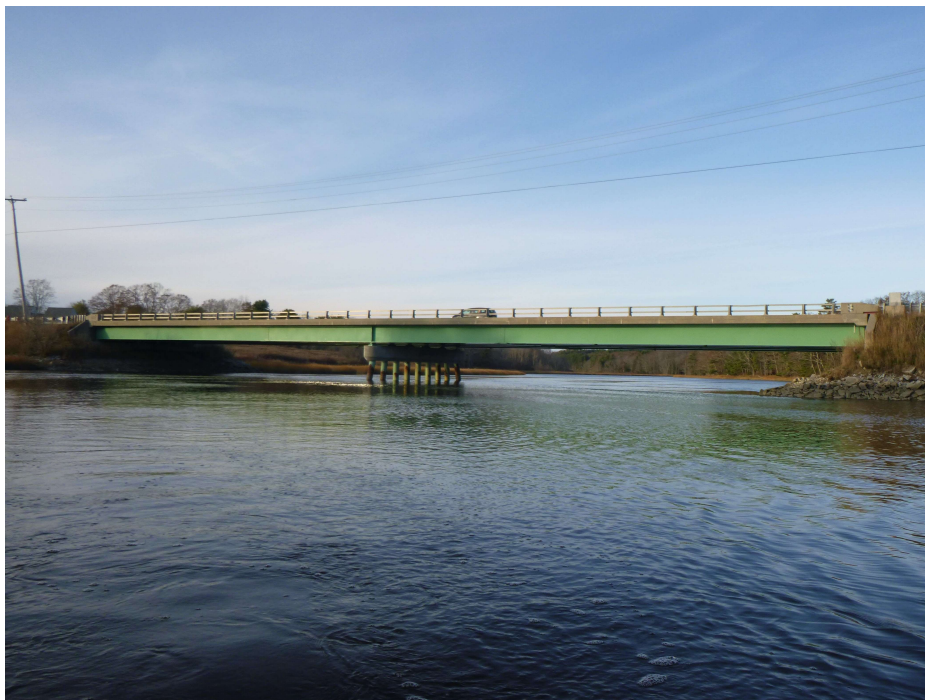
PHOTO 1 Other

Description Overall of bridge looking north.

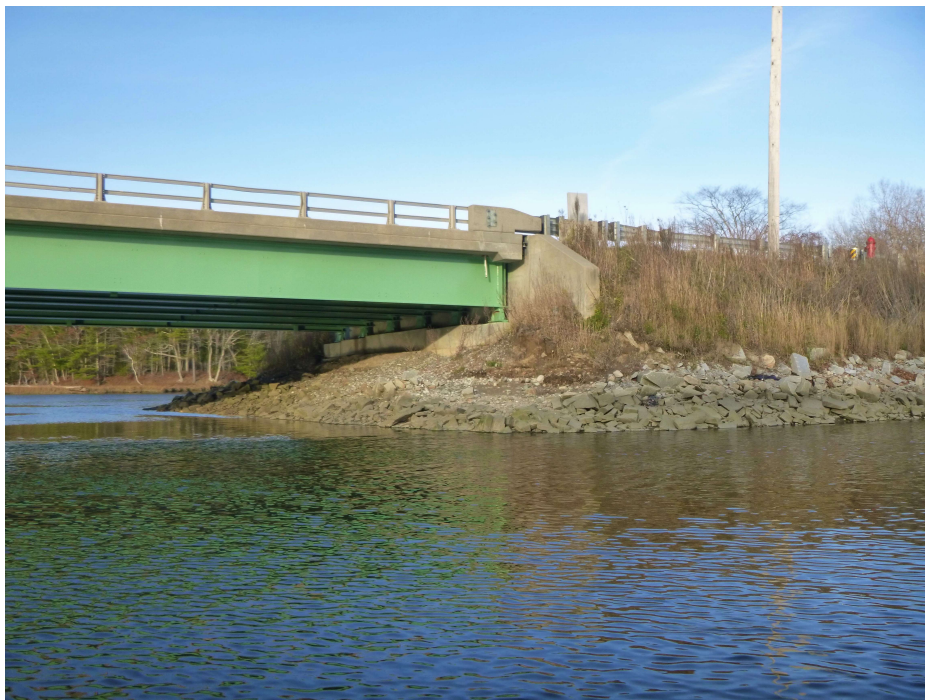
PHOTO 2 Elevation

2019: The abutments are protected with rip rap and appears to be stable. both abutment during the inspection were dry. The coating failure in and above the tidal zone continues to deteriorate on the above water sections of the pipe piles. The top 8' of pipe piles have localized to widespread coating failure that ranges from 20 to 40 percent into vertical piles and 75 to 100 percent to the batter piles. Below water the coating remains is mostly intact with one exception, the north batter pile is 75 percent coated with 3 areas with localized coating, corrosion nodules that are up to 6 inches in diameter that have advanced section loss and exposed concrete fill. The concrete seal extends out roughly 5 feet and is exposed 12 inches along both pier faces. There is an exposed H-pile extending out of the concrete seal adjacent to pile 3 on the west side. The top of the seal is noted to be uneven with variation in height up to 40 inches. There is scour along the north upriver side of the seal that is 4 foot x 4 foot wide x 2 foot deep.

Description Eastern abutment looking northeast.

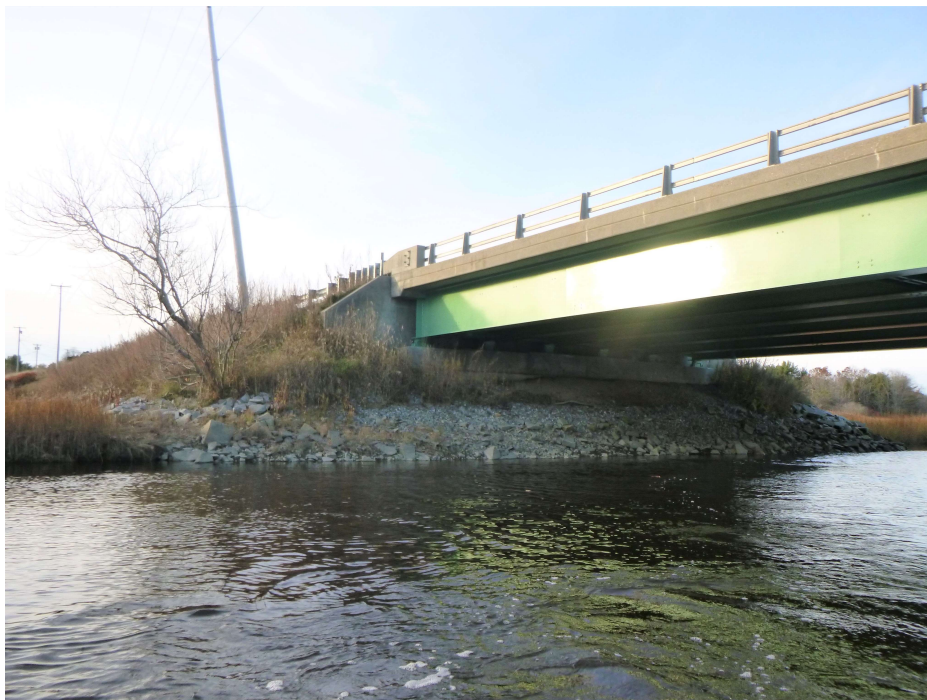
PHOTO 3 Elevation

Description Western abutment looking northwest.

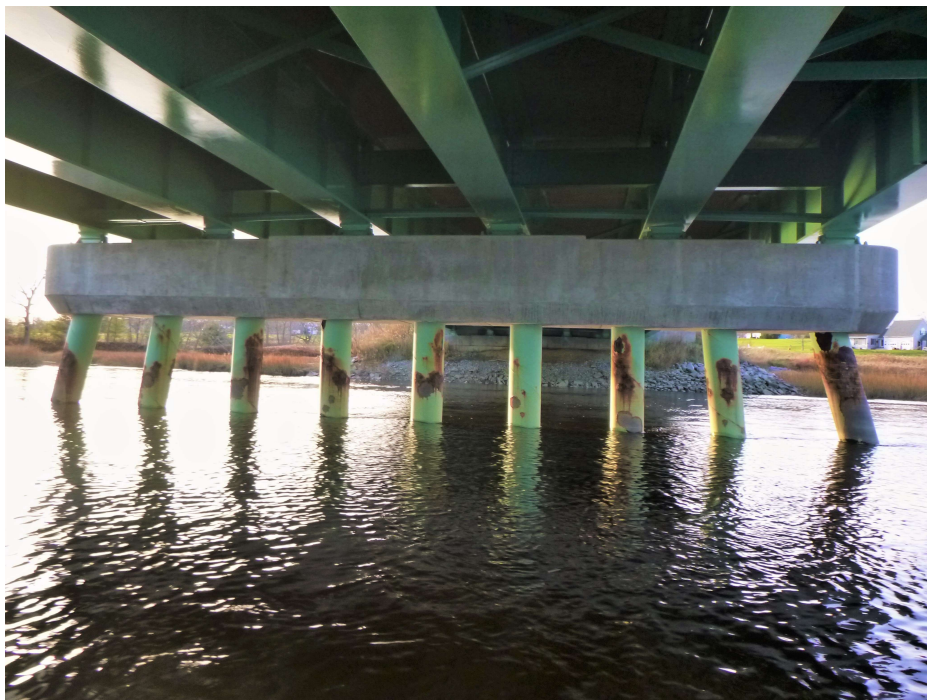
PHOTO 4 Elevation

Description Pier west face.

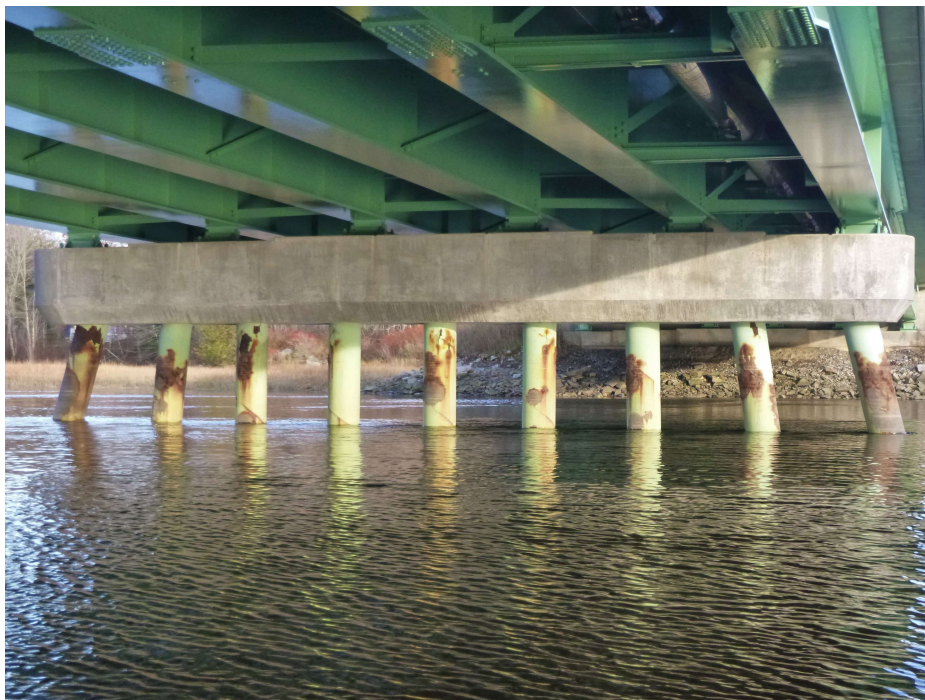
PHOTO 5 Elevation

Description Pier east face.

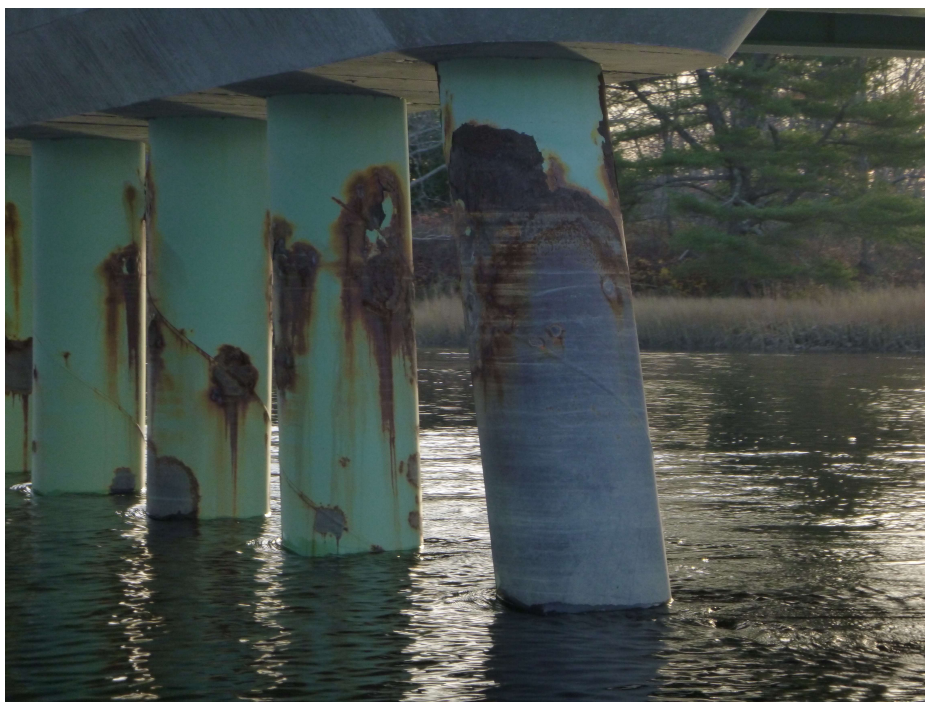
PHOTO 6 Condition

Description North batter pile with 100% coating loss above water.

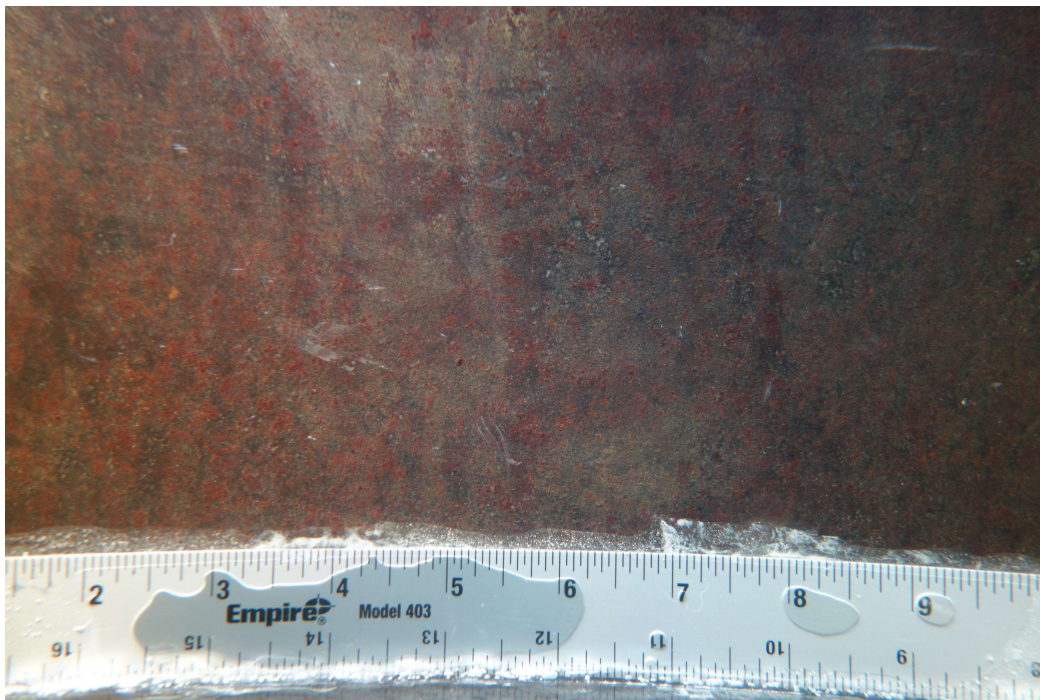
PHOTO 7 Condition

Description North batter pile with 100% coating loss in tidal zone

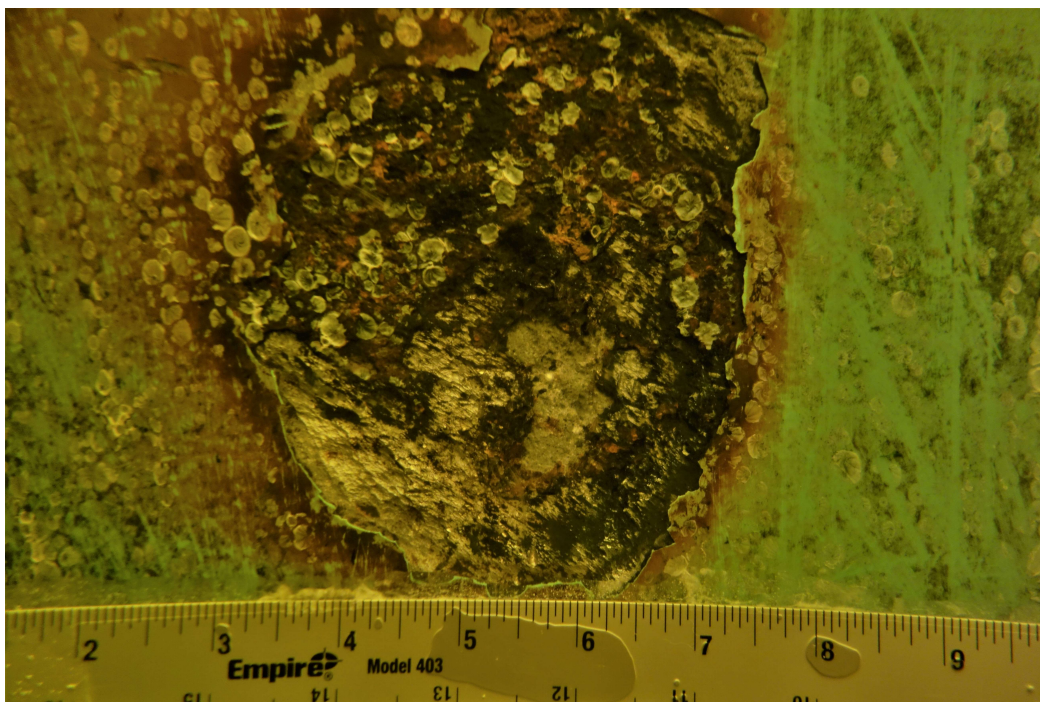
PHOTO 8 Condition

Sub structure rating lowered to a 4, North batter pile has 3 corrosion holes with advance section loss exposing concrete fill. Repairs to the northern steel pipe piles should be made.

Description One of three, corrosion holes in northern batter pipe pile below water.

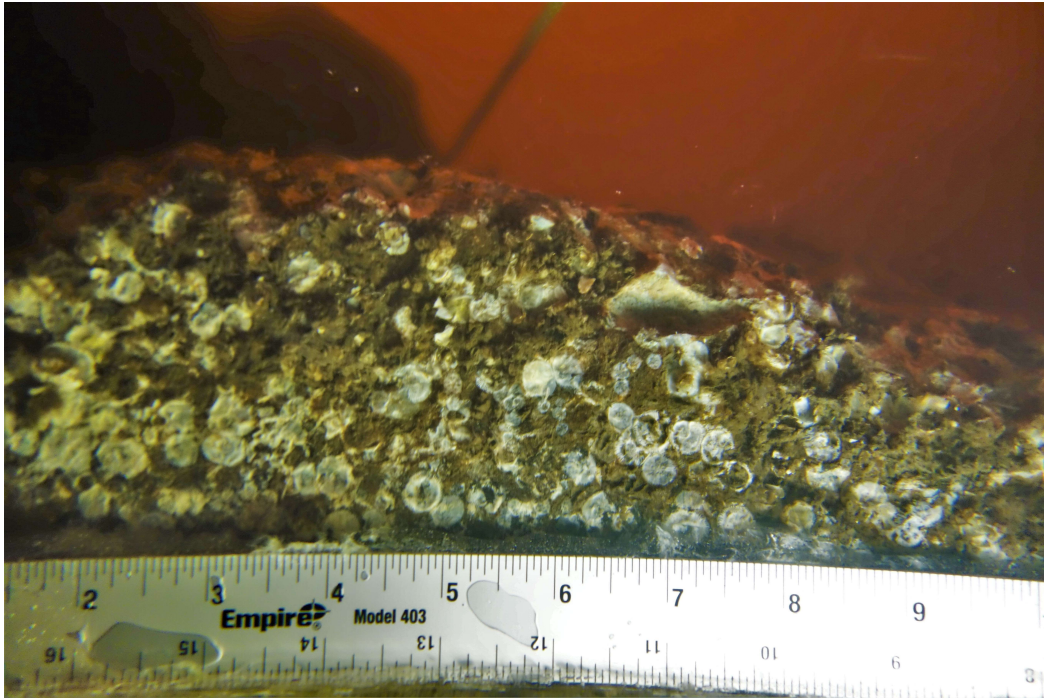
PHOTO 9 Condition

Description Exposed concrete seal on north side of pier in good condition with moderate marine growth.

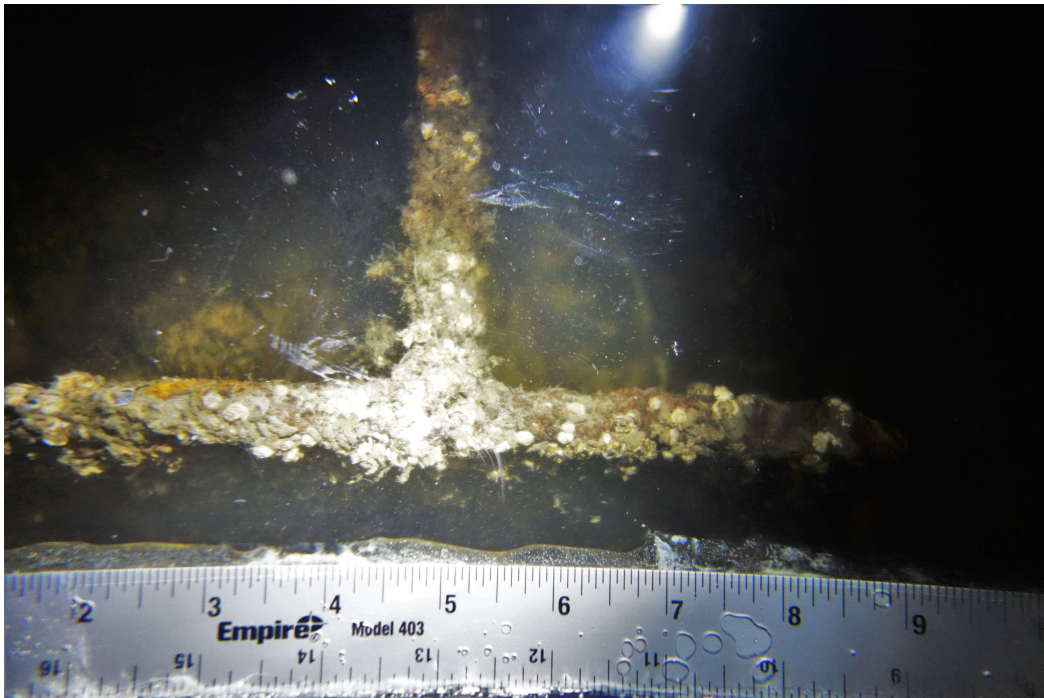
PHOTO 10 Condition

Tidal-strong currents dive @ slack high tide-possible boat traffic. Marine contractor located along east side of bridge
Missed slack tide - strong current
watch for submerged timber piles in river. exposed steel H-pile in northern side of seal.
Long walk with equipment through mud flat if diving at low slack tide.

Description Exposed steel H-Pile in concrete seal located adjacent to pile #3 on north side of pier.

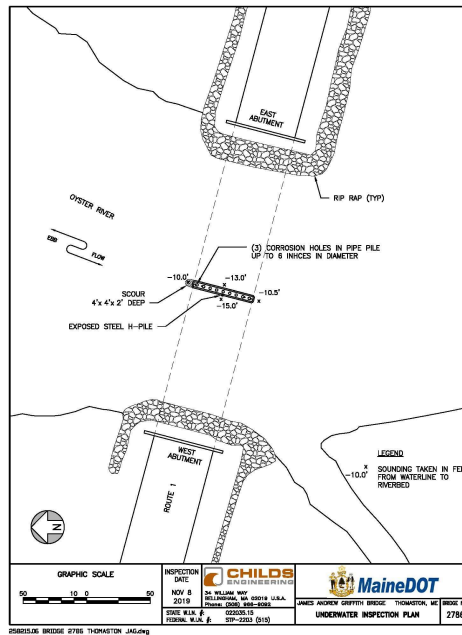
PHOTO 11 Condition

Description Condition plan.
