# Highway Bridge Inspection Report

BR# 2786

JAMES ANDREW GRIFFITH

Inspection Date: 05/25/2021

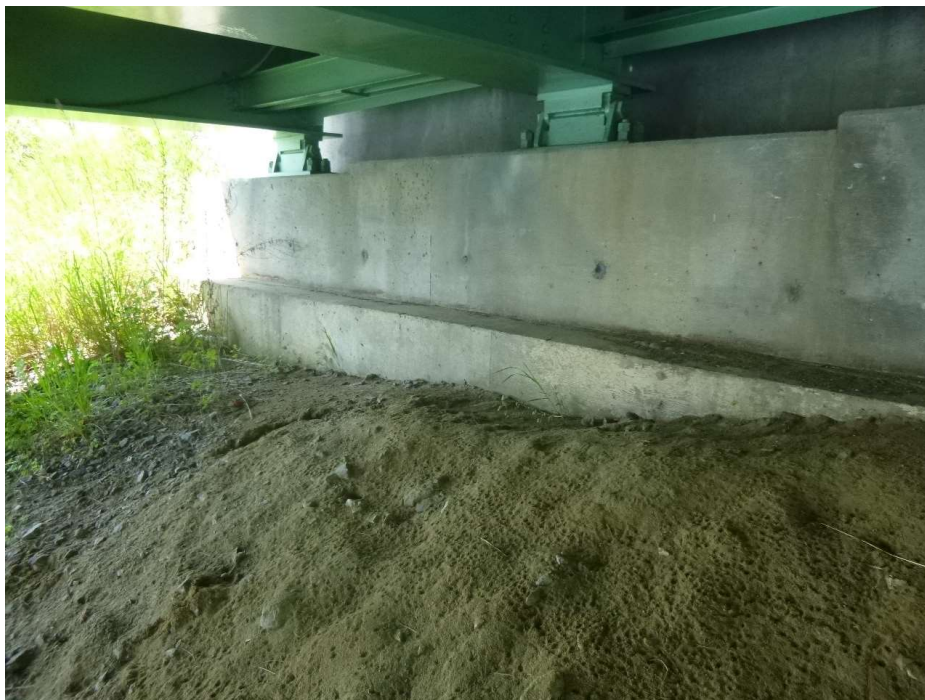
PHOTO 5

Pier pipe piles have paint loss throughout with rusting and some heavy scaling. 2015 Dive report recommends substructure at a '5' due to rusting & paint loss to pipe piles.  
Both abutments have scattered vertical cracking and three areas of exposed footing up to 12' L x 14" H.

Moderate erosion at both stub abutments (founded on piles) with some exposed footing. Most extensive erosion in the SE corner.  
No undermining of abutments.  
Scour along the north upstream side of the pier seal is 4 foot x 4 foot x 2 foot deep according to the dive report.

Description Exposed footing west abutment

Type	Work Item	Priority	Notes
Maintenance	Rehab Substructure	3	Rehab Substructure - rehab piles
Preservation	Other	3	Apply Silane
Maintenance	Repair Scour	3	Add rip rap at Abutment footings
Maintenance	Repair Bridge Rail	4	Replace missing bolt and repair damage (one post cracked south side)
		3	
		3

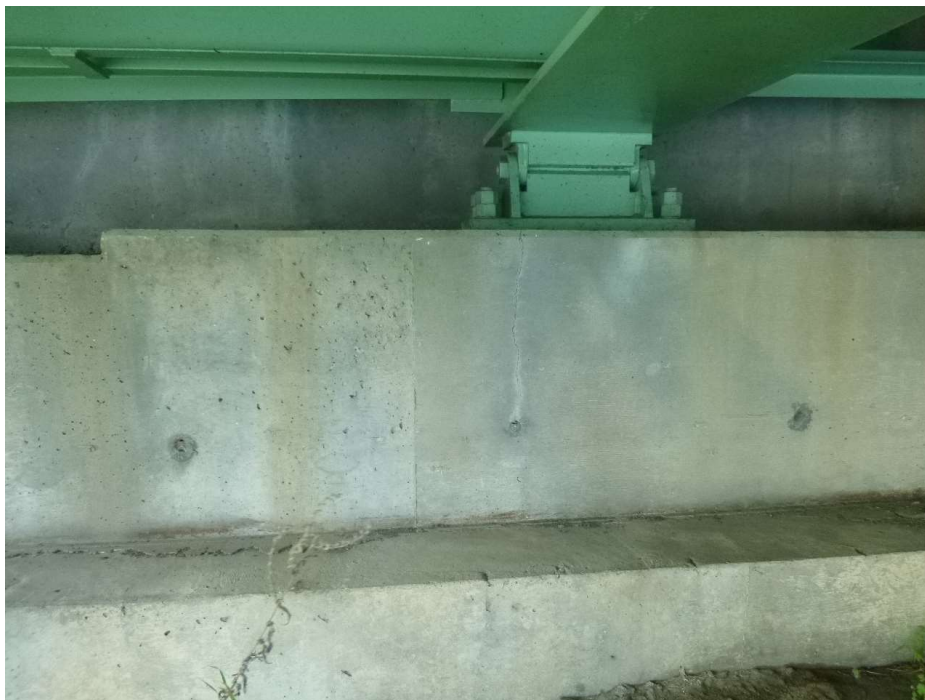
PHOTO 6

Description Cracking in west abutment

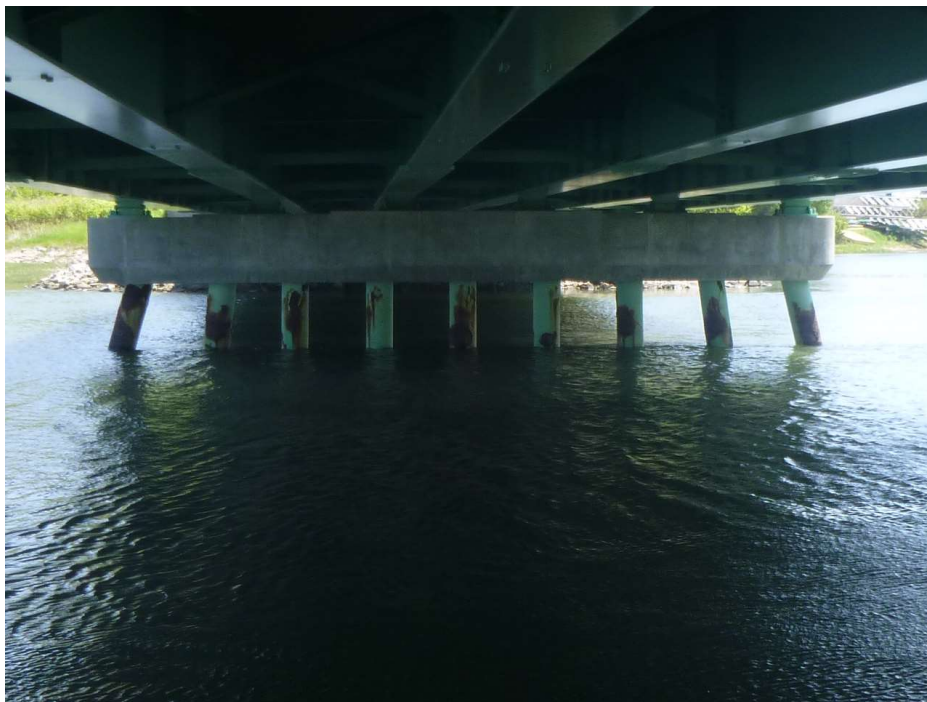
PHOTO 10

Description West side of pier bent

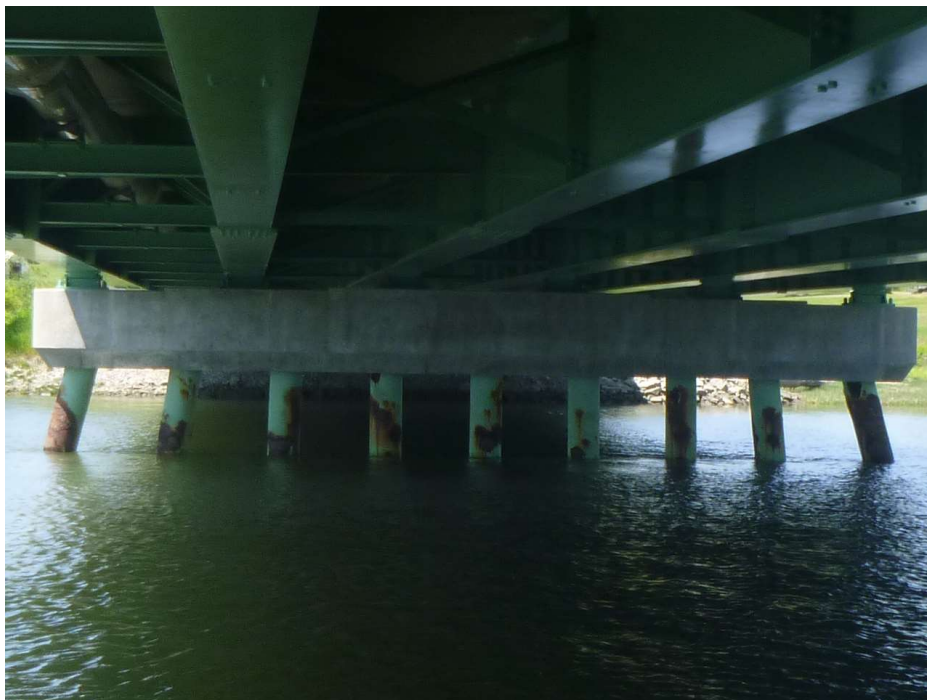
PHOTO 11

Description East side of pier bent

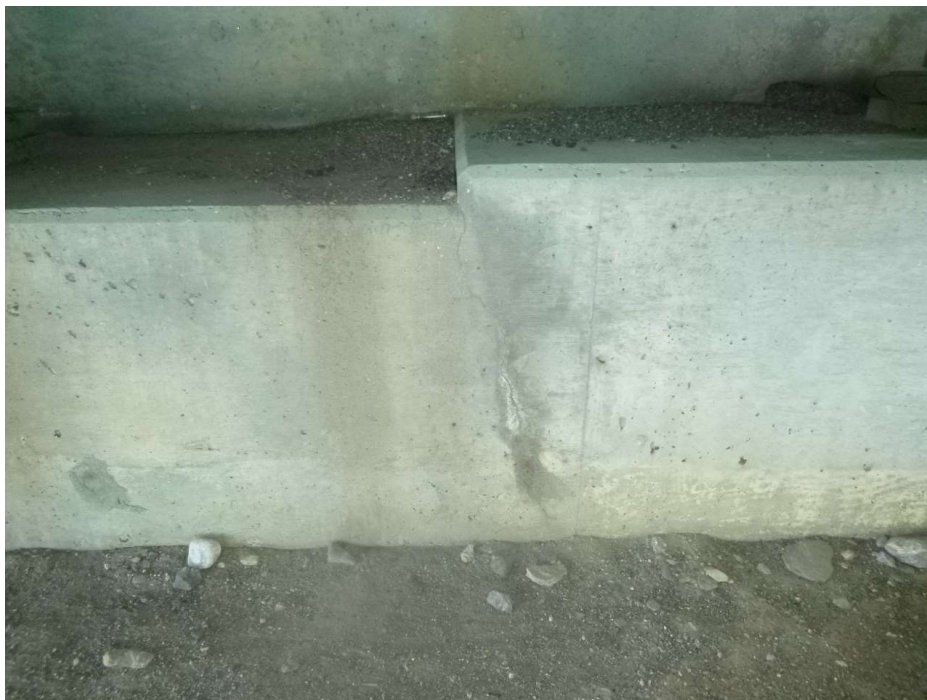
PHOTO 18

Description East abutment cracking

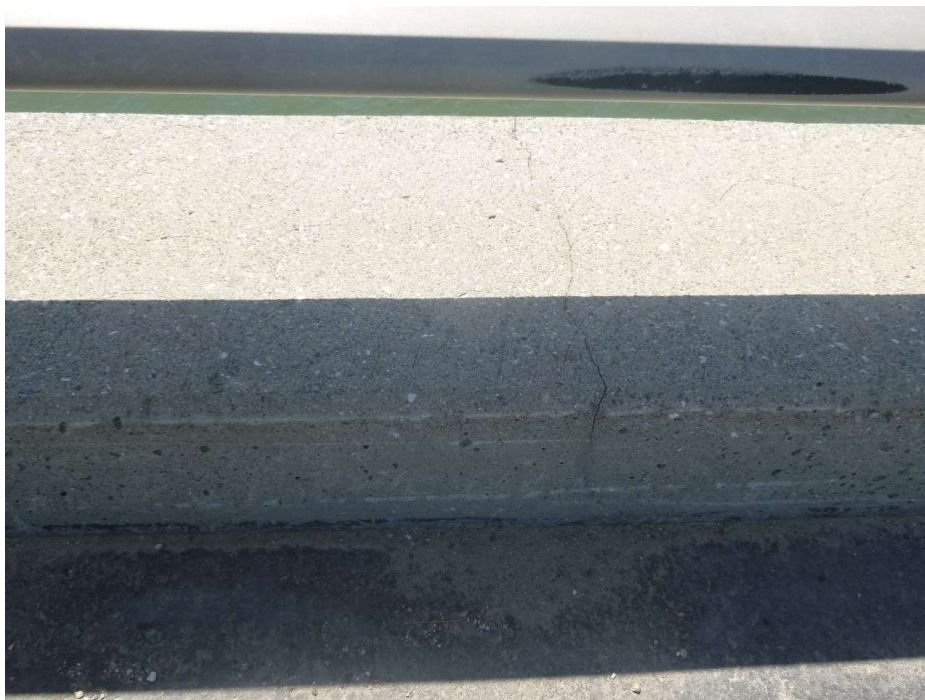
PHOTO 22

Minor cracking and efflo along fascia and scattered fine vertical cracking throughout curbs.  
Several rail posts on both sides have minor collision damage with one cracked post on the south side.  
Modular joint is pinging when vehicular contact is made.

Description Cracking throughout curbs

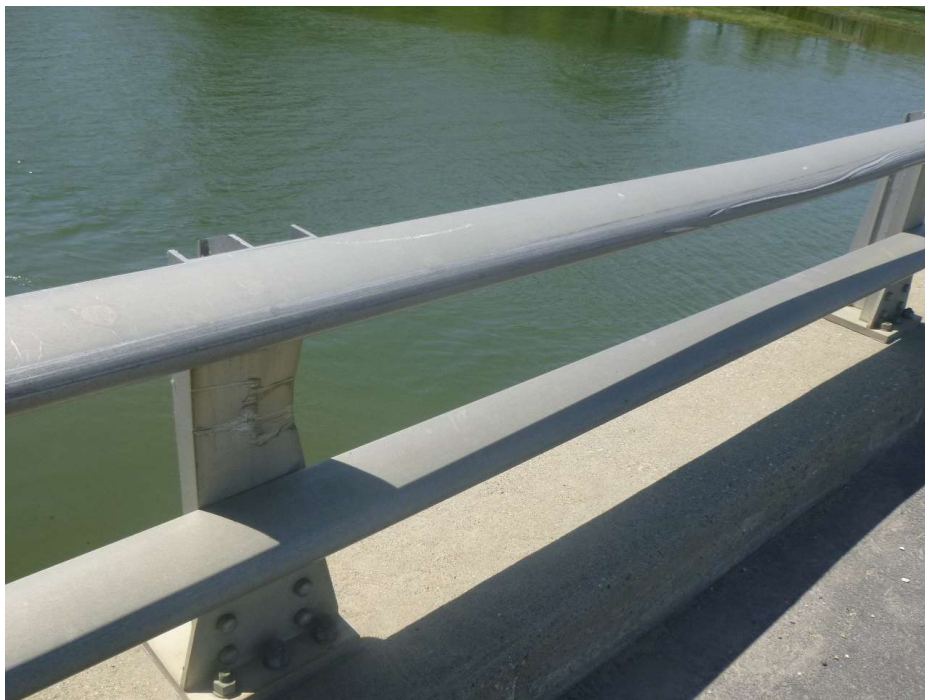
PHOTO 23

Description Damaged guardrail and post south side

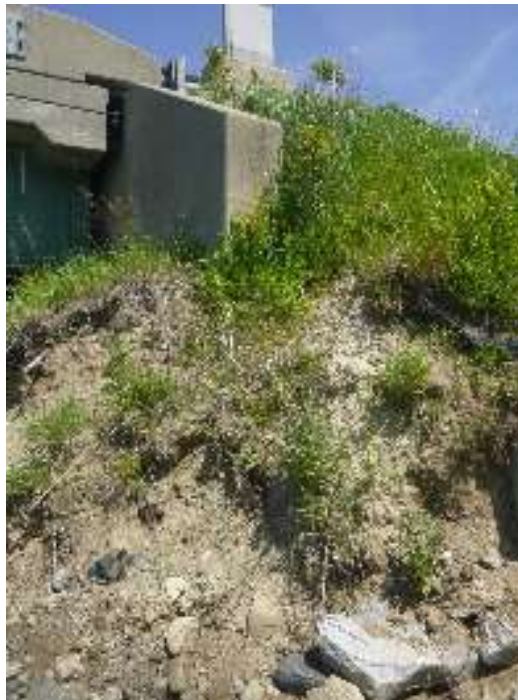
PHOTO 25

Description Erosion SE corner
