# Highway Bridge Inspection Report

BR# 5654

RTE 90 SH 199

Inspection Date: 11/19/2020

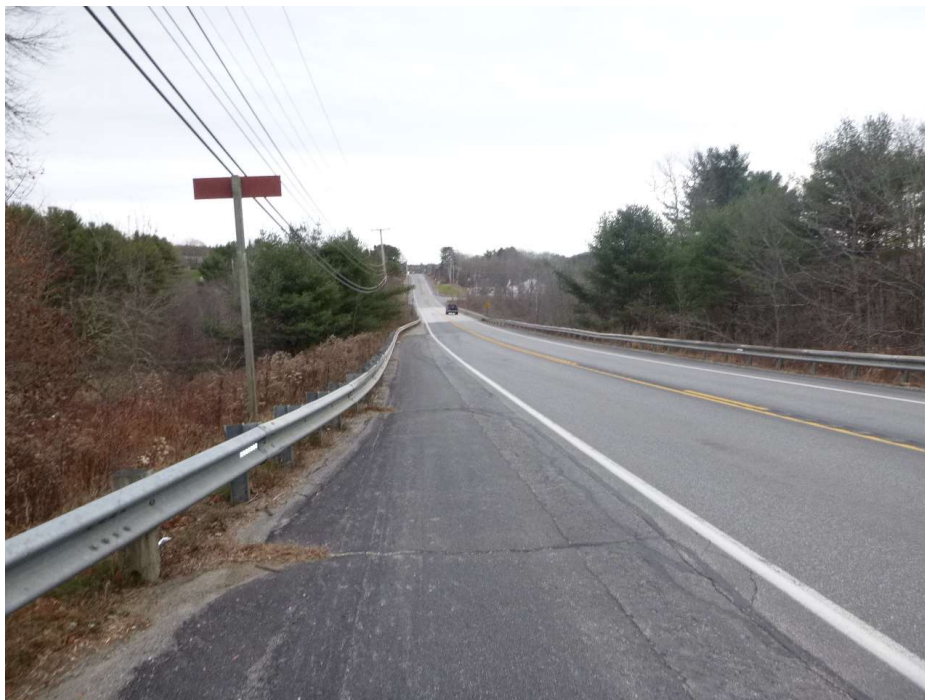
PHOTO 1

Description Roadway looking east

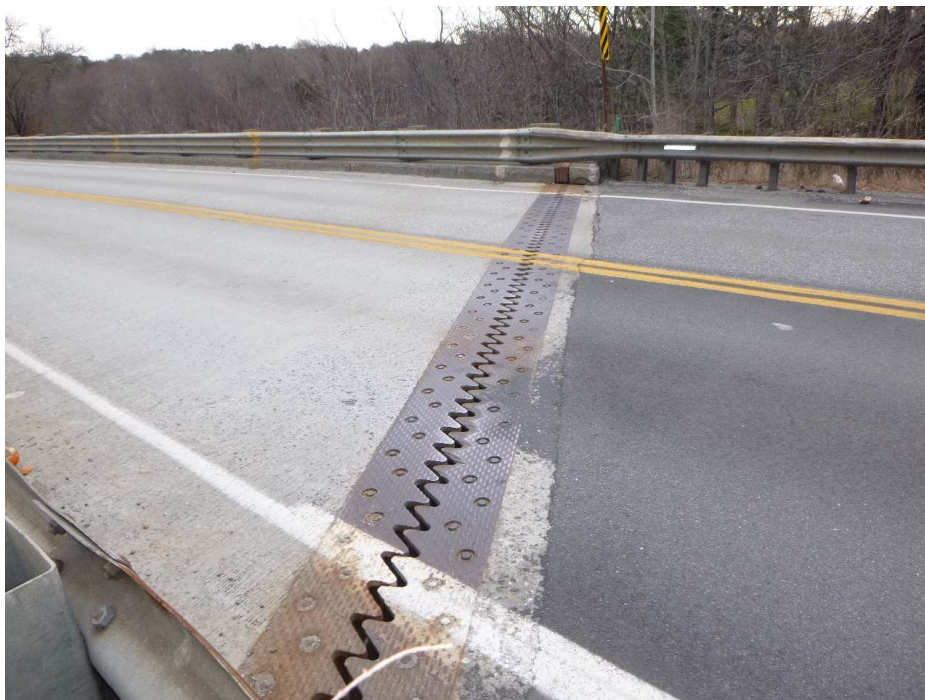
Bottom of deck has prevalent cracking with rust and efflo staining. Scattered areas of delams and spalling with exposed rebar. Some bridge drains have been replaced but others are rusted out. Several haunches over diaphragms are spalled with exposed rebar. East joint haunches underside are deteriorated with rebar missing or hanging. Bridge rail retrofitted with thri-beam. West finger joint fingers out of alignment and contacting adjacent fingers.

Description West joint

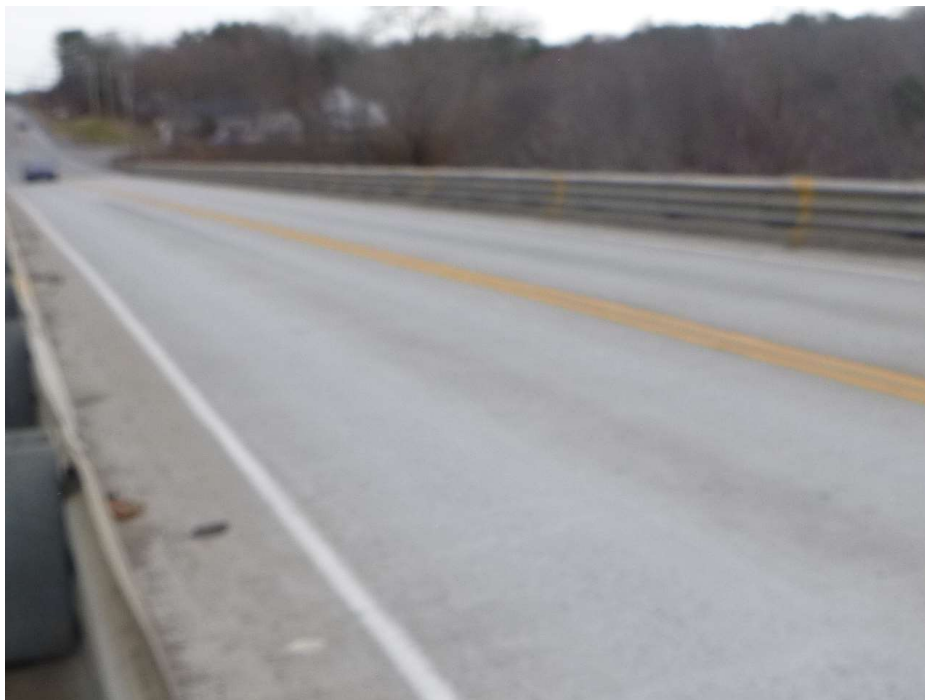
PHOTO 3

Concrete ws has tining worn in wheel paths. 15% scattered minor to moderate transverse cracking through out. 5% isolated delams with one area of exposed rebar from lack of cover. Other delams were found scattered along the center line construction joint.

Description Wearing surface

Type	Work Item	Priority	Notes
Capital	Repair Deck		Future new deck
Capital	Rehab/Replace Drain		Finish replacing drains
Capital	Rehab Substructure		Examine all piles at mud line and repair
Preservation	Paint		Clean and paint all steel
Maintenance	Clean		Clean sand off bridge seat
Preservation	Other		Apply Silane.
Maintenance	Seal Joint		
Maintenance	Repair Joint		headers and grind fingers
Preservation	Repair Wearing Surface		Repair wearing surface at the SE corner.

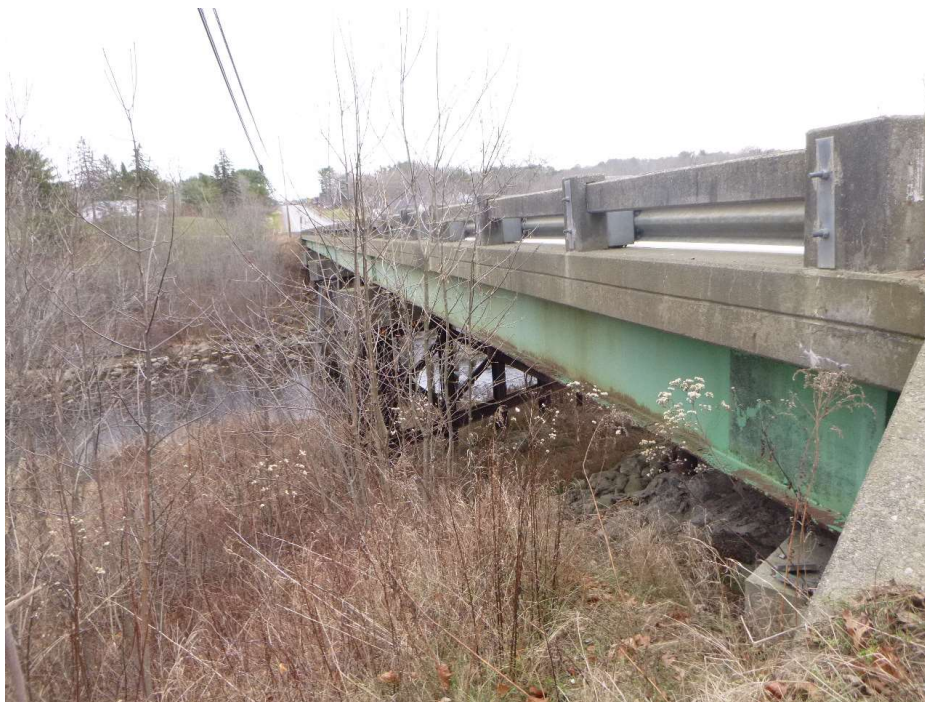
PHOTO 4

Description North face

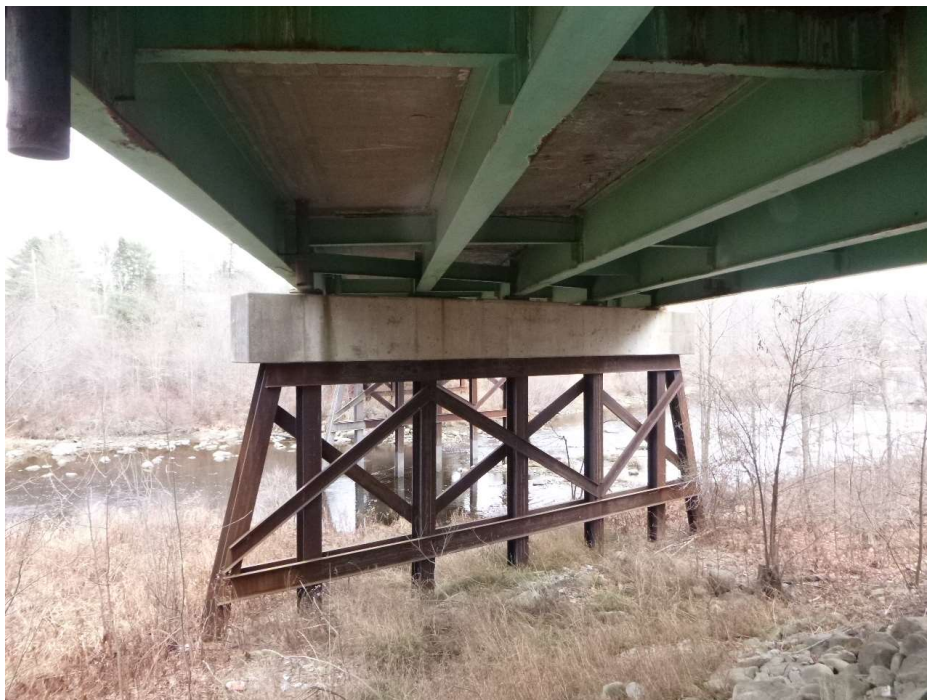
PHOTO 5

Description West pier

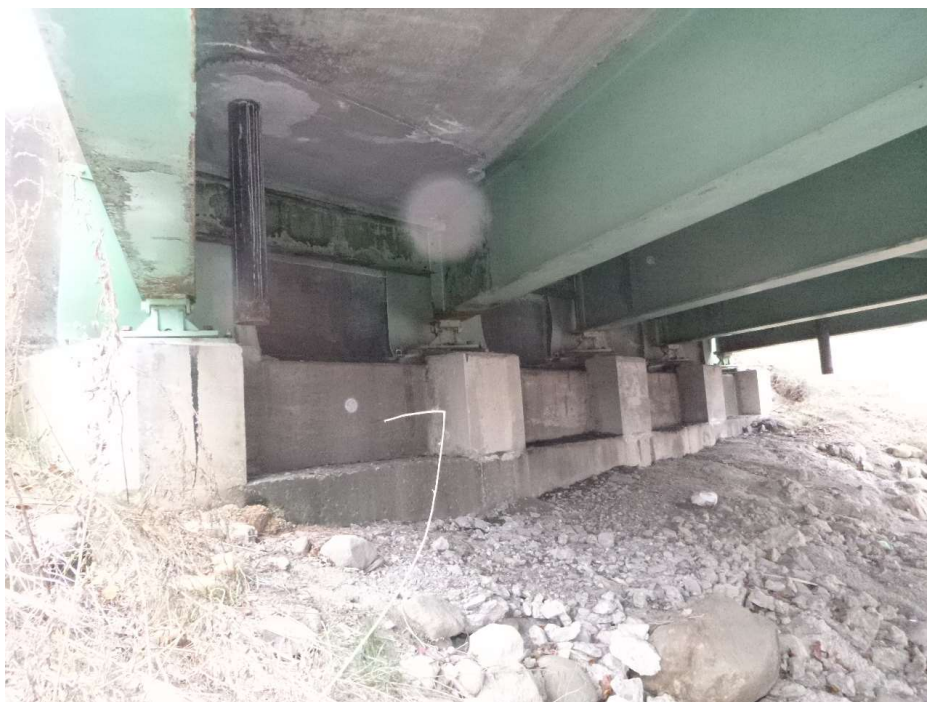
PHOTO 6

Description West abutment

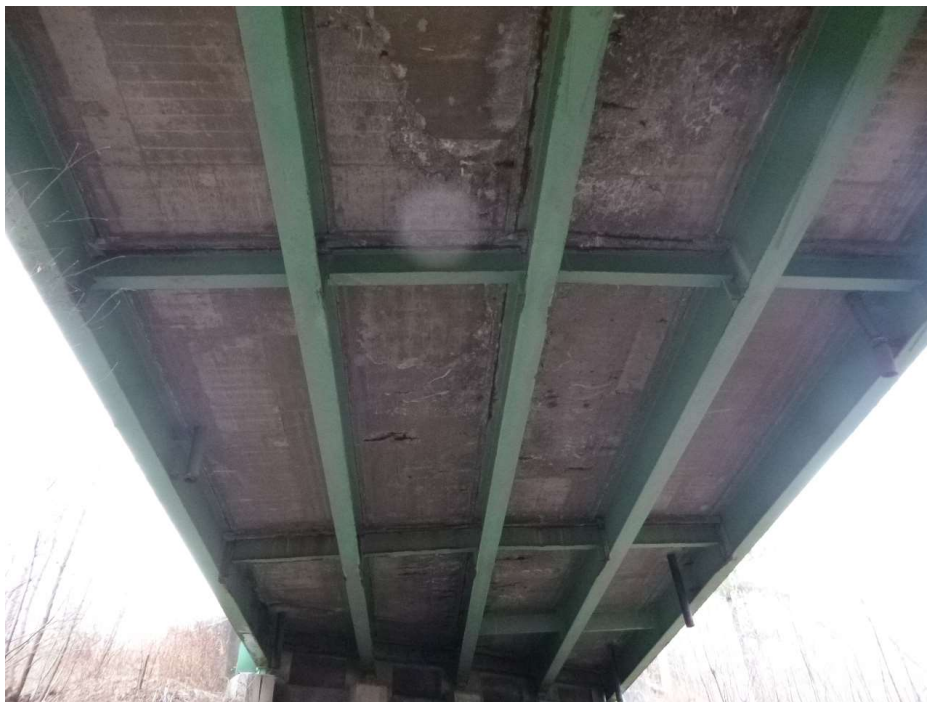
PHOTO 7

Description Span 1 from west

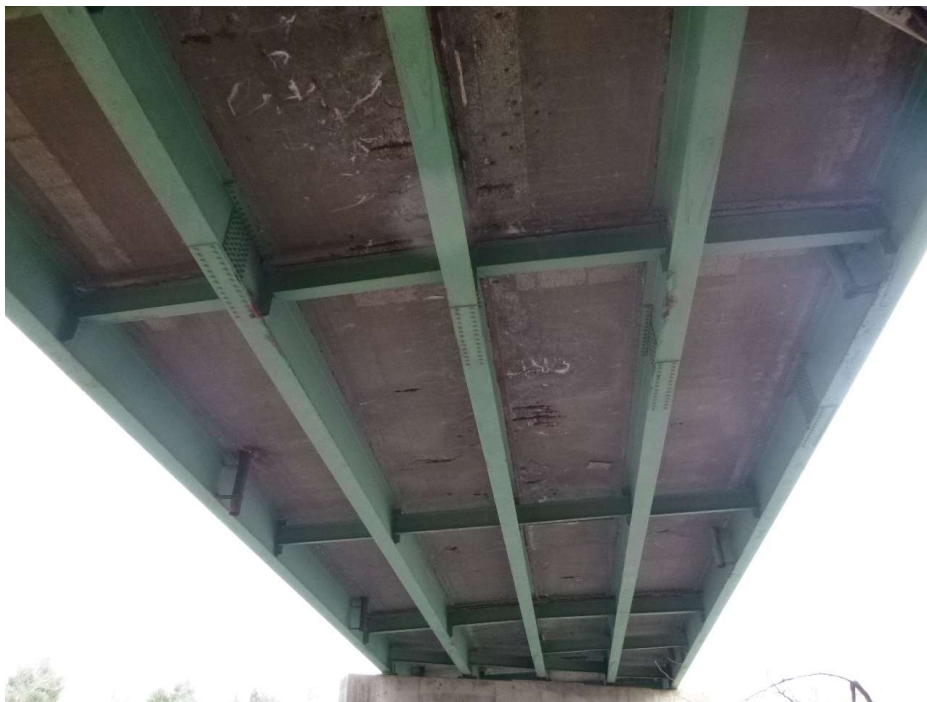
PHOTO 8

Description Span 2 from west

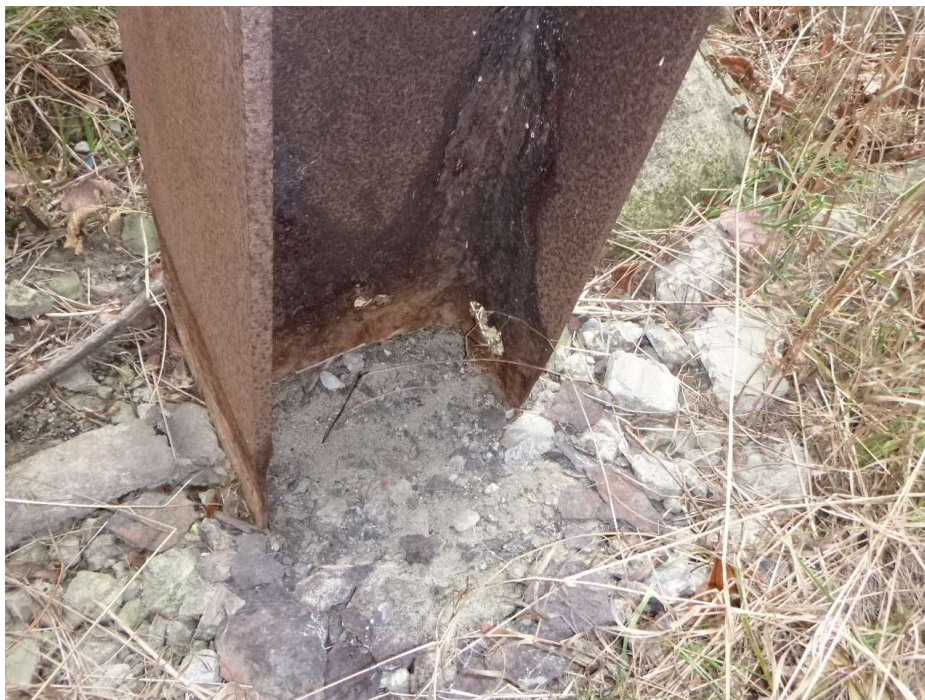
PHOTO 9

Pier steel piles in good condition above mud line. Isolated section loss at the mud line. One steel pile at the west pier mud line has holes thru the web and flange with the remaining area thinning. Pier caps have widely scattered fine cracking. West abutment bridge seat partially covered with winter sand. Mud flaps at west abutment are in place and functioning well.

Section loss at base of piles driving NBI rating.

Description Section loss at west pier - Third pile in from the south

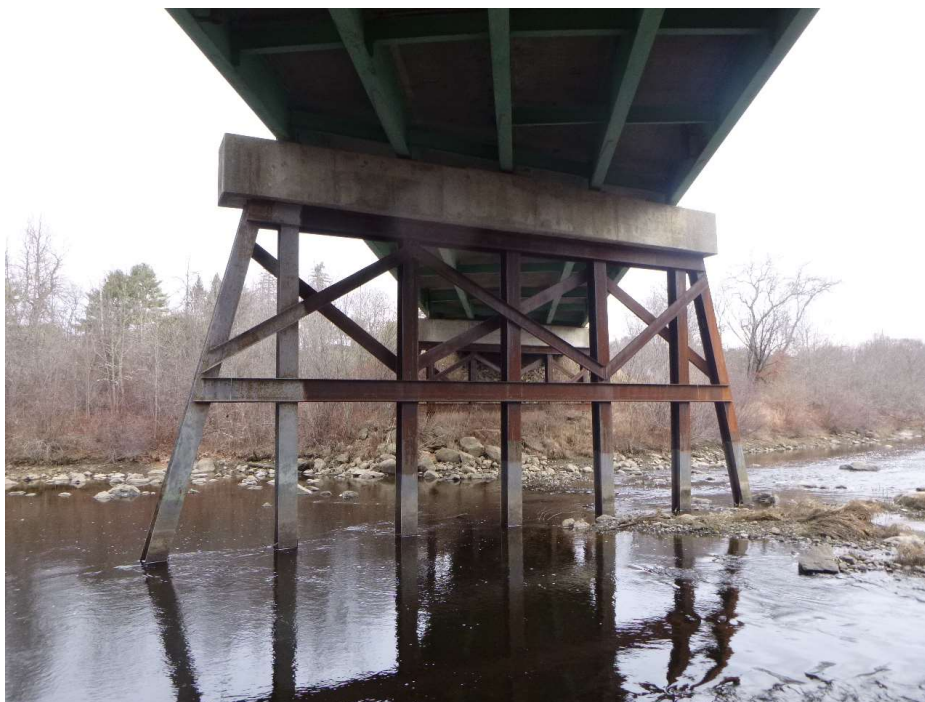
PHOTO 10

Description Center pier

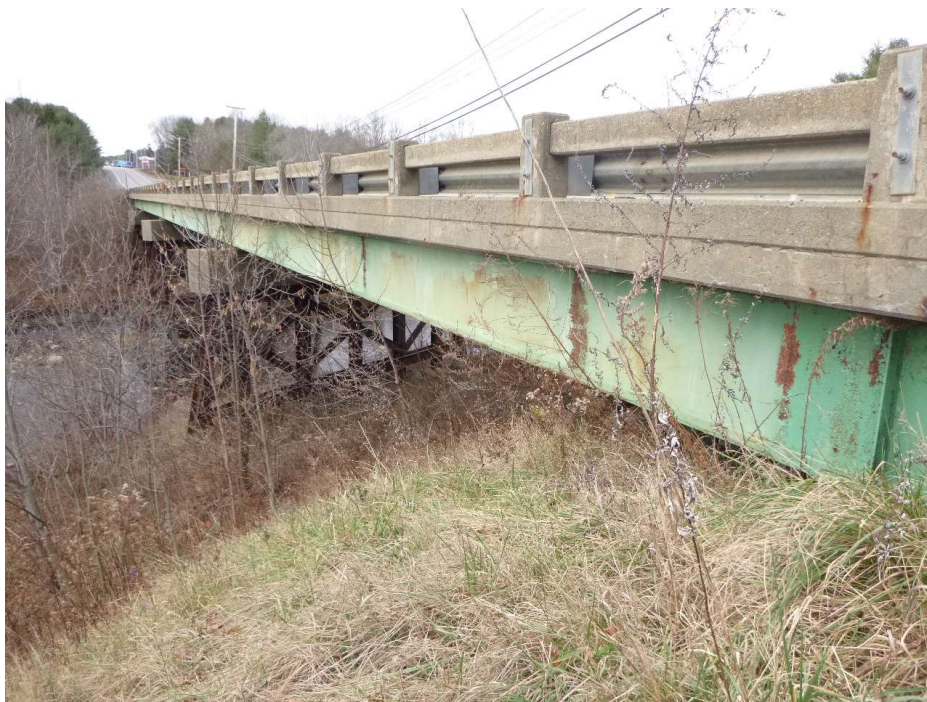
PHOTO 11

Description South face

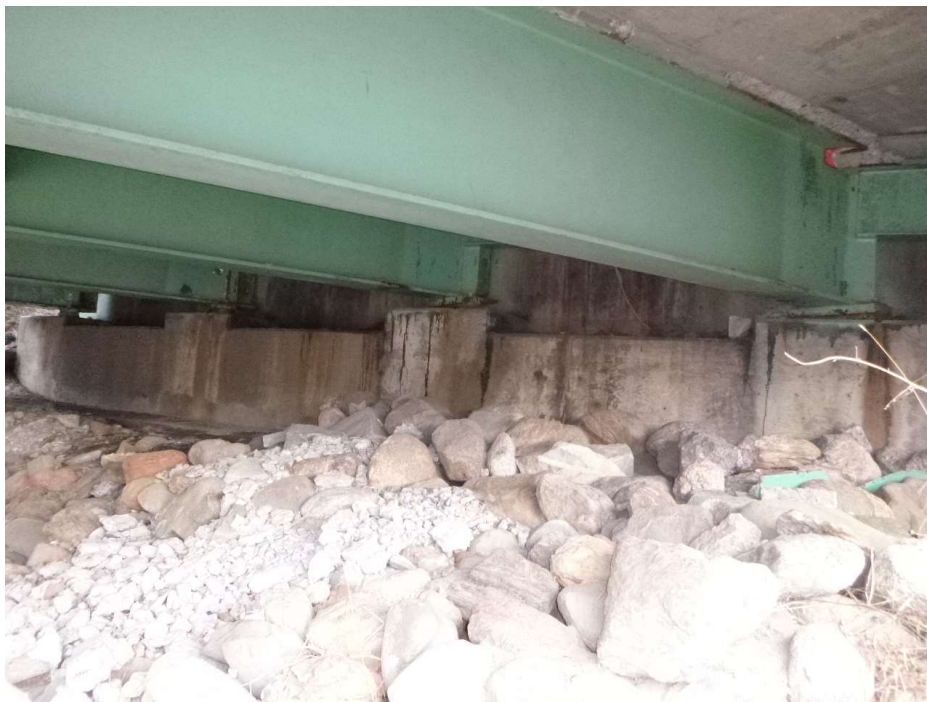
PHOTO 12

Both abutments have footings exposed. West abutment has newer concrete slope protection. East abutment has voids between bridge seat and backwall.

Description East abutment

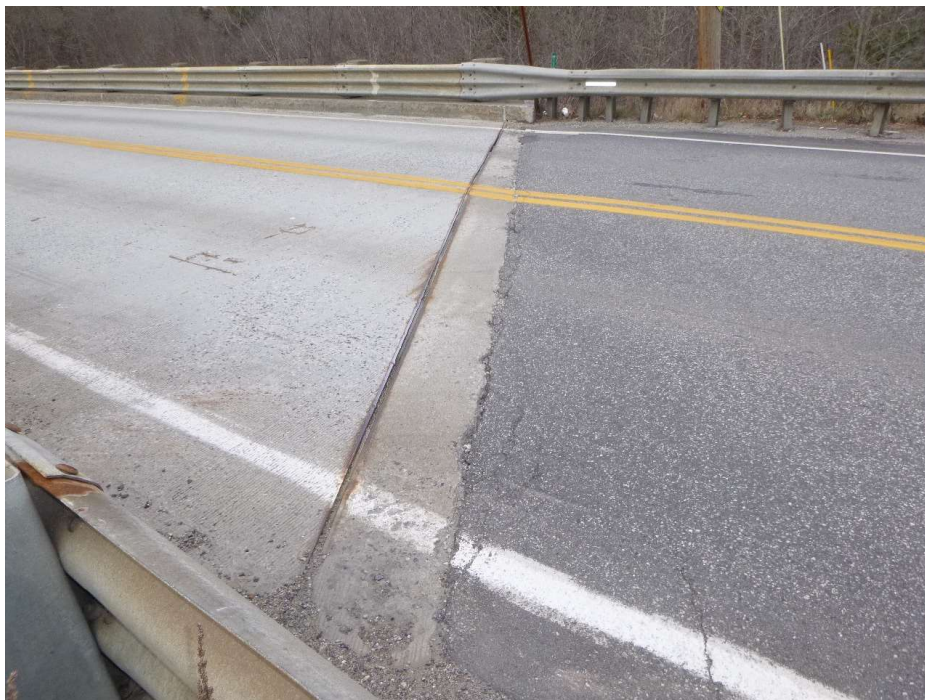
PHOTO 13

Description East joint

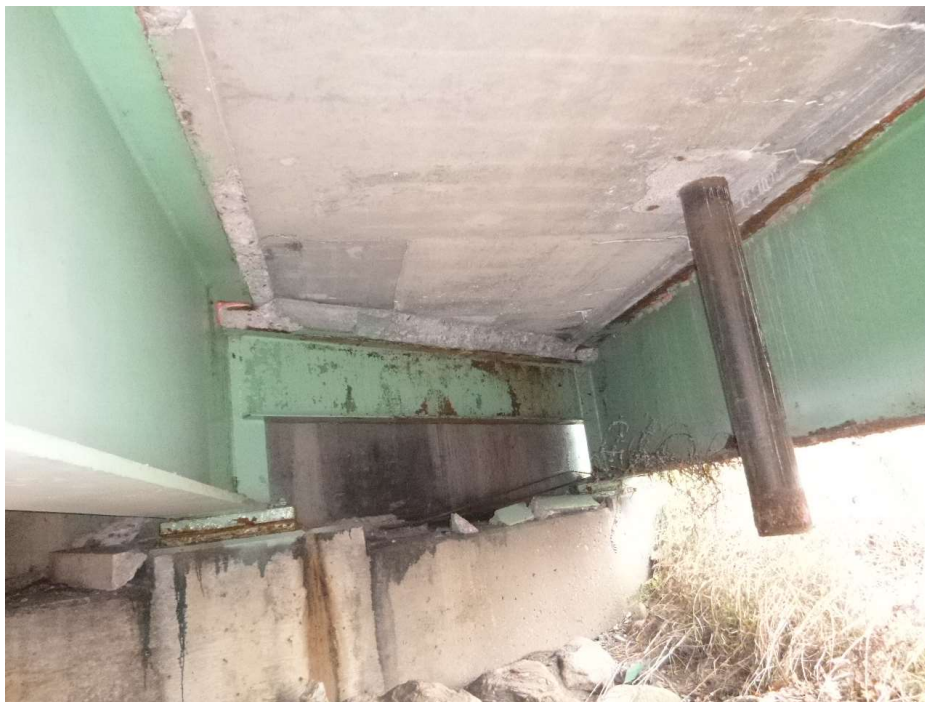
PHOTO 14

Description Spalling at diaphragm haunches

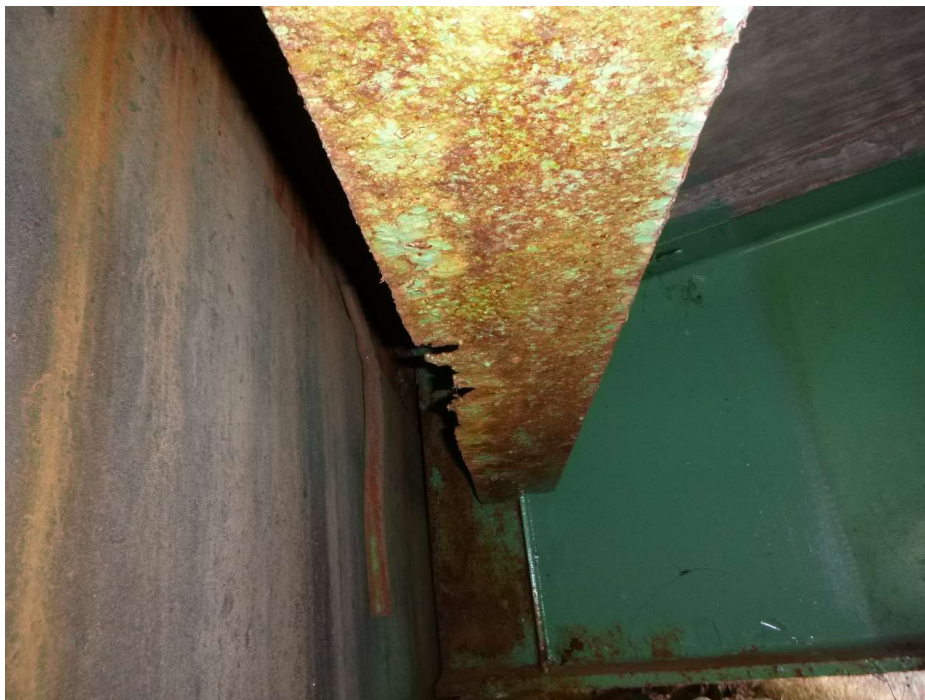
PHOTO 15

Description Section loss at bottom flange of end diaphragm at east abutment

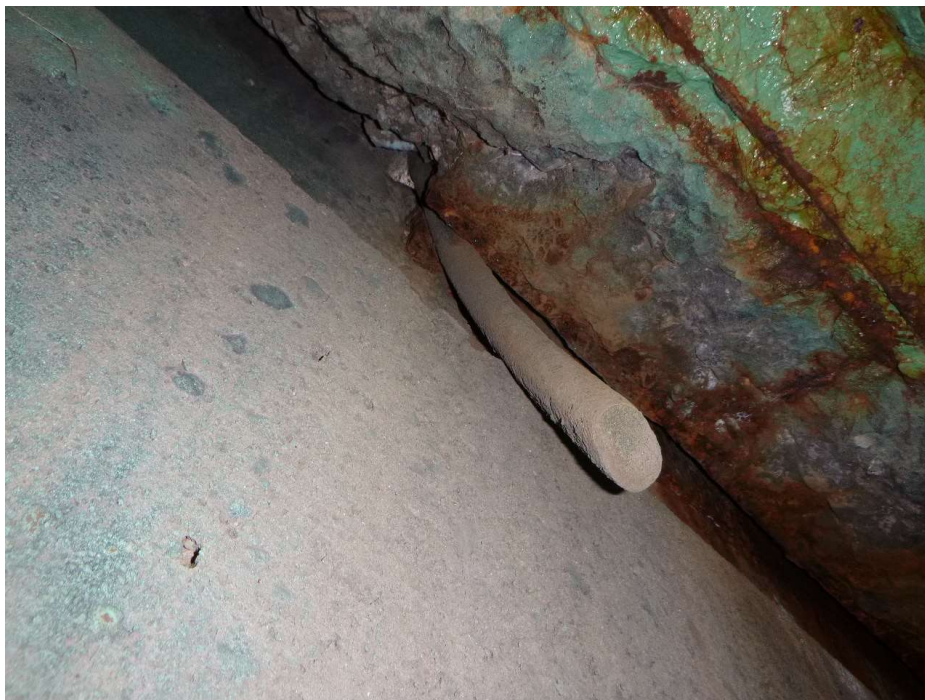
PHOTO 16

Description East joint failed seal

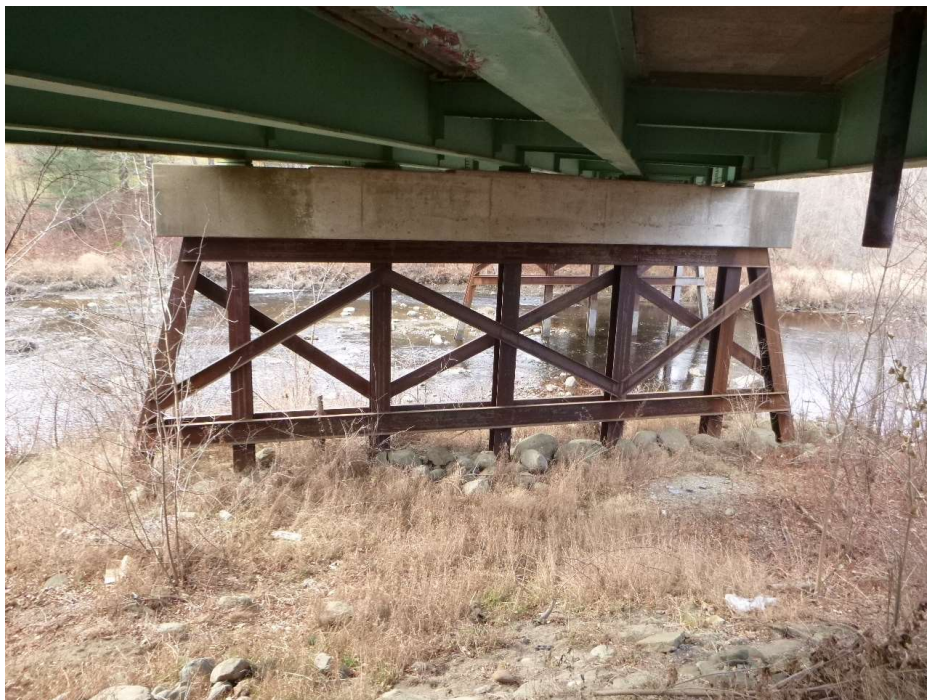
PHOTO 17

Description East pier

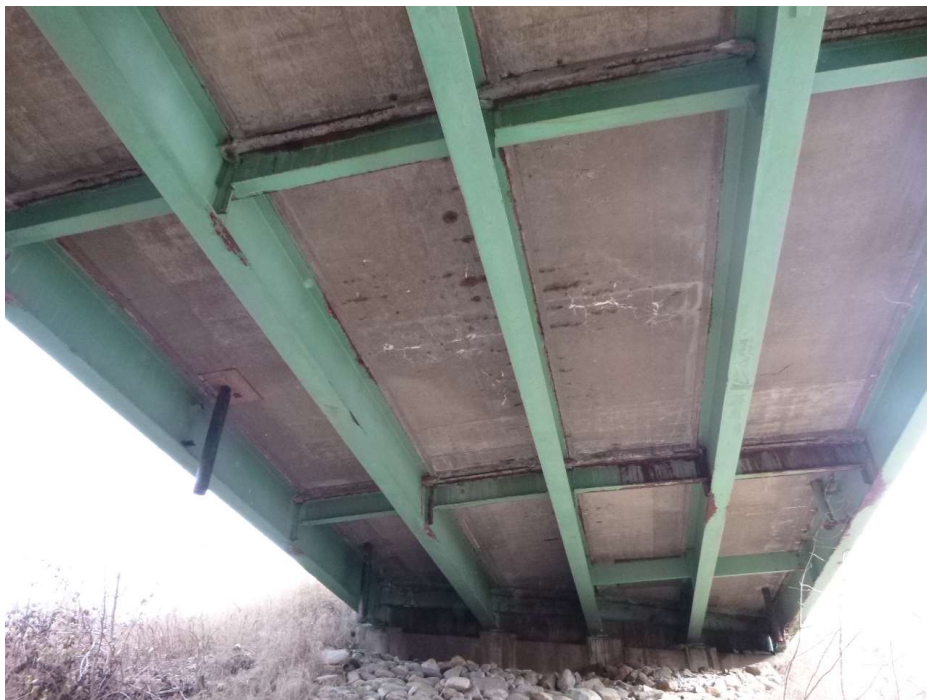
PHOTO 18

Description East span

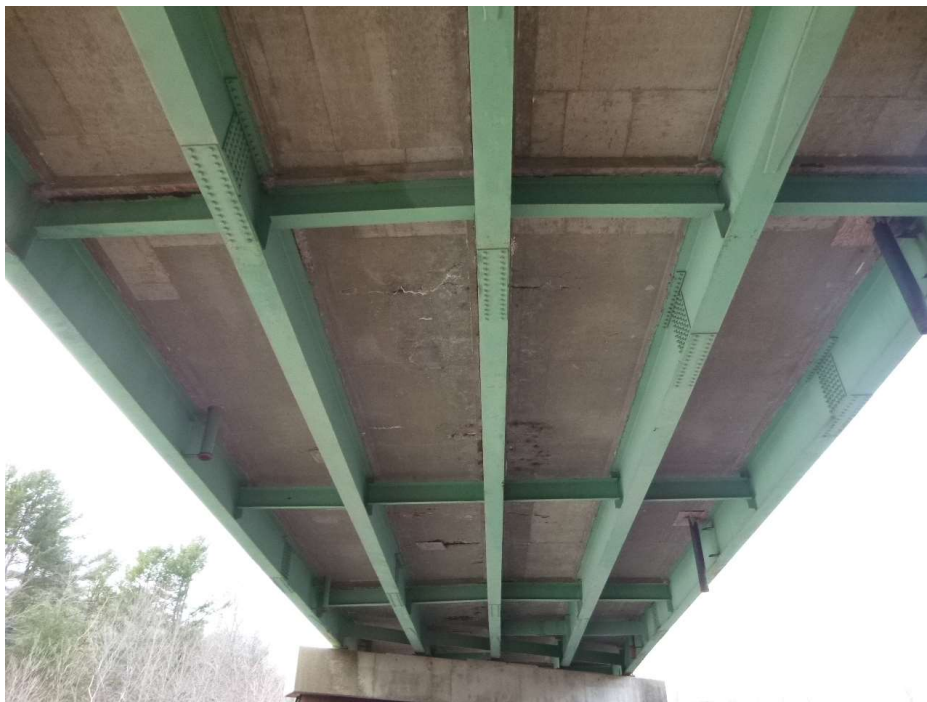
PHOTO 19

Description Span 3 from west

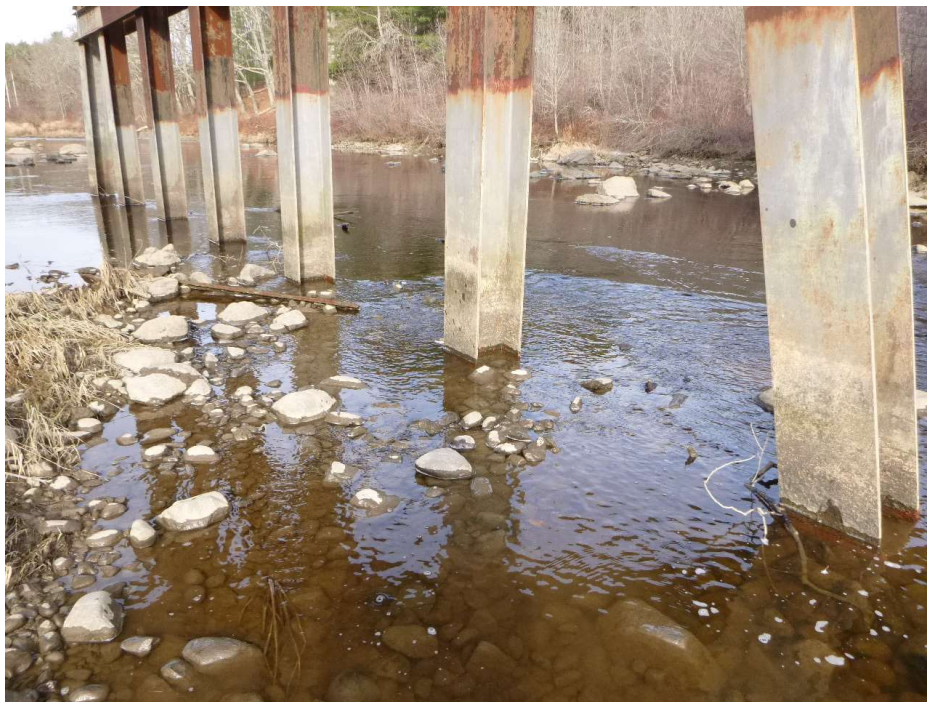
PHOTO 20

Description West face of center pier bottom of pile condition

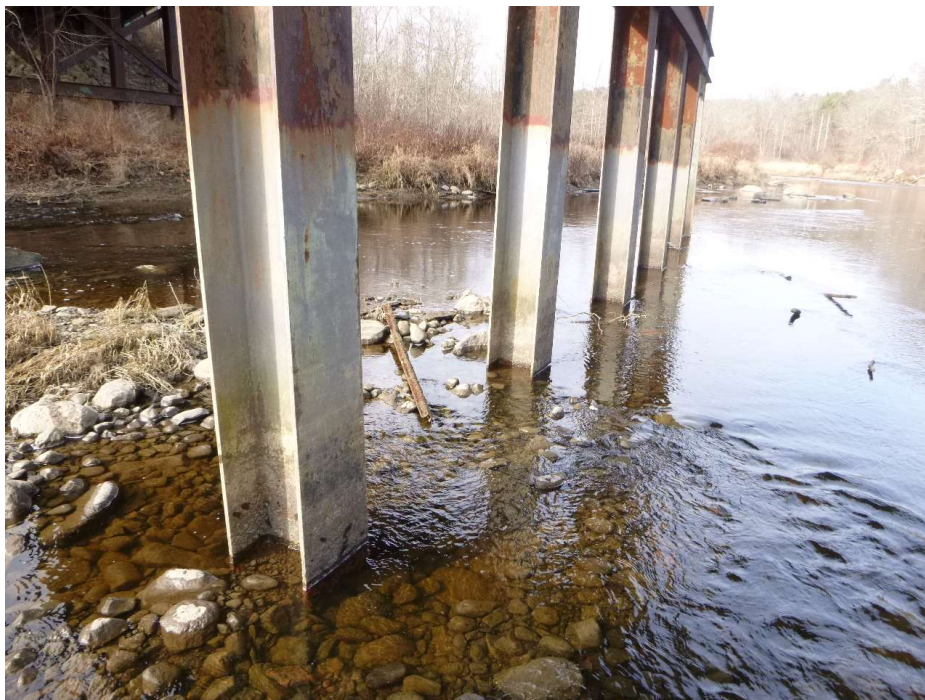
PHOTO 21

Description West face of center pier bottom of pile condition
