## UNDERWATER INSPECTION REPORT

TOWN(S) ABBOTBR. NAME PAGE - CARR193 5 7 2 5

VISIBILITY 10' FT686   8 Repair scourCURRENT moderateINSP. SIGN Carl EdwardsSTREAMBED DESC. Sandy gravel, head sized stones - boulders  
COMMENTS/PROBLEMS/HAZARDS Heavy riprap @ piers.INSPECTION REPORT 3 span continuous steel bridge on conc. spread footings. Large scour basin (22' DEEP) remains downstream in center of channel. No change in footing exposure on Pier #1 compared to previous reports. Large sand bar off downstream end of Pier #2NO MAJOR CHANGES OTHER THAN DEBRIS PILE FOUND @ HEAD OF SCOUR BASIN. 24.0 H2O SURFACE TO BRIDGE CURB.

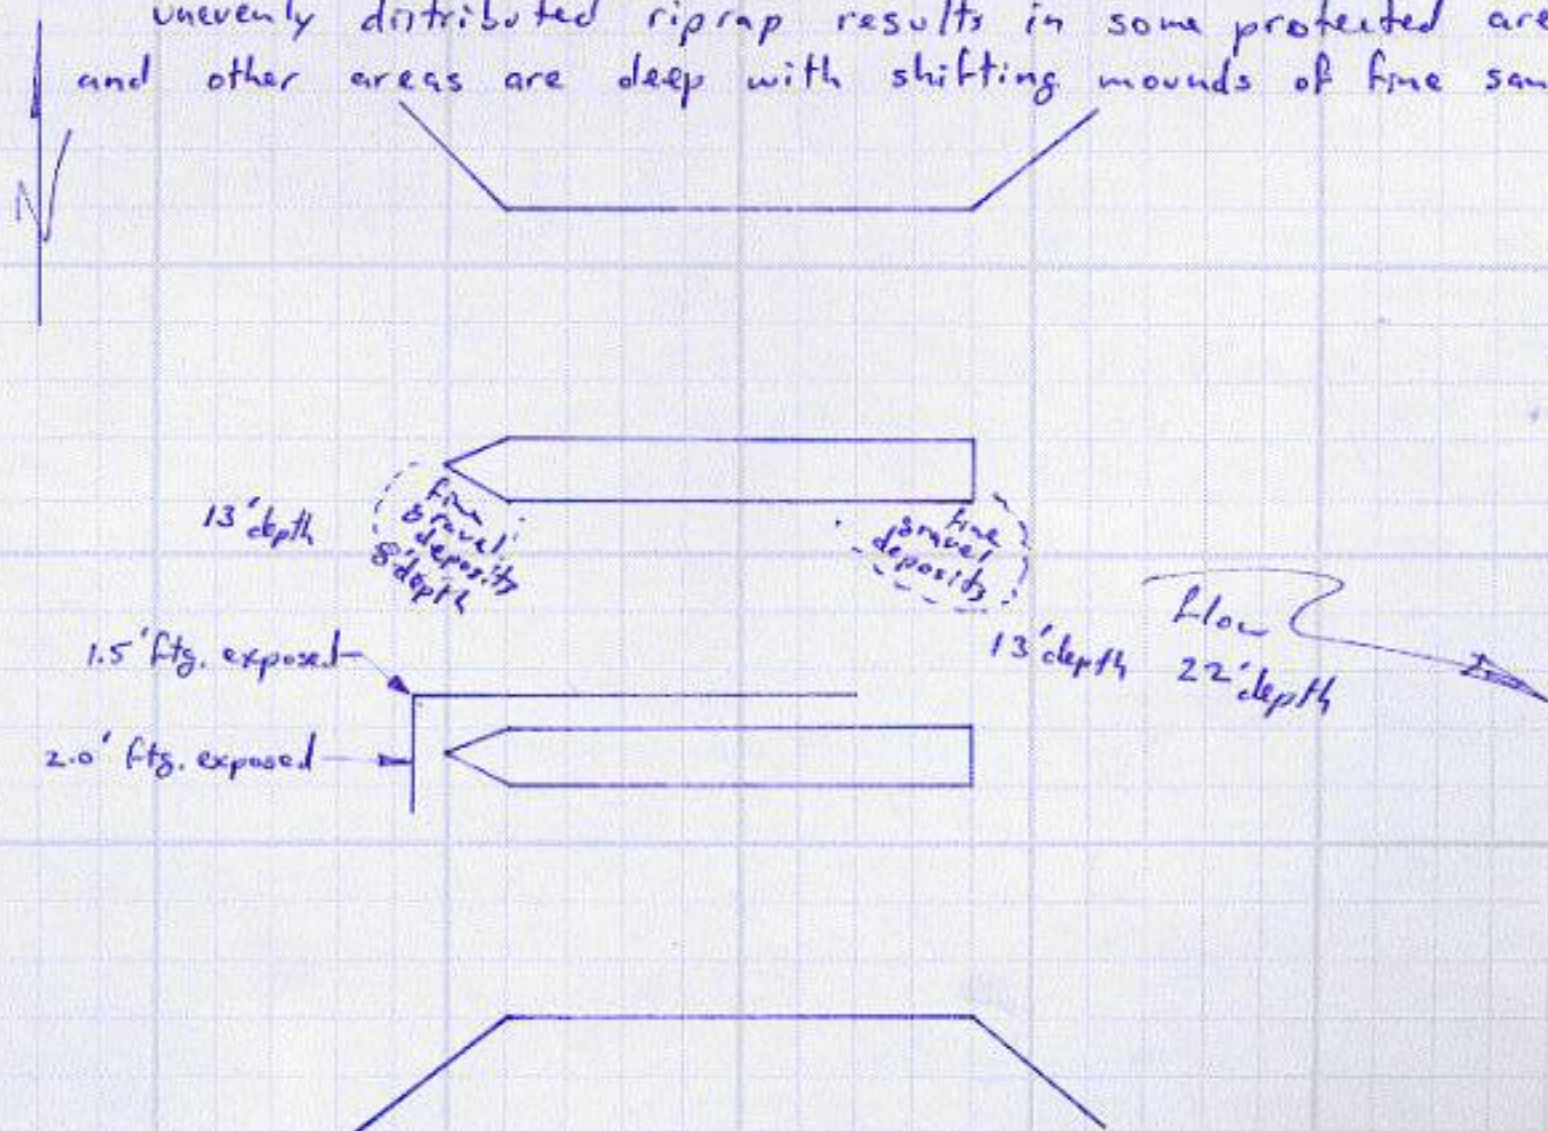
3-span contin. steel bms. on mass conc. spread footings.  
Heavy riprap has been added since last inspection and seems  
to be staying in place.

unevenly distributed riprap results in some protected areas  
and other areas are deep with shifting mounds of fine sand gravel.

Note: THE SOUTHERLY FOOTING WAS NOT NOTED AS  
 BEING EXPOSED IN THE 1990 REPORT. INSPECTION  
 CYCLE TO BE CHANGED FROM 2 YRS TO 1 YR. CYCLE.  
 11/5/92 Gary I. Ford

No repairs needed at this time  
scour evaluation is recommended

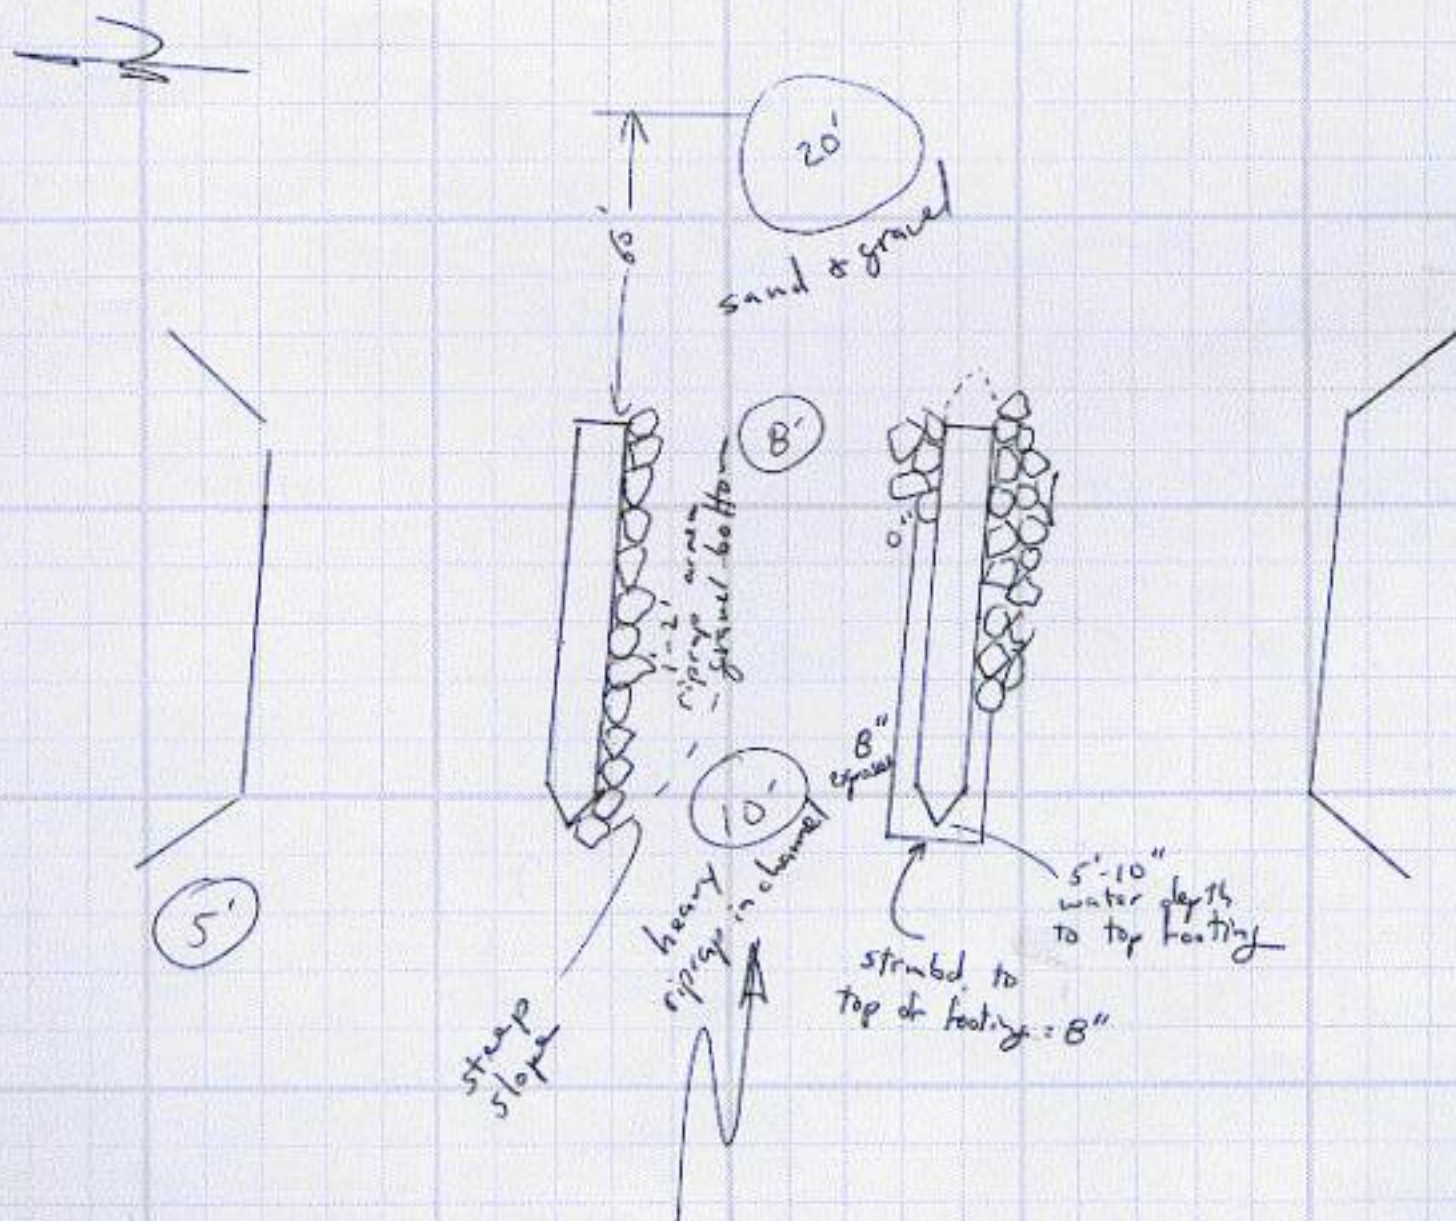
INSPECTION REPORT 3-span continuous steel beam on mass conc. on spread footings. There is a large scour basin immediately downstream from piers. Streambed has a gradual taper from the scour hole to a downstream island. A gradual slope is also found upstream. There The scour at the southerly pier is no deeper than the previous year but it may extend further down the fa. channel side of the pier than the previous year. No repairs are needed at this time. A scour evaluation is recommended.

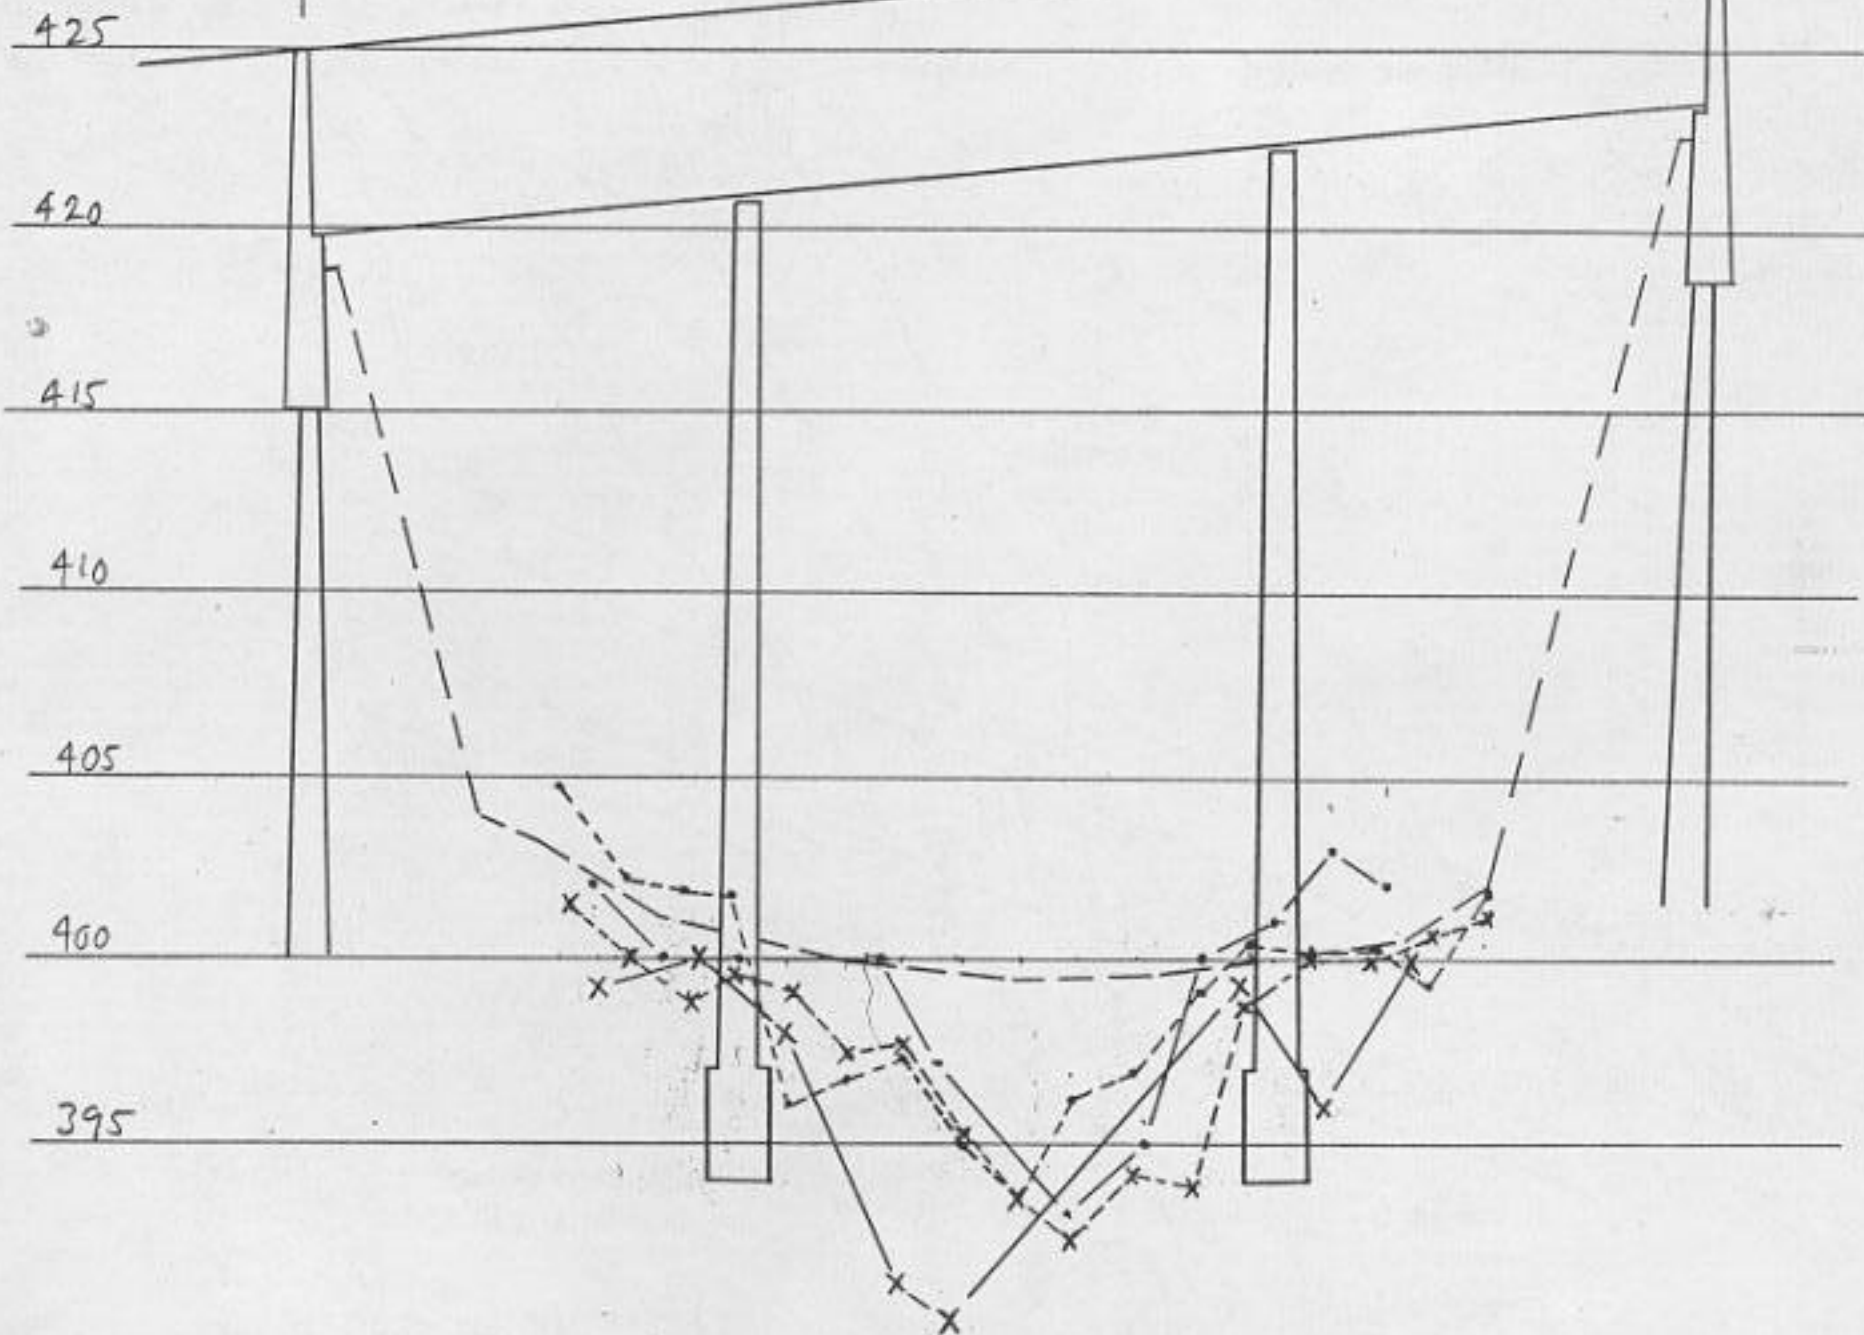
## Sketch (Profile)

Abutment riprap has a lot of round worn stone, not very angular. Left abutment erosion appears due to flood flows washing out bottom of slope.

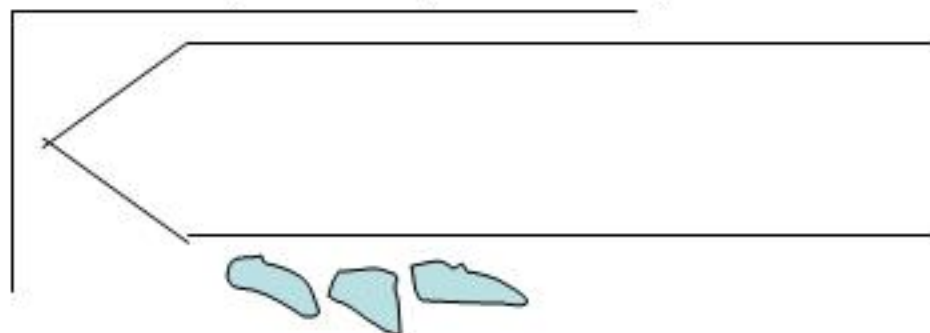
18" exposed

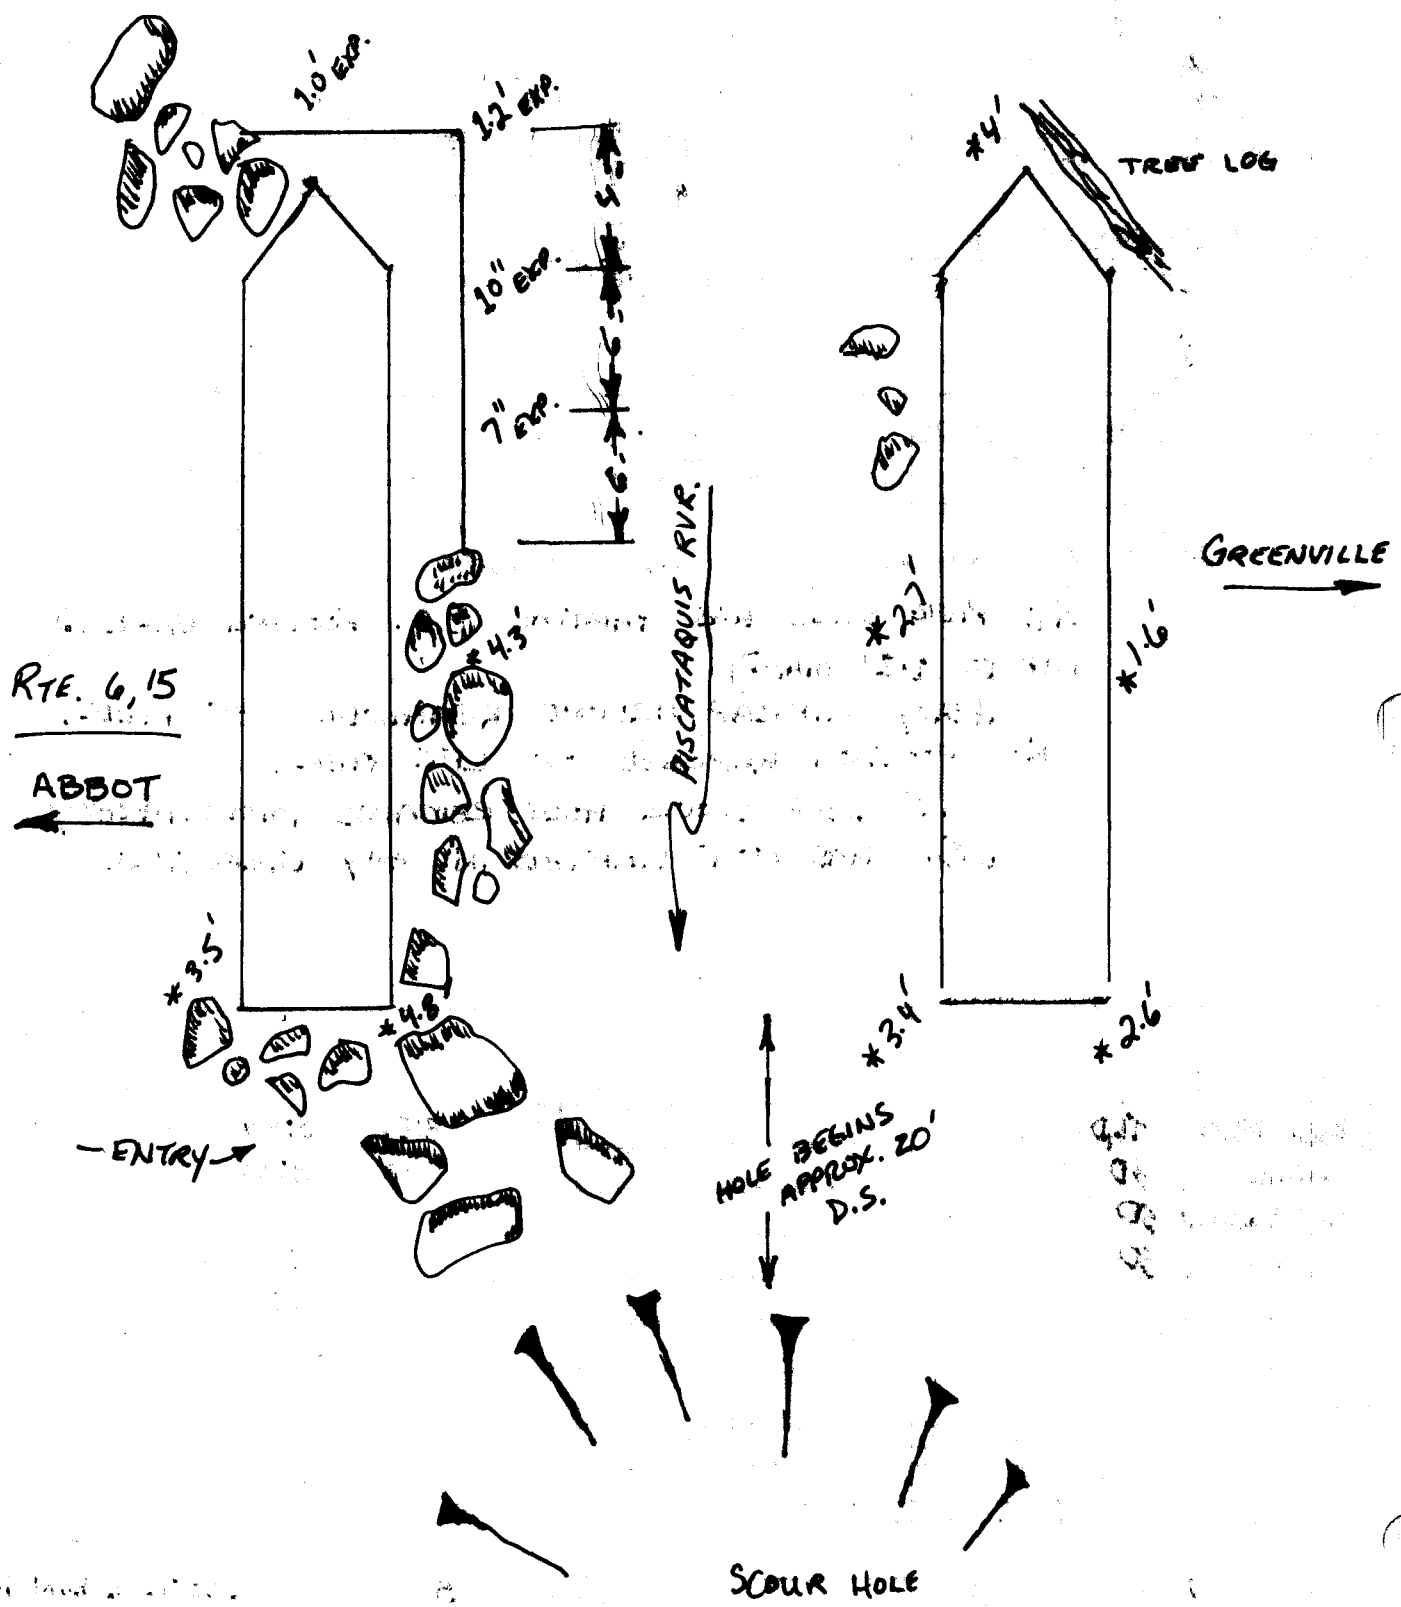
RT. PIER STILL HAS PARTIAL U.S. FOOTING EXPOSED (UP TO 1.2' MAX.)

HEAVY RIPRAP AROUND REMAINDER OF PIER.

NO FOOTING EXPOSED ON LFT. PIER.

17' DEEP SCOUR HOLE REMAINS IMMEDIATELY

D.S. - HAS NOT SHIFTED IN ANY DIRECTION.

SCOUR BASIN D.S.

EXPOSED FOOTINGS

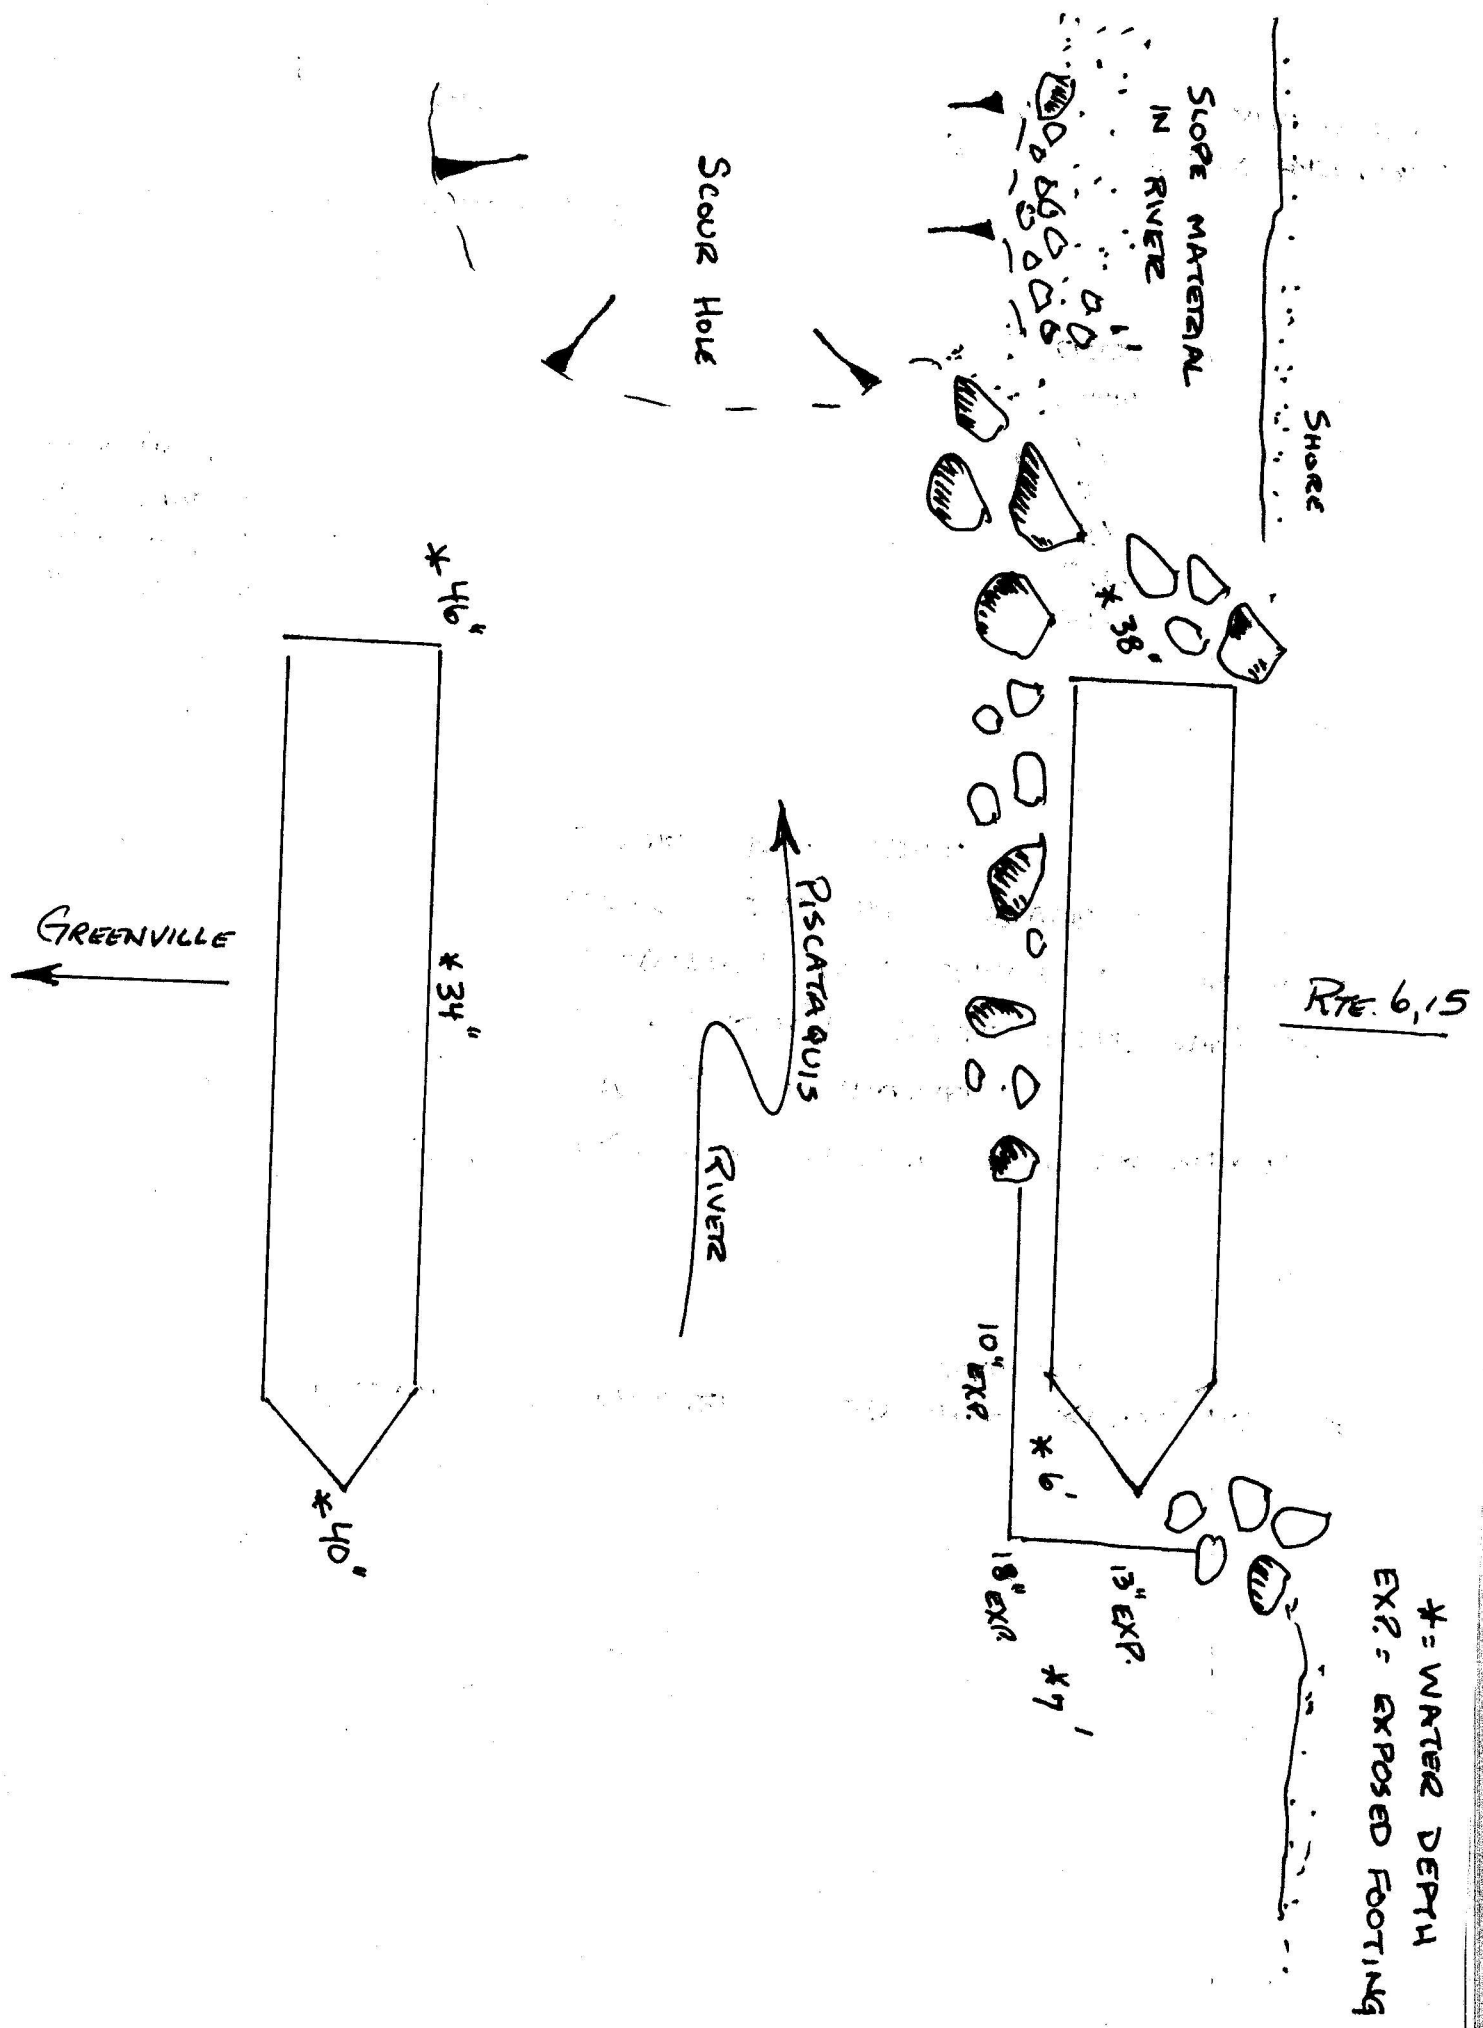
SCOUR BASIN D.S.  
 EXPOSED FOOTING

Defined channel at center. Heavy rip rap around pier ends. More rip rap recently dumped in. Scour hole downstream.  
**EMBANKMENT FAILURE - SLID INTO RIVER D.S. OF BRIDGE.**

2010: EXPOSED FOOTING MEASUREMENTS  
 MOSTLY UNCHANGED.

DOWNSTREAM SCOUR HOLE MAY BE  
 MIGRATING U.S. SLIGHTLY. ABUTMENT  
 SLOPE SLID INTO RIVER OUT TO  
 SCOUR HOLE EDGE.
