town 11-16
 bridge 3244
 State Highway Commission
 Bridge Division
PLEASANT RIVER BRIDGE
 OVER
PLEASANT RIVER
 in the town of
MILO PISCATAQUIS COUNTY
 Bridge Details
 Sheet of Augusta Sept. 4, 1935

Surveyed by MacDannell
 Plotted and Traced by Lyon

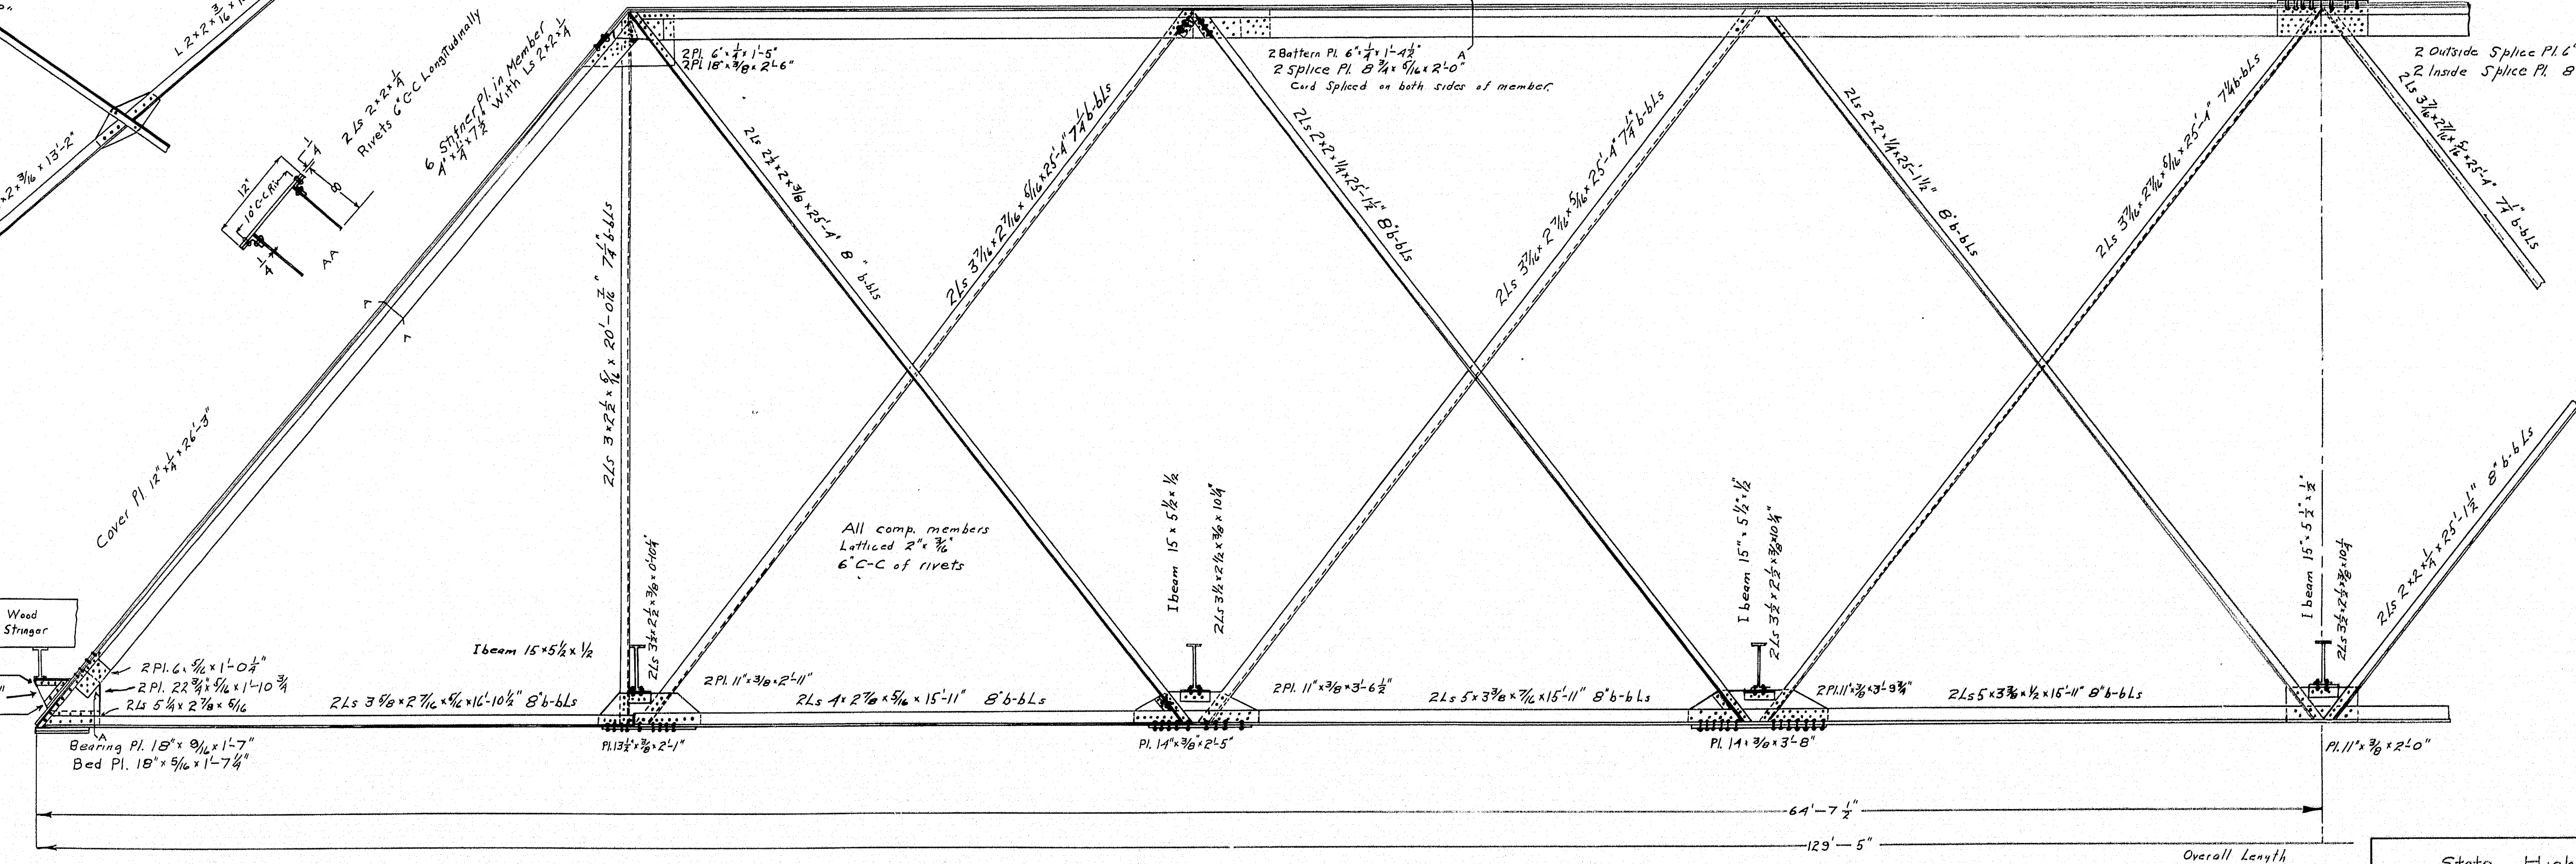
Notes
 No. 1 abut. has timber grillage under it. No. 1 bed plate is .44' lower on D.S. side than U.S. bed plate. Bridge built in 1900 by the Berlin Iron Bridge Co., East Berlin, Conn. Selectmen: E.W. Doble, F.H. Gould, I.E. Sherburn.
 Rollers under bridge are 2' diam. are in bad shape, of no use and badly out of line.
 The top of timber grillage under pier is at elev. 74.0.
 No. 1 abut grillage is undermined 2'-3' on U.S. corner. Small stones are around grillage. Water is 3'-6" deep at U.S. corner and about 6" deep at D.S. corner. Grillage probably large logs slotted parallel to E. road. Three inch planks are on grillage. Plank in center of two trusses at middle of stream is in very poor shape. Several large holes are in top planking. Under planks in two or three places are nearly rotted thru.
 No. 2. abut. timber grillage parallel to E. road, top grillage elev. 73.0. Grillage covered with flagstone on top of which is a row of split stone headers.
