STATE HIGHWAY COMMISSION
BRIDGE DIVISION

GREAT FARM BROOK BRIDGE
OVER
GREAT FARM BROOK
IN THE TOWN OF
JACKSON
WALDO COUNTY

SURVEY PLAN
SHEET 1 OF 5 AUGUSTA, MAINE FEB. 17, 1938

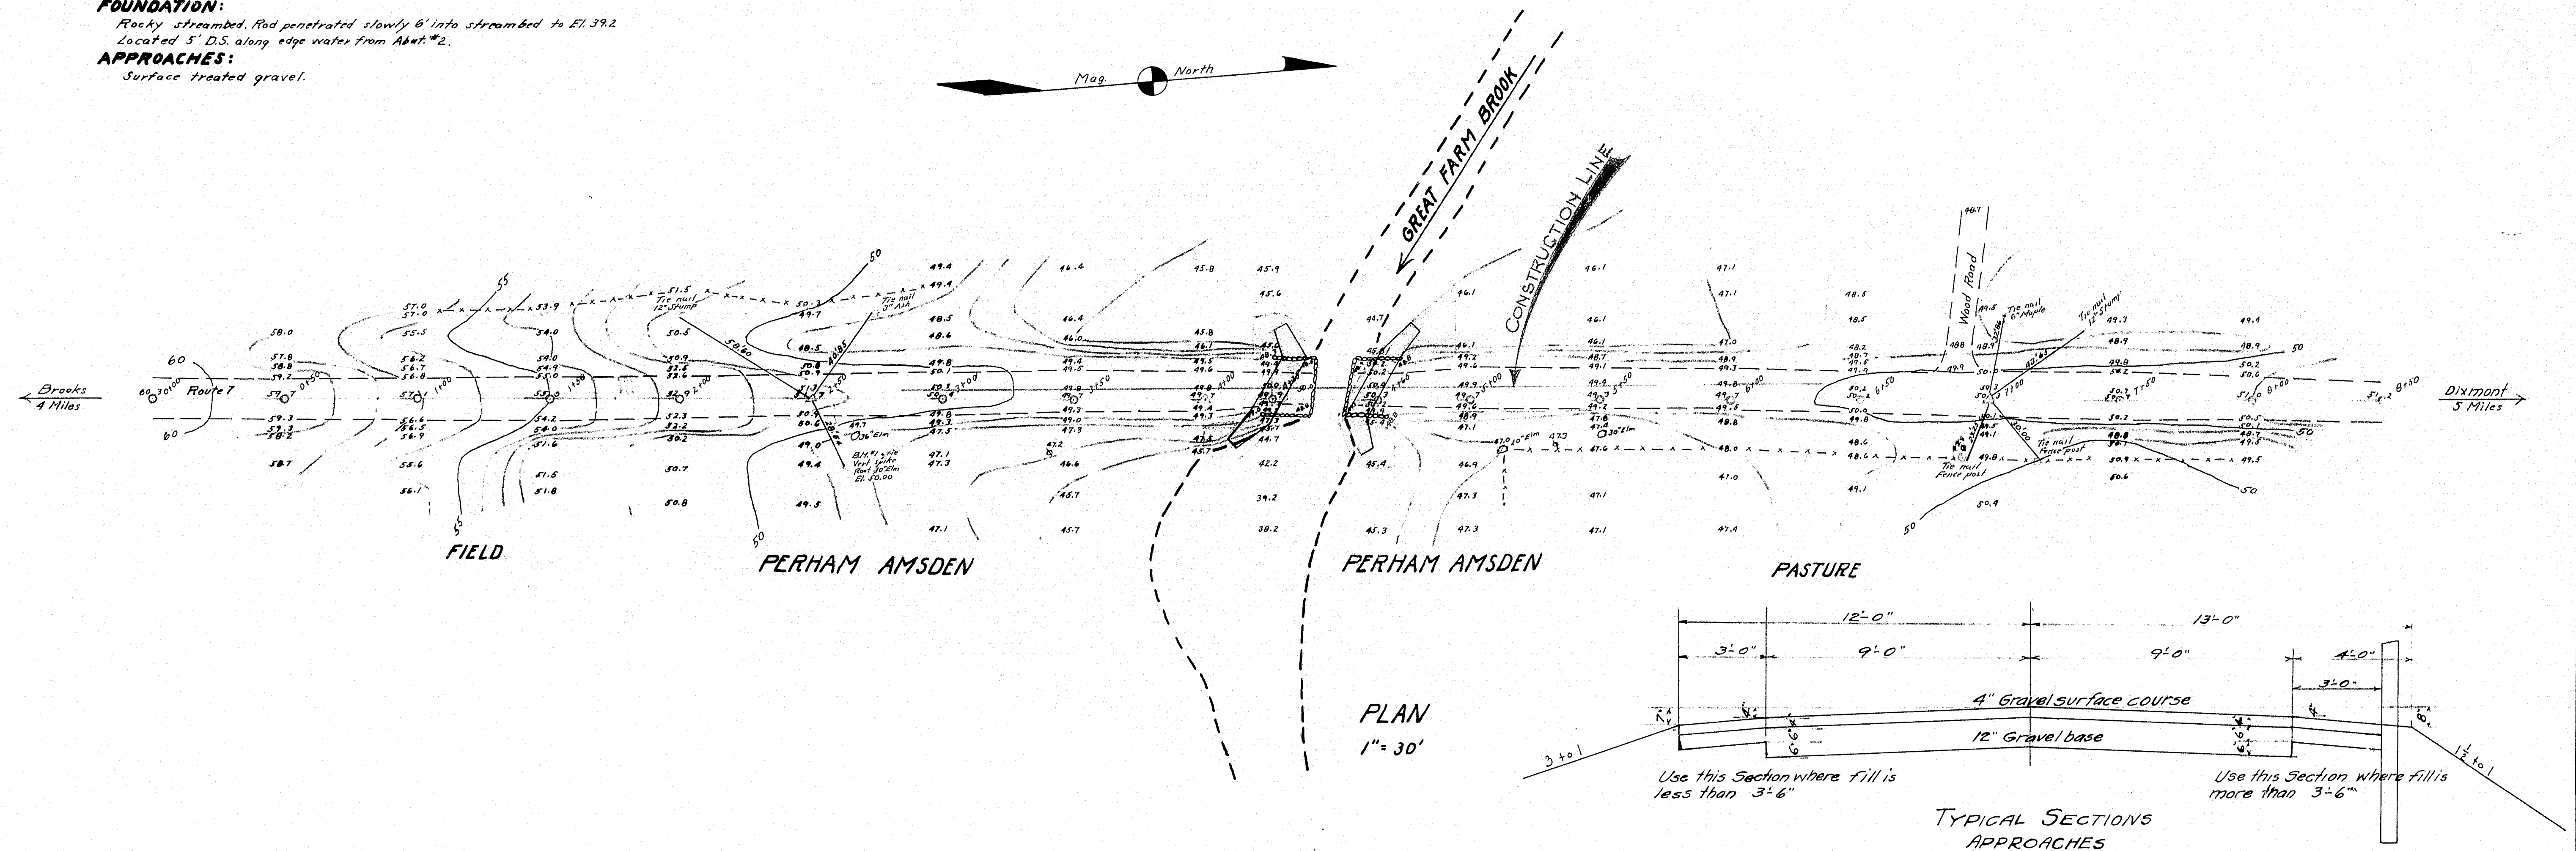
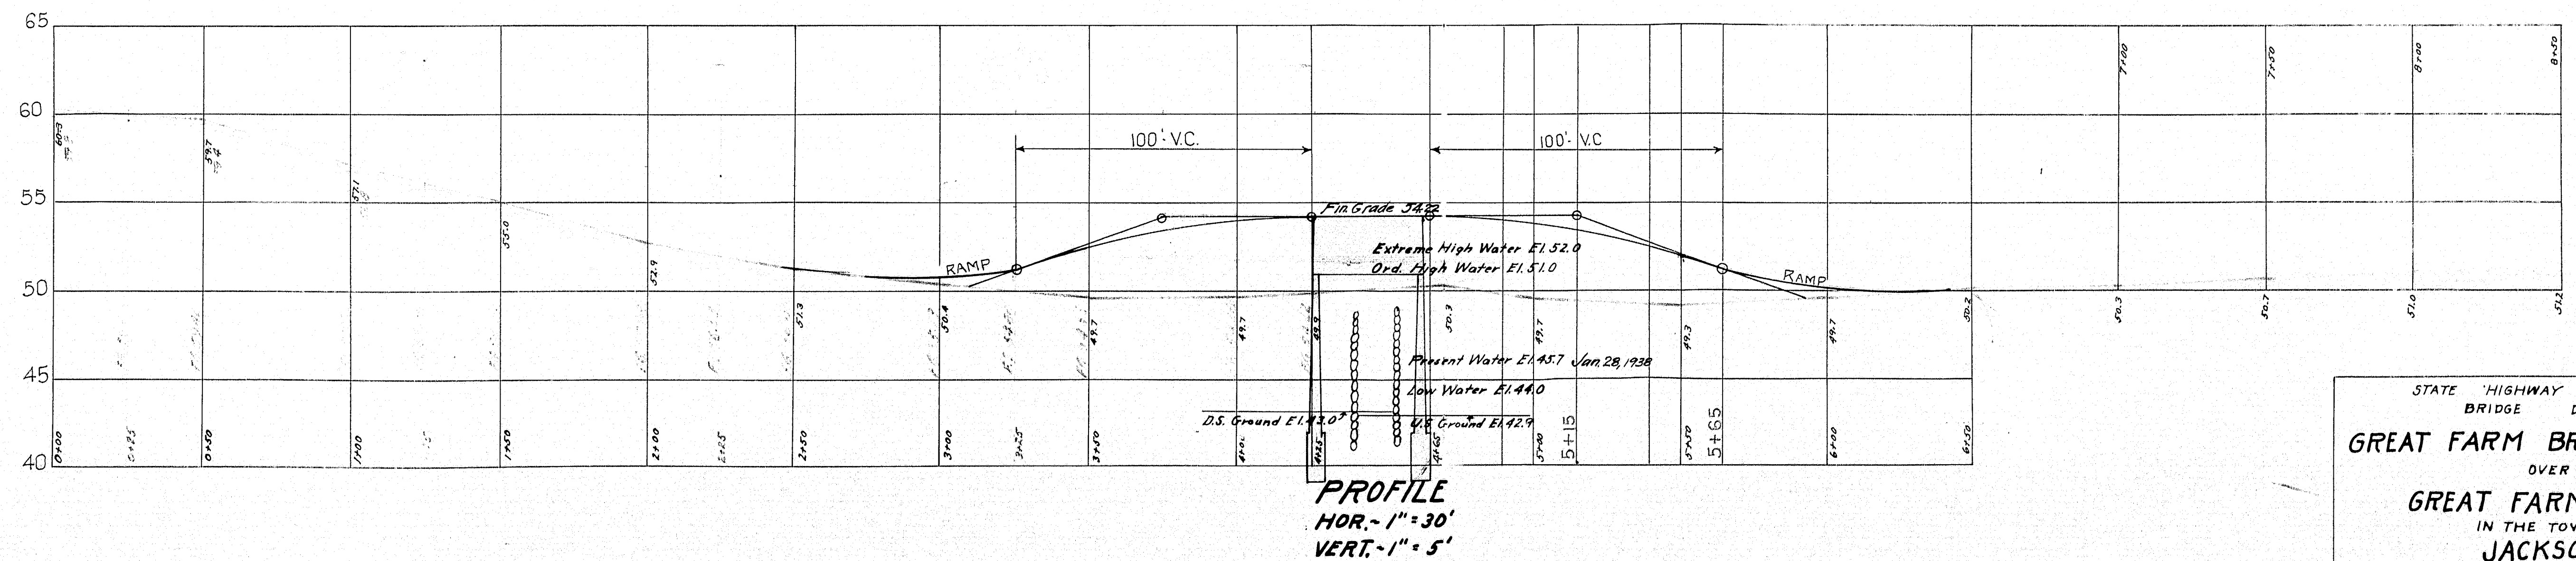
Round log stringers, 3" Transverse and 3" Long plank. Poor condition.

Abutments of small round field stones, laid dry.

Wide flat intervals on each side of brook. Overflow at high water.
Extreme high water at El. 52.0, March 1936. Ordinary high water El. 51.0
Low water about El. 44.0

Rocky streambed. Rod penetrated slowly 6' into streambed to El. 39.2
Located 5' D.S. along edge water from Abut. #2.
