STATE HIGHWAY COMMISSION  
 BRIDGE DIVISION  
**ROUND POND BRIDGE**  
 OVER  
**ROUND POND OUTLET**  
 IN THE TOWN OF  
**CHARLOTTE**  
**WASHINGTON COUNTY**  
 SURVEY  
 SHEET 1 OF 4 AUGUSTA, MAINE JAN. 1941

DESIGN TRACED } Beckman	TOWN	15-10
CHECKED } B.E.L.	BRIDGE	3787
STATE HIGHWAY COMMISSION		
BRIDGE DIVISION		
ROUND POND BRIDGE		
OVER		
ROUND POND OUTLET		
IN THE TOWN OF		
CHARLOTTE		
WASHINGTON COUNTY		
CROSS SECTIONS		
SHEET 2 OF 4 AUGUSTA, ME. JULY, 1941

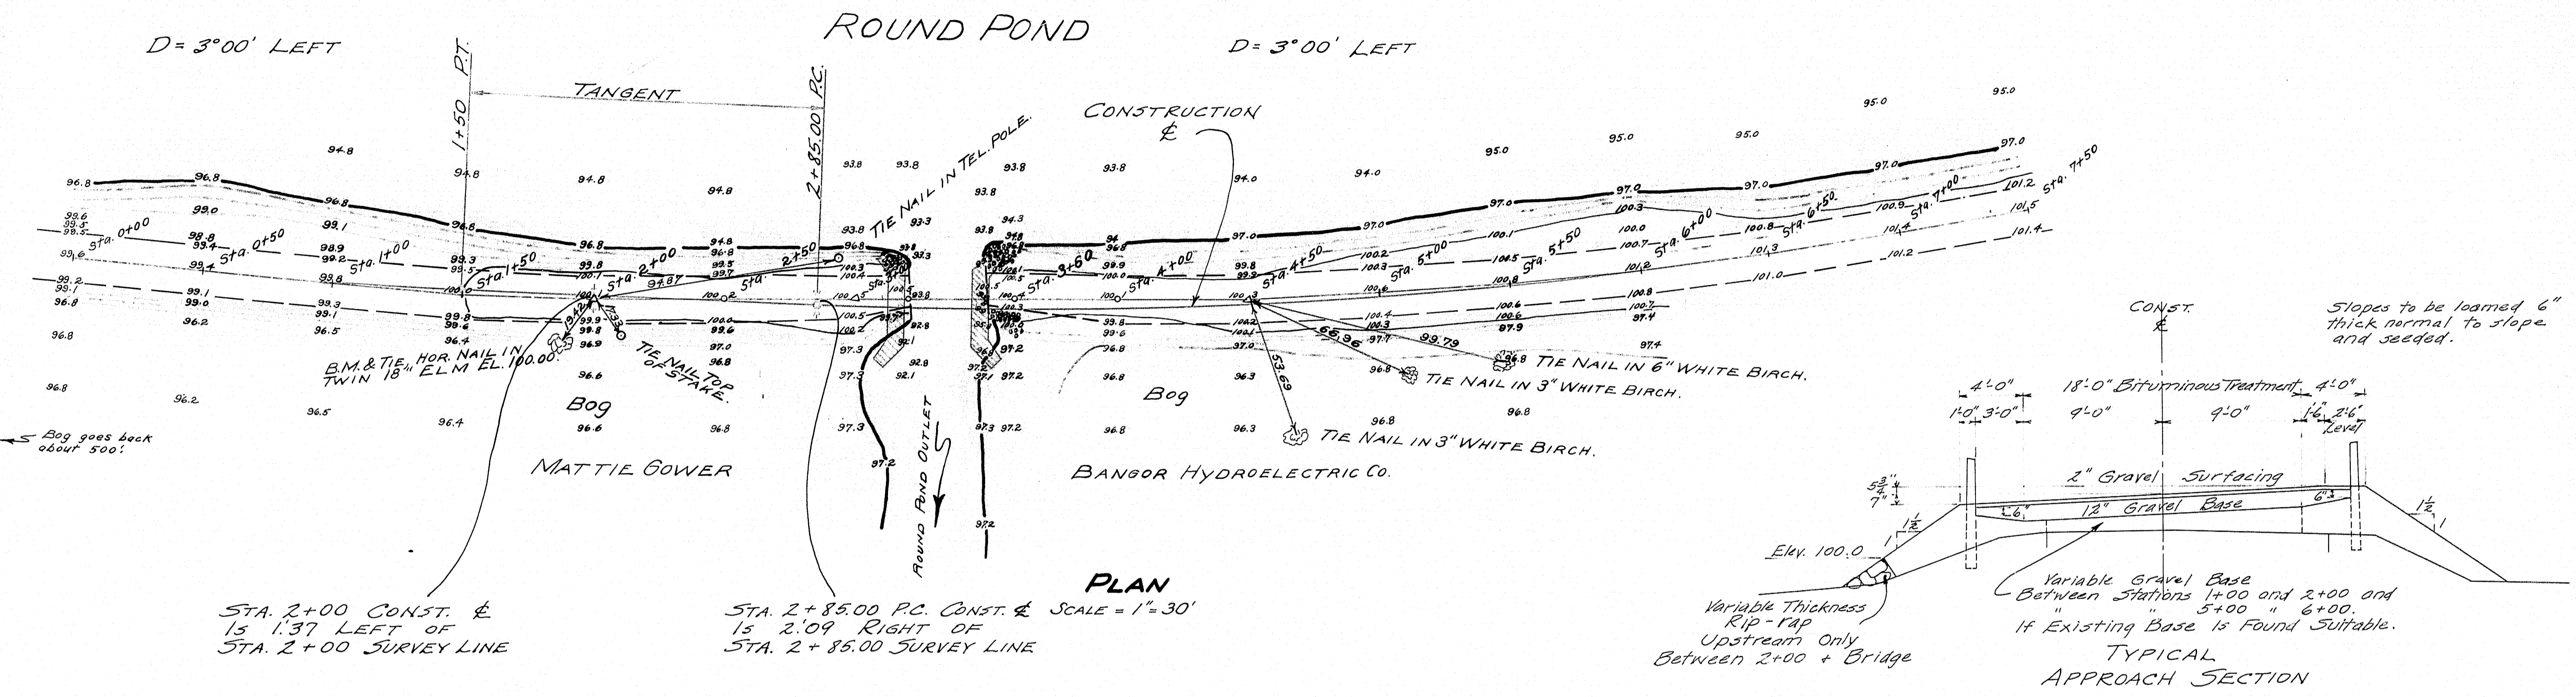
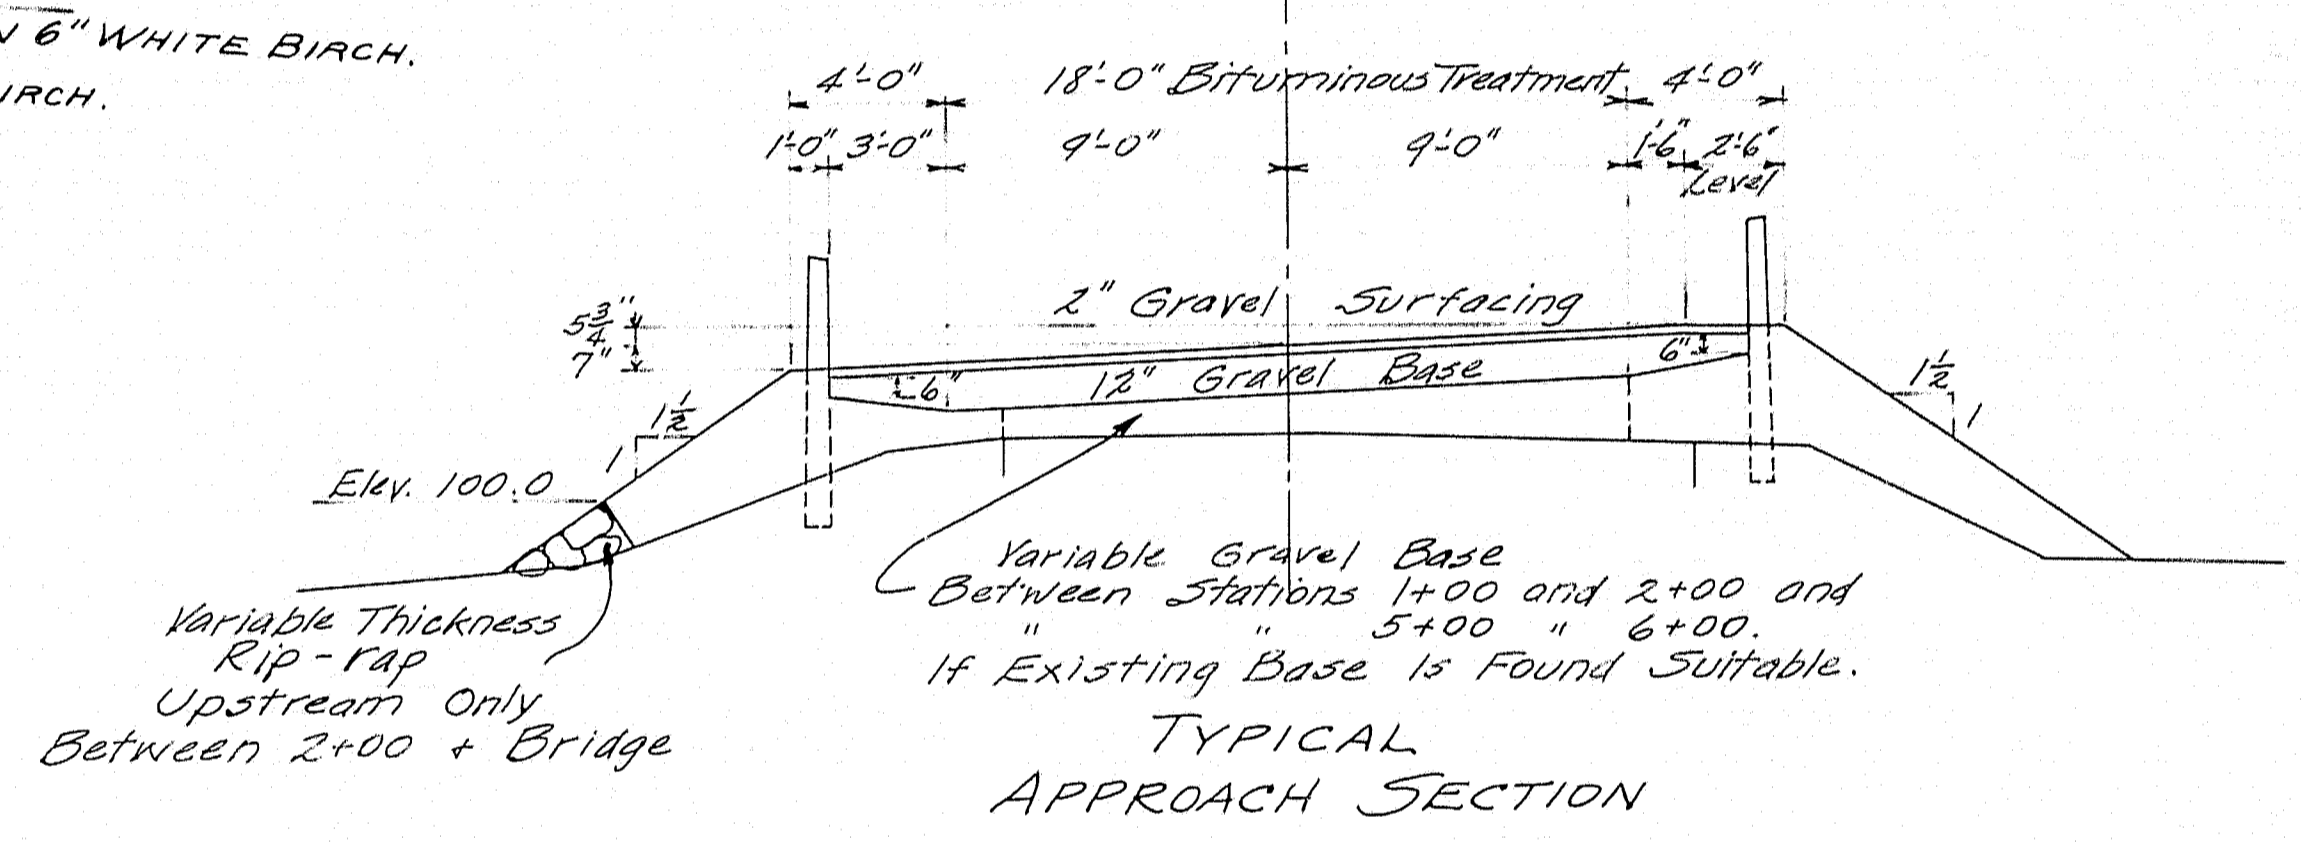
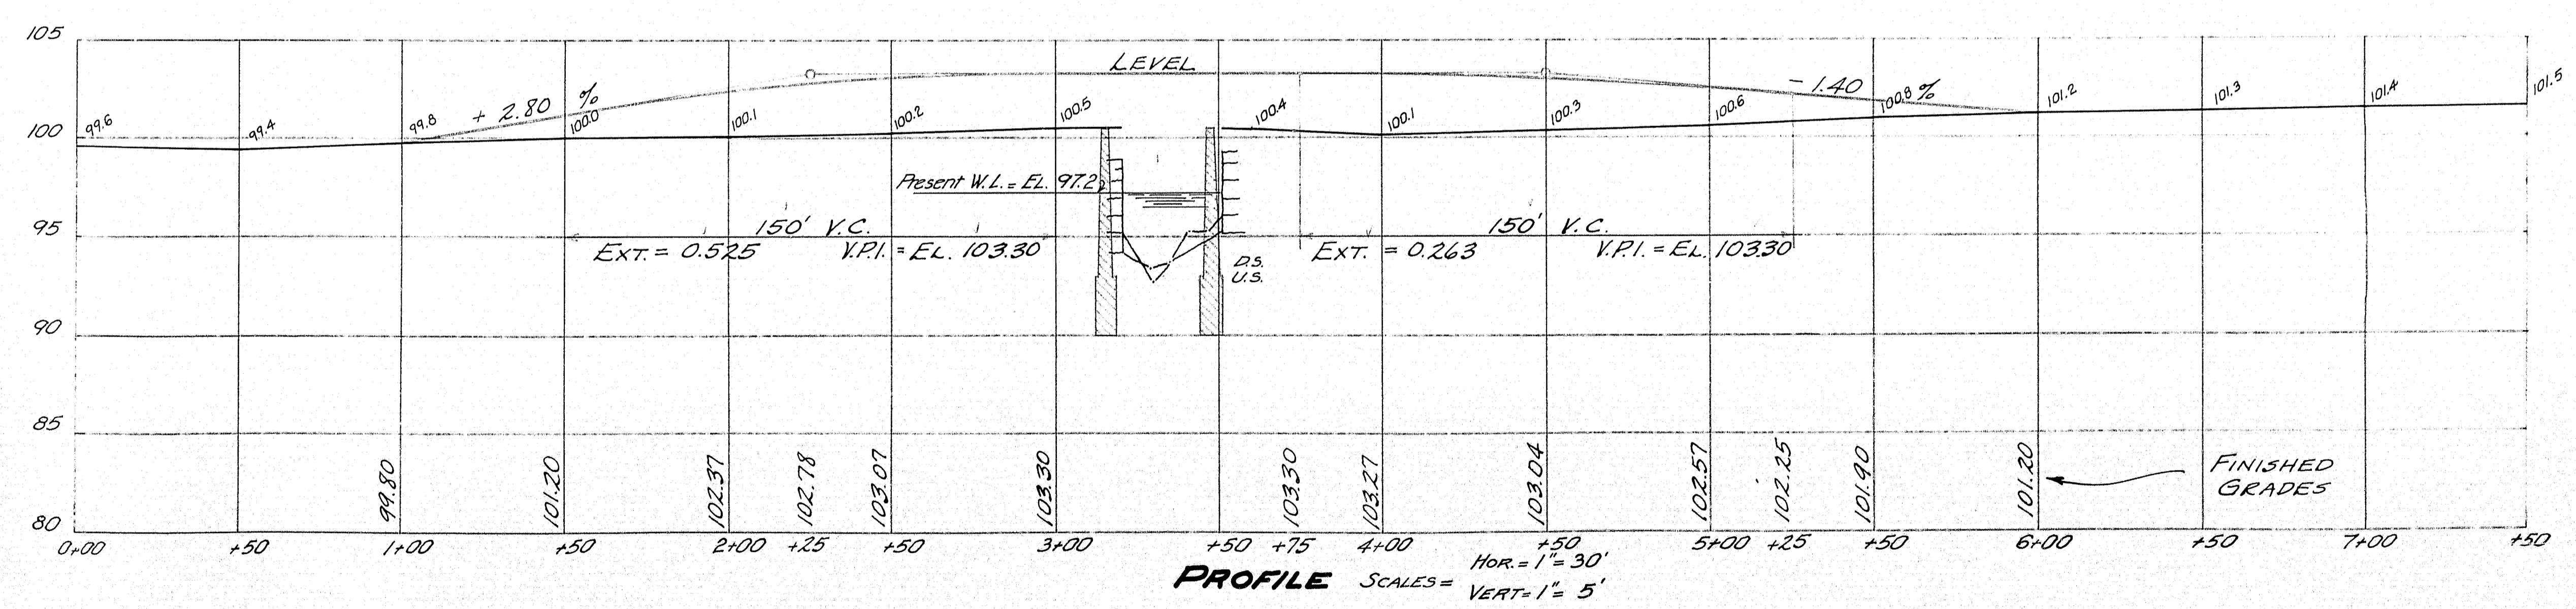
NOTE:  
 SUPERSTRUCTURE: Log stringers in fair condition. Transverse and longitudinal planking, fair condition.  
 SUBSTRUCTURE: Dry laid field stone abutments, poor condition. Three pile bents, fair condition.  
 STREAM: Almost dead water. Brook connects two ponds 1/2 mile apart. Low water about 1' below present level. High water reaches bottom of stringers.  
 FOUNDATION: Sounding taken 20' R of Sta. 4+50. Rod was driven 30' below water to fairly firm material. First 20' thru sandy silt. Remainder thru clay.  
 APPROACHES: Improved gravel. Good condition.
