SURVEY BY BLAKE TOWN 06-14  
 PLANNING BY COTTON BRIDGE 3671  
 STATE HIGHWAY COMMISSION  
 BRIDGE DIVISION  
**BAILEY FLAT BRIDGE**  
 OVER  
**MUD MILL STREAM**  
 IN THE TOWN OF  
**MONMOUTH - KENNEBEC CO.**  
 SURVEY PLAN  
 Sheet 1 of Augusta, Me. July 1939

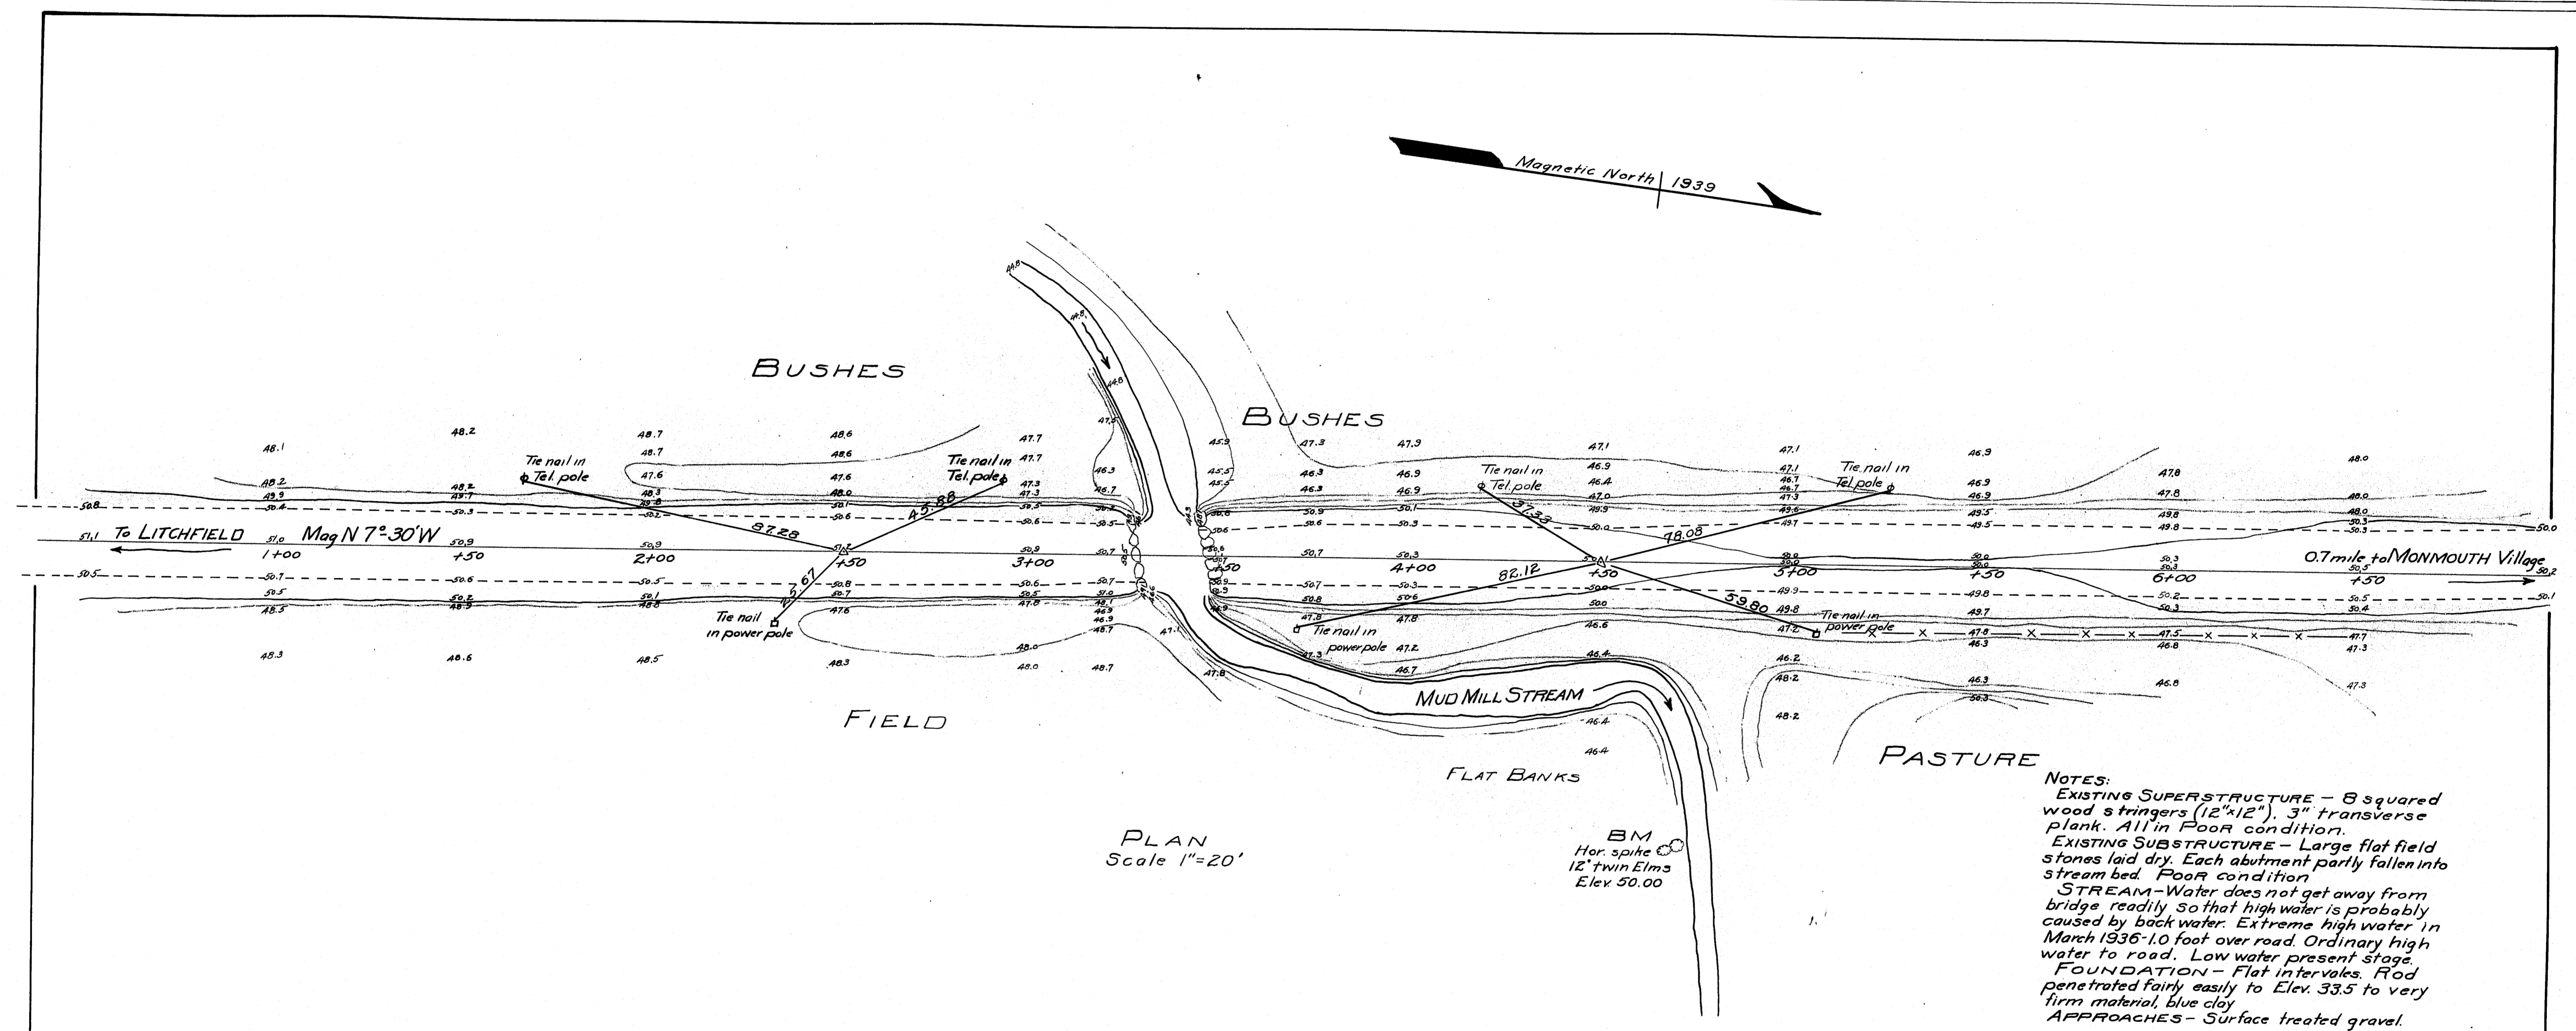
PLAN  
Scale 1"=20'

NOTES:  
 EXISTING SUPERSTRUCTURE - 8 squared wood stringers (12"x12"), 3" transverse plank. All in poor condition.  
 EXISTING SUBSTRUCTURE - Large flat field stones laid dry. Each abutment partly fallen into stream bed. Poor condition.  
 STREAM - Water does not get away from bridge readily so that high water is probably caused by back water. Extreme high water in March 1936 - 1.0 foot over road. Ordinary high water to road. Low water present stage.  
 FOUNDATION - Flat intervals. Rod penetrated fairly easily to Elev. 33.5 to very firm material, blue clay.  
 APPROACHES - Surface treated gravel.
