Project: MAINE LOAD Rating
 Location: Berwick, Maine
 Calculated by: KRW
 Checked by:
 Title BRIDGE Number 1238

Project # 52106.00
 Sheet 1 of 6
 Date: 10-18-11
 Date:
 Field Inspection

Title Bridge # 1238 Field Inspection Notes

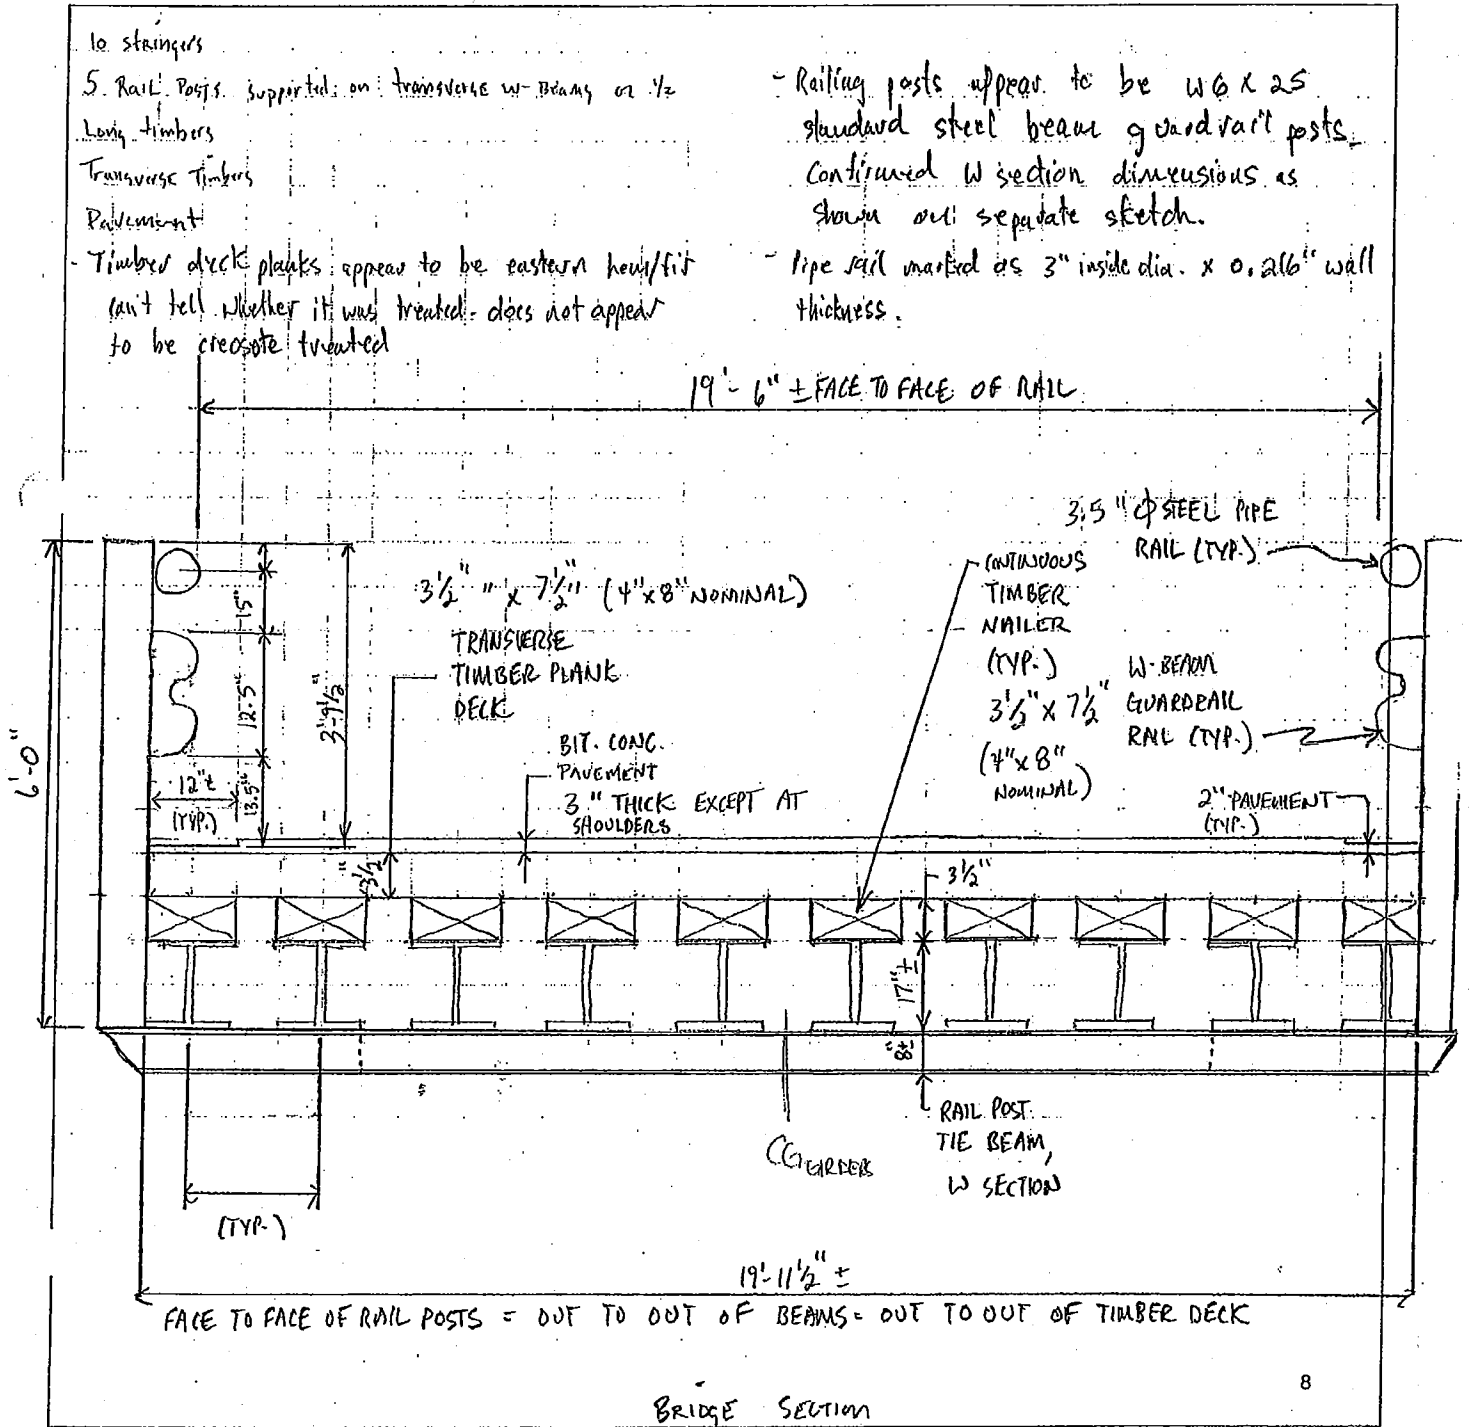
BRIDGE SECTION
(LOOKING NORTH)

- 10 stringers
- 5 Rail Posts supported on transverse W-beams or 1/2 Long timbers
- Transverse Timbers
- Pavement
- Timber deck planks appear to be eastern hemlock (can't tell whether it was treated - does not appear to be creosote treated)

- Railings posts appear to be W6 x 25 standard steel beam guard rail posts. Continuous W section dimensions as shown on separate sketch.
- Pipe rail marked as 3" inside dia. x 0.266" wall thickness.

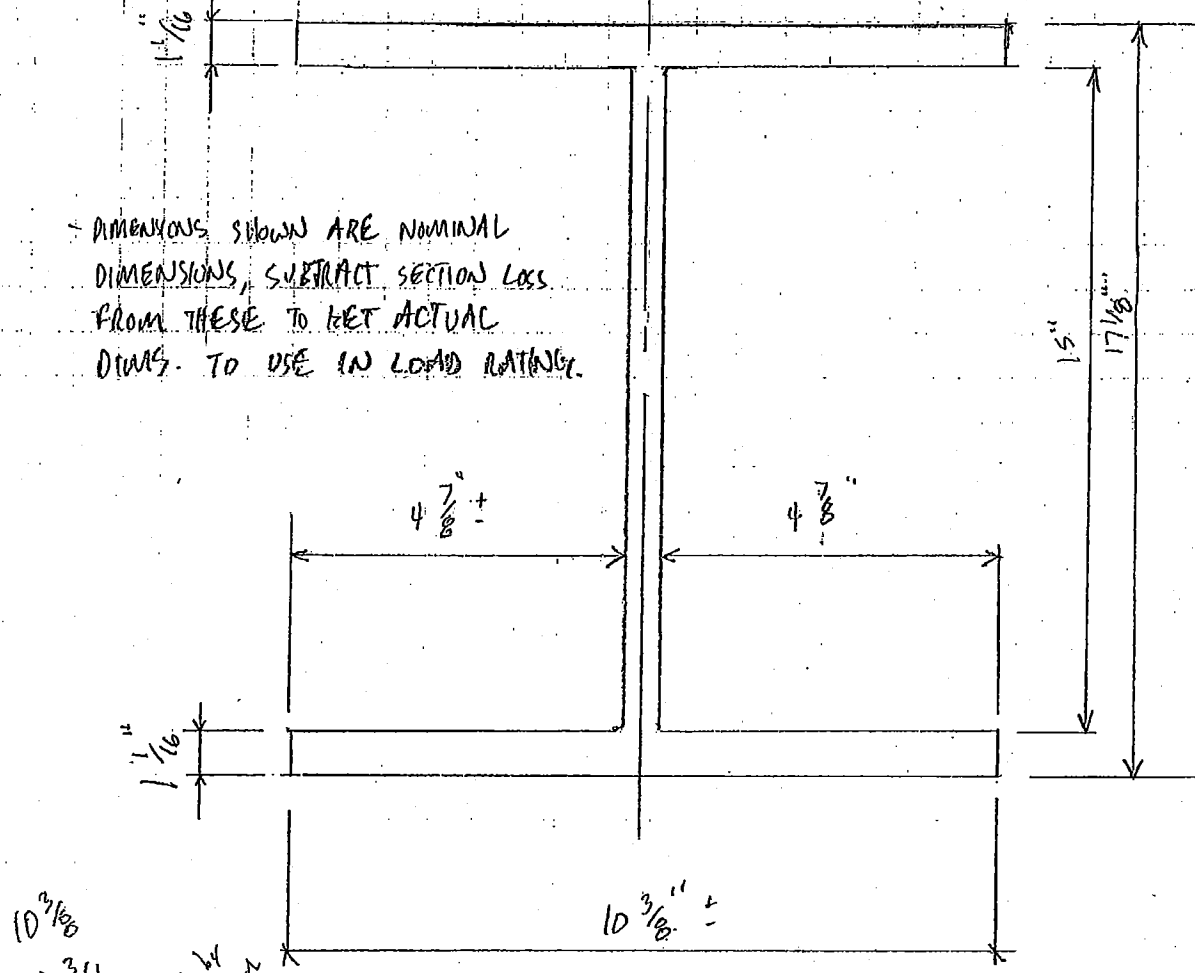
TYPICAL SECTION OF LONGITUDINAL BEAM

NOTE: SEVERE CORROSION ON ALL BEAMS, HEAVY LAMINAR RUST. IN RATING USE
 1/16" SECTION LOSS FROM WEB AND BOTH FLANGE THICKNESSES.
 (TOTAL)

DIMENSIONS SHOWN ARE NOMINAL
 DIMENSIONS, SUBTRACT SECTION LOSS
 FROM THESE TO GET ACTUAL
 DIMS. TO USE IN LOAD RATING.

10 3/8
 - 9 3/4
 5/8 web by calculation

This appears to be
 an HP section.

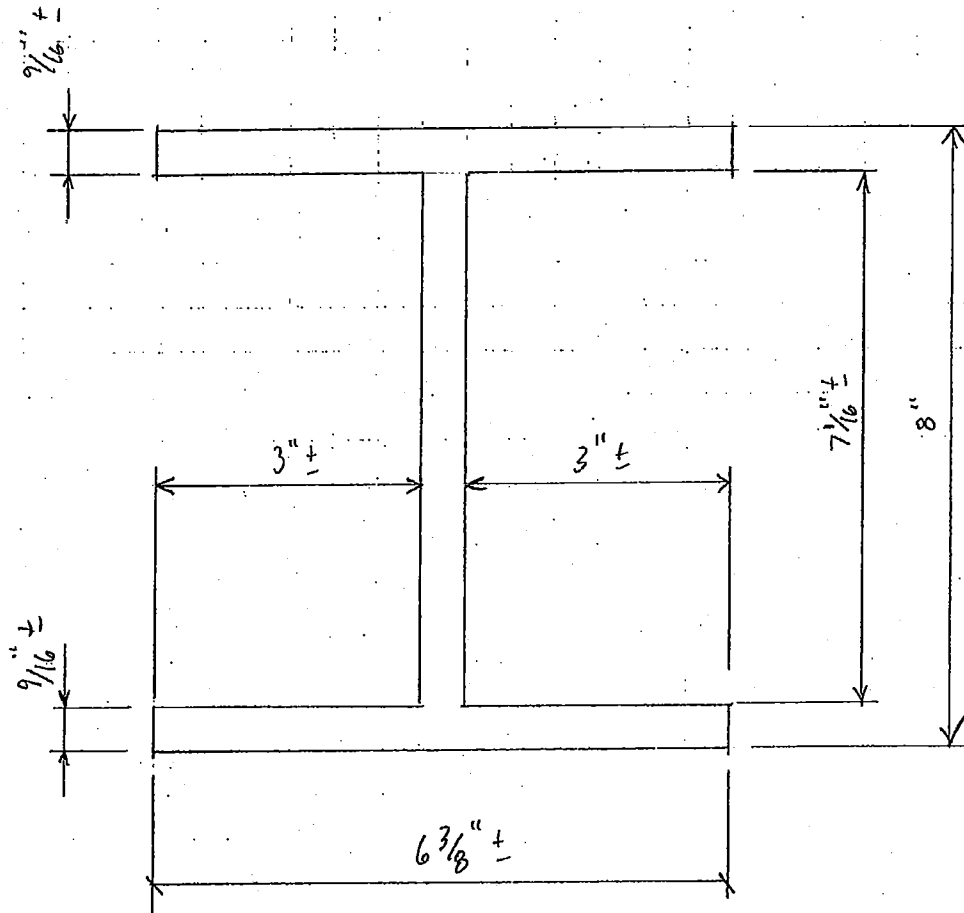
TYPICAL SECTION OF TRANSVERSE RAIL POST TIE BEAM

- THIS IS A NON-STRUCTURAL MEMBER FROM A BRIDGE LOAD RATING PERSPECTIVE
