## TECHNICAL MEMORANDUM

**Project No.** 31404817.004

**RE: GEOTECHNICAL SOIL CORROSIVITY FINDINGS – REV01  
HOGAN ROAD BRIDGE REPLACEMENT, BANGOR, MAINE  
WIN 018595.10**

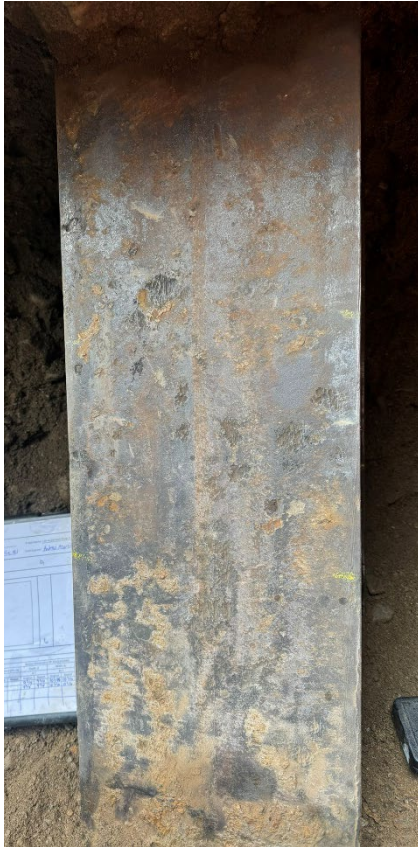
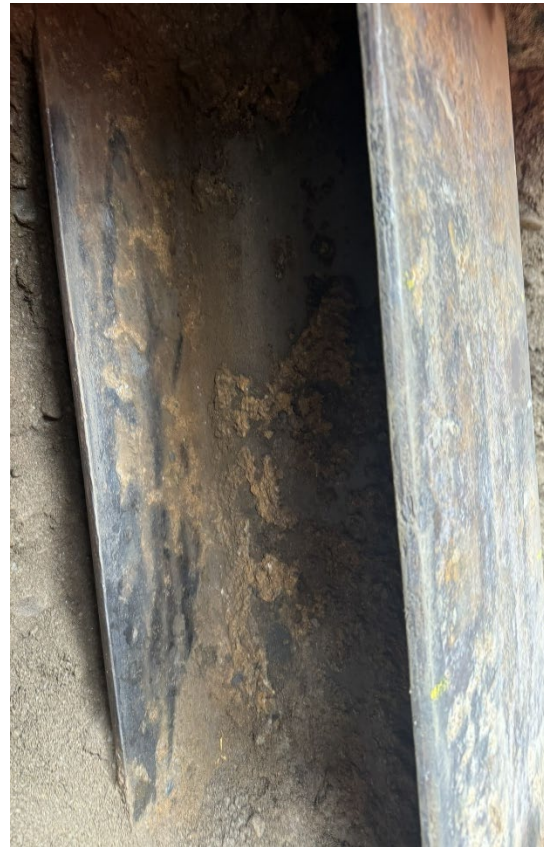
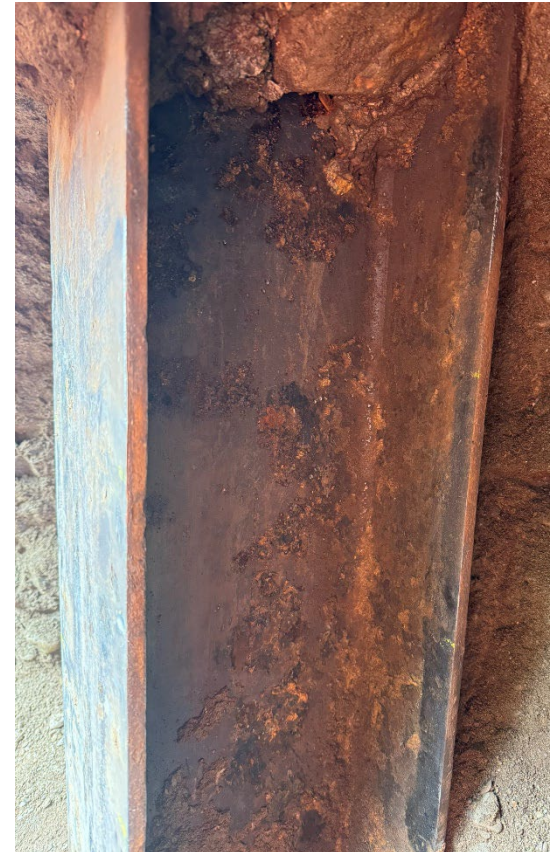
**Abutment 1 Pile #1**

Small spots of rust were observed on the pile, otherwise the pile was in good condition. Pile cap installed in the fill layer. No Groundwater observed during excavation of the piles.

Because of the presence of some rust on the three exposed abutment piles and measured resistivity that could lead to corrosion, WSP recommends corrosion section loss be part of the evaluation of the pile structural resistance for the bridge renovation. In an email<sup>6</sup> dated July 26, 2024, WSP was directed by MaineDOT's Laura Krusinski and Tim Aguilar to consider section loss for the existing bridge for the future 50-year design life for the lesser of either 1/16<sup>th</sup> of an inch or WSP's calculated section loss over 50 years.

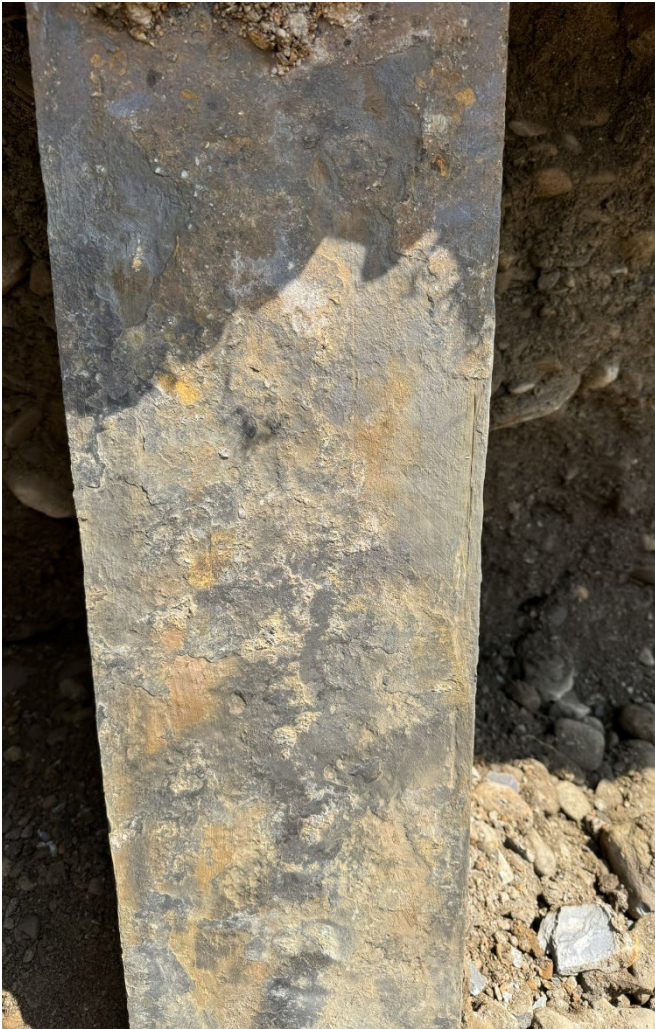
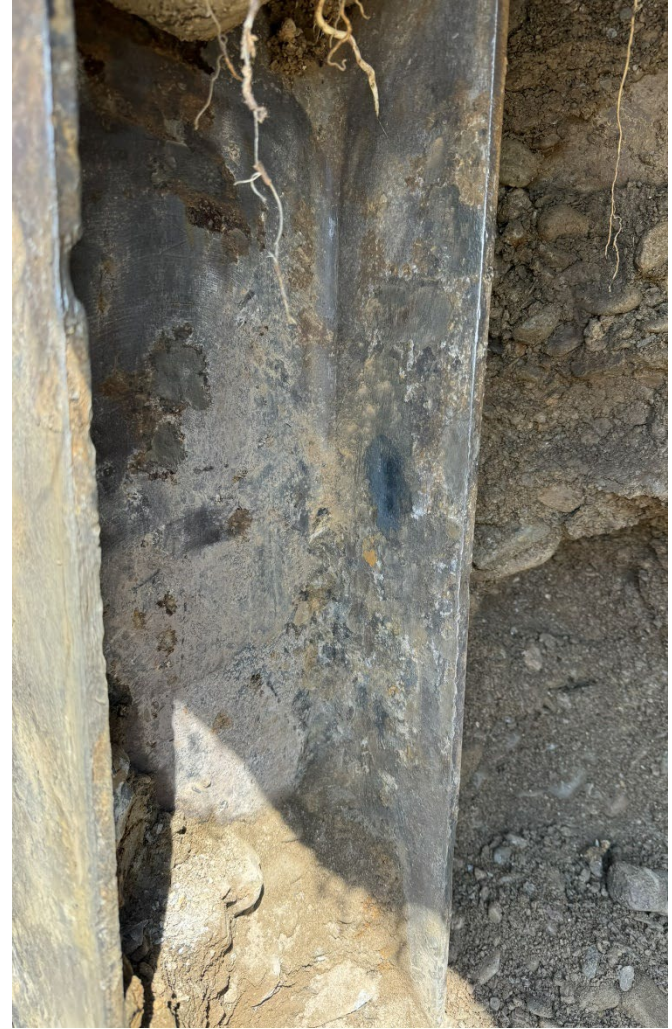
**Abutment 2 Pile #1**

Small spots of rust were observed on the pile, otherwise the pile was in good condition. Pile cap installed in the fill layer. No Groundwater observed during excavation of the piles.

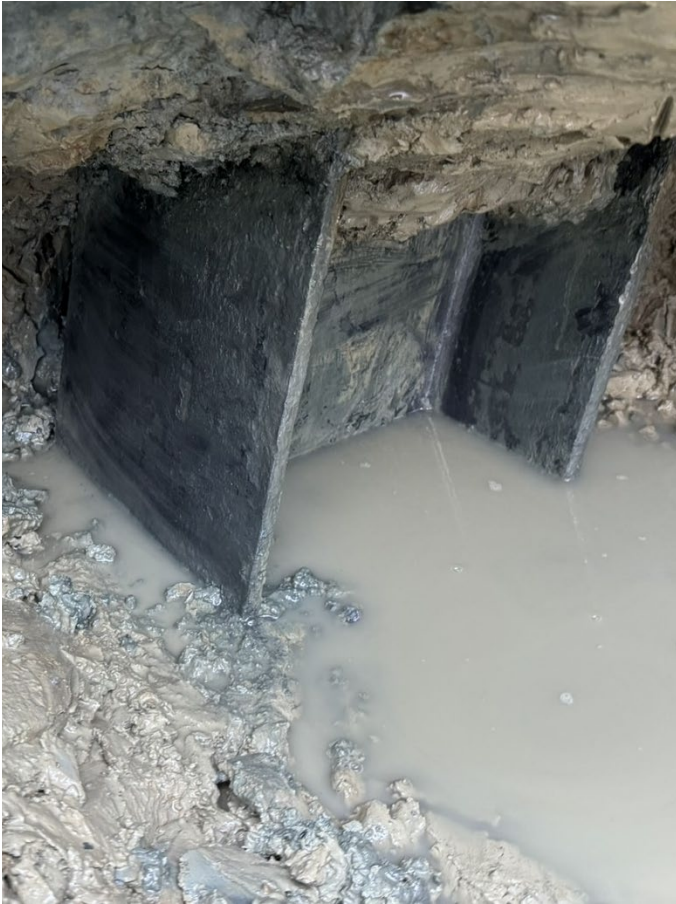
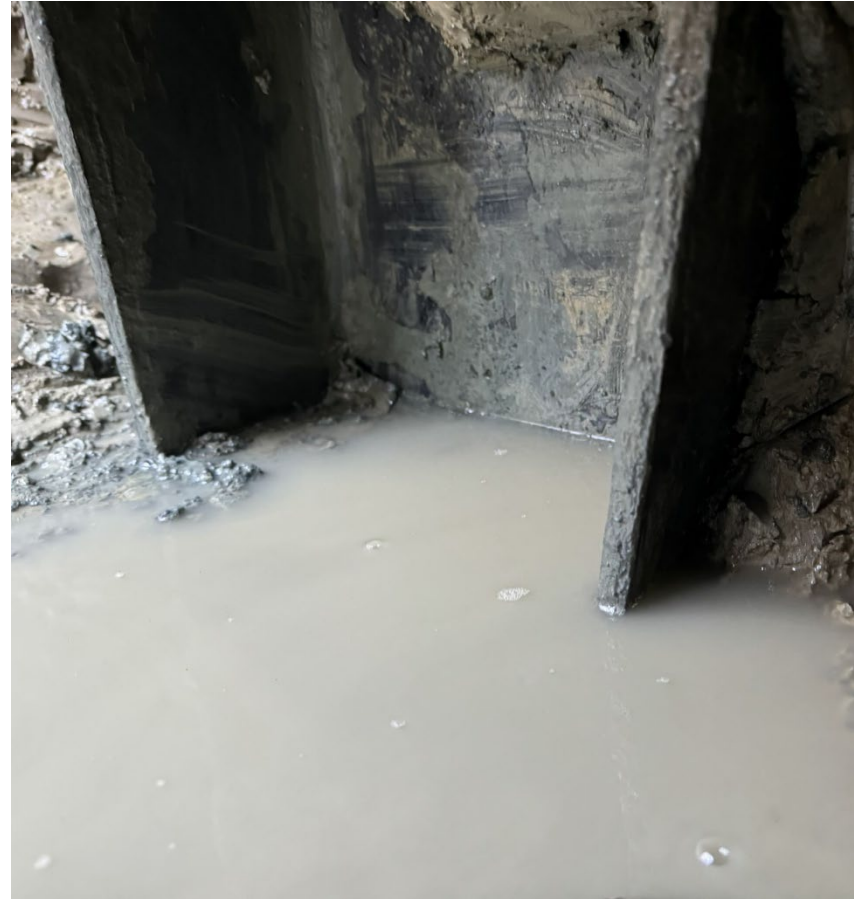
Pier 5 Pile #1

No rust was observed on either pile measured at Pier 5. The pile cap was installed on a silty clay layer. Groundwater was observed seeping in to the excavation approximately 1-foot below the pile cap.
