FINAL ROCK SLOPE REMEDIATION DESIGN REPORT
PROSPECT SOUTH ROCK SLOPE
MAINEDOT WIN 022966.00
PROSPECT, MAINE

File No. 42690-008
May 2023

Subject: Final Rock Slope Remediation Design Report
Prospect South Rock Slope
MaineDOT WIN 022966.00
Prospect, Maine

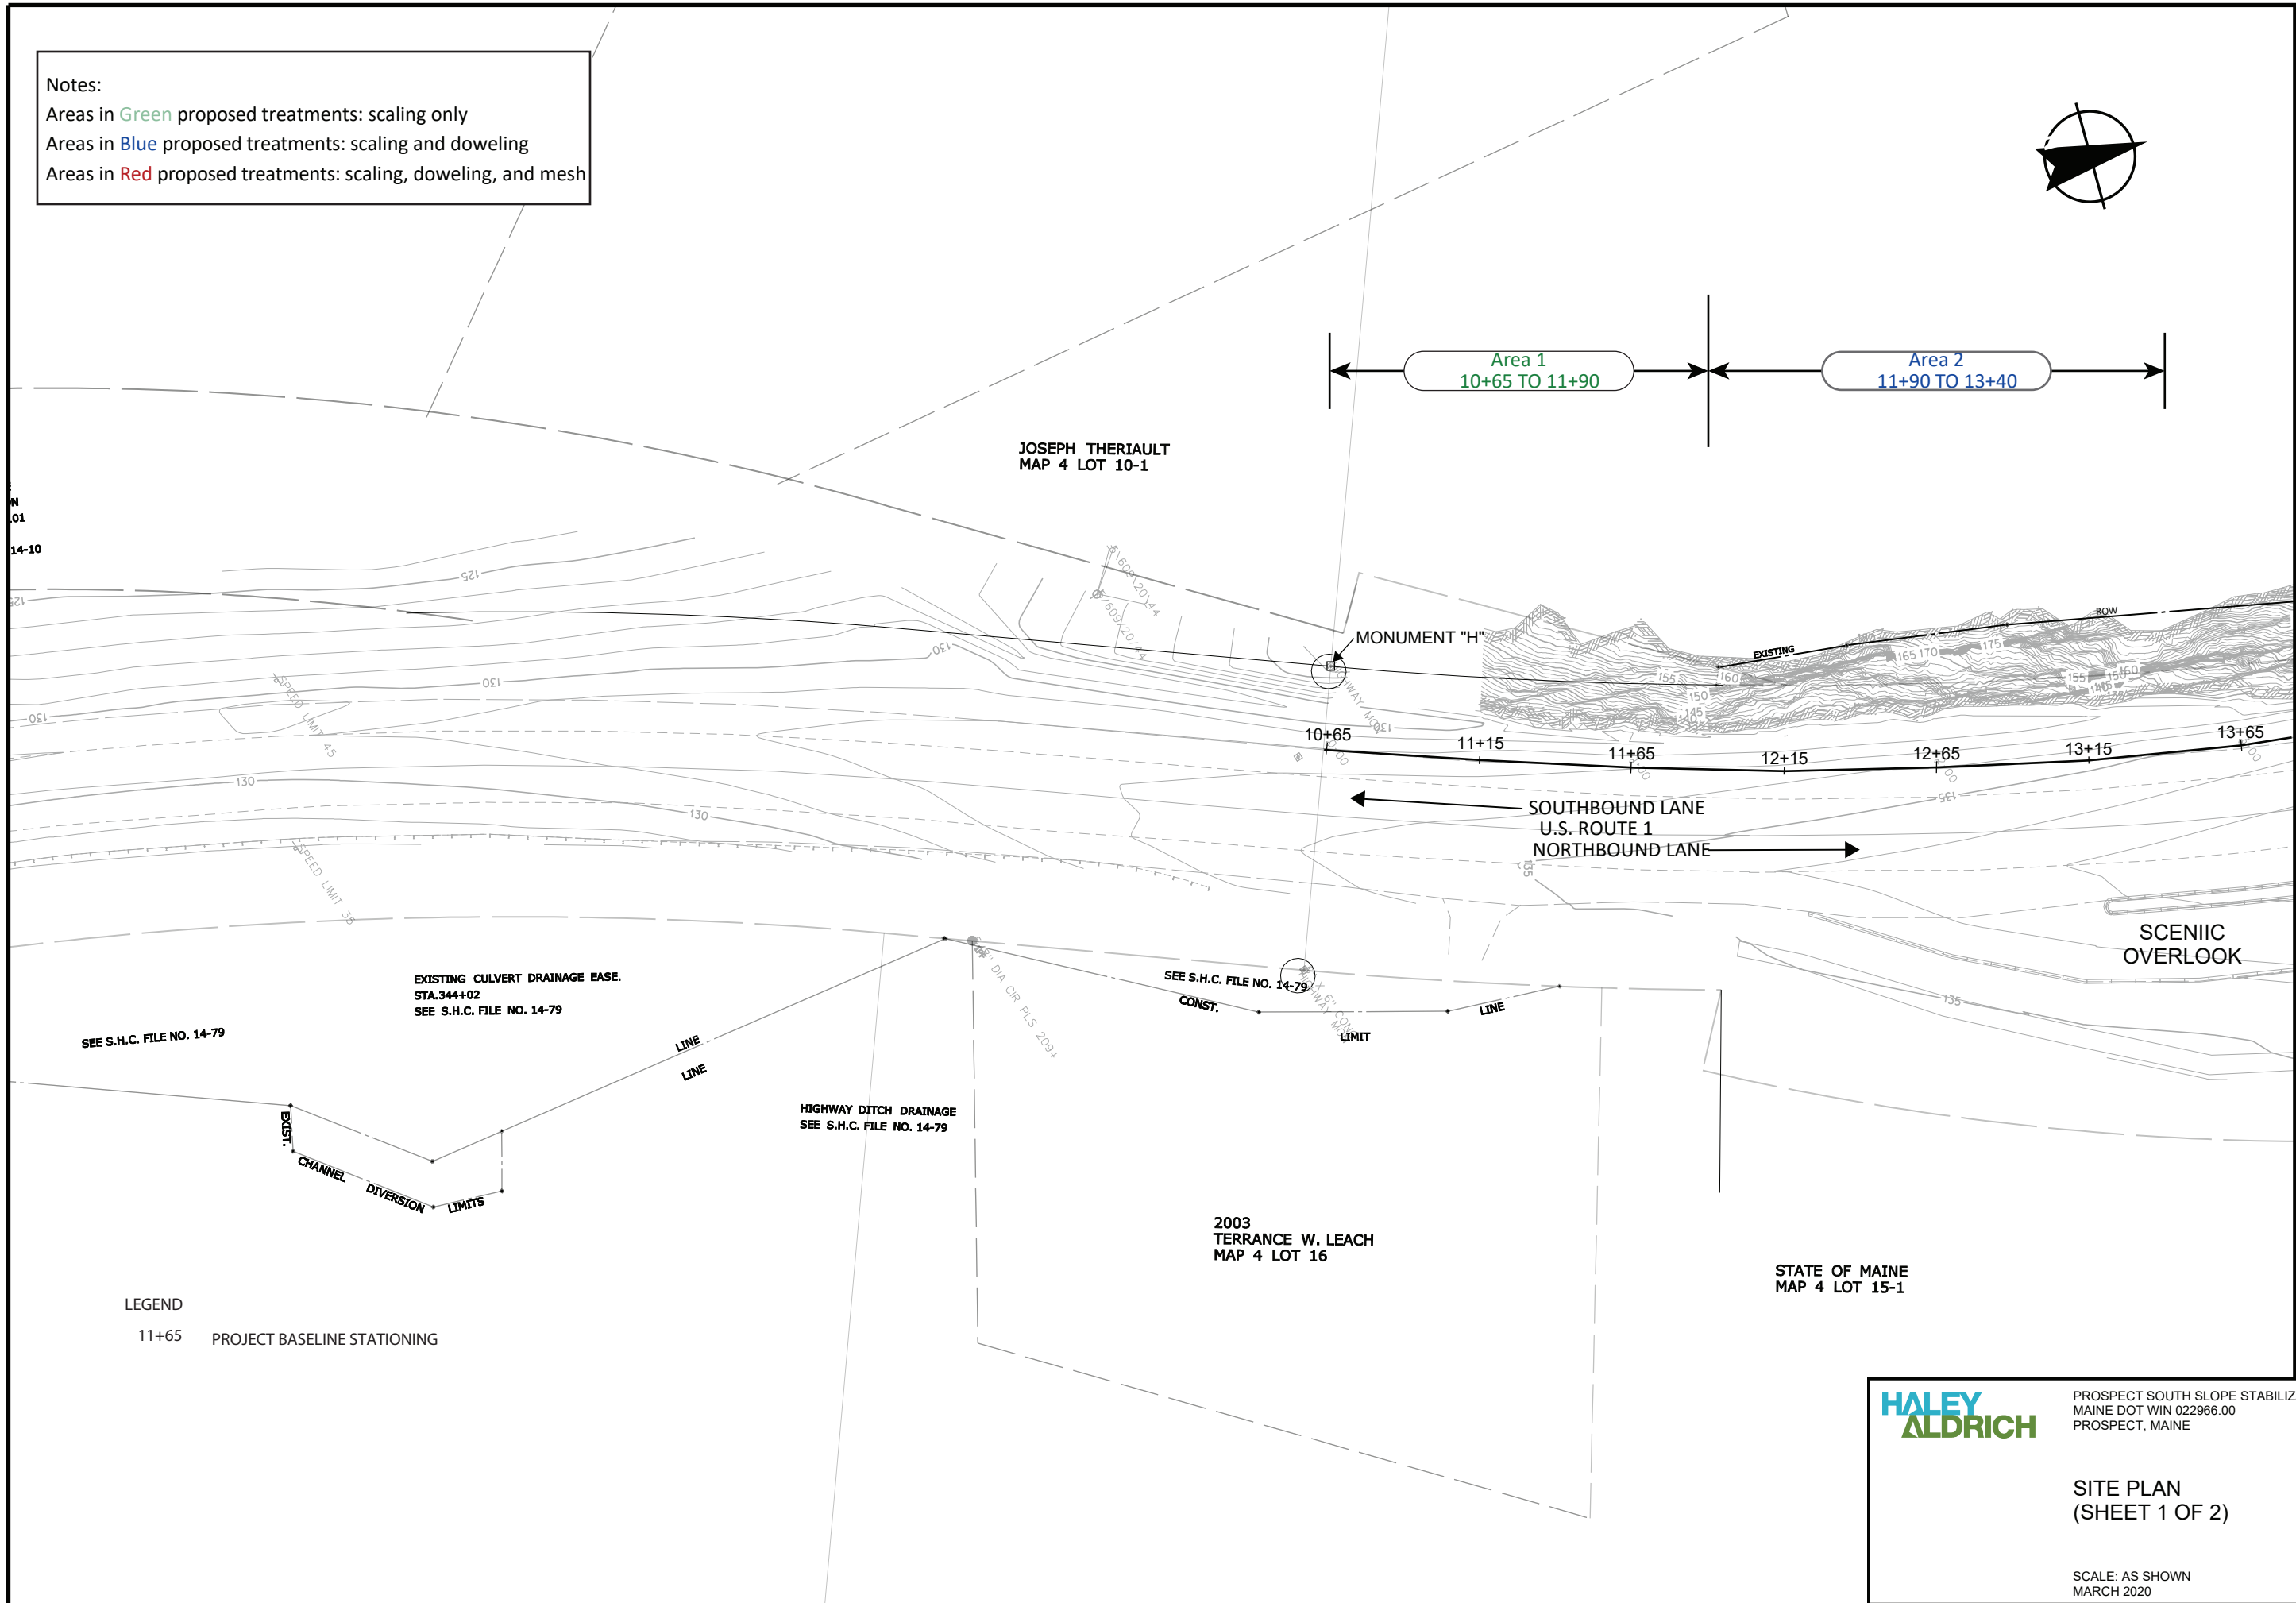
Notes:
 Areas in **Green** proposed treatments: scaling only
 Areas in **Blue** proposed treatments: scaling and doweling
 Areas in **Red** proposed treatments: scaling, doweling, and mesh
