# Highway Bridge Inspection Report

**VARNEYS  
VINE STREET  
over  
GREAT WORKS RIVER**

**Inspection Date:** 10/29/2015

**Structure Number:** 3312

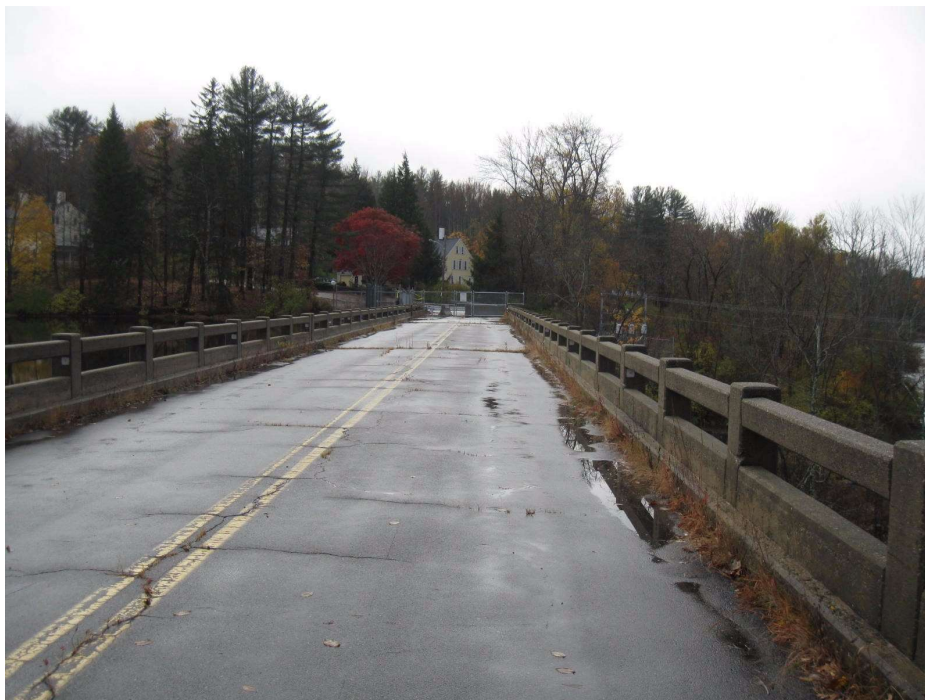
PHOTO 2

Description 3312\_2015\_p02 Topside view closed
