Highway Bridge Inspection Report

**VARNEYS
VINE STREET
over
GREAT WORKS RIVER**

Asset Code: 3312

Inspection Date: 08/08/2017

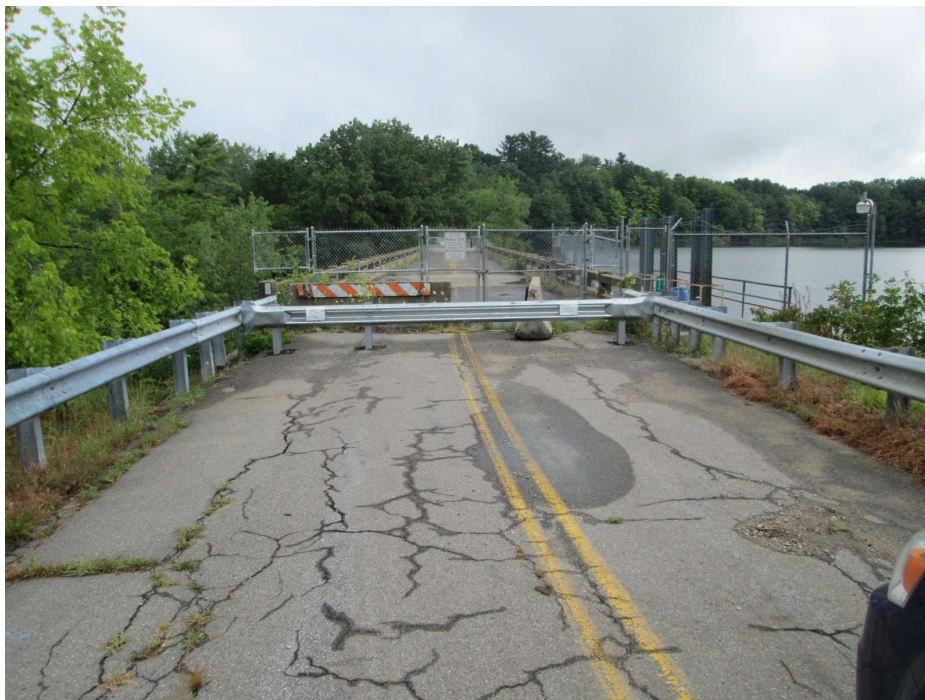
PHOTO 1

Description Roadway looking North - Bridge Closed

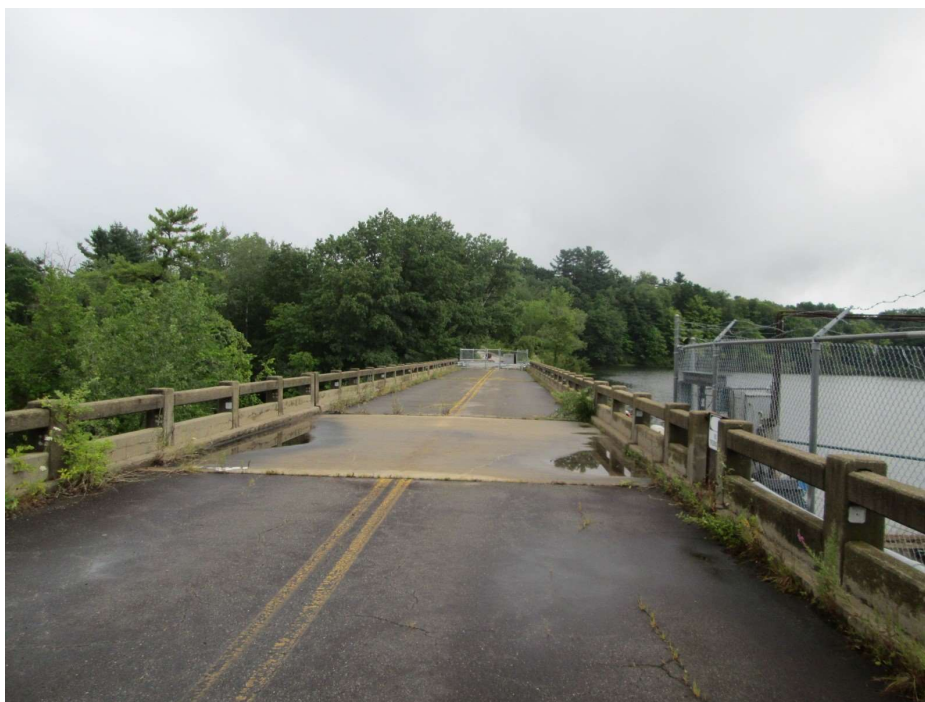
PHOTO 2

Description Wearing surface View
