Routine & Special Member Inspection Report

Bridge No. 2399
BRIDGE AVENUE (INTERNATIONAL BRIDGE)
OVER
ST. JOHN RIVER & CNRR
MADAWASKA, MAINE (U.S.A.) / EDMUNDSTON, NEW BRUNSWICK (CANADA)

June 19, 2020

WIN #: 22035.20

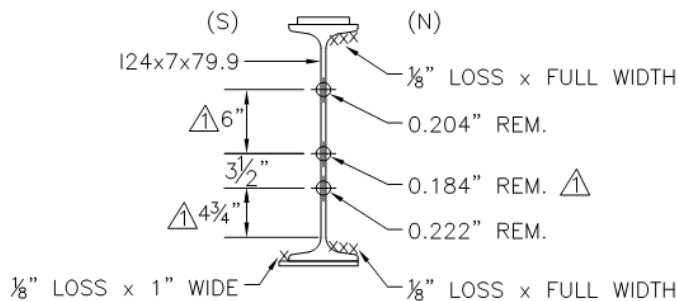
SPAN 1, FLOORBEAM FB0S AT STRINGER S5

NOTE:
SPAN 1, FLOORBEAM FB0S AT STRINGERS S2 & S4: SIMILAR LESS SEVERE CONDITION.

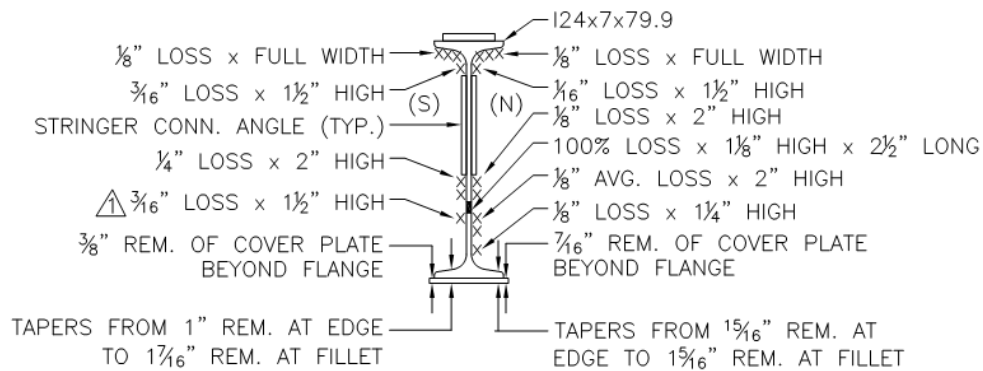
SPAN 3, FLOORBEAM FB5S AT STRINGER S6

NOTE:
 \triangle EAST OF THIS SECTION WITH $\frac{1}{4}$ " LOSS x 1'-3" HIGH ON NORTH FACE AND $\frac{1}{8}$ " AVG. LOSS x 10" HIGH ON SOUTH FACE.

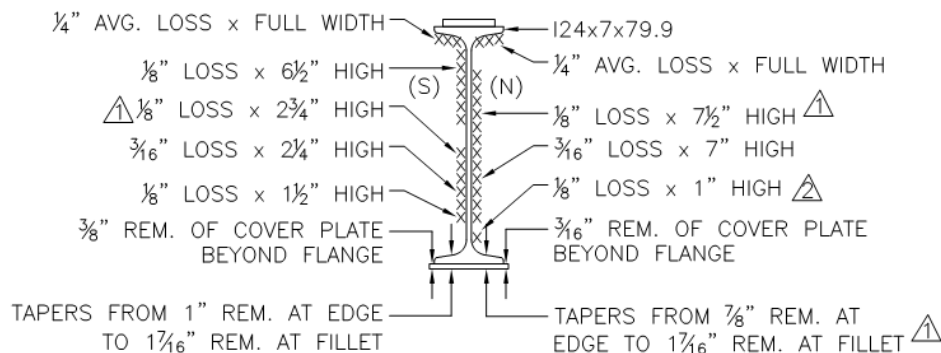
SPAN 4, FLOORBEAM FB1N AT STRINGER S2

NOTES:
1. SIMILAR CONDITION ON THIS FLOORBEAM AT STRINGER S5.
2. SPAN 4, FLOORBEAMS FB2N, FB3N, FB4N & FB6 AT STRINGER S2: SIMILAR LESS SEVERE CONDITION.

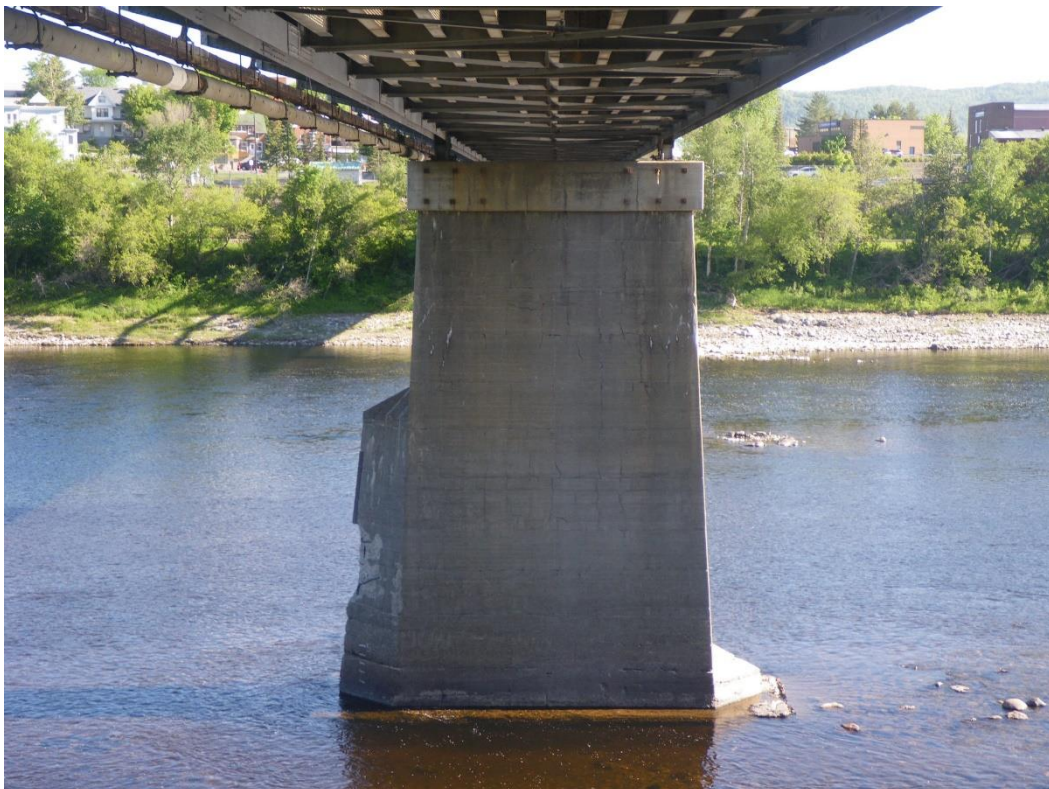
Photo 10: Pier 3, South Face. Note steel post-tensioning rods in pier cap.

- Replacement of the steel grid deck in spans 3 and 4.
- Replacement of the steel curb and fill plate along both trusses in spans 3 and 4.
- Replacement of stringers S1 through S9 (roadway stringers) within all floorbeam bays in spans 3 and 4. All stringer to floorbeam connection angles for these stringers were also replaced.
- Concrete repair with steel post-tensioning rods in the south abutment bridge seat (**see photo 9**).
- Concrete repairs in the exposed surfaces of the south abutment breastwall and wingwalls.
- Concrete repair with steel post-tensioning rods in the pier 3 cap (**see photo 10**).

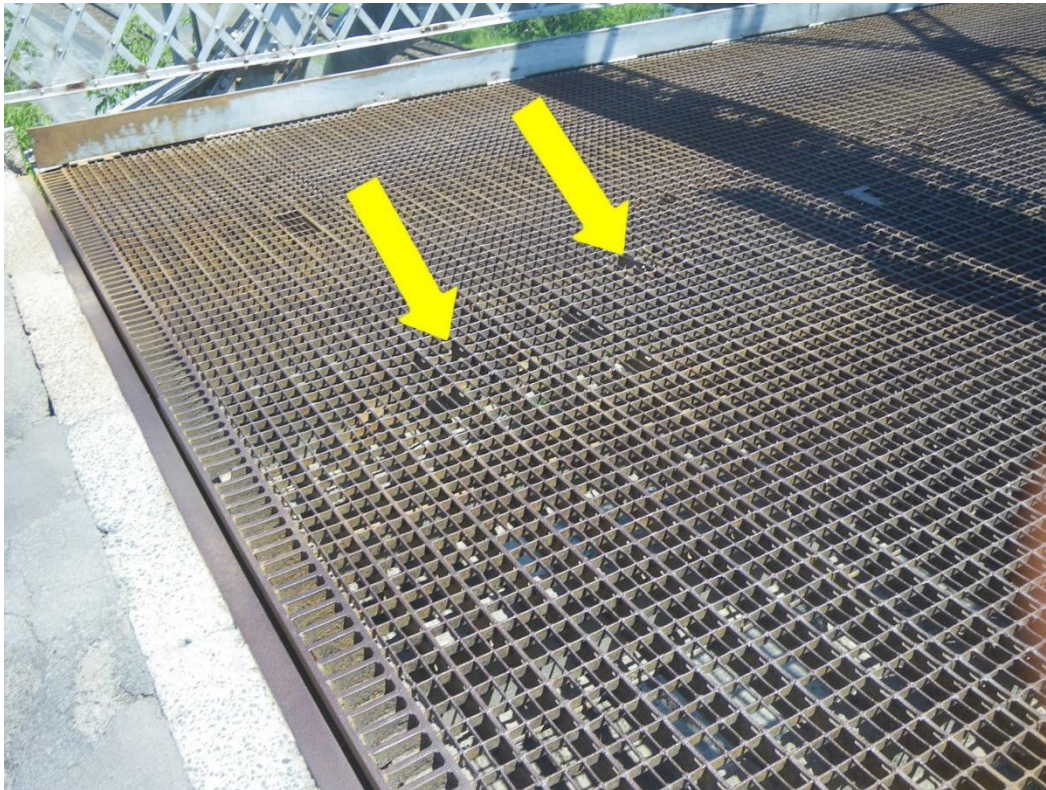
The deck in spans 1 and 2 exhibits numerous distressed areas comprised of cracked, failed or missing sections of the transverse and longitudinal distribution bars (**see chart 1 and photos 11 through 15**). Most of these distressed areas have multiple consecutive distribution bars (up to twelve) with full height cracks and/or missing sections (**see chart 1 and photos 11 through 15**). Isolated distressed areas deflect under truck tire loading (**see chart 1**). The missing sections of the distribution bars form up to 9" long by 6" wide openings in the deck.

Photo 11: Deck between Stringers S5 and S6, near North Abutment, Span 1, Looking Southeast - Transverse and longitudinal distribution bars with missing sections.

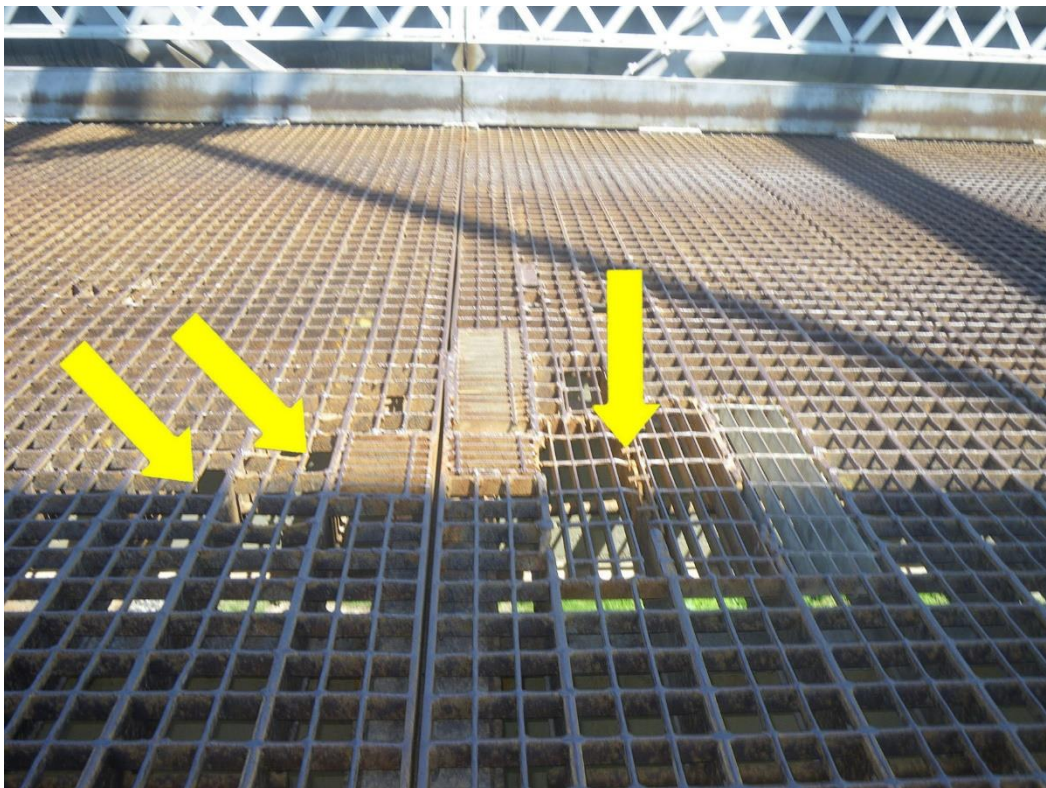
There are numerous previous repairs in the deck in spans 1 and 2 (**see photos 12 and 13**). Scattered repairs have failed, particularly adjacent to distressed areas of distribution bars (**see chart 1 and photos 12 & 13**). Some of these failed repairs have become detached with sharp edges and/or deflect under truck tire loading (**see chart 1 and photo 12**). Isolated failed repairs protrude up to 1/2" higher than the top of the deck. Some repairs have been performed since the 2019 Routine and Fracture Critical Inspection.

Photo 12: Deck between Stringers S4 and S9, at Floorbeam FB4N, Span 1, Looking East - Area of repairs and missing longitudinal and transverse distribution bars. Note one repair with sharp edges.

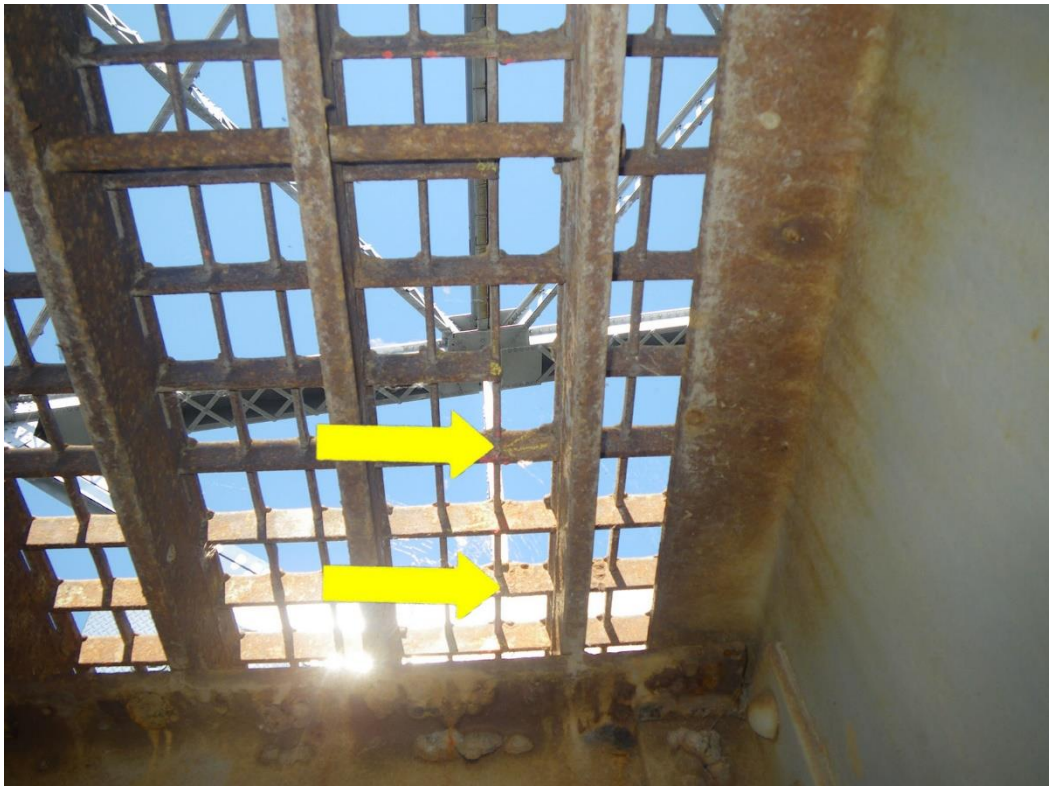
Photo 14: Deck between Stringers S2 and S3, at South Side of Floorbeam FB3S, Span 1, Looking West - Transverse distribution bars with full height cracks or missing sections.

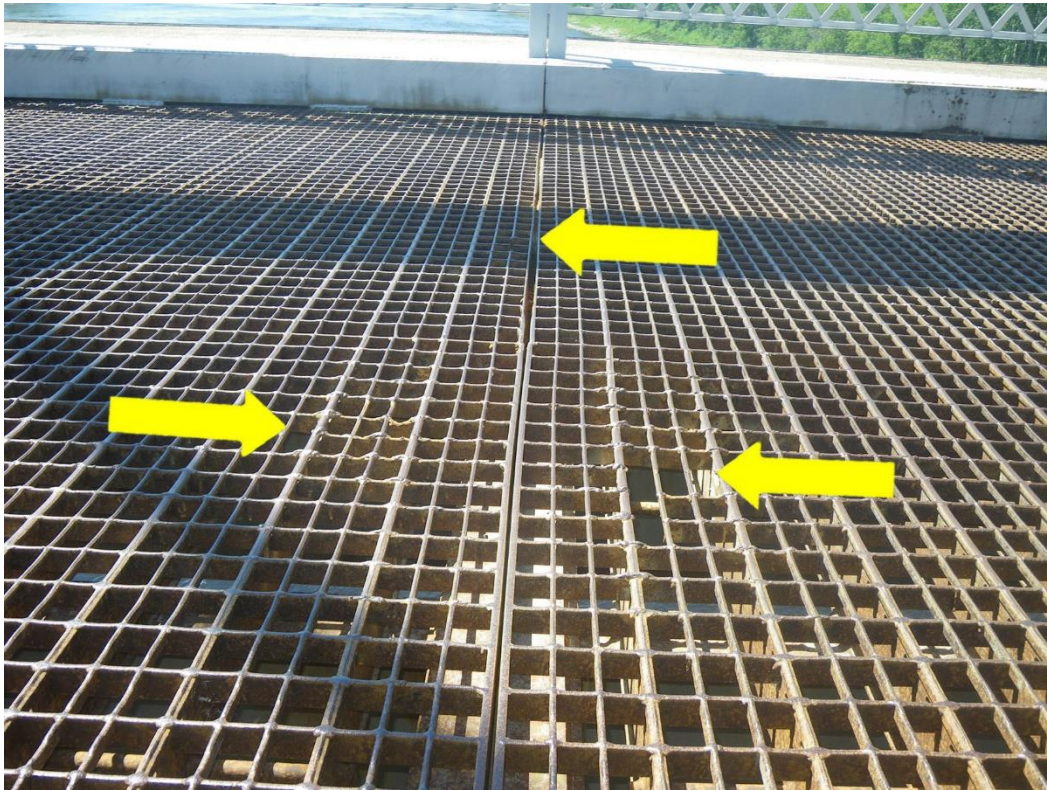
Photo 15: Deck between Stringers S4 to S6, at Floorbeam FB5N, Span 2, Looking West - Failed/missing distribution bars. Note impacted rust between adjacent grid deck panels causing section loss to the edges of the transverse bearing bars.

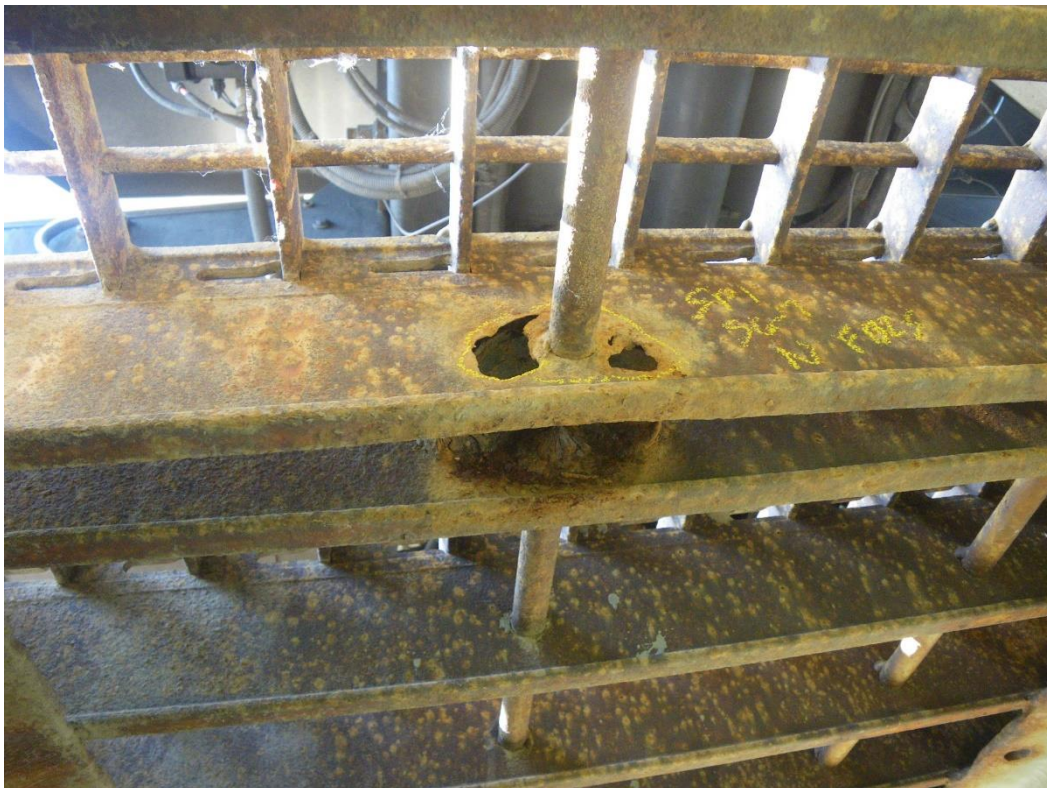
Scattered transverse bearing bars have 100% section loss by up to 2 1/4" high by 3" long around the longitudinal circular diaphragm bar (**see chart 1 and photo 16**). There is up to 1" impacted rust between adjacent grid deck panels at isolated floorbeams. This impacted rust is causing advanced section loss to the edges of the transverse bearing bars (**see chart 1 and photo 15**). In span 1, four transverse welds between the grid deck and the floorbeam FB5N top flange are cracked between stringers S6 and S9 (**see chart 1 and photo 13**). These cracked welds do not propagate into the floorbeam top flange.

Photo 16: Deck between Stringers S6 and S7, at 3'-6" North of Floorbeam FB2S, Span 1, Looking South - Transverse bearing bar with area of 100% section loss around the longitudinal circular diaphragm bar.

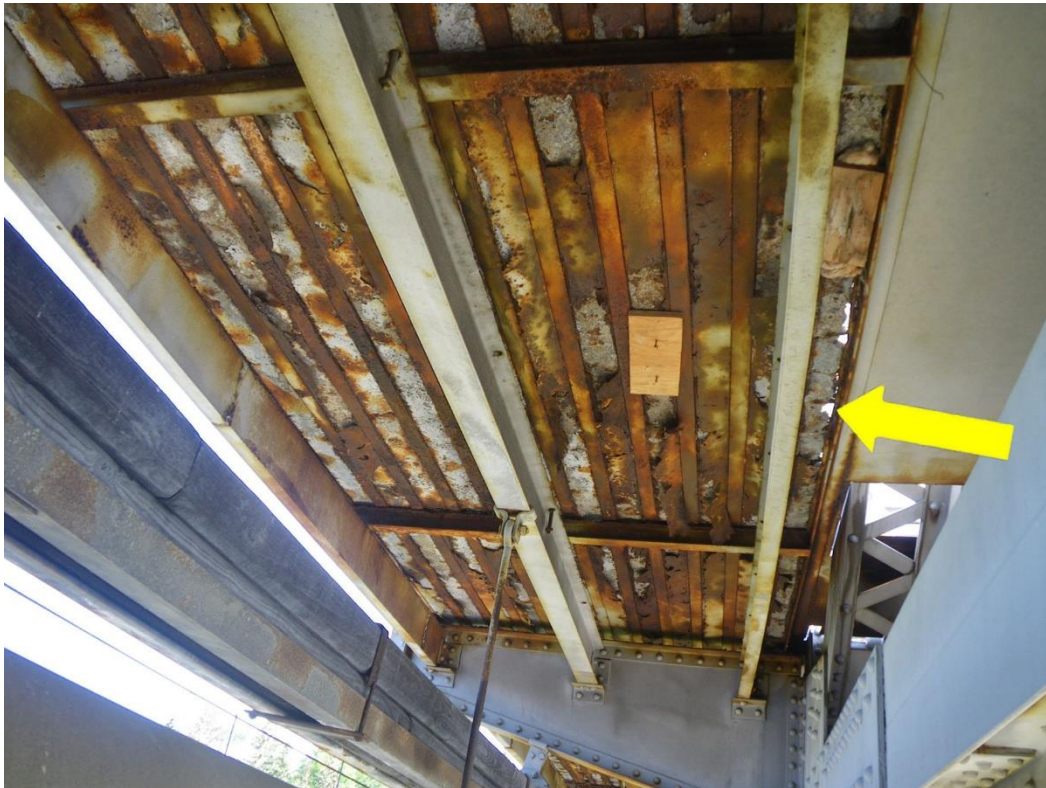
The stay-in-place forms in spans 1 and 2 are in serious condition and govern the condition rating of Item 58.3. The stay-in-place forms for the sidewalk in spans 1 and 2 exhibit extensive areas of 100% section loss by full width between the longitudinal bars of the concrete filled steel grid deck sidewalk throughout (**see photo 17**). These areas of 100% section loss extend up to full sidewalk width by up to full floorbeam bay length. The remaining areas of stay-in-place forms in spans 1 and 2 exhibit heavy rust and advanced section loss. Refer to Item 58.6 for additional comments.

There are scattered full width 1/16" wide transverse cracks in the top of the sidewalk in spans 1 and 2. The top of the sidewalk in spans 1 and 2 exhibits areas of 1/2" deep scaling, particularly throughout span 1 and near pier 1 in span 2 (**see photos 18 and 19**). The top of the sidewalk in spans 1 and 2 exhibits scattered up to 3'-0" long by up to 5" wide by 3/4" deep spalls along the edges, isolated extending up to 5'-8" long by up to 1 1/4" deep. The sidewalk in span 1 has scattered full depth spalls along the edges extending up to 11" long by 9" wide or 1'-6" long by up to 3" wide (**see photos 17 through 19**).

The longitudinal (main) bars of the concrete filled steel grid deck sidewalk in spans 1 and 2 exhibit a failed paint system and moderate rust (**see photo 17**). The underside of the concrete infill for the sidewalk in spans 1 and 2 is predominately exposed due to the 100% section loss of the stay-in-place forms and exhibits isolated areas of up to 1 1/2" deep spalling (**see photo 17**).

Photo 17: Stay-In-Place Forms between Floorbeams FB4S and FB3S, Span 1, Looking North - 100% section loss by full sidewalk width by full floorbeam bay length. Note sidewalk with failed paint system and rust of longitudinal bars, up to full depth spalls and previous repairs.

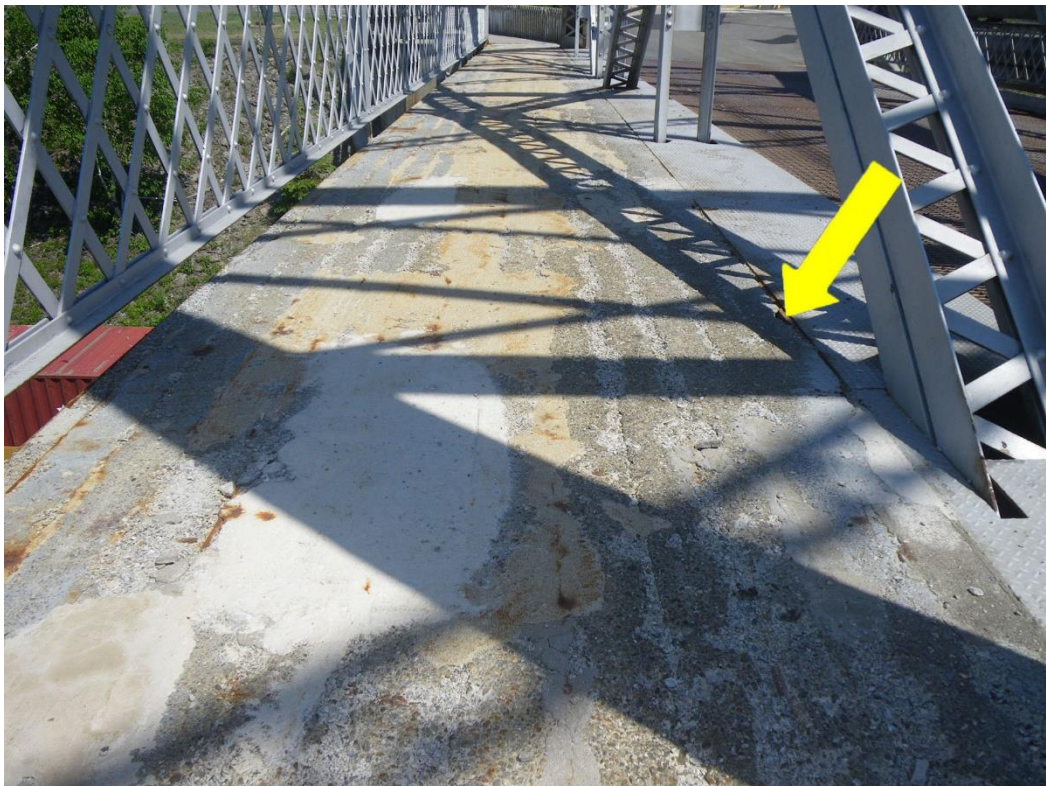
The top of the concrete filled steel grid deck sidewalk in spans 1 and 2 is in poor condition and governs the condition rating of Item 58.6. There is a thin concrete patch layer on top of the sidewalk in spans 1 and 2, particularly the north half of span 1 (**see photo 18**). This thin concrete patch layer does not cover the full width of the sidewalk and is in scattered areas for the south half of span 1 and all of span 2. The thin concrete patch layer on top of the sidewalk is breaking up along the interface with the approach sidewalk at the north abutment. The top of the distribution bars of the steel grid deck sidewalks in spans 1 and 2 are exposed throughout with moderate surface rust (**see photos 18 and 19**).

Photo 18: Top of Sidewalk between Panel Points L3N and L4N, Span 1, Looking North - Thin concrete patch layer not covering full width of sidewalk, exposed distribution bars with rust, scaling, full depth spalling along curb and previous repairs.

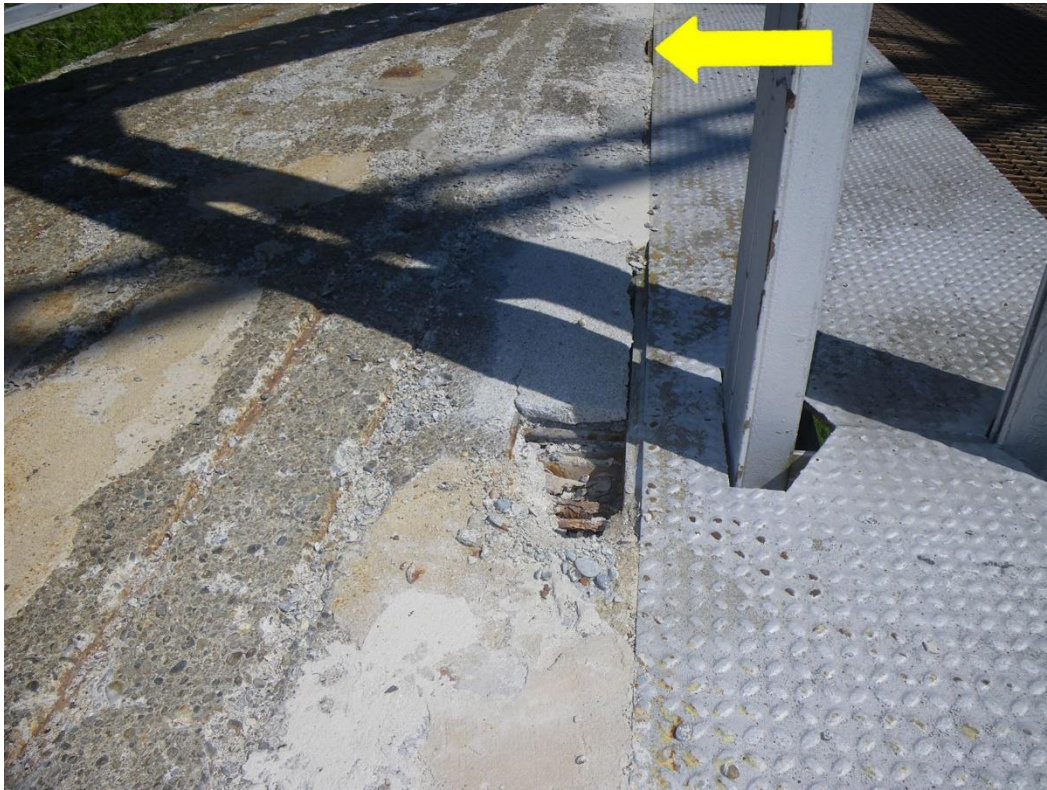
Photo 19: Top of Sidewalk at Panel Point L3S, Span 1, Looking North - Exposed top of distribution bars with surface rust, scaling, full depth spall and previous repairs.

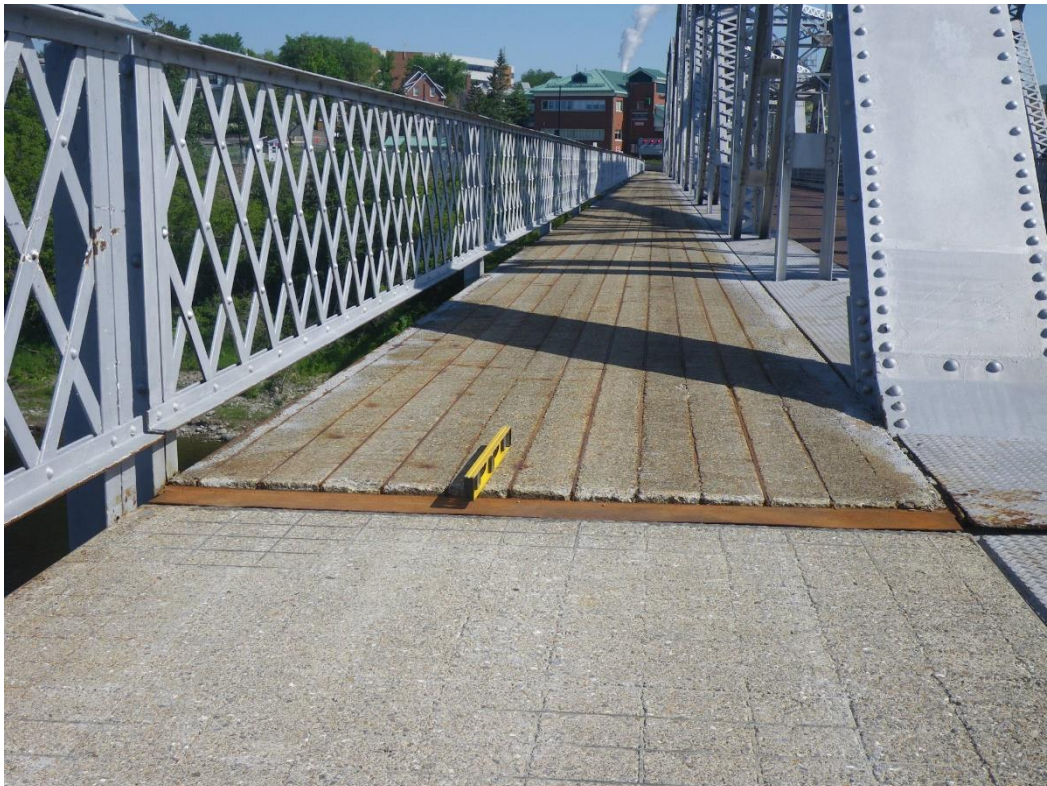
Photo 20: Deck Top of Sidewalk at Pier 2, Spans 2 and 3, Looking North - Vertical differential between spans.

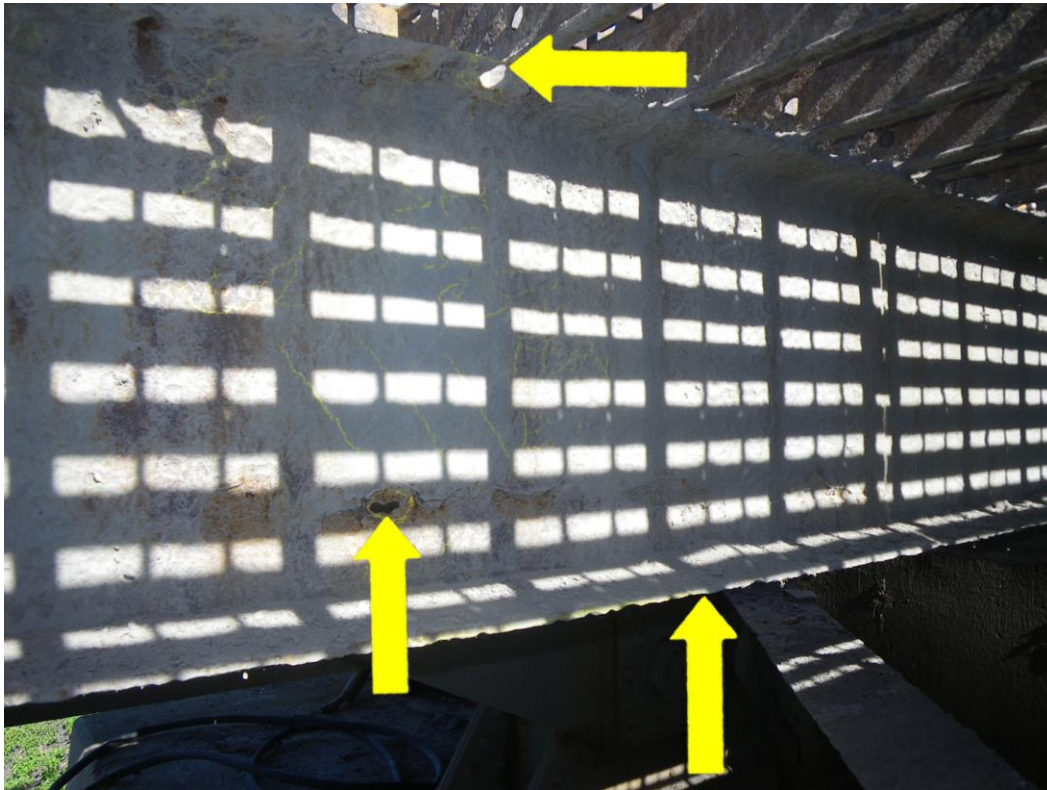
Photo 21: Stringer S8 at 5'-6" from Floorbeam FB0N, East Face, Span 1 - Section loss of flanges and web including areas of 100% section loss. Note top flange 100% section loss encompasses a vacant drilled hole.

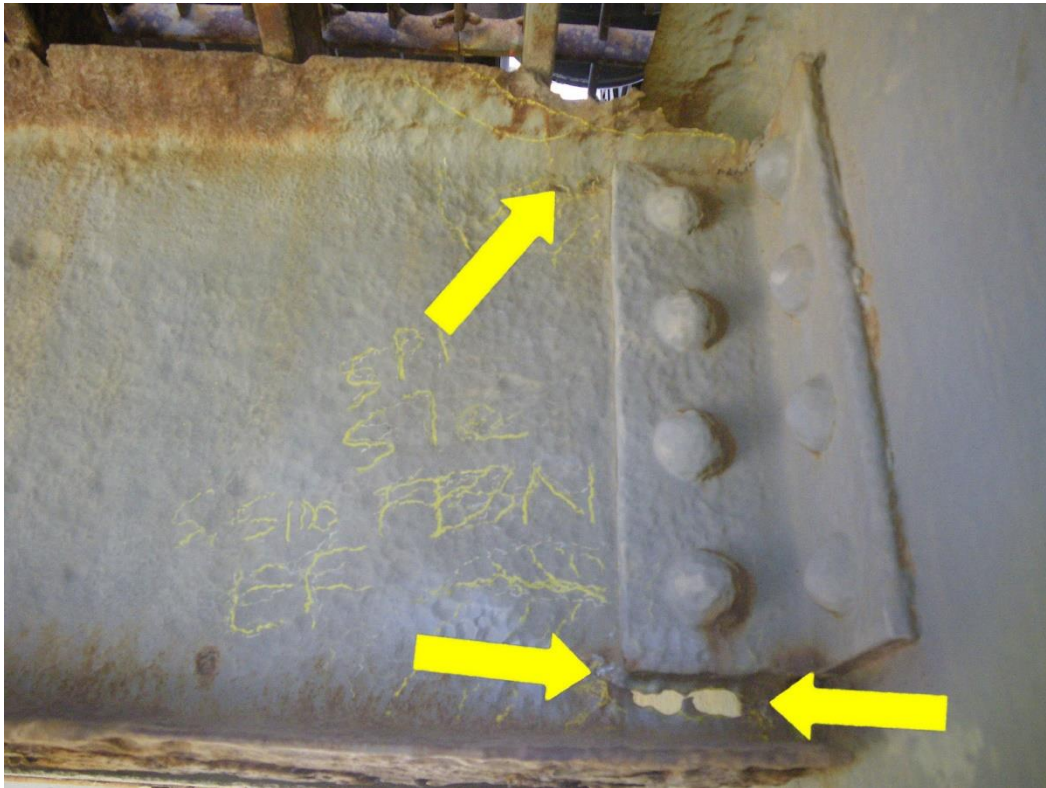
The roadway stringers (stringers S1 to S9) in spans 1 and 2 are in poor condition and govern the condition rating of Item 59.1, particularly in span 1. The roadway stringers in spans 1 and 2 exhibit advanced section loss of the top flange throughout including areas of 100% section loss by up to 1 5/8" wide of one/both edges within the midspan region (**see sketches 4 through 8 and photos 21 through 25**). Many of these areas of 100% section loss in the top flanges encompass a vacant 7/8" diameter drilled hole, which is most likely from the anchors for the removed timber deck (**see sketches 4, 5 & 8, and photos 21 & 22**). Numerous roadway stringers have 100% section loss by up to full width of one/both halves of the top flange at the floorbeams (**see sketches 5 through 7 and photos 23 through 25**).

Photo 23: Stringer S7 at South Side of Floorbeam FB3N, East Face, Span 1 - Section loss of flanges and web including areas of 100% section loss. Note corrosion cracks in web.

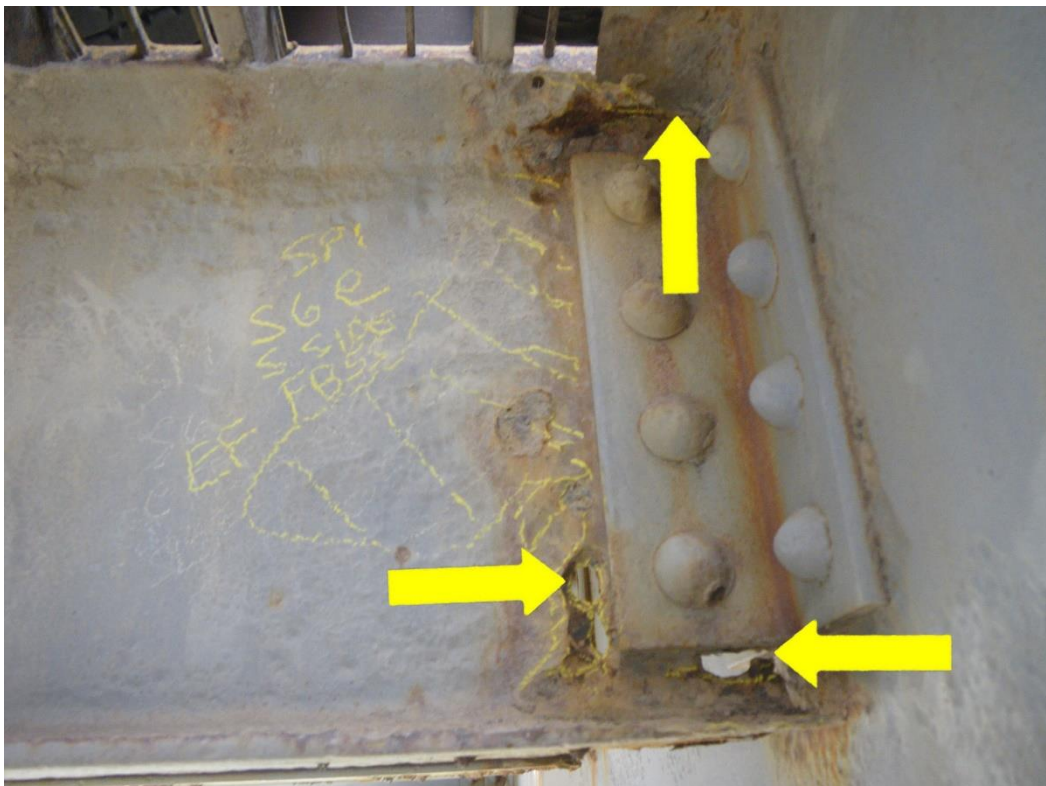
Photo 24: Stringer S6 at South Side of Floorbeam FB5S, East Face, Span 1 - Section loss of flanges and web including areas of 100% section loss. Note corrosion crack in web and failed paint system.

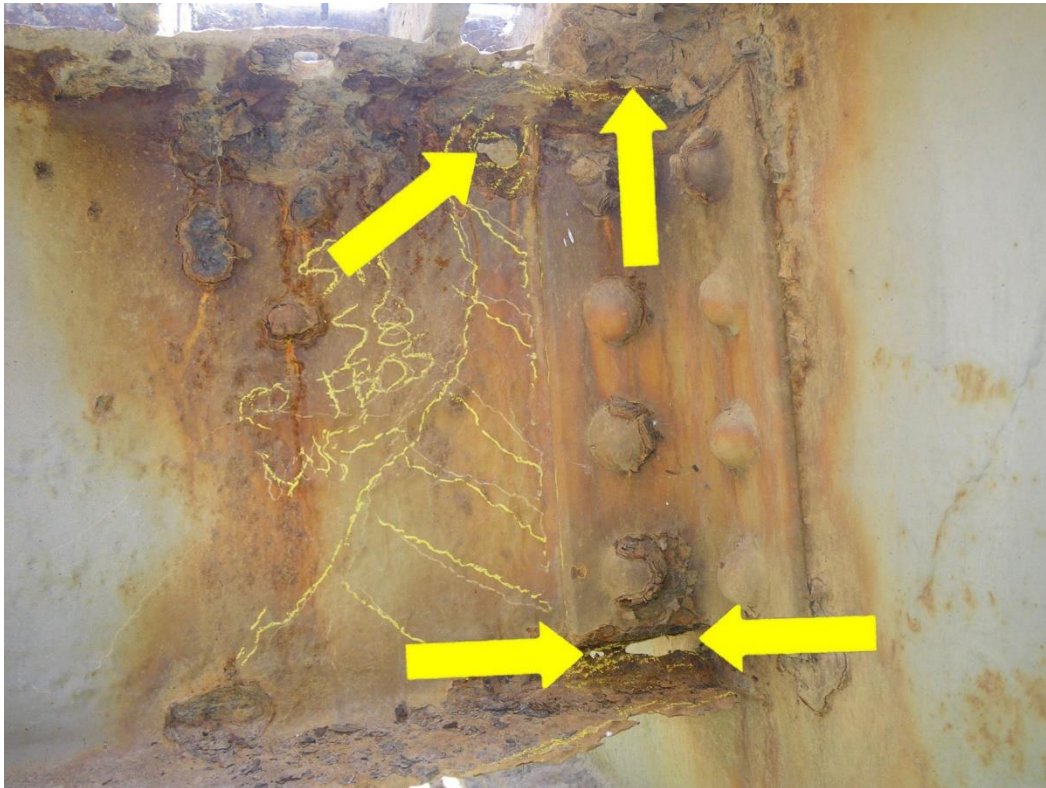
Photo 25: Stringer S8 at North Side of Floorbeam FB0S, West Face, Span 1 - Section loss of flanges and web including areas of 100% section loss. Note failed paint system.

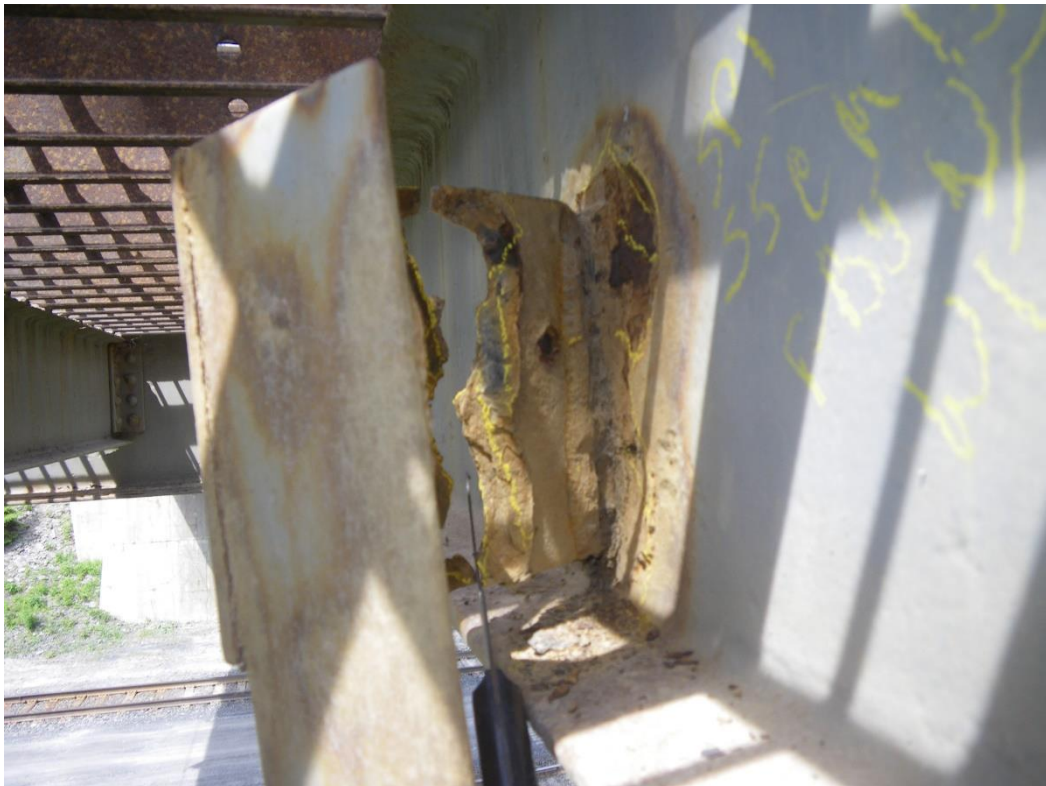
Photo 26: Stringer S5 at Midspan, btwn Floorbeams FB5N & FB6, West Face, Span 1, Looking North - Web section loss adj. to lateral bracing conn. plate. Note lower lateral bracing bent plate w/ 100% section loss by full height.

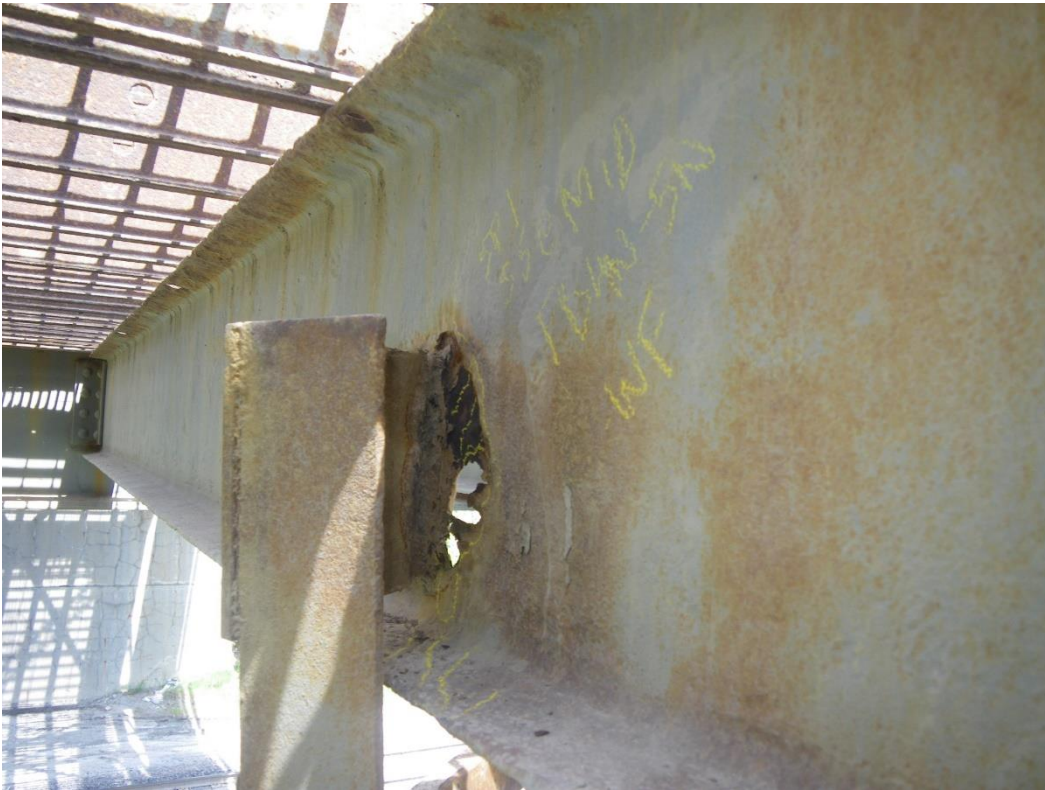
Photo 27: Stringer S5 at Midspan, between Floorbeams FB4N and FB5N, West Face, Span 1, Looking North - Web section loss adjacent to lateral bracing connection plate including area of 100% section loss.

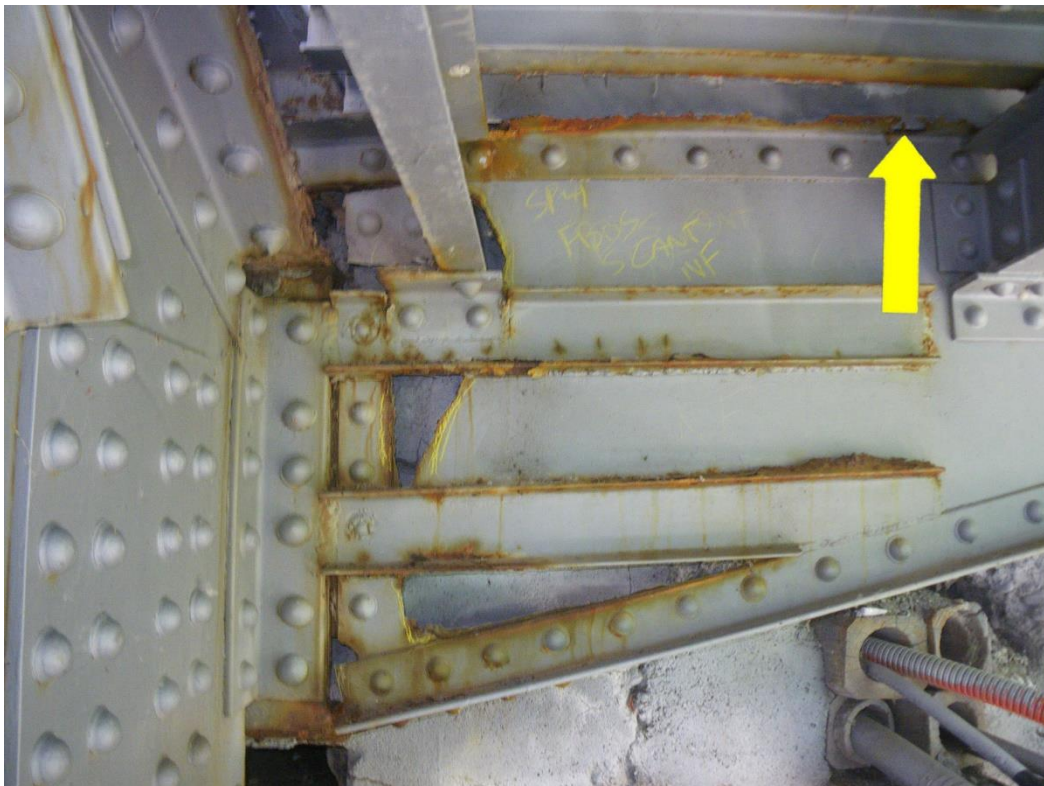
Photo 30: Stringer S10 at Floorbeam FB0S Cantilever, North Face, Span 4 - Not connected to floorbeam web due to 100% section loss of floorbeam web. Note 100% section loss of floorbeam cantilever top flange and repairs.

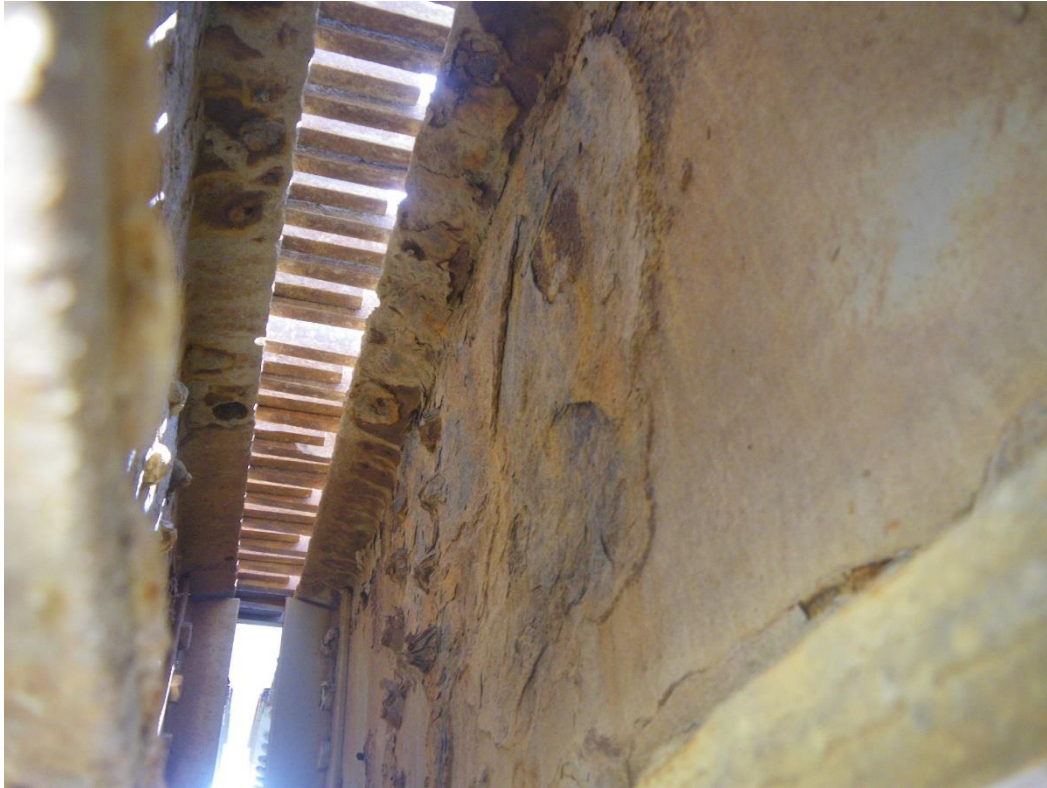
Photo 31: Floorbeam FB0N between Stringers S2 and S3, South Face, Span 2, Looking West - Web section loss. Note failed paint system.

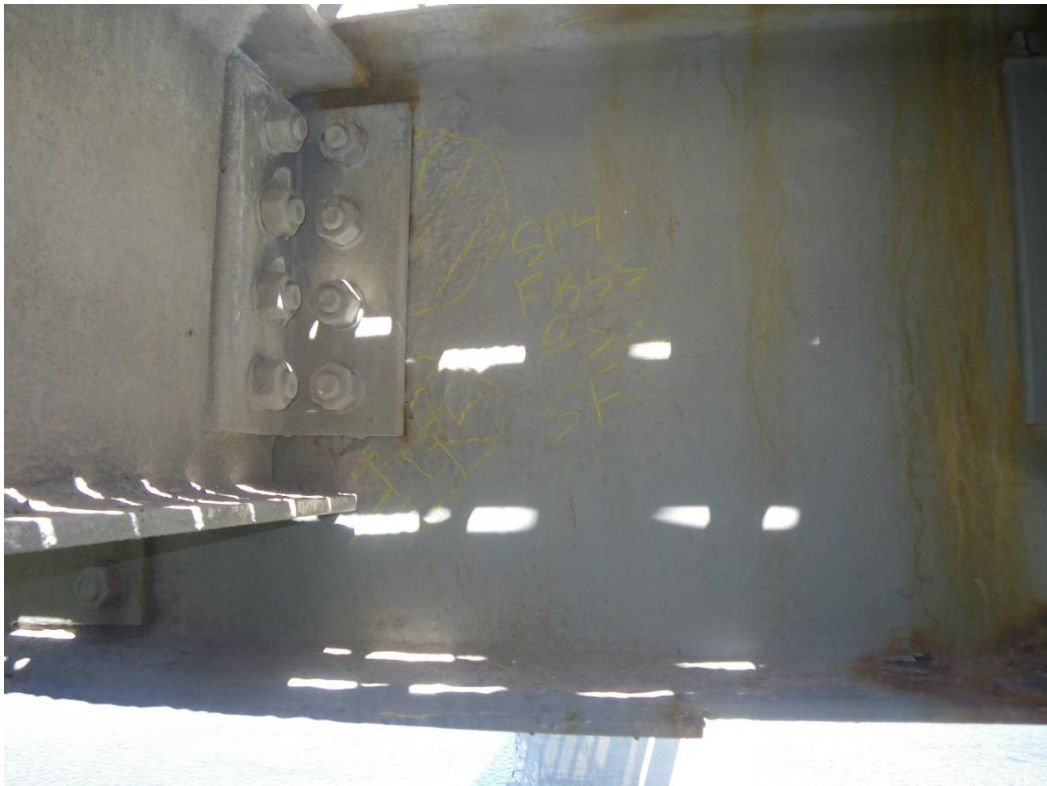
Photo 32: Floorbeam FB5S at Stringer S2, South Face, Span 4 - Web section loss adjacent to/above stringer connection and flange section loss.

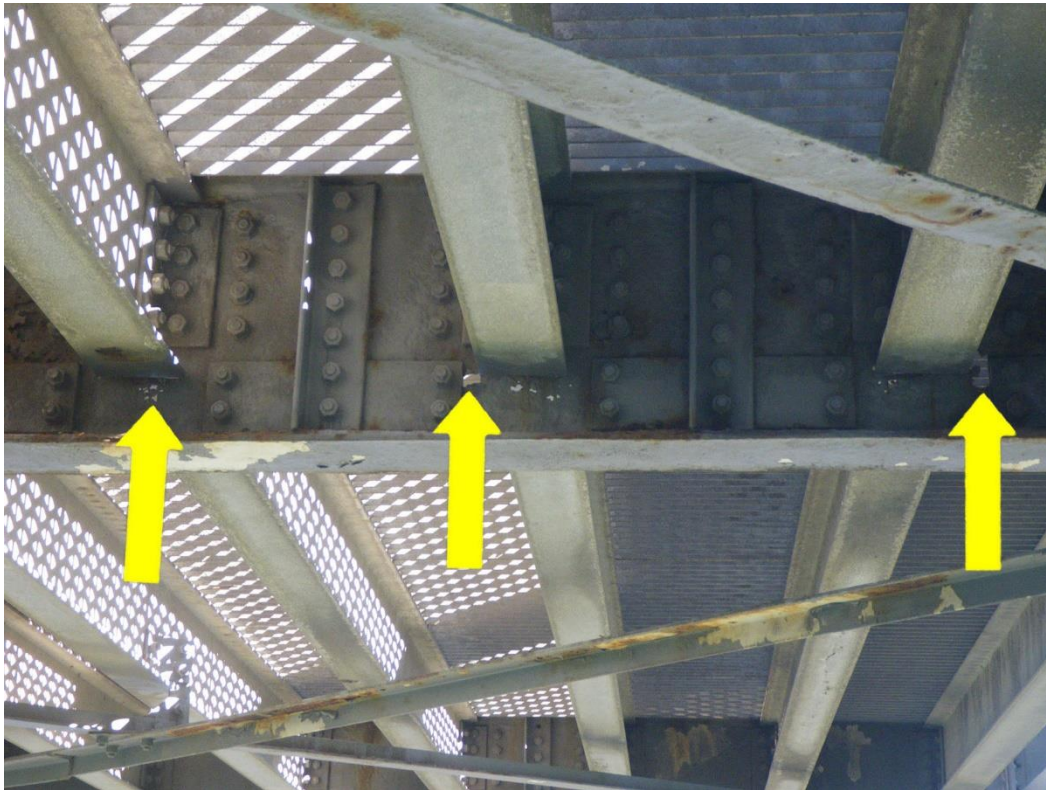
Photo 33: Floorbeam FB2S btwn Stringers S2 & S4, South Face, Span 4 - Web section loss below stringer connections including areas of 100% section loss. Note repair plates not covering 100% section loss & failed paint system.

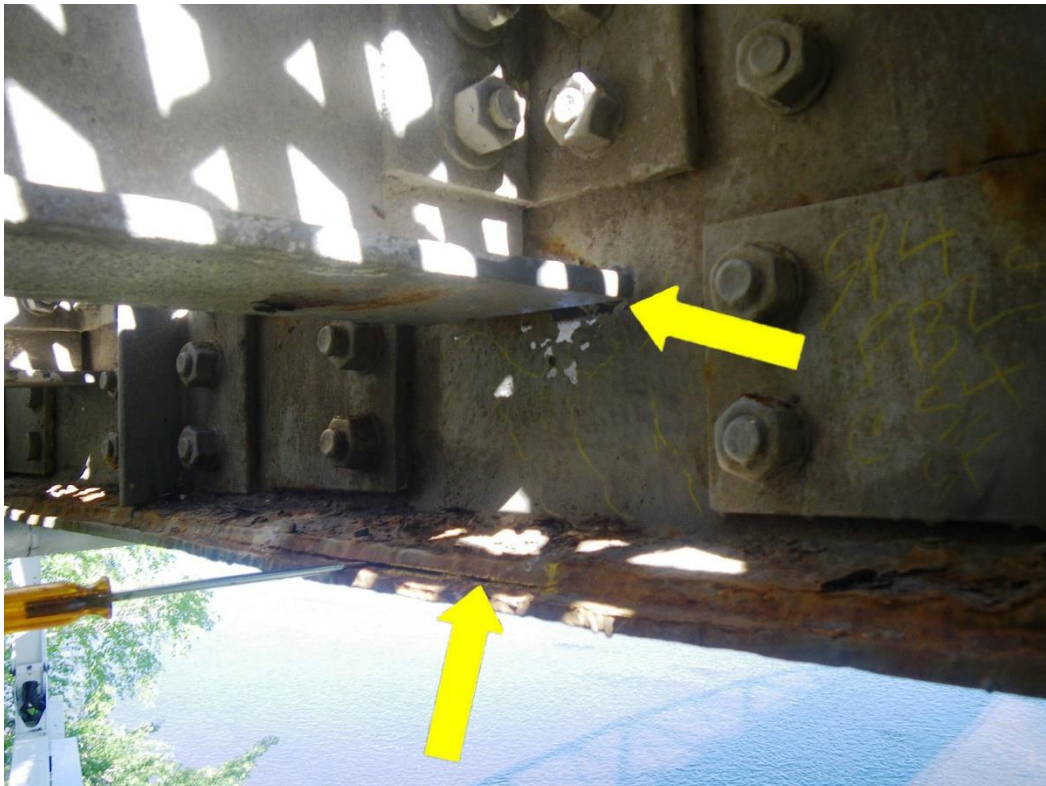
Photo 34: Floorbeam FB2S at Stringer S4, South Face, Span 4 - Web section loss below stringer connection including area of 100% section loss and bottom flange section loss. Note repair plates not covering 100% section loss and cracked/separated weld between bottom flange and cover plate.

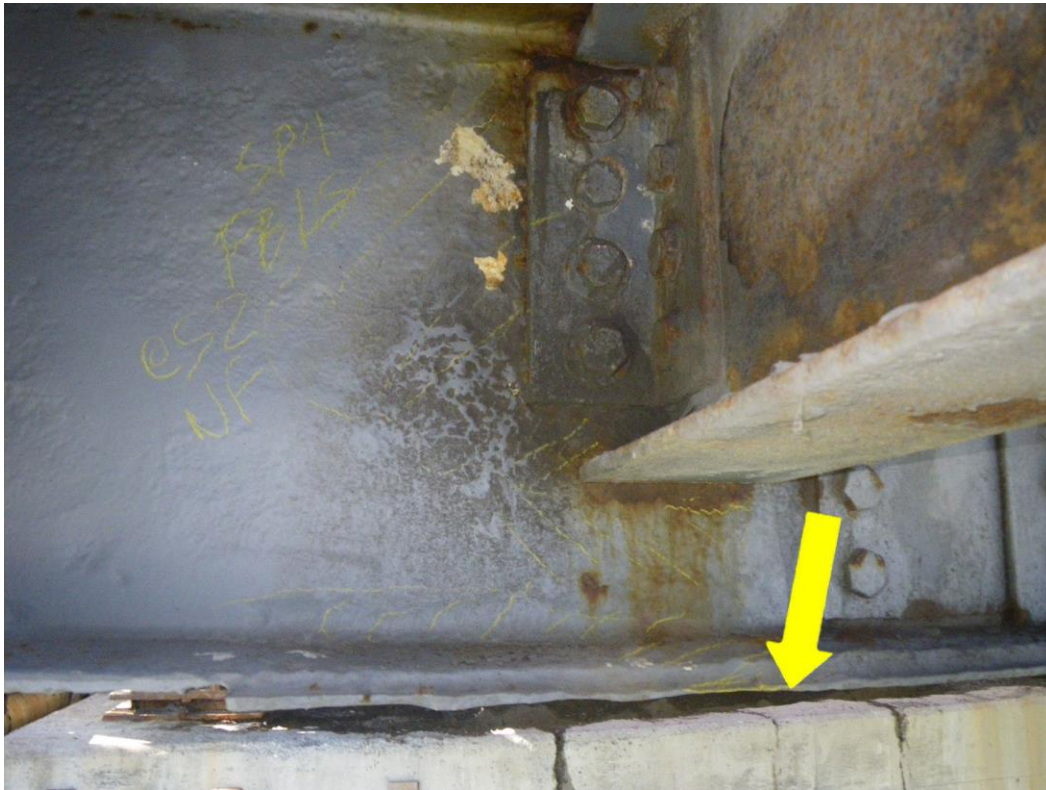
Photo 35: Floorbeam FB1S at Stringer S2, North Face, Span 4 - Web and bottom flange section loss adjacent to/below stringer connection. Note rust forming under paint system.

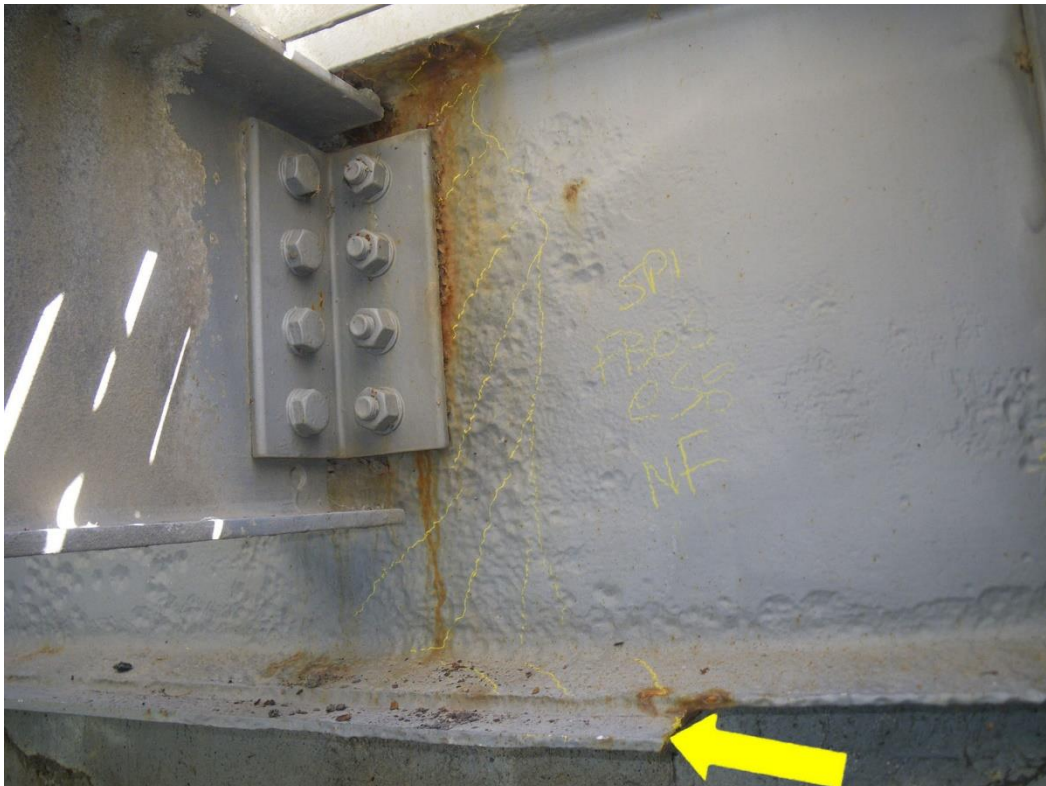
Photo 36: Floorbeam FB0S at Stringer S8, North Face, Span 4 - Web, bottom flange and cover plate section loss adjacent to/below stringer connection. Note misaligned bottom flange cover plate.
