Routine & Special Member Inspection Report

Bridge No. 2399
BRIDGE AVENUE (INTERNATIONAL BRIDGE)
OVER
ST. JOHN RIVER & CNRR
MADAWASKA, MAINE (U.S.A.) / EDMUNDSTON, NEW BRUNSWICK (CANADA)

June 19, 2020

WIN #: 22035.20

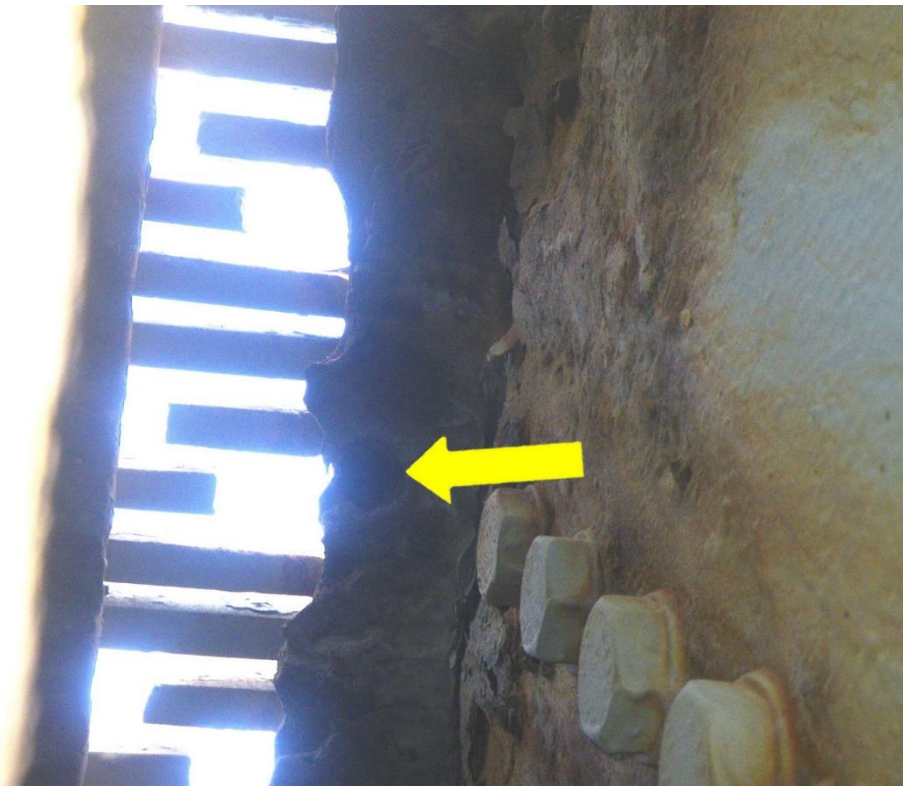
Photo 38: Floorbeam FB0S between Stringers S1 and S3, North Face, Span 2, Looking East - Top flange section loss including area of 100% section loss encompassing a vacant drilled hole. Note failed paint system.

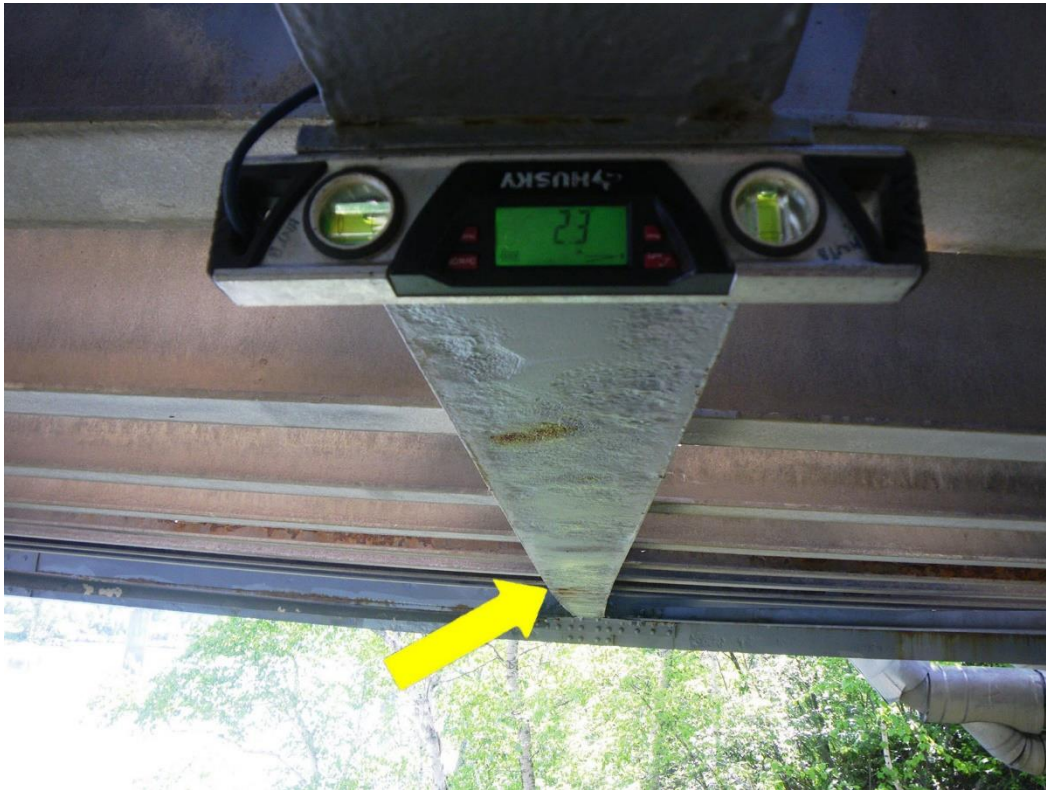
Photo 39: Floorbeam FB1S between Stringers S8 and S9, Span 4, Looking East - Bottom flange cover plate section loss and rotation. Note floorbeam sweep.

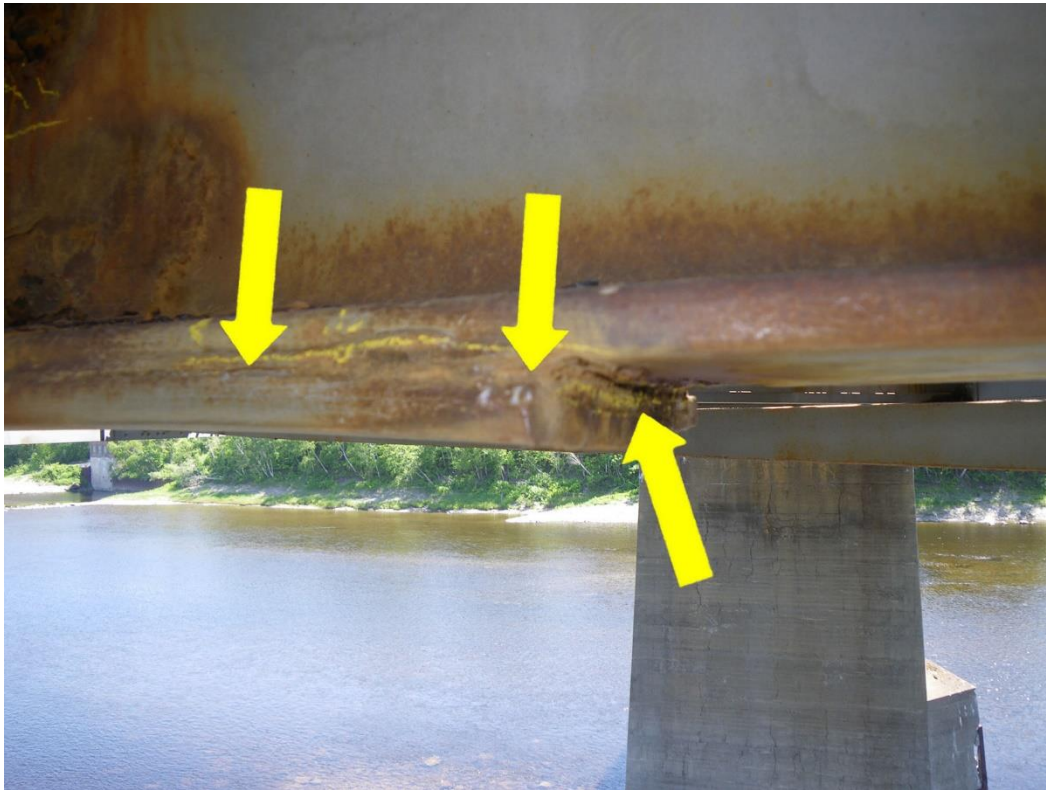
Photo 41: Floorbeam FB5S between Stringers S8 and S9, North Face, Span 2 - Impacted rust between the bottom flange and cover plate. Note weld between bottom flange and cover plate extends to cover plate edge and is cracked.

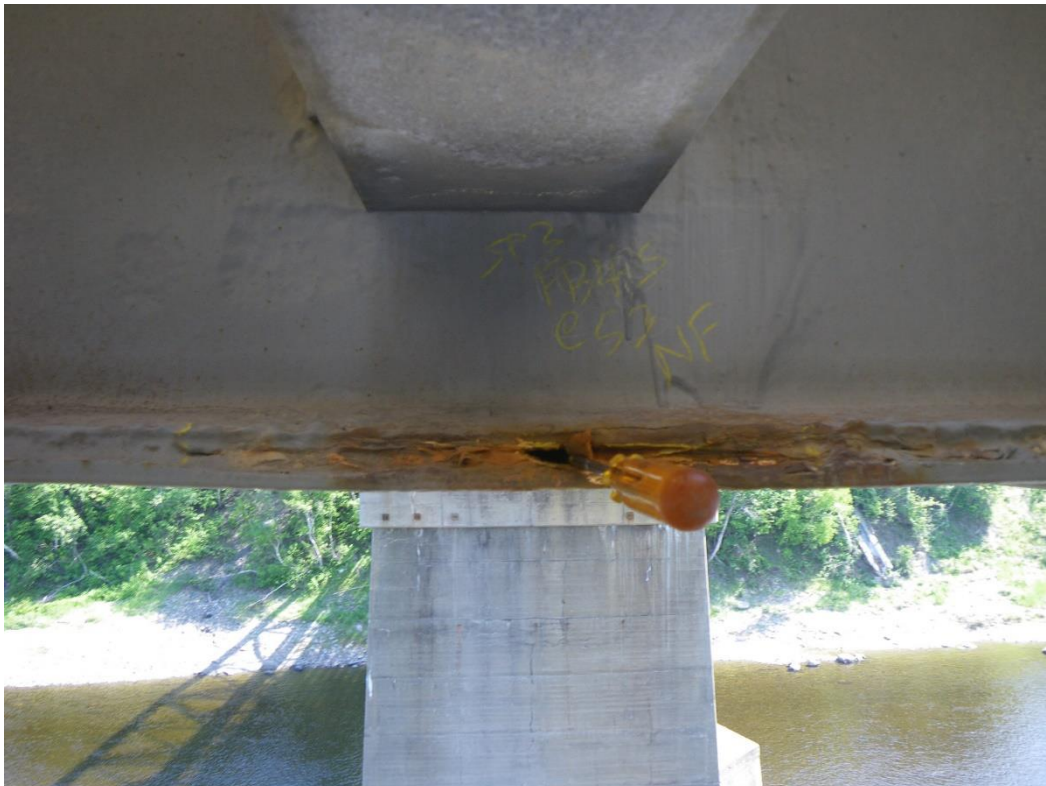
Photo 42: Floorbeam FB4S at Stringer S3, North Face, Span 3 - Bottom flange cover plate weld with crack/separation and gap.

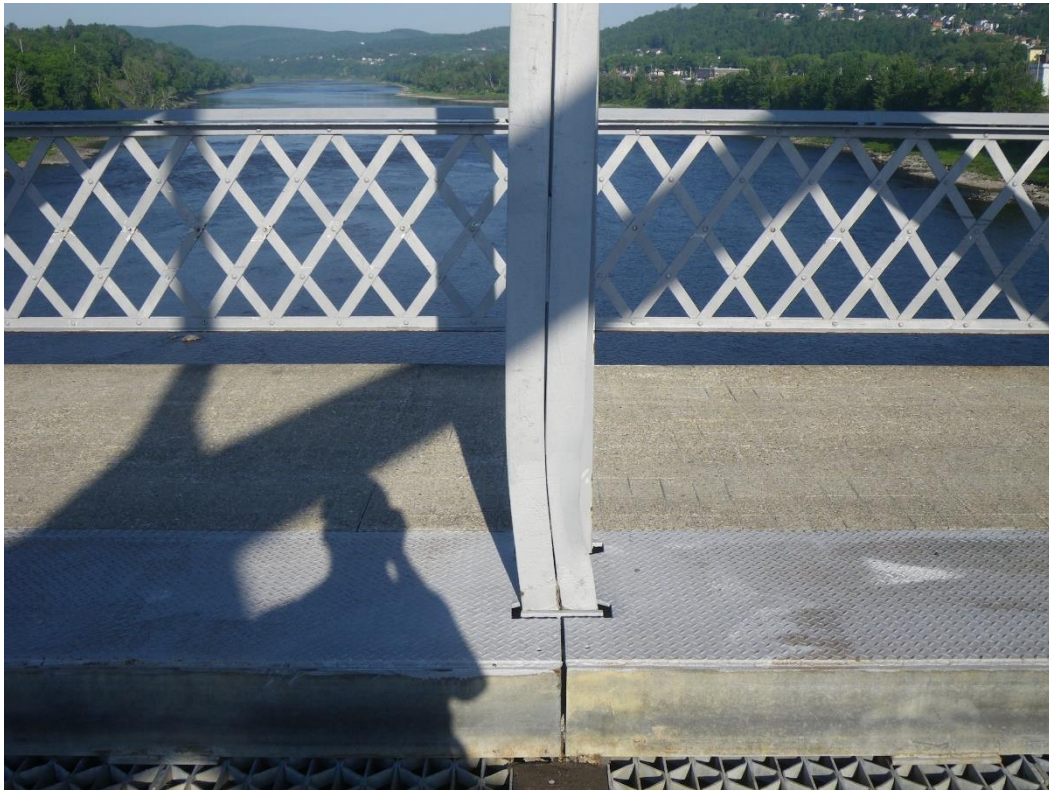
Photo 43: Vertical U3NL3N near Curb, East Face, West Truss, Span 3 - Flange angles with sweep, rotation and bend due to collision damage.

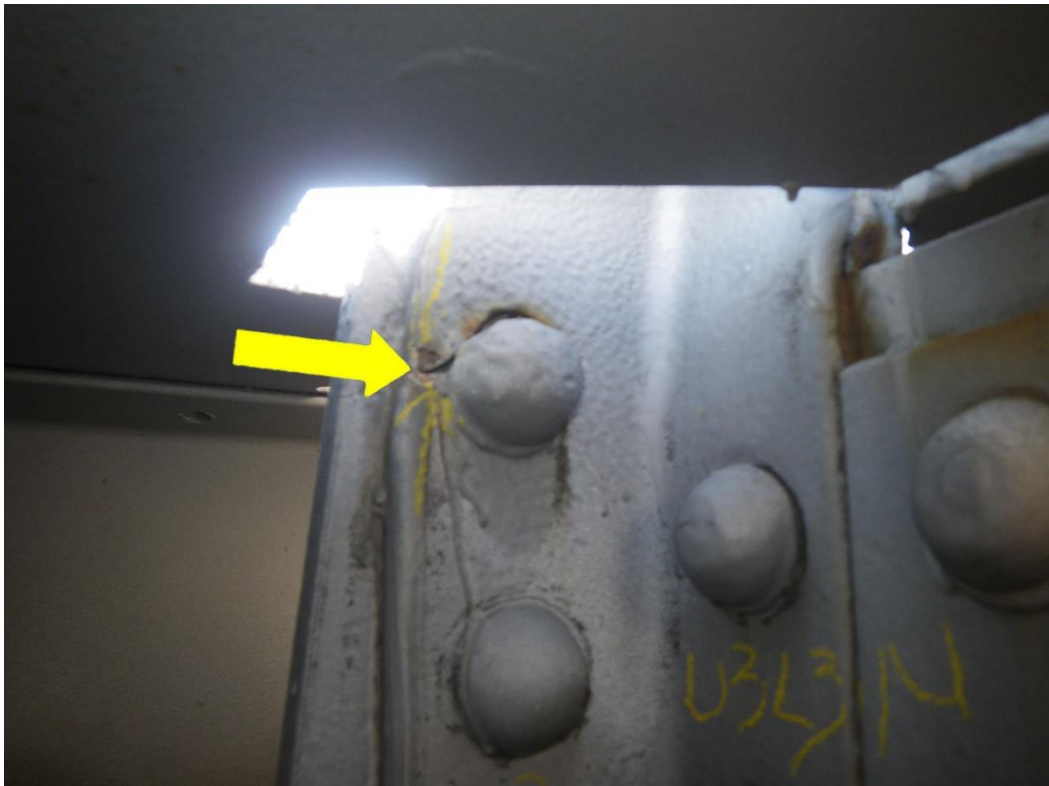
Photo 44: Vertical U3NL3N at Panel Point L3N, West Face, West Truss, Span 3 - Crack in outstanding leg of flange angle due to collision damage above the curb and section loss along the edge of the drilled hole.

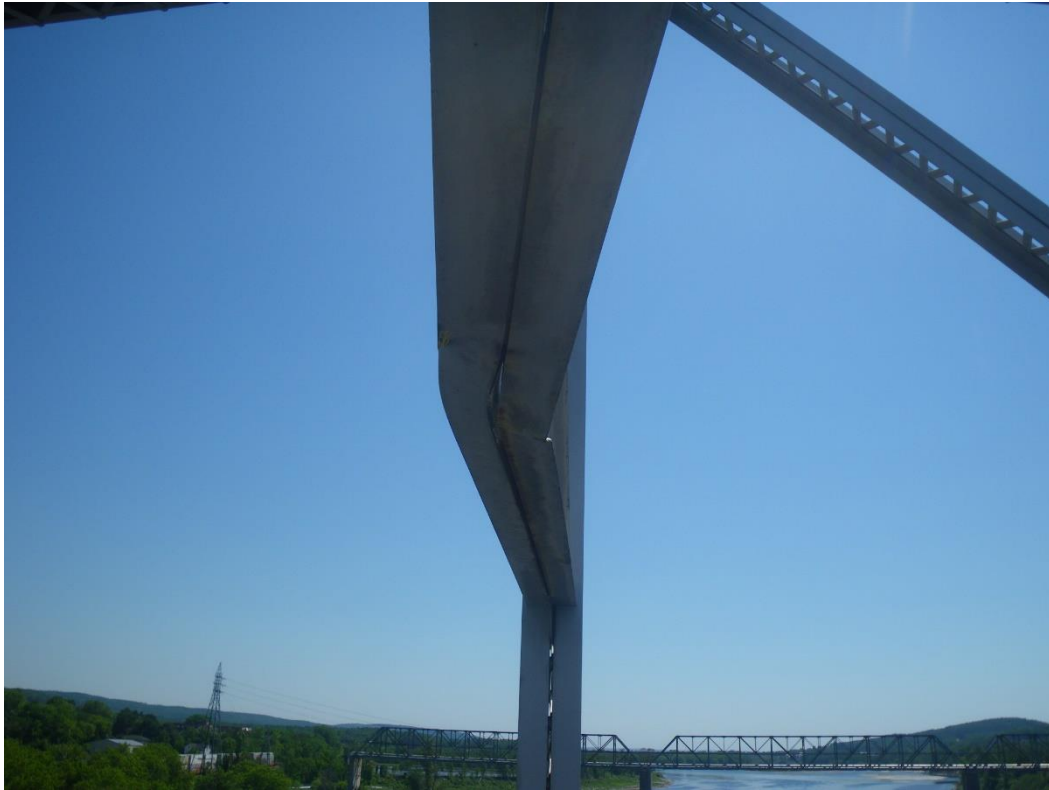
Photo 45: Sway Bracing Lower Horizontal Strut above Northbound Lane, Panel Point 4N, Span 2, Looking East - Flange angles with sweep and bend in outstanding leg due to collision damage.

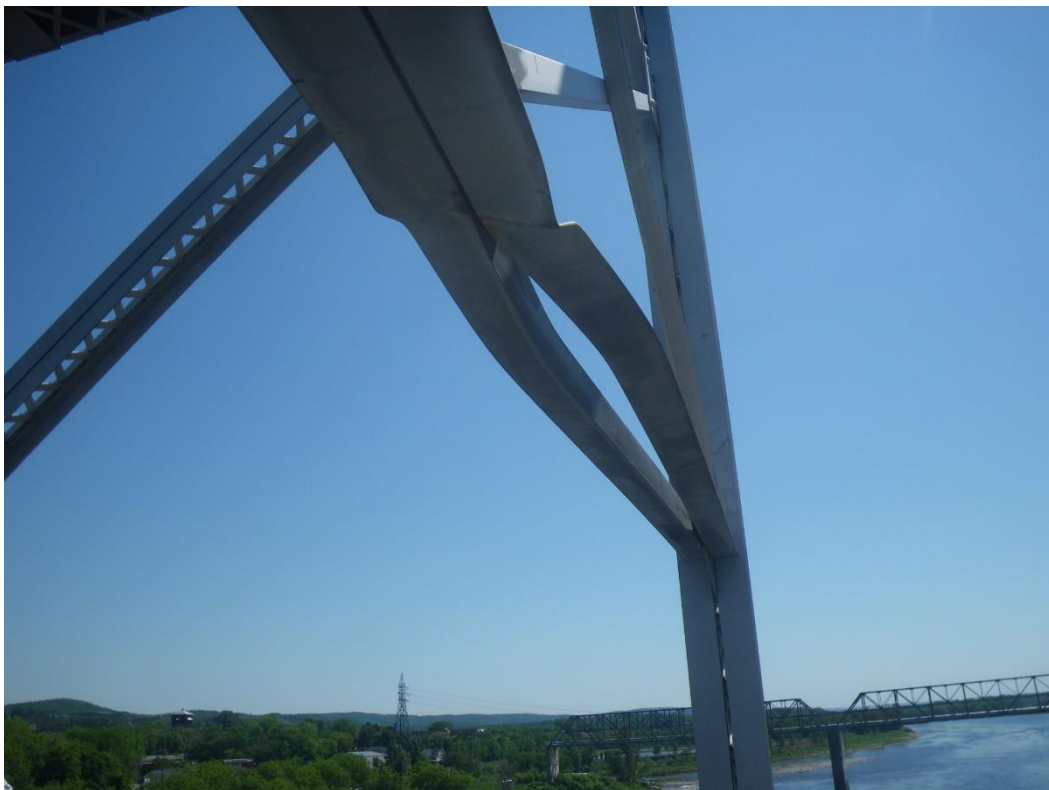
The minimum roadway vertical clearance was measured to be 14'-2" from the underside of the lower horizontal strut of the sway bracing at panel point 4S in span 2 to the northbound lane of Bridge Avenue. This measurement was taken at a location of collision damage.

Photo 46: Sway Bracing Lower Horizontal Strut above Northbound Lane, Panel Point 4S, Span 2, Looking East - Flange angles with sweep, twisting, separation between back to back vertical legs and upward bend in outstanding leg due to collision damage.

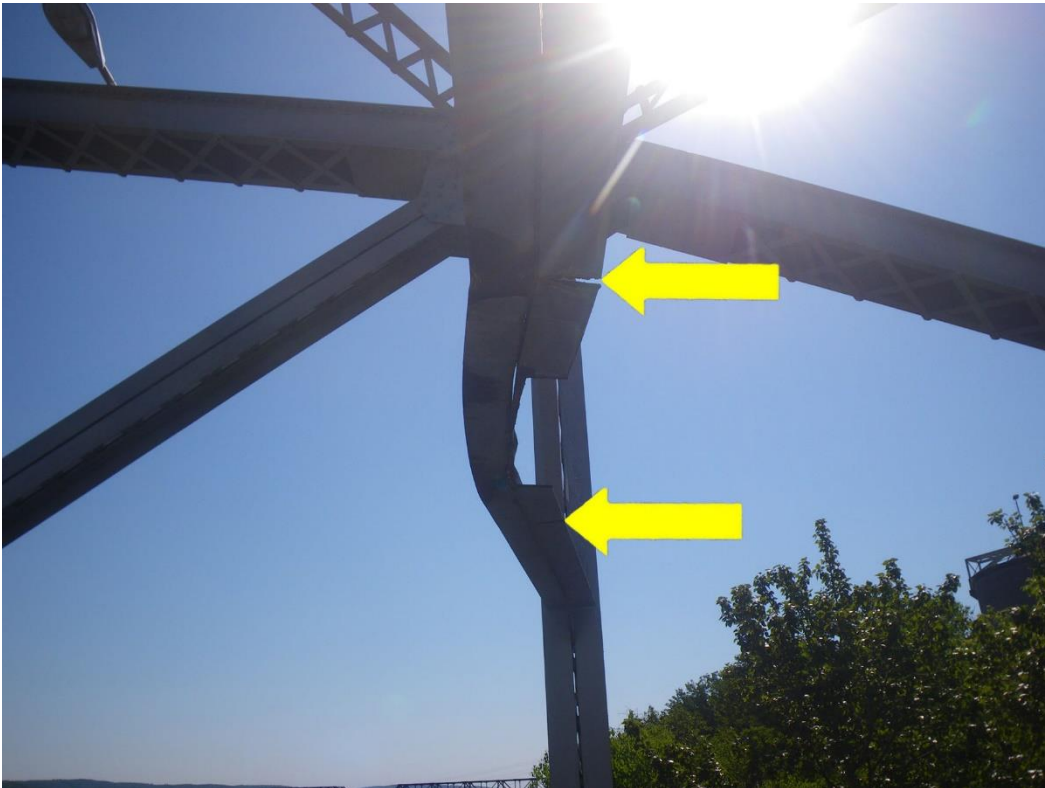
Photo 47: Sway Bracing Lower Horizontal Strut above Northbound Lane, Panel Point 2S, Span 4, Looking East - Flange angles with sweep, separation between back to back vertical legs, tear and cut out portion the outstanding leg due to collision damage.

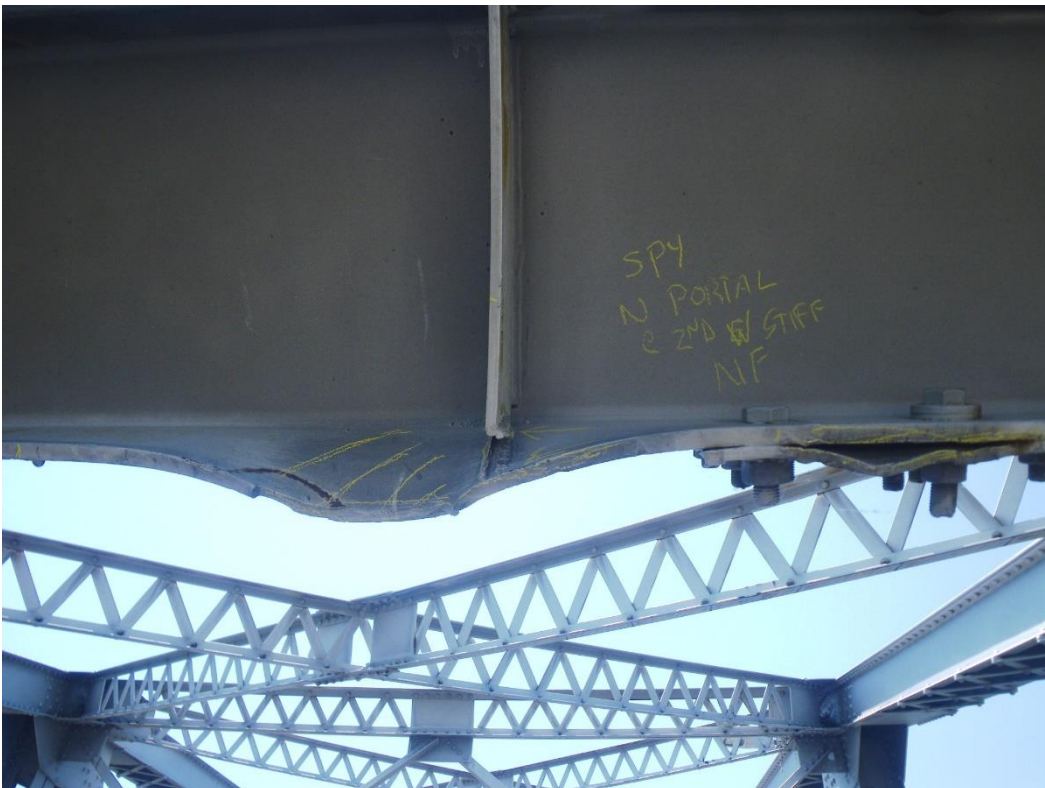
Photo 48: Portal Bracing Lower Transverse Brace above SB Lane, North Face, North Portal, Span 1 - Bottom flange with bend and gouge, bent and detached web stiffener and bent connection plate due to collision damage.

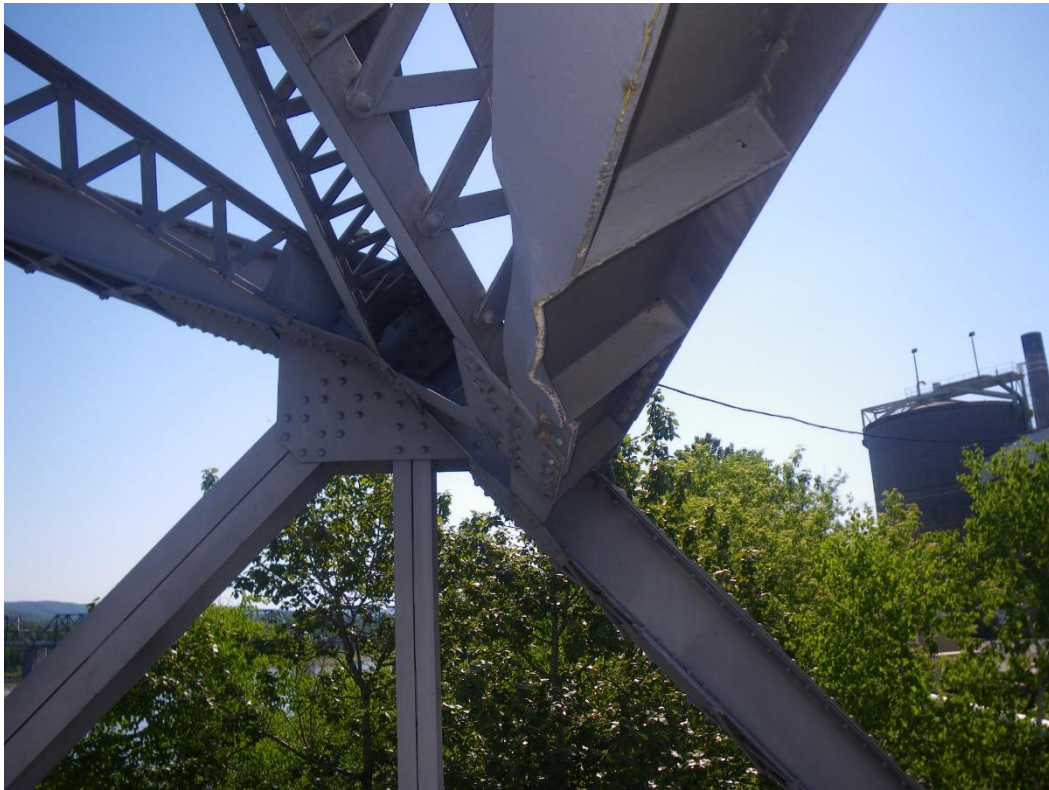
Photo 49: Portal Bracing Lower Transverse Brace above NB Lane, South Portal, Span 4, Looking East - Bottom flange with rotation/twisting, sweep and bend due to collision damage. Note cut out portion with above repair plate.

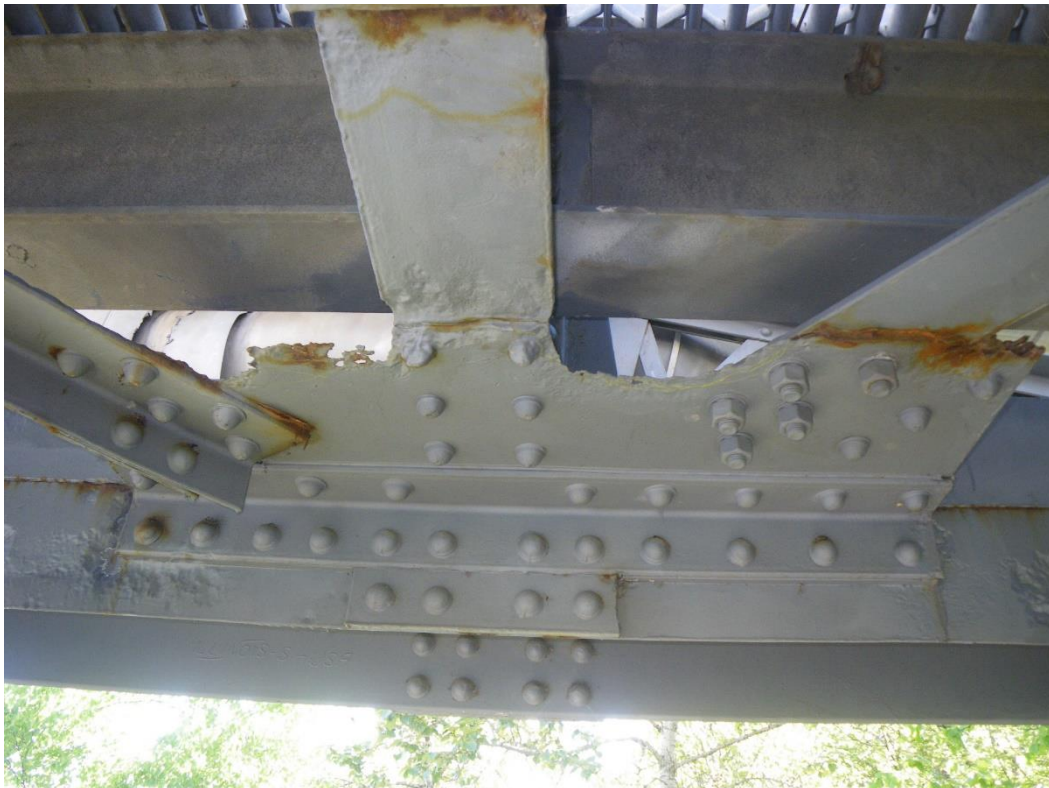
Photo 50: Lower Lateral Bracing Connection Plate at Panel Point L1S, East Truss, Span 4, Looking East - Areas of 100% section loss.

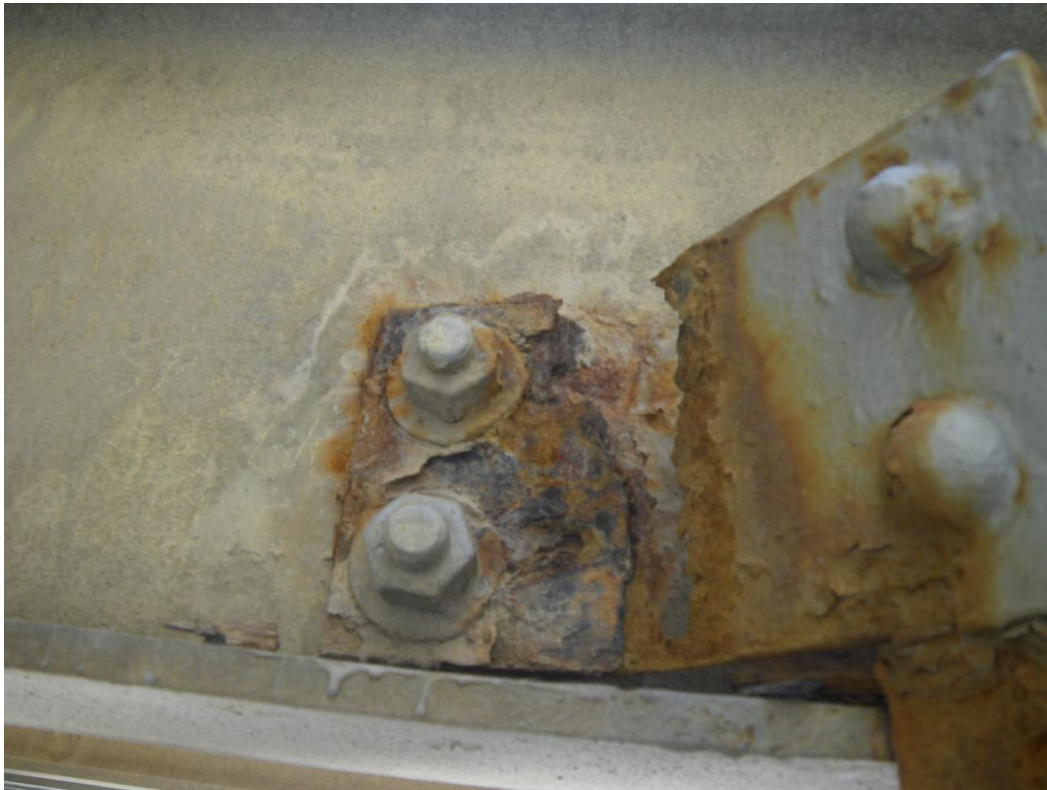
Photo 51: Lower Lateral Bracing Midspan Connection at Stringer S5, between Floorbeams FB5S and FB4S, Span 3, Looking East - Area of 100% section loss.

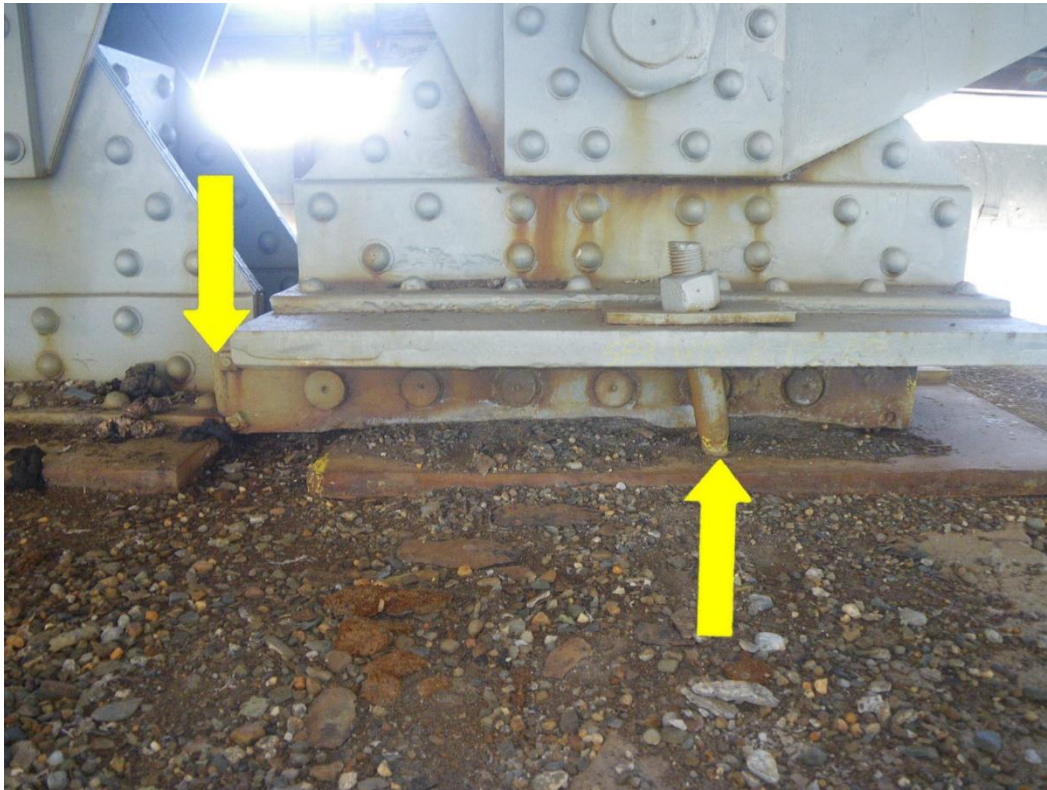
Photo 53: West Truss Bearing at Pier 3, East Face, Span 3 - Nested roller assembly expanded beyond the masonry plate edge and in contact with adjacent fixed bearing. Note anchor bolt severely bent with section loss.

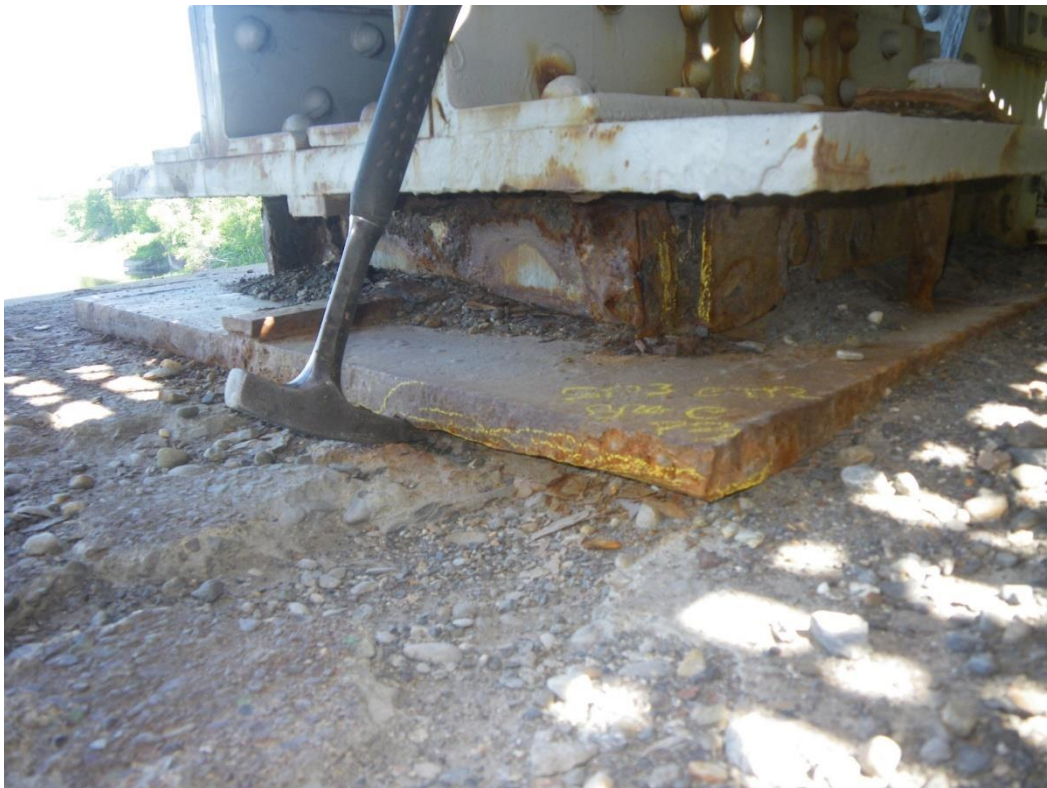
Photo 56: East Truss Bearing at Pier 3, North Face, Span 3, Looking Southeast - Undermining of masonry plate due to pier cap spall.

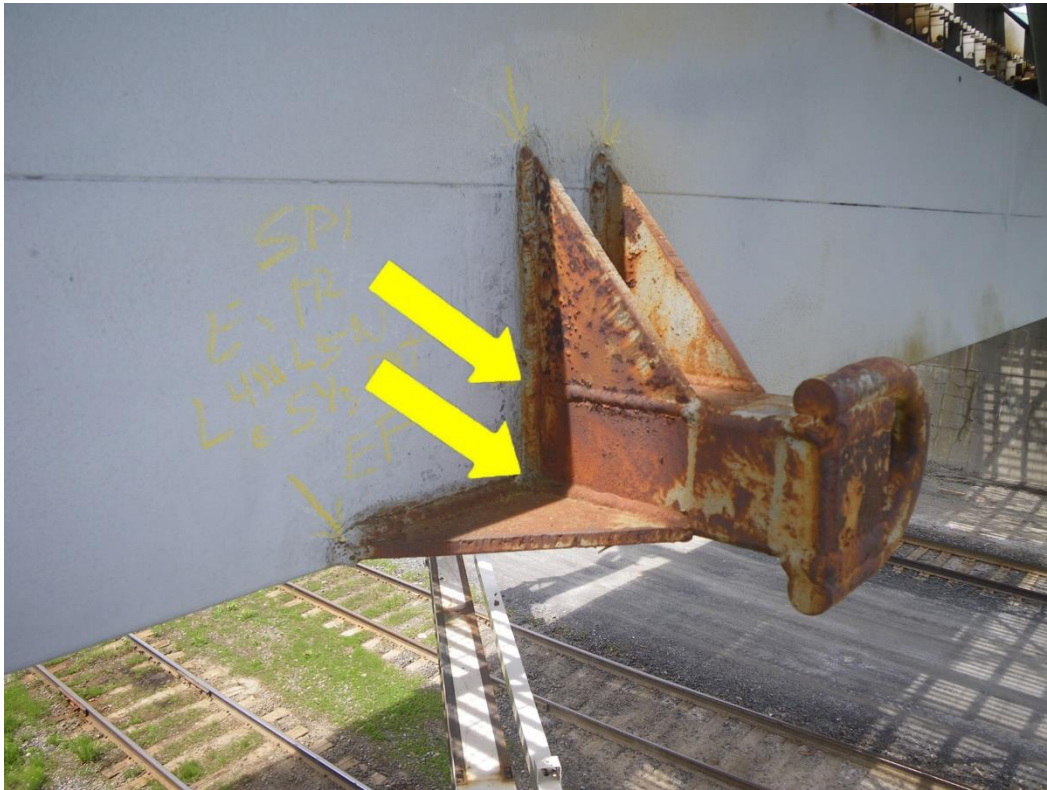
Photo 57: Lower Chord L4NL5N at South Third Point, East Face, East Truss, Span 1, Looking Northwest - Intersecting welds of the abandoned anchor point on the flange angles.

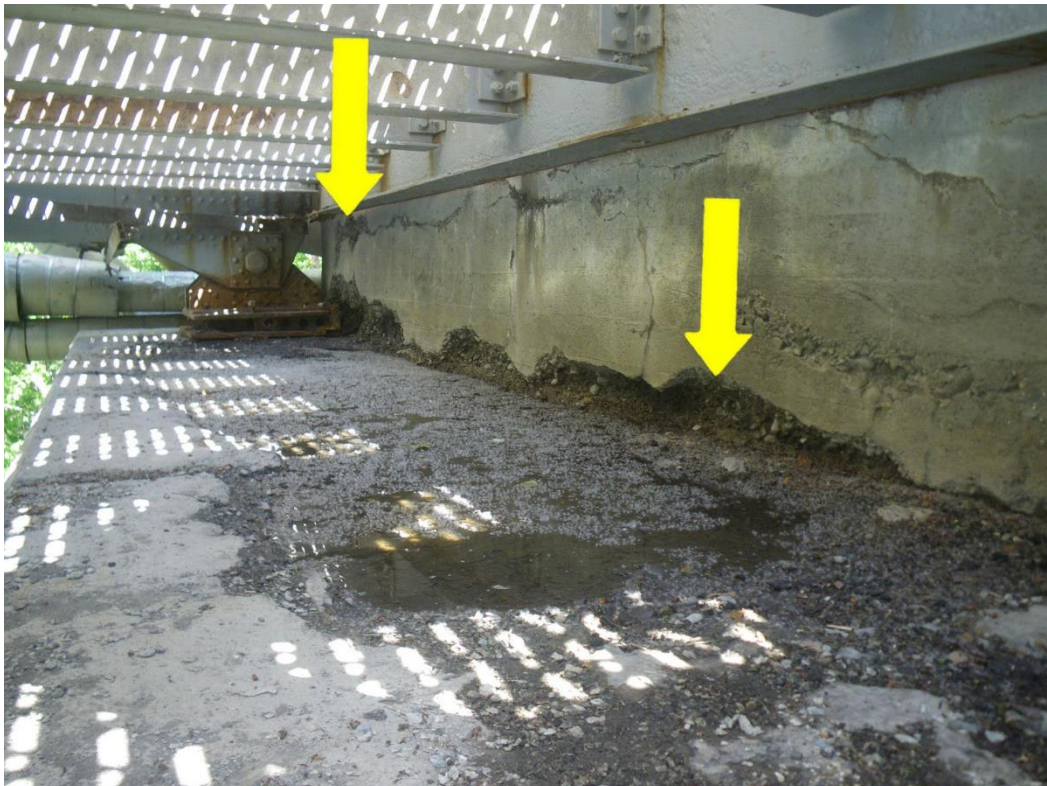
Photo 58: South Abutment Backwall between East and West Trusses, Looking East - Spalling and map cracking with moisture.

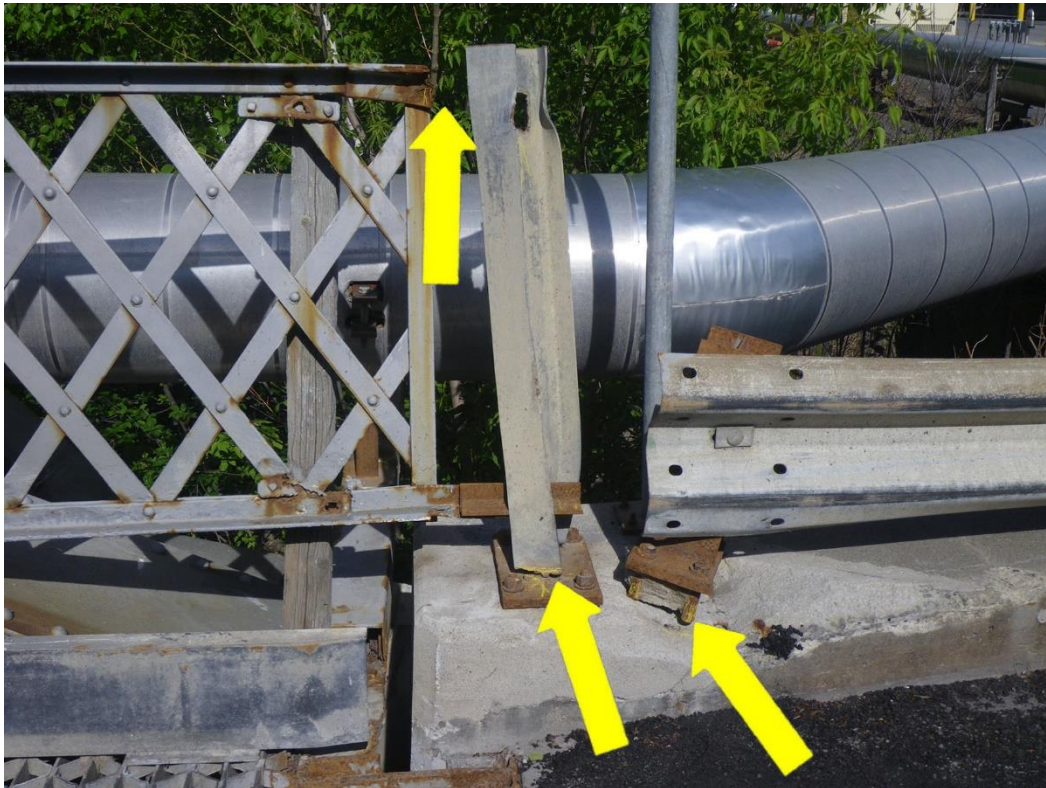
Photo 59: SE Bridge Railing Transition, Looking East - Tall rail post with warping, bent flanges, full width fracture in both flanges along the base plate, partially connected to bridge railing and not connected to guardrail. Note guardrail rail post with debonded/pulled out anchor bolts.

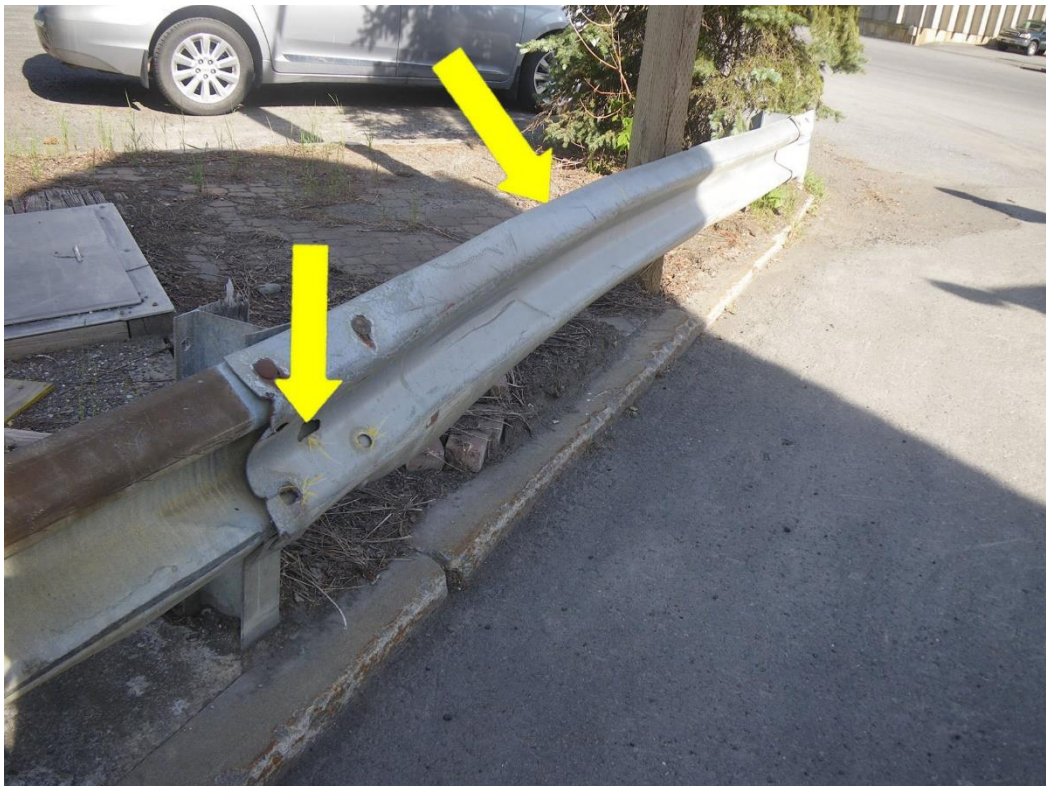
Photo 60: SE Approach Guardrail at Third Rail Post from South Abutment, Looking SE - Splice with 2 of 4 bolts in place, loose horizontal bolt connecting guardrail to rail post and bend of rail section due to collision damage.

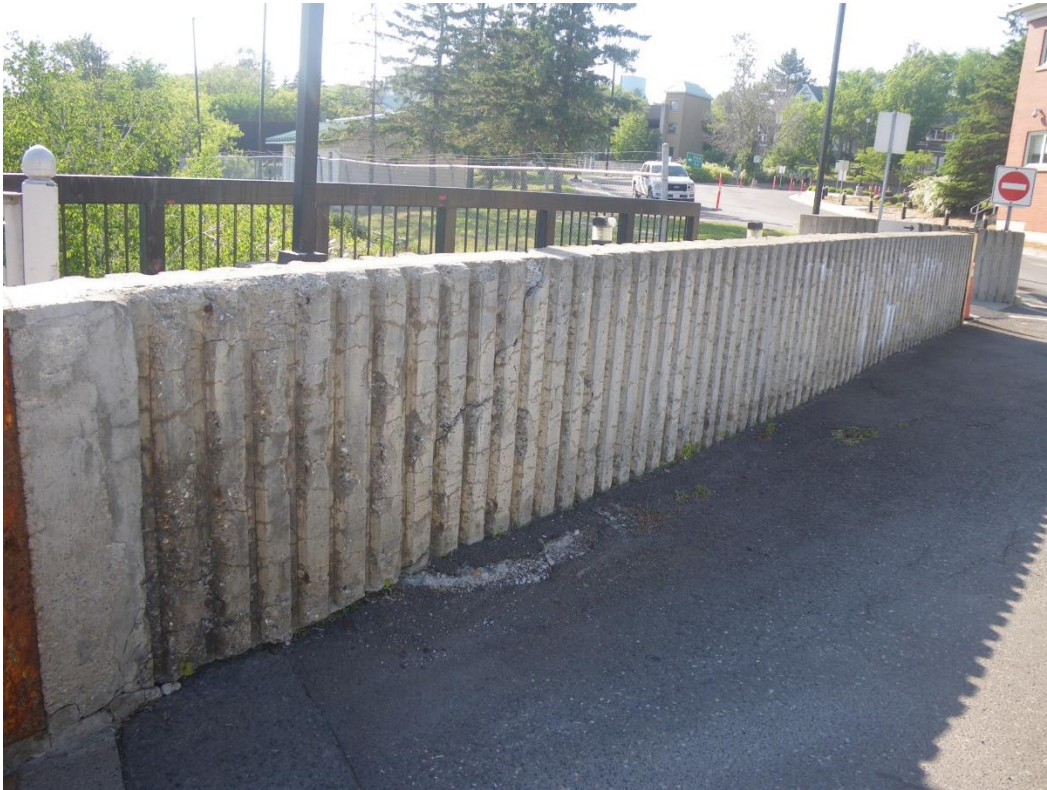
Photo 61: Northwest Traffic Barrier near North End, East Face, Looking Northwest - Extensive map cracking with moisture and efflorescence, diagonal crack, delamination and spalls.

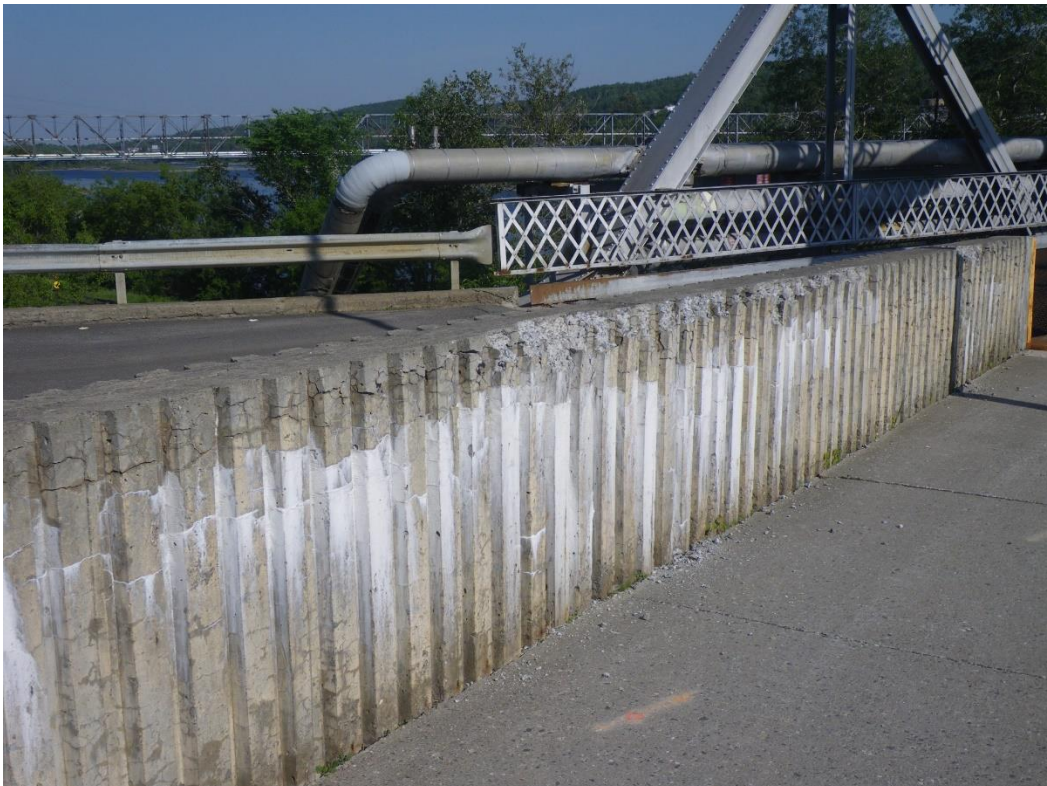
Photo 62: Northwest Traffic Barrier near North End, West Face, Looking Southeast - Extensive map cracking with moisture and efflorescence, delamination and spalls.
