Highway Bridge Inspection Report

BR# 6339

BASS HARBOR FERRY SLIP

Inspection Type(s): Routine and Fracture Critical

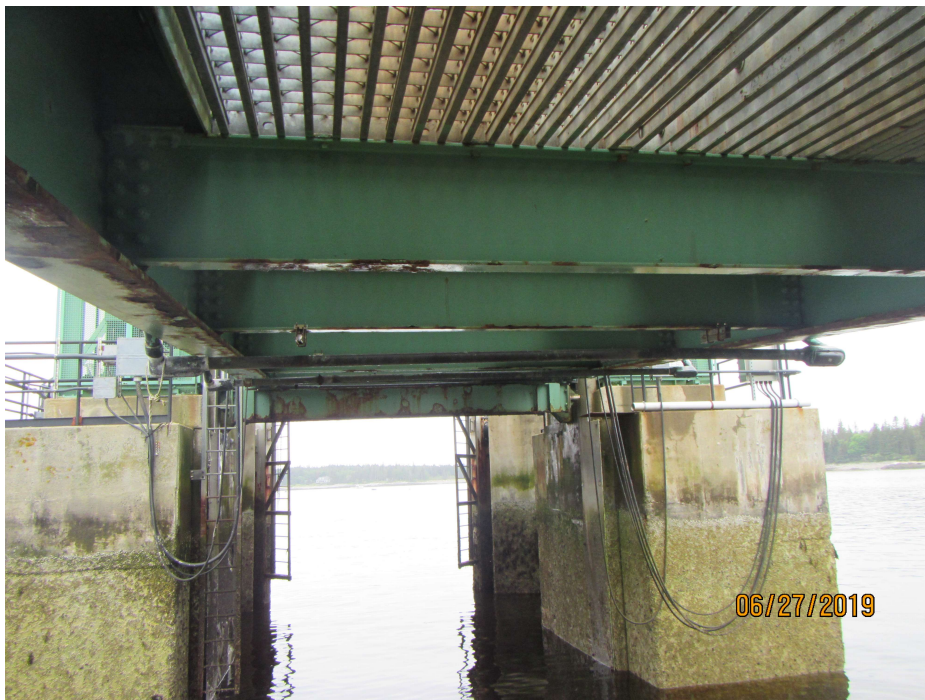
PHOTO 1

Description floor beams.open grate deck

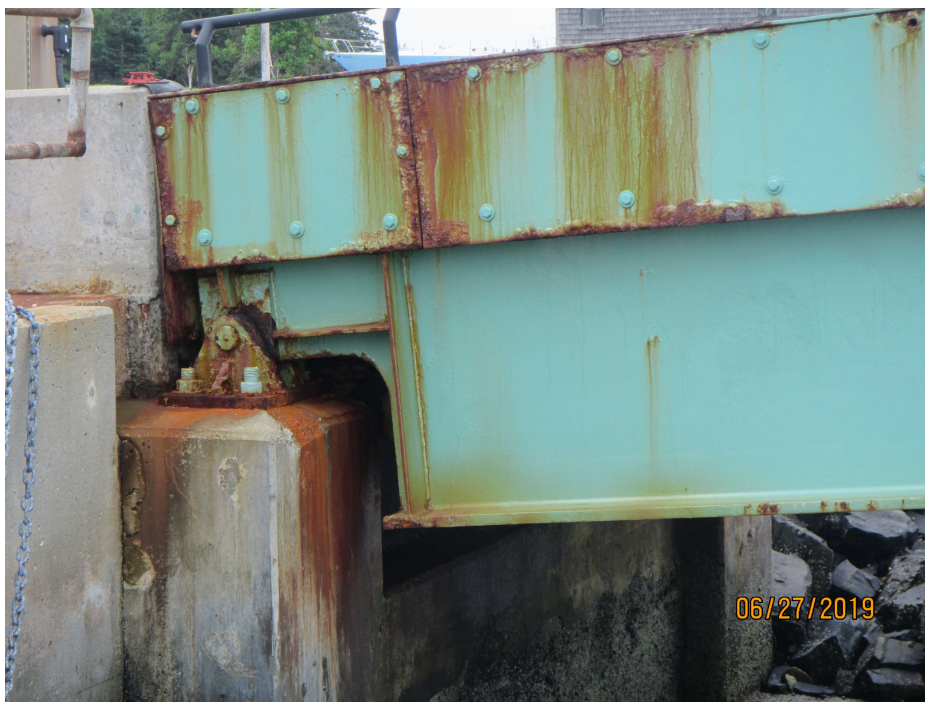
PHOTO 2

Description Nly bearing/beam end

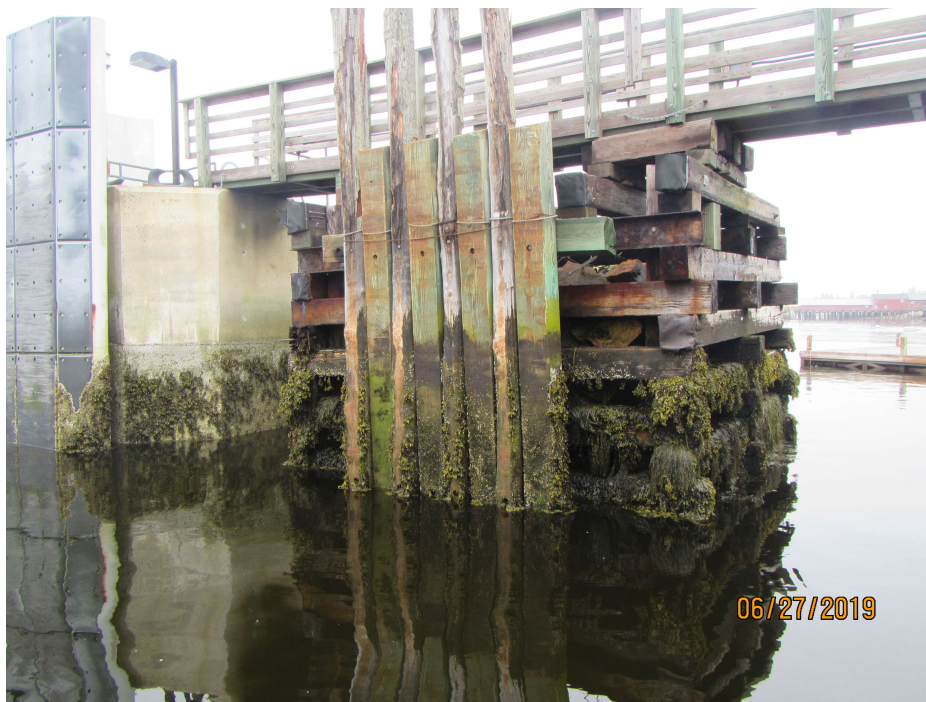
PHOTO 4

Description vertical timber fender on stone-filled crib on north side

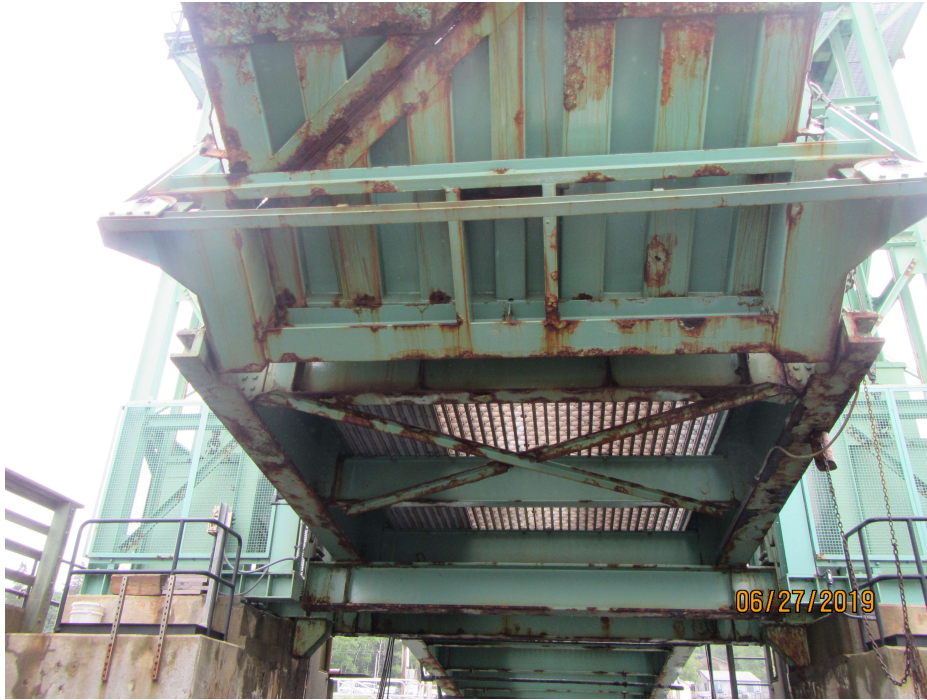
PHOTO 5

Description under apron/ramp end

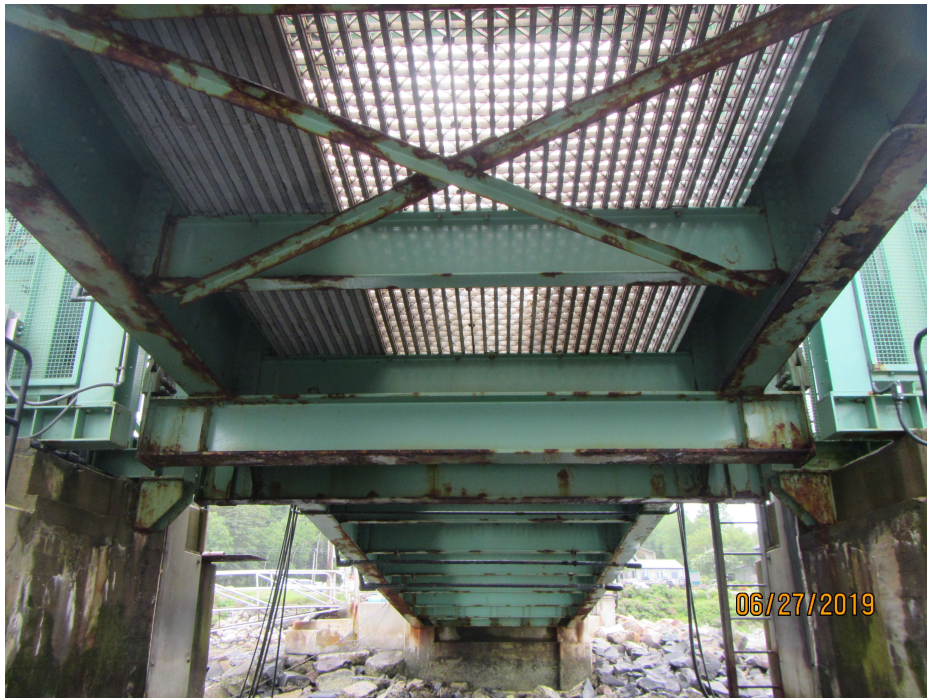
PHOTO 6

Description floor beams,main carrying girders, counter weight hoist beams

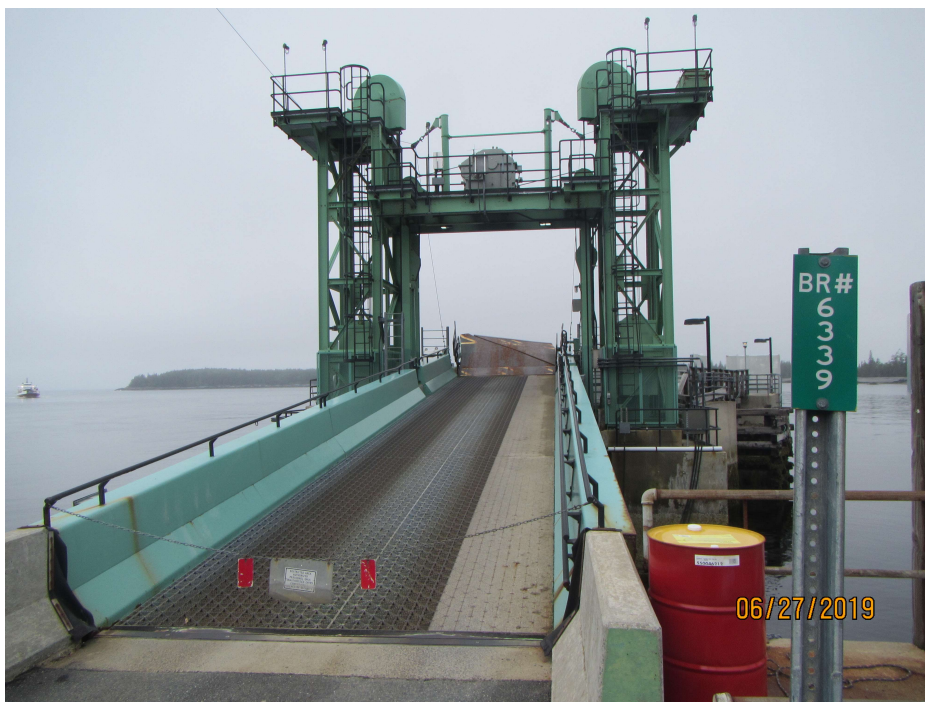
PHOTO 8

Description ramp/towers

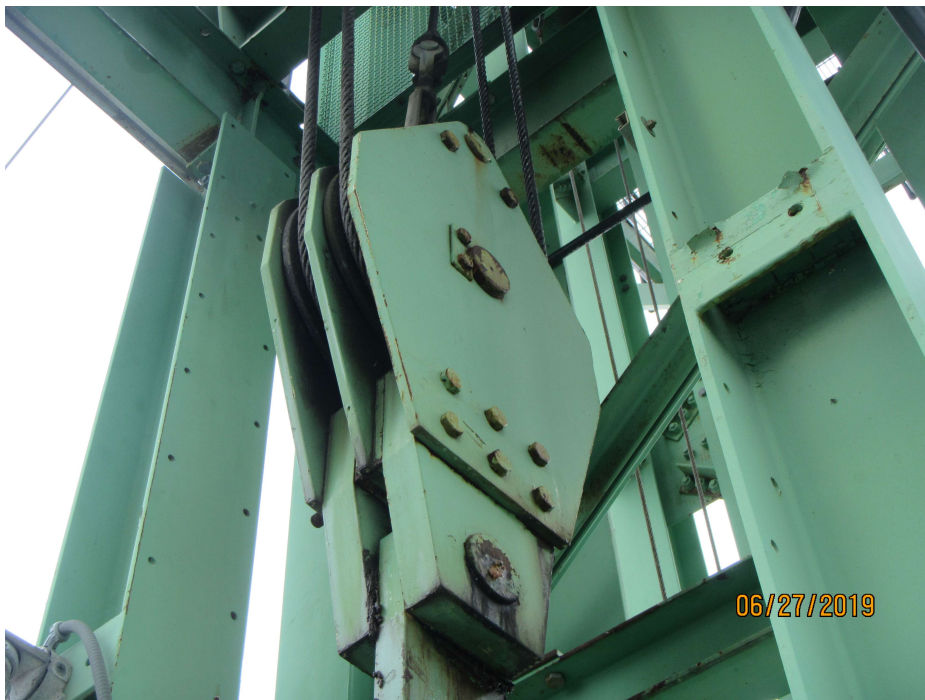
PHOTO 9

Description Nly lower sheave case

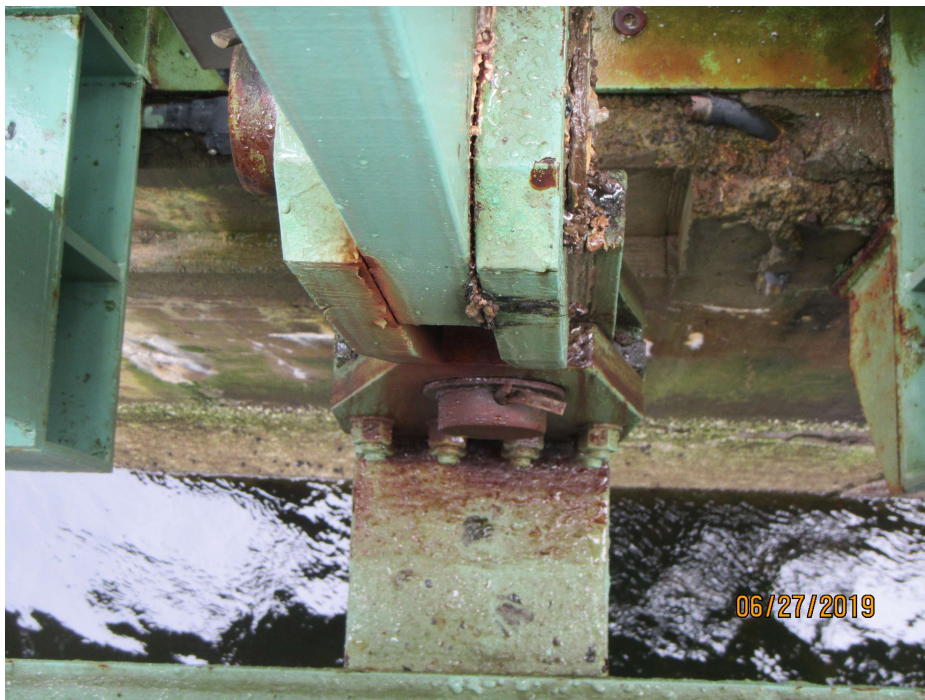
PHOTO 10

Description link bar

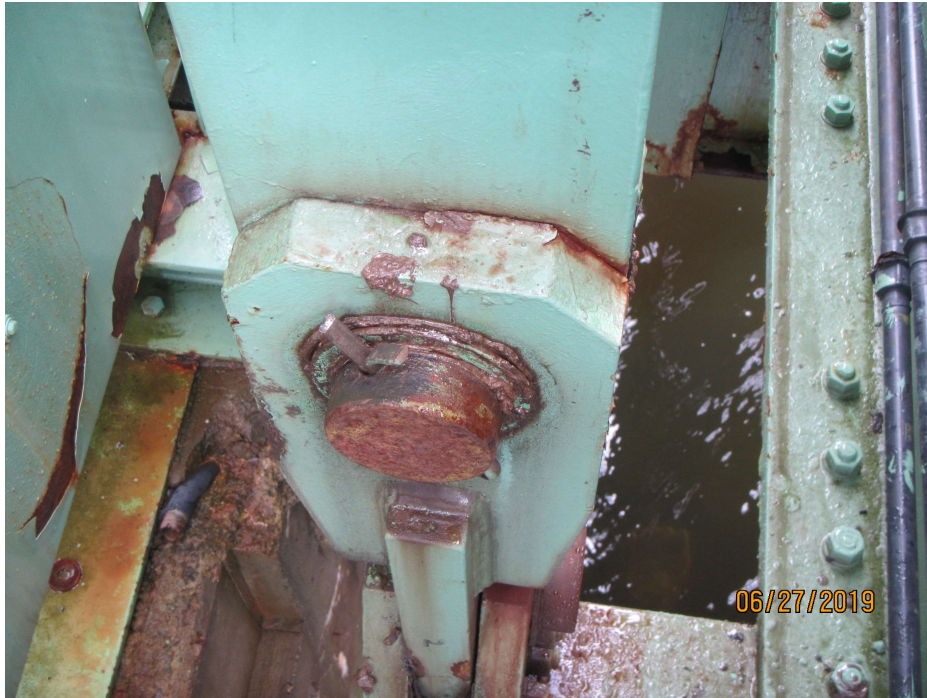
PHOTO 11

Description pin in link bar of counter weight hoist

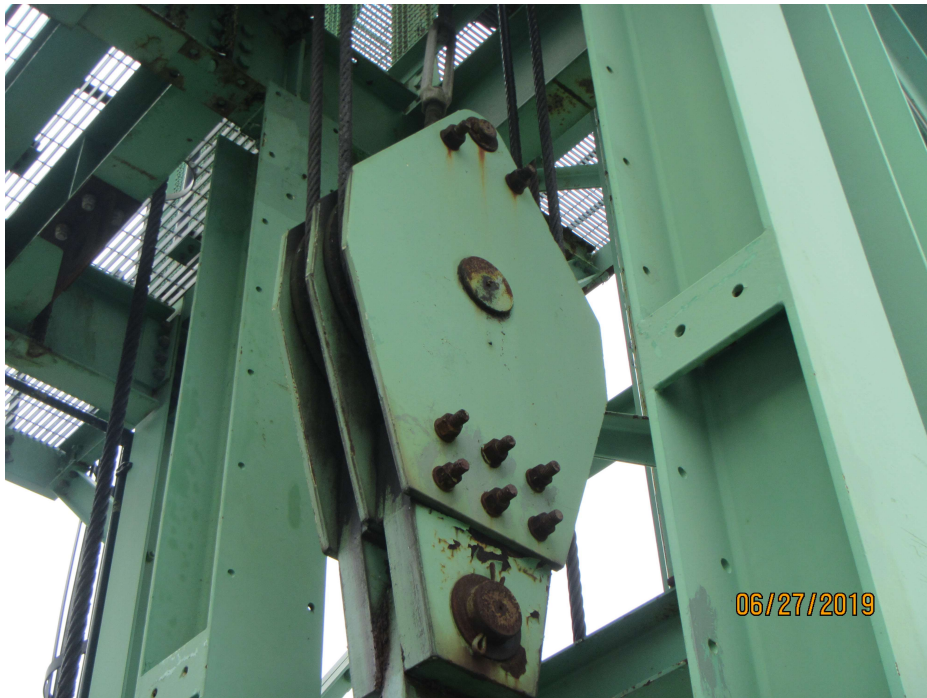
PHOTO 12

Description Sly lower sheave case

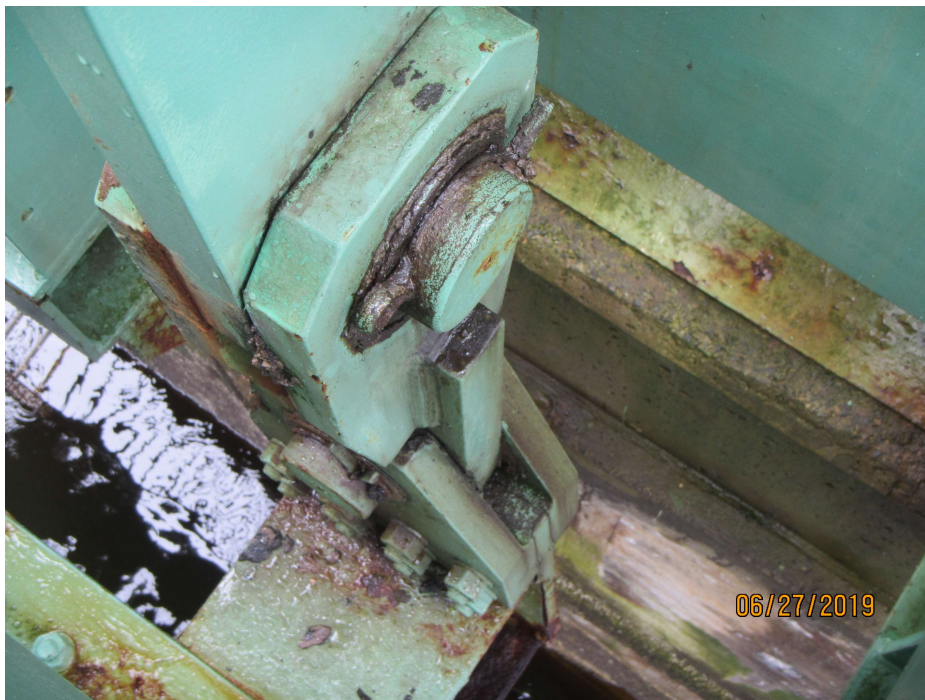
PHOTO 13

Description Pin & link bar

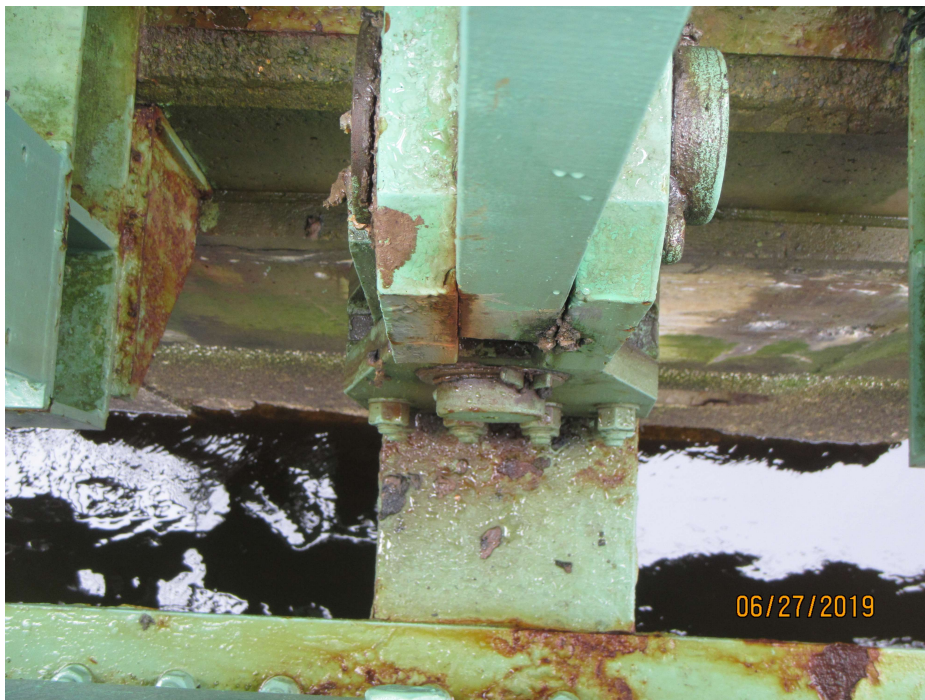
PHOTO 14

Description Link bar

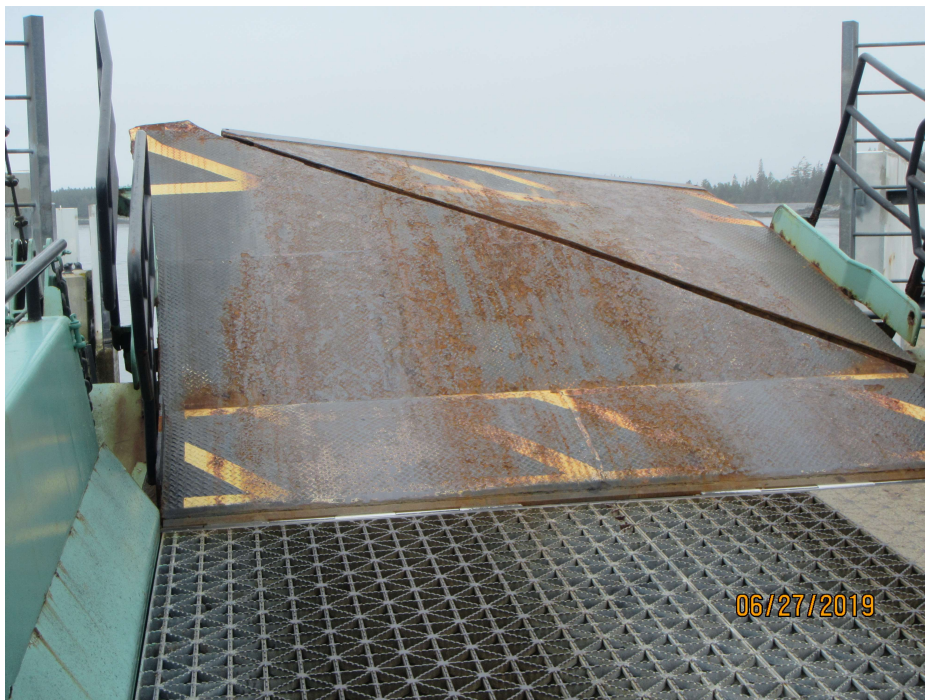
PHOTO 15

Description apron

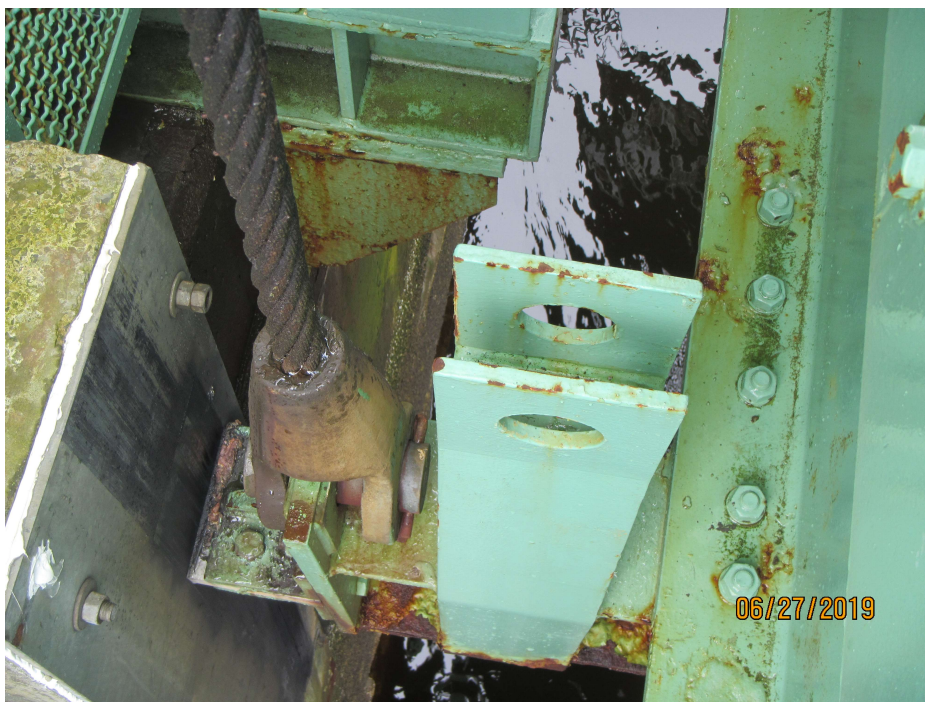
PHOTO 16

Description cable clevis (typ)

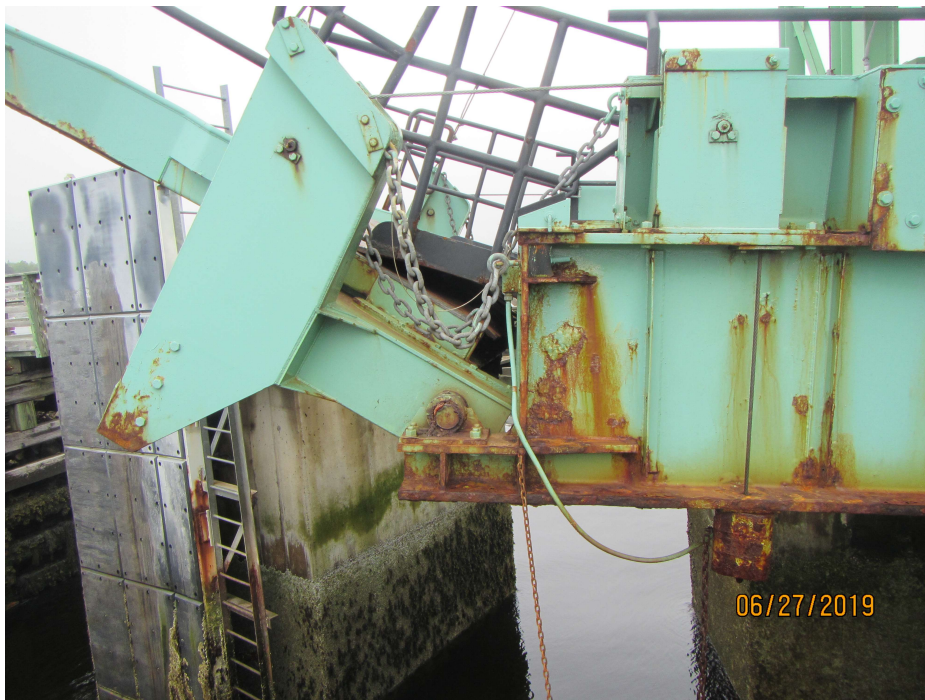
PHOTO 17

Description apron bearing

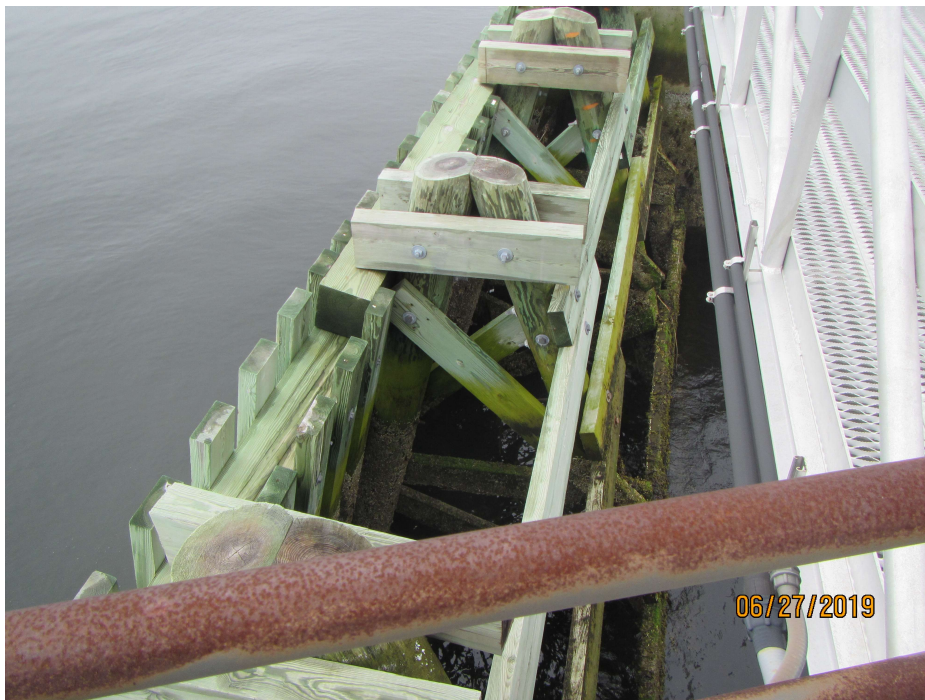
PHOTO 18

Description newer timber wave fence pieces

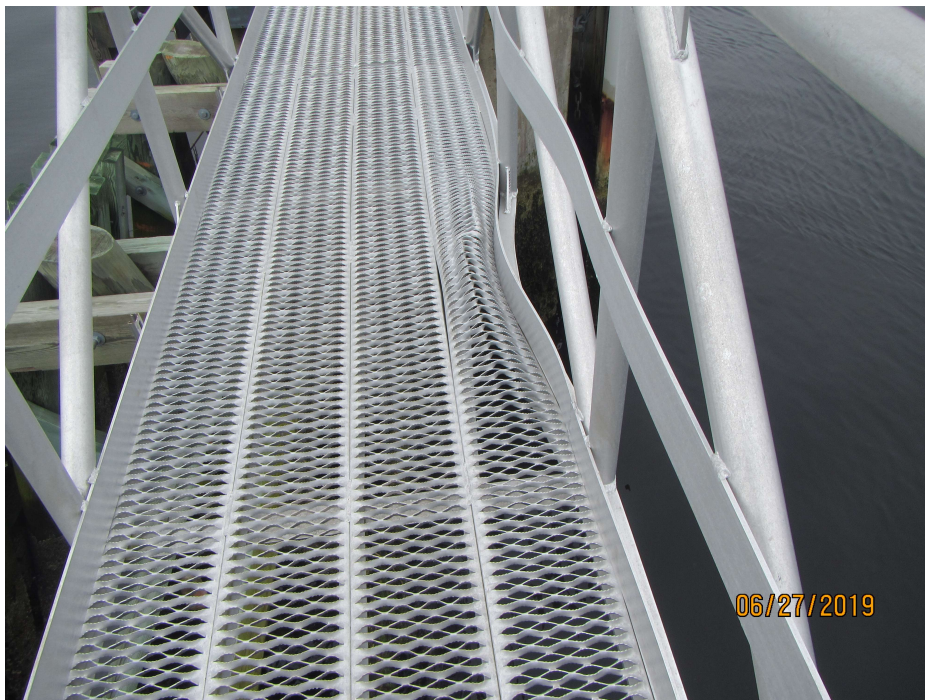
PHOTO 19

Description damaged cat walk on Sly side

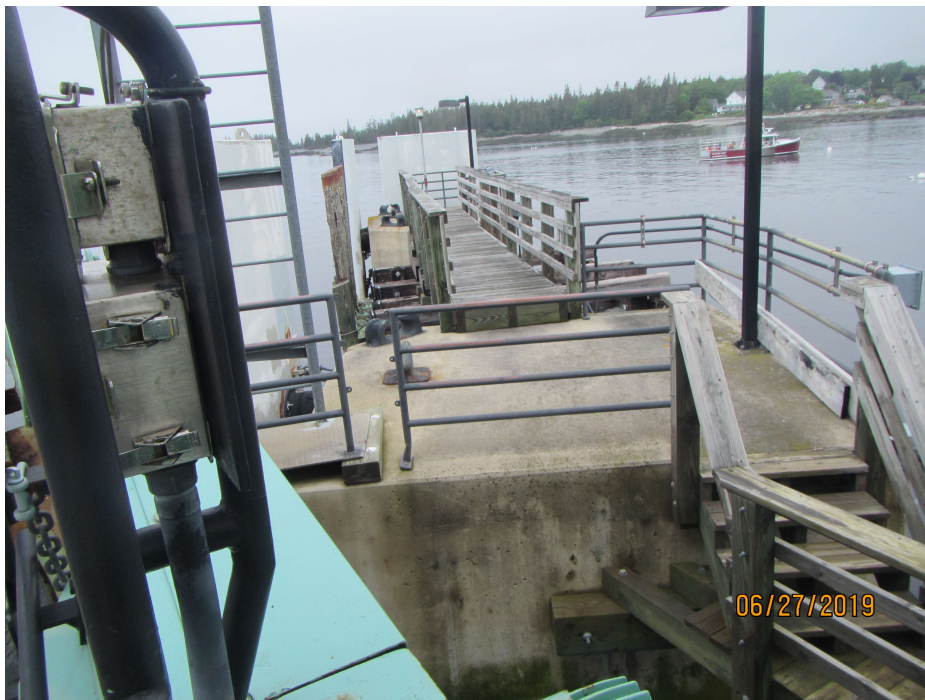
PHOTO 21

Description Nly cat walk

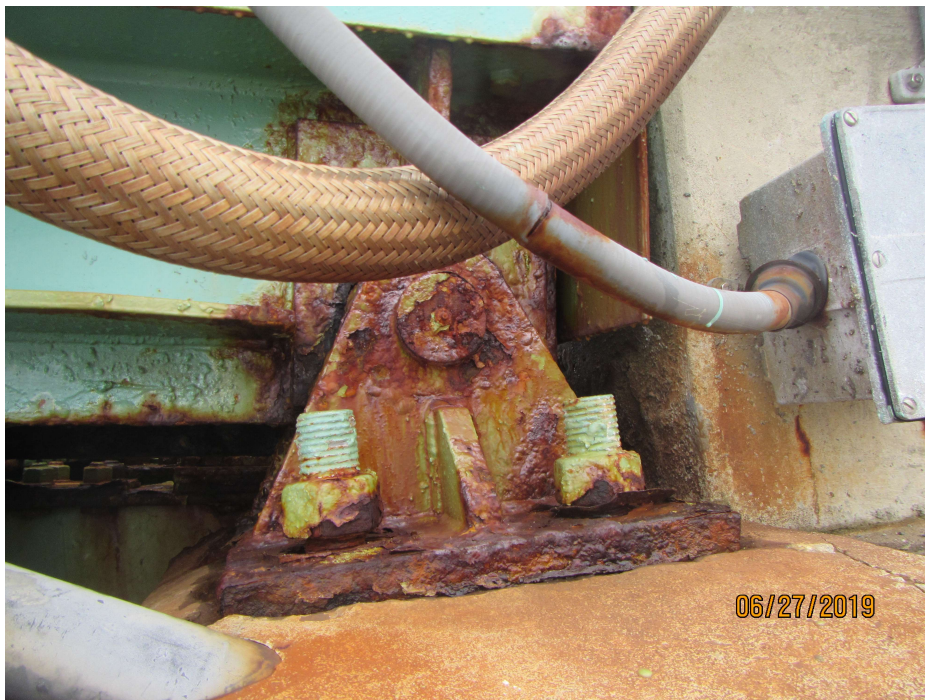
PHOTO 22

Steel girders are in satisfactory condition with moderate paint failure and rusting mostly bottom flanges.
Bearings have paint failure and corrosion.
Towers are in Good Condition.
All fender skins appear to be in good condition and secure.

Description Sly bearing/beam end

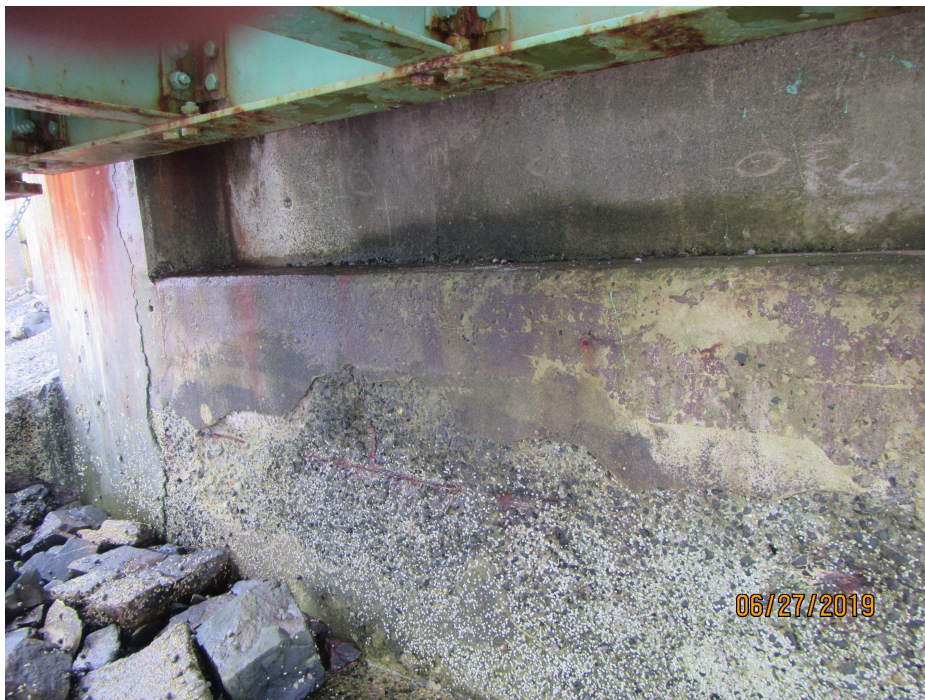
PHOTO 23

The abutment is in Satisfactory condition with patched area.
Pipe pile supported dolphins in satisfactory condition - anode protection (see latest U/W report for details of anodes)

Description abutment bridge seat

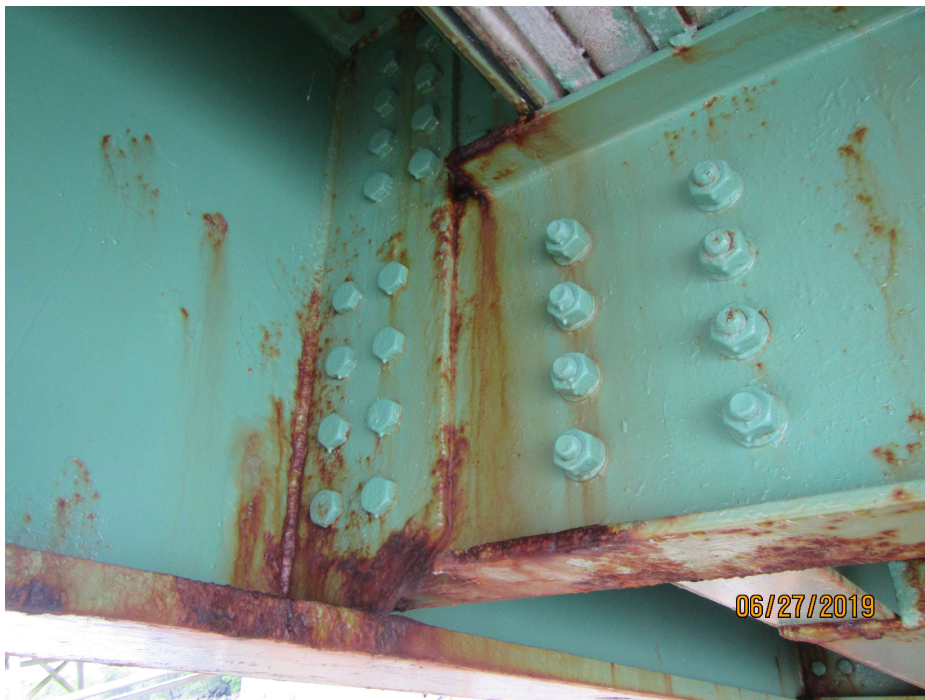
PHOTO 24

Description floor beam/girder connection - Nly side

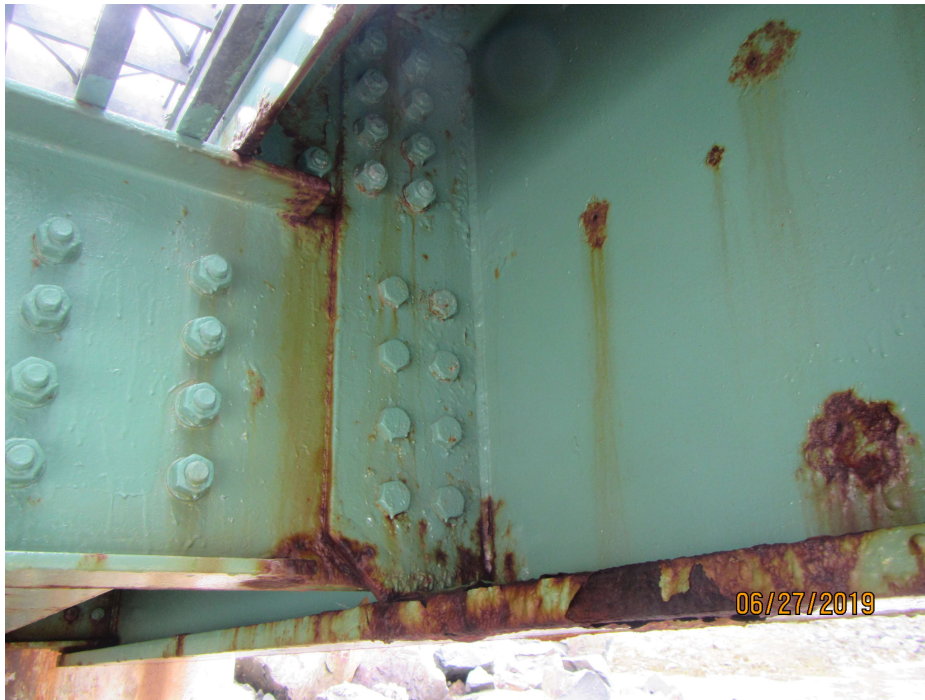
PHOTO 25

Description floor beam/girder connection - Sly side
