# Highway Bridge Inspection Report

BR# 6340

## FRENCHBORO ISLAND FERRY SLIP

Ferry Slip  
Over  
Lunt Harbor

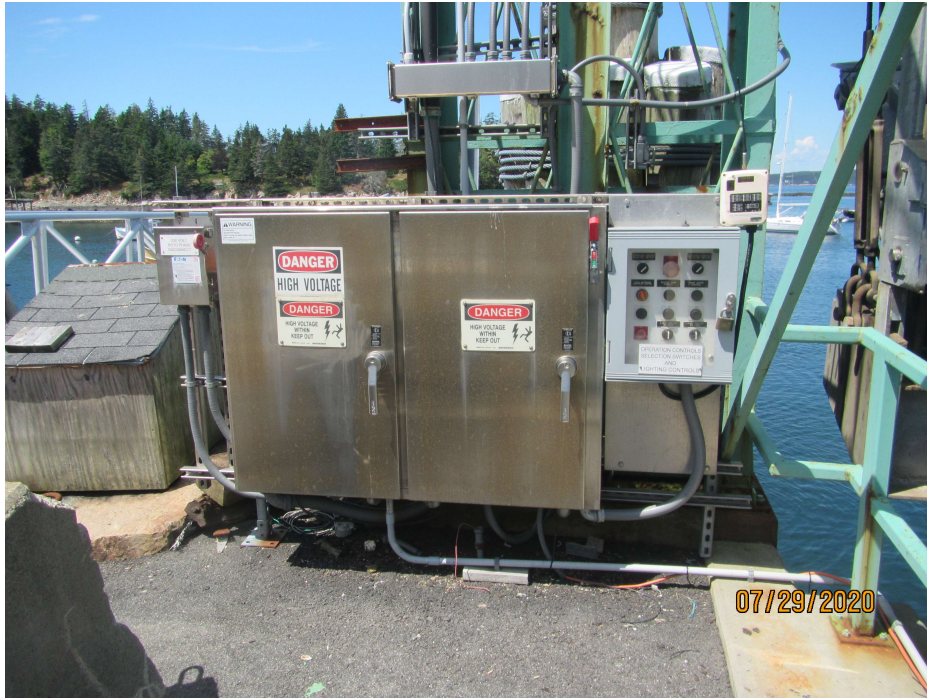
PHOTO 1

Description electrical panel

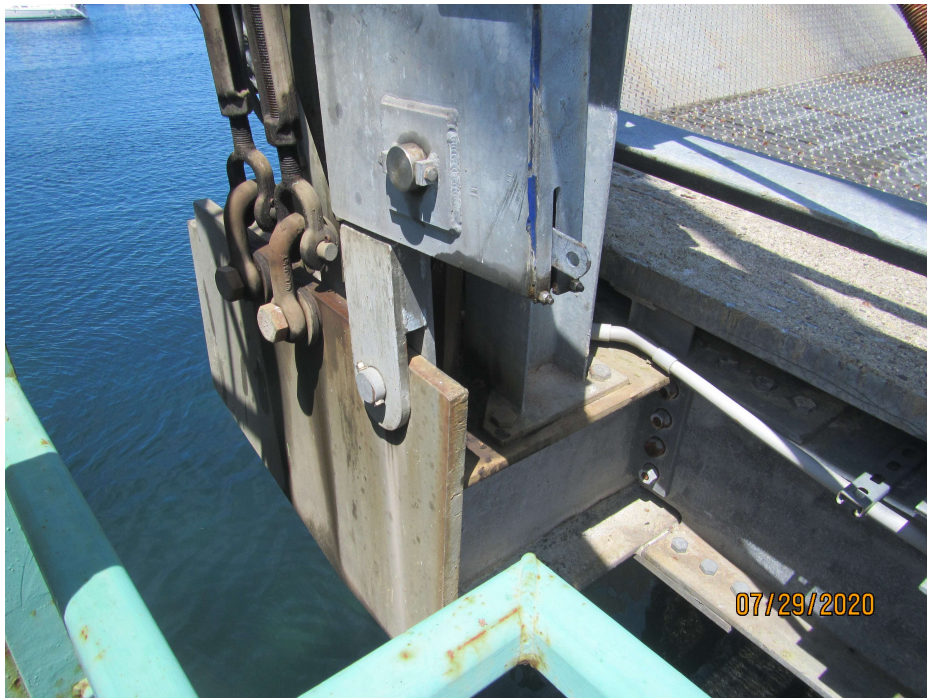
PHOTO 2

Description Ratchet Bar conn.

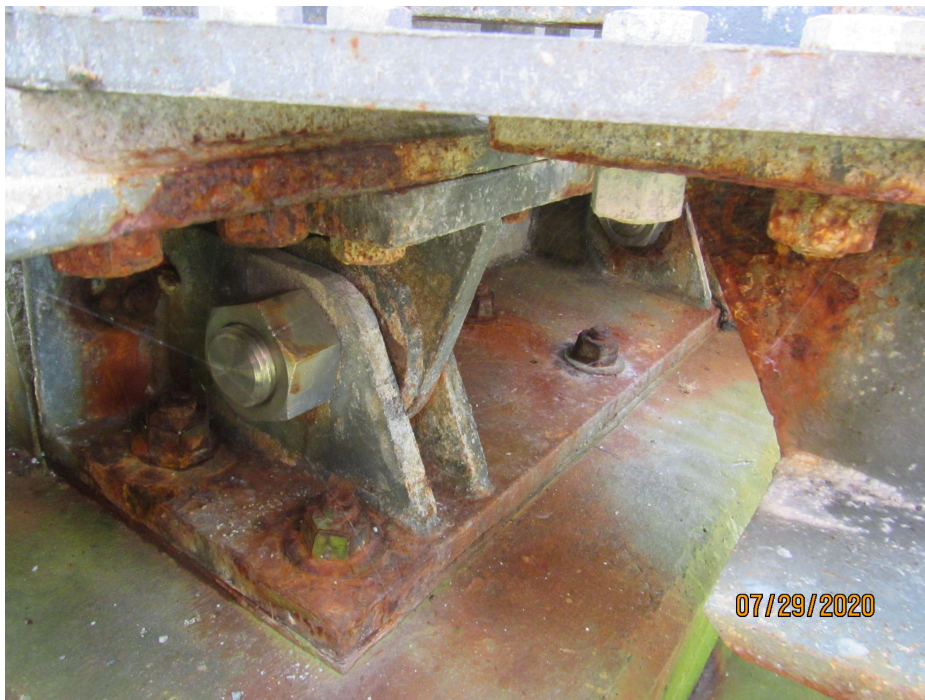
PHOTO 3

Steel galvanized steel girders, diaphragms, and needle beams are in good condition with freckle rust, except end 4' of girders have moderate corrosion with scaled rust near bearings.  
Bearings have moderate corrosion.

Description Nly bearing

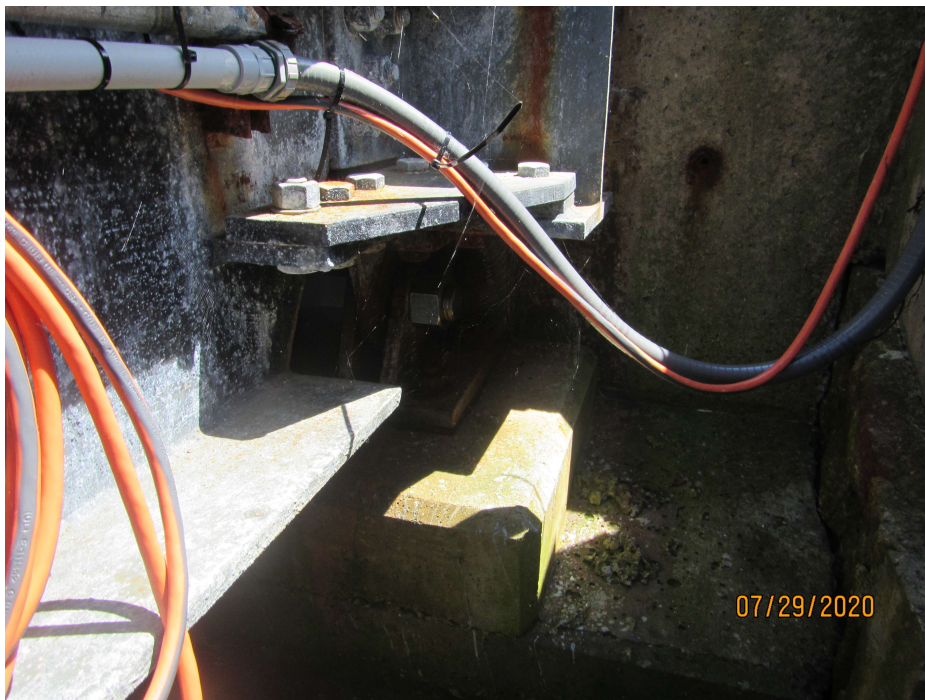
PHOTO 4

Description Sly bearing

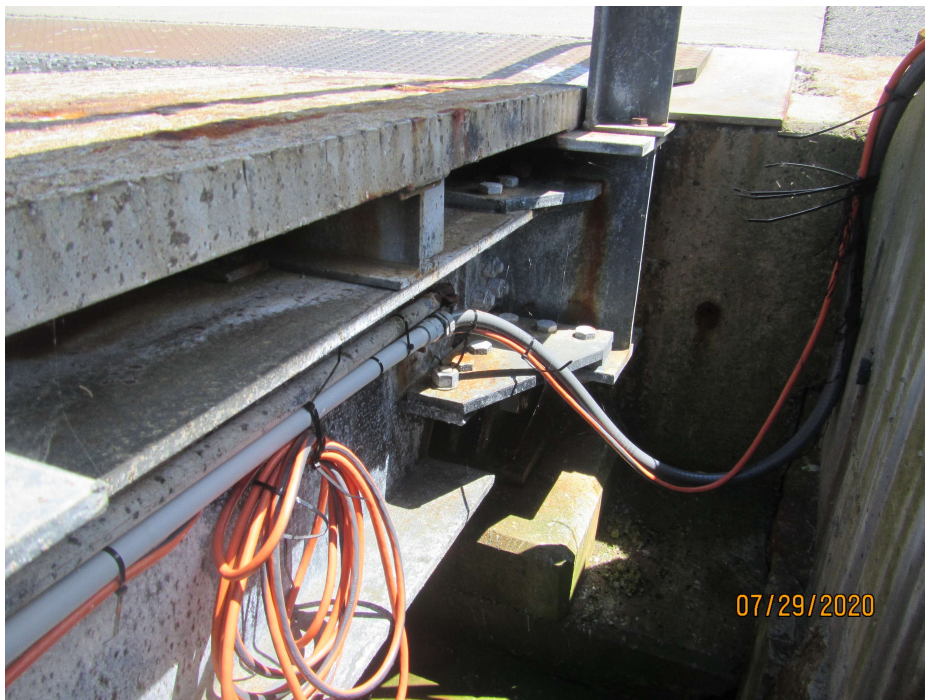
PHOTO 5

Description Sly side of ramp

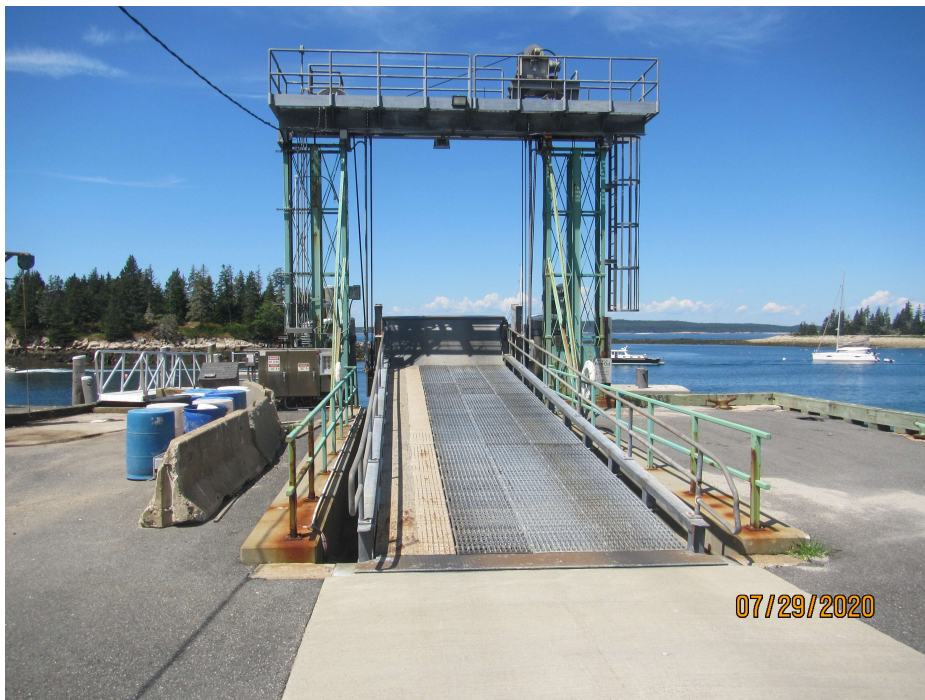
PHOTO 6

Description looking out toward pen

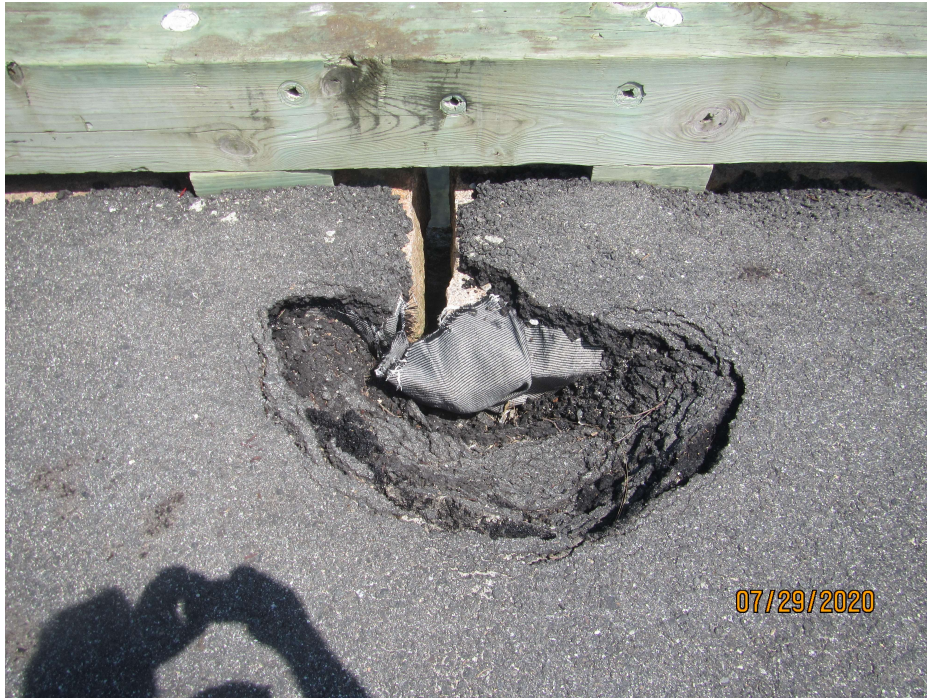
PHOTO 7

The grid deck and concrete filled deck sidewalk are in good condition.  
Nearby parking area continues to be plagued with isolated sink holes.

Description sink hole on Nly parking area

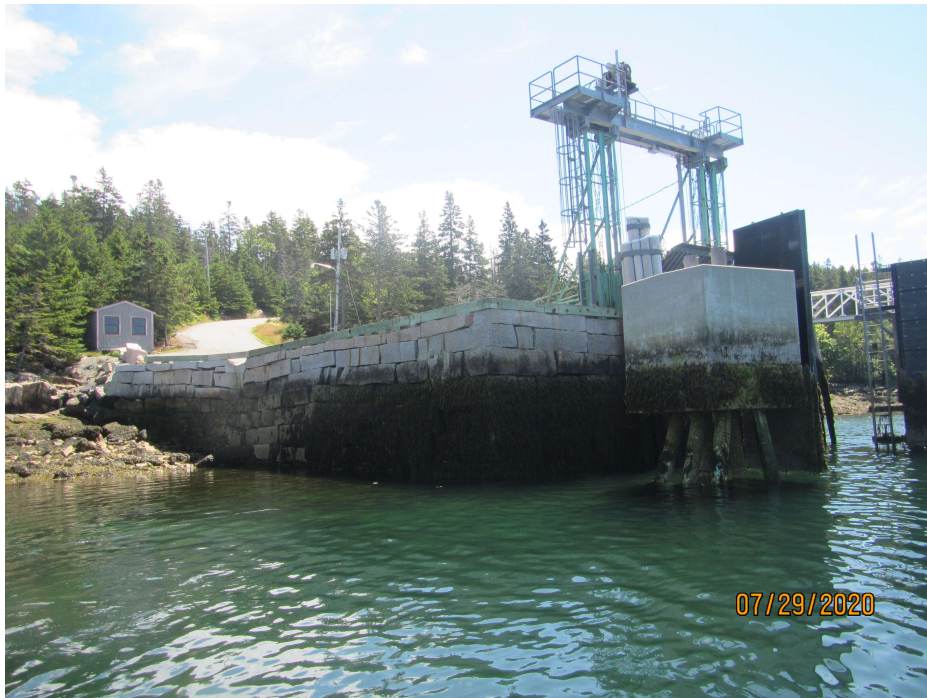
PHOTO 8

Description Nly side

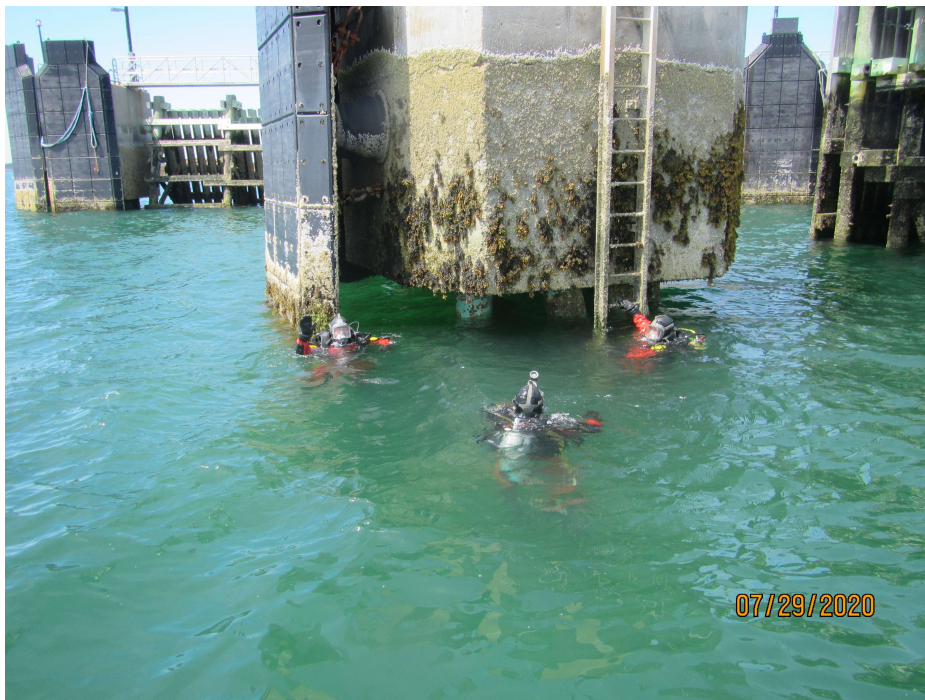
PHOTO 9

Description divers on outer pen area on Eel Grass dive

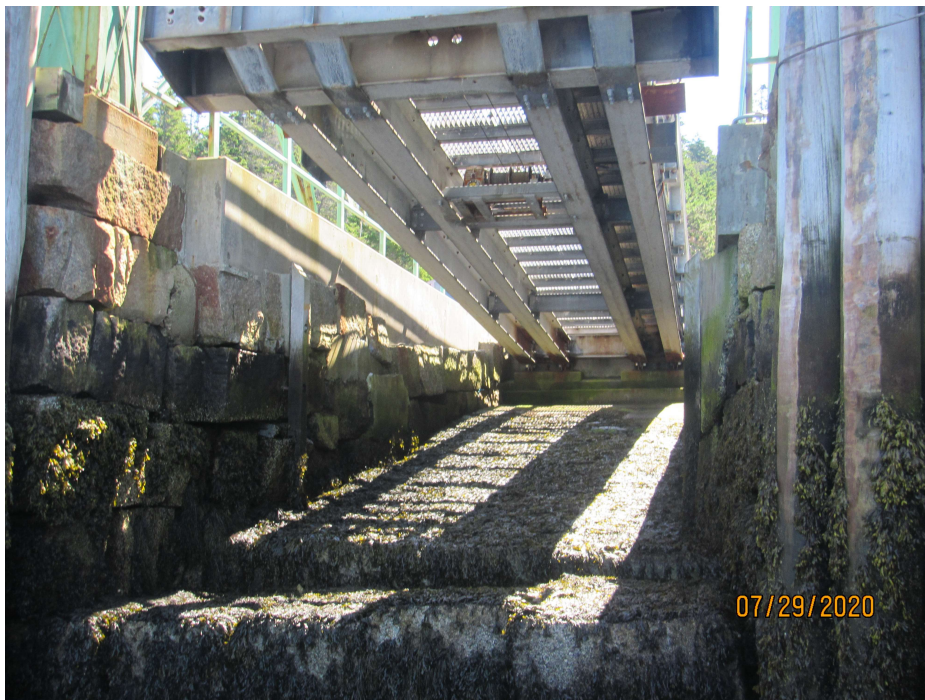
PHOTO 10

Description transfer under carriage

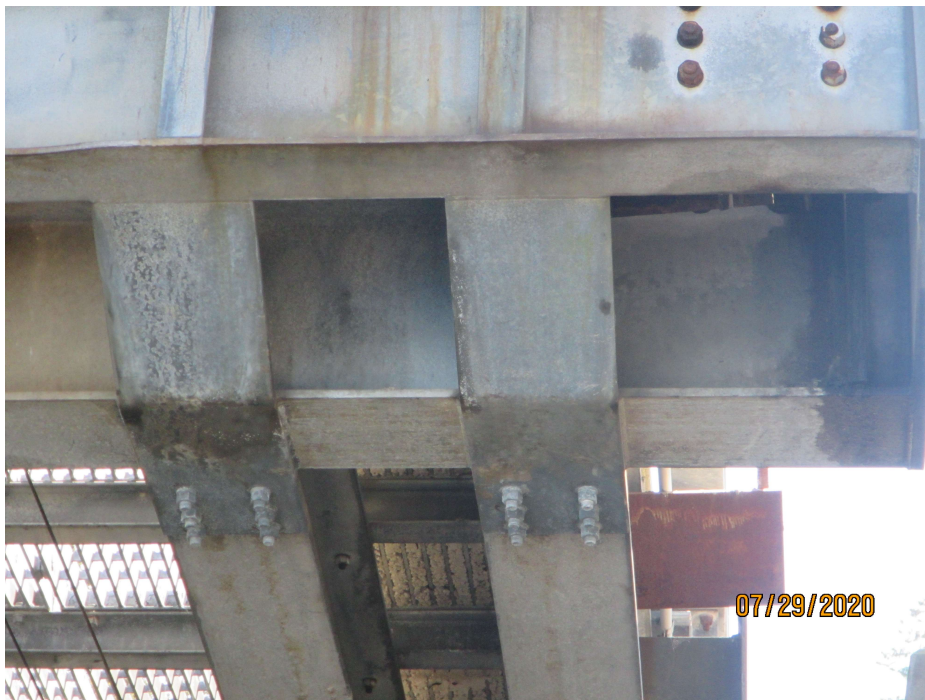
PHOTO 11

Description Sly carrying beam

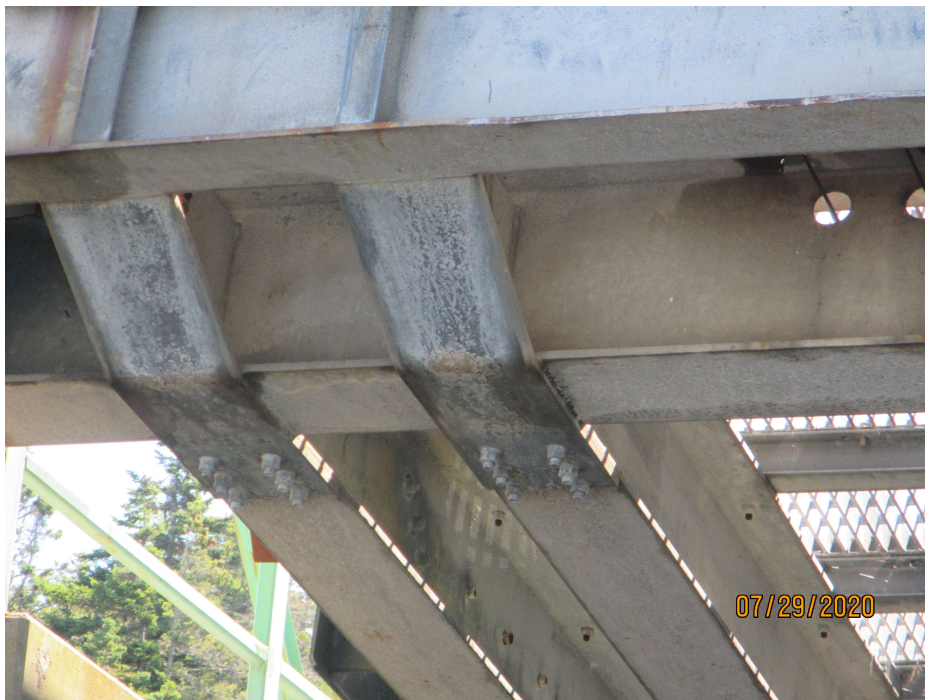
PHOTO 12

Description Nly carrying beam

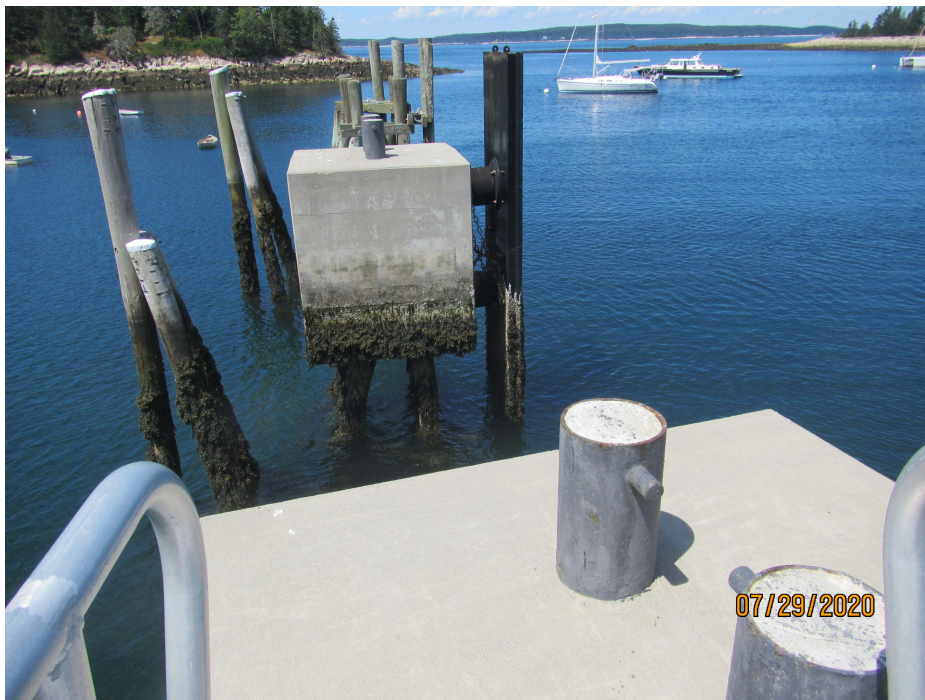
PHOTO 13

Description Sly dolphins

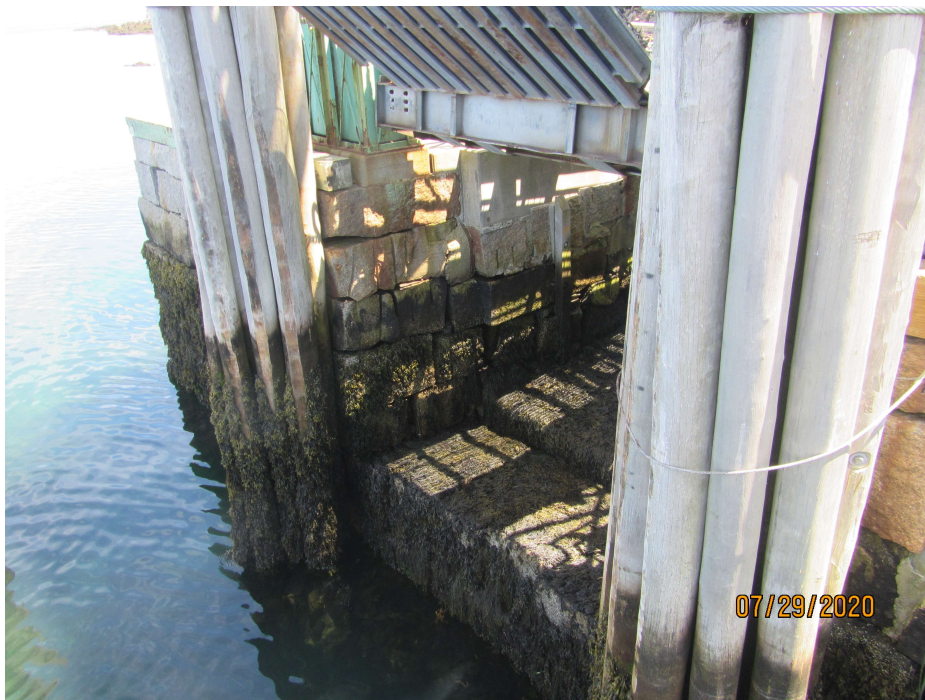
PHOTO 14

Description basin

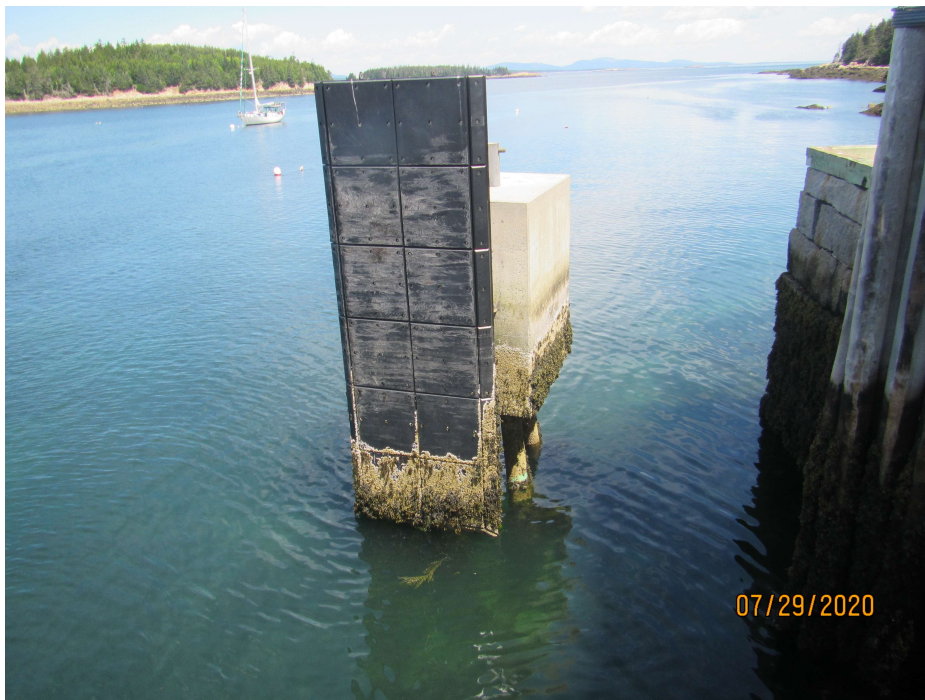
PHOTO 15

Description Nly dolphin

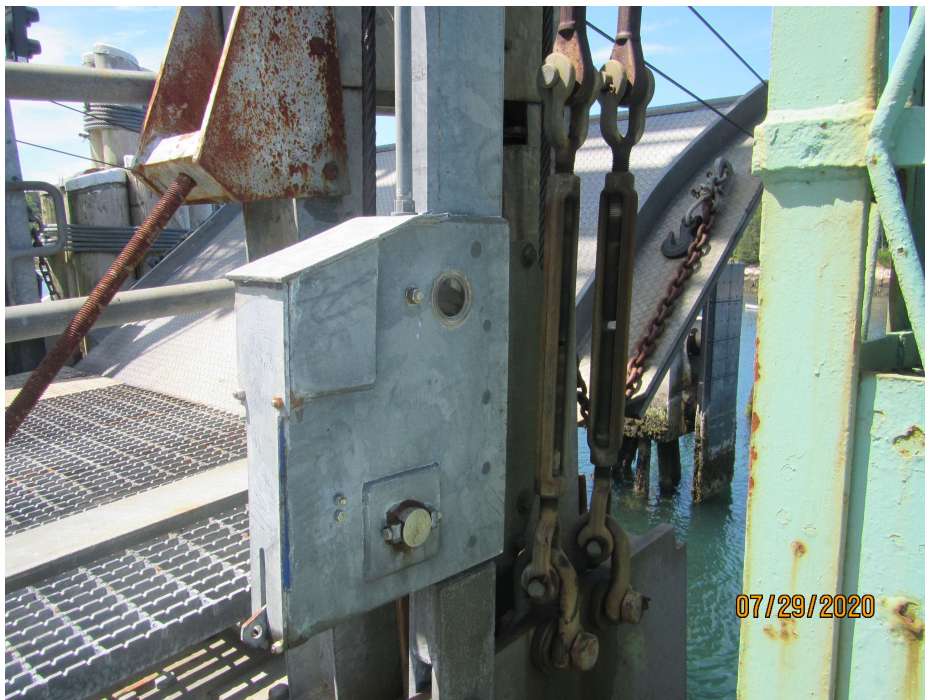
PHOTO 16

Description ramp/apron

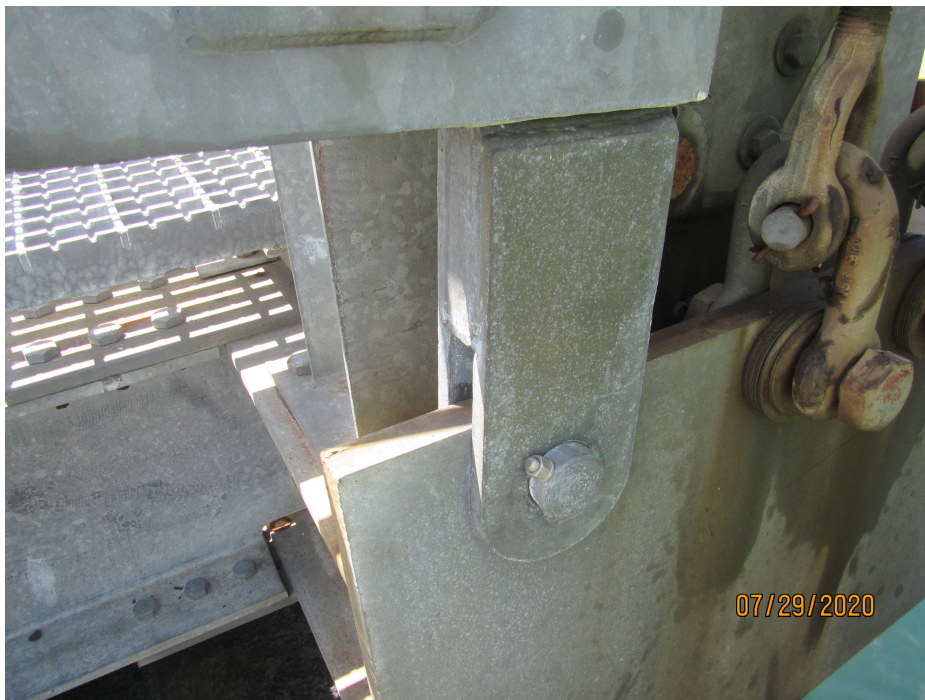
PHOTO 17

Description Nly Ratchet Bar connection

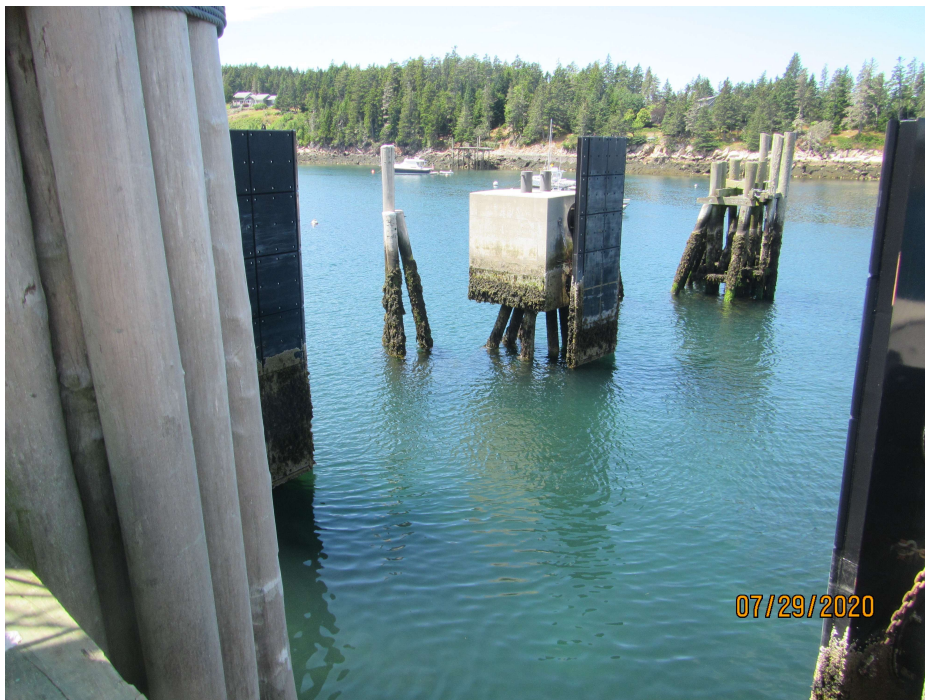
PHOTO 18

Description pen area

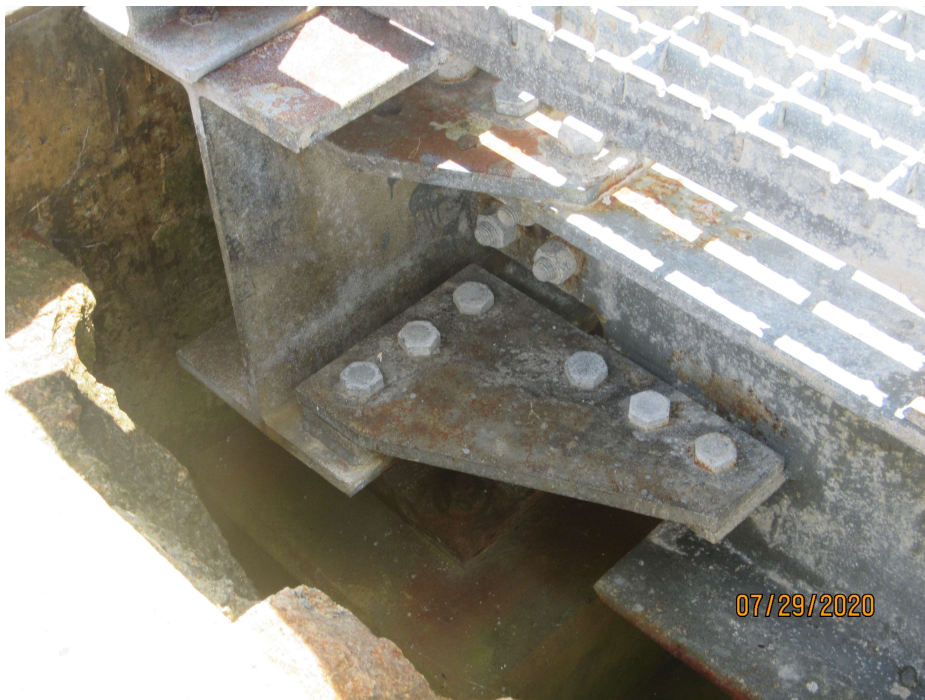
PHOTO 19

Description bearing area/conn plates
