# Highway Bridge Inspection Report

BR# 6349

## SWANS ISLAND FERRY SLIP

Inspection Date: 07/09/2019

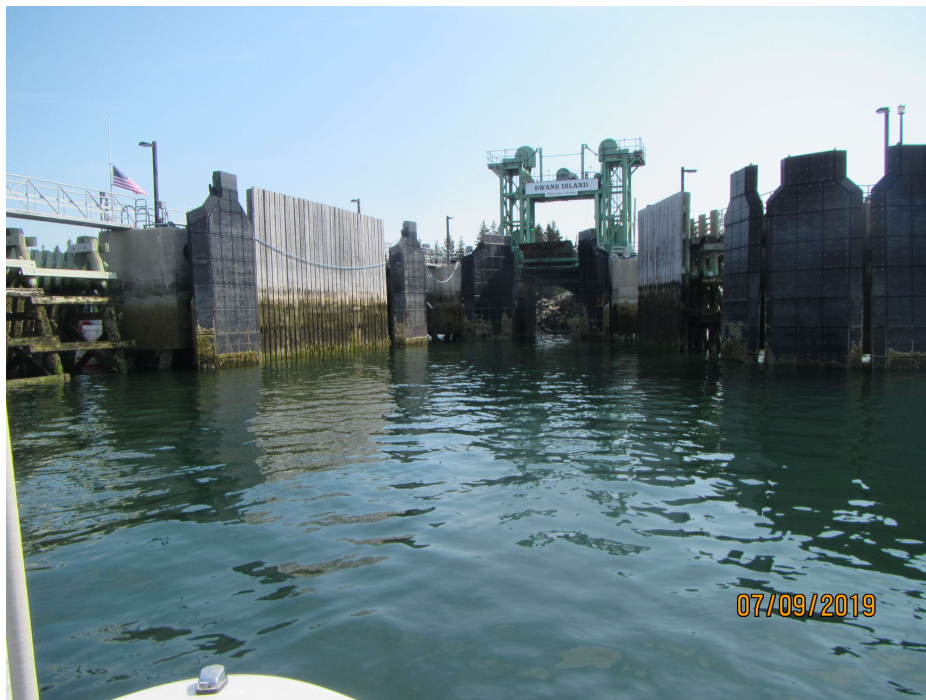
PHOTO 1

Description pen area

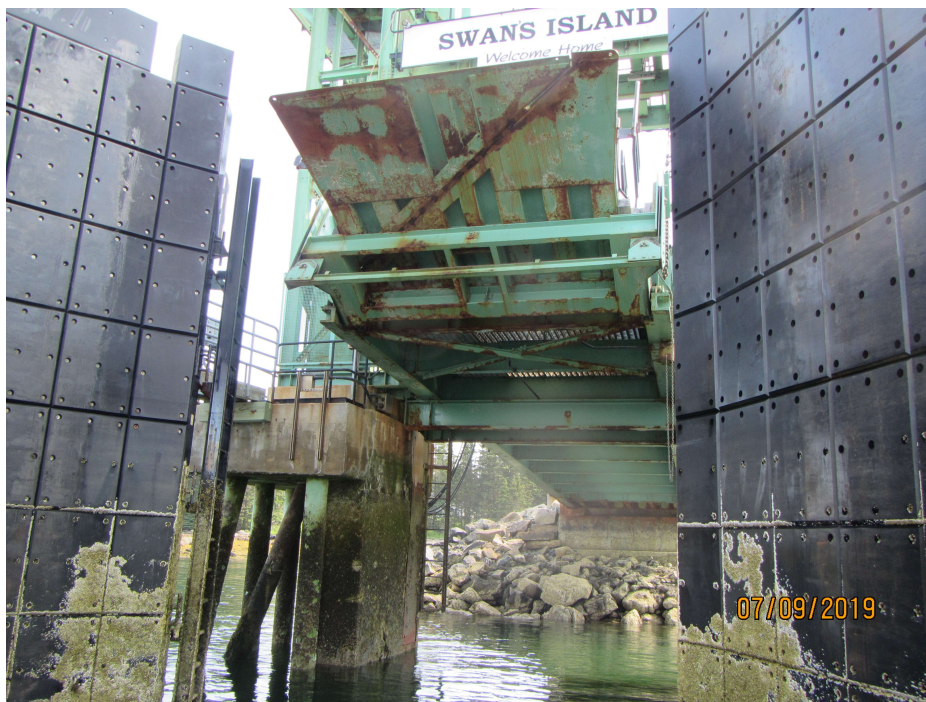
PHOTO 2

Description apron/ramp

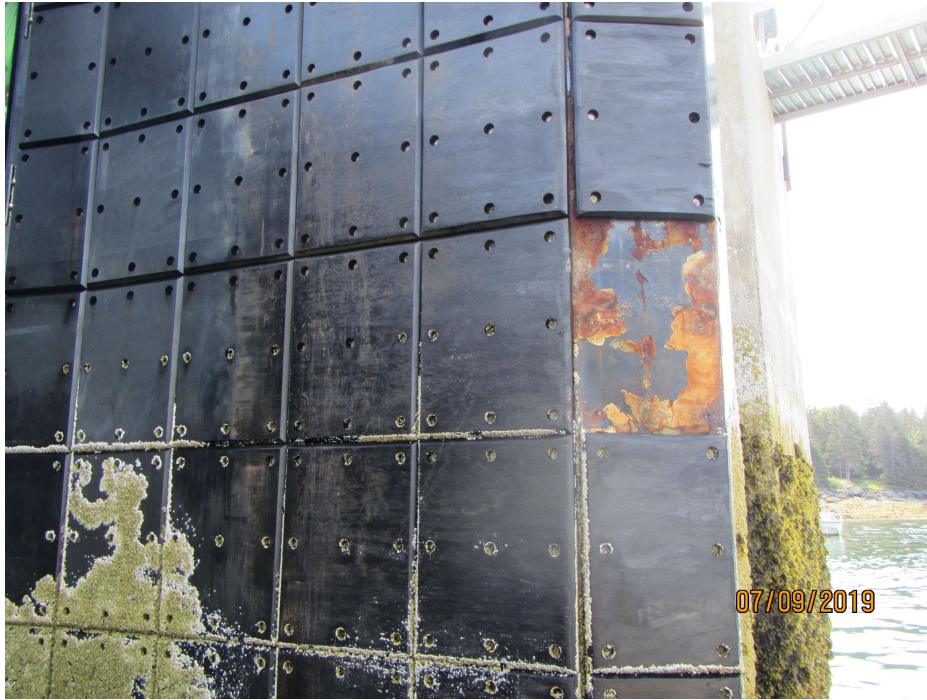
PHOTO 3

Description close-up of fender

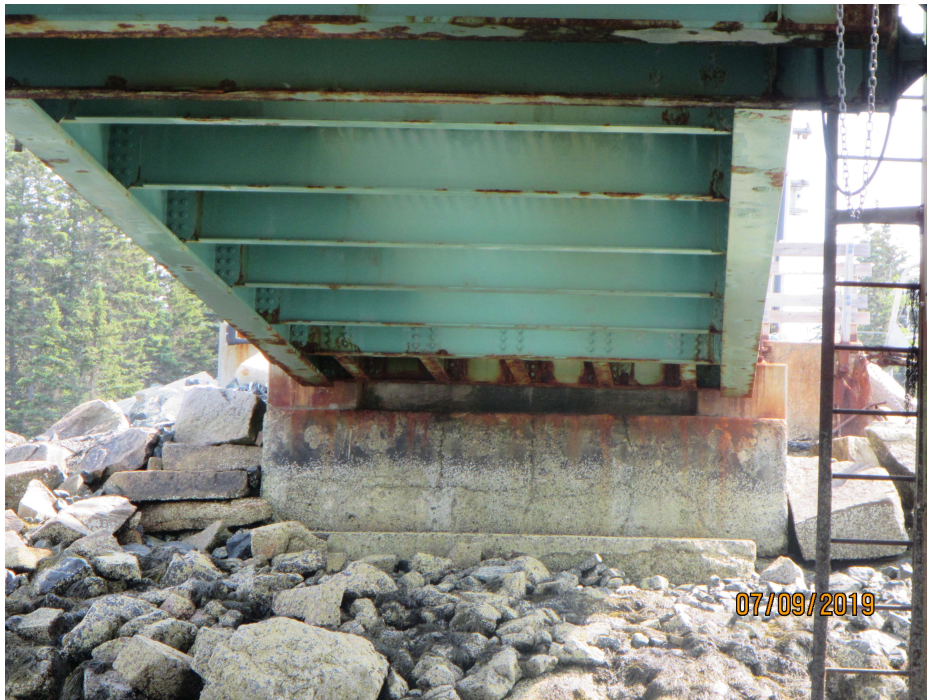
PHOTO 4

Concrete abutment is in fair condition with large longitudinal crack between bearing pedestals.  
Dolphins and fenders are in satisfactory condition.  
Some anodes missing or disconnected. see u/w report for details.  
Pile wraps coming undone.

Description abutment

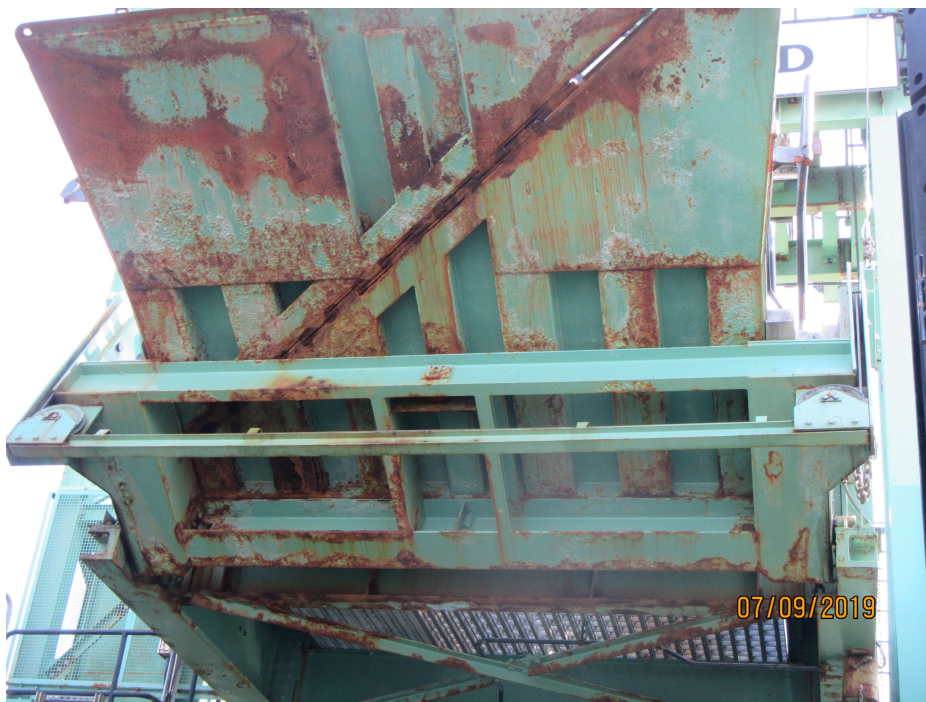
PHOTO 5

Description underside of apron

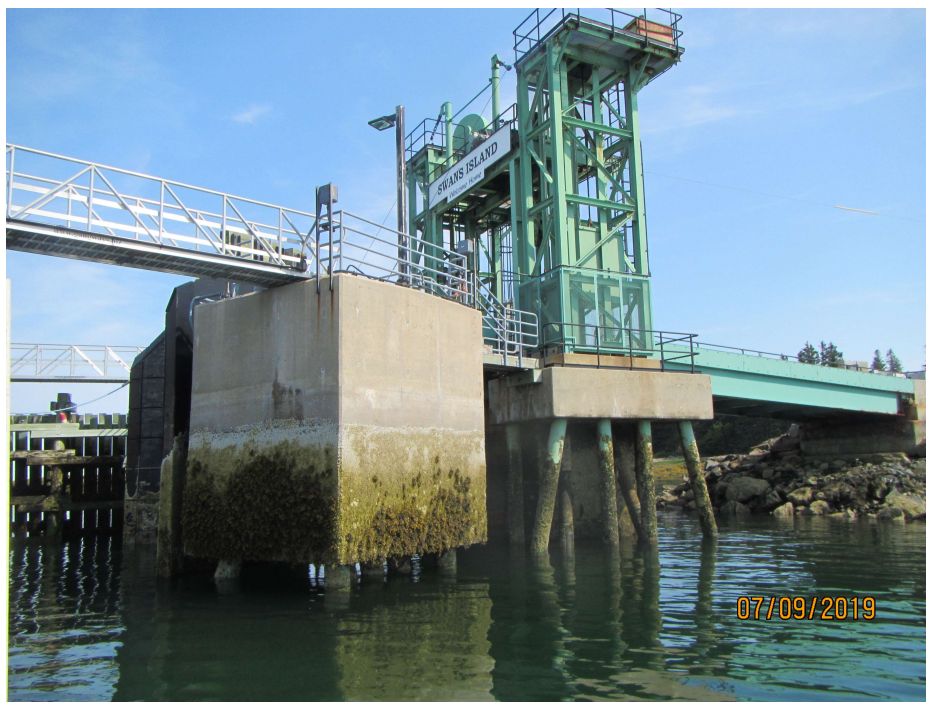
PHOTO 6

Description general view

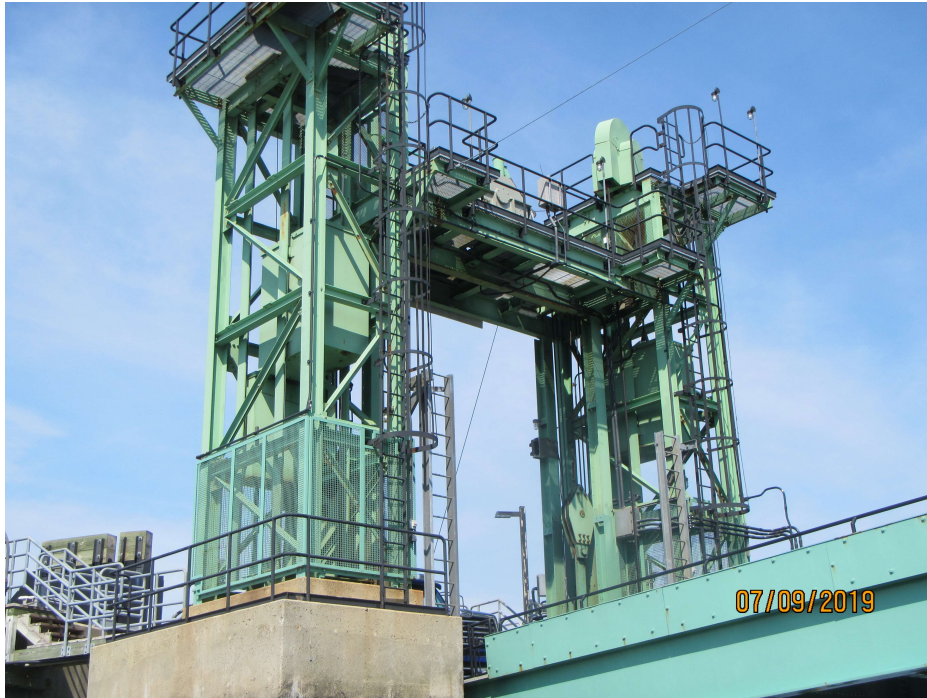
PHOTO 7

Description towers

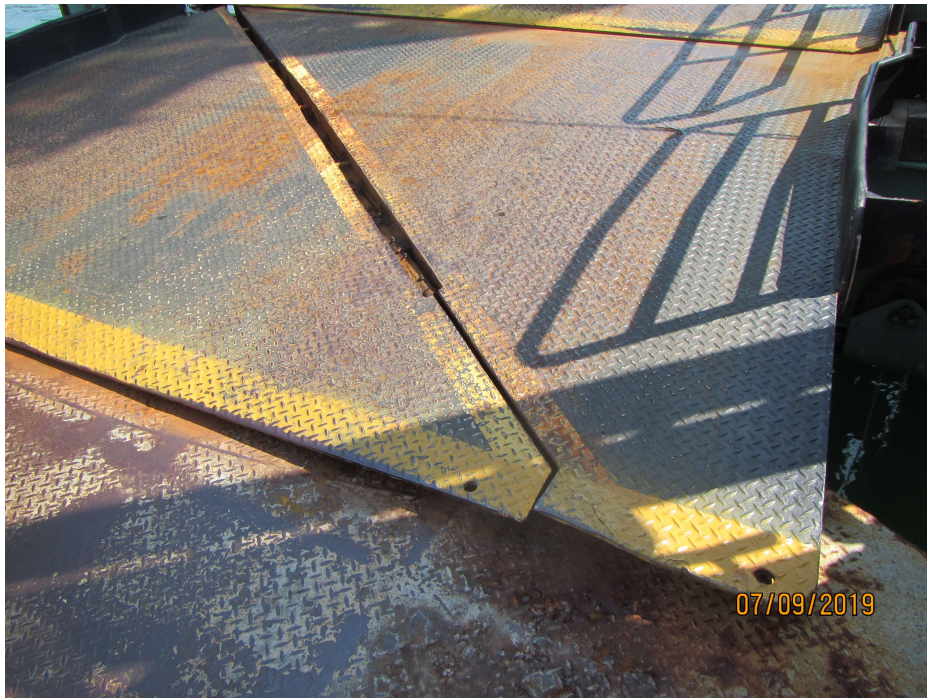
PHOTO 8

Description close-up of apron, note bent up lower right corner of plate

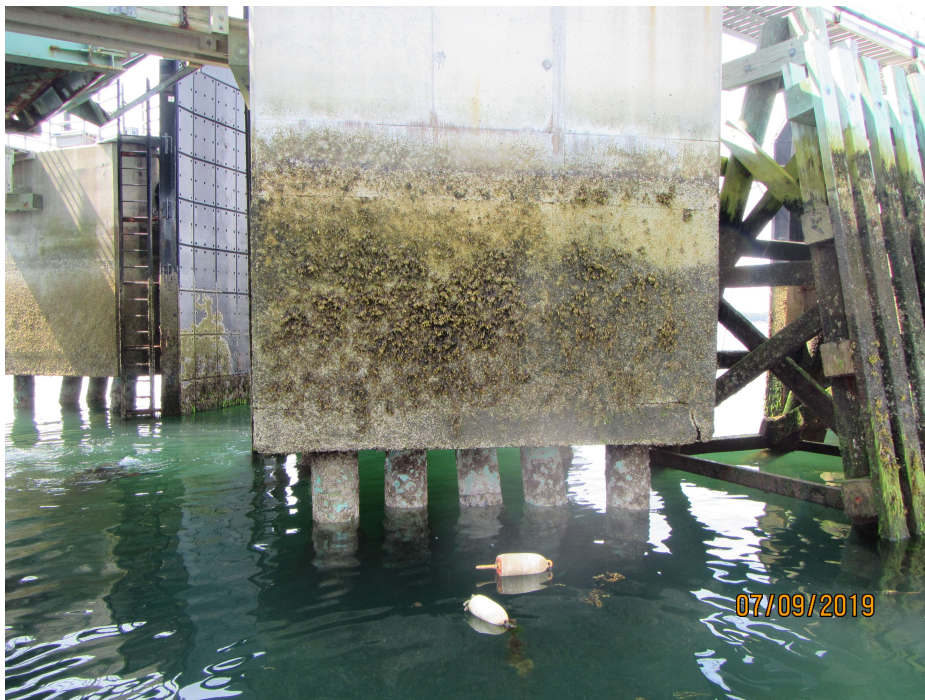
PHOTO 9

Description back side of Nly tower dolphin

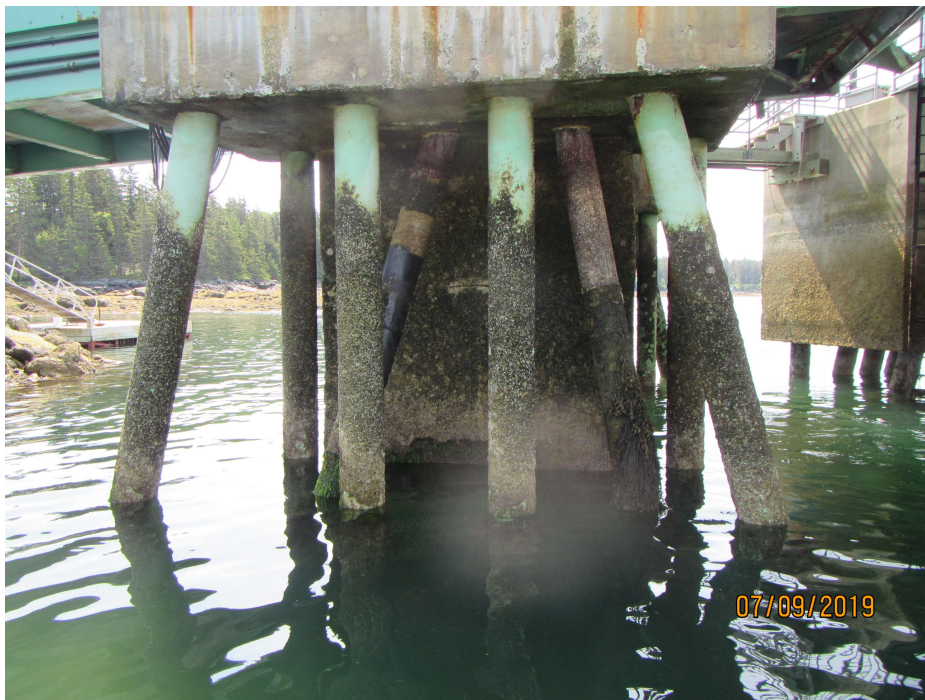
PHOTO 10

Description back side of Nly tower dolphin - note wrapped piles

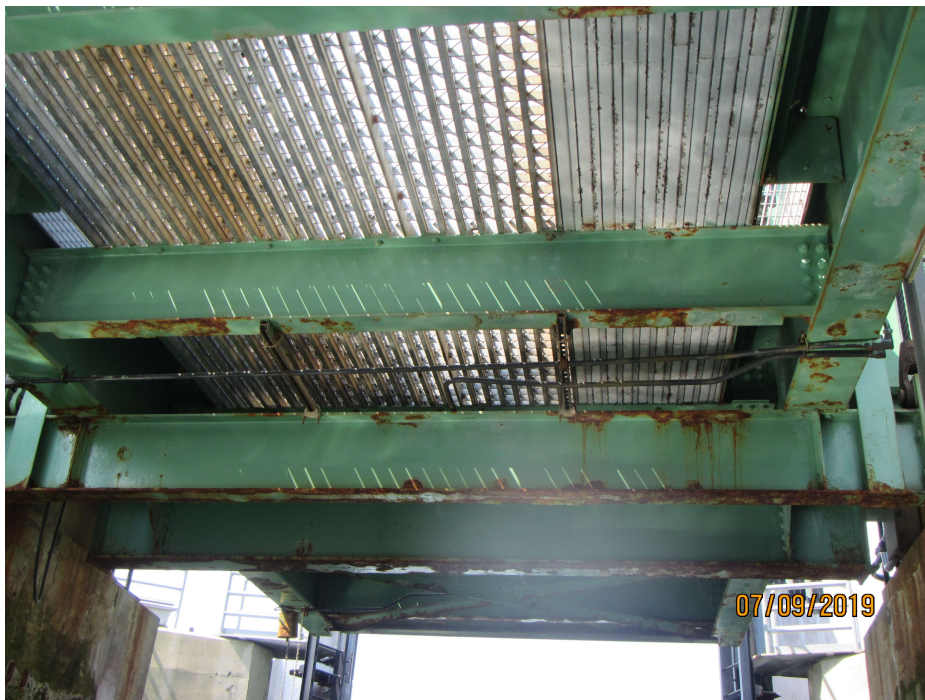
PHOTO 11

Description floor beams looking toward apron

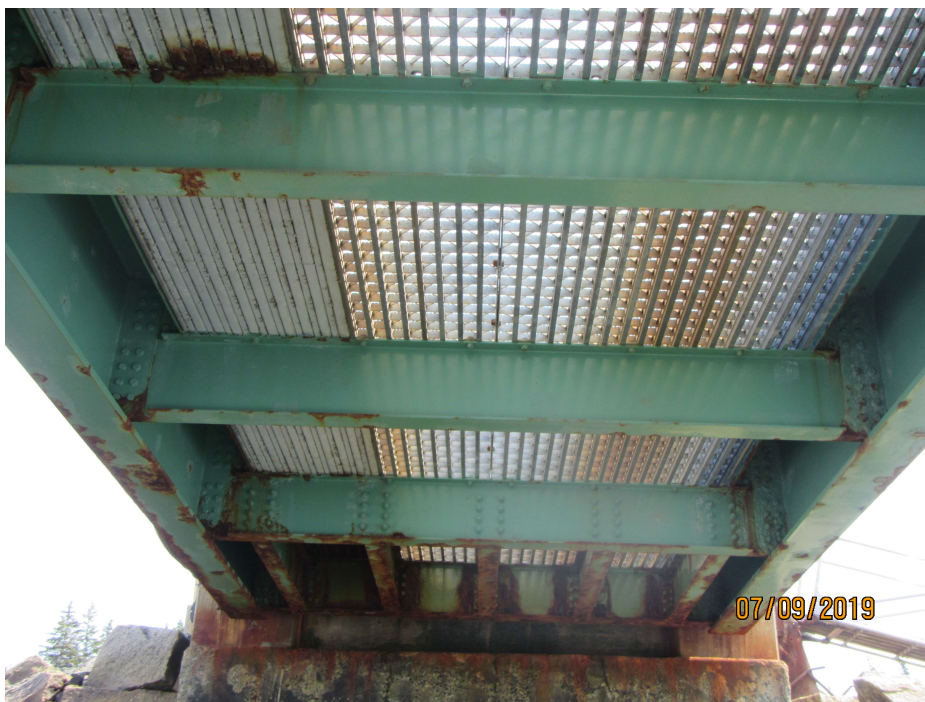
PHOTO 12

Description floor beams

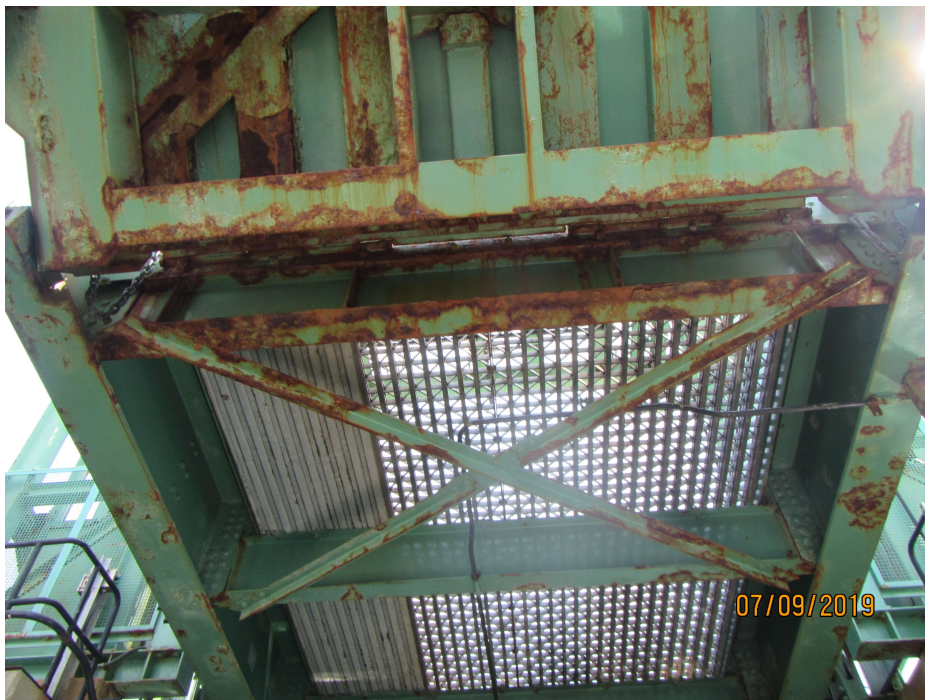
PHOTO 13

Description Apron/ramp hinge

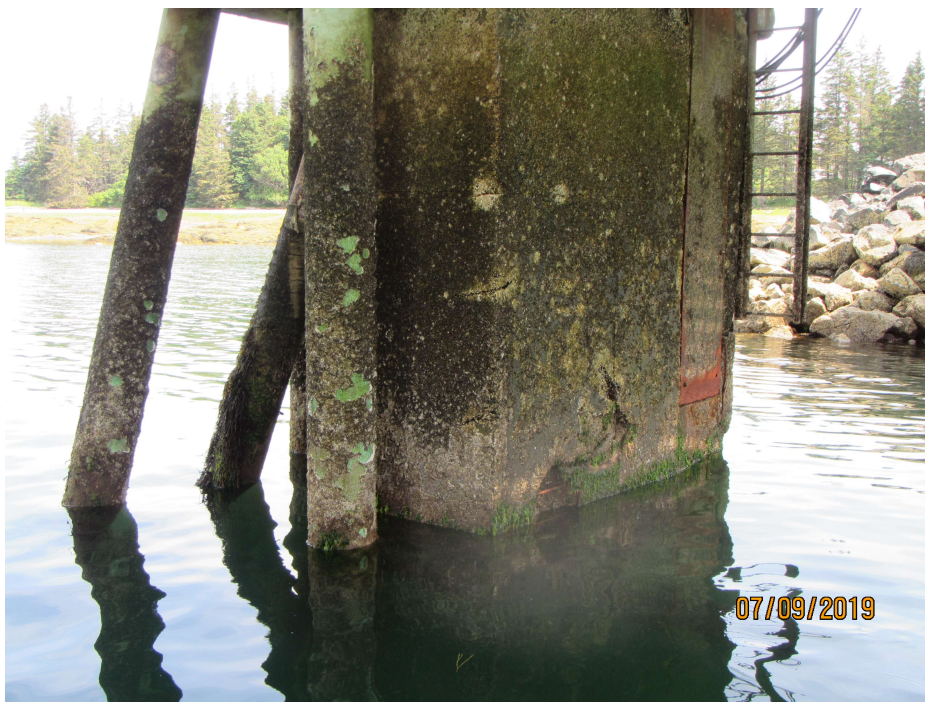
PHOTO 14

Description Nly tower pier

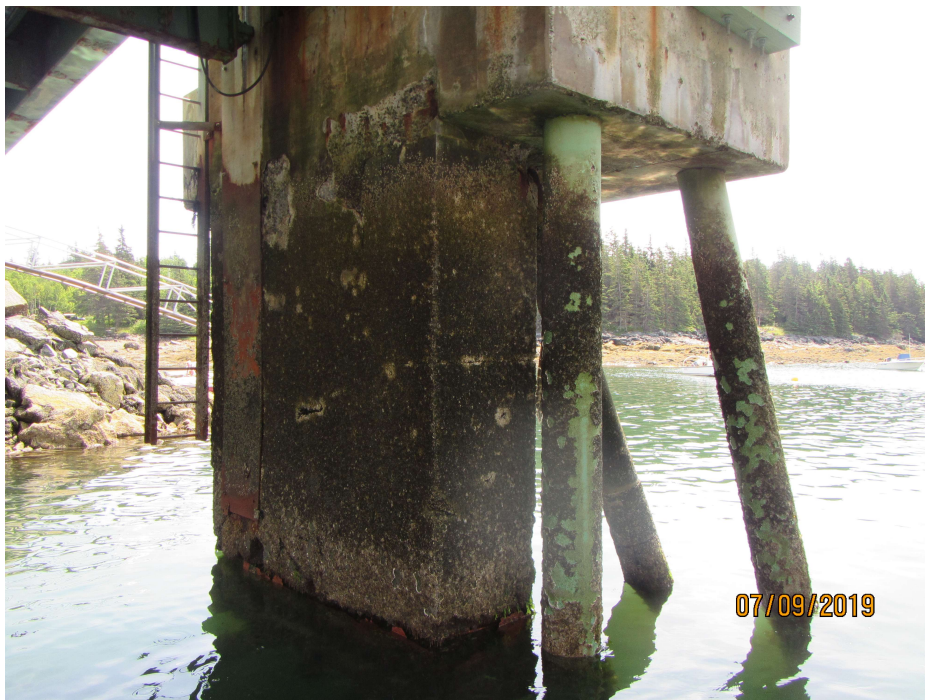
PHOTO 15

Description Sly tower pier

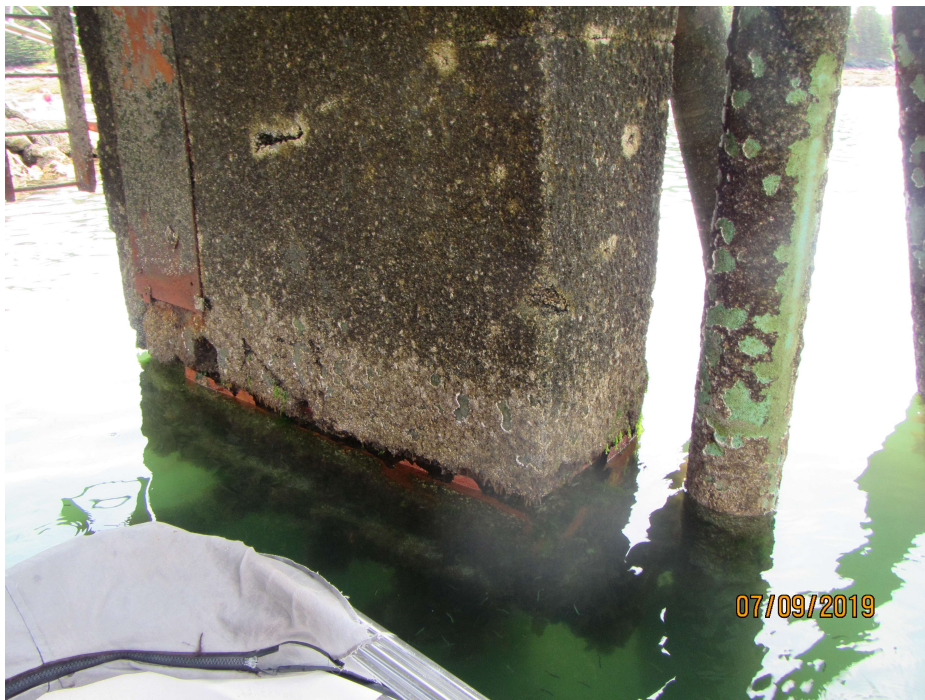
PHOTO 16

Description bottom of Sly dolphin pier concrete

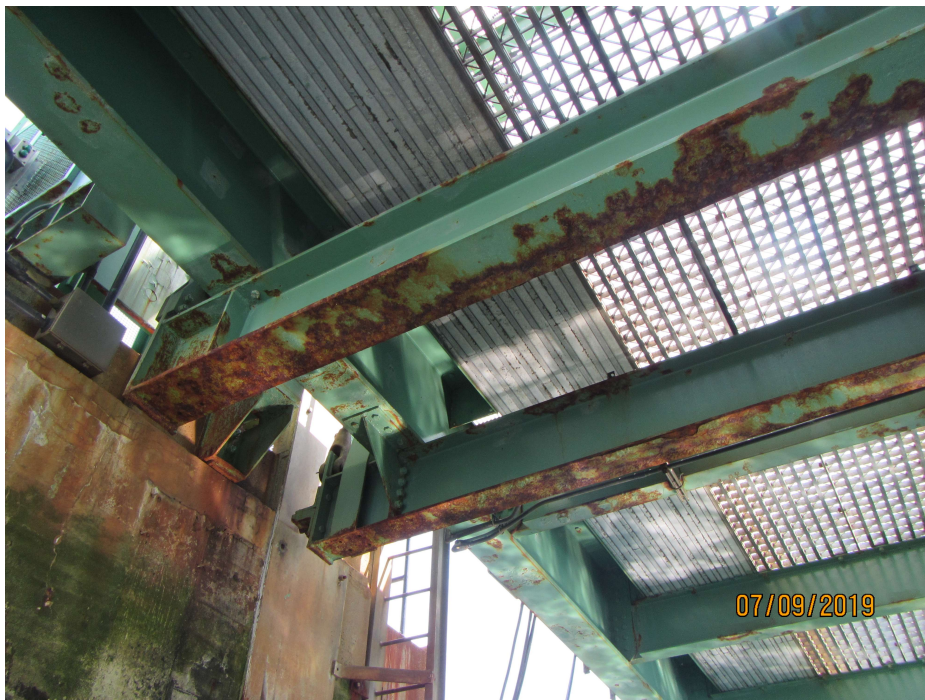
PHOTO 17

Description bottom of counter weight/ hoist beams

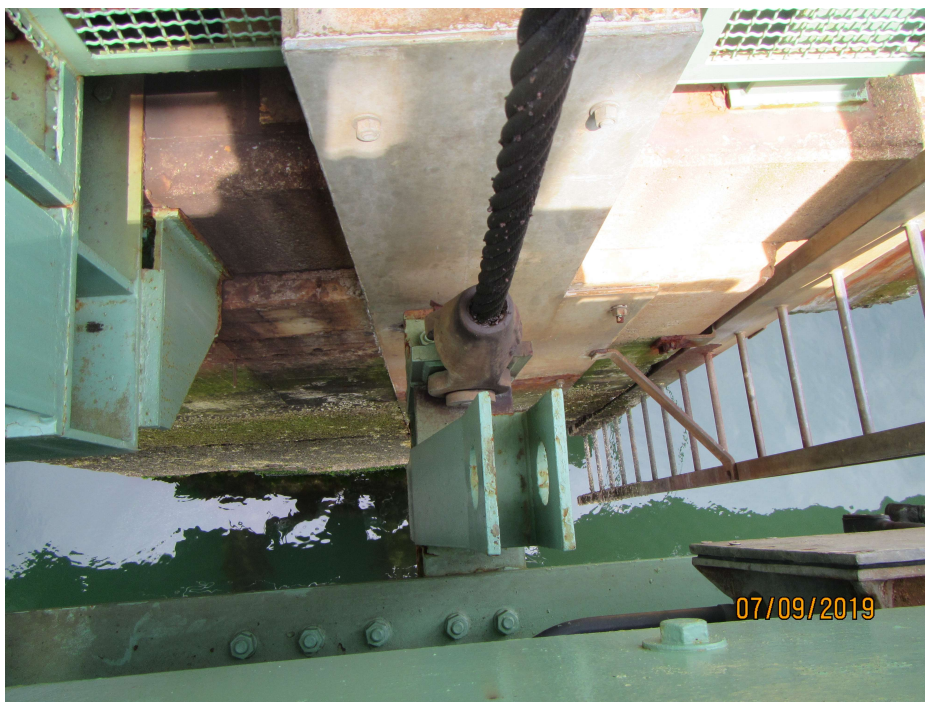
PHOTO 18

Description cable clevis (typ)

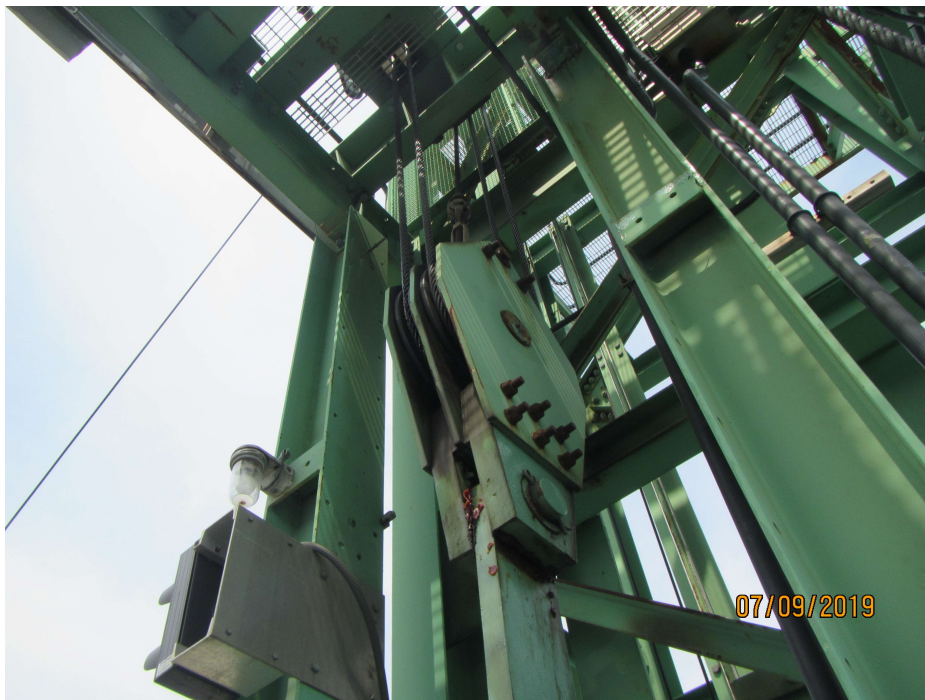
PHOTO 20

Description Nly sheave & link bar

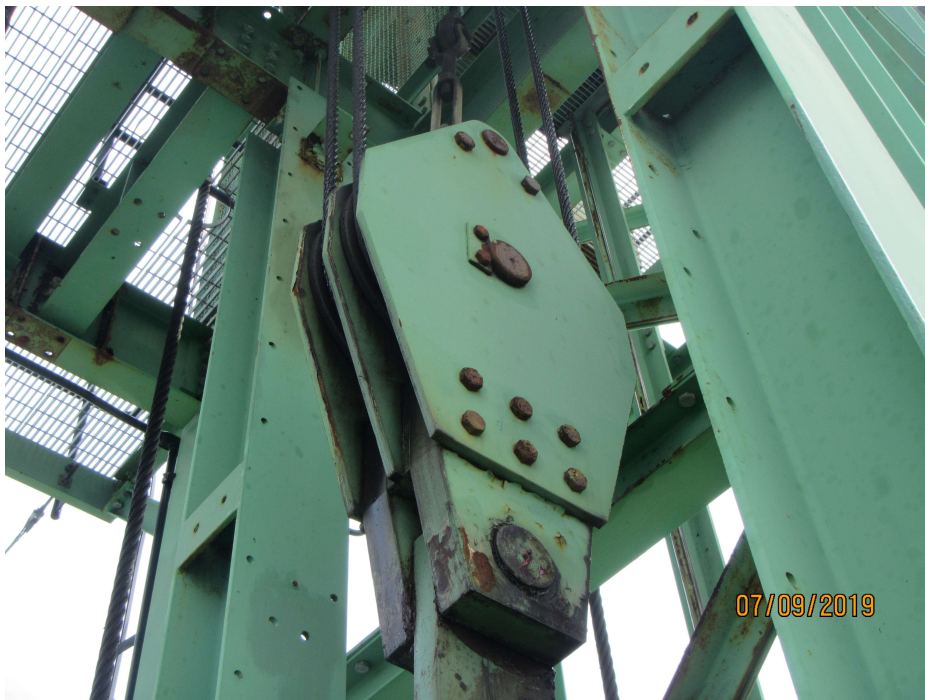
PHOTO 21

Description close up of Nly sheave

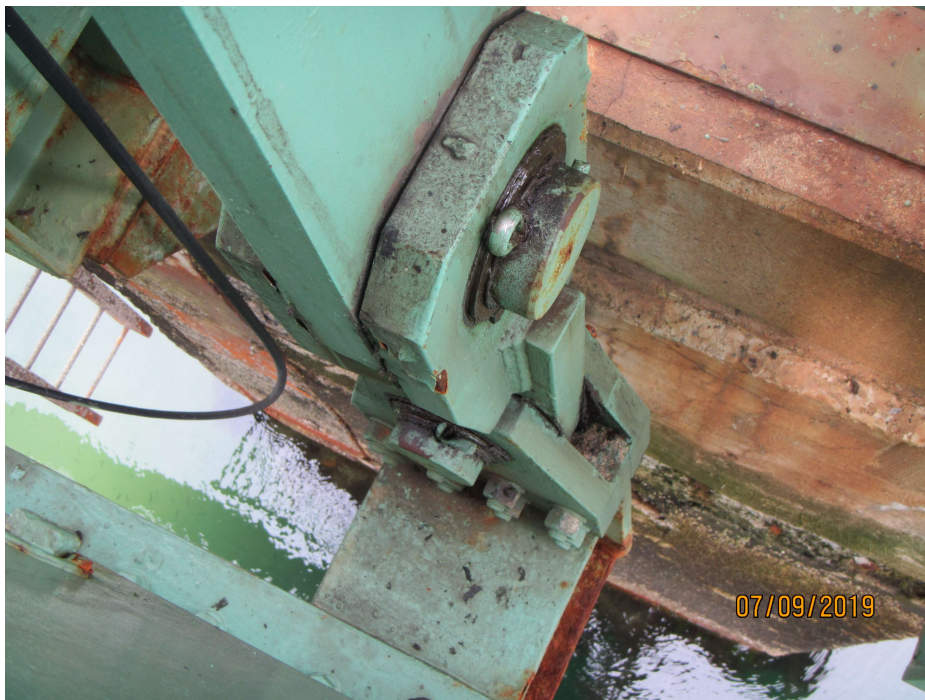
PHOTO 22

Description Nly link bar & pin

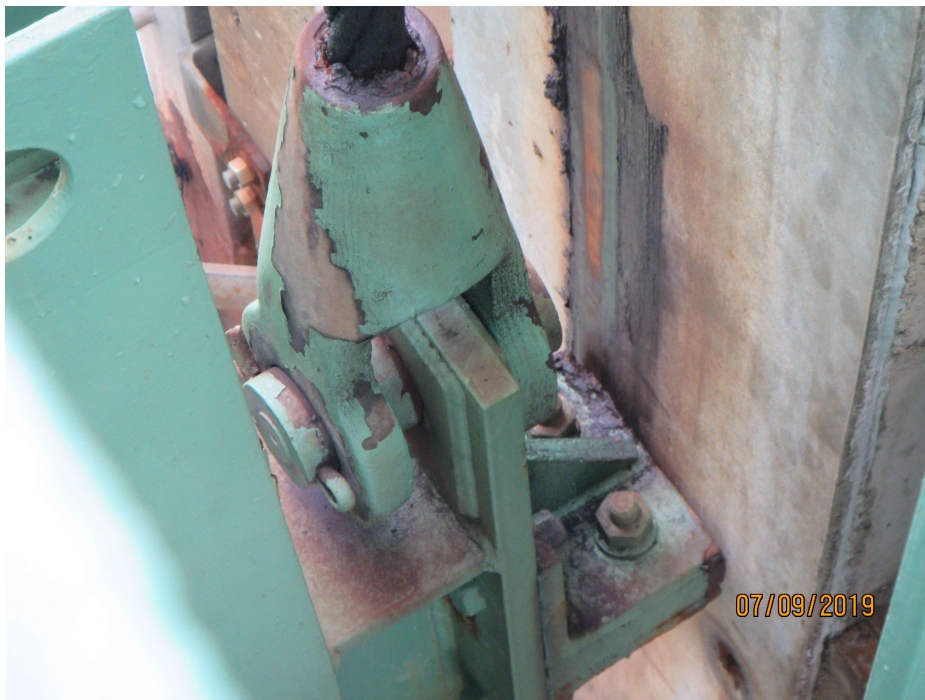
PHOTO 23

Description Nly cable clevis

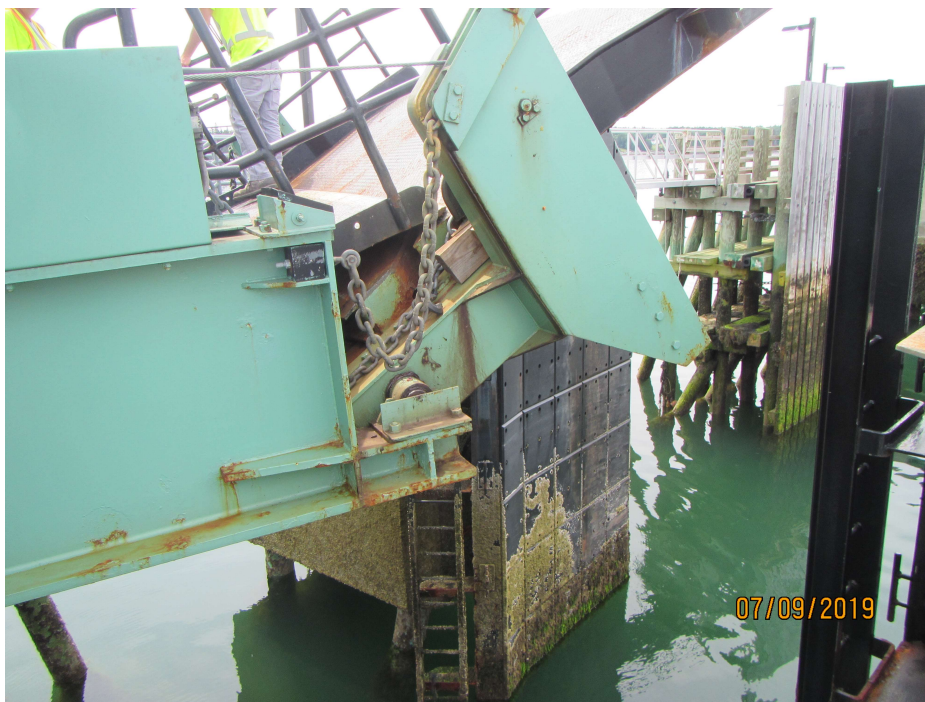
PHOTO 24

Description Nly apron bearing

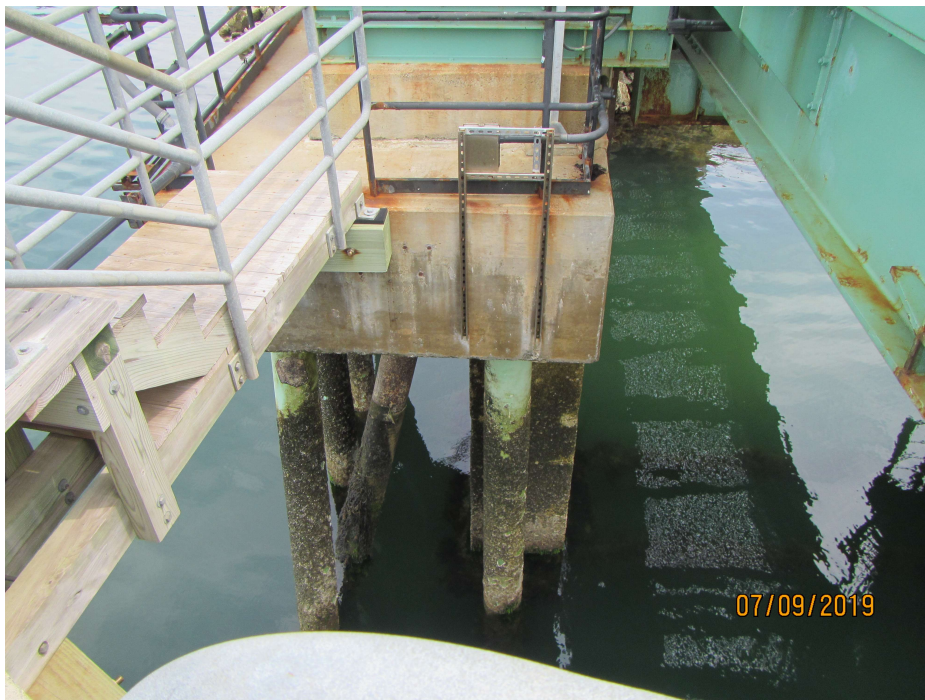
PHOTO 25

Description Nly dolphin piles

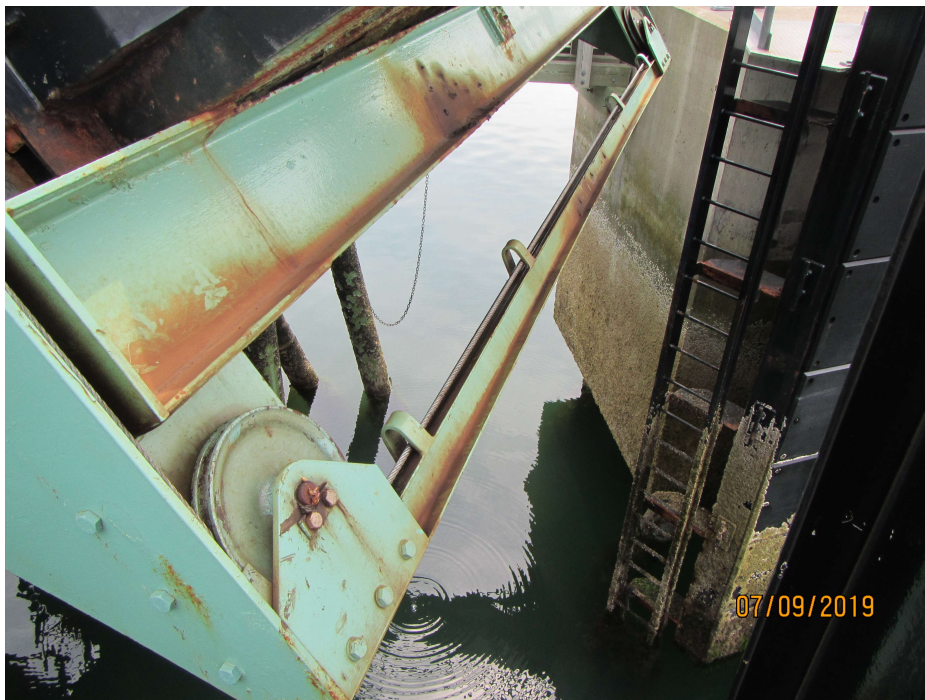
PHOTO 26

Description apron under carriage

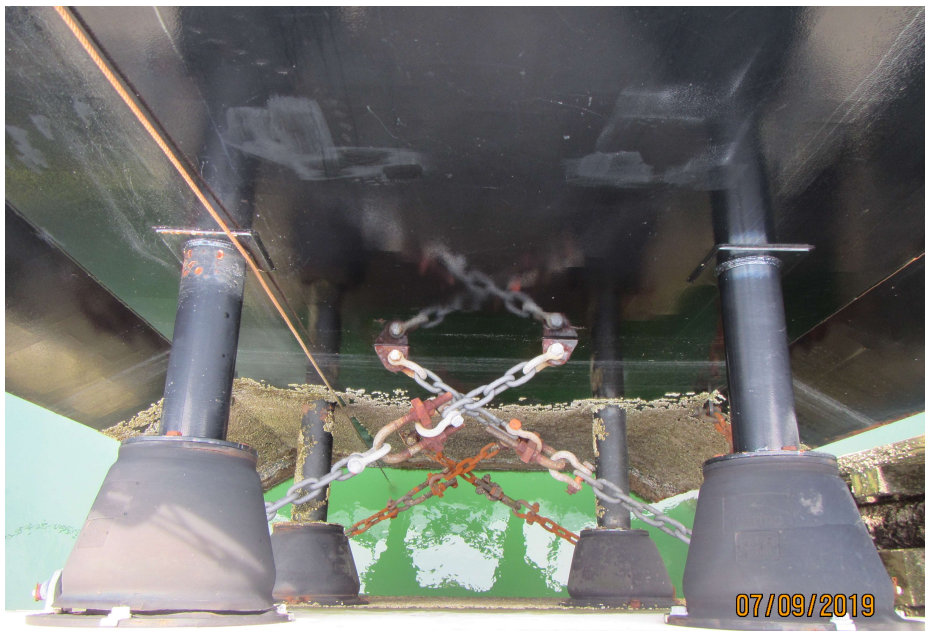
PHOTO 27

Description fender connections (typ)

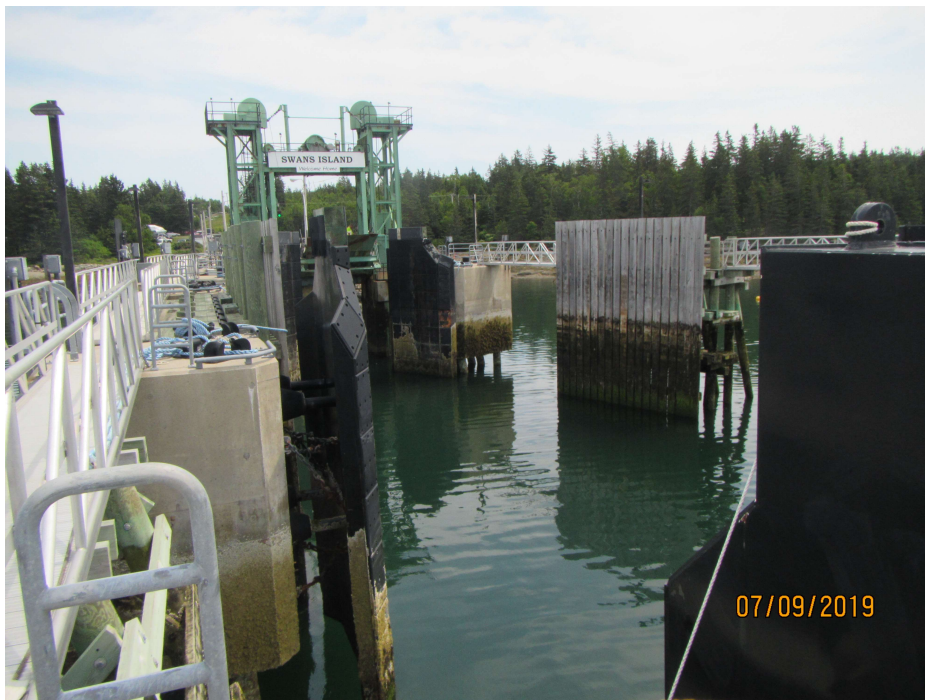
PHOTO 28

Description looking at pen from Nly dolphin

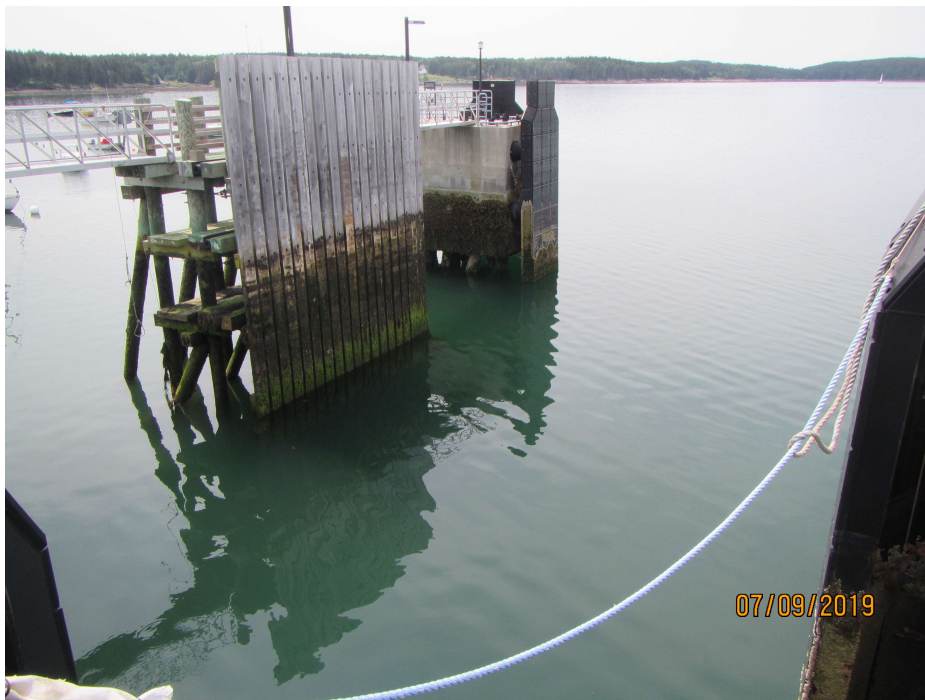
PHOTO 29

Description Sly dolphin and wave attenuator

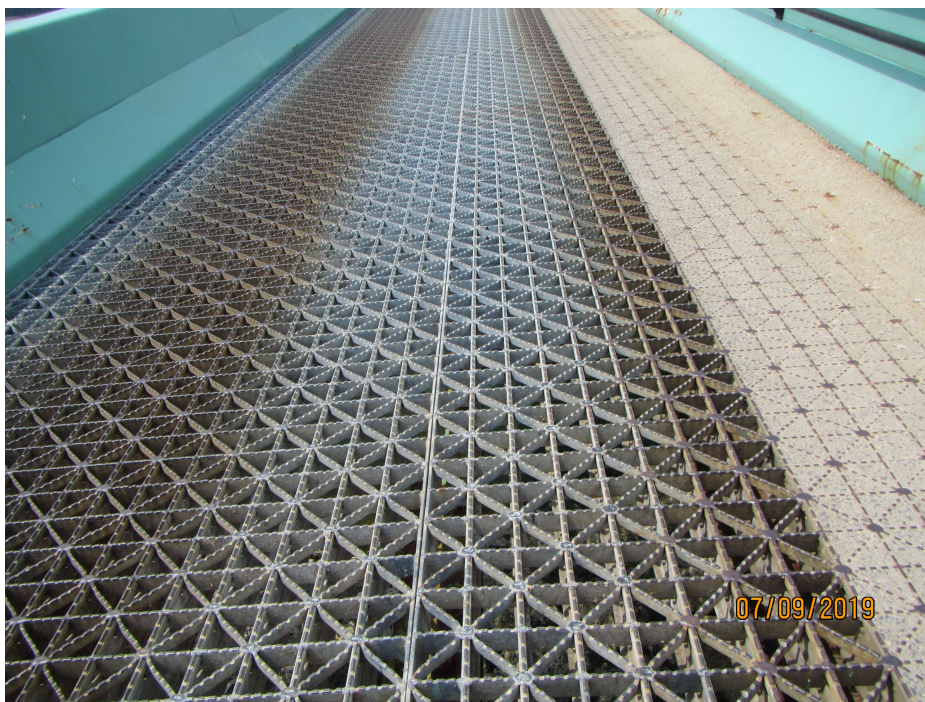
PHOTO 30

tread on open grate deck portion in good condition.

Description open grate deck surface

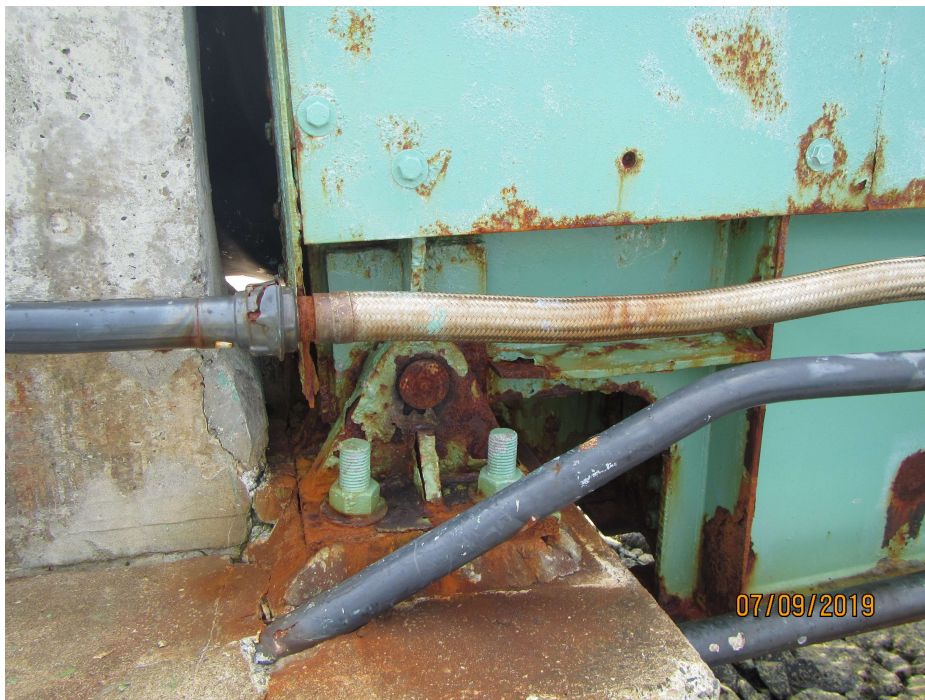
PHOTO 31

Description Nly abutment bearing

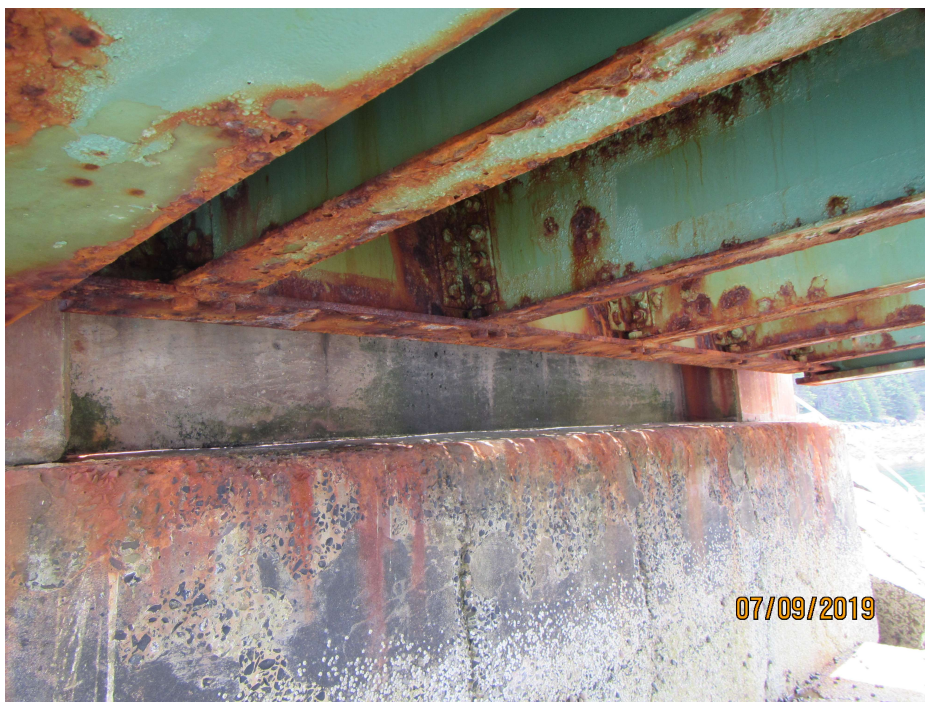
PHOTO 32

Description abutment seat

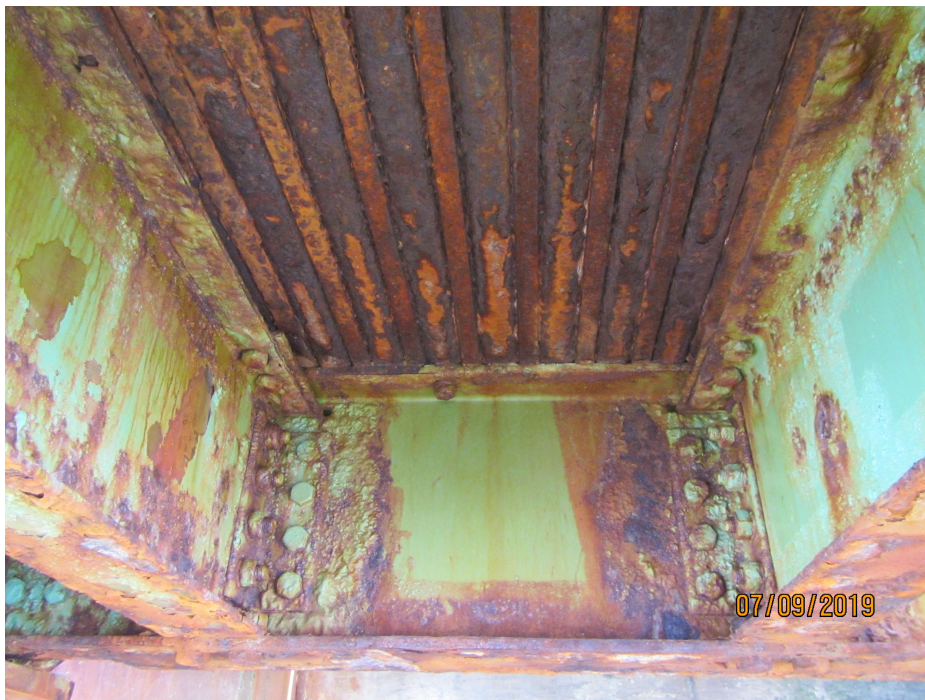
PHOTO 33

Description heavily rusted stay-in-place form

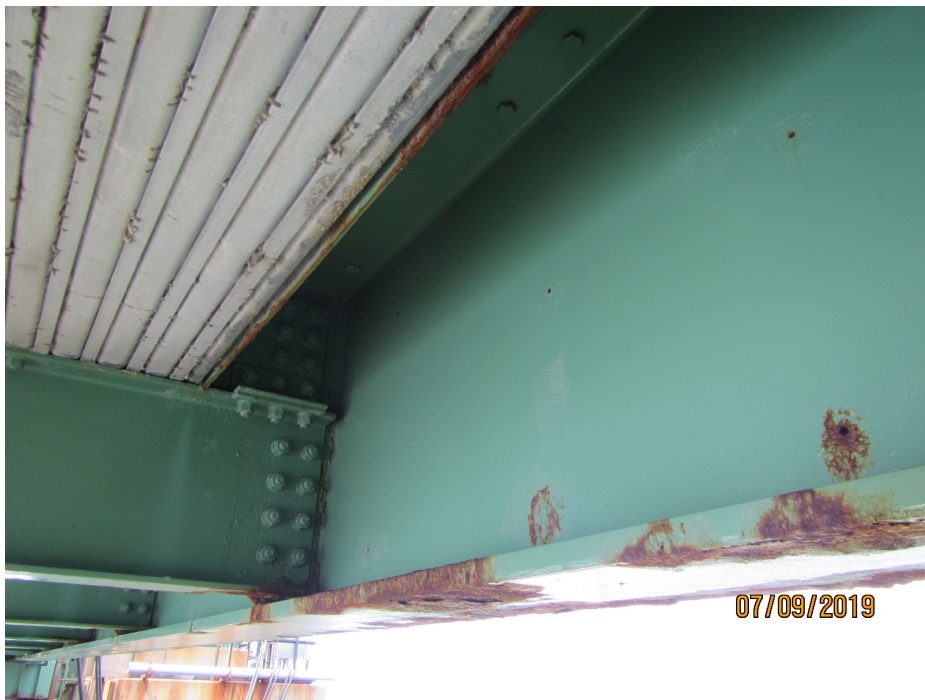
PHOTO 34

Description floor beam connections/ carrying beam

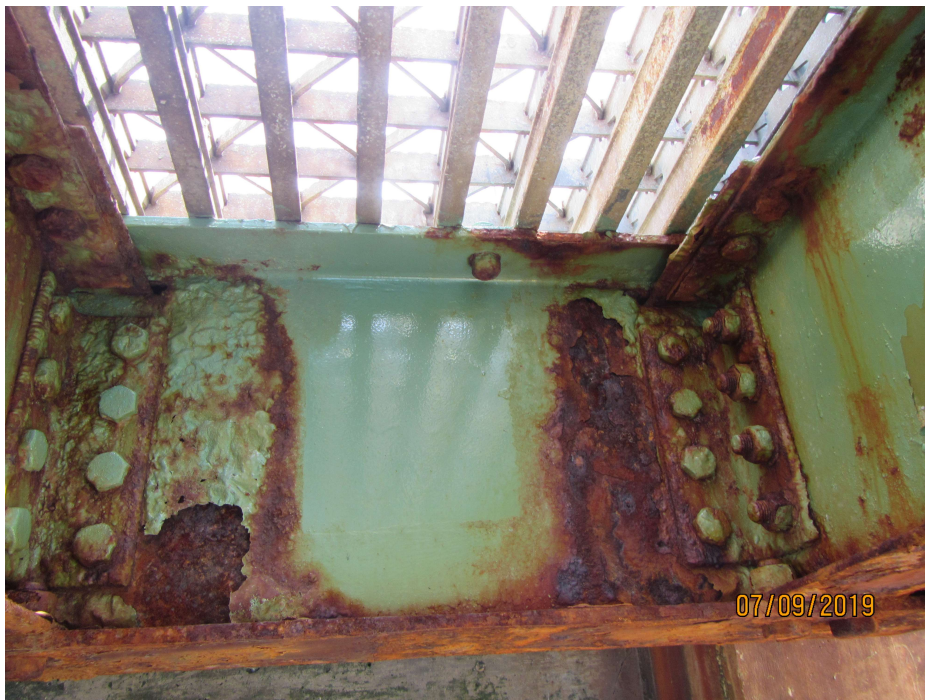
PHOTO 35

Steel Girders are in generally satisfactory condition with minor section loss to underside of bottom flanges.  
The floor beams are in mostly good condition except where stringer connections are by abutment. Heavily rusted and bubbled paint over connections.  
Bearings are in satisfactory condition but cracking of bridge seat below and bubbled paint coating.

Description heavily rusted floor beam/stringer connections

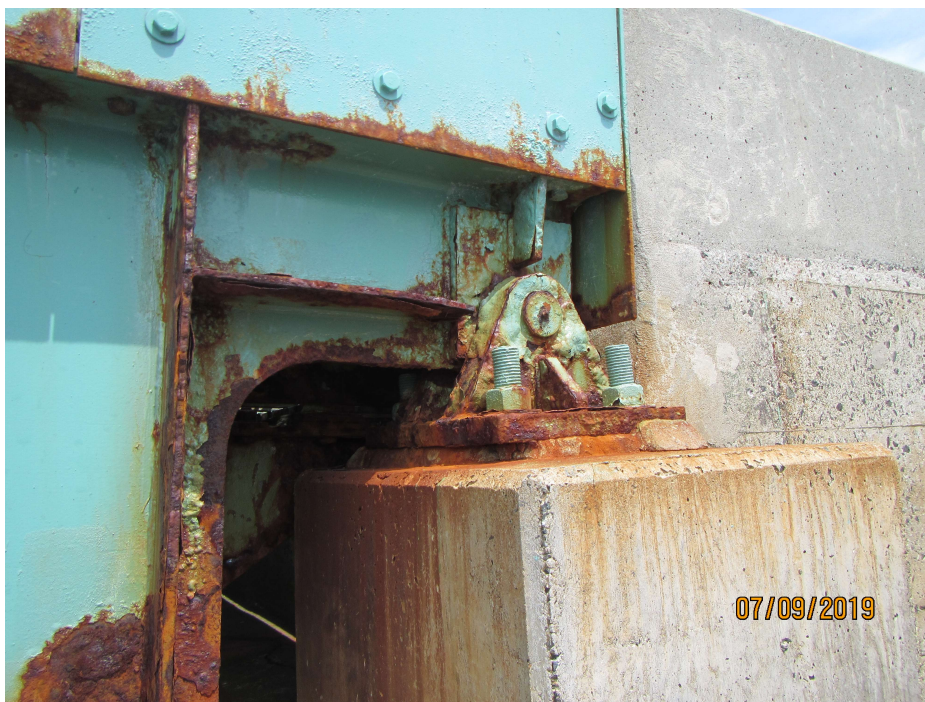
PHOTO 36

Description Sly abutment bearing
