# Highway Bridge Inspection Report

BR# 6349

## SWANS ISLAND FERRY SLIP

Inspection Date: 07/09/2019

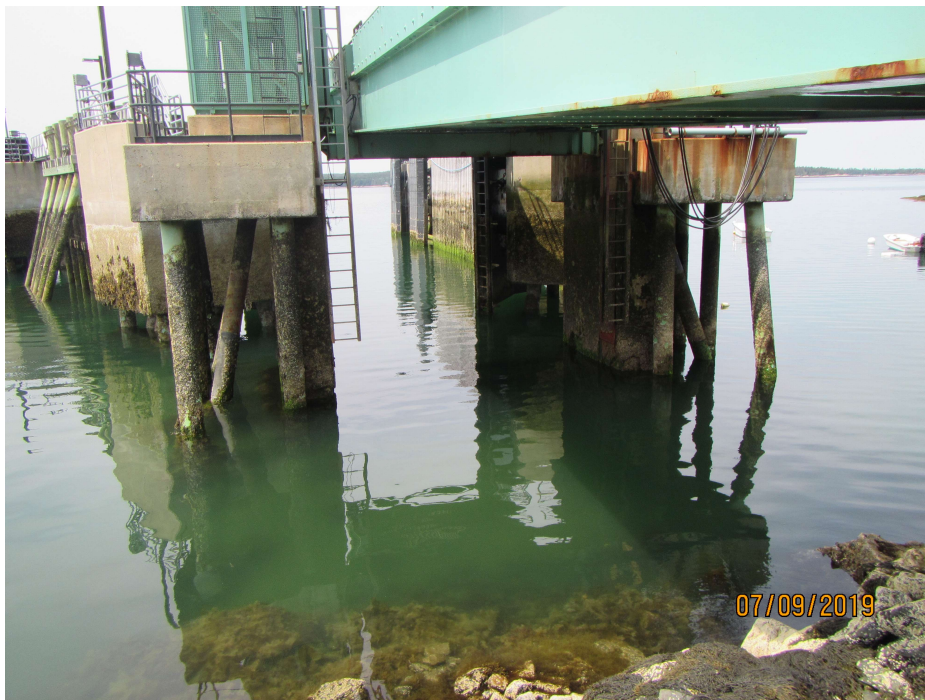
PHOTO 37

Description tower piers at low tide

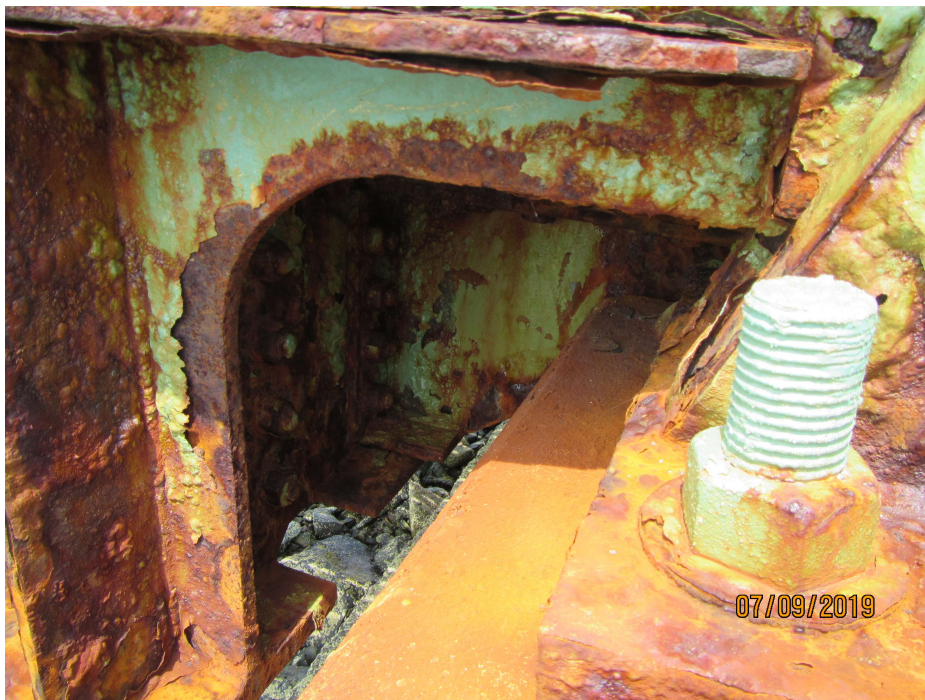
PHOTO 38

Description heavy rust layers at beam end near bearing (typ)

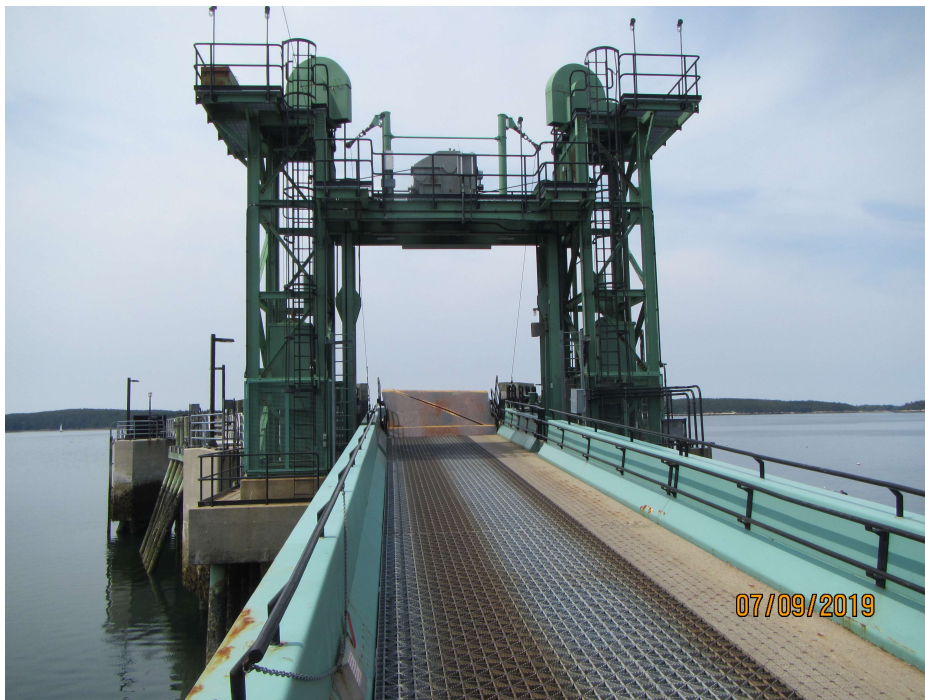
PHOTO 39

Description ramp
