# Highway Bridge Inspection Report

## AUGUSTA MEMORIAL BRIDGE MEMORIAL DR over KENNEBEC RIVER + MCRR

**Inspection Date:** 01/29/2026

Structure Number: 5196  
Facility Carried: MEMORIAL DR

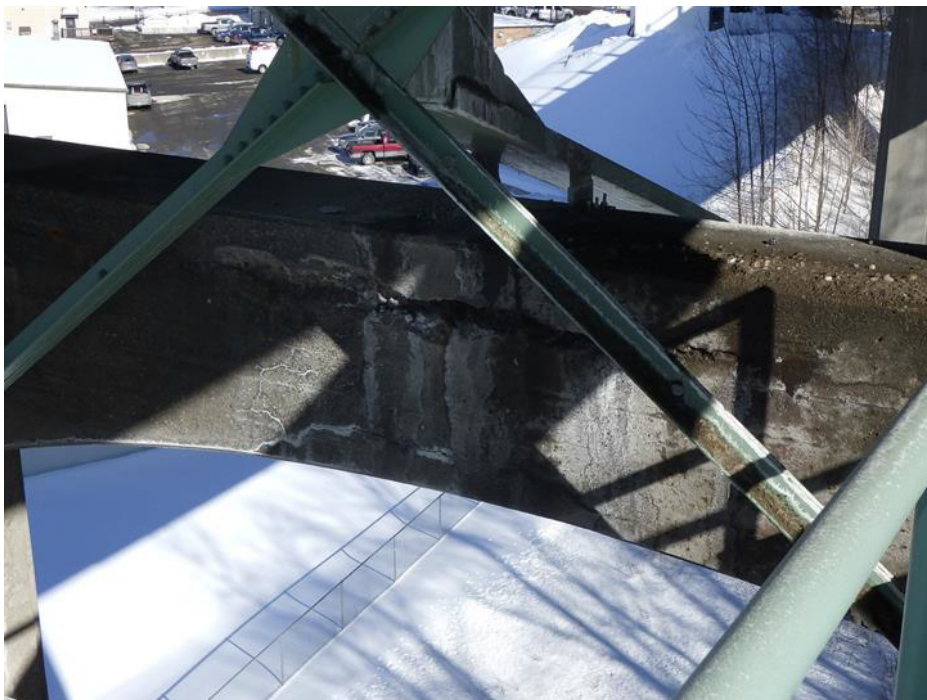
PHOTO 2

Description      Cracking on Pier cap

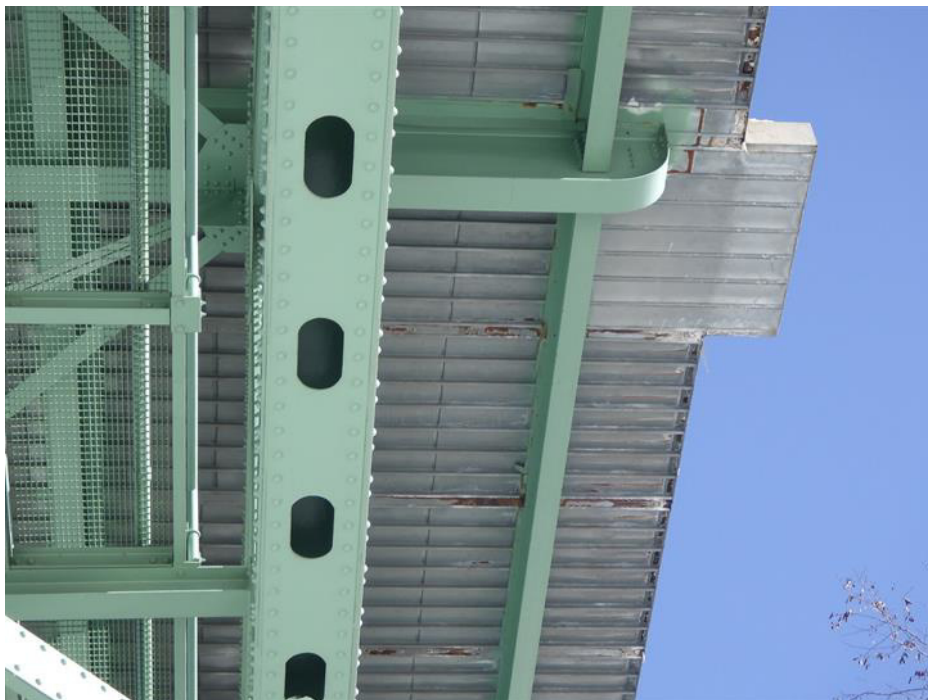
PHOTO 3

The deck was replaced in 2006 with steel grid deck panels, half-filled with lightweight concrete. It is hidden by a hot mix asphalt wearing surface above and stay-in-place forms below. The visible portion of the transverse main bars of the steel grid (below the stay-in-place forms) exhibit isolated areas of rusting, typically along areas of heavy corrosion to the stay-in-place forms. These areas of heavy corrosion are scattered through the bottom of the deck.

Description Deck with rusting

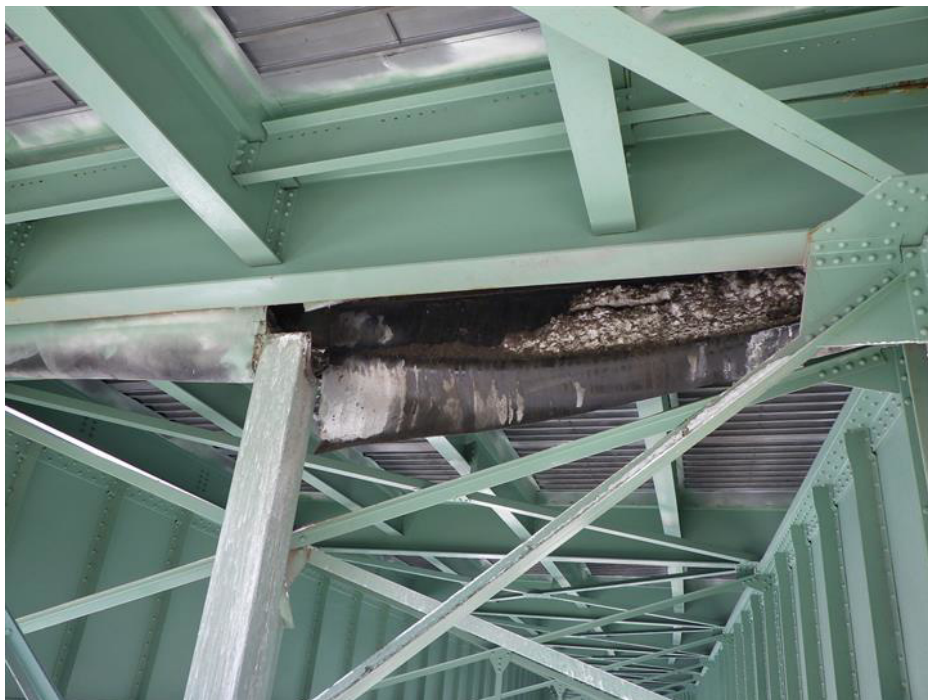
PHOTO 4

There are neoprene drainage troughs beneath the finger joints at pier 1, pier 6, and in span 4 at truss joint U26. The neoprene drainage troughs are typically collecting sand and debris and exhibit leakage around the downspouts and each end of the drainage trough.

Description North trough failed

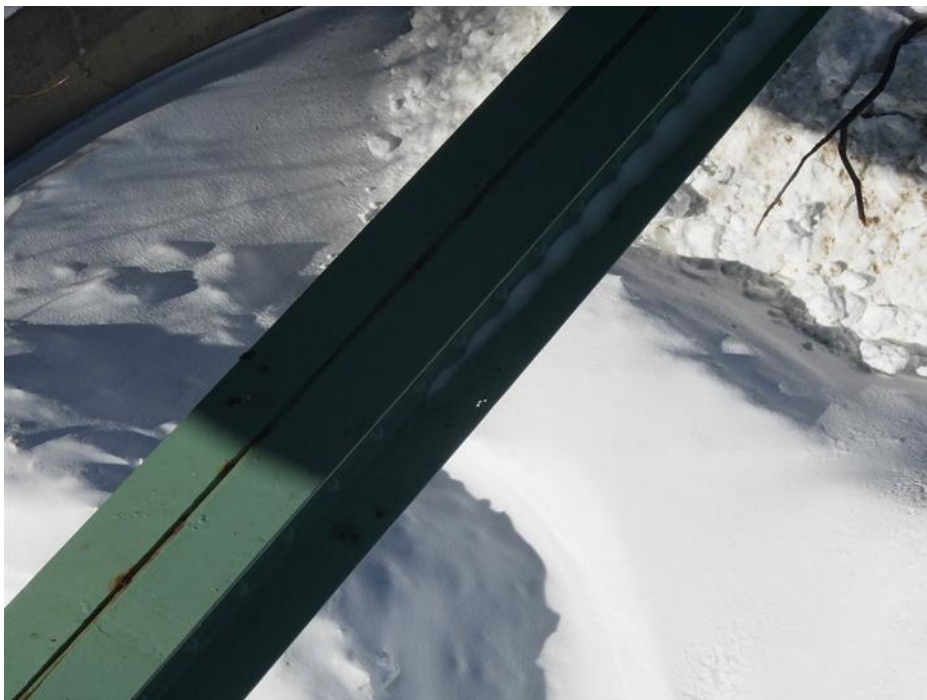
PHOTO 6

Description Pinholes in crossframe

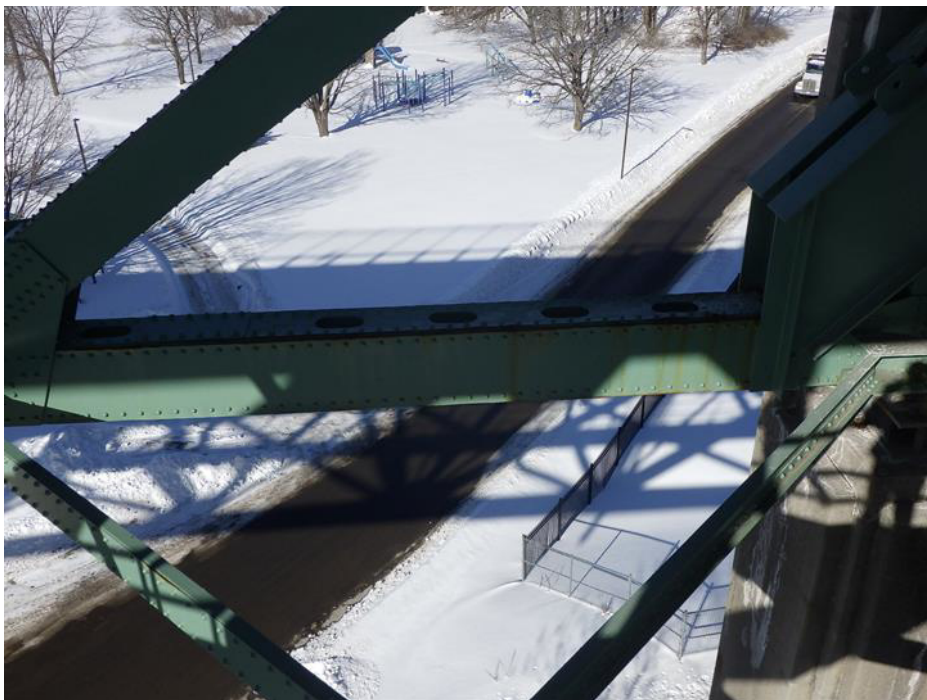
PHOTO 7

Description Rust backing between plates

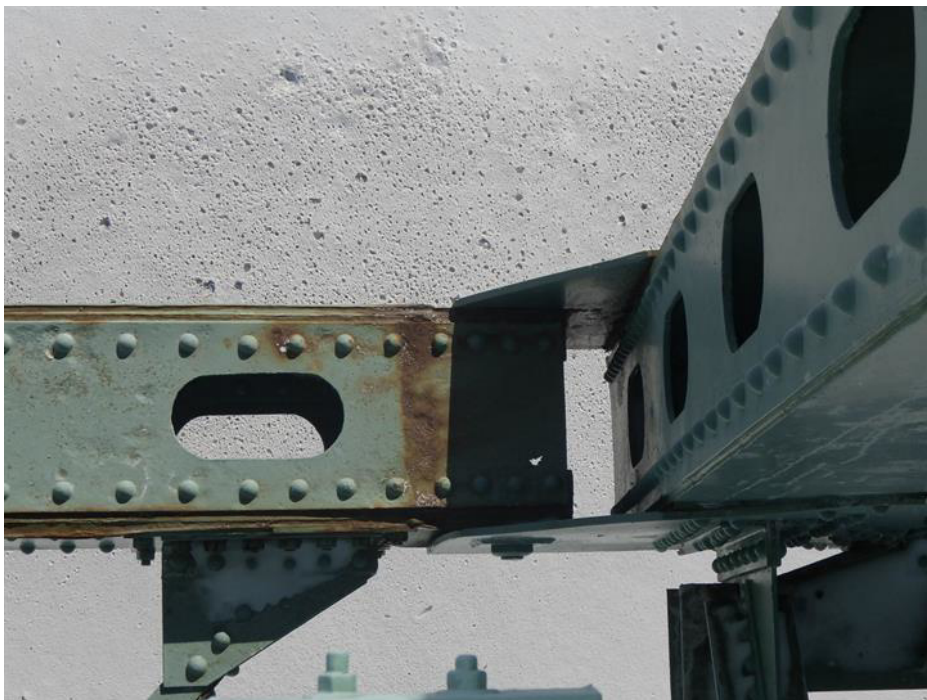
PHOTO 8

The truss members typically exhibit scattered areas of up to 1/4" painted over pitting to all components and isolated areas of minor corrosion holes in the perforated plates up to 7" wide x 2" long. The corrosion holes are typically located within the limits of or adjacent to the gusset plates at the truss joints. There is up to 1 1/4" pack rust between the flange angles and top/bottom perforated plates and between the flange angles and web plates.

Description Small hole in truss

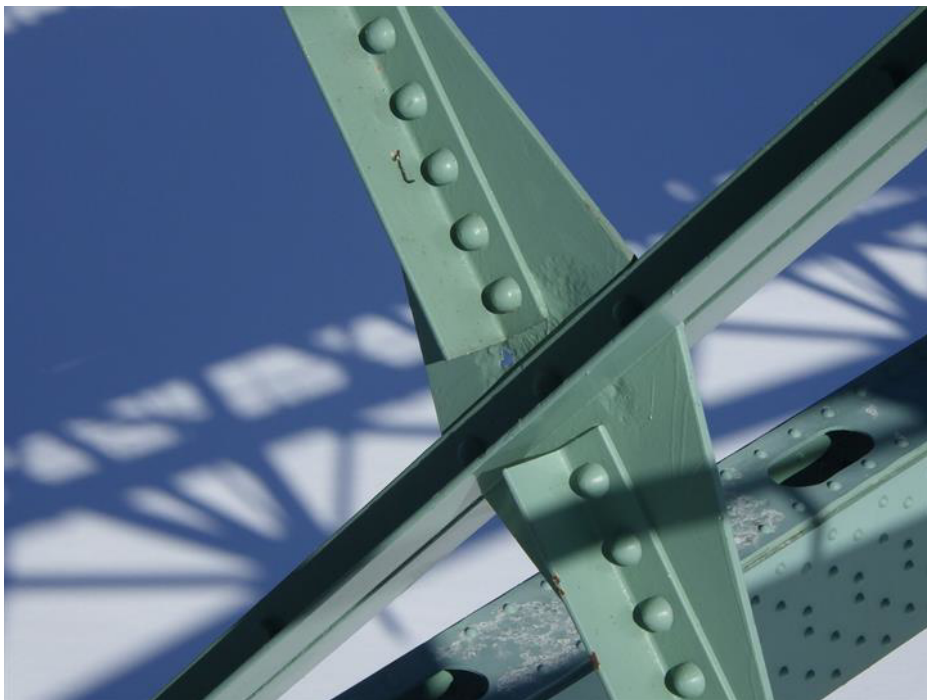
PHOTO 9

Description Small hole is cross brace

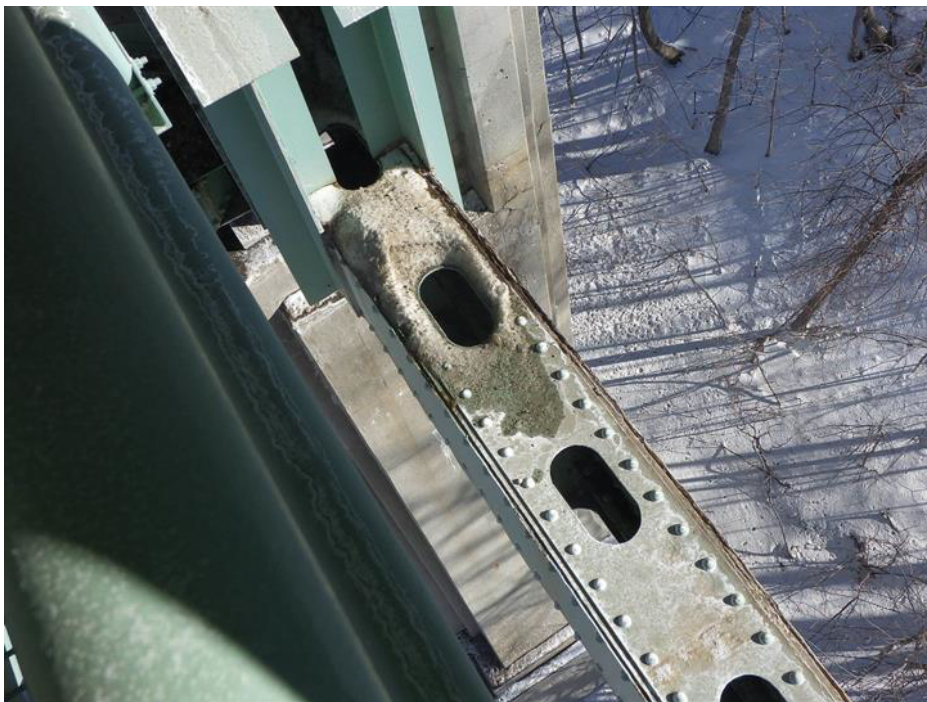
PHOTO 10

Description Snow and sand buildup

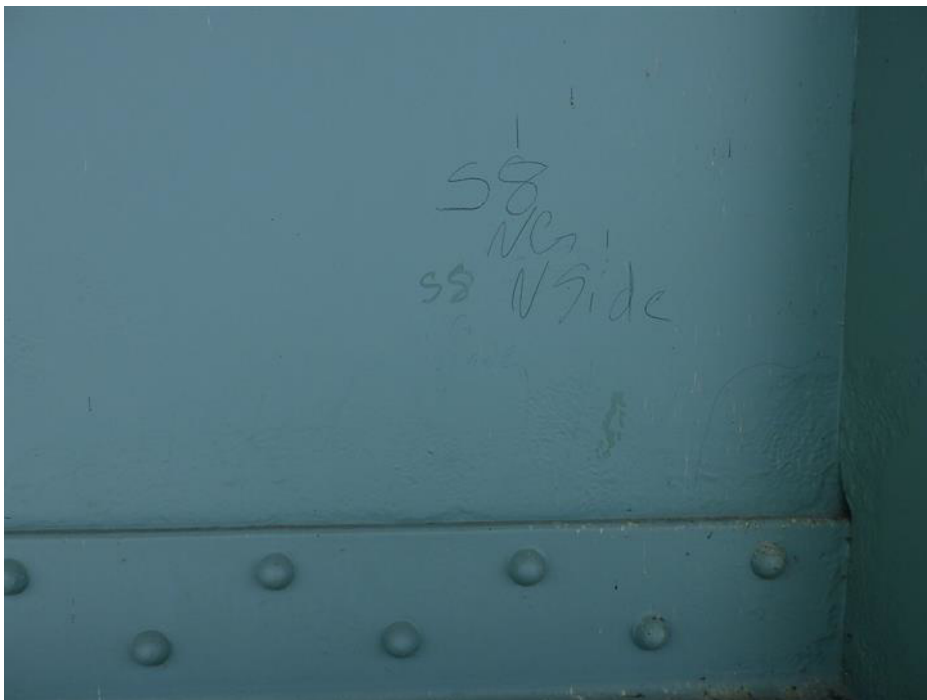
PHOTO 18

Description 58 North truss North side old pitting

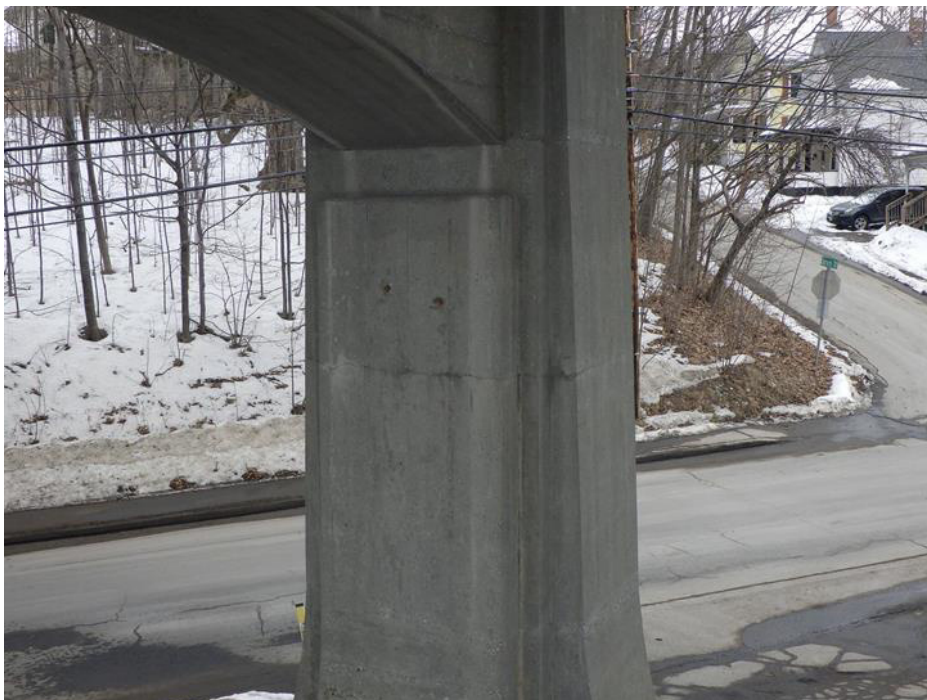
PHOTO 20

Description Cracking on column

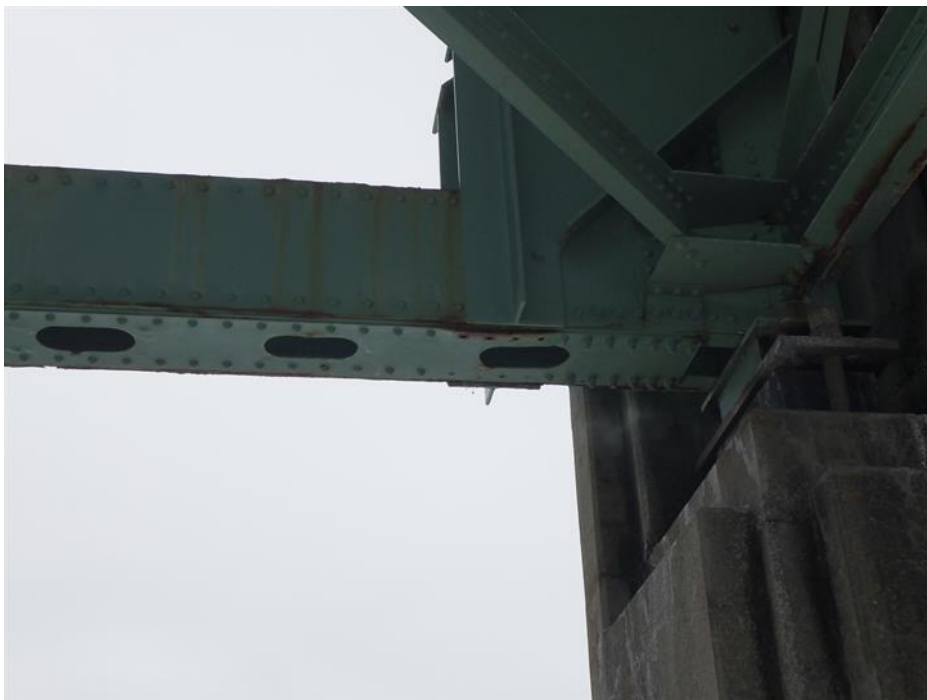
PHOTO 21

Description East end of truss North side missing rivets

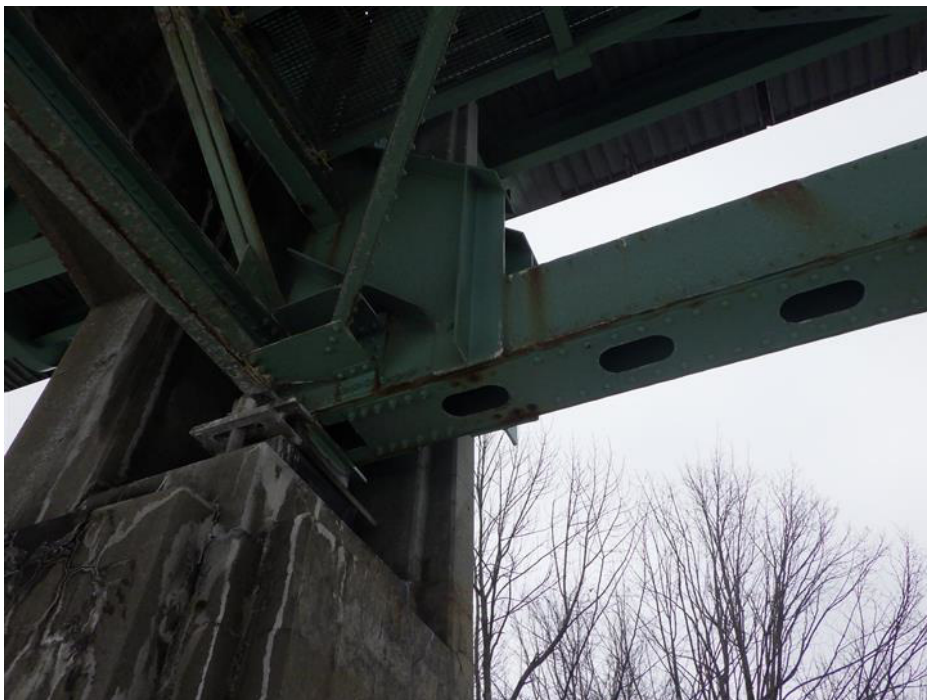
PHOTO 22

Description East end of truss South side missing rivets

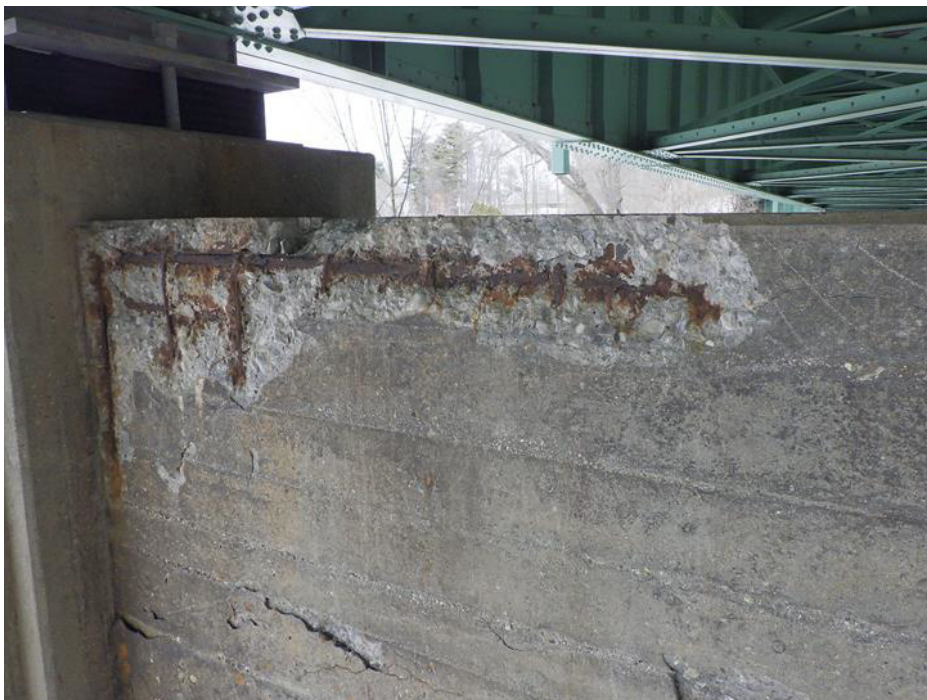
PHOTO 26

The piers typically exhibit up to 1/4" wide map cracks, some with efflorescence. The pierwalls of piers 2 through 4 within the tidal zone exhibit heavy scaling with vertical cracks up to 1" wide with penetrations up to 4" deep. In addition, the columns, pierwalls and pier caps exhibit up to 6'-5" wide x 8'-0" long x 1 3/4" deep spalls and delaminations.

Description Exposed rebar on pier

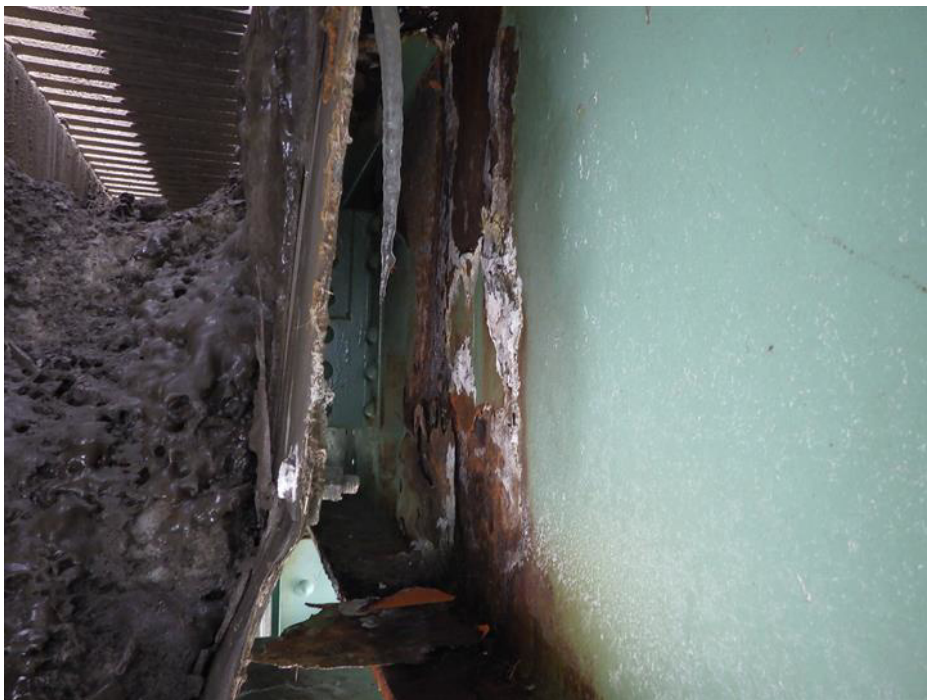
PHOTO 27

There is heavy active rusting on the floorbeams adjacent to the broken trough on the East side. Difficult to gauge section loss but thin sheets of rust could be chipped away.

Description Heavy rusting in FB around broken trough

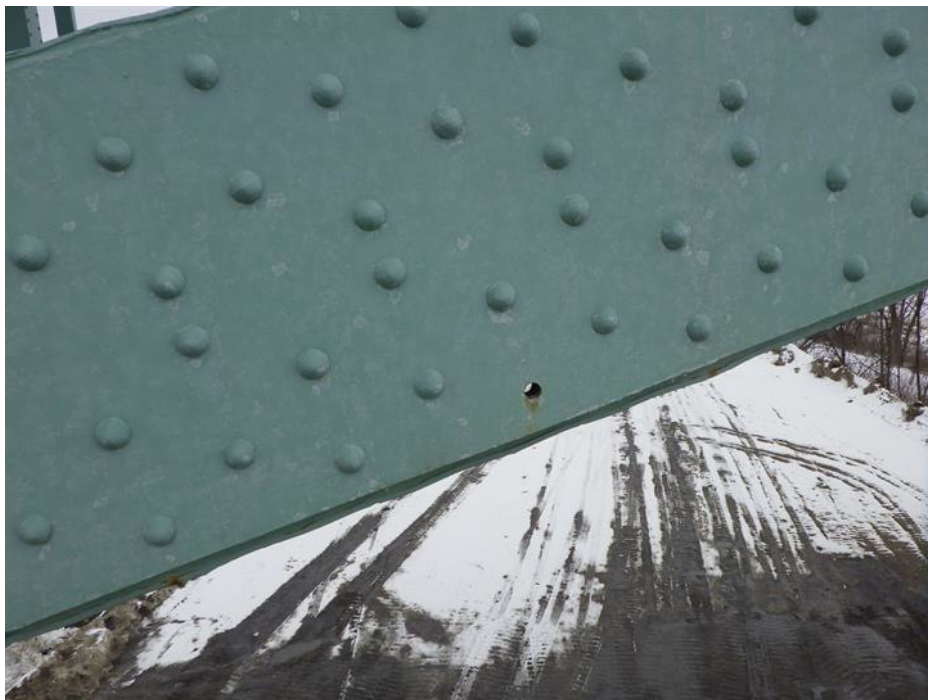
PHOTO 29

Description Missing rivet

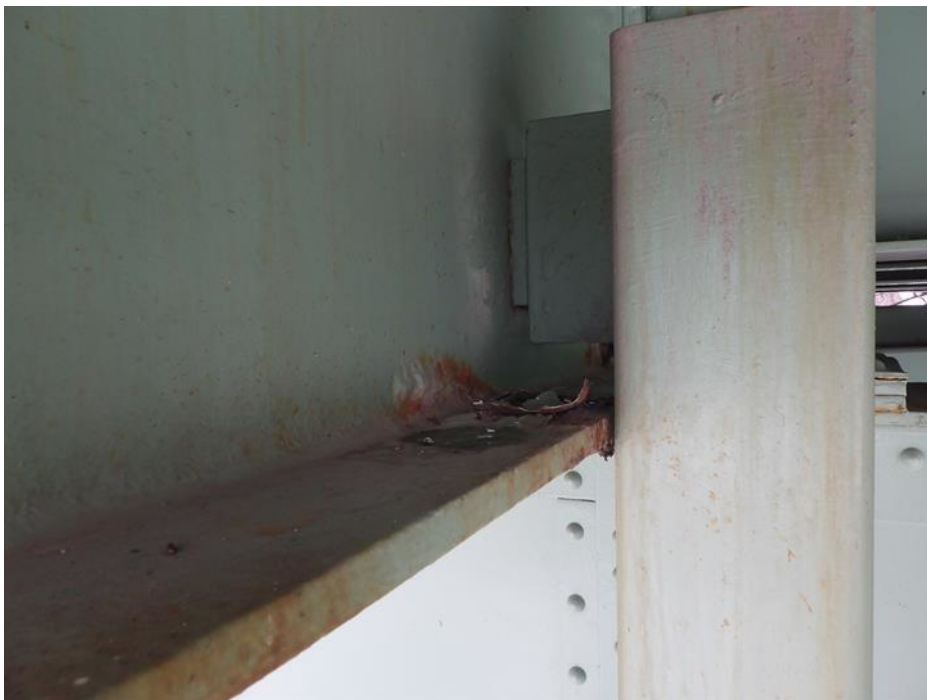
PHOTO 31

Description Paint peeling

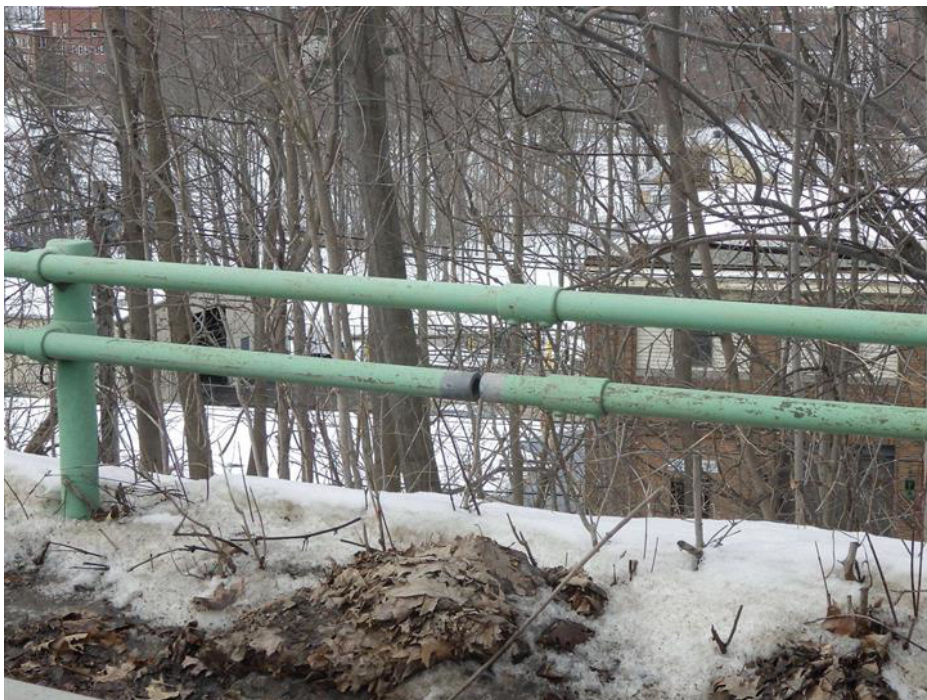
PHOTO 32

On the South rail there are two missing bolts connecting the rail.

Description Rail not connected

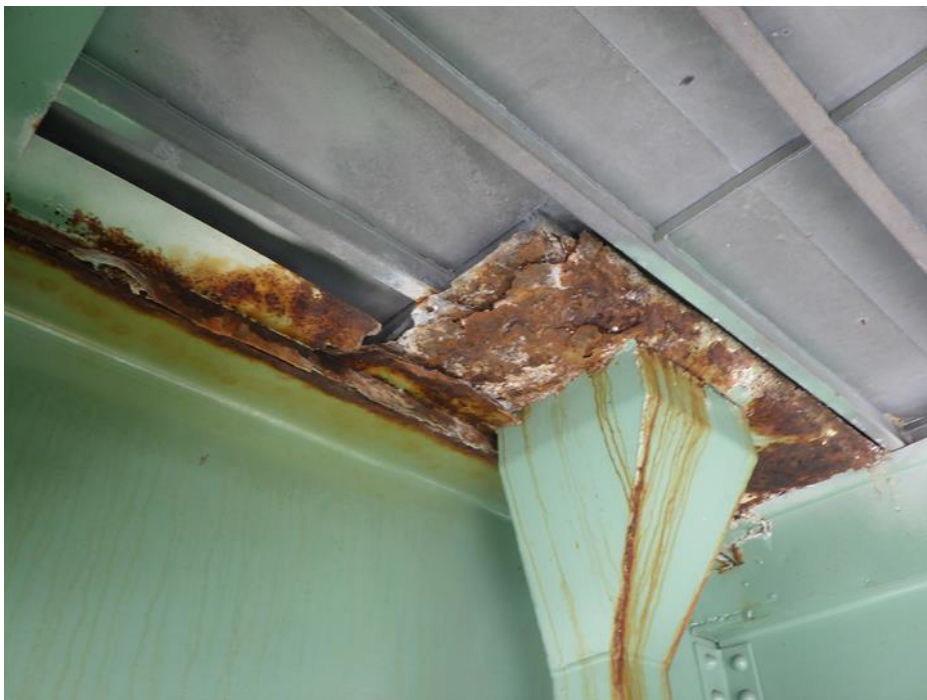
PHOTO 36

The stay-in-place forms exhibit moderate to heavy rust adjacent to the scupper downspouts, along the neoprene drainage troughs, at the steel grid deck panel splices and floorbeam top flanges between stringers S1-S2 and S6-S7. At a few locations, the stay-in-place forms are rusted through or exhibit minor bulges that expose the concrete portion of the deck.

Description Rusting around drain

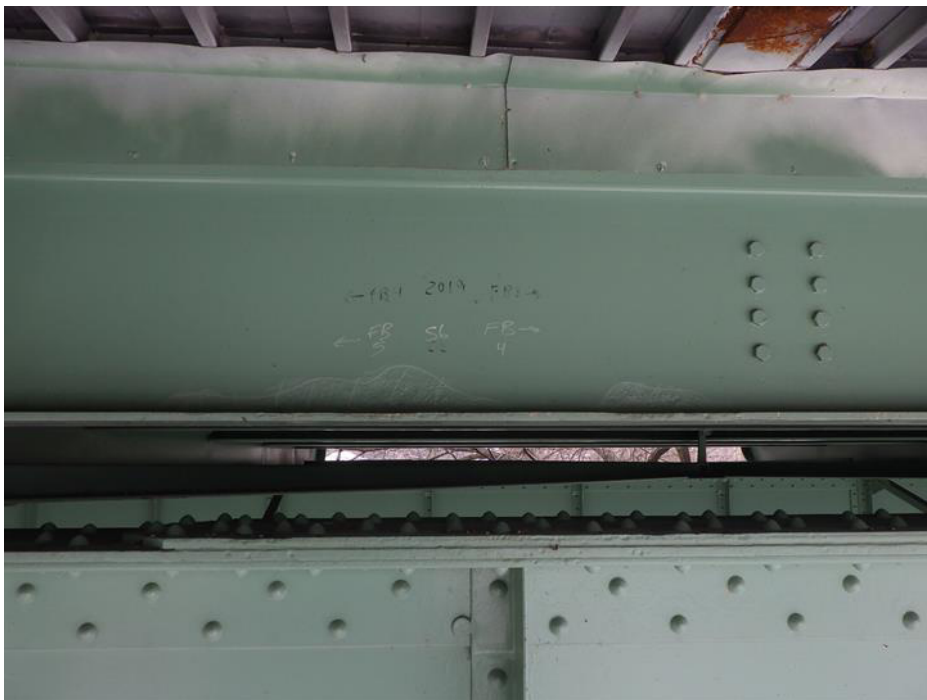
PHOTO 37

Description Signs of older pitting (2)

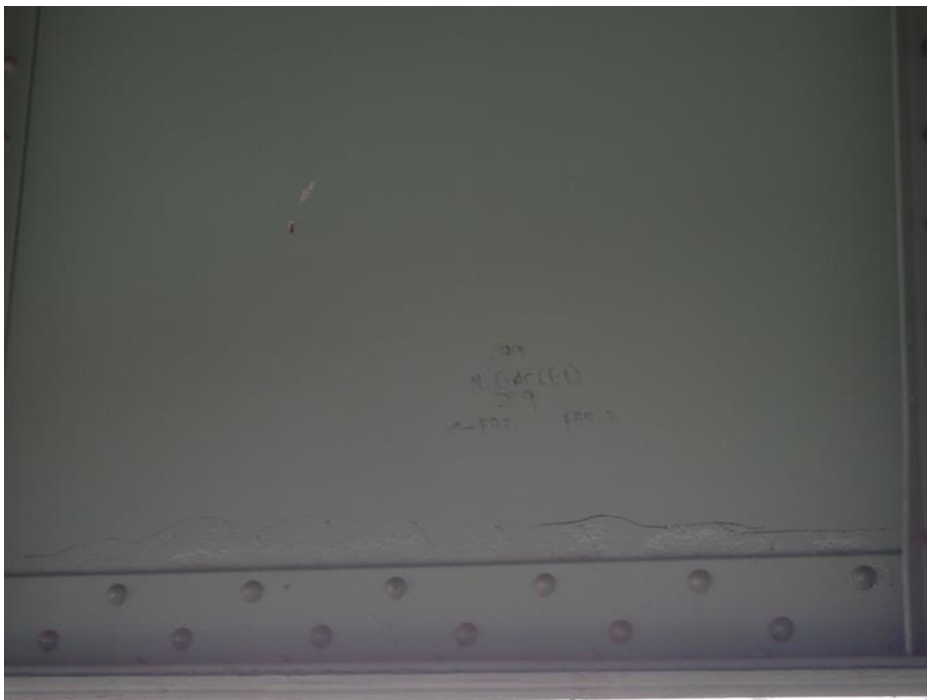
PHOTO 38

Description Signs of older pitting

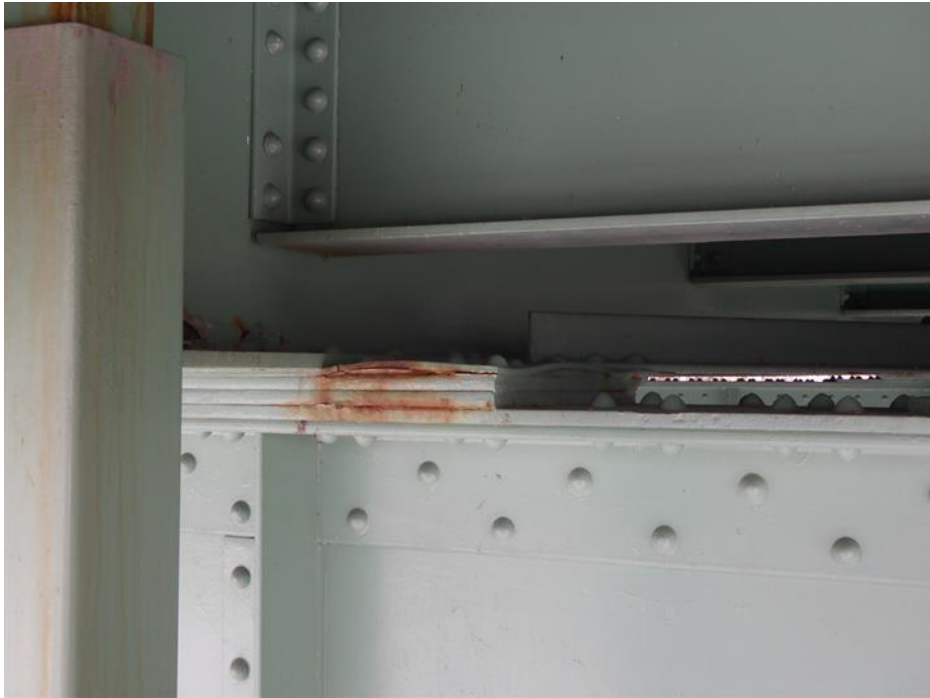
PHOTO 39

Description Signs of older rust swelling

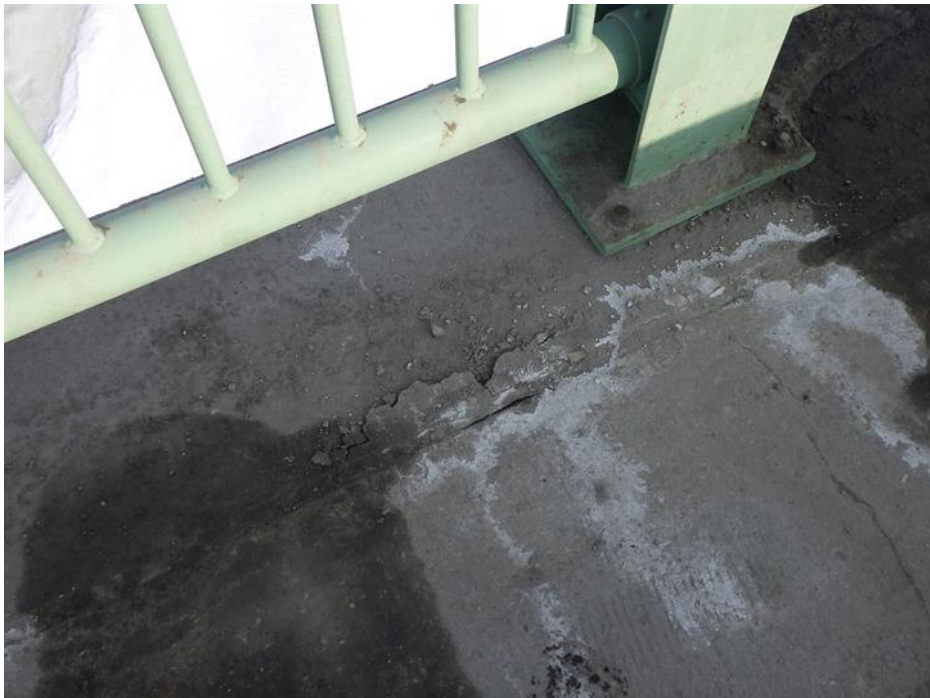
PHOTO 40

Description Some delams on sidewalk under rail

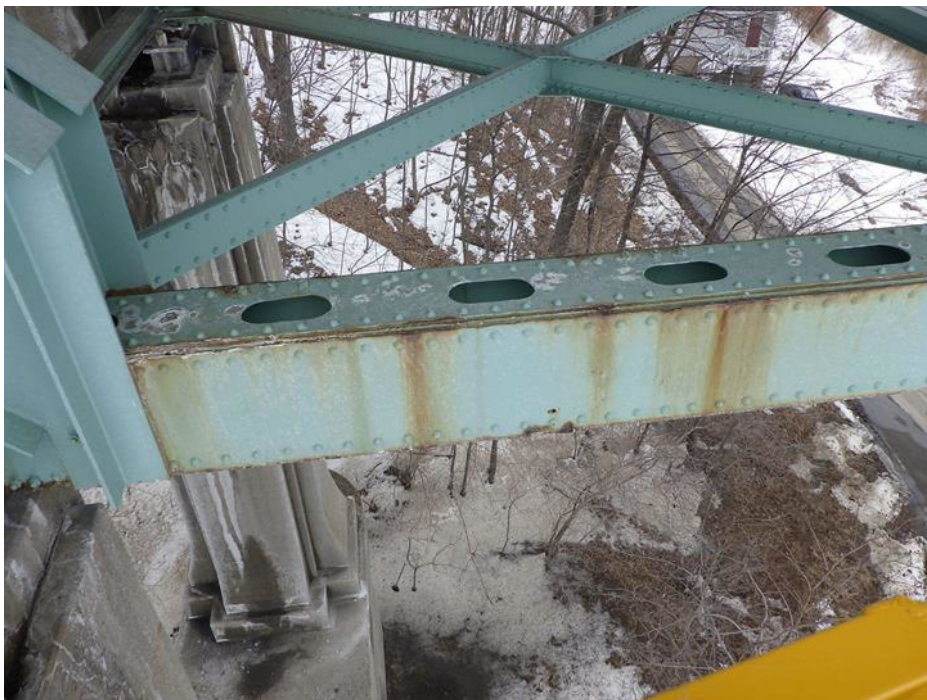
PHOTO 41

Description Some signs of newer rusting isolated

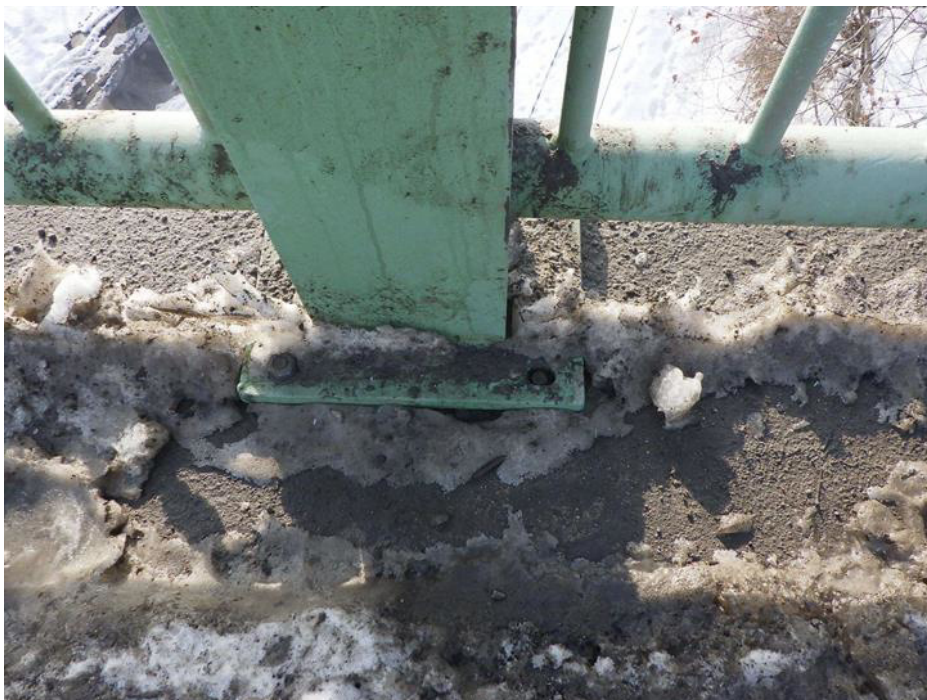
PHOTO 42

Description South side bolt missing 2

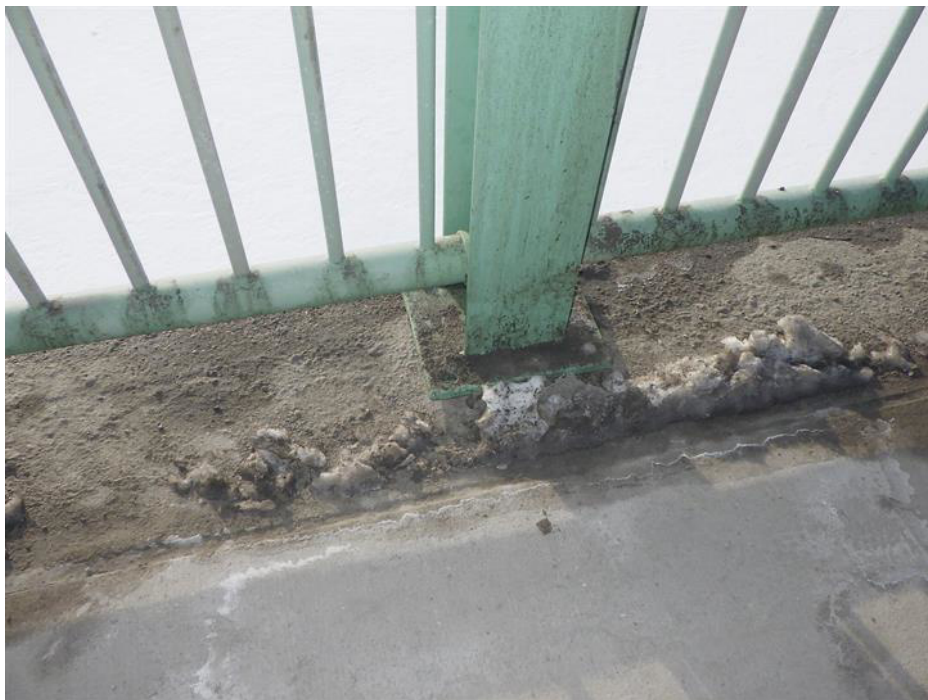
PHOTO 43

Description South side bolt missing

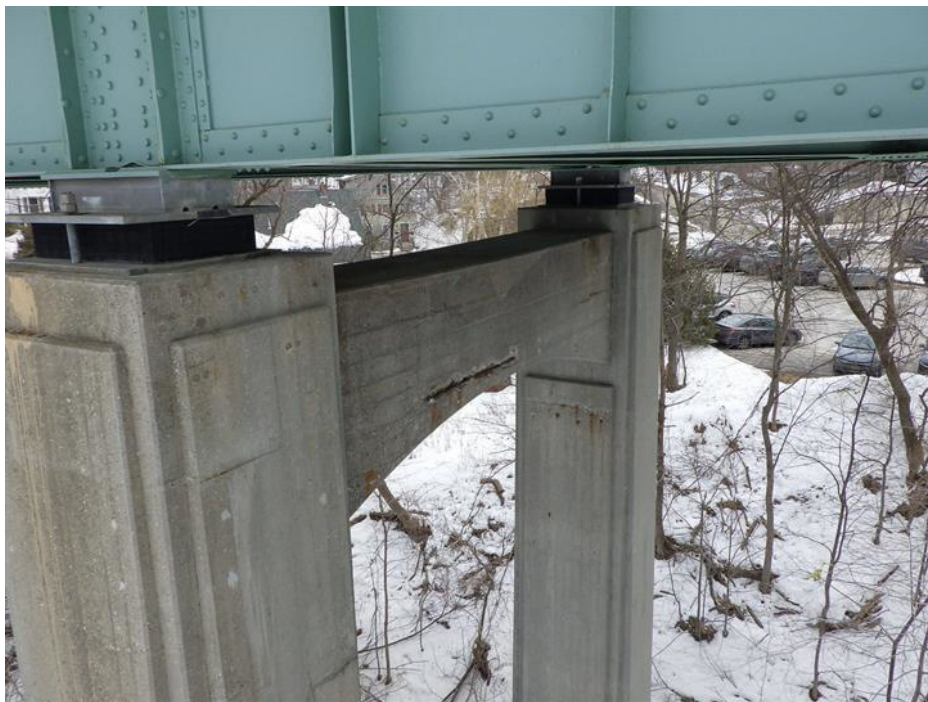
PHOTO 44

Description Spalling in pier (2)

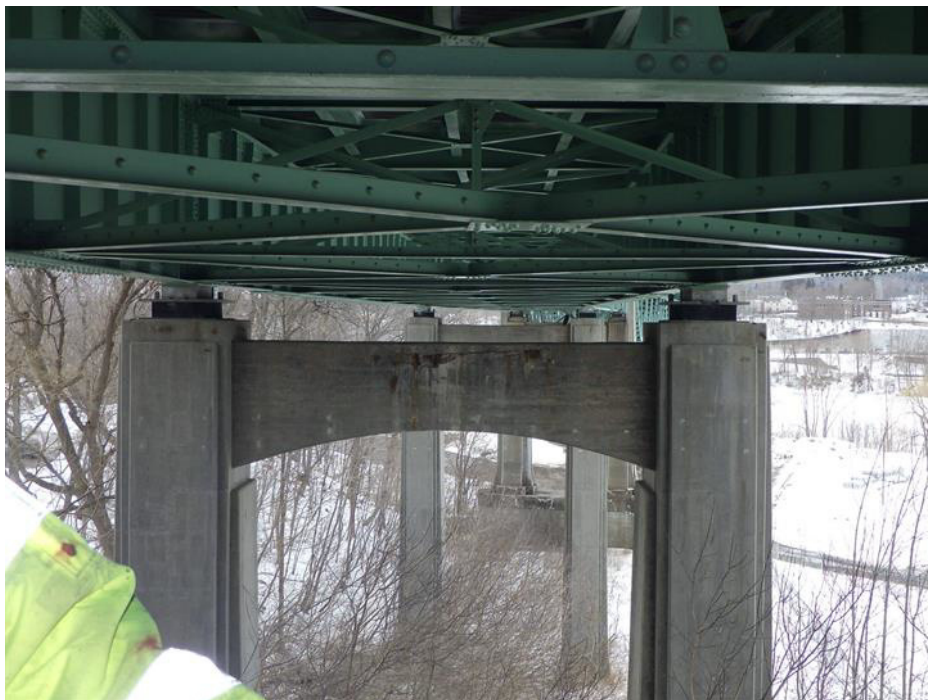
PHOTO 45

Description Spalling in pier

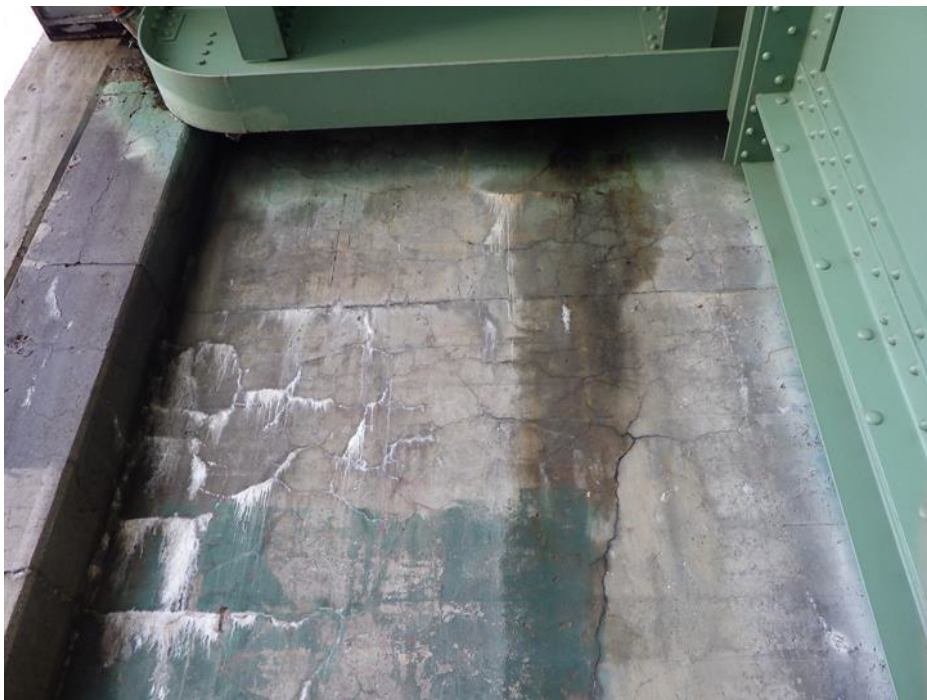
PHOTO 50

The abutments typically exhibit scattered hairline vertical, diagonal and map cracks, some with light efflorescence. In addition, the breastwalls exhibit isolated spalls and delaminations.

Description East backwall North side cracking

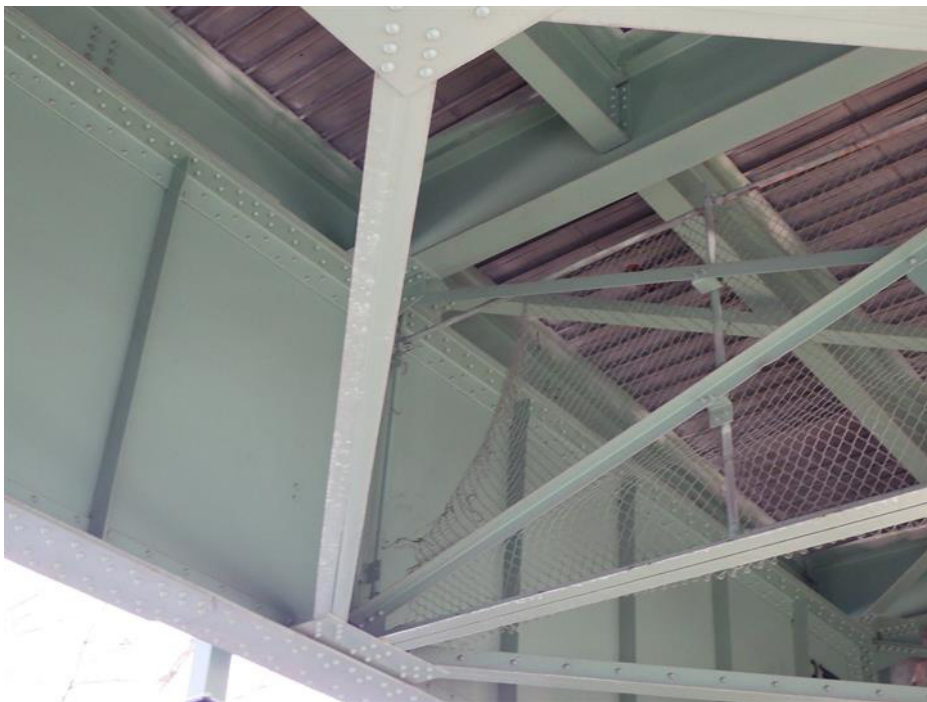
PHOTO 52

Description East end damaged fencing

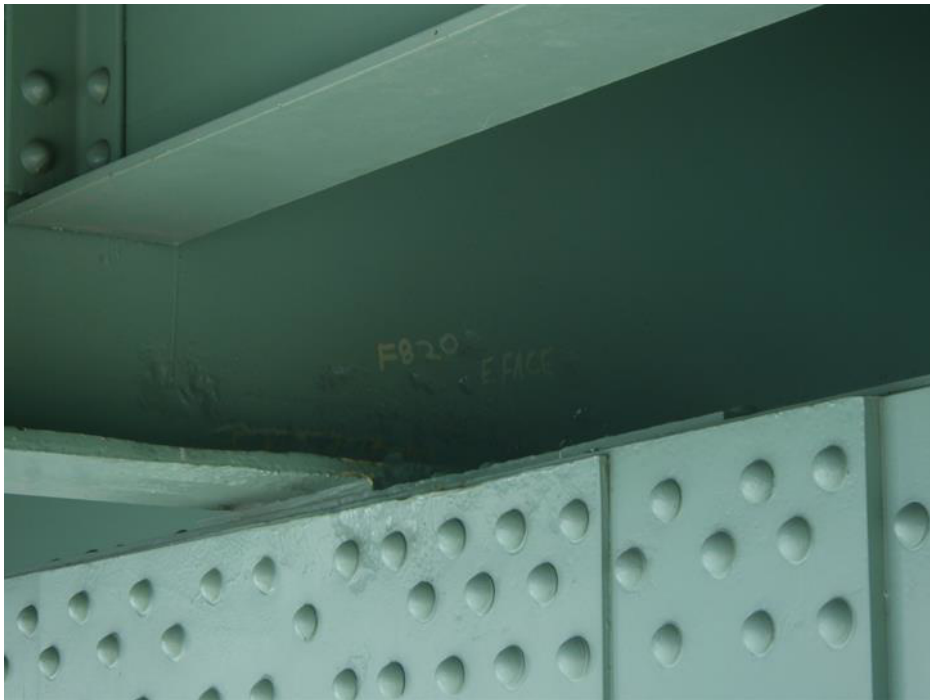
PHOTO 54

Description FB 20 East face old pitting

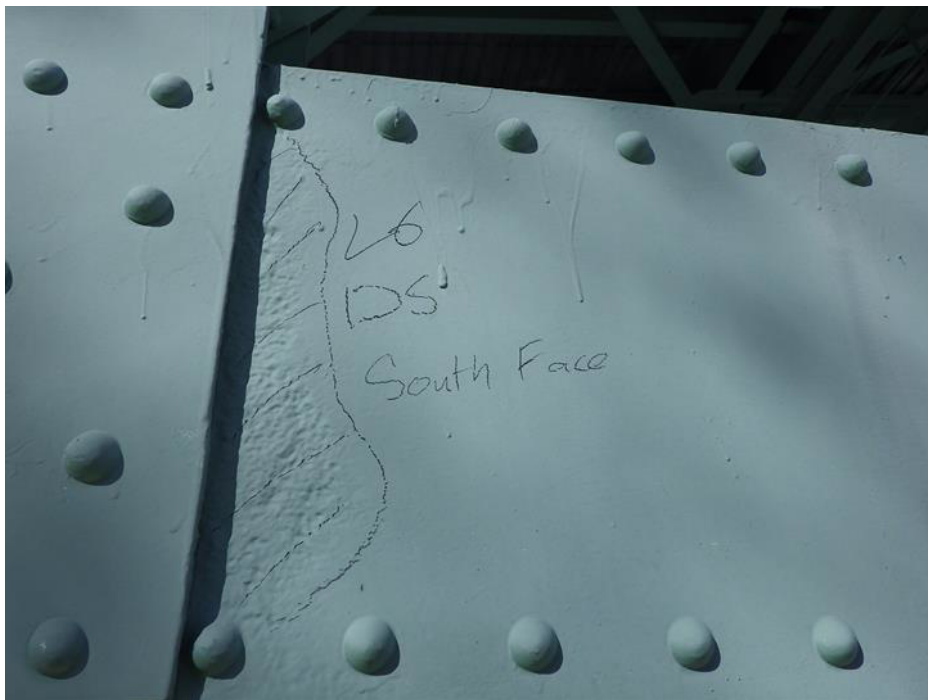
PHOTO 55

Description L6 South side South face old section loss

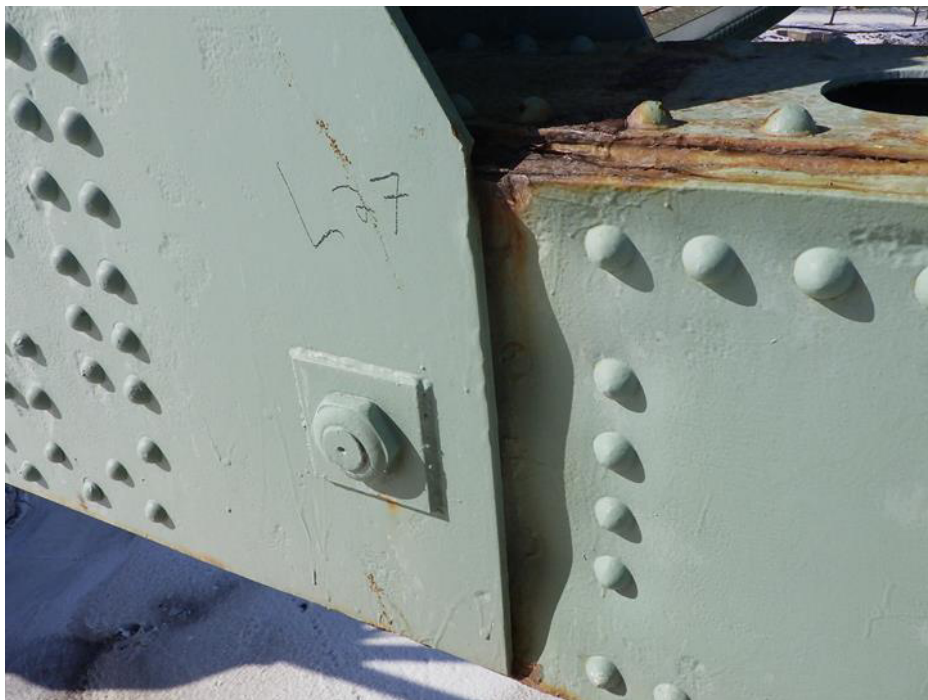
PHOTO 56

Description L27 pin new rusting

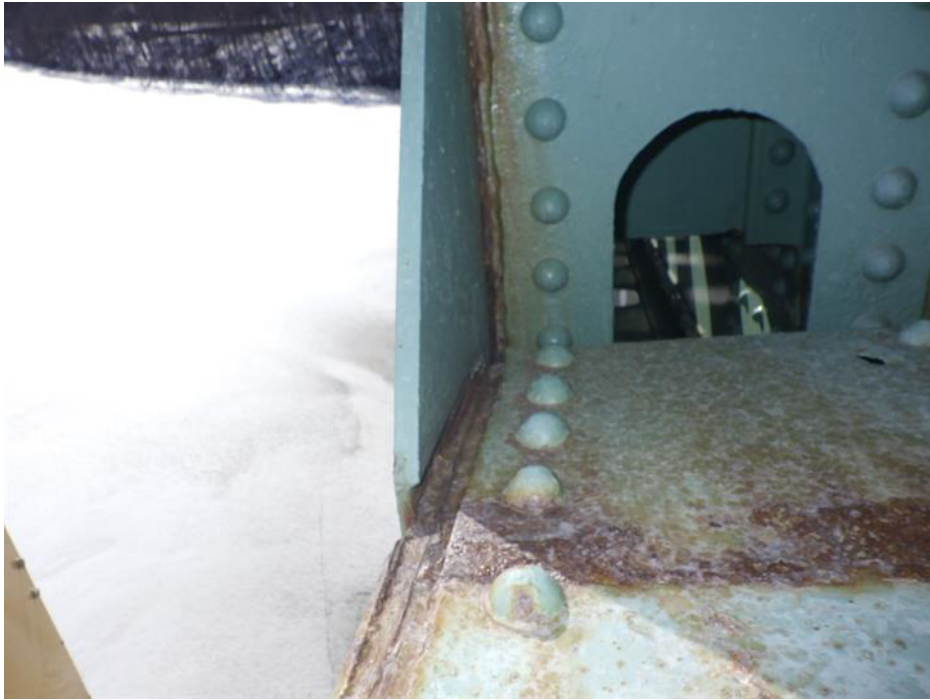
PHOTO 57

Description L27 pin South newer rusting

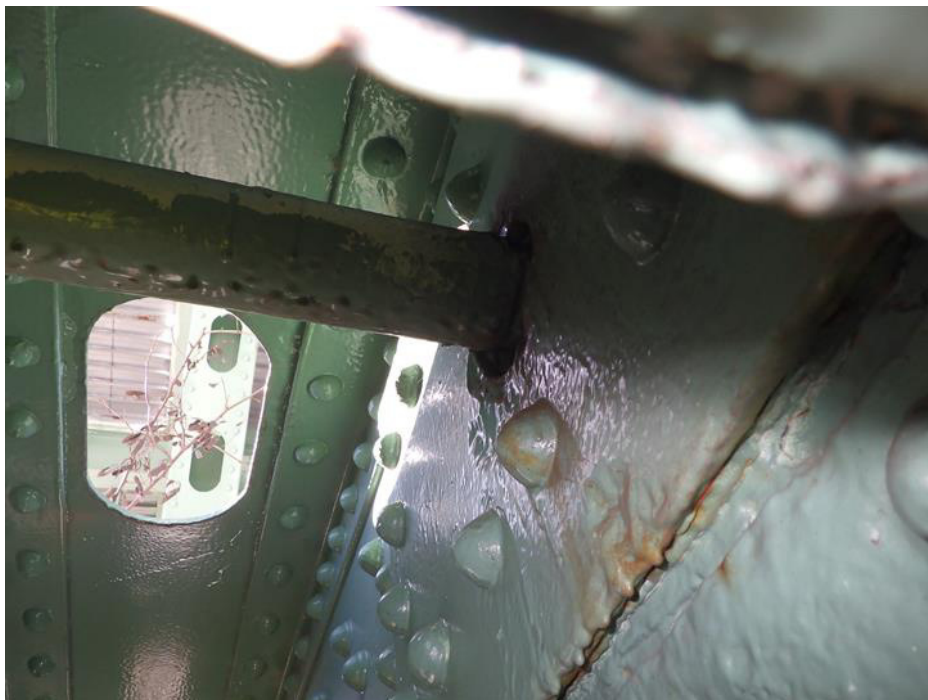
PHOTO 60

Description Previous thinning of pin
