# Highway Bridge Inspection Report

## AUGUSTA MEMORIAL BRIDGE MEMORIAL DR over KENNEBEC RIVER + MCRR

**Inspection Date:** 01/29/2026

Structure Number: 5196  
Facility Carried: MEMORIAL DR

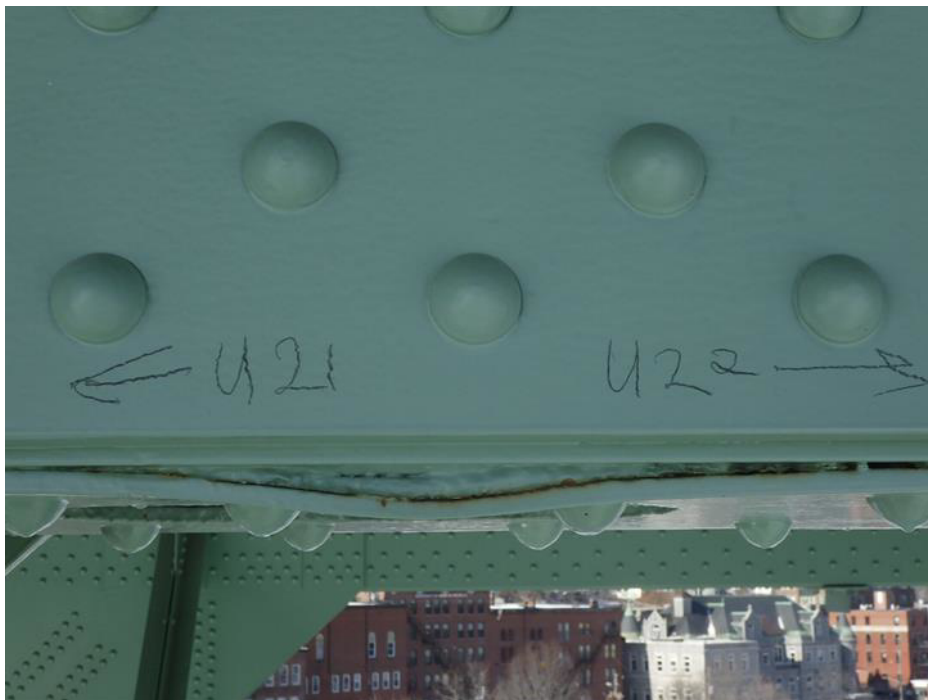
PHOTO 63

Description South truss South side between U21 and U22 old pack rust

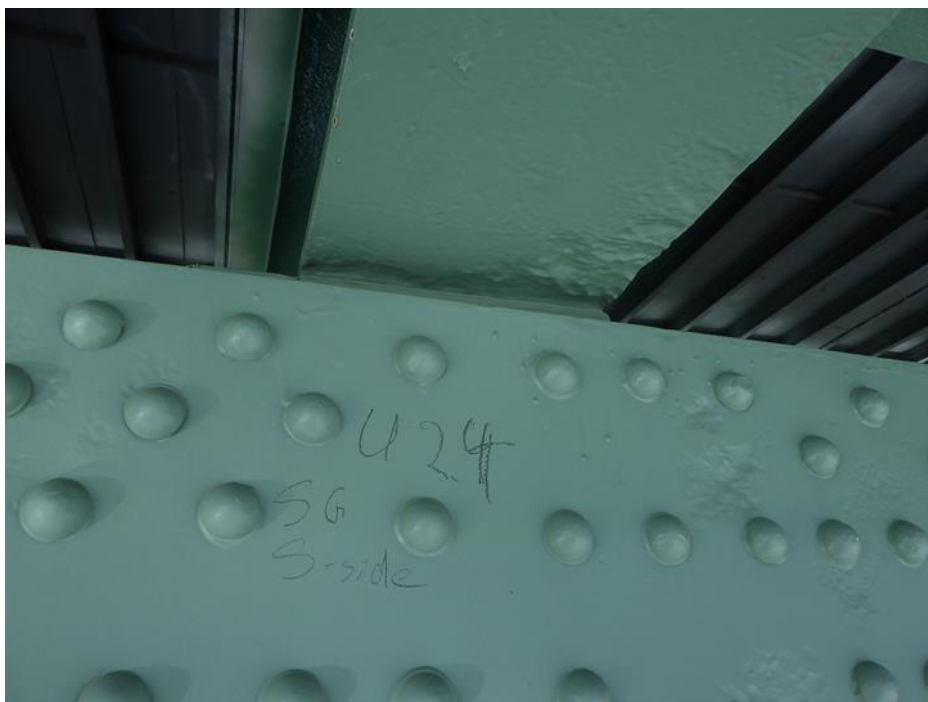
PHOTO 64

Description U24 South side section loss in above floorbeam
