# Highway Bridge Inspection Report

**SPECIALIST WADE A SLACK MEMORIAL BRIDGE**  
**I 95 SB**  
**over**  
**ROUTE 104 (MAIN ST)**

**Inspection Date:** 02/13/2026

**Inspection Type(s):** Damage (SNBI)

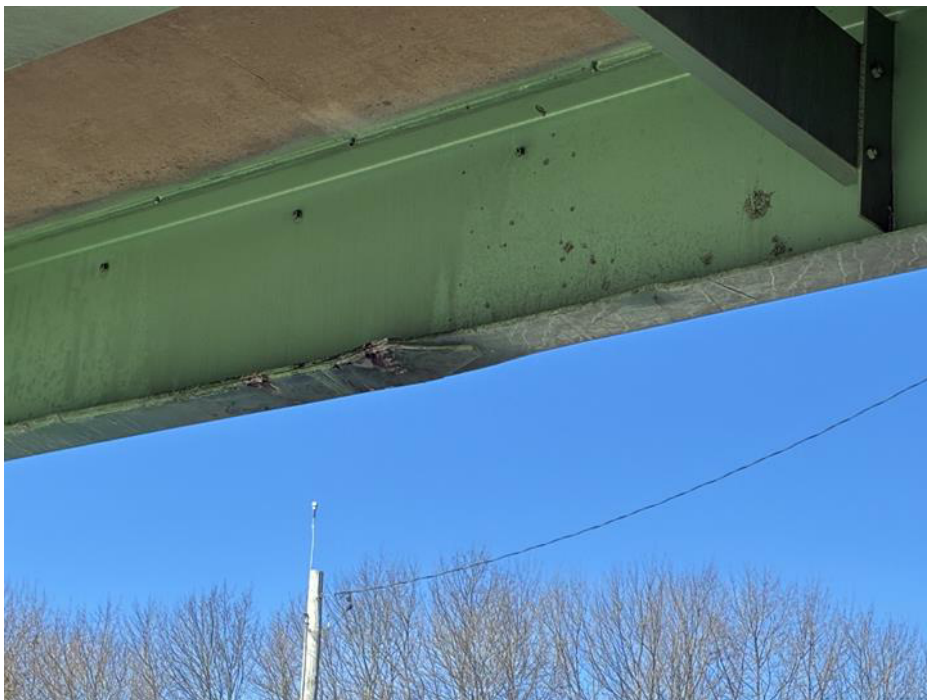
2/13/2026 - A trailer carrying a large forklift struck the western most exterior beam. The bridge strike caused considerable damage to the beam. Keen observations from the ground by our initial inspection team of Shawn Brann, Dave Allen and Ken Dyer III lead to a hands-on inspection of the damaged areas. Local maintenance crews closed a lane allowing access with a ladder. Here is a summary of the damage to the exterior girder.

PHOTO 1      Condition  
Description      Location of impact

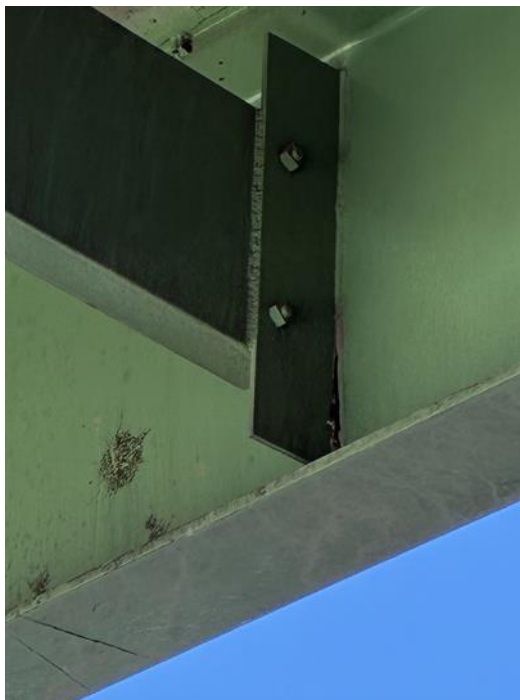
PHOTO 2      Condition  
Description      Adjacent diaphragm. Tear in web connecting the web and connection plate.

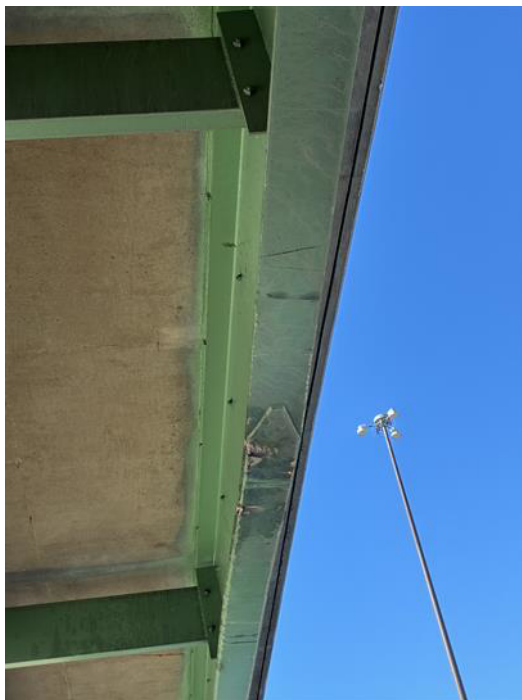
PHOTO 3 Condition

- 2"-3" outward sweep
- Bottom flange impact damage
- Beam web to connection plate weld tearing in 2 locations
- Fresh crack 10' toward midspan from the point of impact.
  - o Crack extends through the flange and up 5"-6" up the web.
  - o Can see completely through the flange and bottom of the web.
  - o Inside of crack is metallic silver in color with no signs of corrosion indicating a new crack

Description Bottom flange of exterior girder. Note beam sweep.

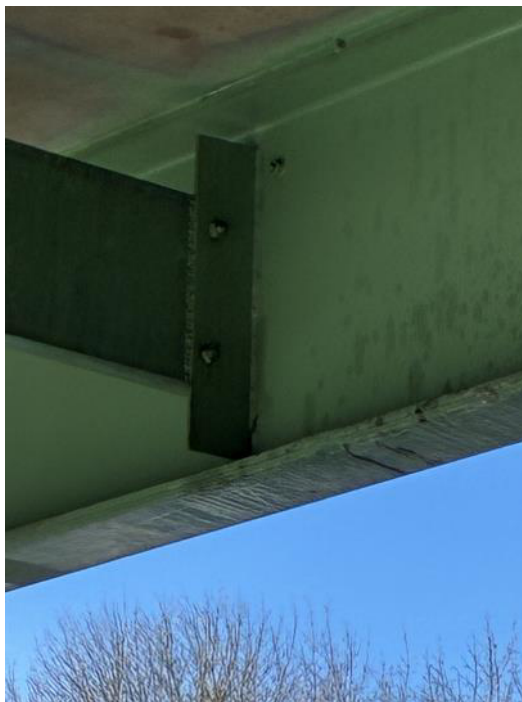
PHOTO 4 Condition

Description Adjacent diaphragm. Web tear at bottom of connection plate.

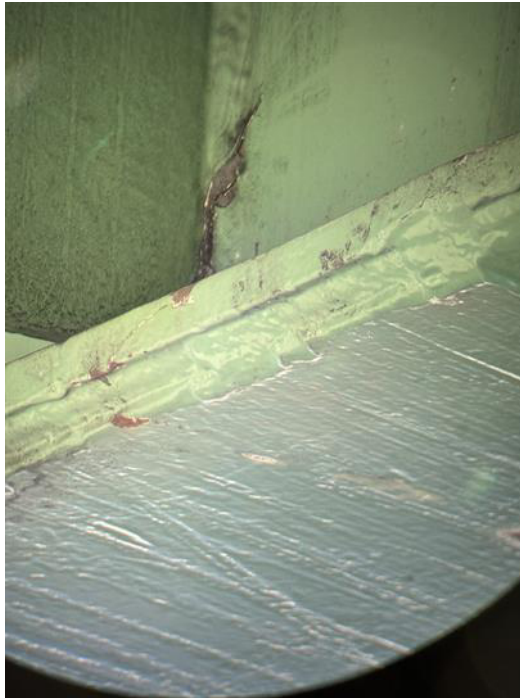
PHOTO 5      Condition  
Description      Close up of web tear

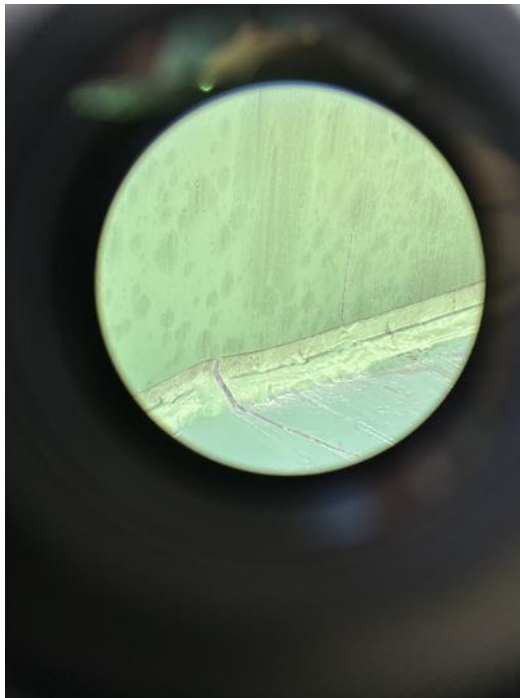
PHOTO 6      Condition  
Description      Beam crack through spotting scope.

Monitor crack in westerly exterior girder. Visual end of crack and the date of inspection labeled on the beam.- BWF

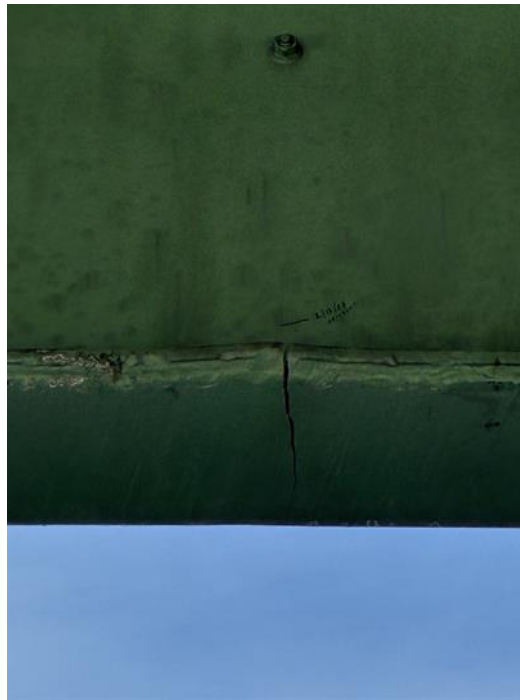
PHOTO 7 Condition

Description Crack through cover plate and bottom flange.

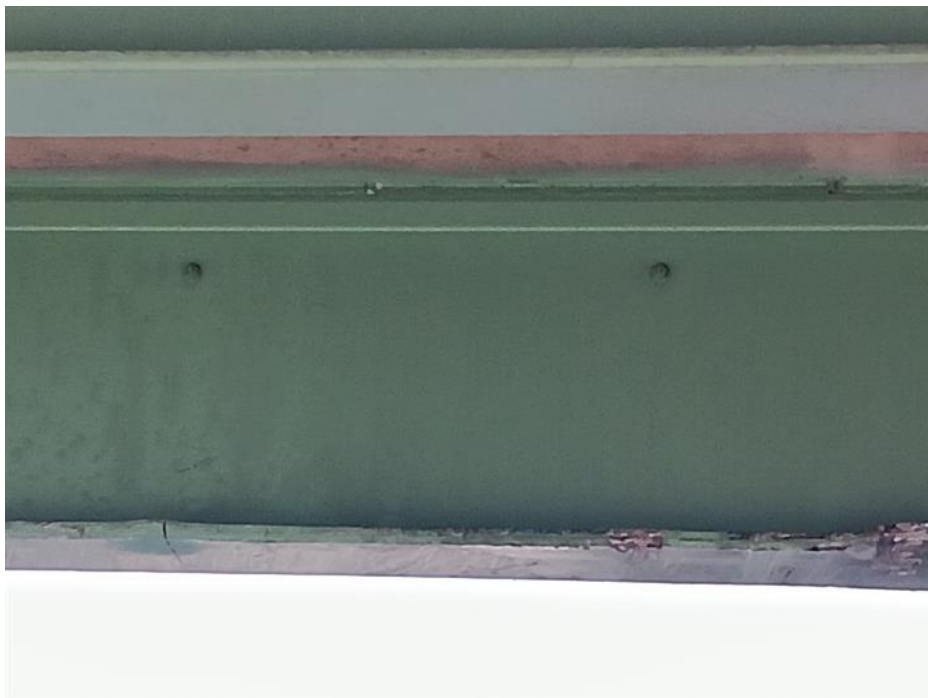
PHOTO 8 Condition

Description Location of crack in relation to impact location.

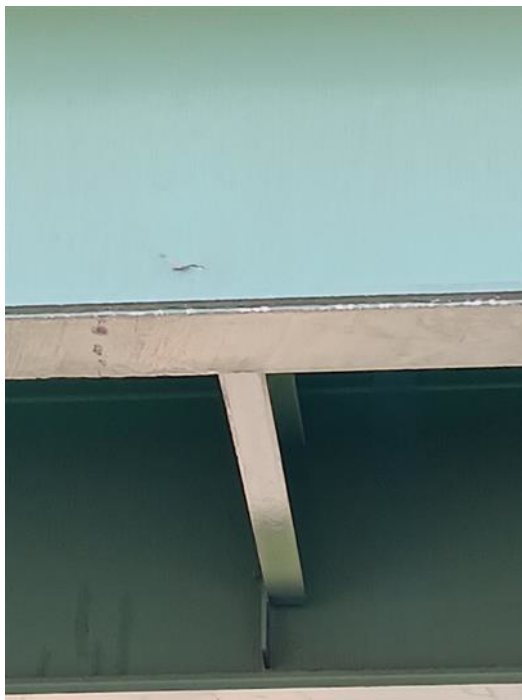
PHOTO 9 Condition

Description Web tear of the exterior girder.

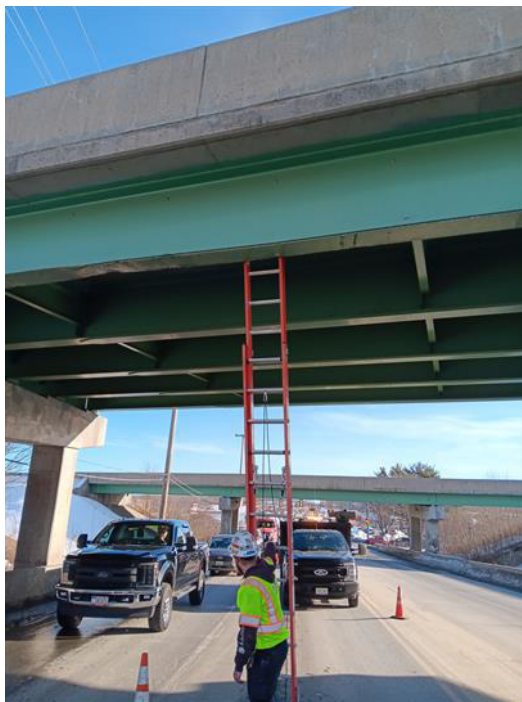
PHOTO 10 Condition

Description Hands-on access of crack

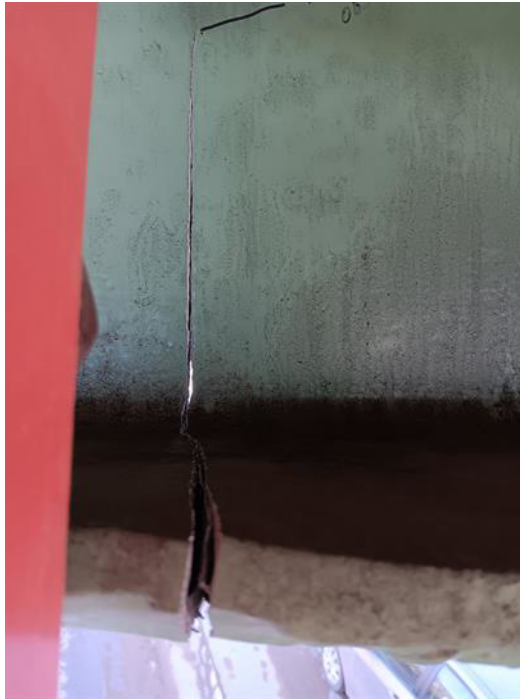
PHOTO 11 Condition

Description Close up of crack. Daylight through web.

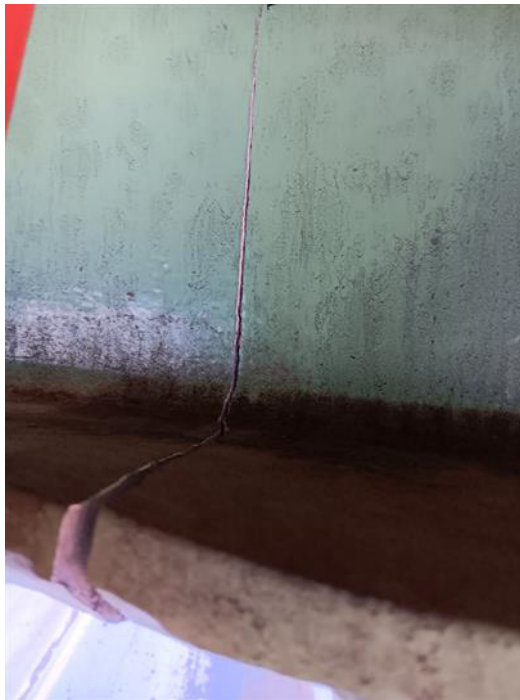
PHOTO 12 Condition

Description Inside of crack.

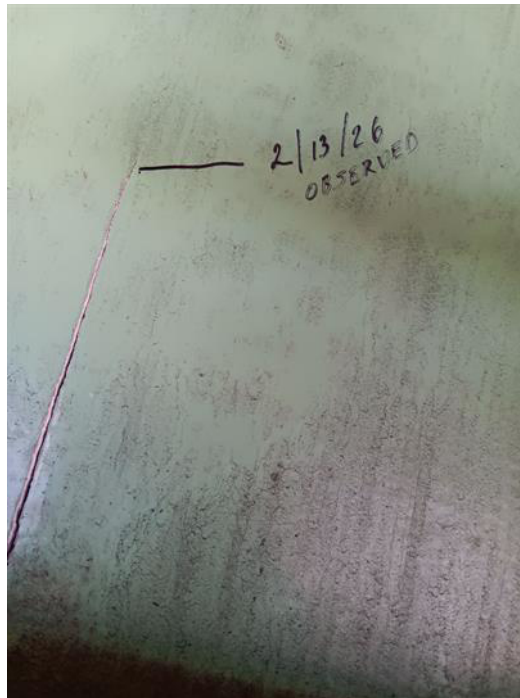
PHOTO 13 Condition

Description Crack through the beam web.
