# Highway Bridge Inspection Report

**SPECIALIST WADE A SLACK MEMORIAL BRIDGE**

**Inspection Type(s):** Special (SNBI)

Structure Number: 1457  
Facility Carried: I 95 SB

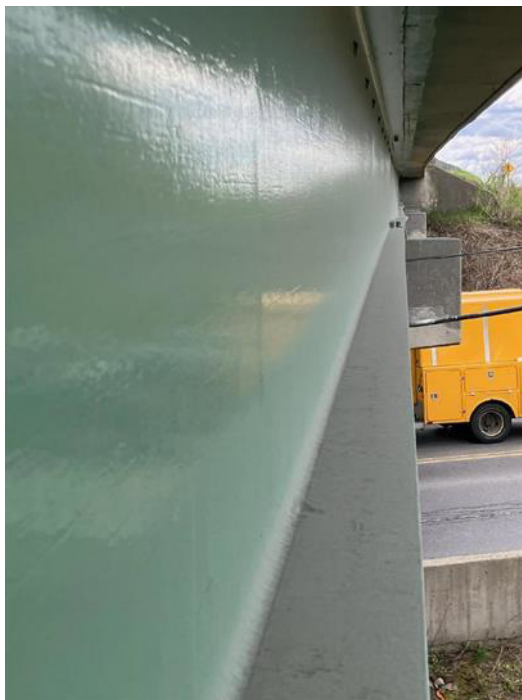
PHOTO 1

- 2"-3" outward sweep
- Bottom flange impact damage
- Beam web to connection plate weld tearing in 2 locations
- Fresh crack 10' toward midspan from the point of impact.
  - o Crack extends through the flange and up 5"-6" up the web.
  - o Can see completely through the flange and bottom of the web.
  - o Inside of crack is metallic silver in color with no signs of corrosion indicating a new crack

Description Beam sweep looking south

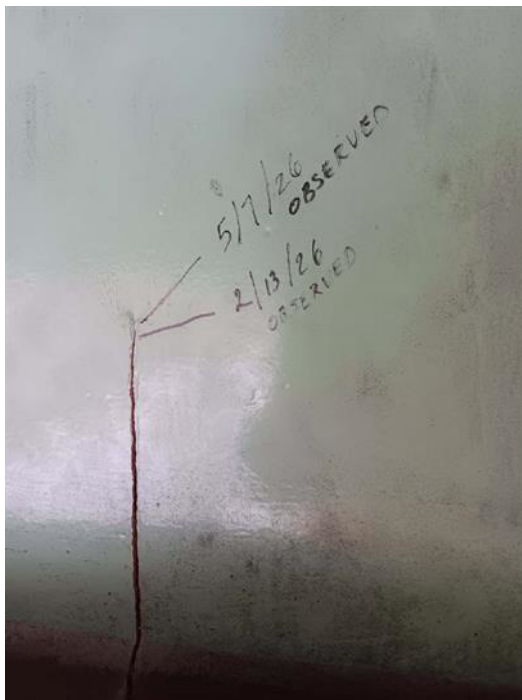
PHOTO 2

5/7/2026 - Hands-on access with scissor lift during delam removal operation. No appreciable change in crack length. Better access was achieved during this inspection versus the damage inspection in February. End of crack was labeled on the west side of the beam.

Description Crack tip change

Monitor crack in westerly exterior girder. Visual end of crack and the date of inspection labeled on the beam.- BWF

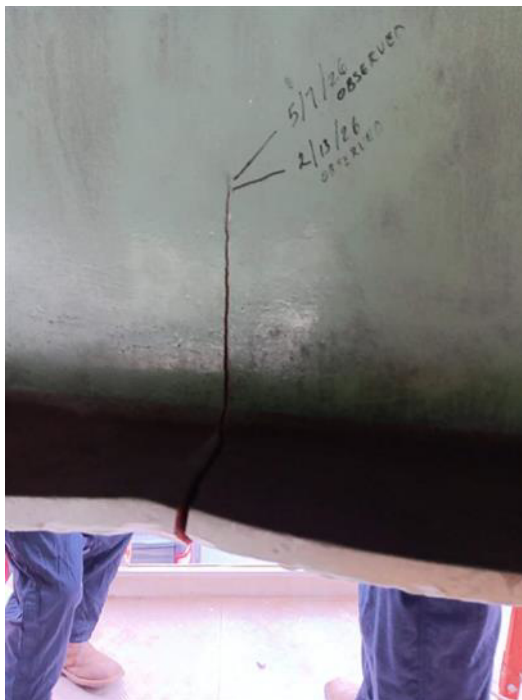
PHOTO 3

Description East side of beam at crack

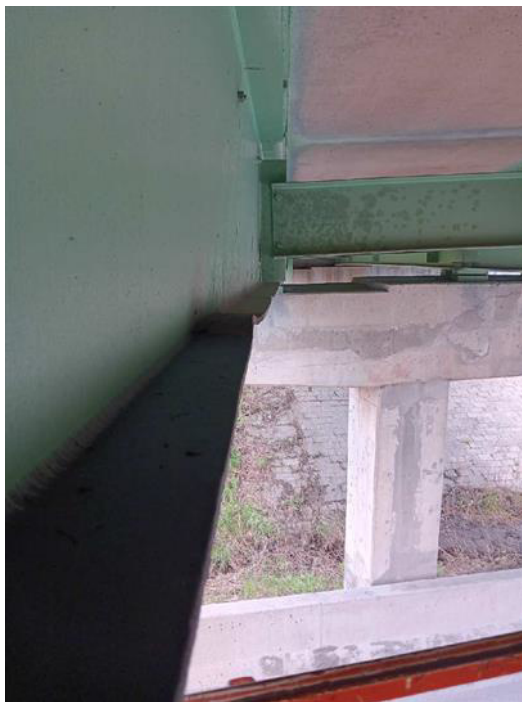
PHOTO 4

Description Bottom flange damage east side of beam looking north

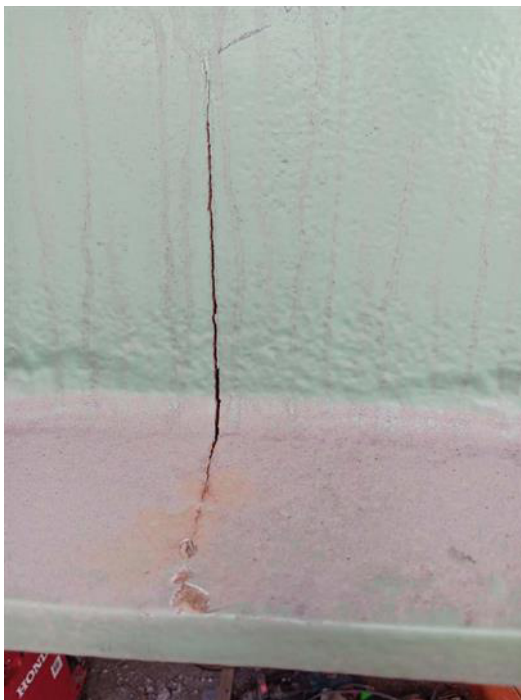
PHOTO 6

Description Crack location west side of beam

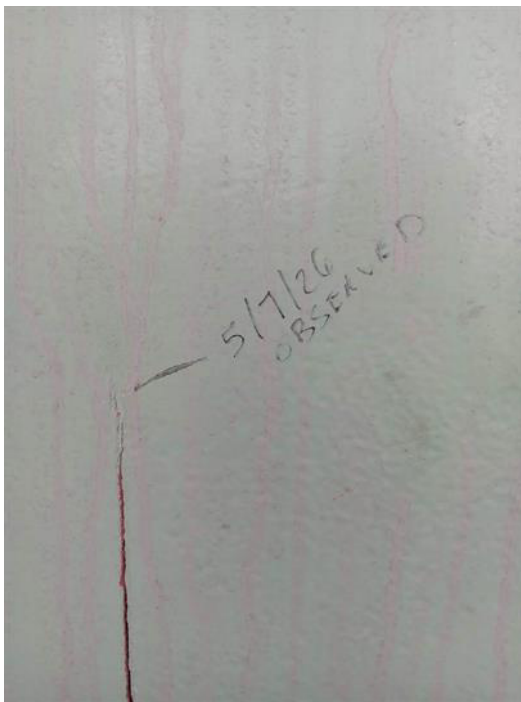
PHOTO 7

Description End of crack west side of beam
