Railroad Bridge Substructure Rehabilitations

Maine Northern Railway – Madawaska Subdivision
MaineDOT WIN 23488.00

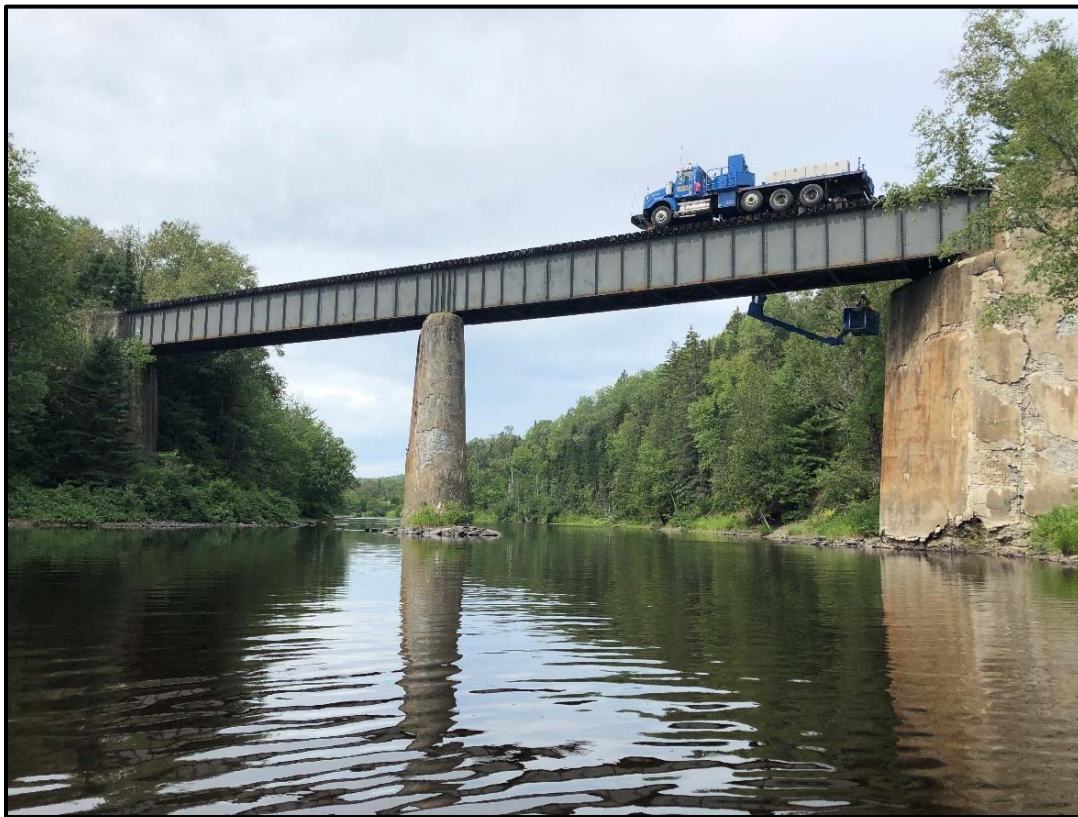
Elevation View of Bridge Looking West

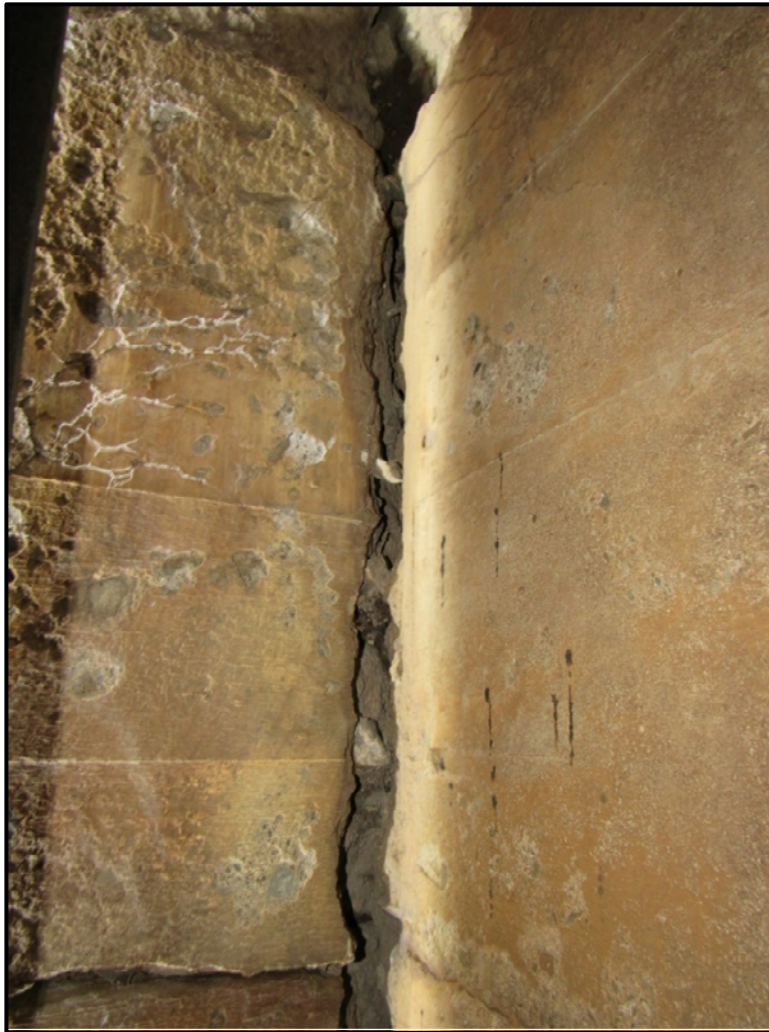
Crack in North Abutment at End of the East Girder, Up to 2" Wide

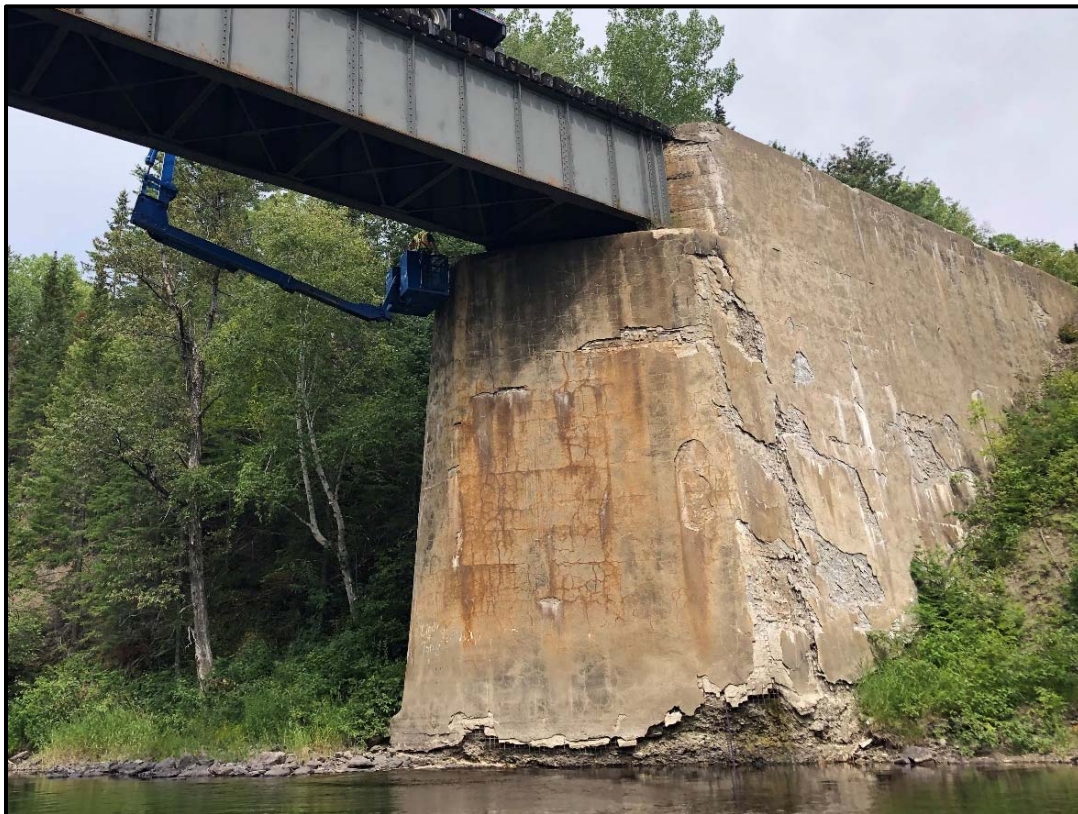
View of North Abutment and Northeast Wingwall

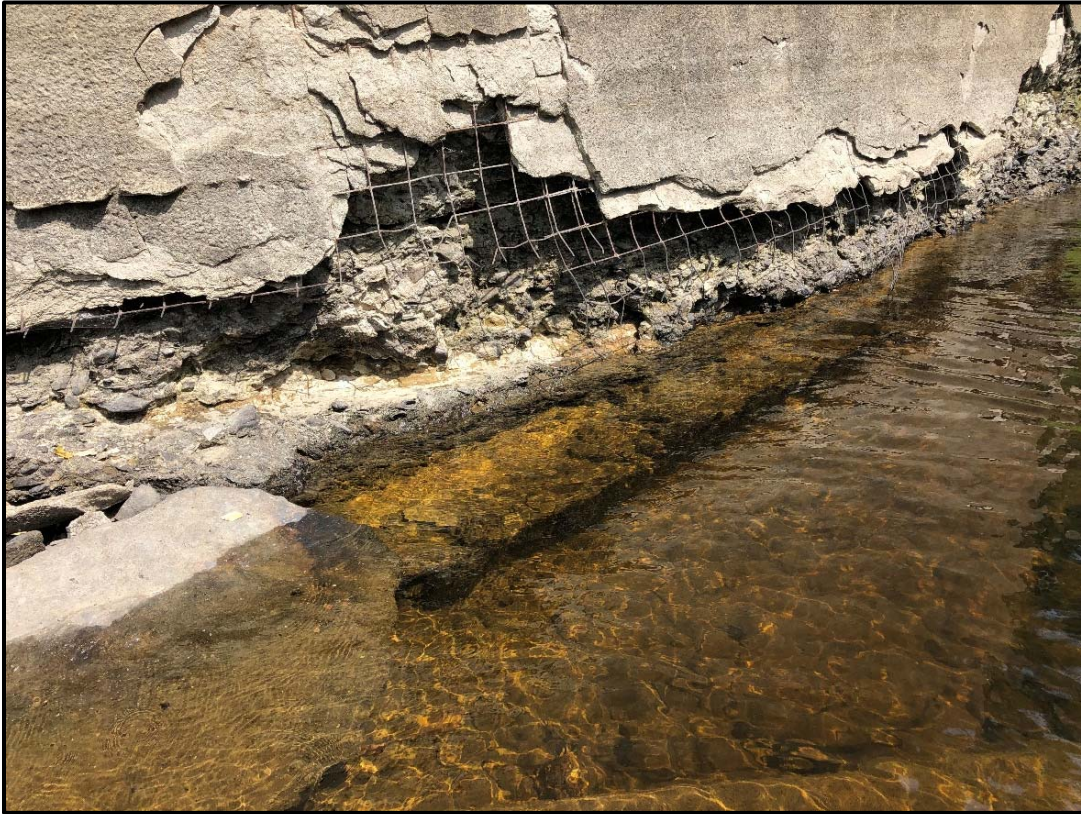
Deteriorated and Abraded Concrete at Base of North Abutment

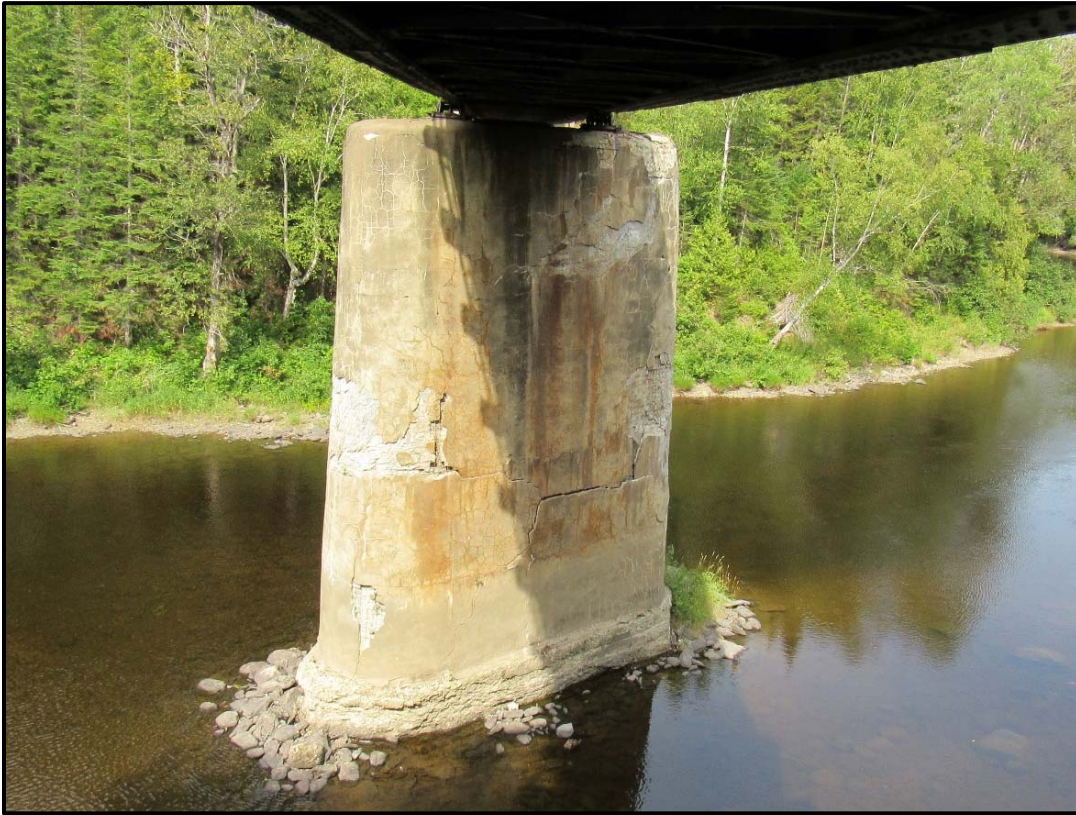
View of South Face of Pier

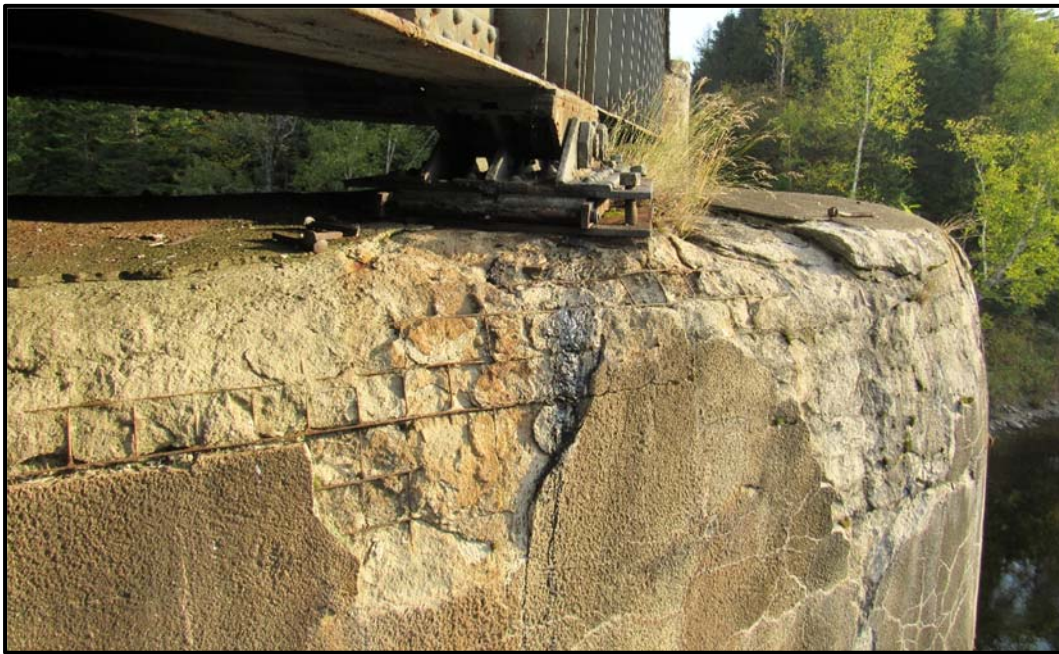
Heavily Deteriorated Concrete and Undermined Bearing at Top of Pier

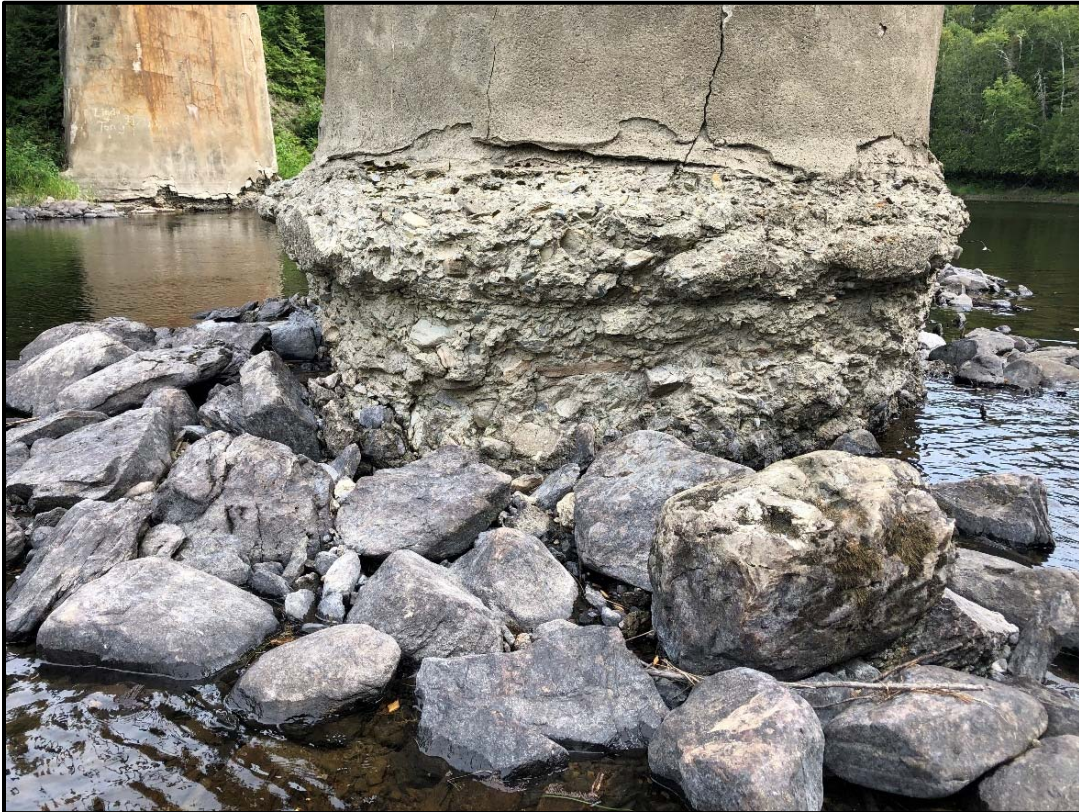
Deteriorated Concrete at Base of Pier

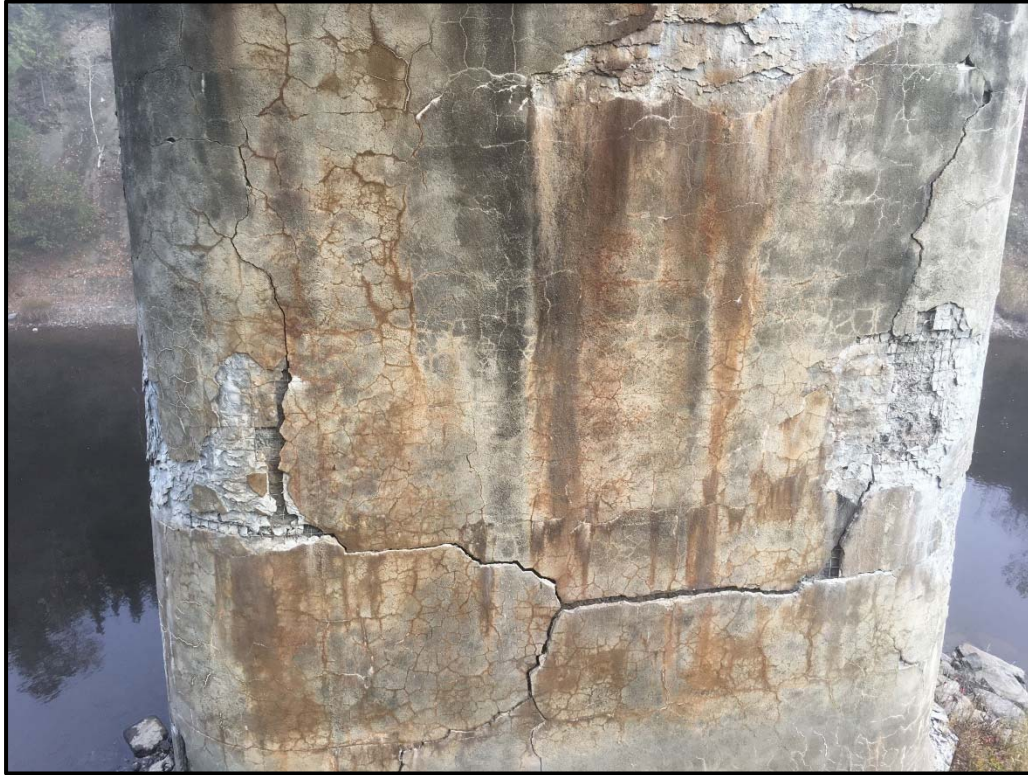
Delamination and Cracking on the South Face of Pier

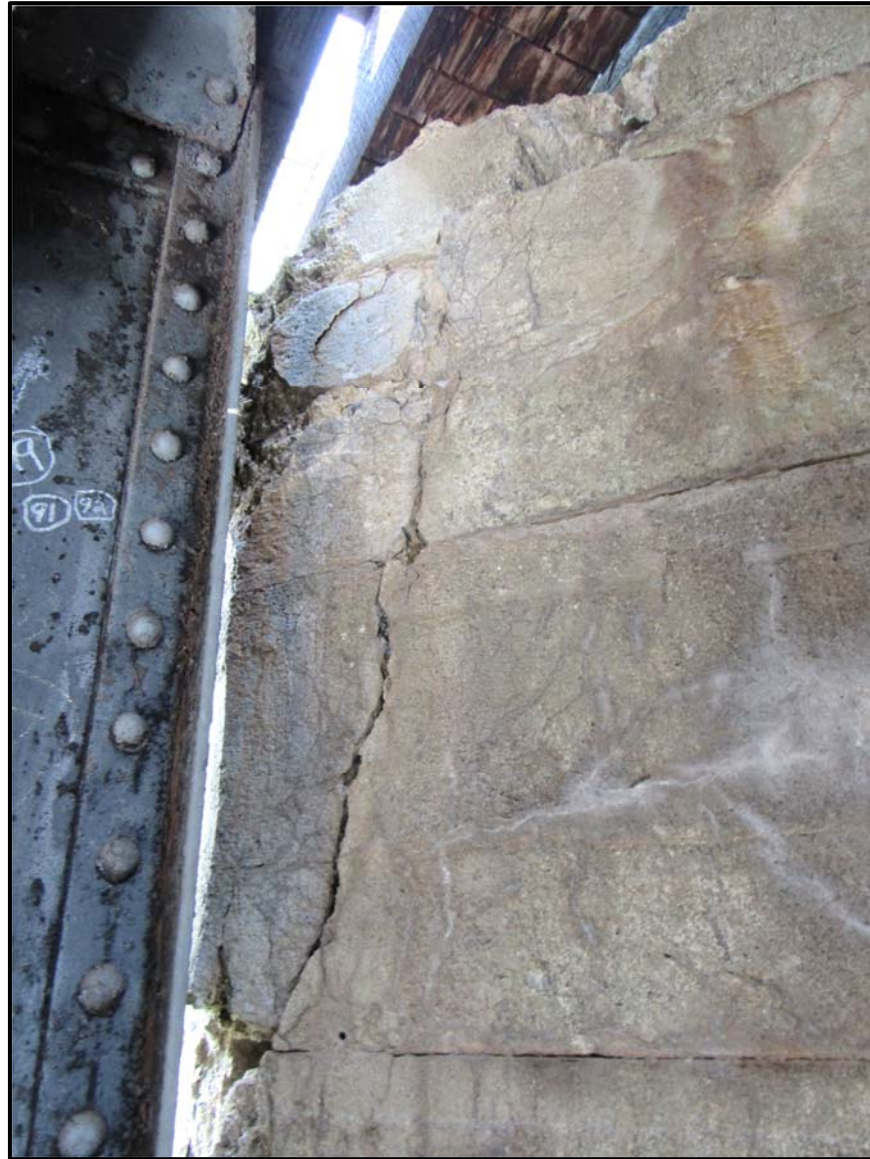
Diagonal Shear Crack in the Upper West Corner of the North Abutment Backwall Under Bridge Timber

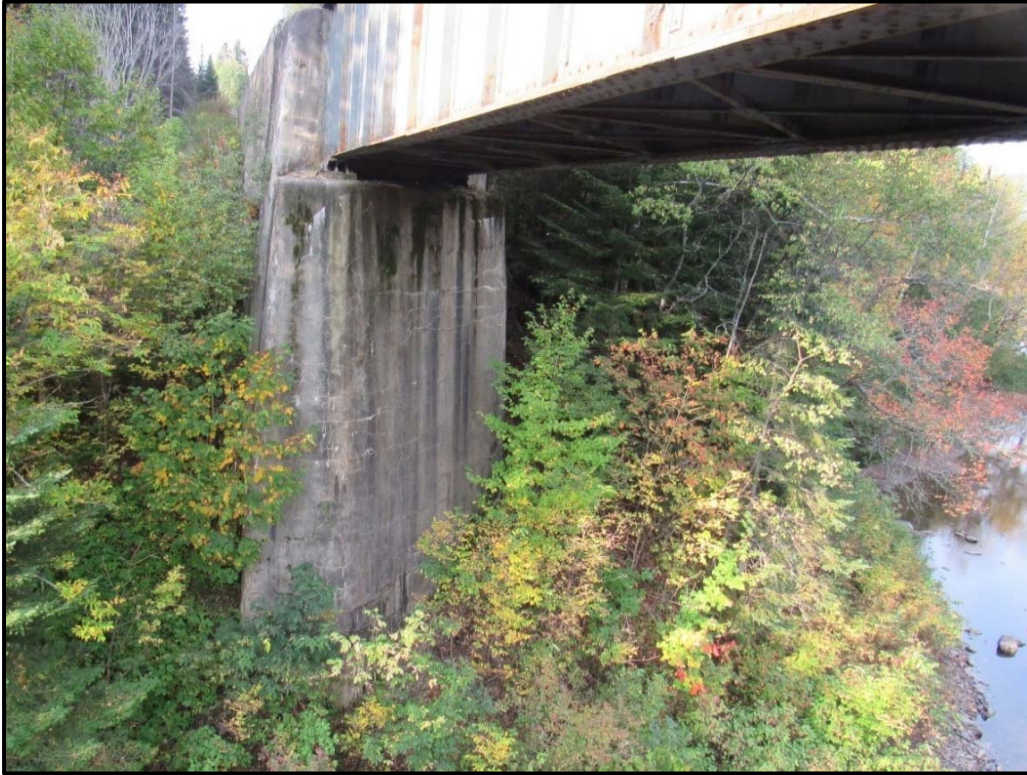
View of South Abutment

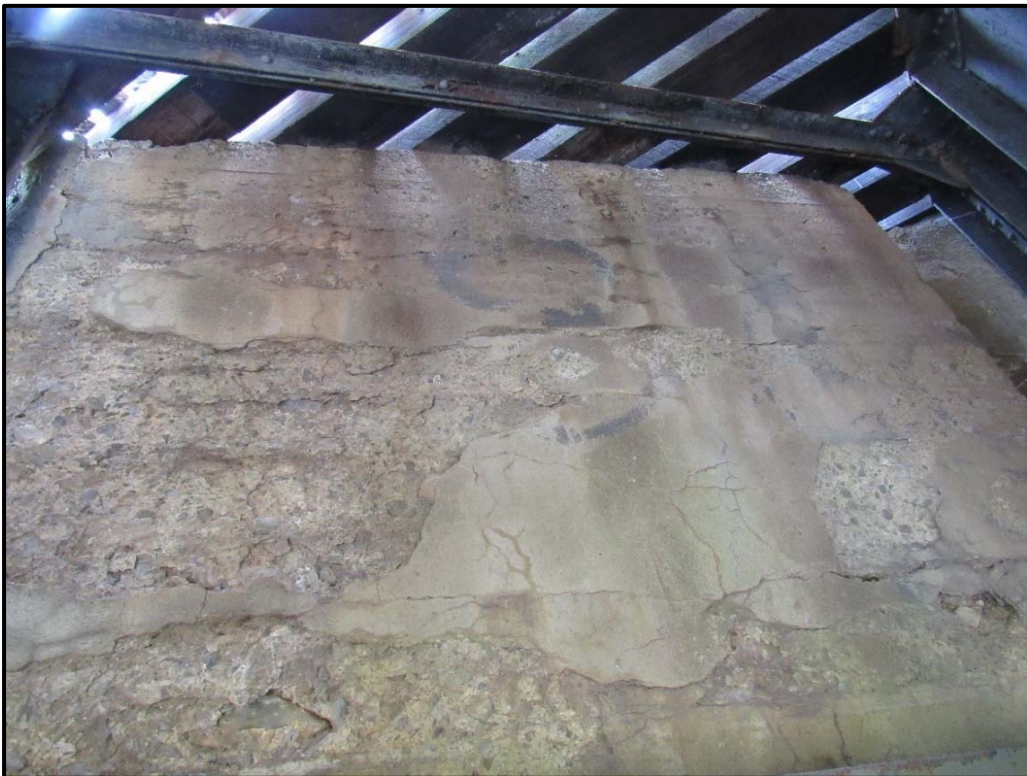
Spalled and Deteriorated Concrete in the Backwall of the South Abutment

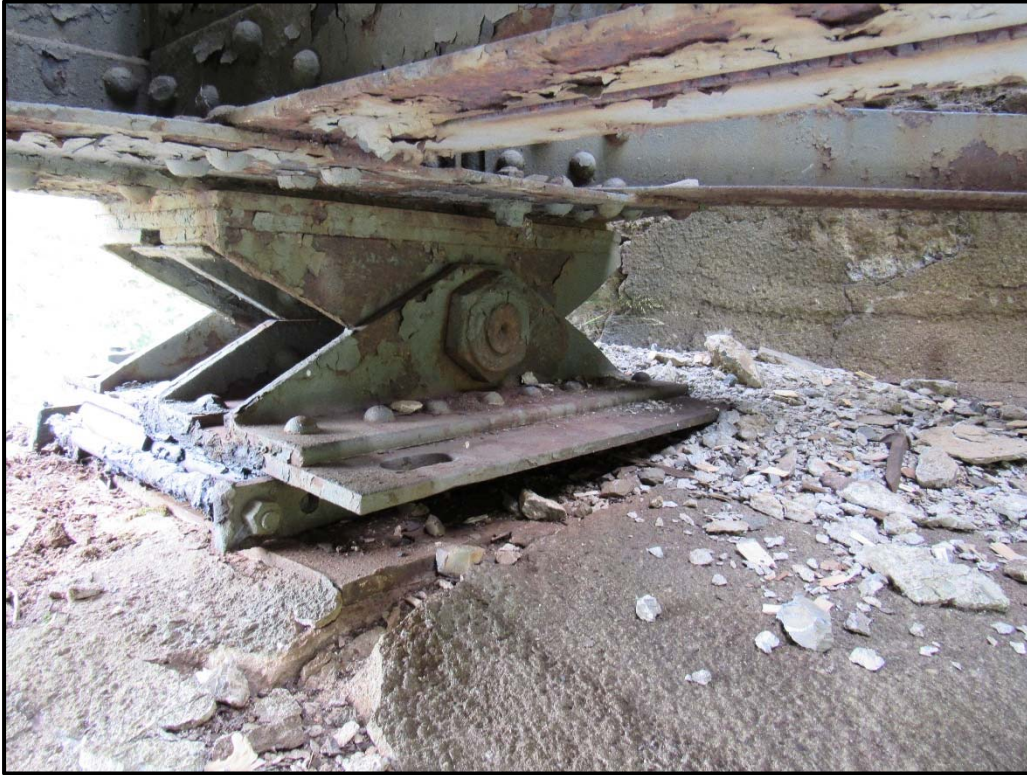
Failed Expansion Bearing at North Abutment

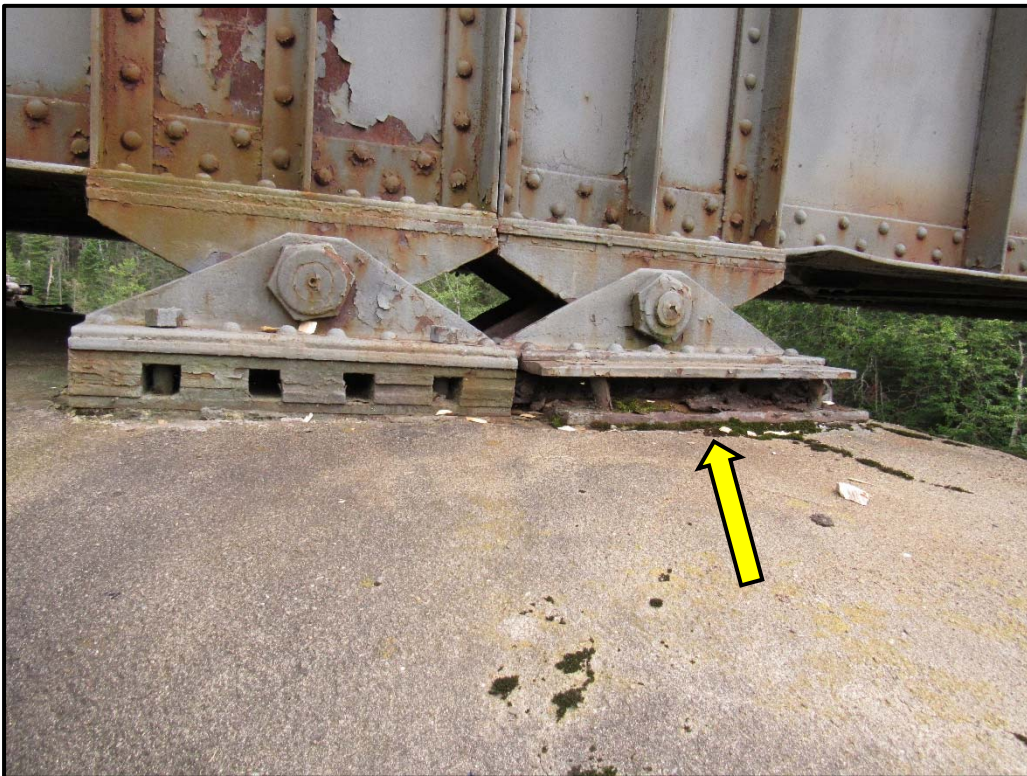
Failed Expansion Bearing on Southwest Side of Pier

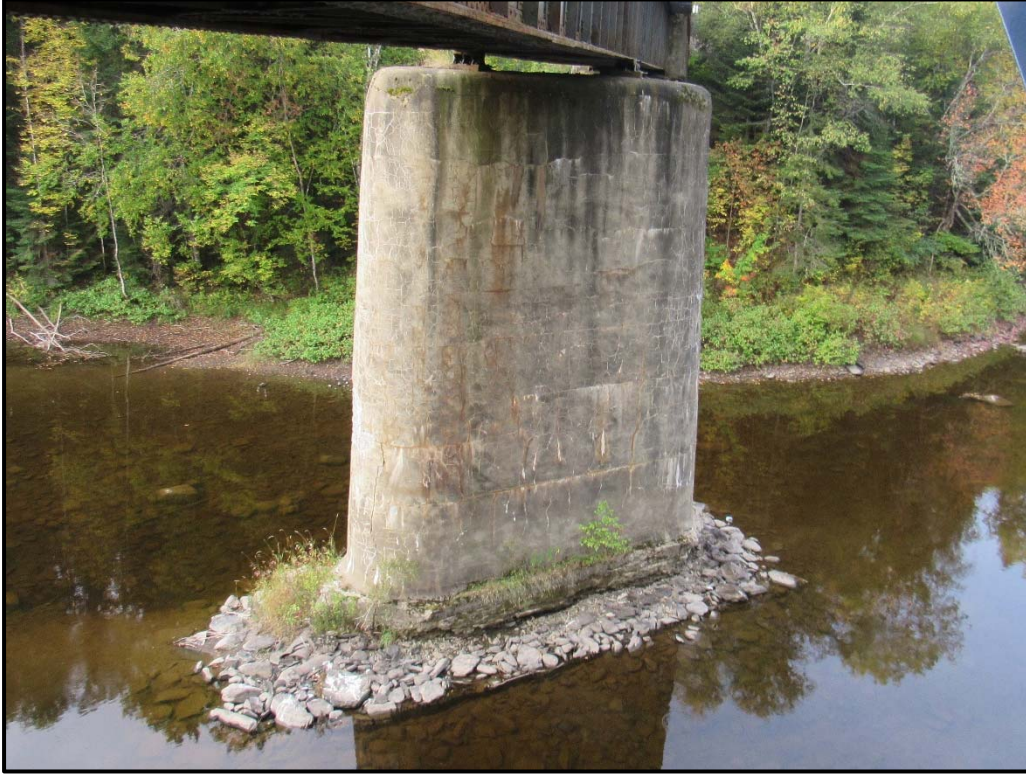
North Face of Pier (Encased in Shotcrete)

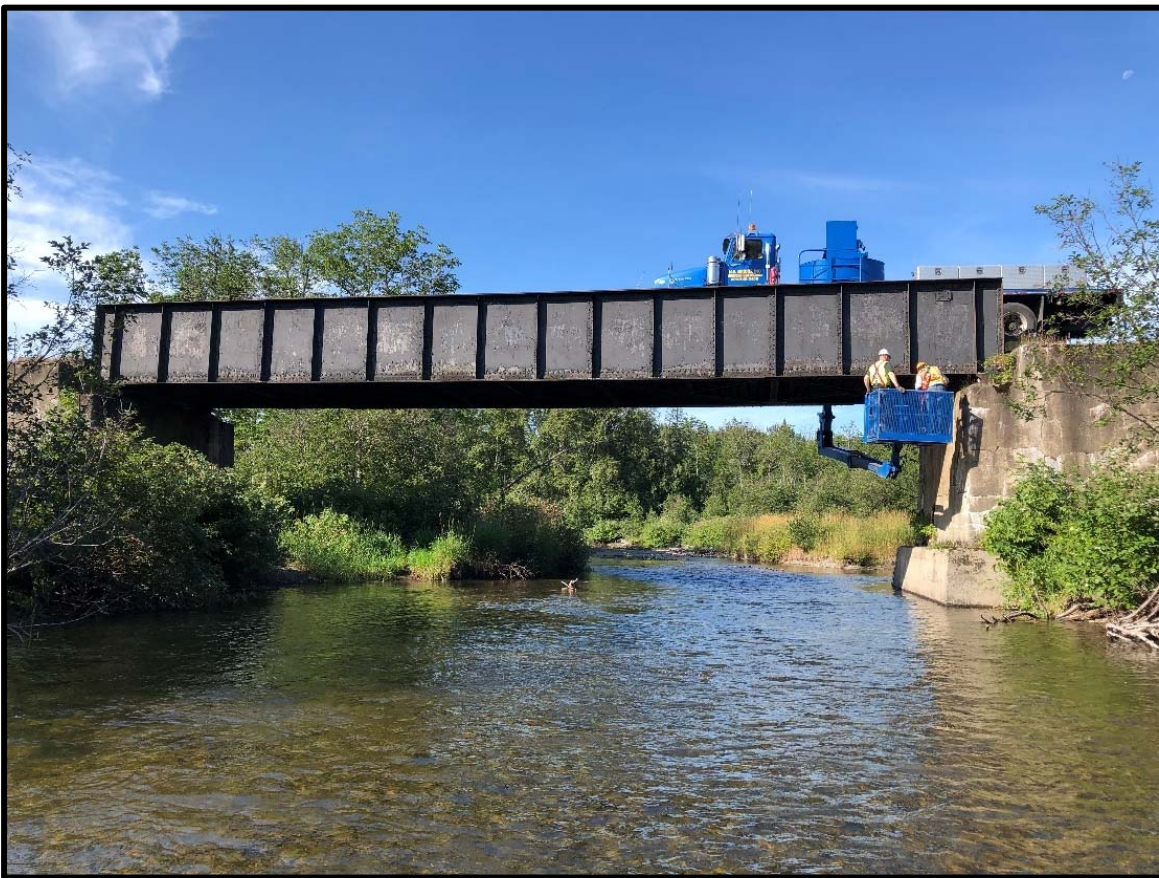
Elevation View of Bridge Looking West

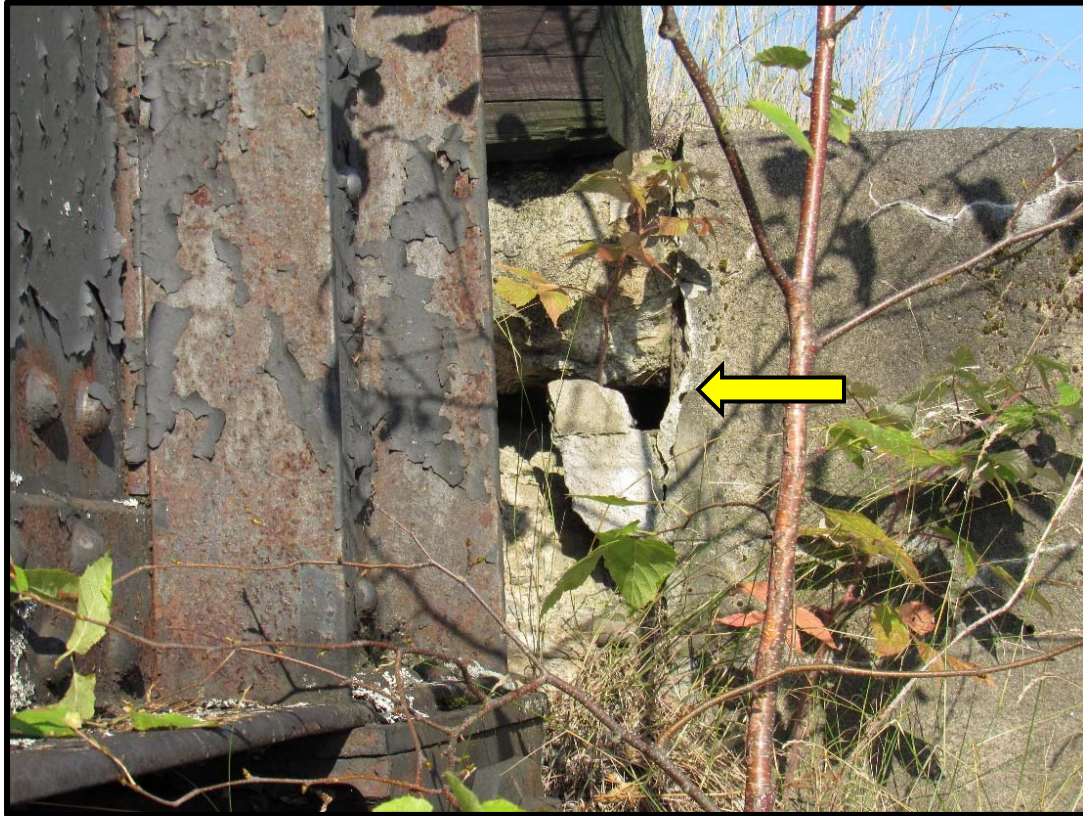
Deteriorated and Crumbling Concrete Backwall at Northeast Bearing

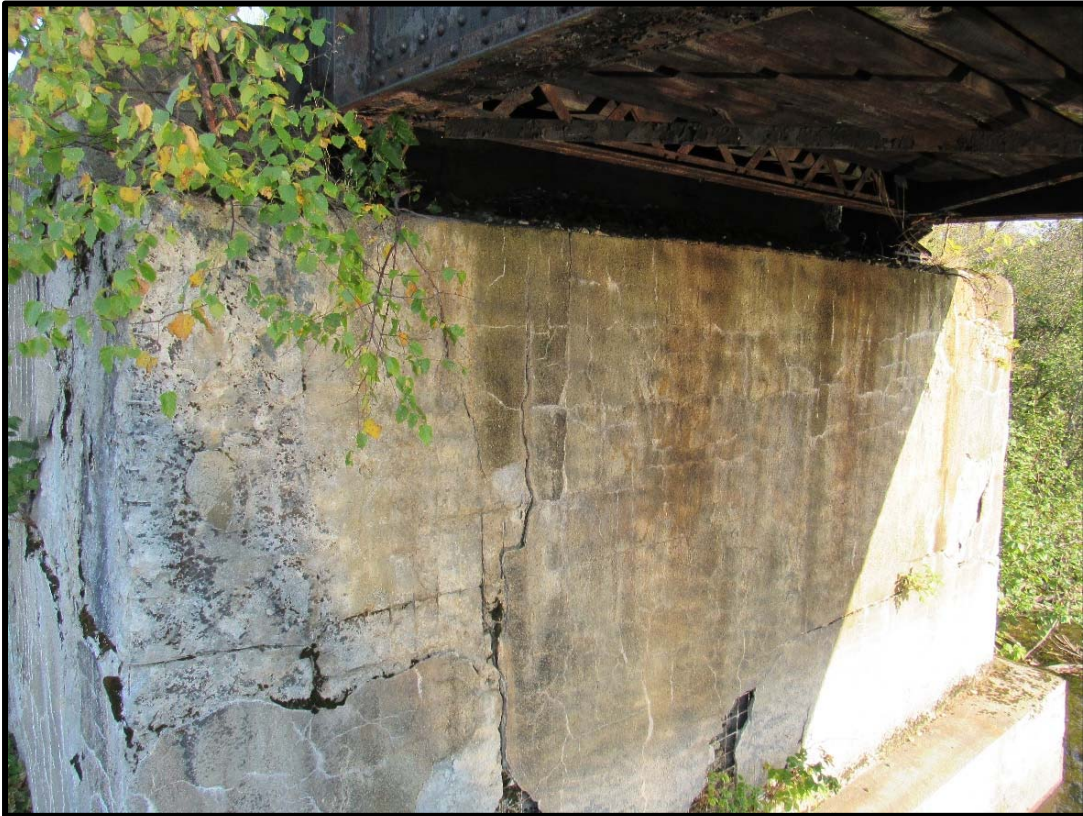
View of North Abutment Bridge Seat and Breast Wall

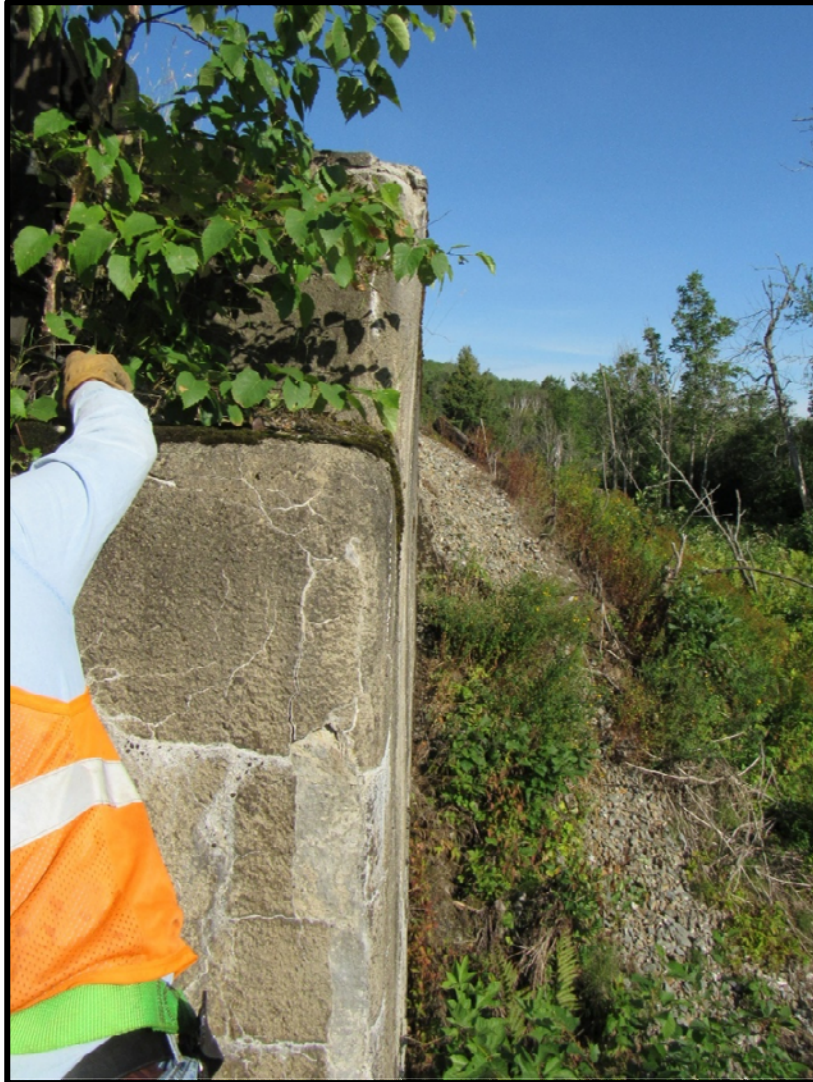
Northeast Wingwall Tilting Outward (Originally Battered)

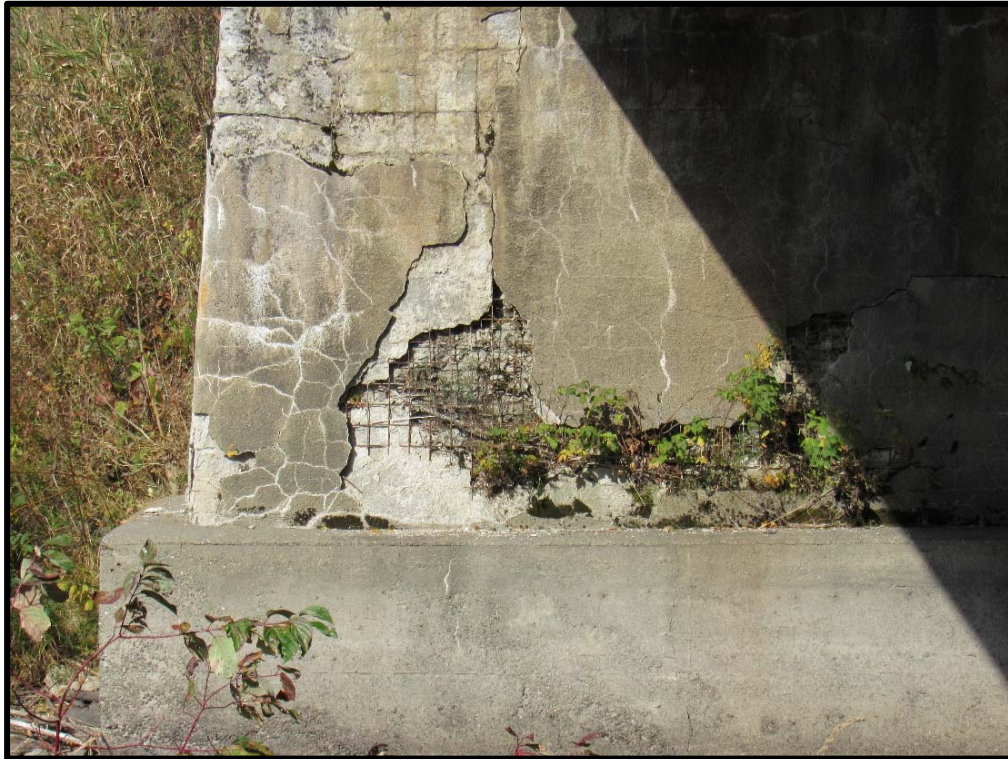
Heavy Deterioration in Shotcrete on North Abutment

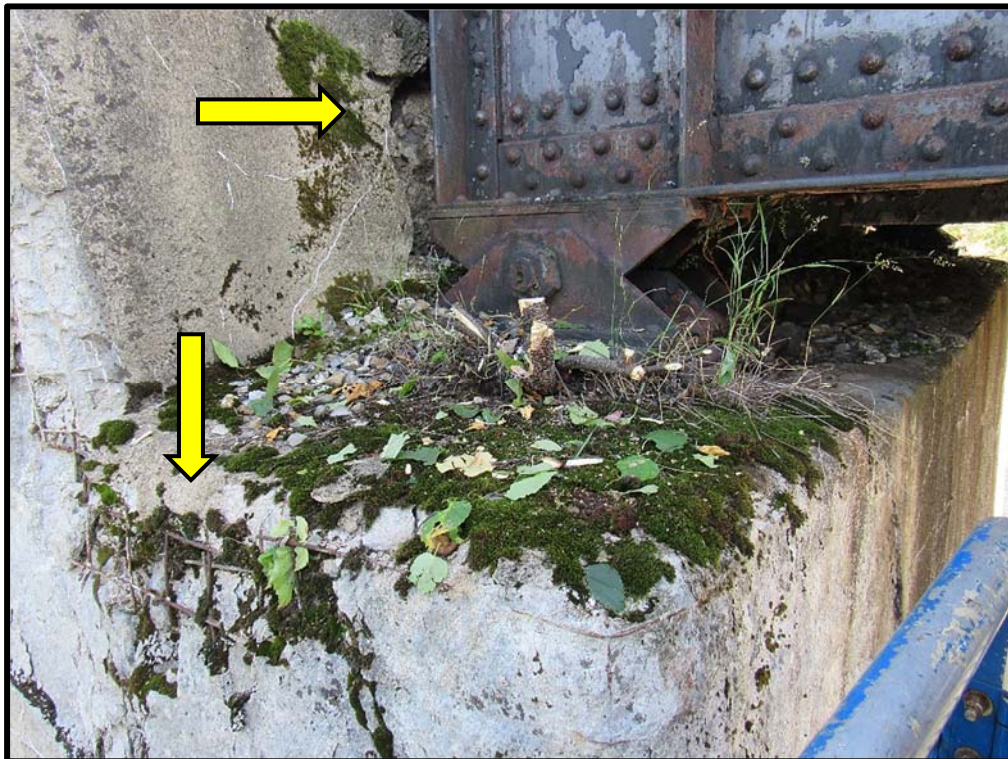
Deterioration in Bridge Seat and Backwall at Northwest Bearing

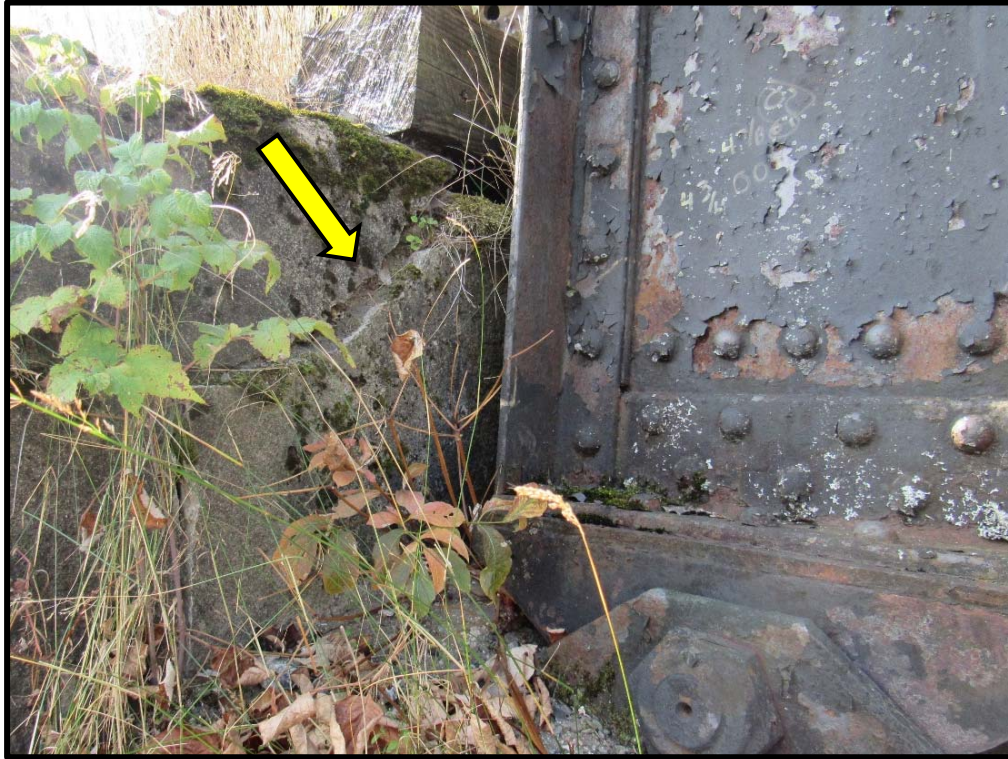
Crack in Backwall at Southeast Bearing

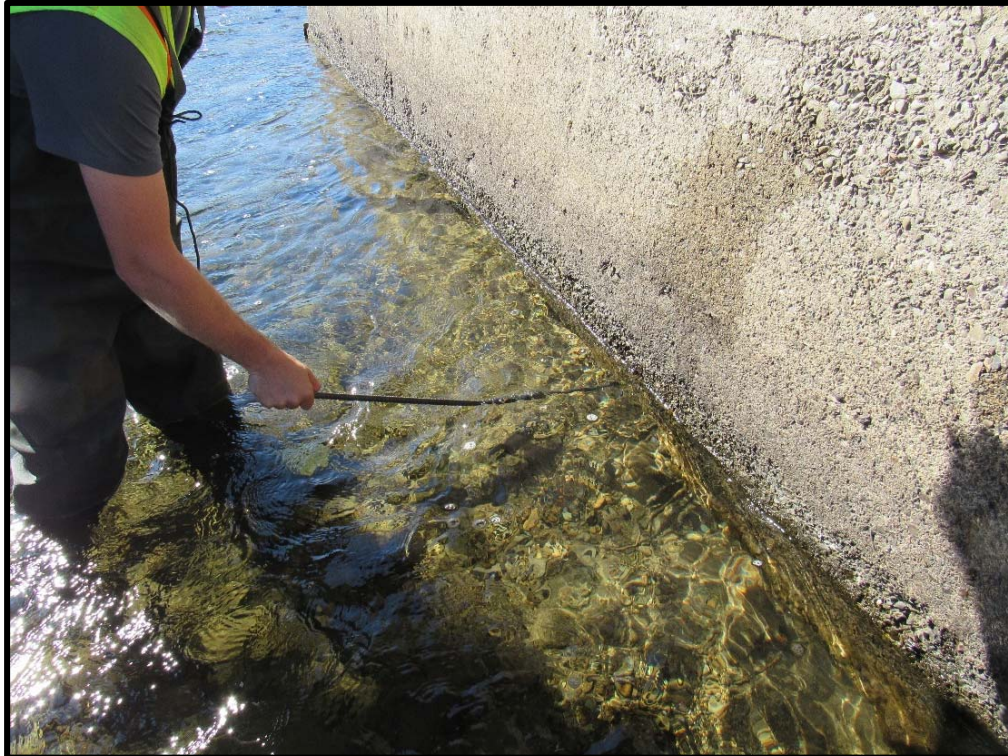
Gap Between the Bottom of the Concrete Encasement and the River Bed, at North Abutment

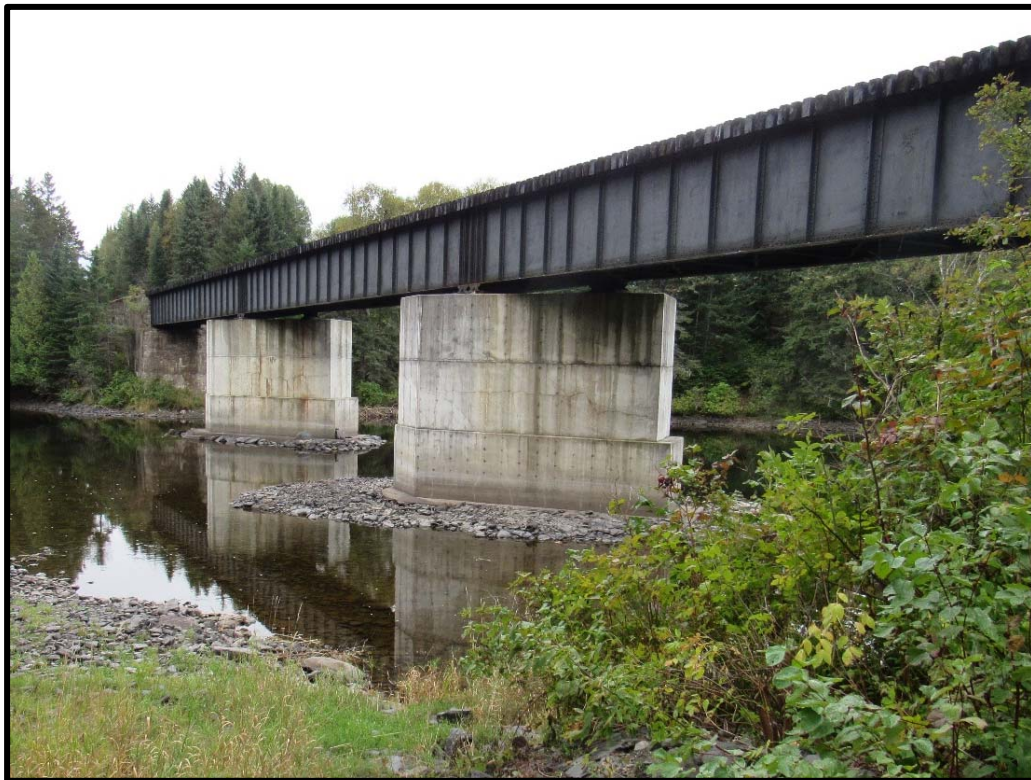
Elevation View of Bridge Looking Southwest

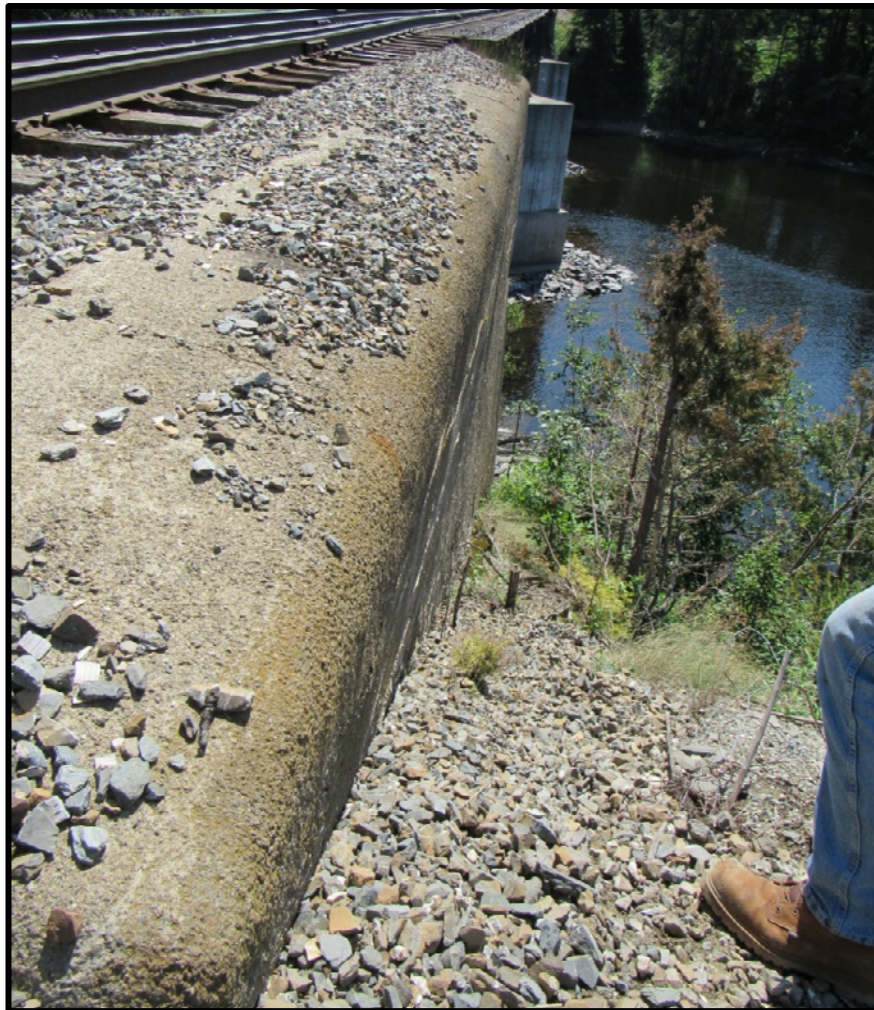
Northwest Wingwall Tilting Outward (Originally Battered Inward)

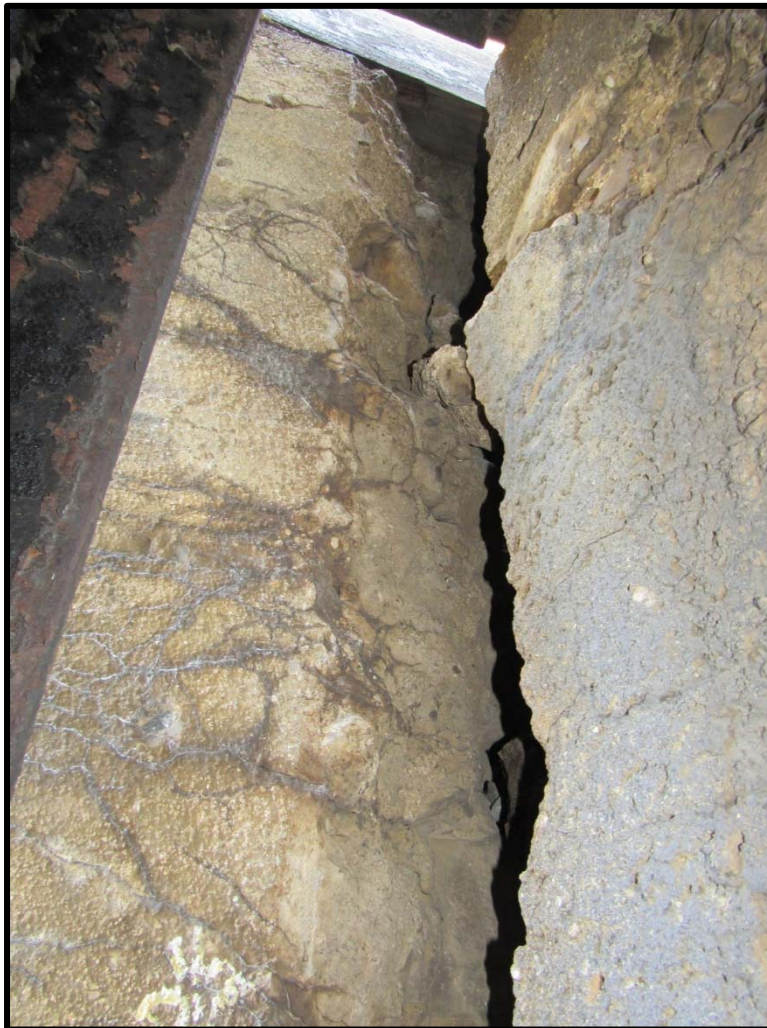
Crack in North Abutment at End of the West Girder, Up to 3" Wide

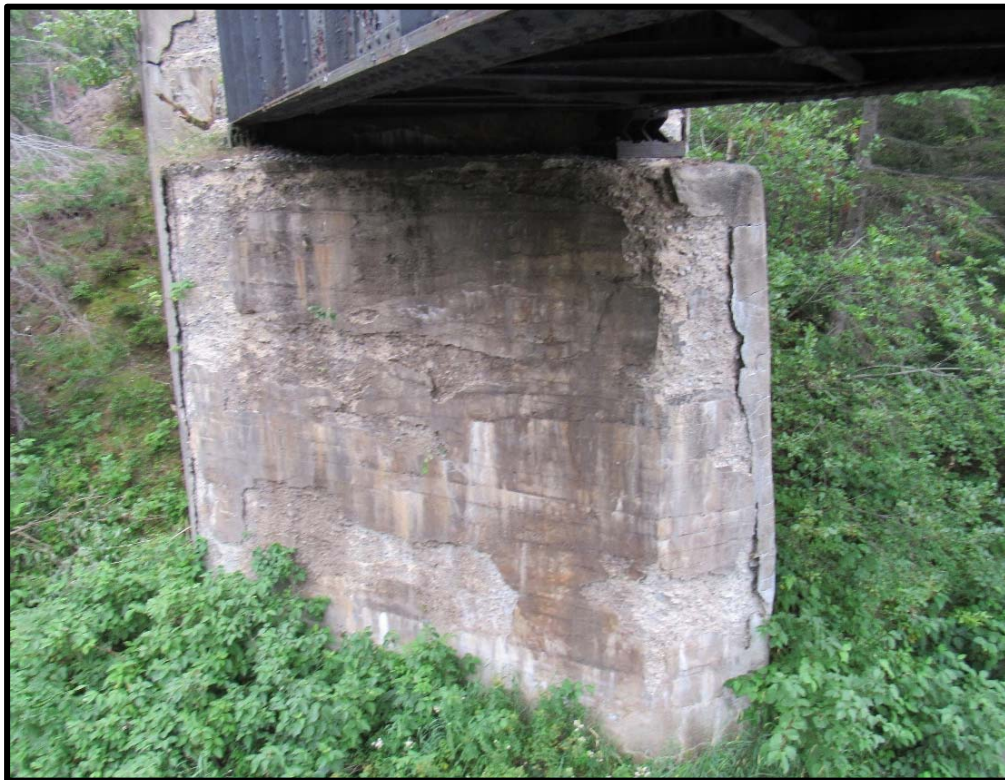
View of South Abutment

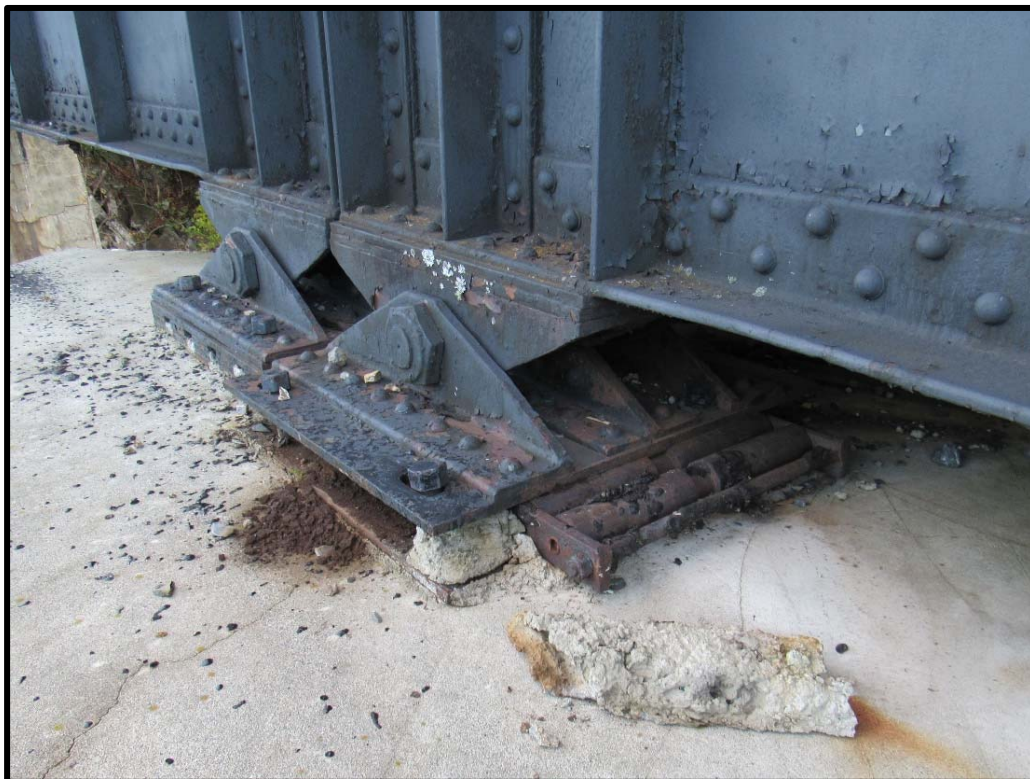
Failed Expansion Bearing at North Pier
