Railroad Bridge Substructure Rehabilitations

Maine Northern Railway – Madawaska Subdivision
MaineDOT WIN 23488.00

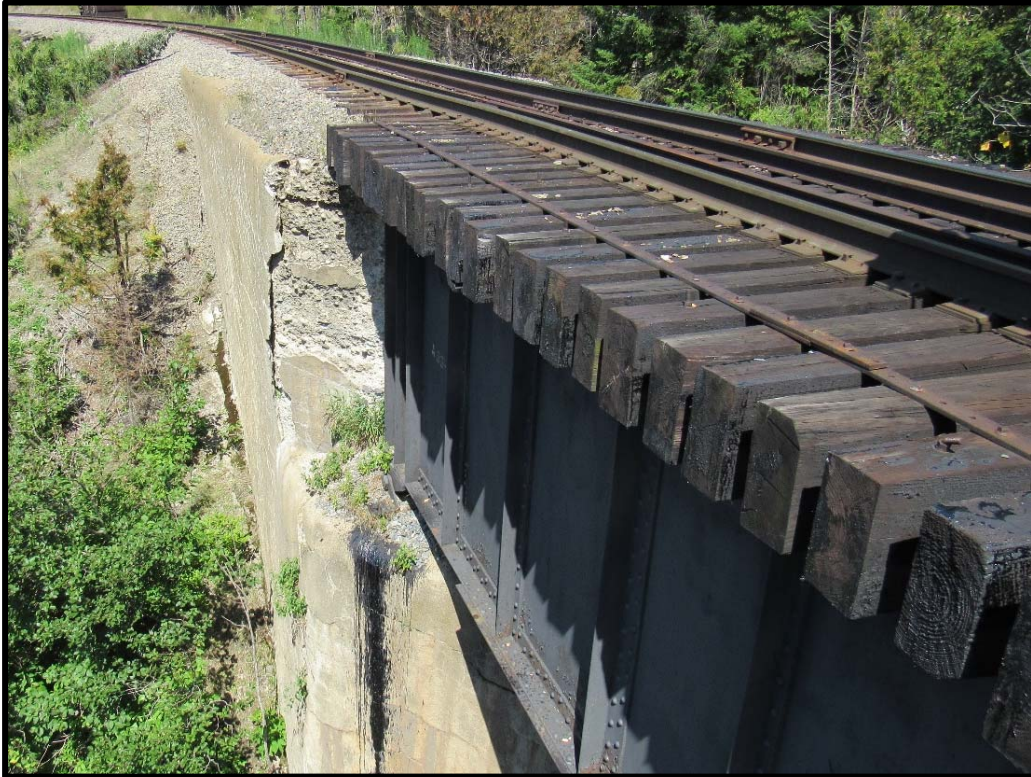
Heavy Deterioration at the Interface of Northwest Wingwall and Backwall

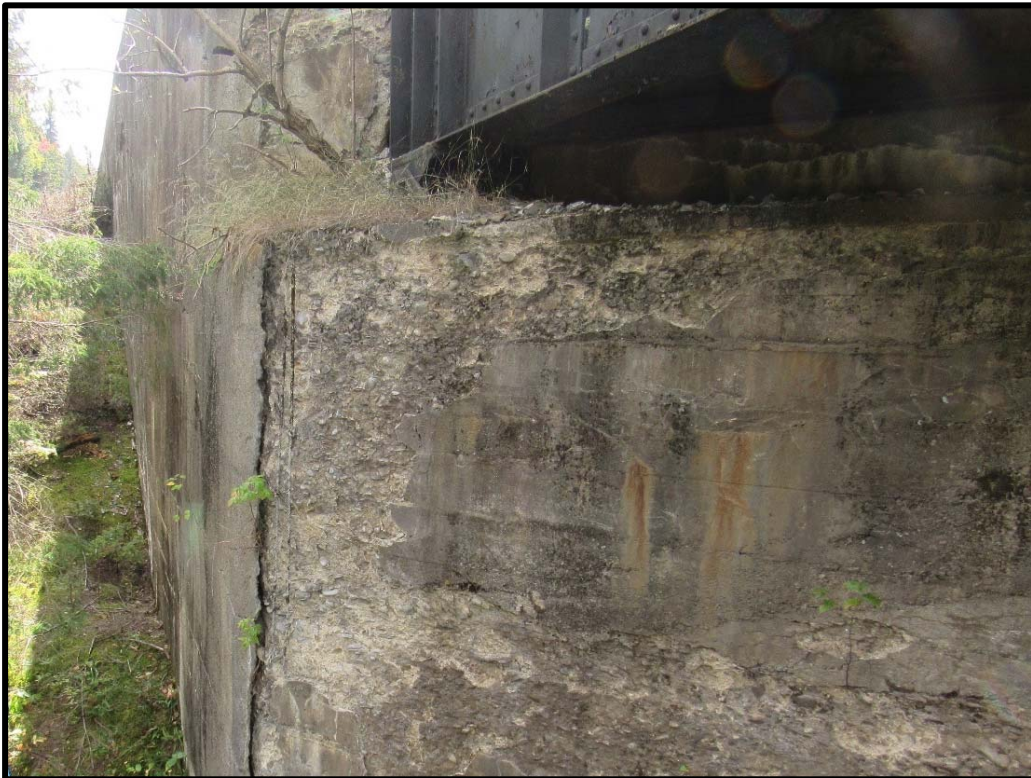
Heavy Deterioration in Bridge Seat at South Abutment

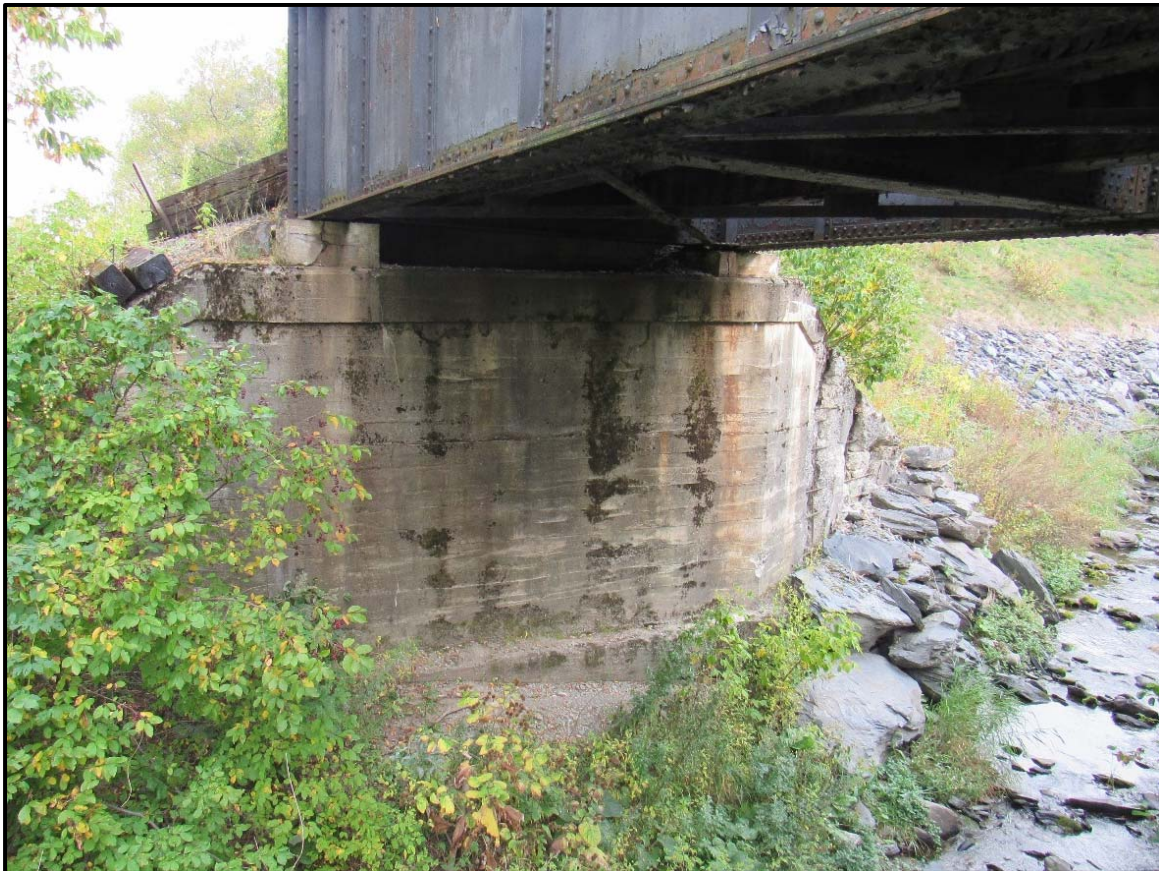
Elevation View of North Abutment

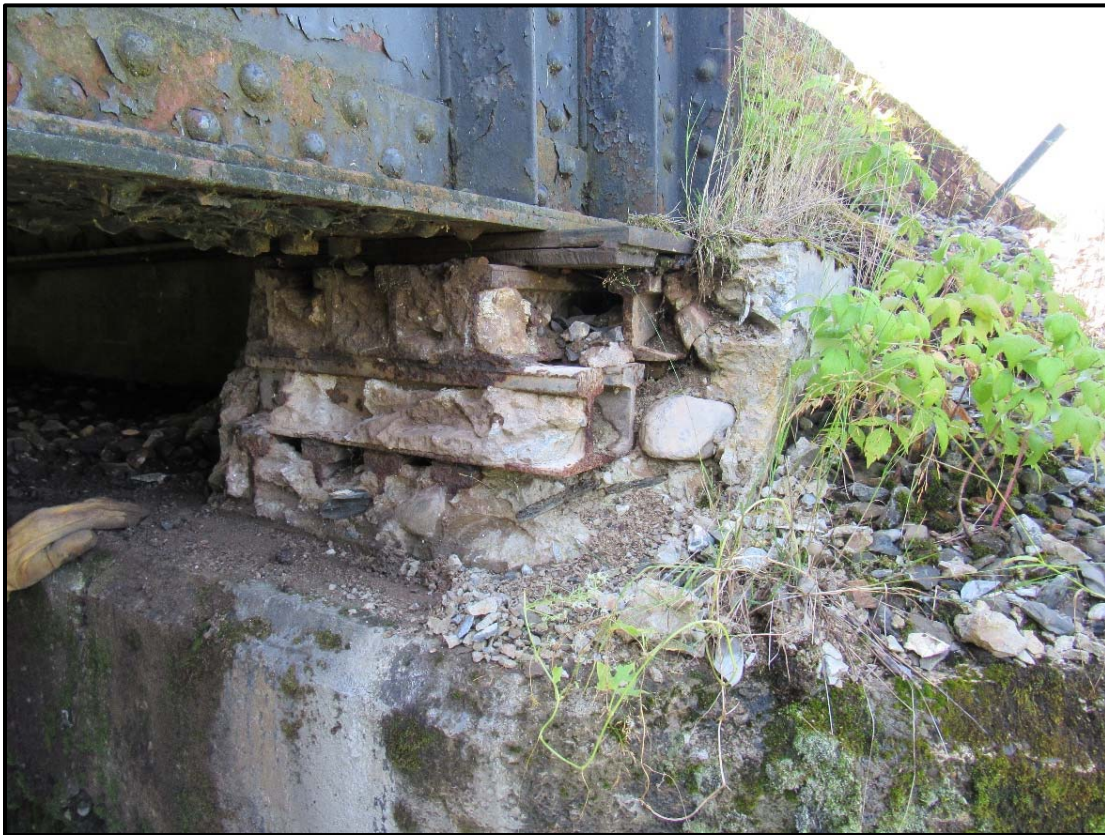
Deteriorated Concrete Around Grillage at Southwest Bearing

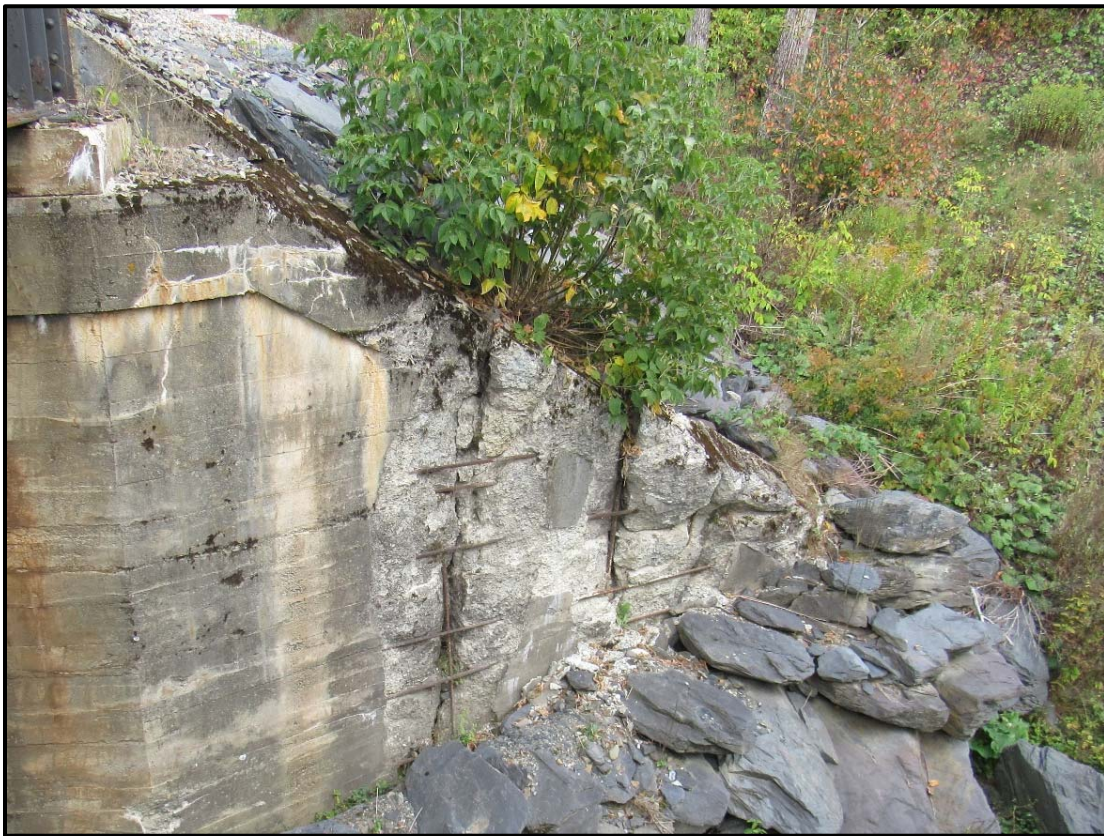
Heavy Deterioration and Cracking at the Northeast Wingwall

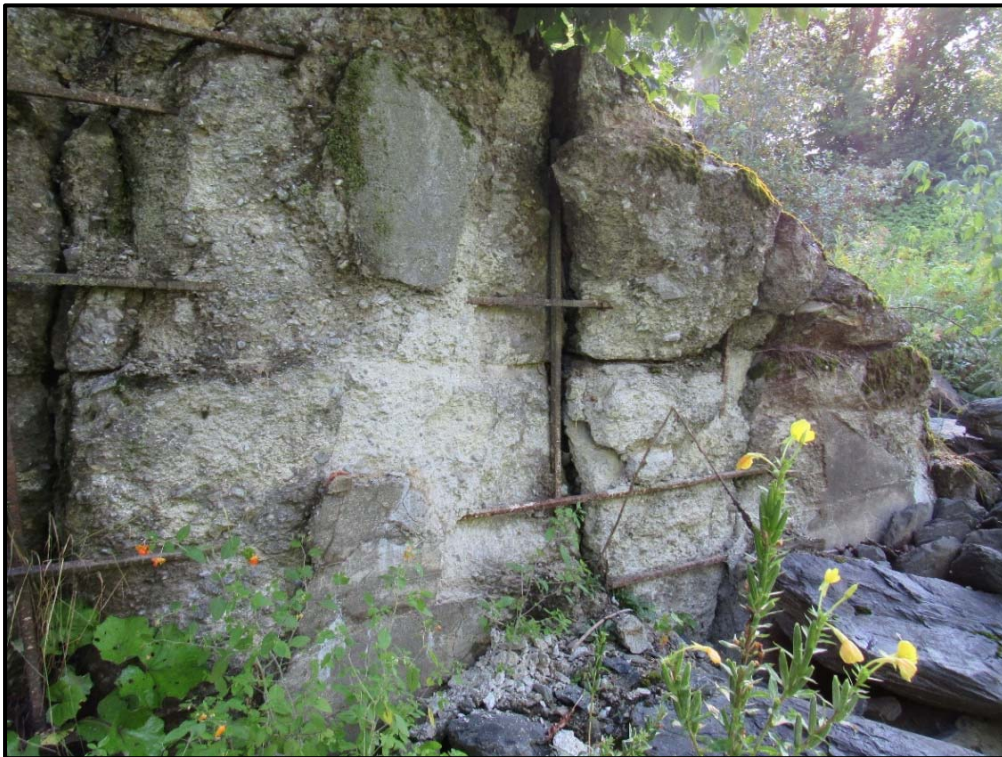
Heavy Deterioration and Cracks at the Northeast Wingwall

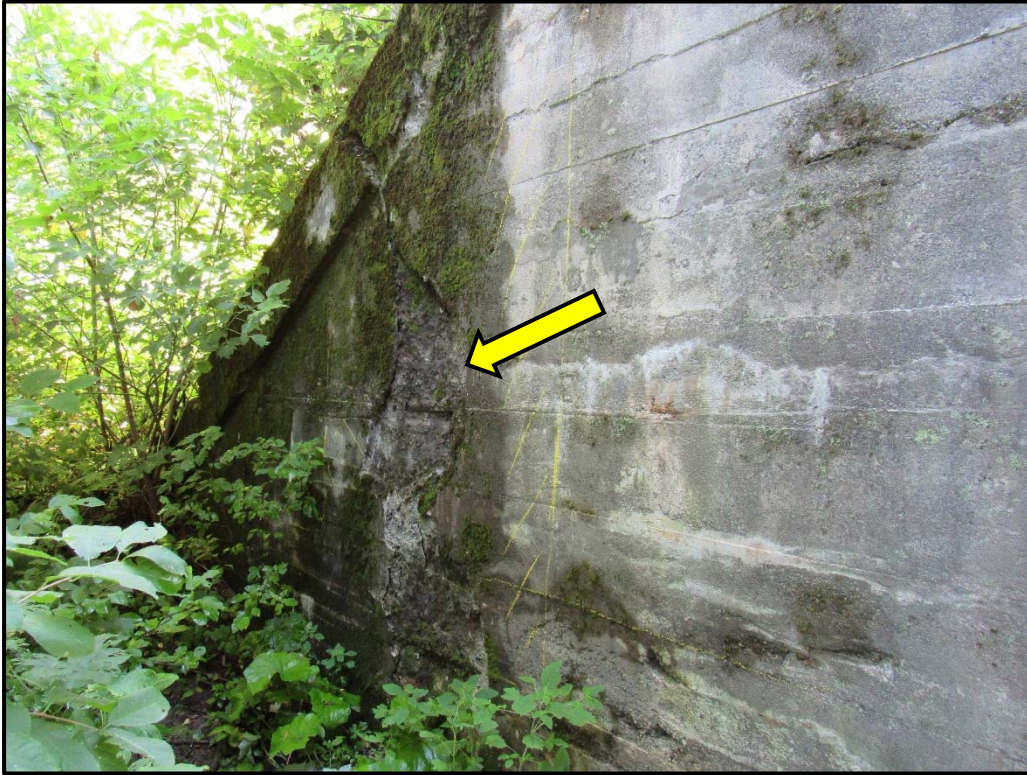
Spalled, Deteriorated, and Cracked Area at the Northwest Wingwall

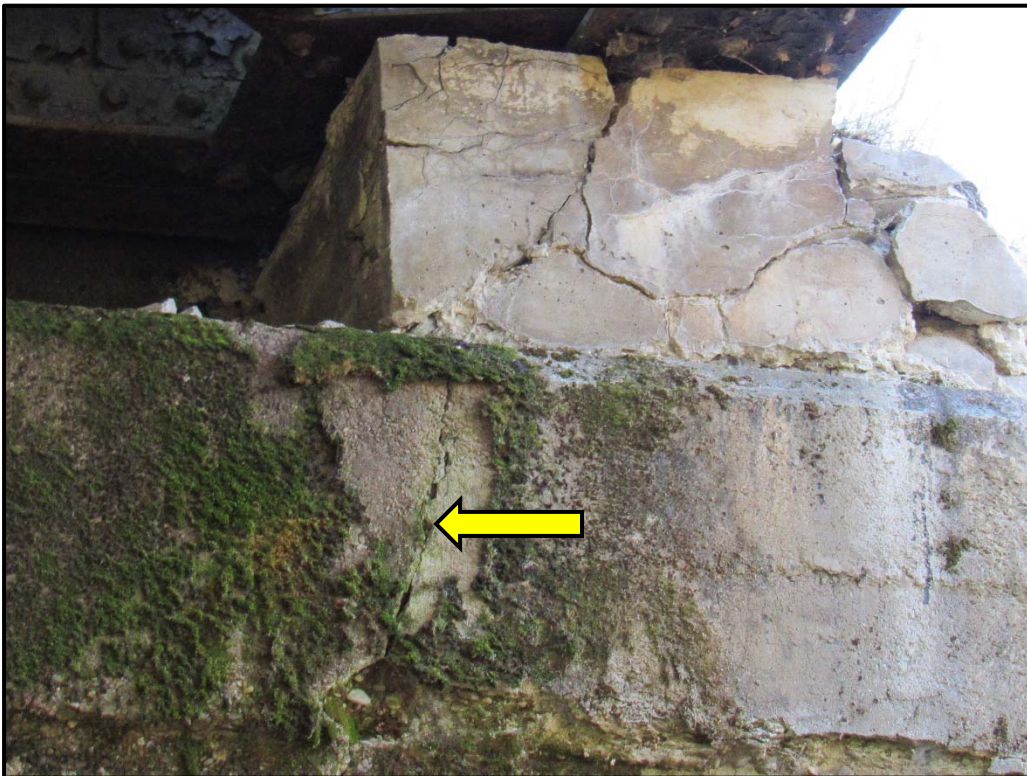
Cracking in Bridge Seat Directly Under Southwest Bearing

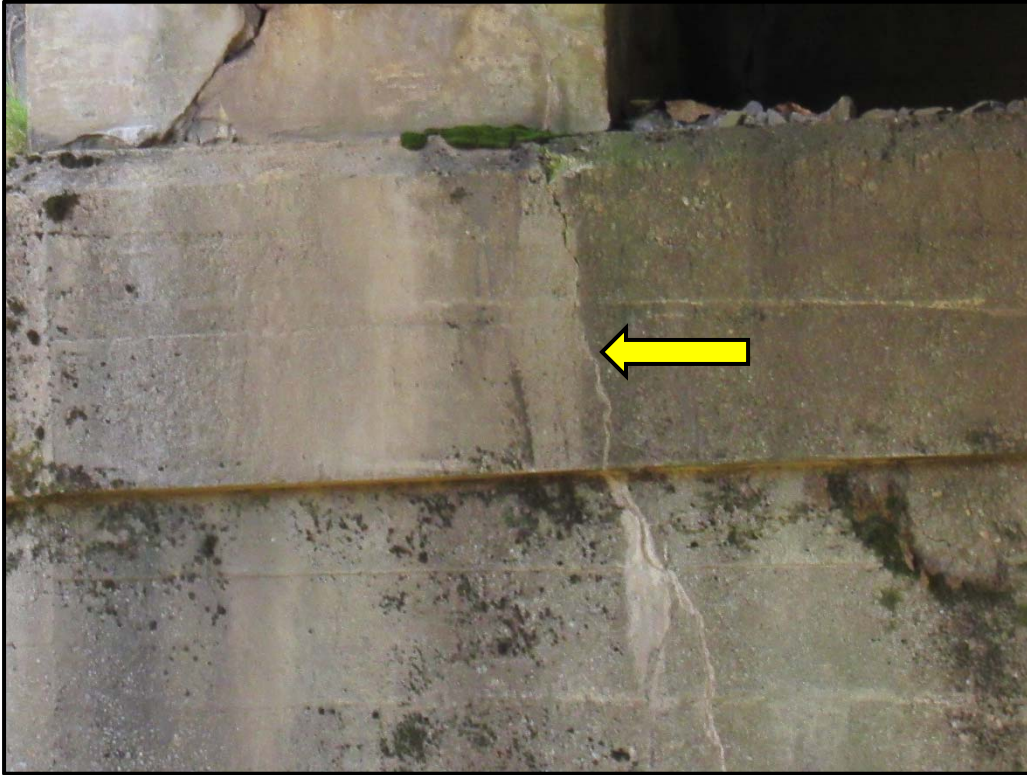
Cracking in Bridge Seat Directly Under Northwest Bearing
