Preliminary Design Report

Bridge 7800 (MP P10.07)

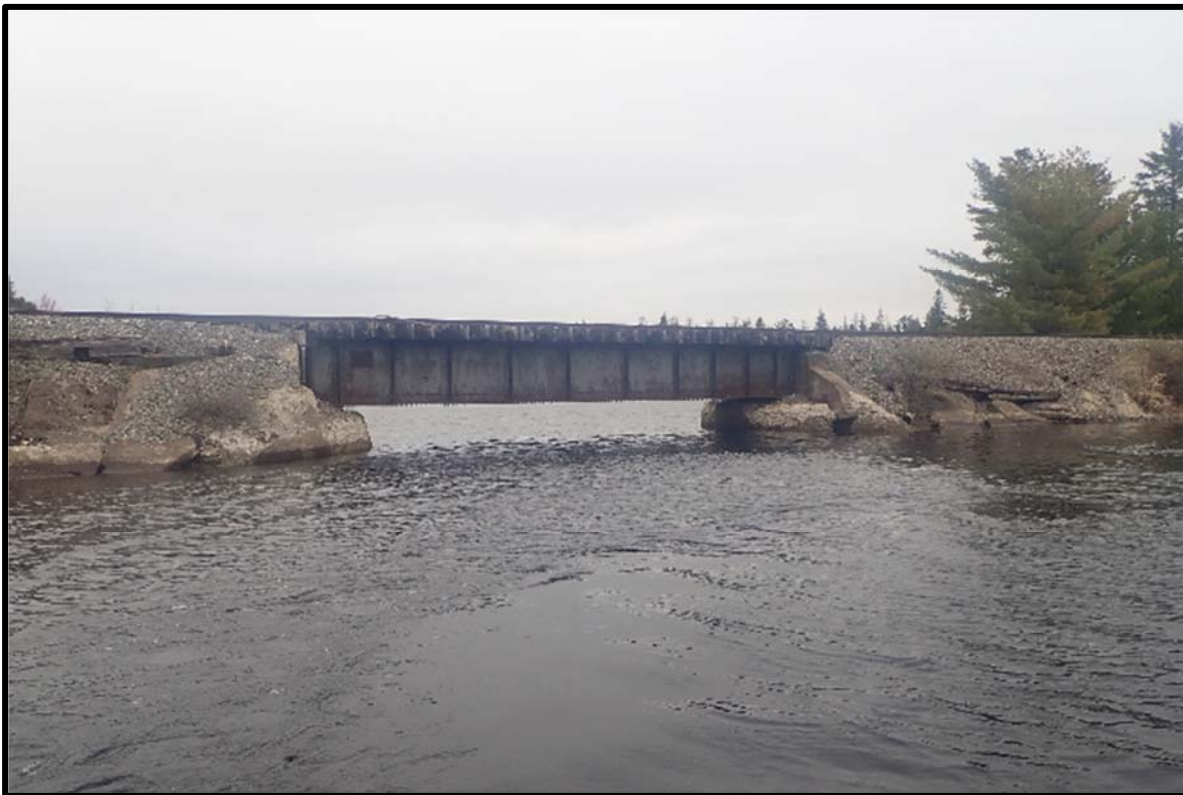
Elevation View of Bridge Looking North

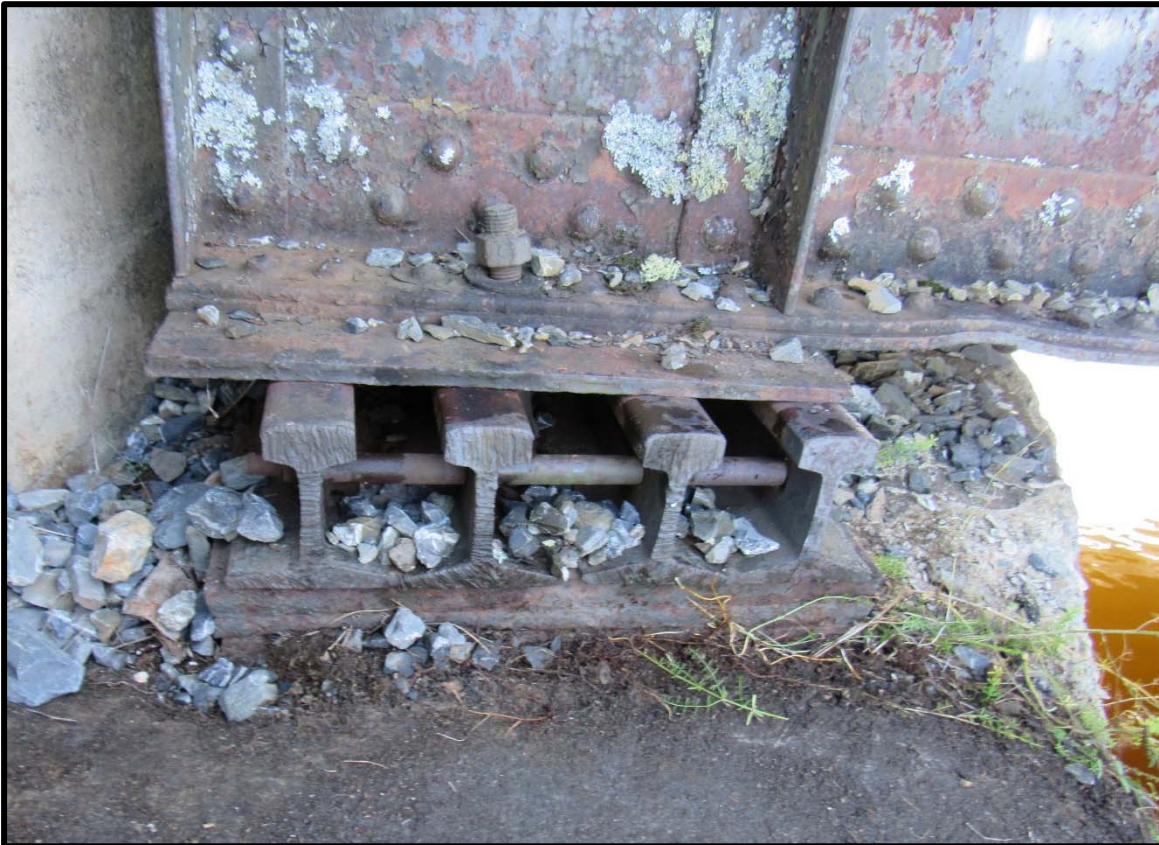
Girder Shifted Three Inches Laterally at the Northeast Bearing Due to Failed Anchor Bolts

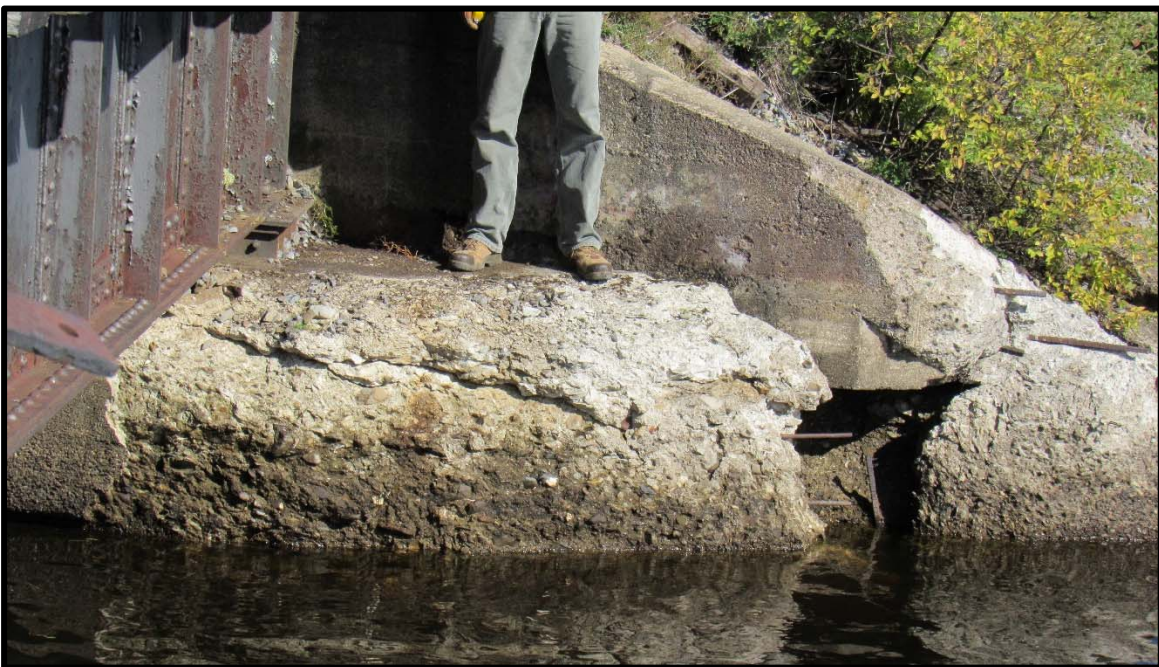
Heavy Deterioration and Large Hole at Southeast Corner of Bridge Seat and Wingwall

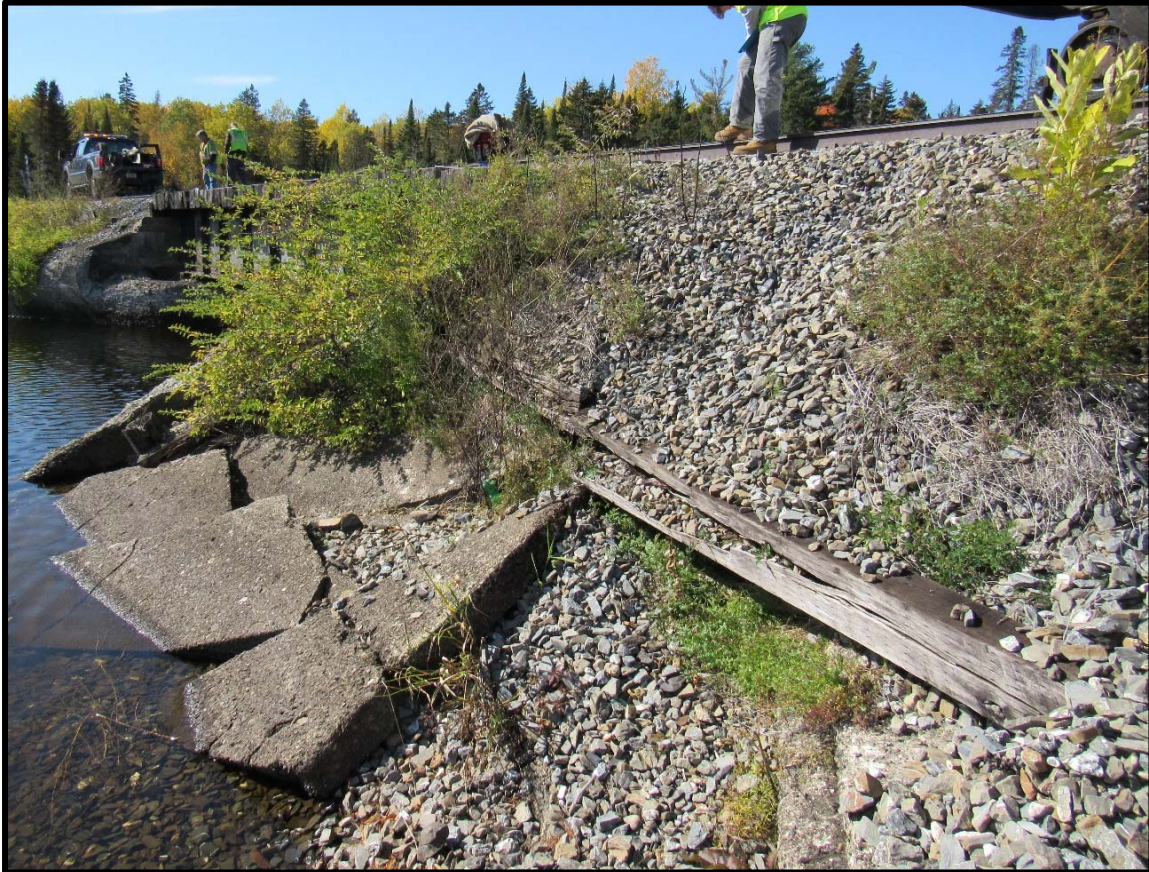
Failed Slope Protection Behind Southeast Wingwall

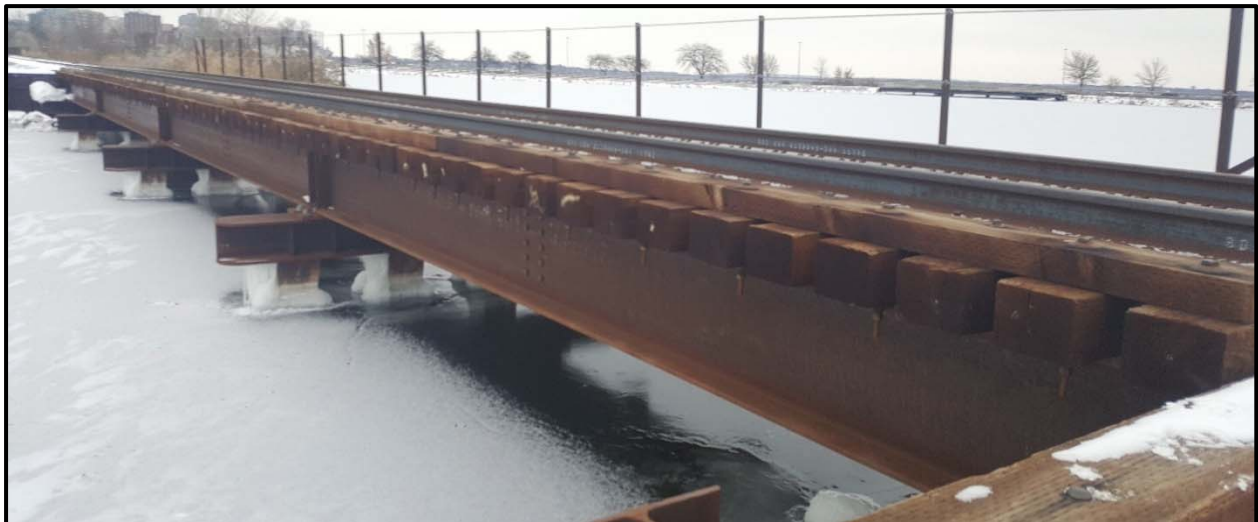
2017 Construction: Steel Girders on Steel Pile Bents on Wisconsin Southern Railroad (WSOR)- Madison WI

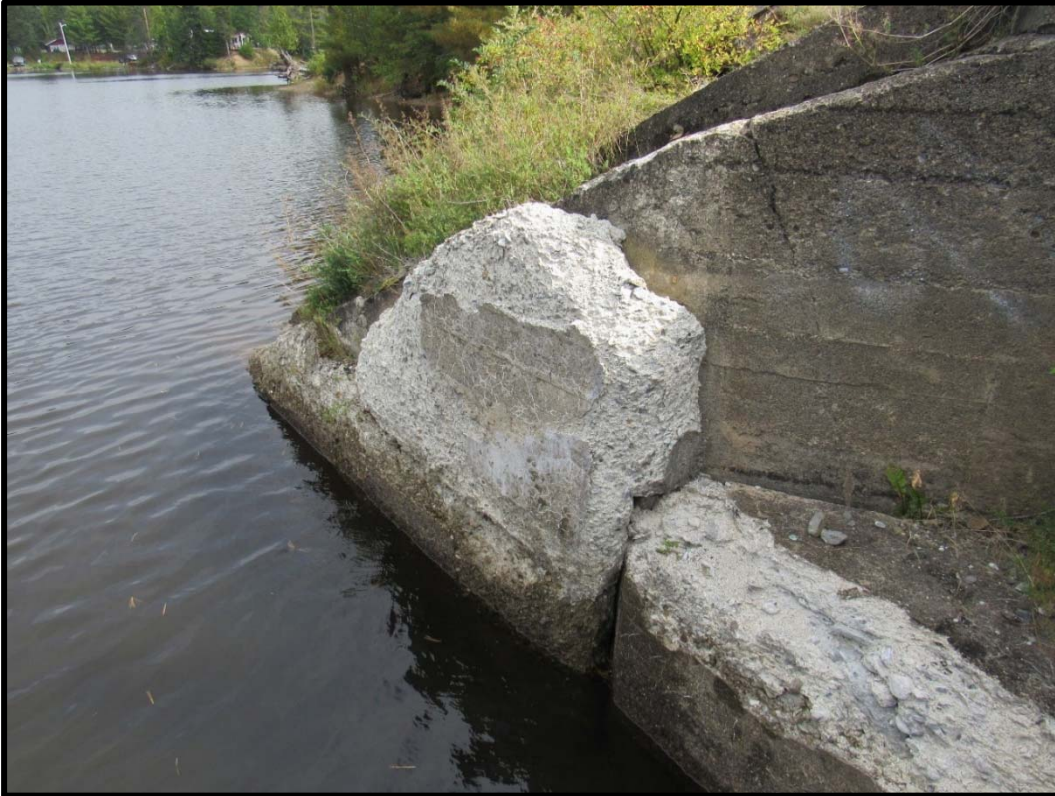
Heavy Deterioration and Cracking at Northeast Corner of Bridge Seat and Wingwall

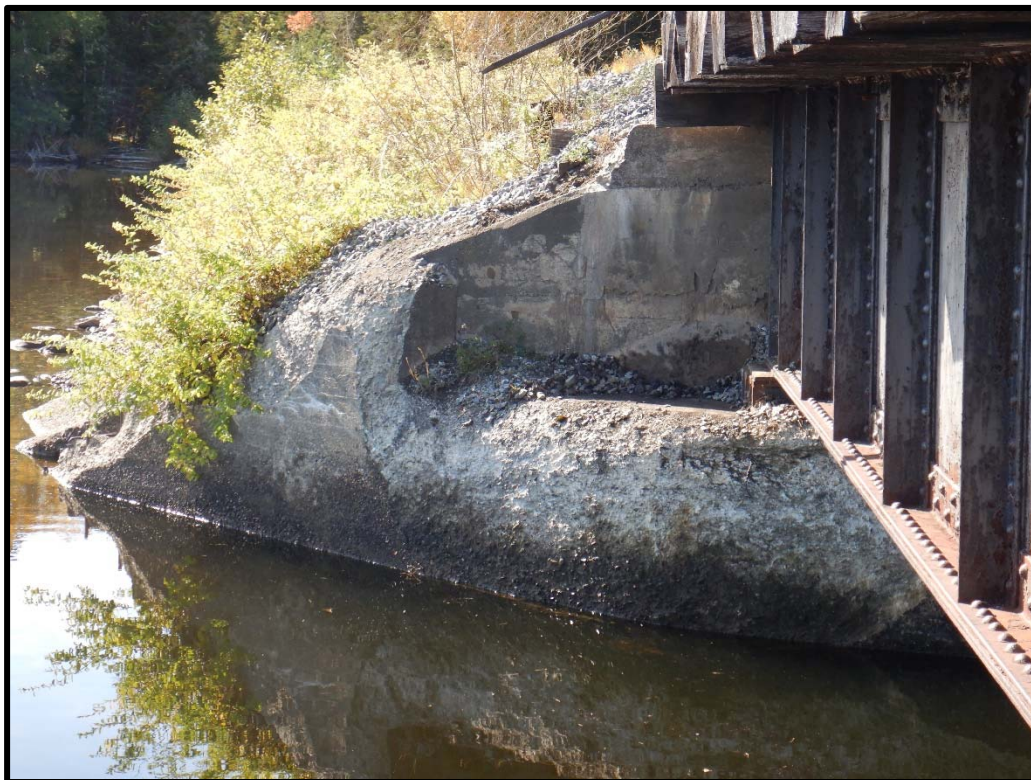
Heavy Deterioration on the Southwest Corner of Bridge Seat and Wingwall

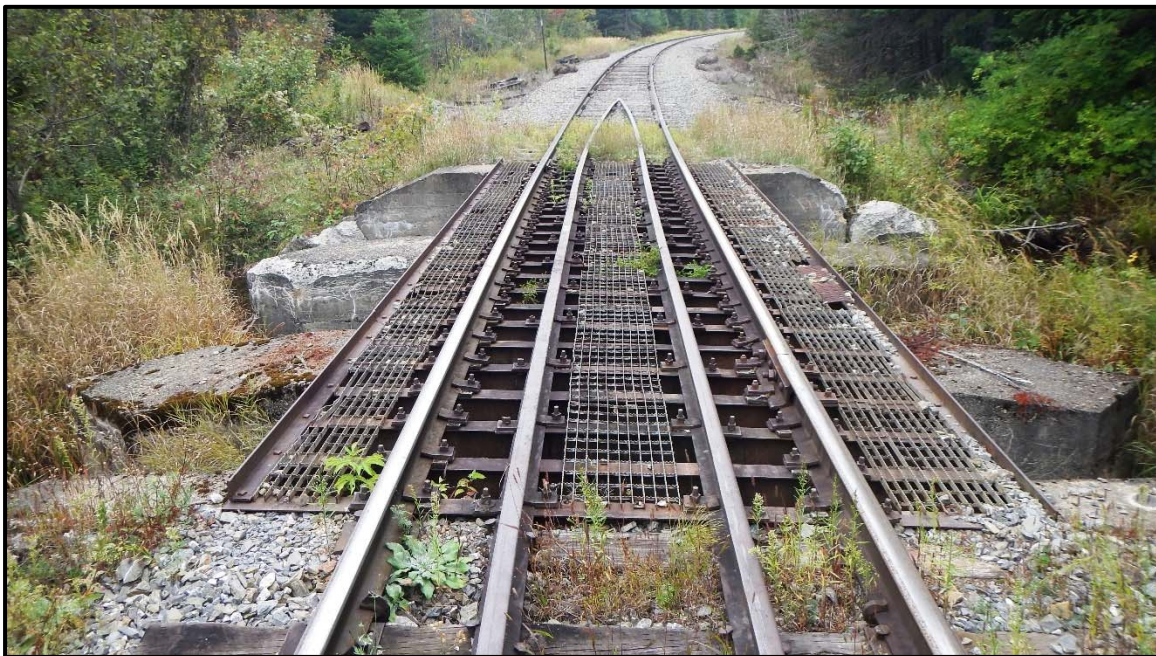
View on Centerline of Bridge Looking Northeast

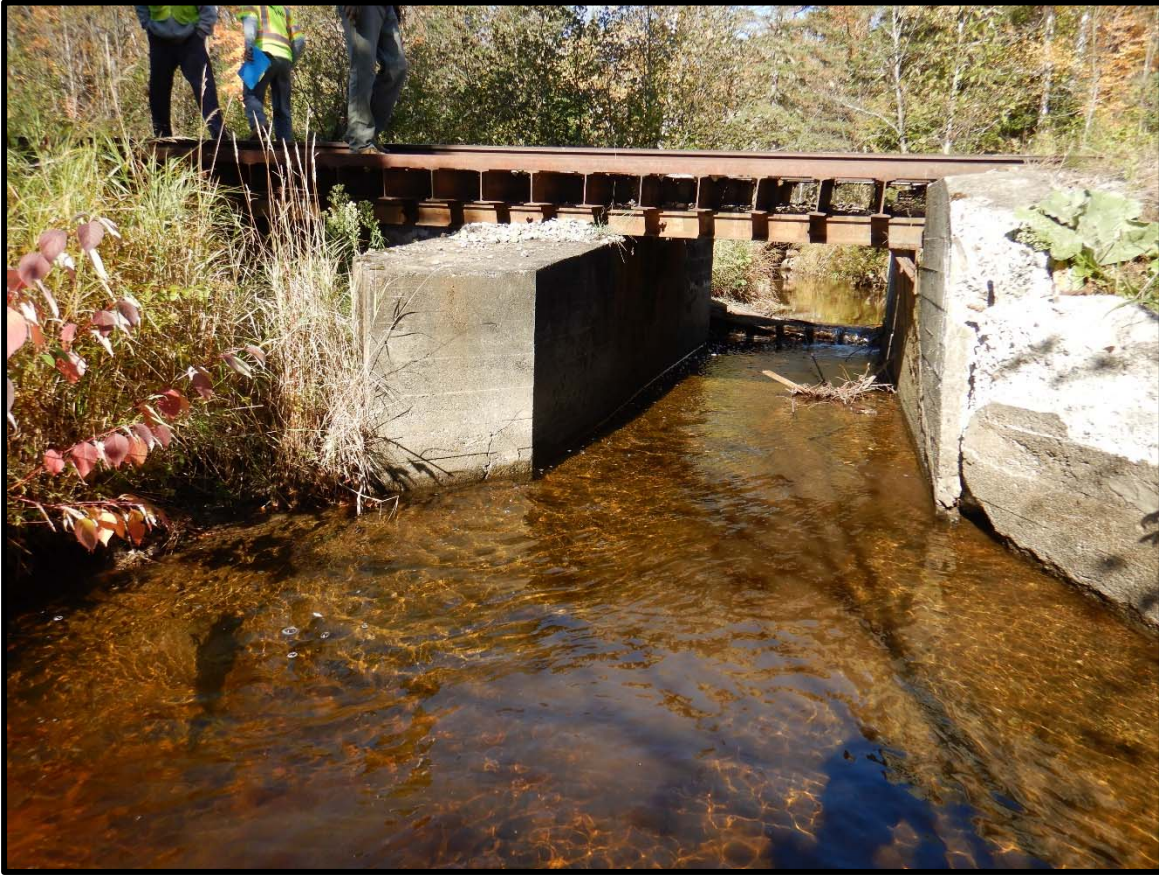
View of Northeast Wingwall, North Abutment and Pier Looking West

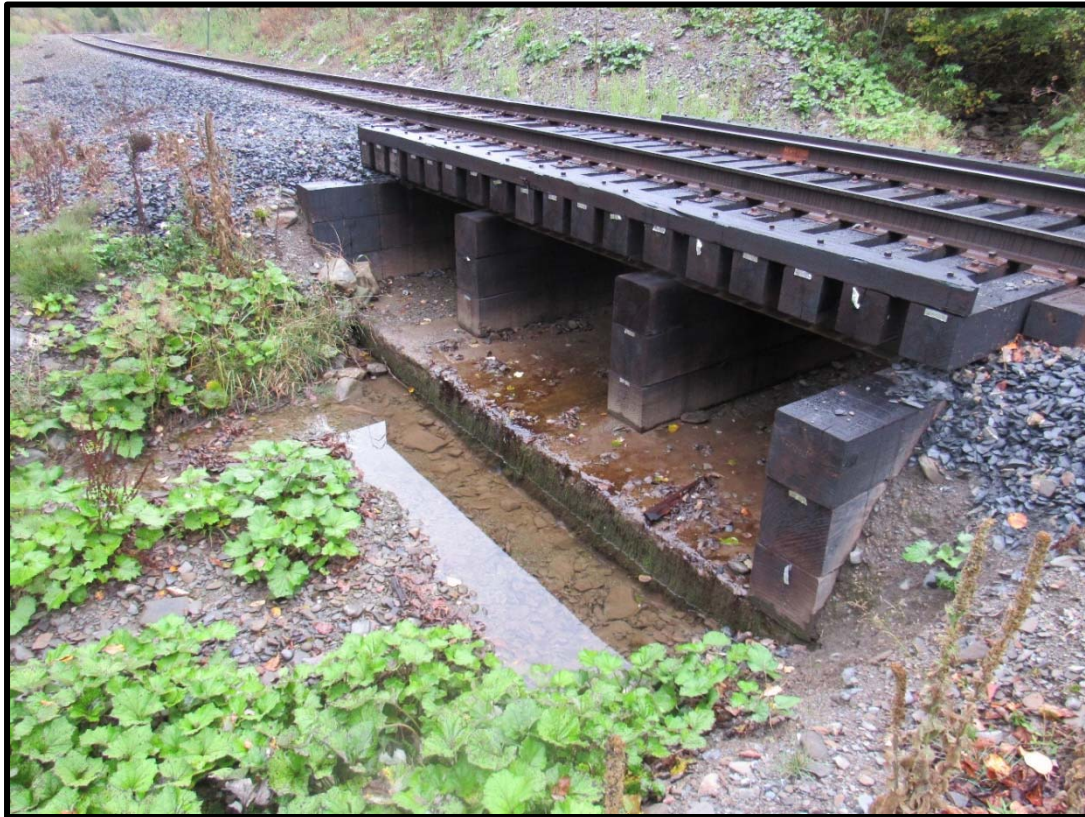
2014 Replacement "Rail-top" Superstructure on Madawaska Subdivision (Br. 7791 MP251.75)

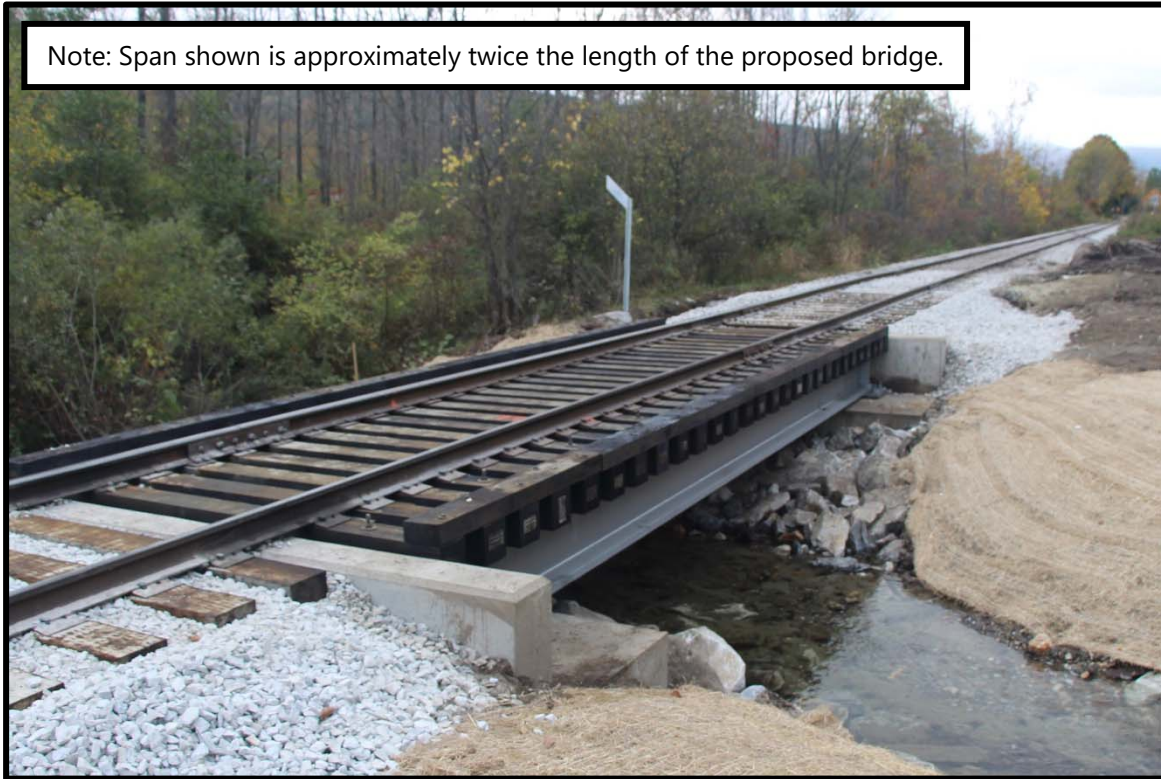
2014 Replacement Steel Girder on Precast Concrete Substructure on Vermont Railway (VTR) – Dorset, VT

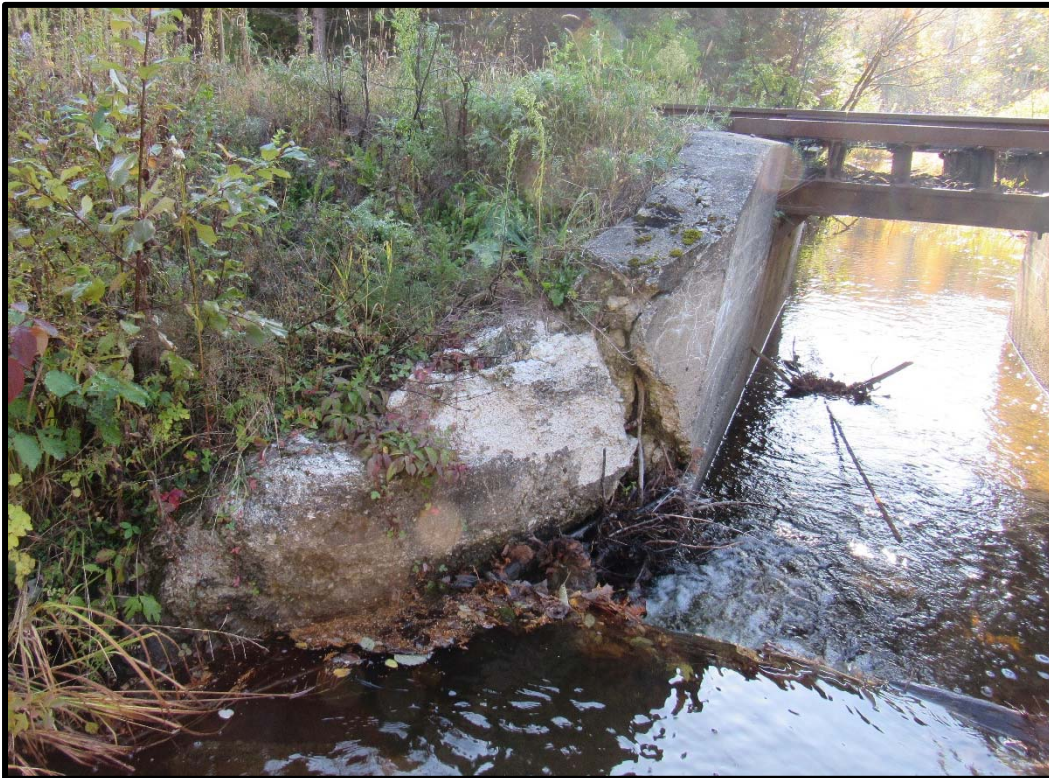
Northwest Wingwall Heavily Deteriorated and Cracked, North Abutment Tipping Forward

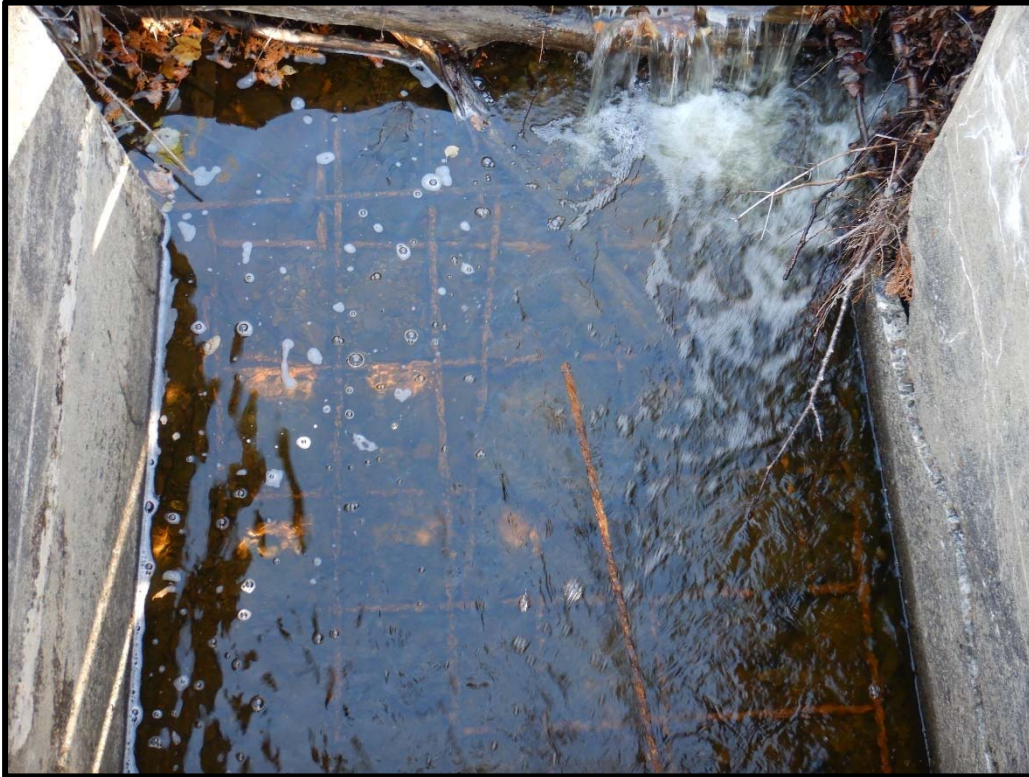
Invert Slab of North Span Completely Deteriorated

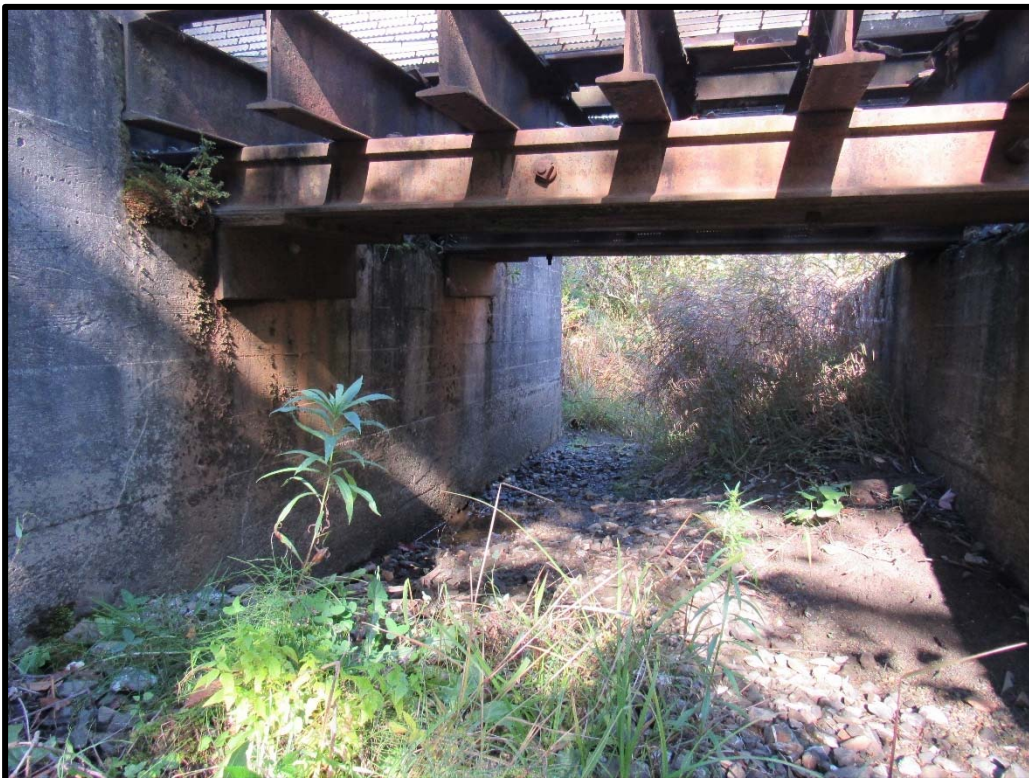
South Span Heavily Silted, Filled With Debris and Dry

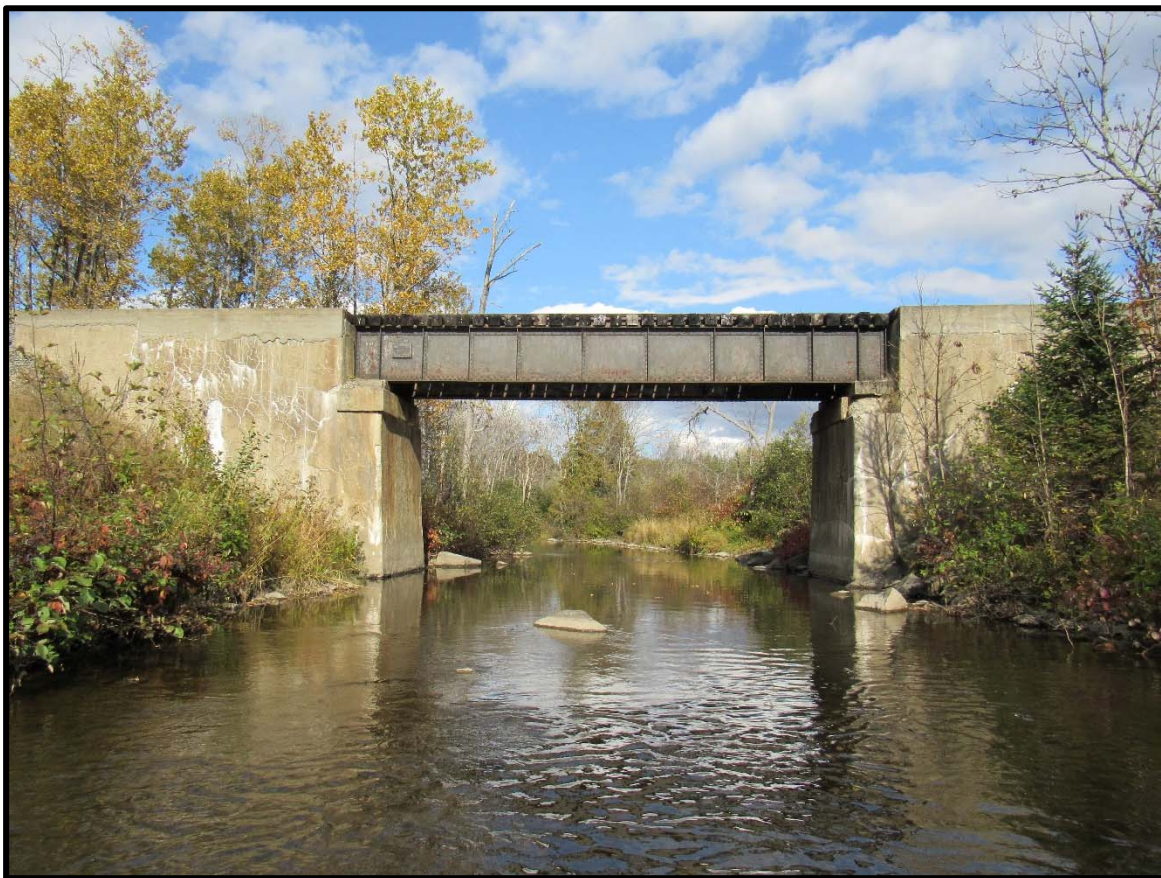
Elevation View of Bridge Looking East

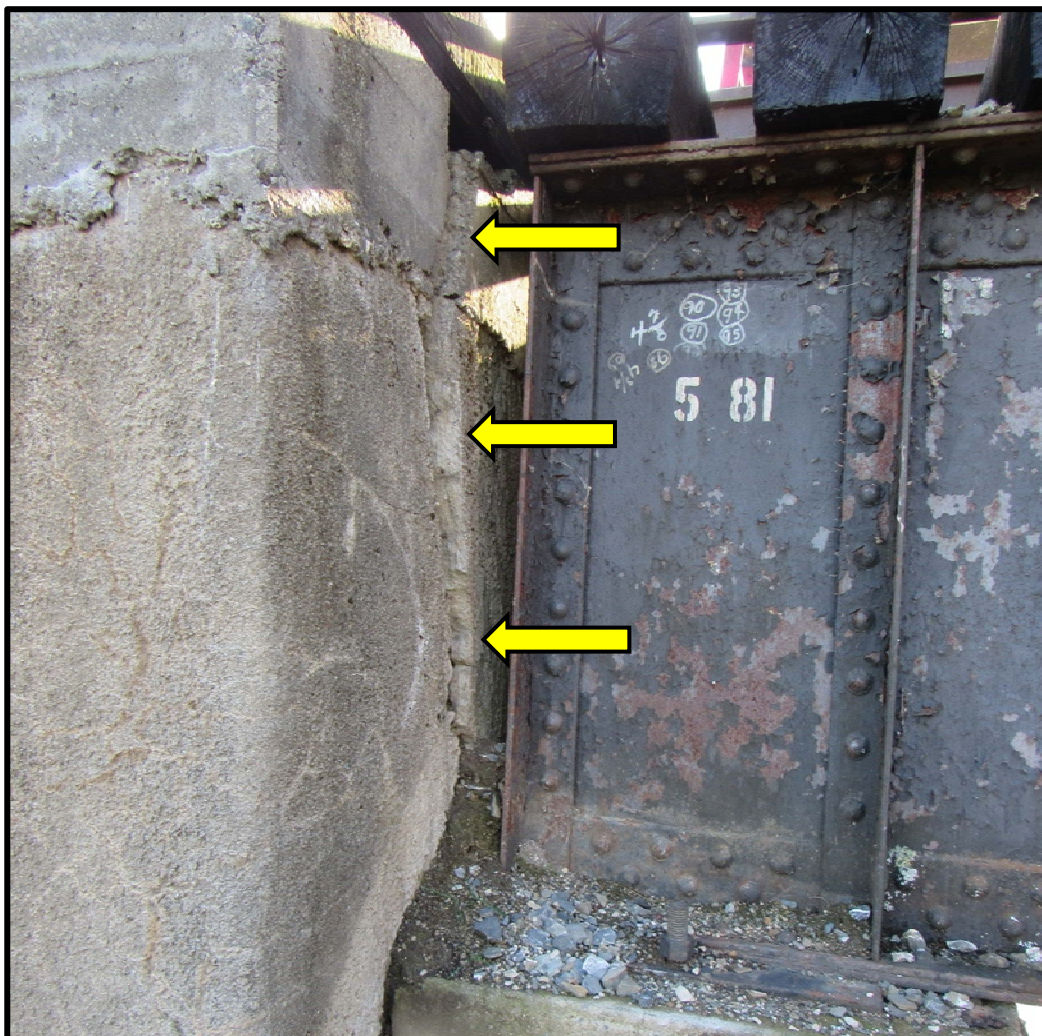
Full-Height Crack with Ballast Spilling Thru and Backwall Tipping Forward on the East Abutment

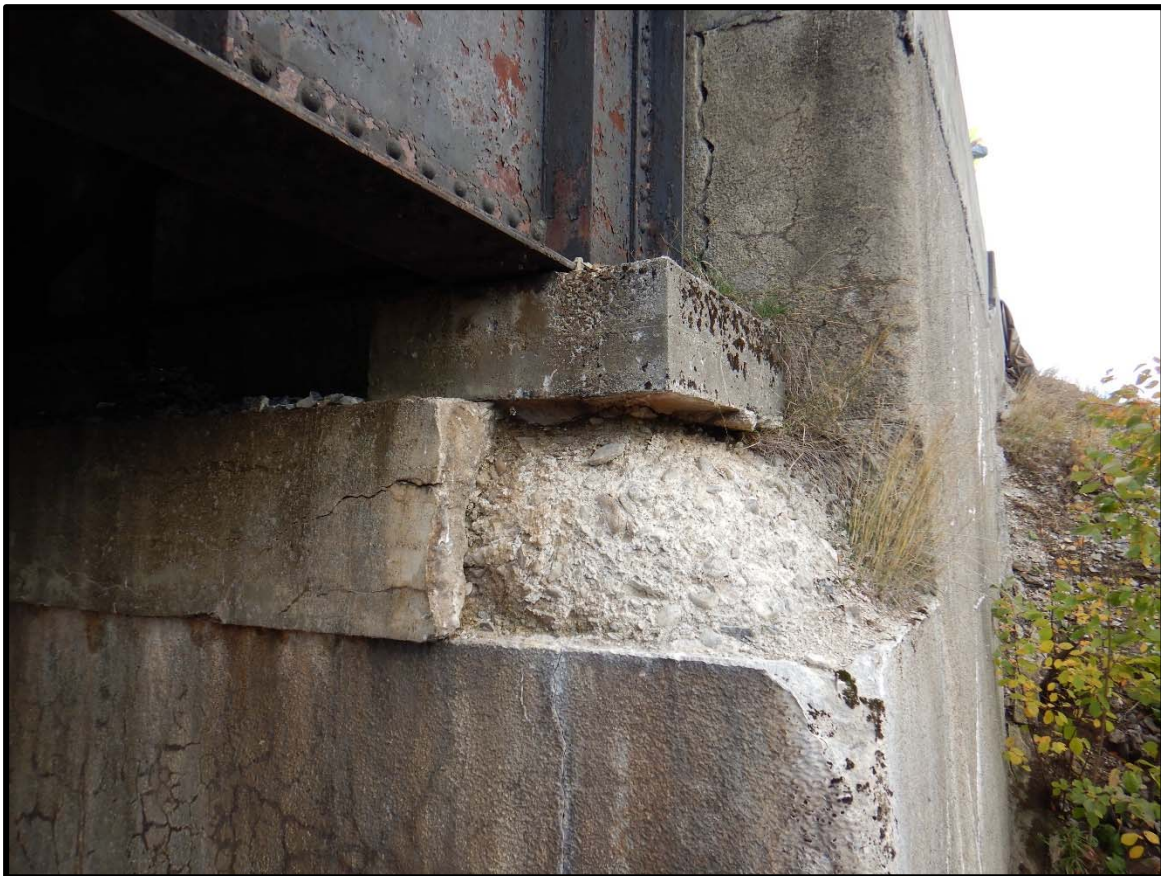
Coping Along Face of Bridge Seat Heavily Deteriorated at East Isle Abutment

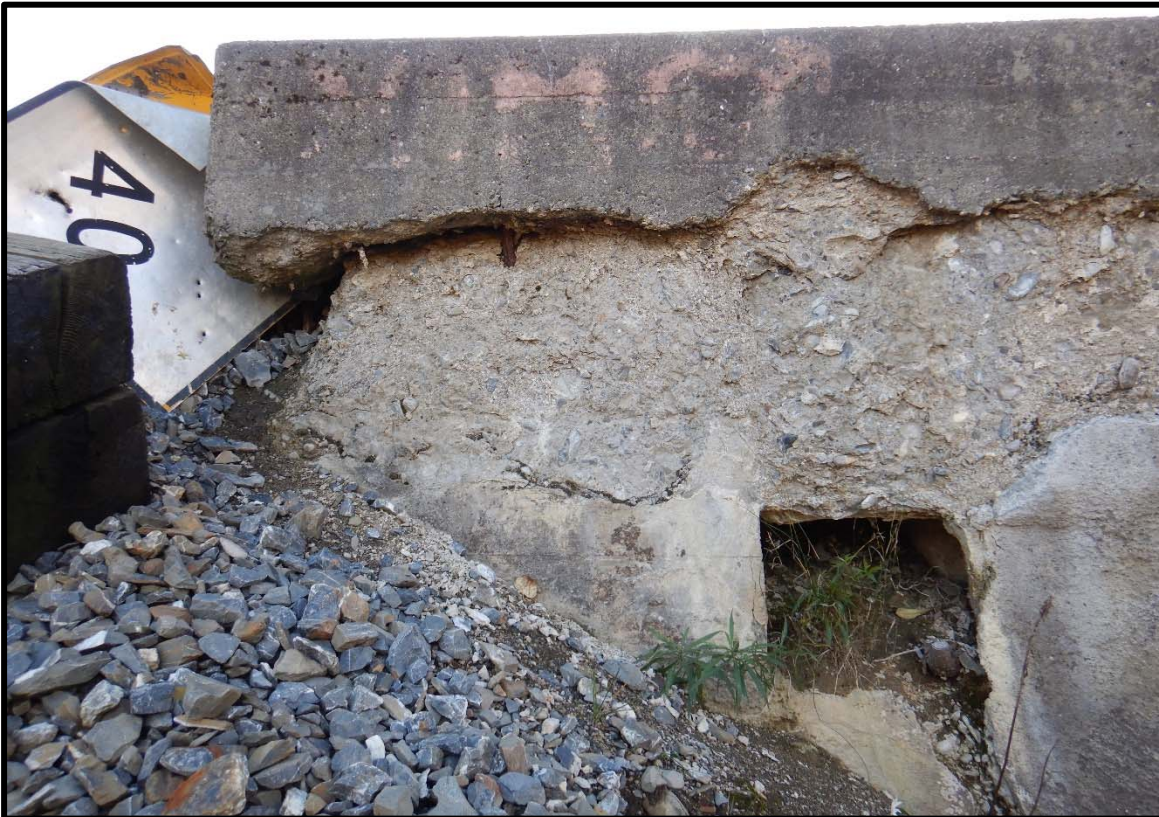
Deteriorated Concrete and Hole in the Northeast Wingwall

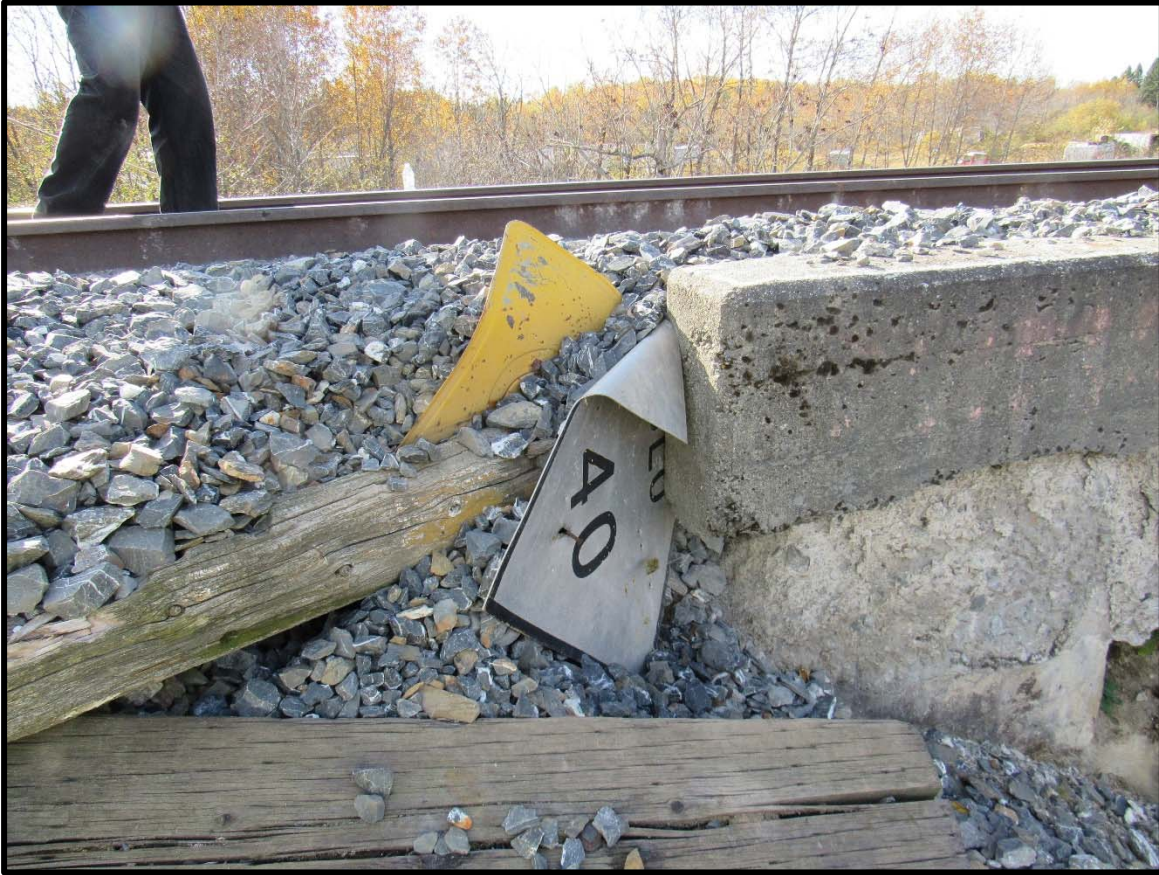
Failed Ballast Retainer behind the East Abutment

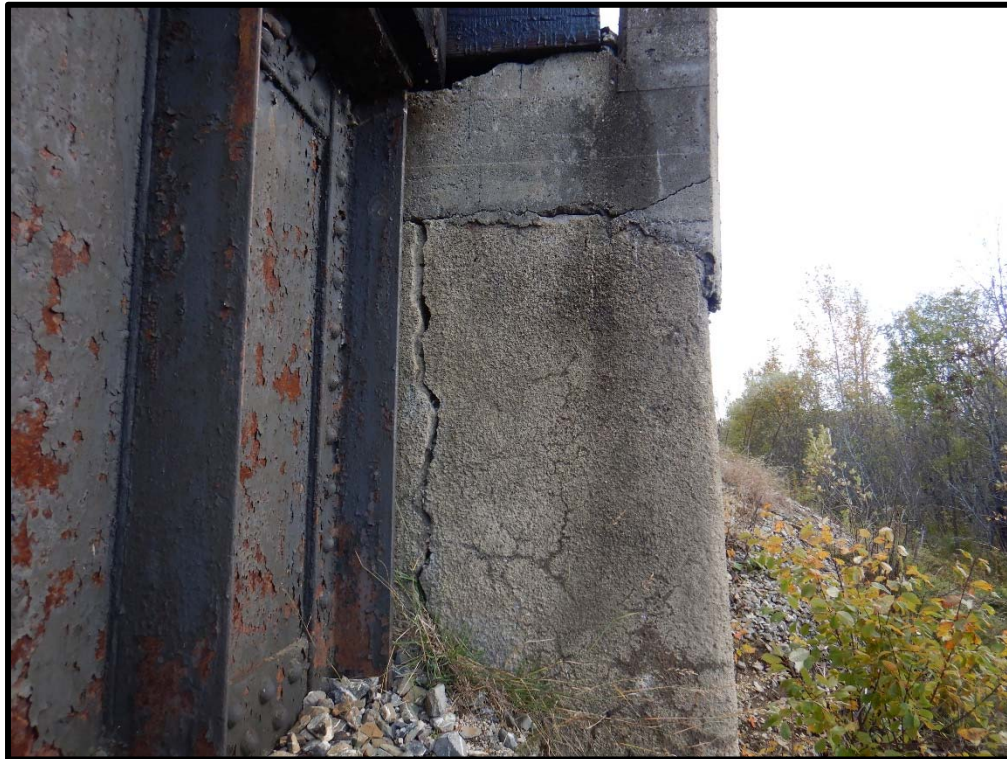
Half Inch Full-Height Crack in Backwall of East Abutment

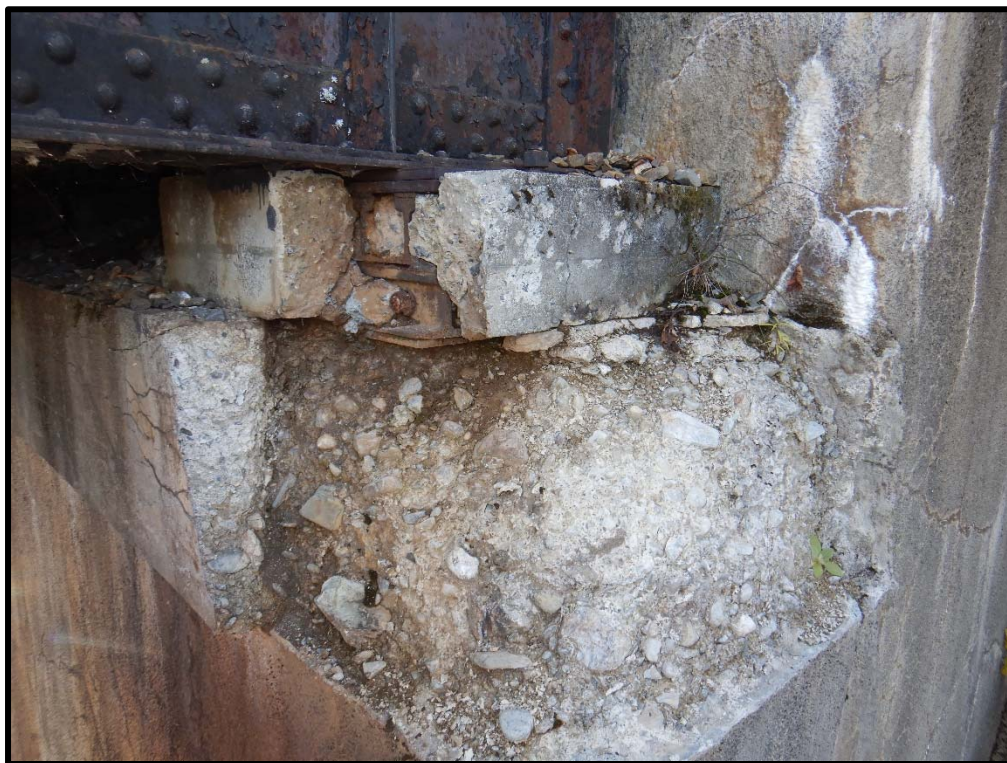
Coping Along Face of Bridge Seat Heavily Deteriorated at West Abutment

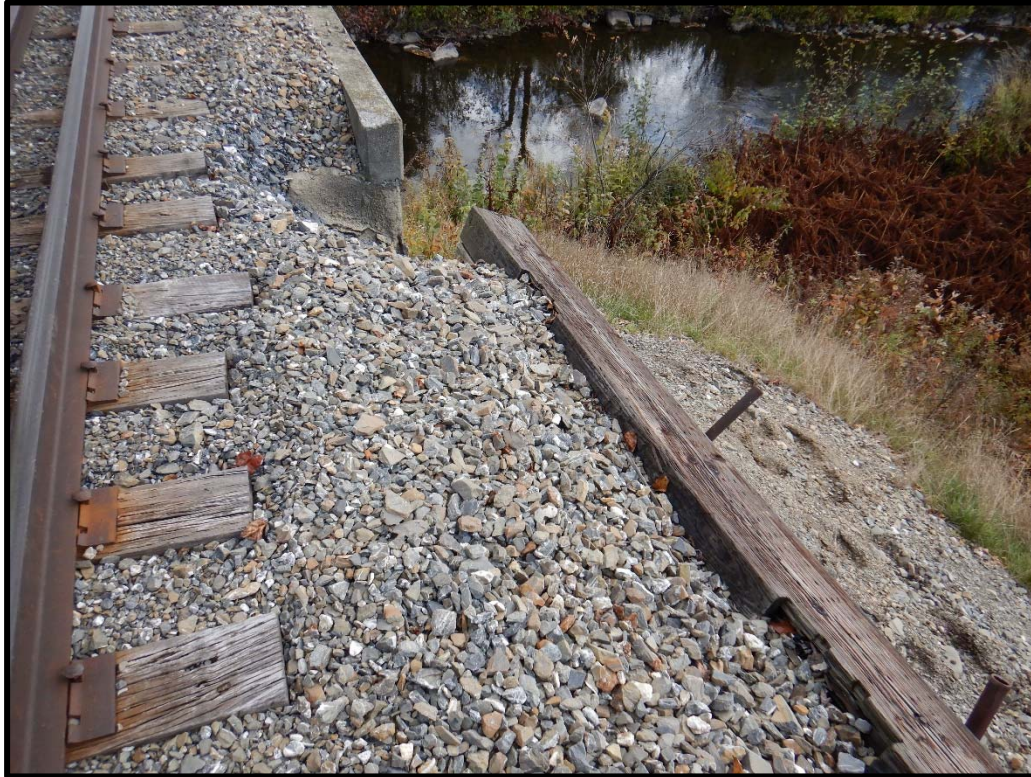
Failed Ballast Retainer Behind the West Abutment

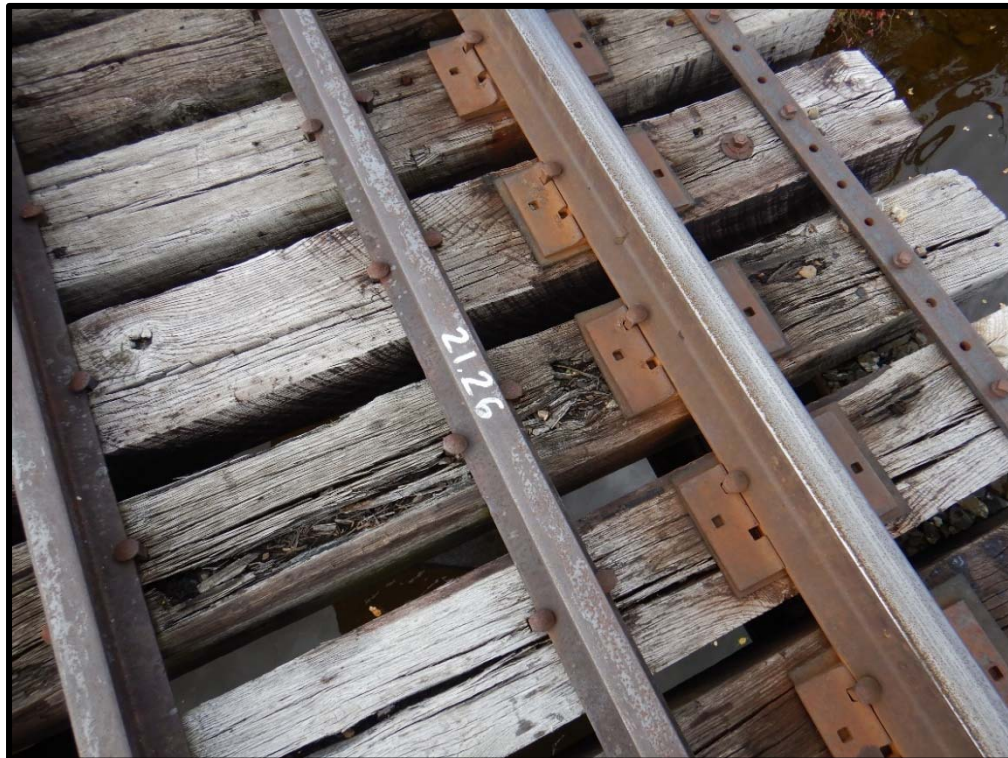
Bridge Timbers in Poor Condition

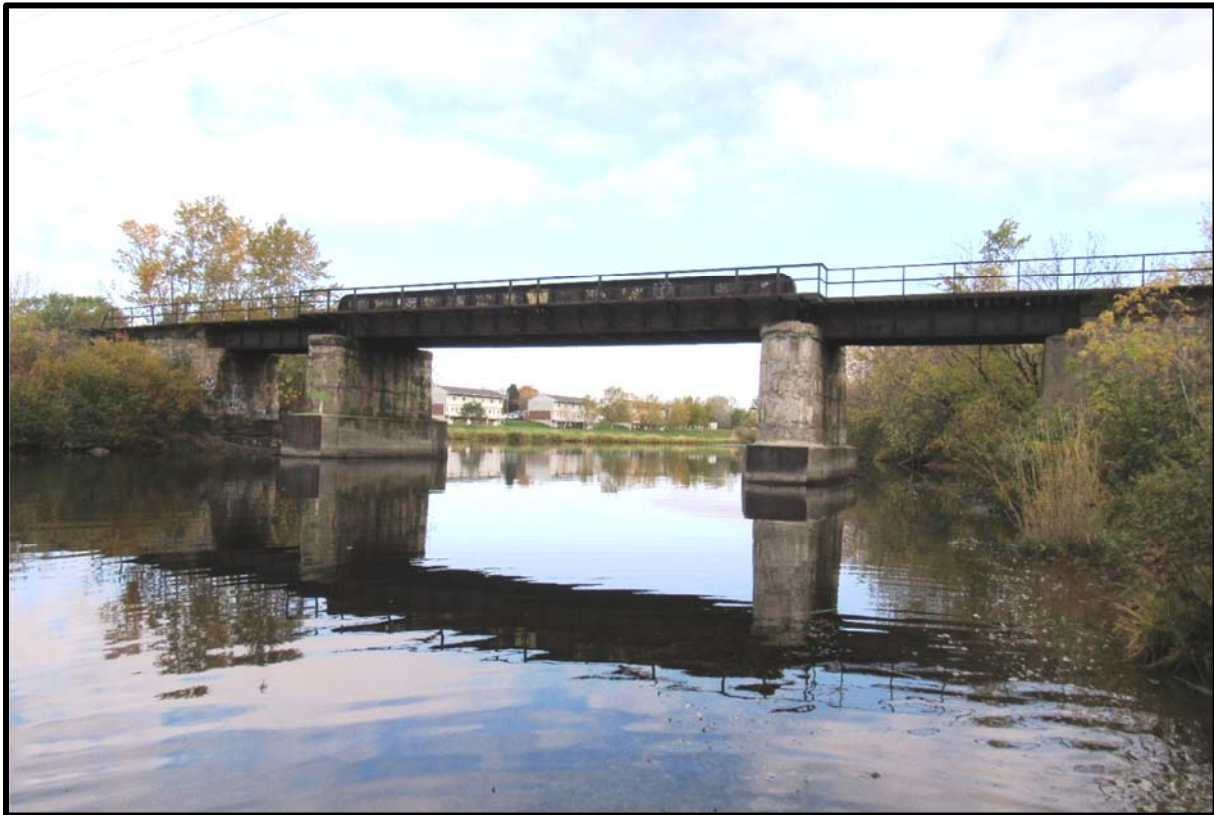
Elevation View of South Fascia of Bridge

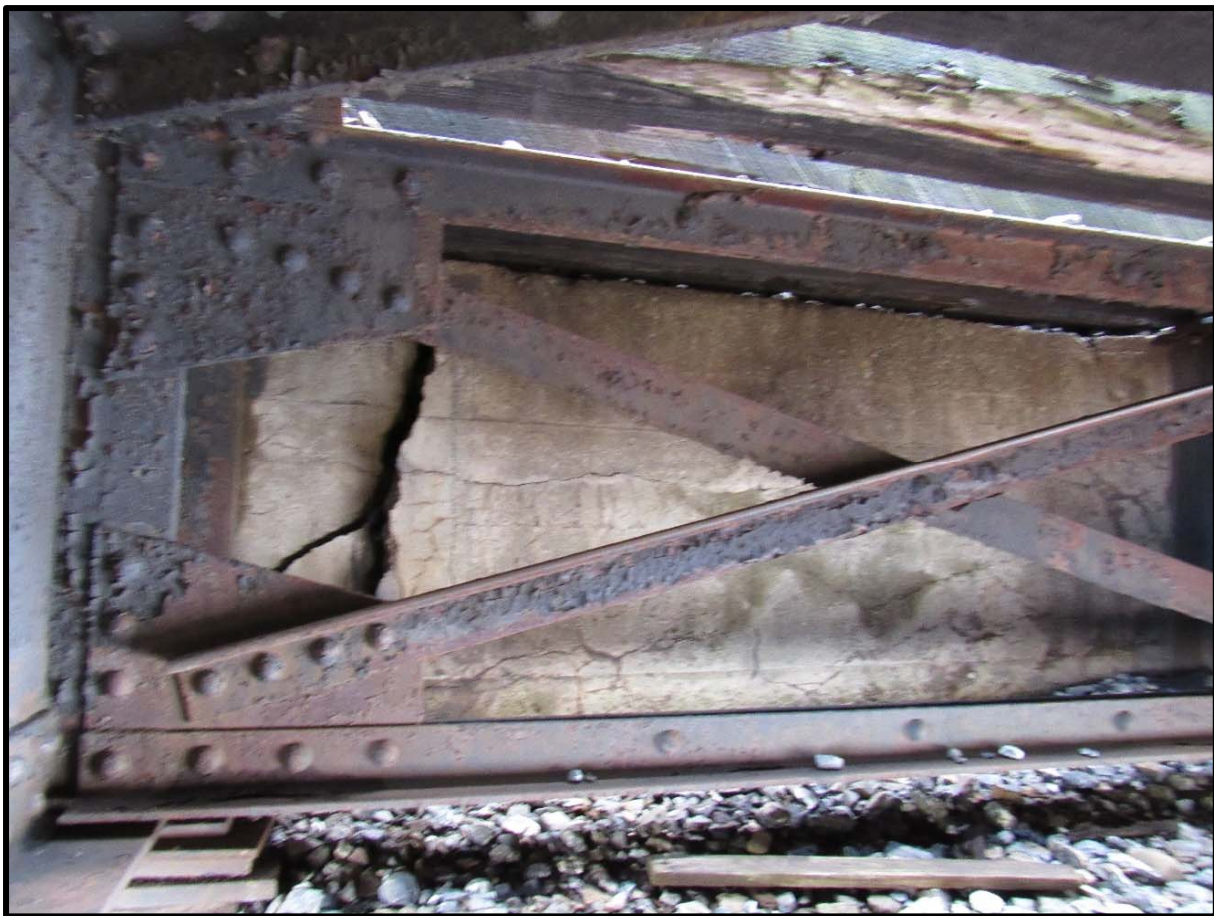
Full-Height Crack and Backwall Tipping Forward at East (Track North) Abutment
