Preliminary Design Report

Bridge 7800 (MP P10.07)

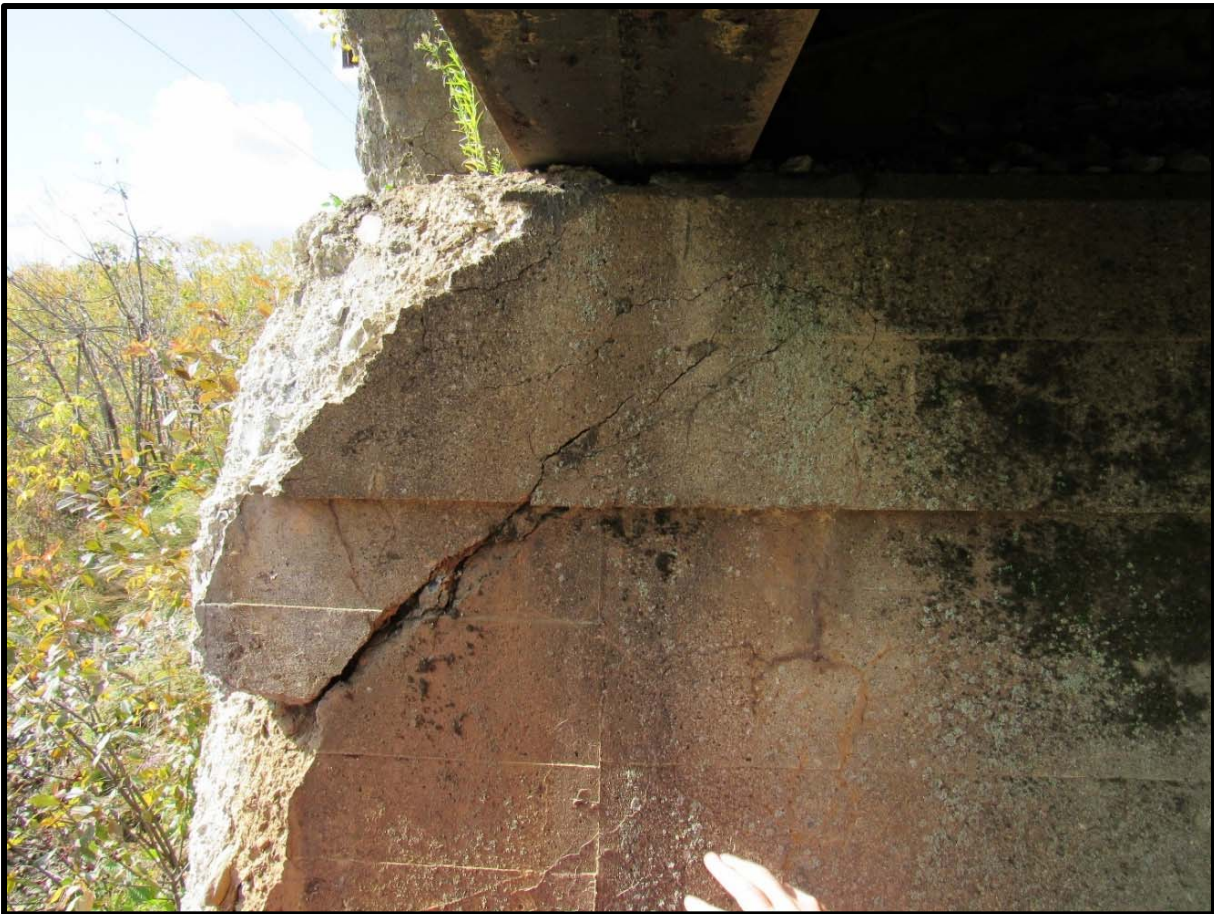
Shear Crack in Bridge Seat Under South Girder on West (Track South) Abutment

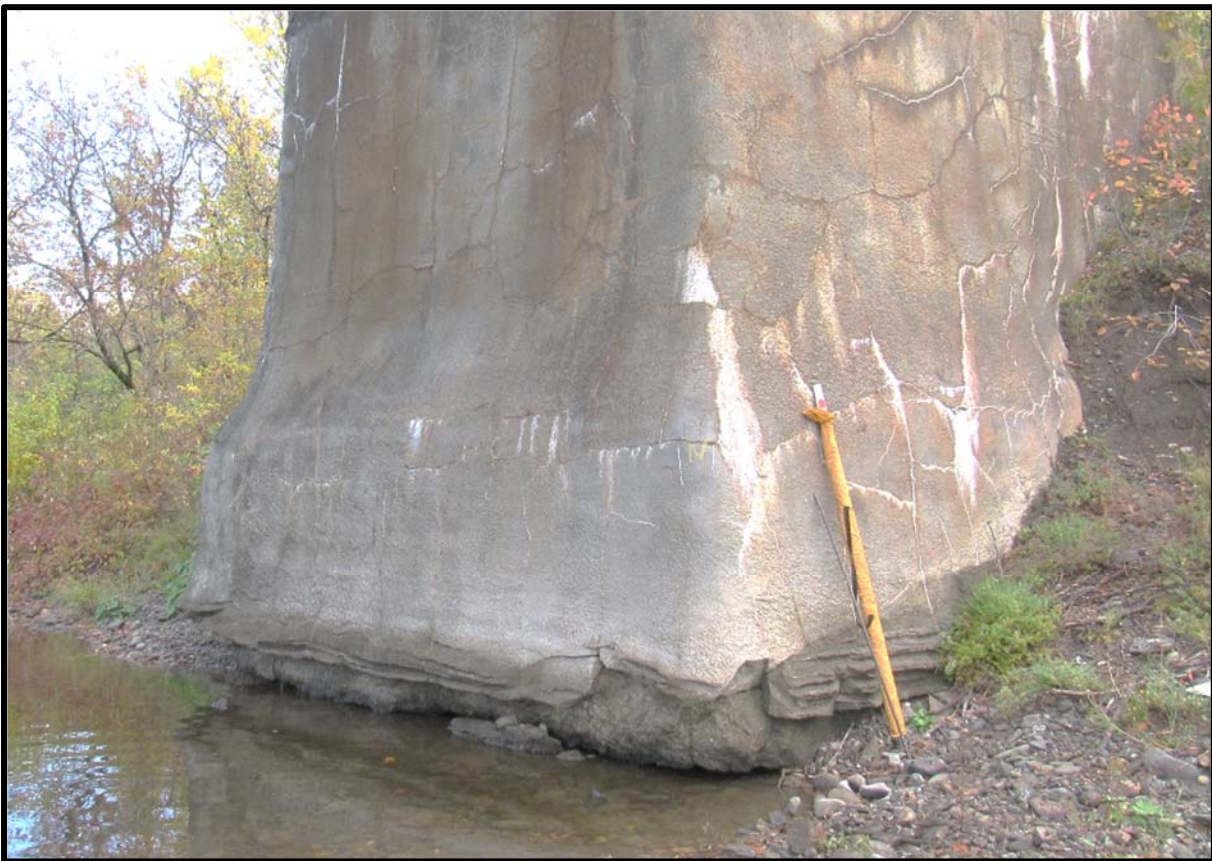
Abraded and Deteriorated Concrete Along the Base of the East (Track North) Abutment

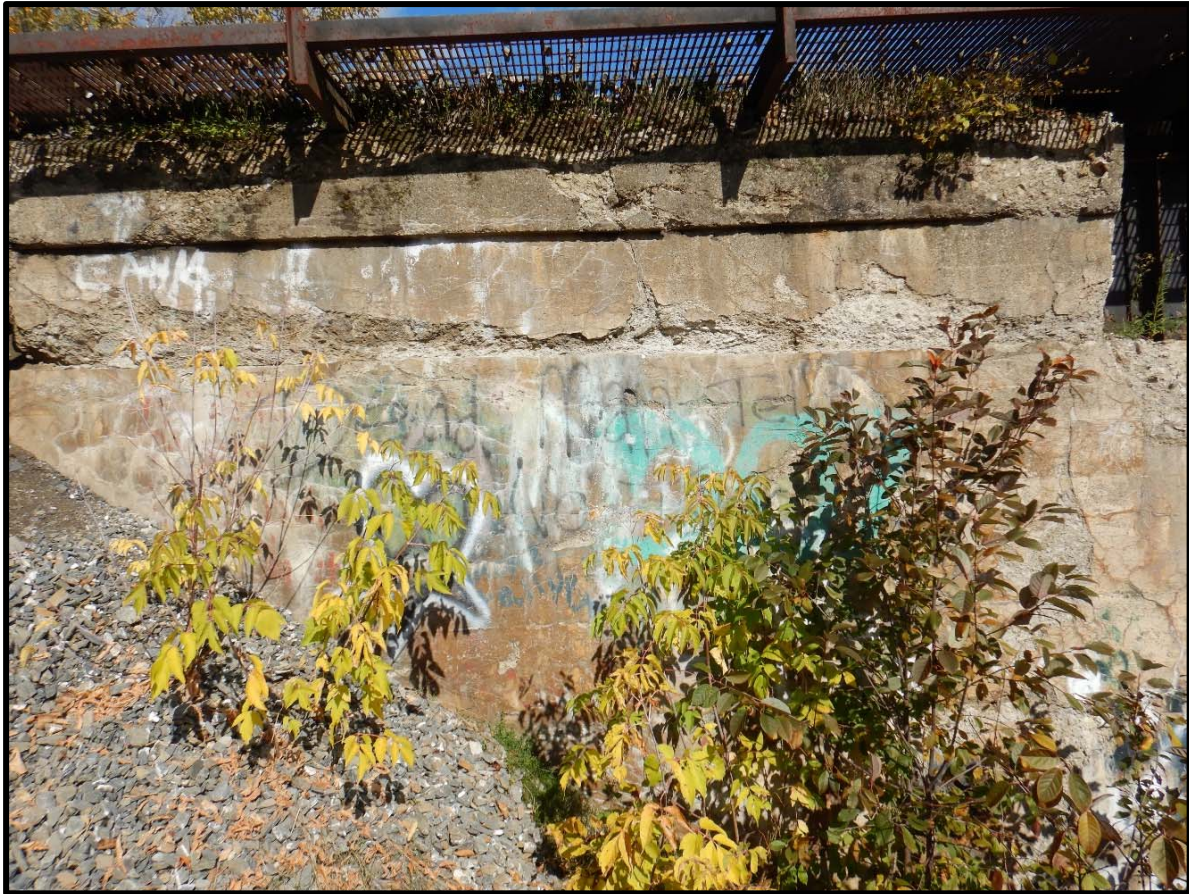
Deteriorated and Delaminated Concrete Along the Upper Portion of the Southwest Wingwall

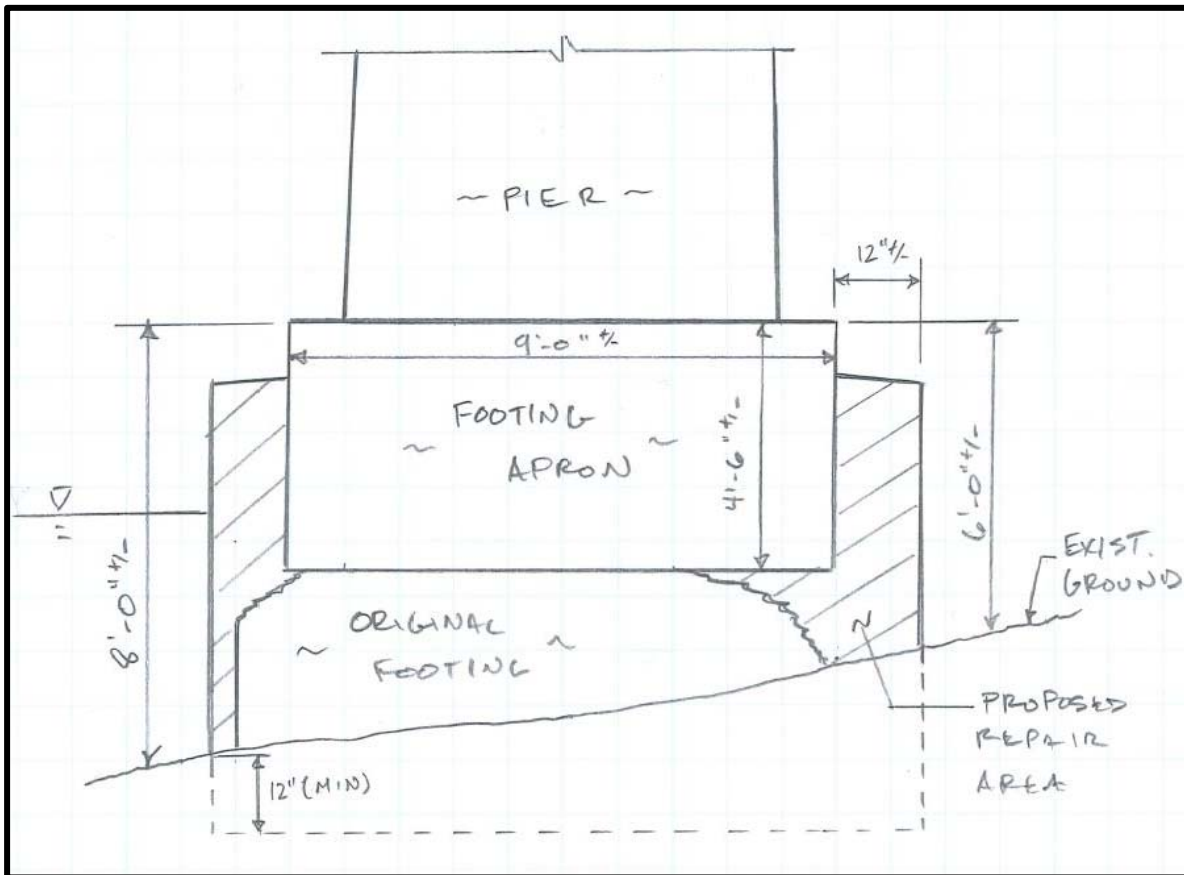
Sketch Showing Undermining of Footing Apron at Upstream End of East (Track North) Pier

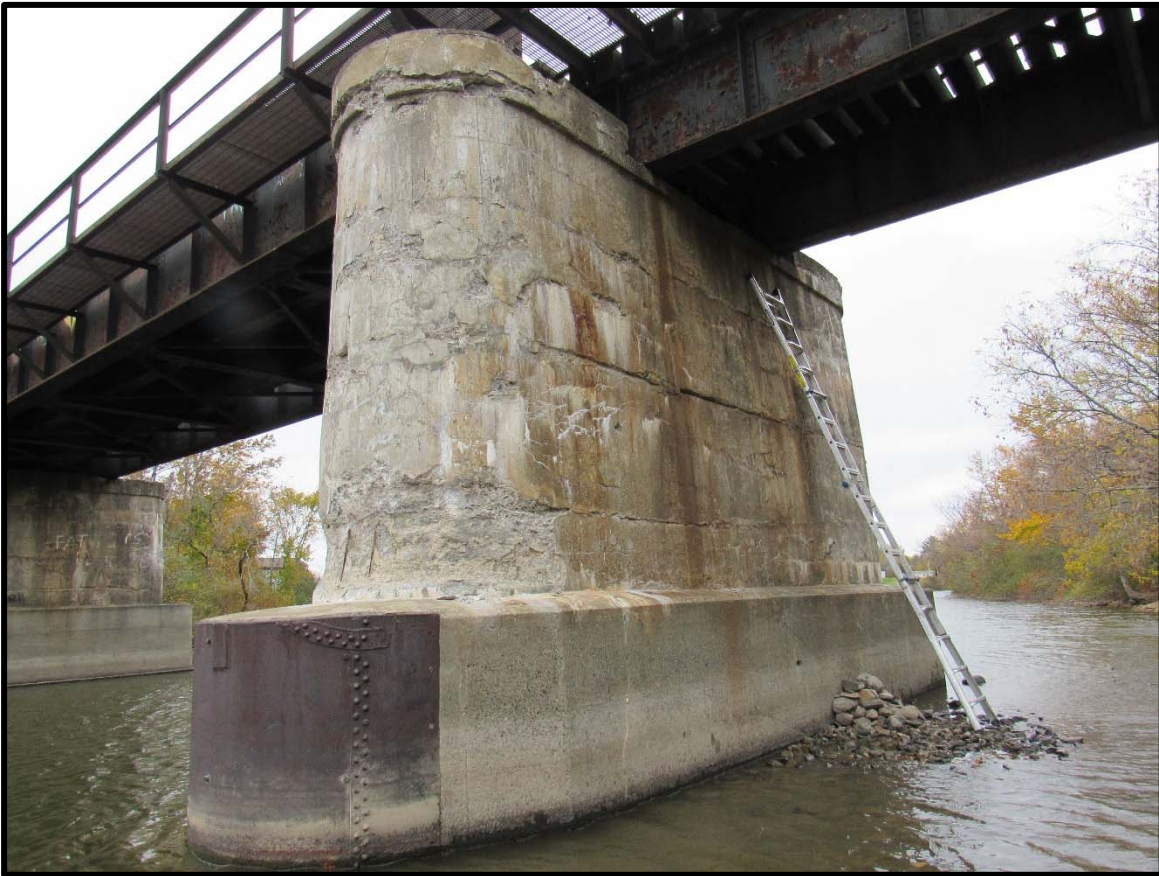
Heavy Spalling and Delaminations on Upstream End of the East (Track North) Pier

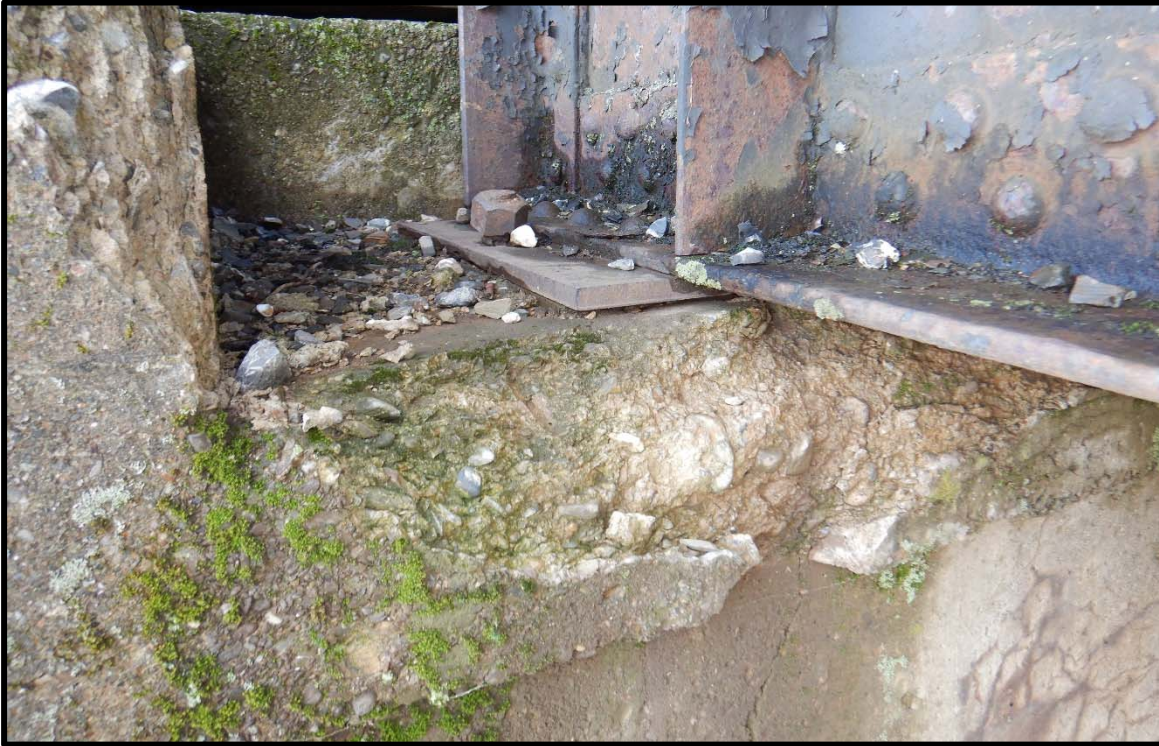
Bent/Corroded Anchor Bolts and Deteriorated Concrete on Bridge Seat of East (Track North) Pier

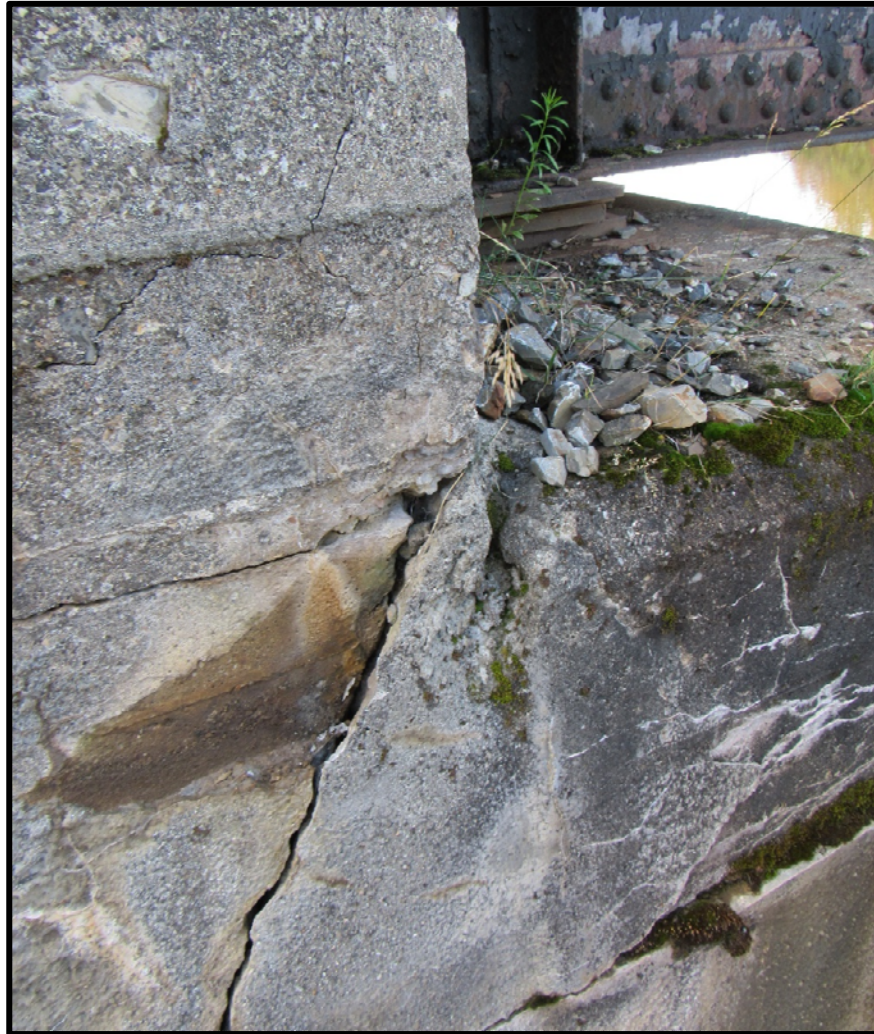
Cracking at Backwall and Wingwall Interface on East (Track North) Abutment

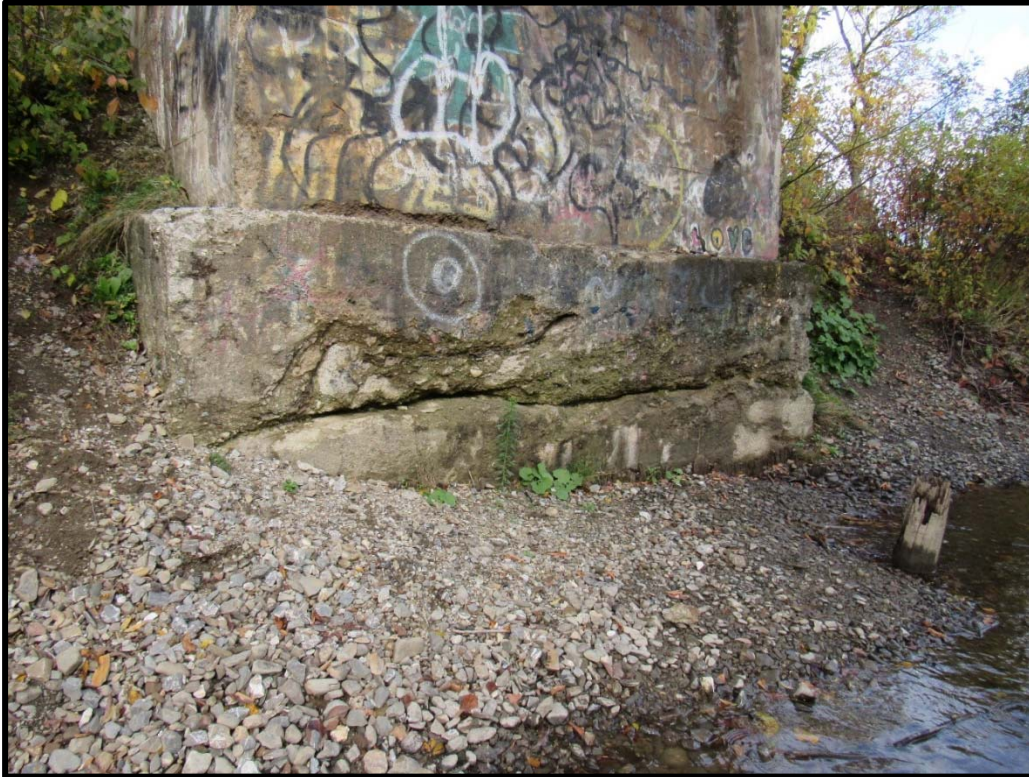
Heavy Deterioration and Abrasion on the Base of the West (Track South) Abutment

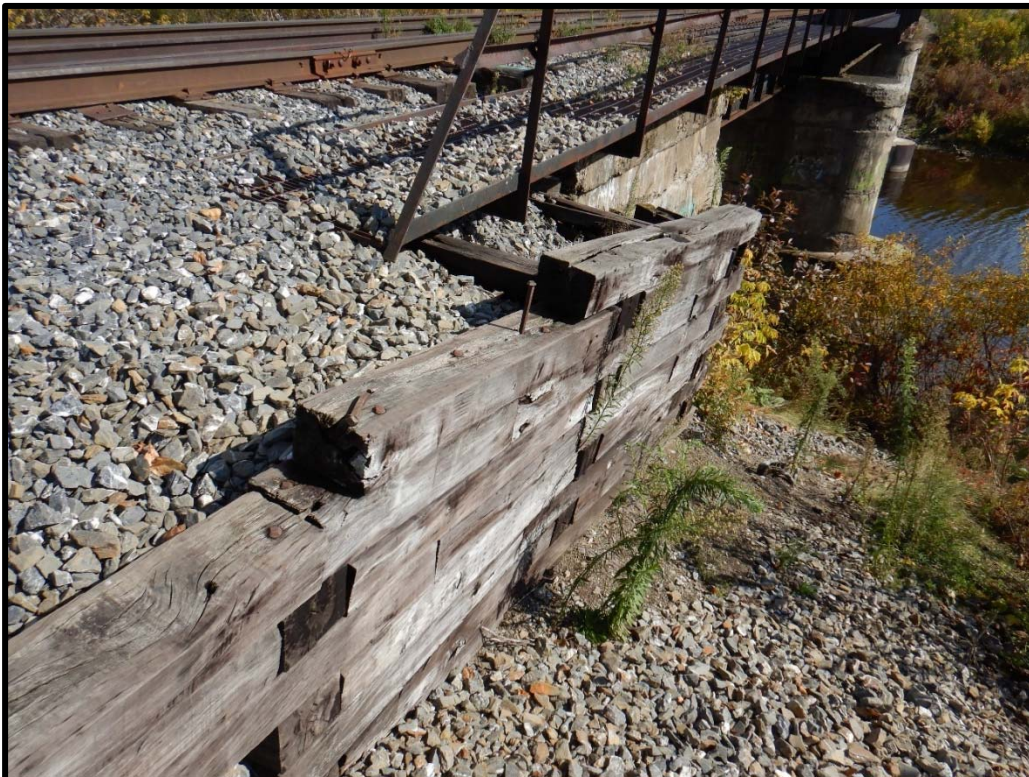
Failed Ballast Retainer behind the Southwest Wingwall

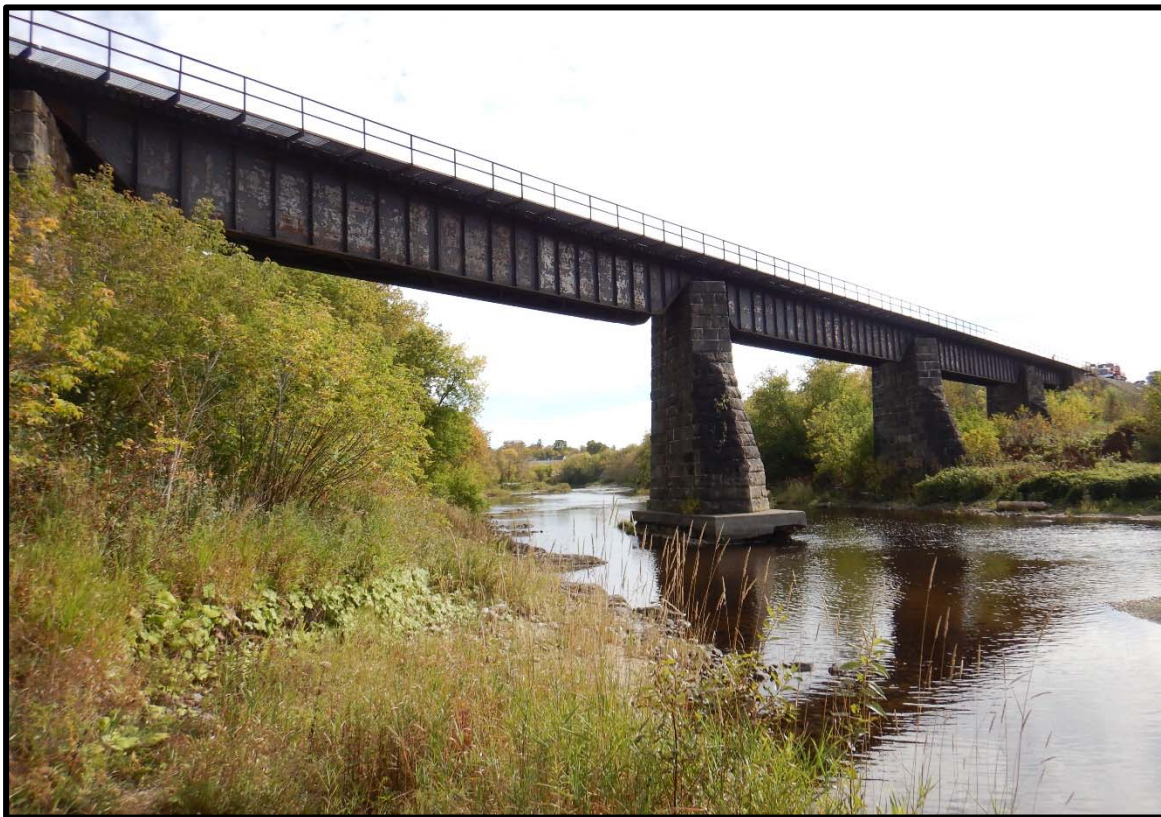
Elevation View of Bridge Looking South

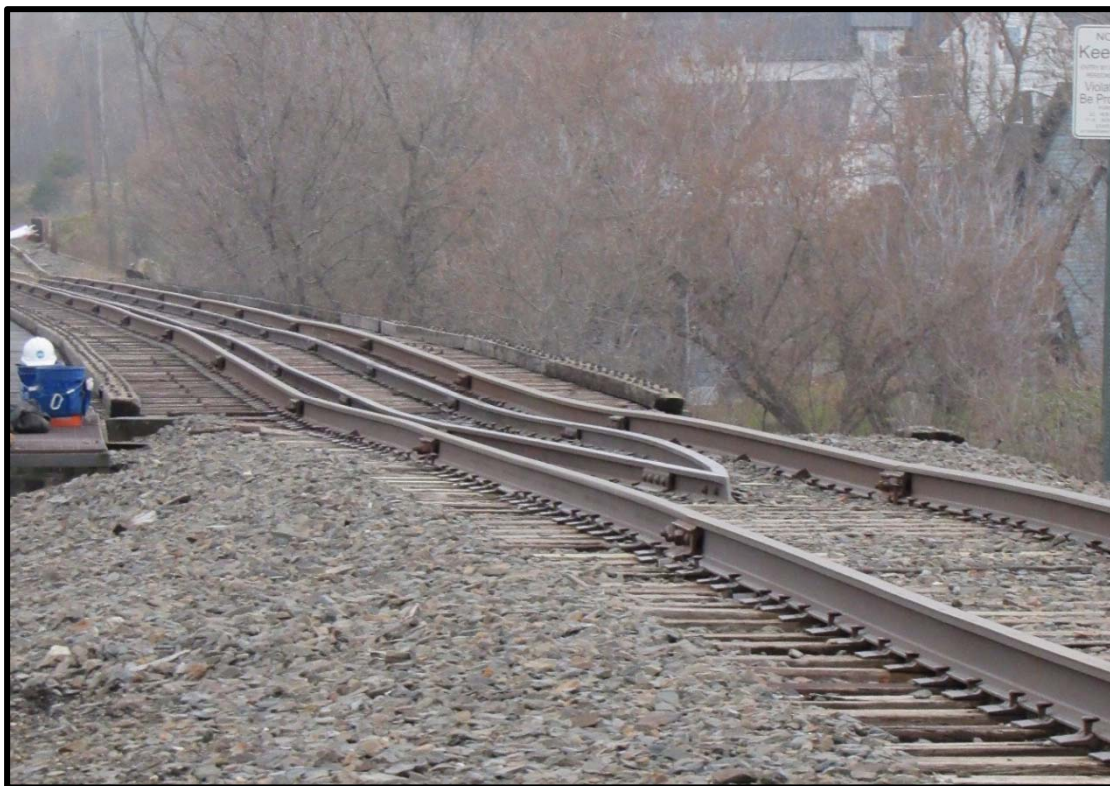
Settlement in Approach Track Just Prior to South Abutment (Looking North)

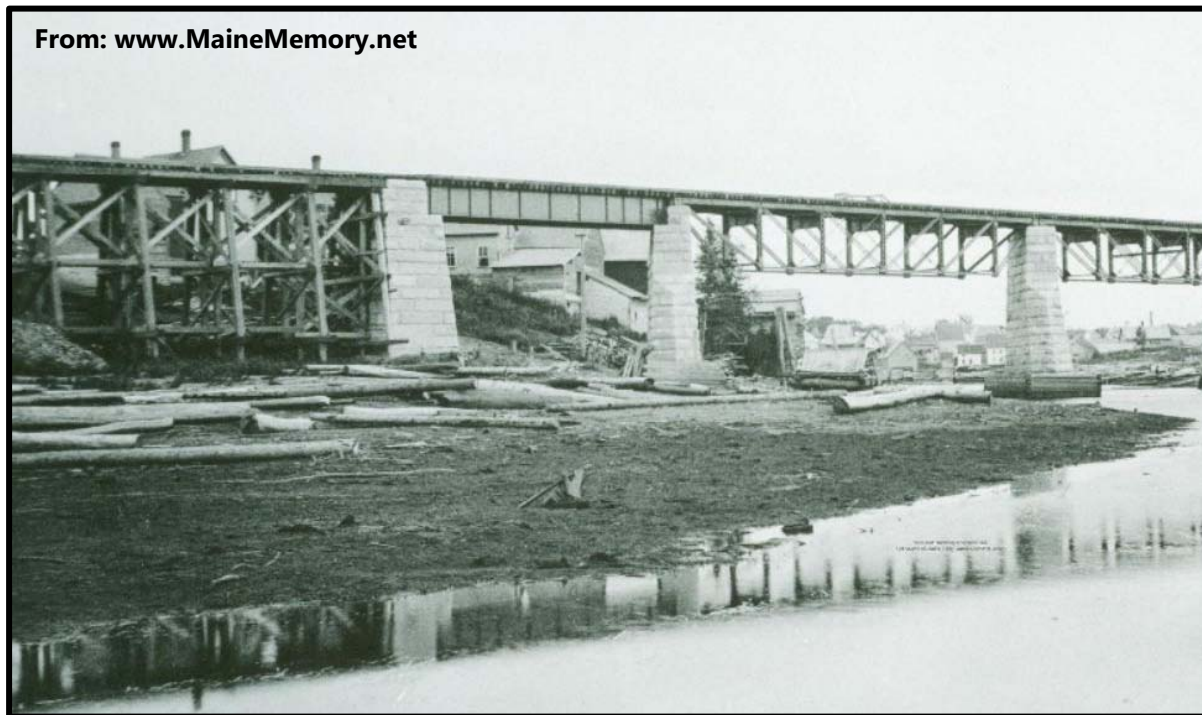
Photo from 1895 Showing Timber Trestle Leading Up to Bridge in Lieu of Embankment in Place Today
(North Abutment Shown, South Abutment Similar)

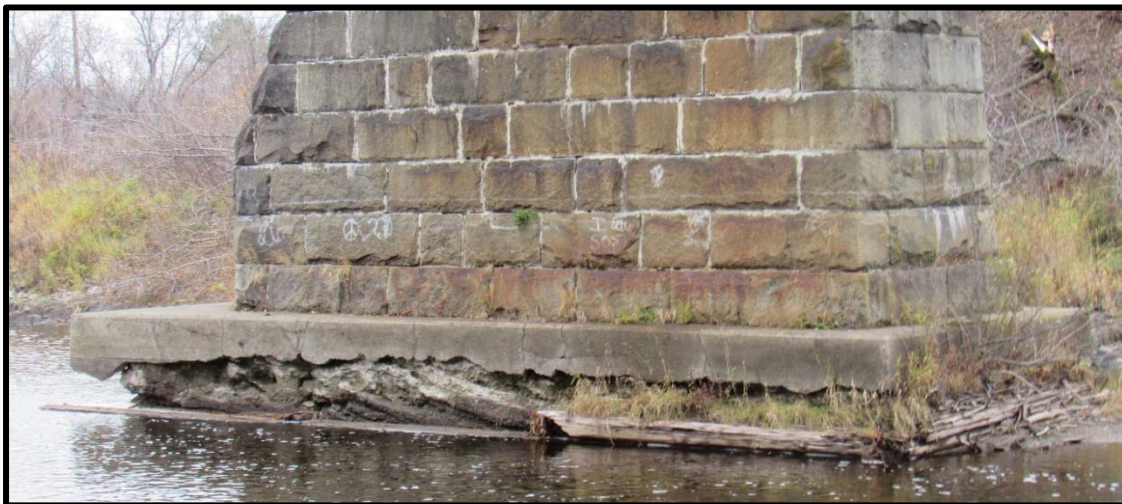
Heavy Deterioration and Undermining on South End of Pier 3 Footing Apron

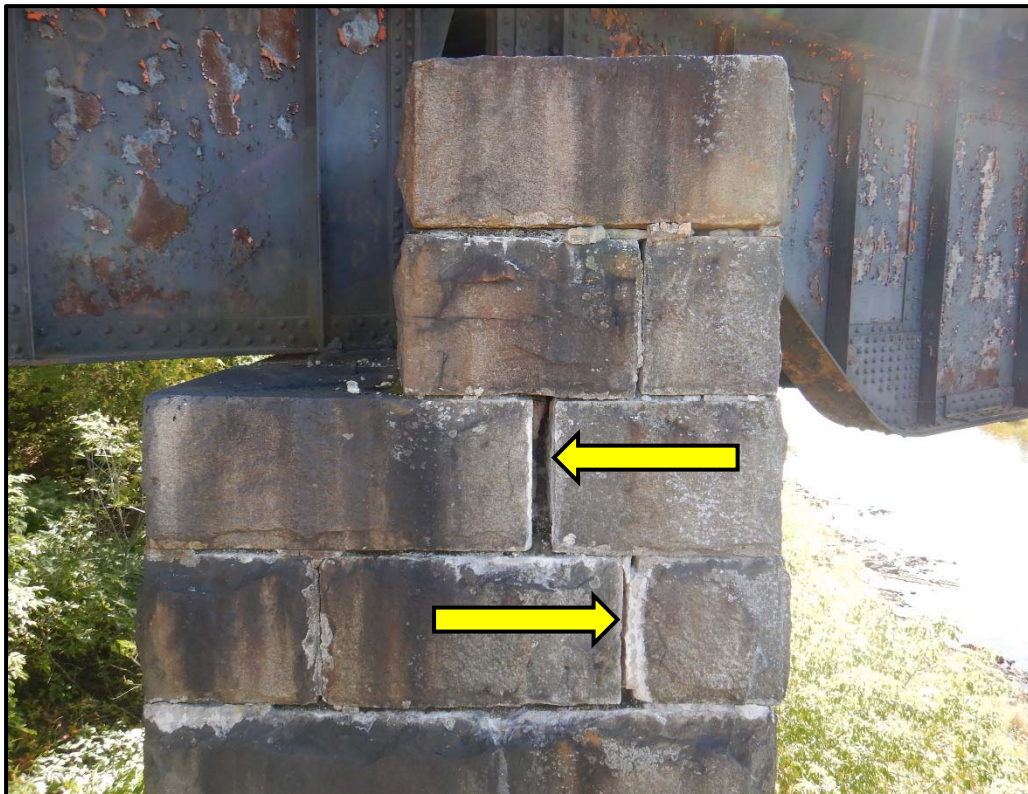
Blocks Shifting and Joints Open Up to 3 Inches on the West Face of Pier 4

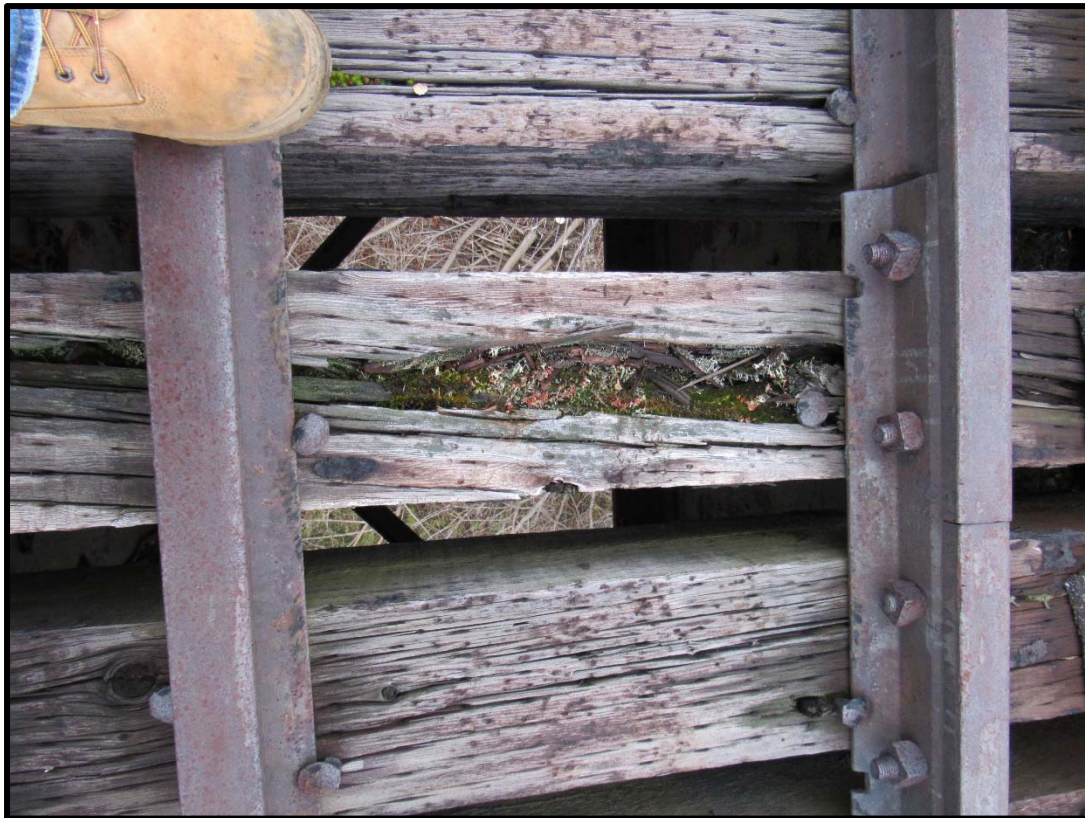
Bridge Timber in Serious Condition, Multiple Other Timbers in Similar Condition

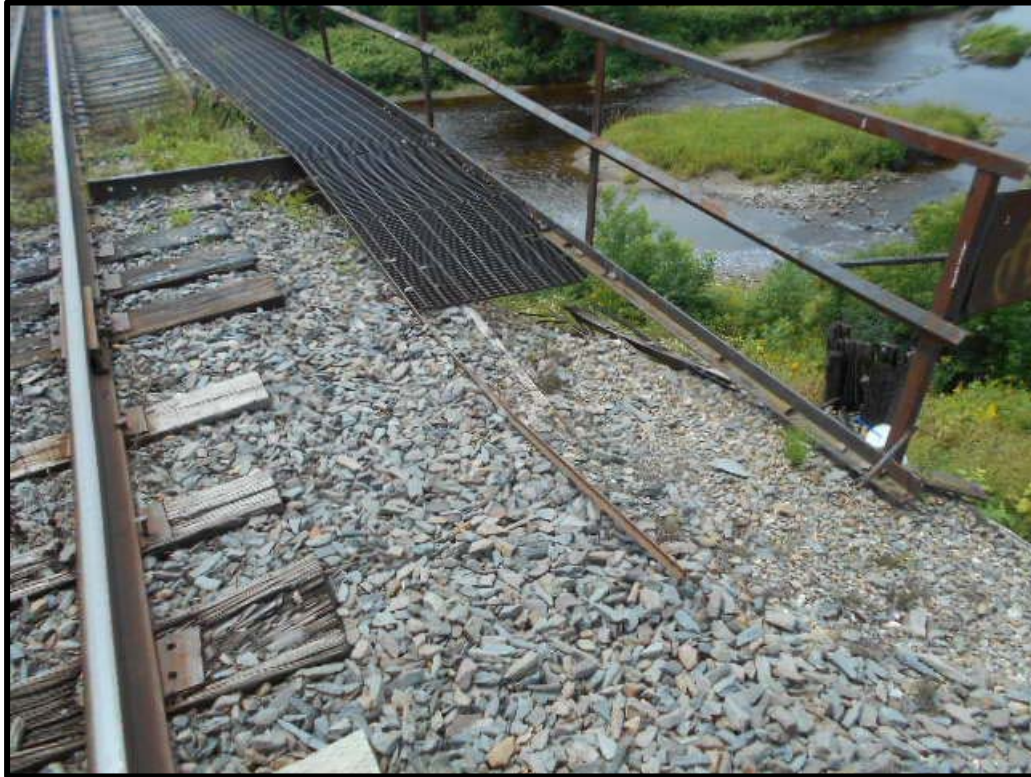
Damaged Walkway Section at North End of Bridge

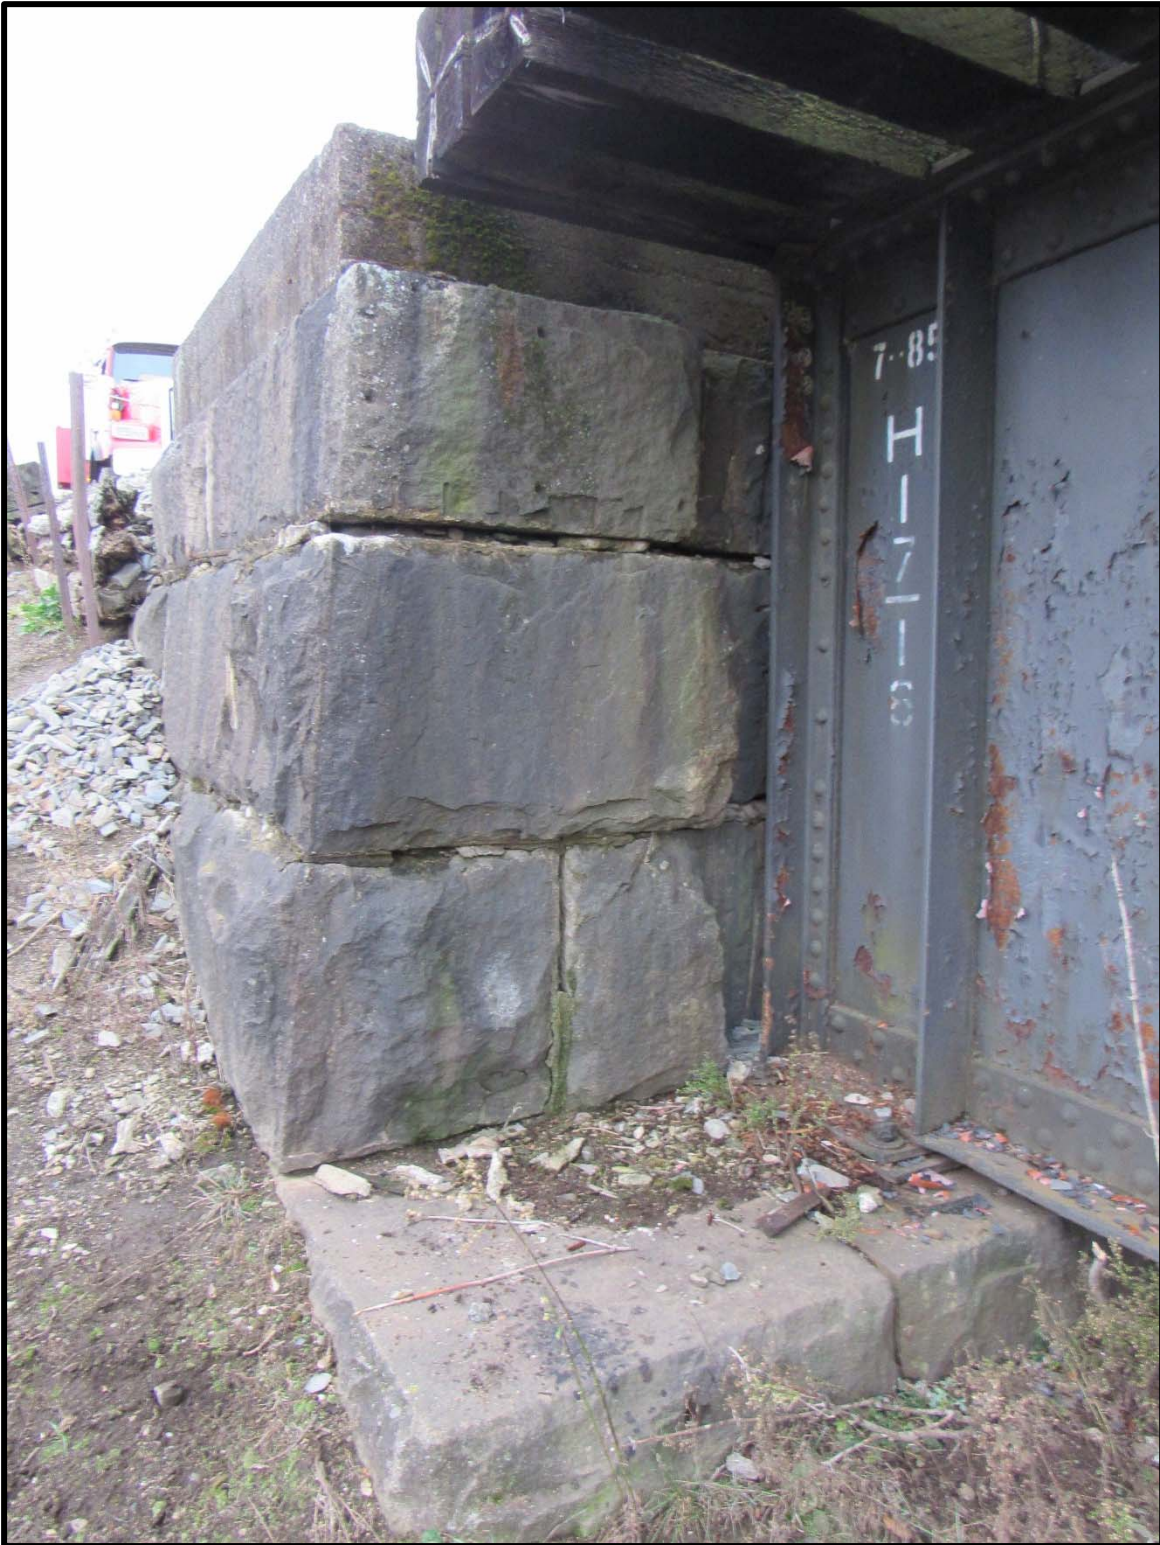
East End of South Abutment

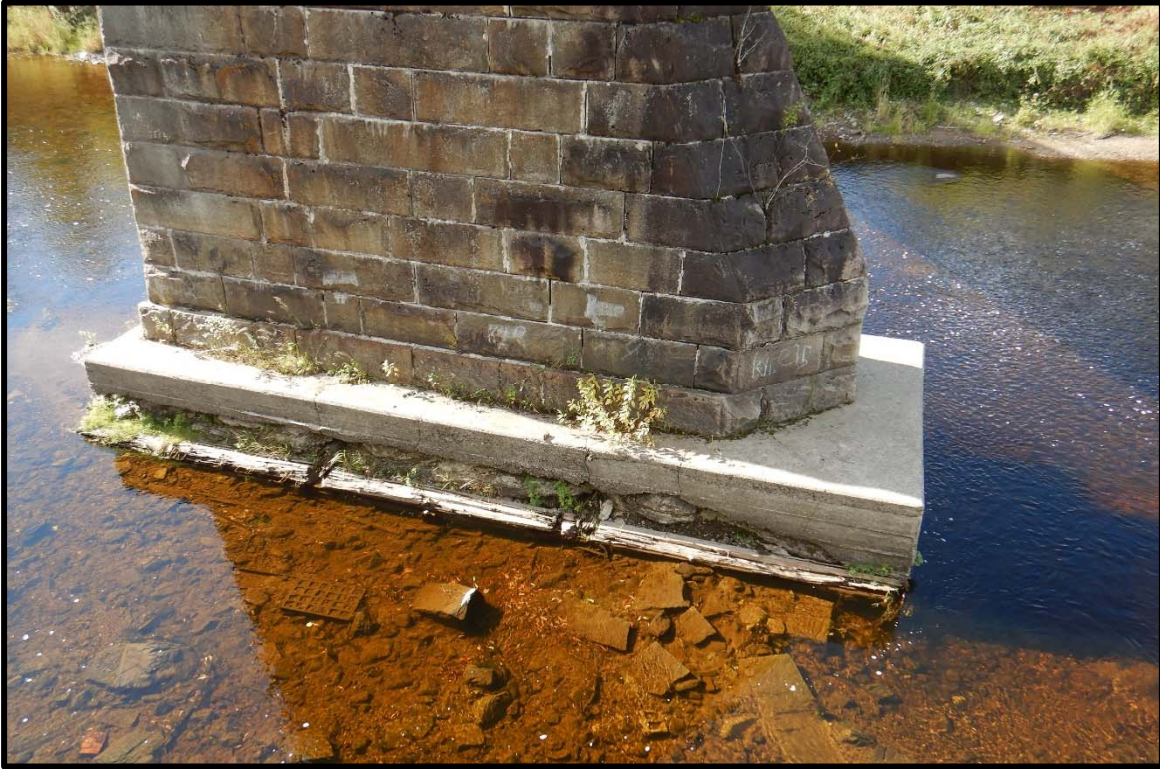
Heavy Deterioration and Undermining on South End of Pier 3 Footing Apron

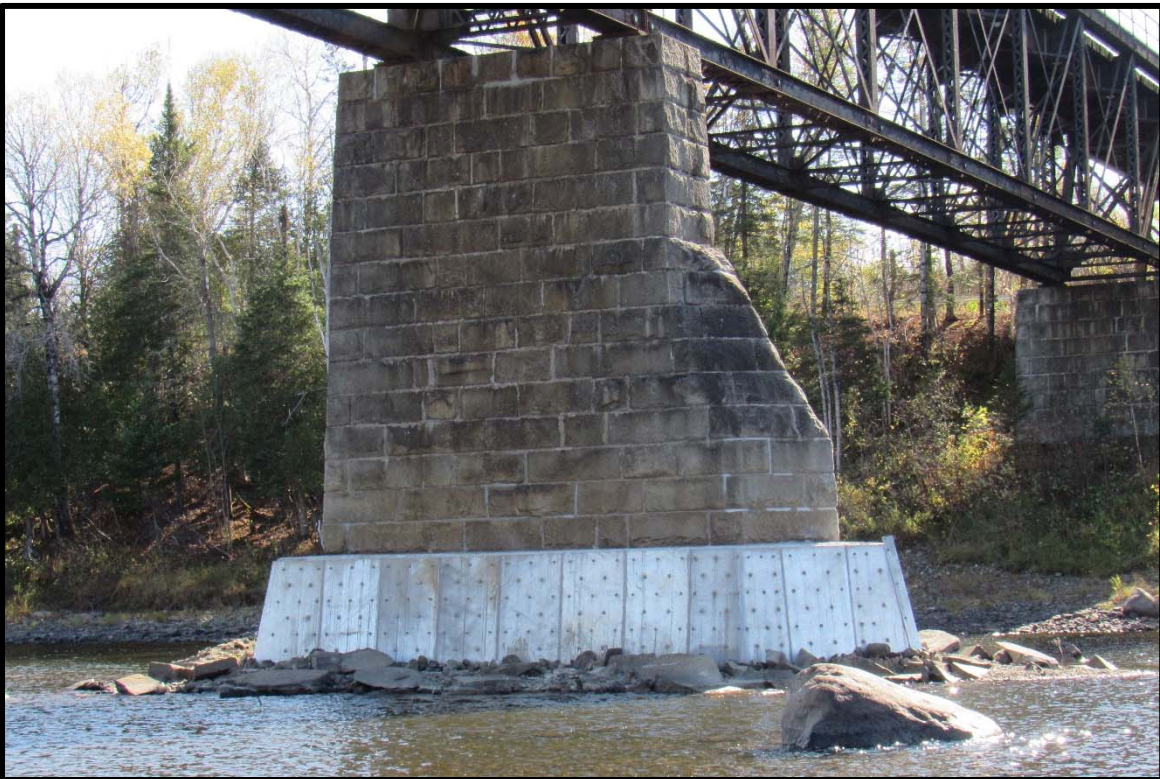
Sample – Steel Plated Footing Apron Repair on Sheridan Truss in Ashland on Madawaska Subdivision

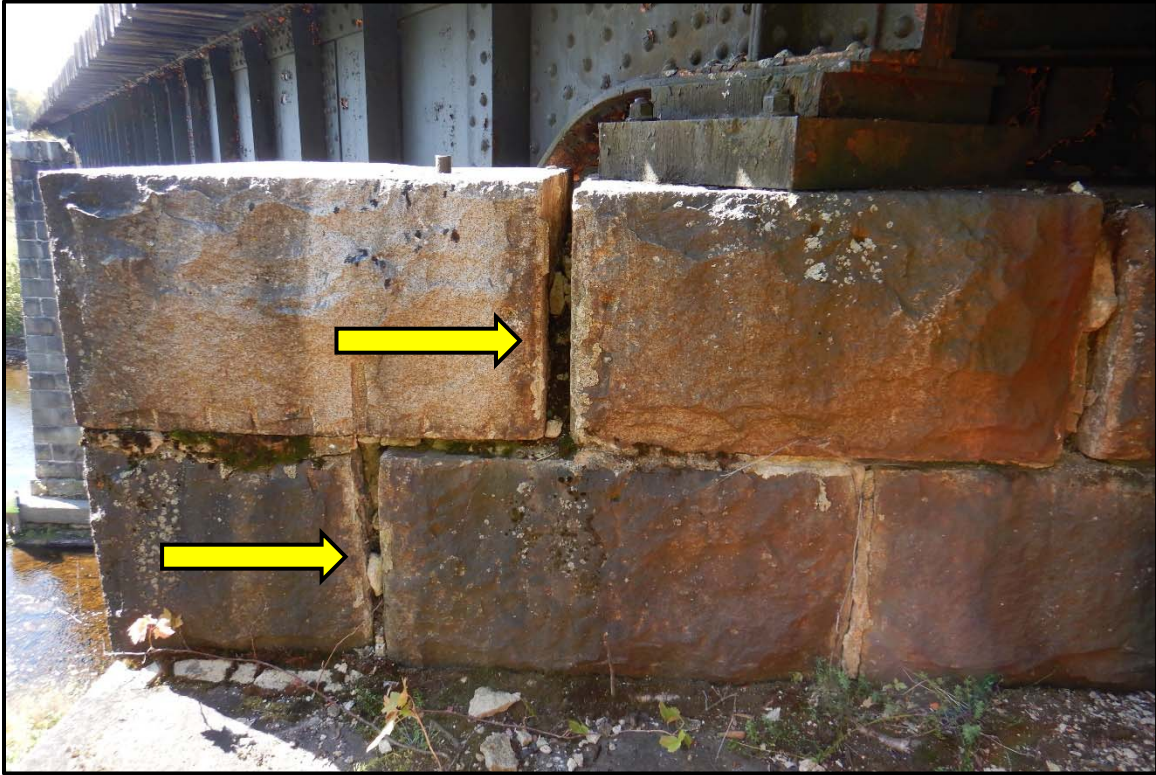
Blocks Shifting and Joints Open Up on the East Corner of the North Face of Pier 4
