Scour Critical Bridge
Plan of Action (POA) Report

Town: Burnham

Bridge Number: 6209

Bridge Name: Eel Weir

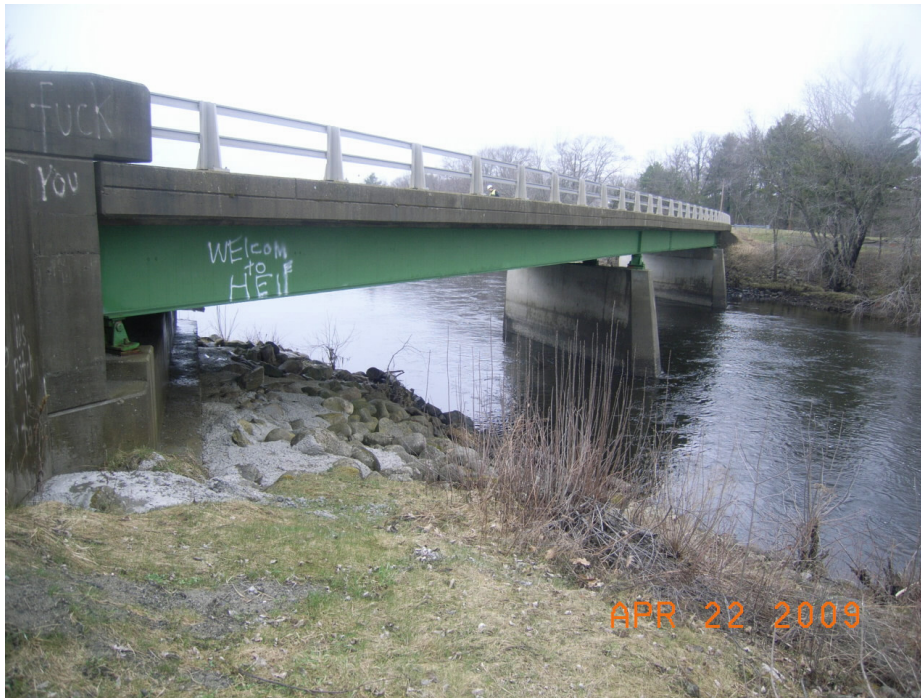
Bridge: Burnham 6209
Date Taken: 4/22/2009 7:34:43 PM
Source: CHAScourInsp
Description: Upstream elevation

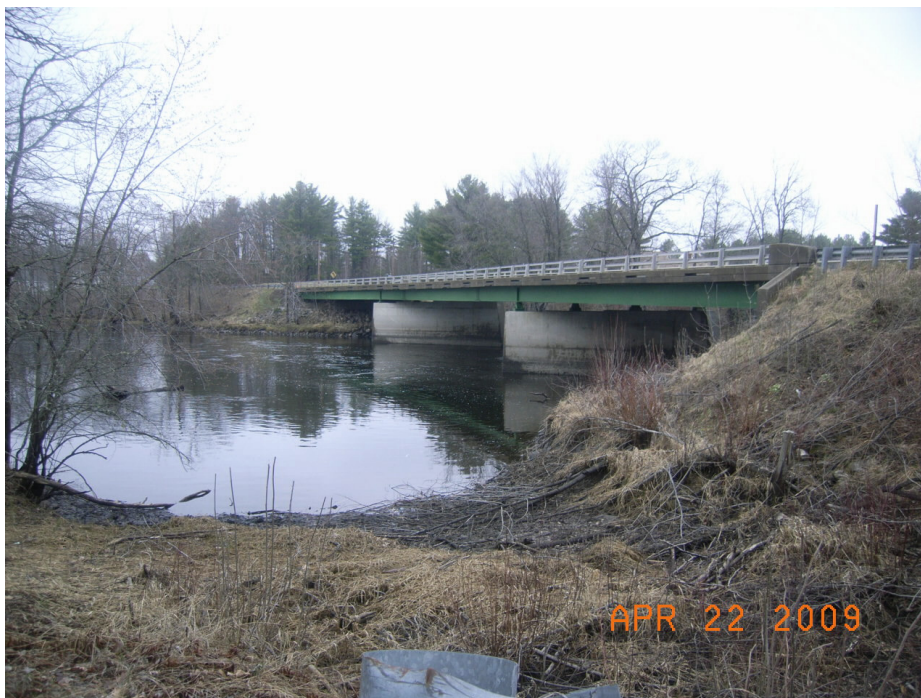
Bridge: Burnham 6209
Date Taken: 4/22/2009 7:34:46 PM
Source: CHAScourInsp
Description: Downstream elevation

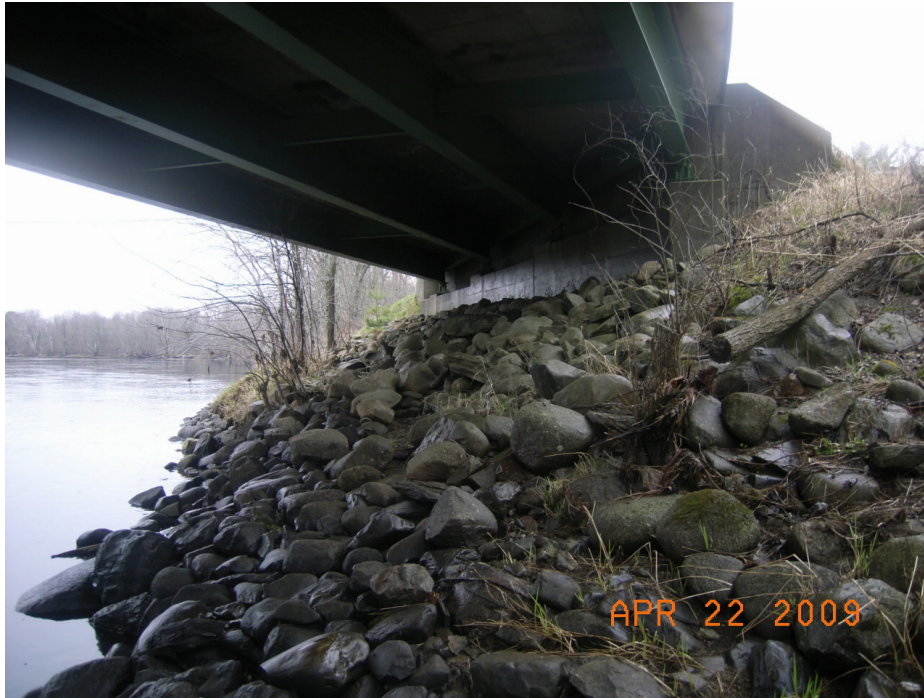
Bridge: Burnham 6209
Date Taken: 4/22/2009 7:34:42 PM
Source: CHA
Description: Right Abutment

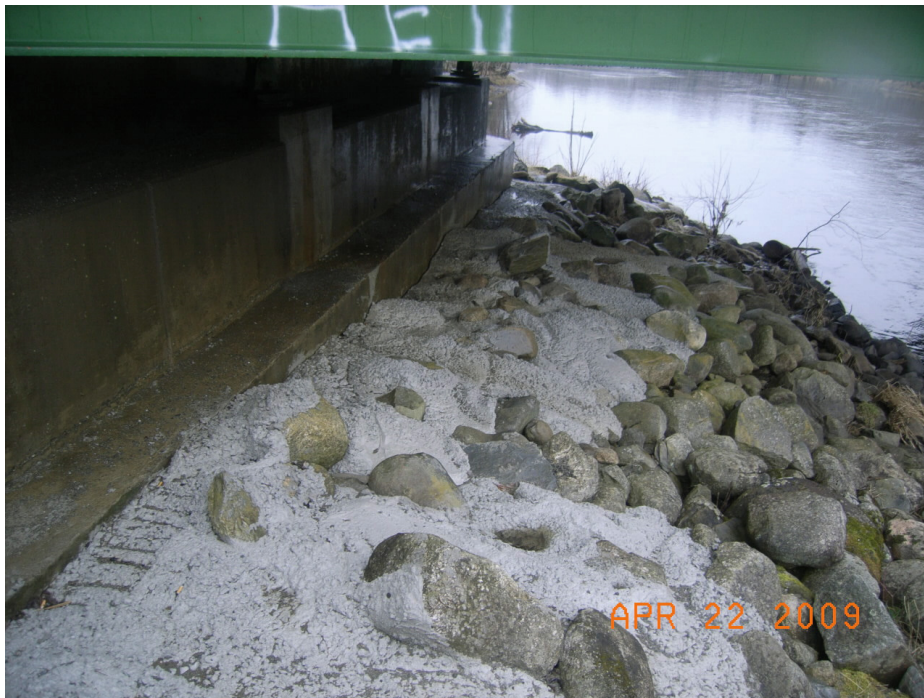
Bridge: Burnham 6209
Date Taken: 4/22/2009 7:34:45 PM
Source: CHAScourInsp
Description: Left abutment

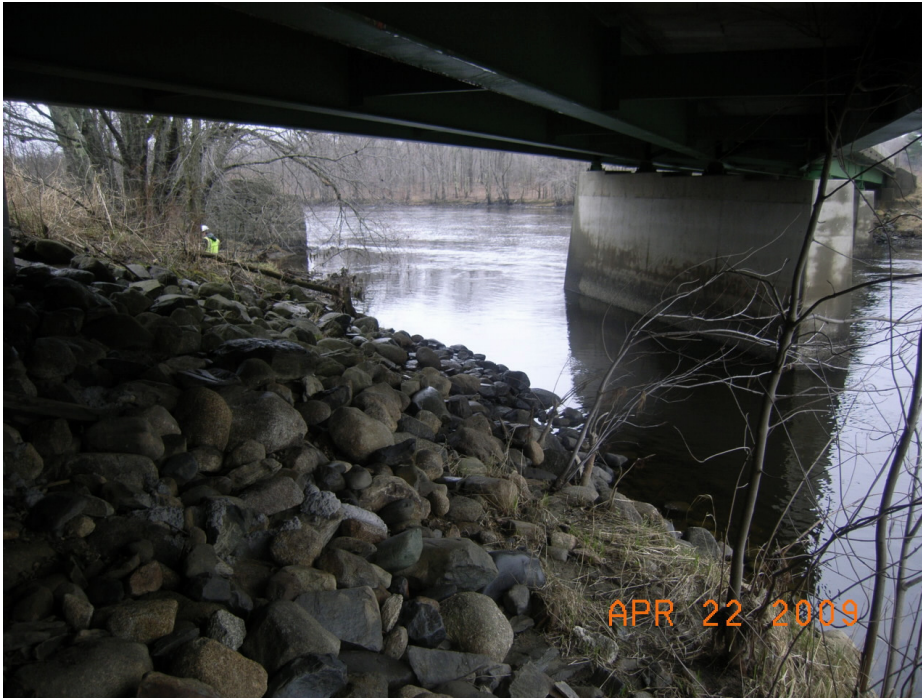
Items to Watch: Changes to embedment at piers. Pier 1 and 2 concrete seal foundations were exposed 1.3 ft and 1.2 ft, respectively. Riprap protection only existing on the right side of Pier 2. Provide photo documentation of countermeasures at abutments and piers.

Bridge: Burnham 6209
Date Taken: 4/22/2009 7:34:40 PM
Source: CHA
Description: Pier 2 Right

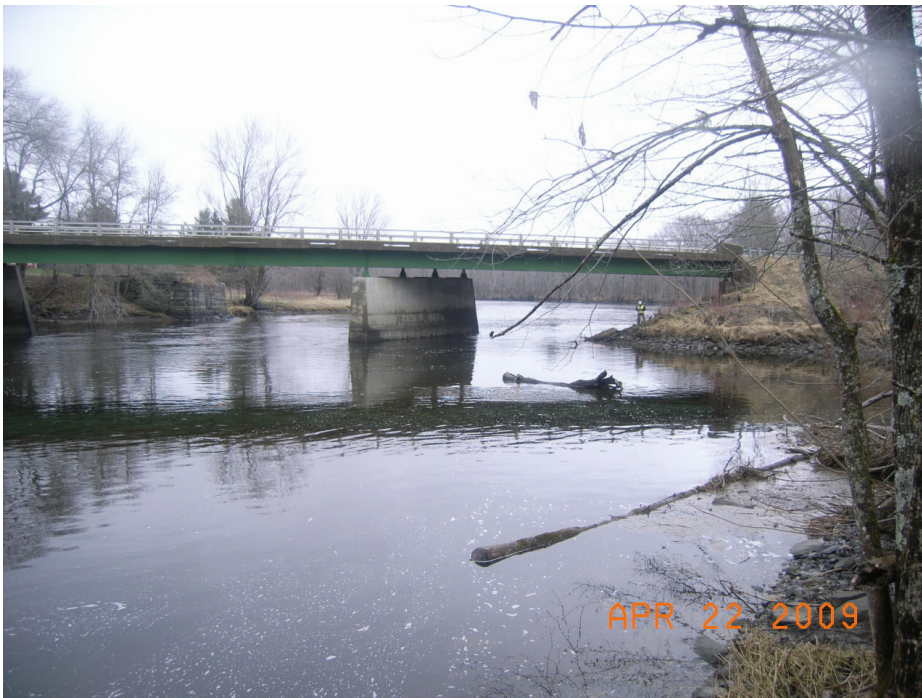
Bridge: Burnham 6209
Date Taken: 4/22/2009 7:34:48 PM
Source: CHAScourInsp
Description: Debris in channel (downstream of bridge)

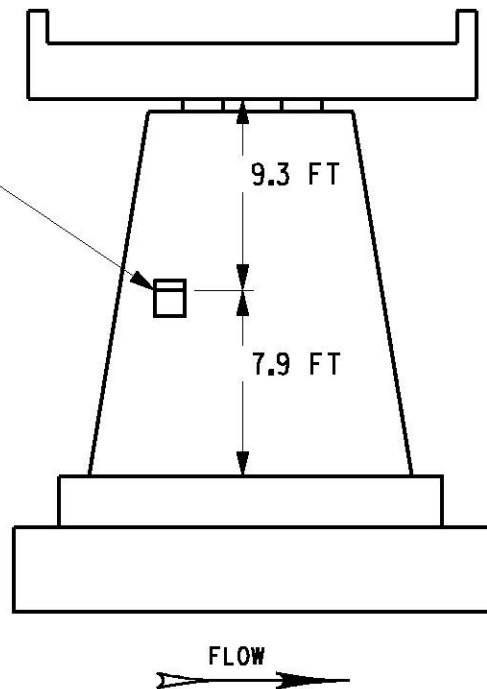
PIER 1 ELEVATION
N.T.S.

10-YEAR FLOOD
ELEVATION 169.5
(SEE NOTE 1)

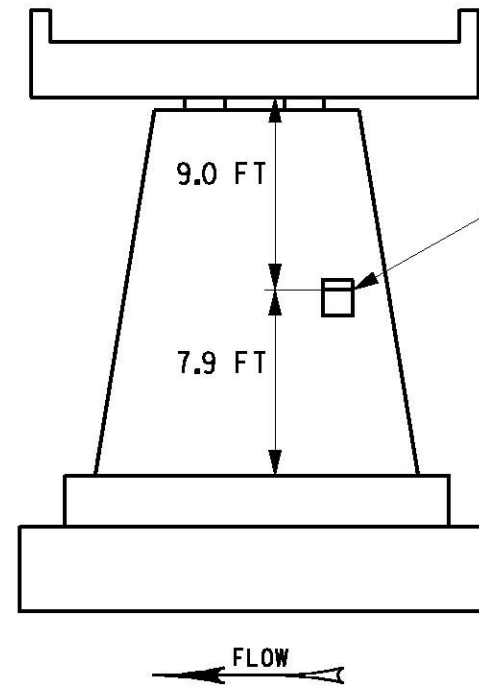
PIER 2 ELEVATION
N.T.S.

10-YEAR FLOOD
ELEVATION 169.5
(SEE NOTE 1)

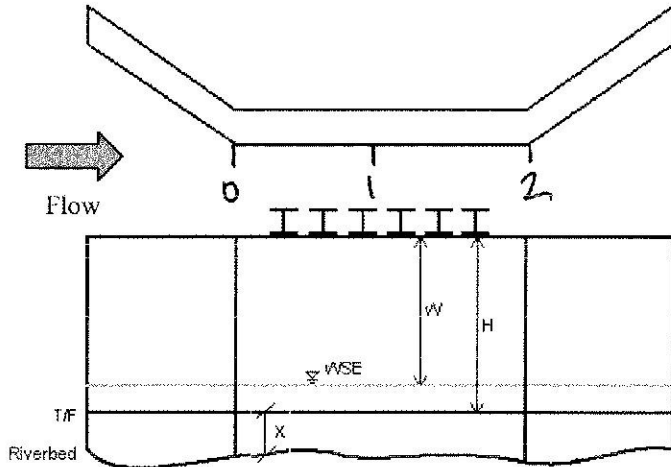
Abutment: Left

W = Distance from Low Chord to Water Surface = DRY ft

H = Distance from Low Chord to top of footing = 4.6+/- ft

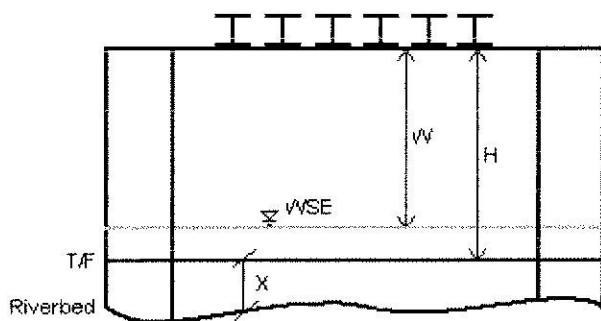
Pier: 1

W = Distance from Low Chord to Water Surface = 13.9± ft

H = Distance from Low Chord to top of footing = 17.2 ft

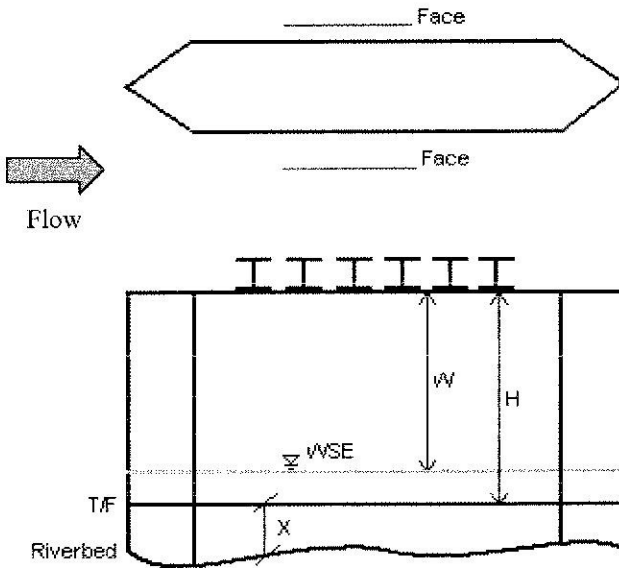
Pier: 2

W = Distance from Low Chord to Water Surface = 13.9± ft

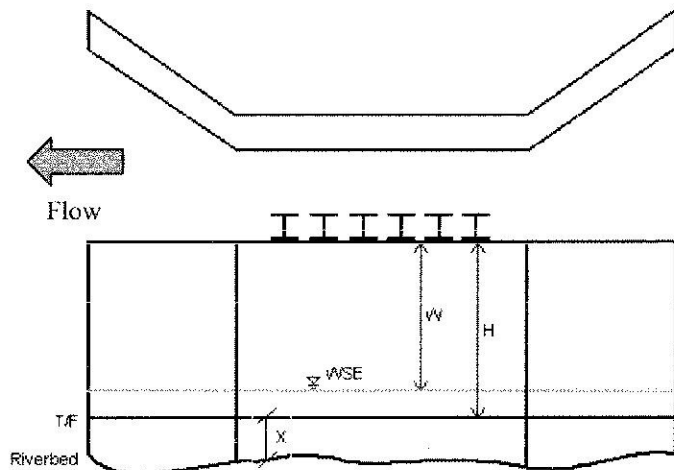
Abutment: Right

W = Distance from Low Chord to Water Surface = DRY ft

H = Distance from Low Chord to top of footing = 7.2 ft

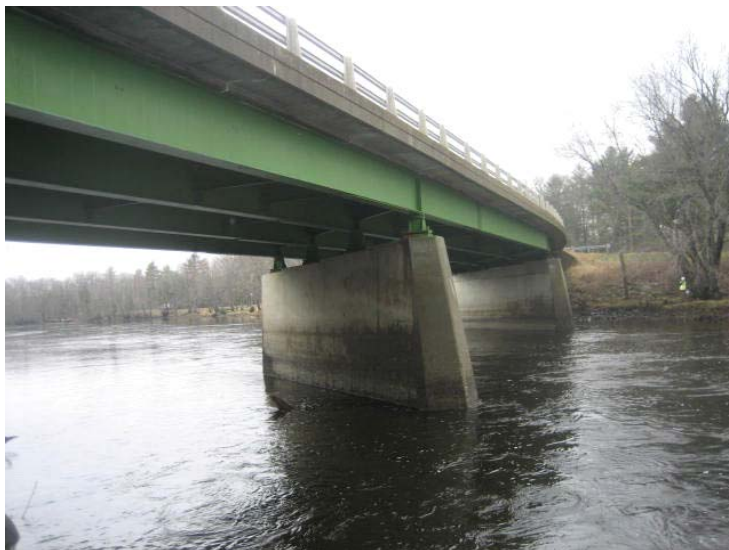
Scour Critical Feature at Low Water
