WIN 28846.00 Brownville ADA Pedestrian Ramp Report

WIN 28846.00 Corinna ADA Pedestrian Ramp Report

WIN 28846.00 Guilford ADA Pedestrian Ramp Report

WIN 28846.00 Milo ADA Pedestrian Ramp Report

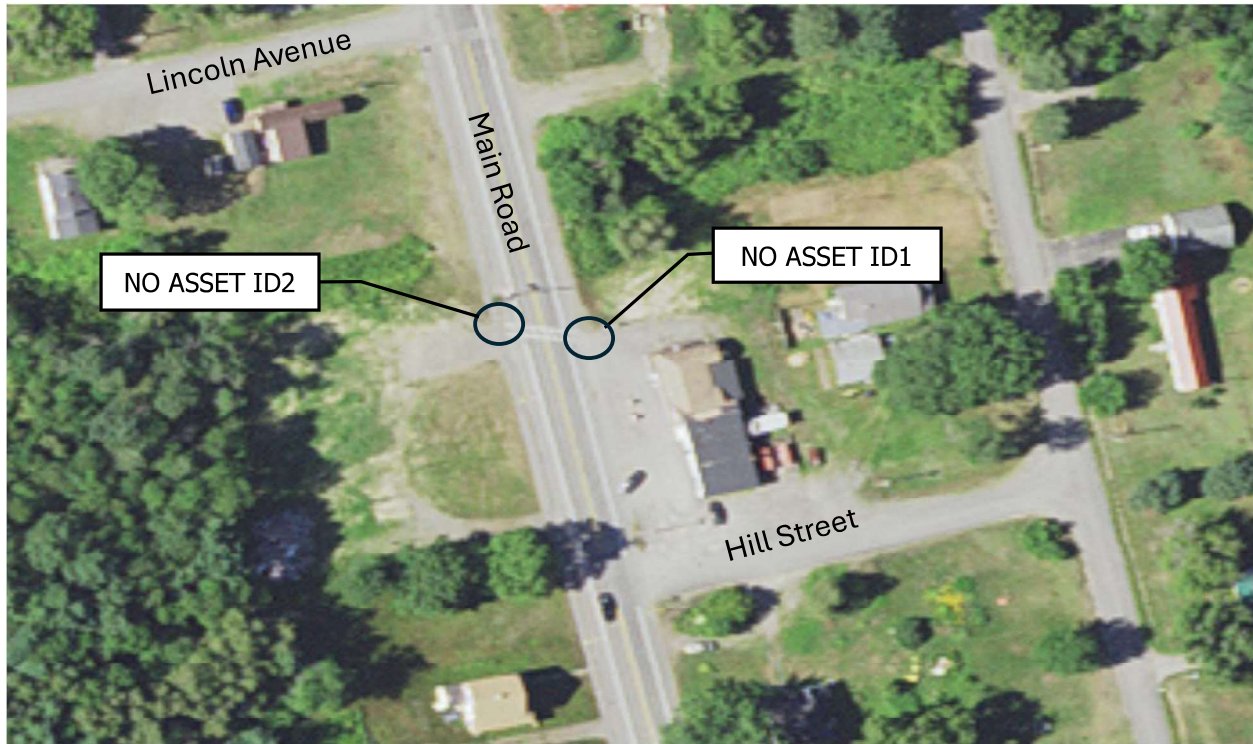
Main Road / Triple Goddess Shop (NO ASSET ID1)

Reconstruct Pedestrian Ramp

- Remove Existing pavement on sidewalk approx. 5' x 5'.
- Regrade existing sidewalk approx. 5' x 5'.
- Repave existing sidewalk approx. 5' x 5'.
- Install 5' x 2' Detectable warning Fields.

- Reconstruct similar to Standard Details 801 (27).
- Remove Existing pavement on sidewalk approx. 10' x 5'.
- Regrade existing sidewalk approx. 10' x 5'.
- Repave existing sidewalk approx. 10' x 5'.
- Install 5' x 2' Detectable warning Fields.
- Install new curb Type 3 approx. 10'.
- Repaint crosswalk across Main Road between No Asset ID's 1 and 2.

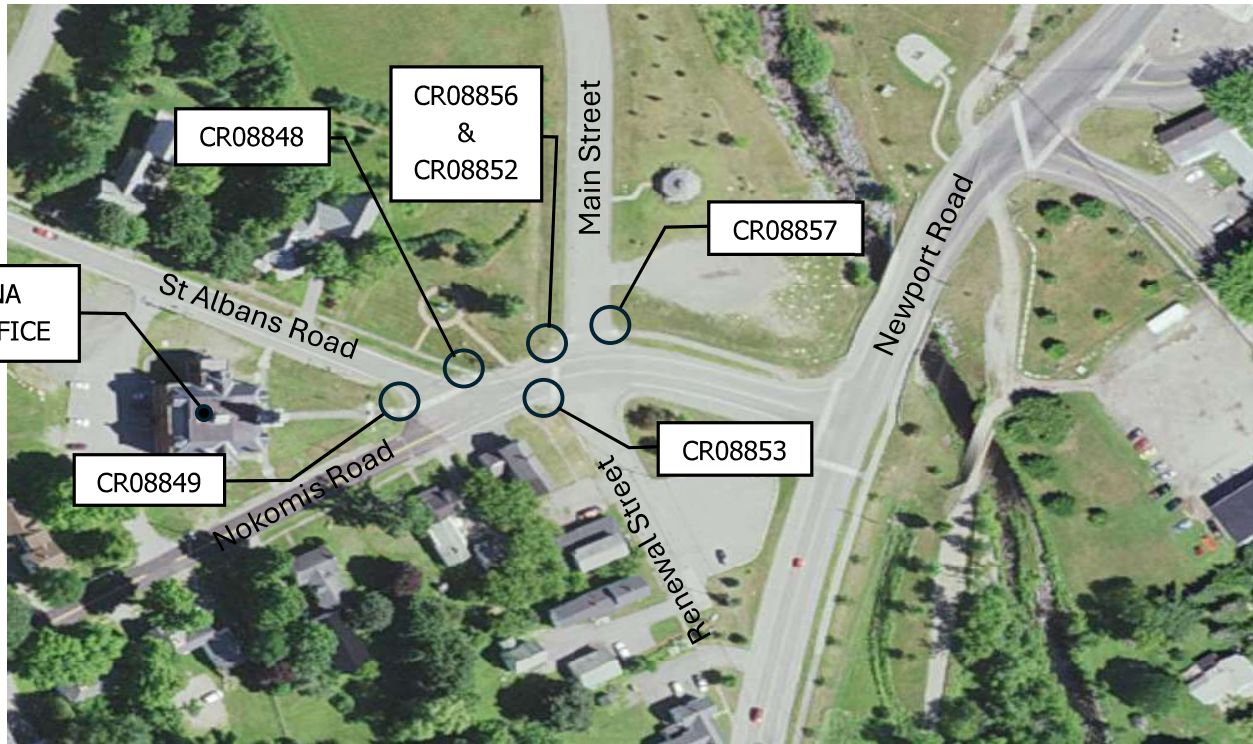
Main Street/St. Albans Road East (CR08857)

Reconstruct Pedestrian Ramp

- Reconstruct similar to Standard Details 801 (27).
- Remove Existing pavement on sidewalk approx. 15' x 5'.
- Regrade existing sidewalk approx. 15' x 5'.
- Repave existing sidewalk approx. 15' x 5'.
- Install 5' x 2' Detectable warning Fields.
- Repaint crosswalk across Main Street Between Asset ID's CR08857 and CR08856.

- Reconstruct similar to Standard Details 801 (16). Do make 2 different landings with an in-between apex.
- Remove Existing pavement on sidewalk approx. 30' x 5'.
- Regrade existing sidewalk approx. 30' x 5' and shoulder approx. 16' x 2'.
- Repave existing sidewalk approx. 30' x 5' and existing shoulder 16' x 2'.
- Install 5' x 2' Detectable warning Fields each landing.
- Install Terminal 8' Curb type 1.

- Reconstruct similar to Standard Details 801 (20).
- Remove Existing pavement on sidewalk approx. 25' x 5'.
- Regrade existing sidewalk approx. 25' x 5' and shoulder approx. 16' x 2'.
- Repave existing sidewalk approx. 25' x 5' and existing shoulder 16' x 2'.
- Install 5' x 2' Detectable warning Fields.
- Repaint crosswalk across St Albans Road between Asset ID's CR08852 and CR08853.

- Remove Existing pavement on sidewalk approx. 5' x 5'.
- Regrade existing sidewalk approx. 5' x 5'
- Repave existing sidewalk approx. 5' x 5'.
- Install 5' x 2' Detectable warning Fields each landing.
- Repaint crosswalk across St Albans Road between Asset ID's CR08848 and CR08849.
- Install new Regulatory Pedestrian Sign

- Remove Existing pavement on sidewalk approx. 5' x 5'.
- Regrade existing sidewalk approx. 5' x 5'
- Repave existing sidewalk approx. 5' x 5'.
- Install 5' x 2' Detectable warning Fields each landing.
- Install new Regulatory Pedestrian Sign

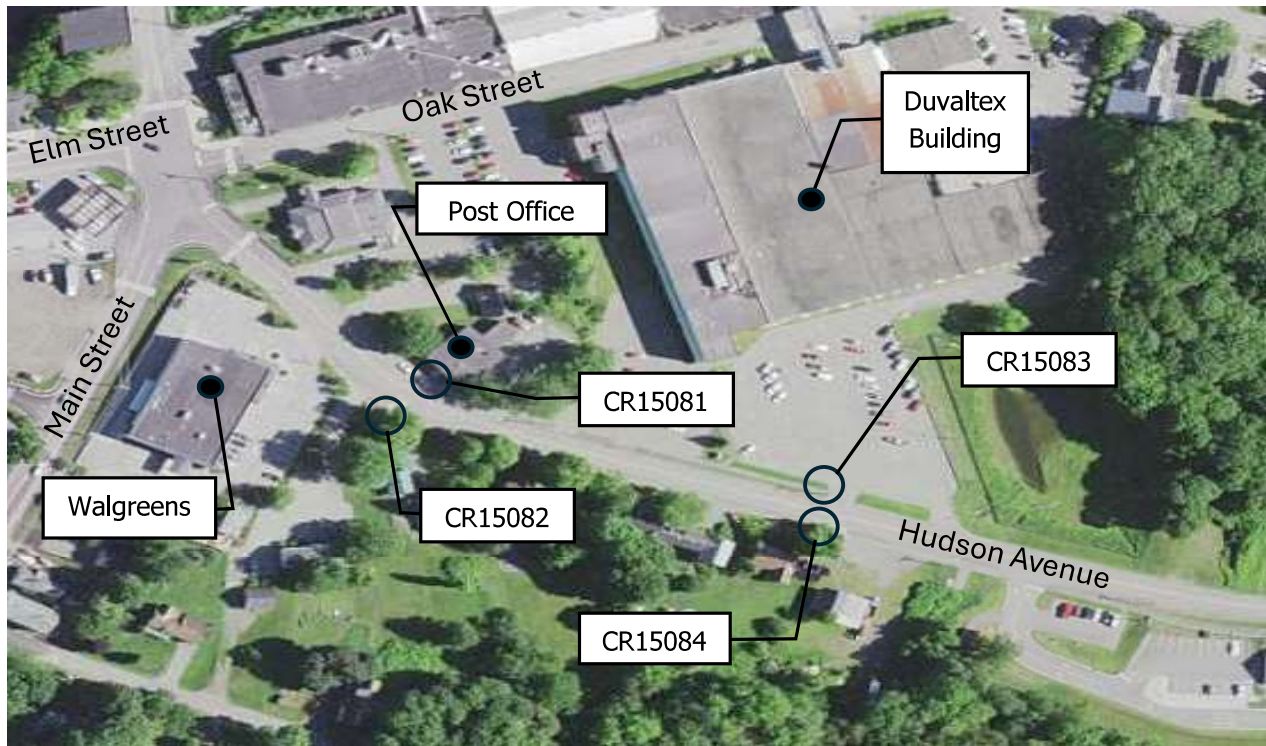
Hudson Avenue at Post Office (CR15081)

Reconstruct Pedestrian Ramp

Relocate/Reconstruct Pedestrian Ramp

- Remove Existing pavement on sidewalk approx. 25' x 5'.
- Regrade existing sidewalk approx. 25' x 5' and shoulder approx. 16' x 2'.
- Repave existing sidewalk approx. 25' x 5' and existing shoulder 16' x 2'.
- Install 5' x 2' Detectable warning Fields.
- Reset 16' curb type 1.
- Paint crosswalk across Hudson Avenue Between Asset ID's CR15081 and CR15082.
- Install new Regulatory Pedestrian Sign.

- Reconstruct similar to Standard Details 801 (27).
- Remove Existing pavement on sidewalk approx. 20' x 5'.
- Regrade existing sidewalk approx. 20' x 5' and shoulder approx. 16' x 2'.
- Repave existing sidewalk approx. 20' x 5' and existing shoulder 16' x 2'.
- Install 5' x 2' Detectable warning Fields.
- Reset 16' curb type 1.
- Install new Regulatory Pedestrian Sign.

- Relocate the Pedestrian ramp further up the existing sidewalk, avoiding the existing pole.
- Reconstruct similar to Standard Details 801 (23).
- Remove Existing Pavement on sidewalk approx. 25' x 5'.
- Regrade existing sidewalk approx. 25' x 5' and shoulder approx. 21' x 2'.
- Repave existing sidewalk approx. 25' x 5' and existing shoulder 21' x 2'.
- Install 5' x 2' Detectable warning Fields.
- Reset 21' curb type 1.
- Remove and abandon existing crosswalk paint.
- Paint a new crosswalk across the new ramp at Hudson Avenue between Asset ID's CR15083 and CR15084.
- Install new Regulatory Pedestrian Sign.

- Relocate the Pedestrian ramp just across CR15083
- Reconstruct similar to Standard Details 801 (14).
- Remove Existing Pavement on sidewalk approx. 25' x 5'.
- Regrade existing sidewalk approx. 25' x 5' and shoulder approx. 16' x 2'.
- Repave existing sidewalk approx. 25' x 5' and existing shoulder 16' x 2'.
- Install 5' x 2' Detectable warning Fields.
- Install new Regulatory Pedestrian Sign.

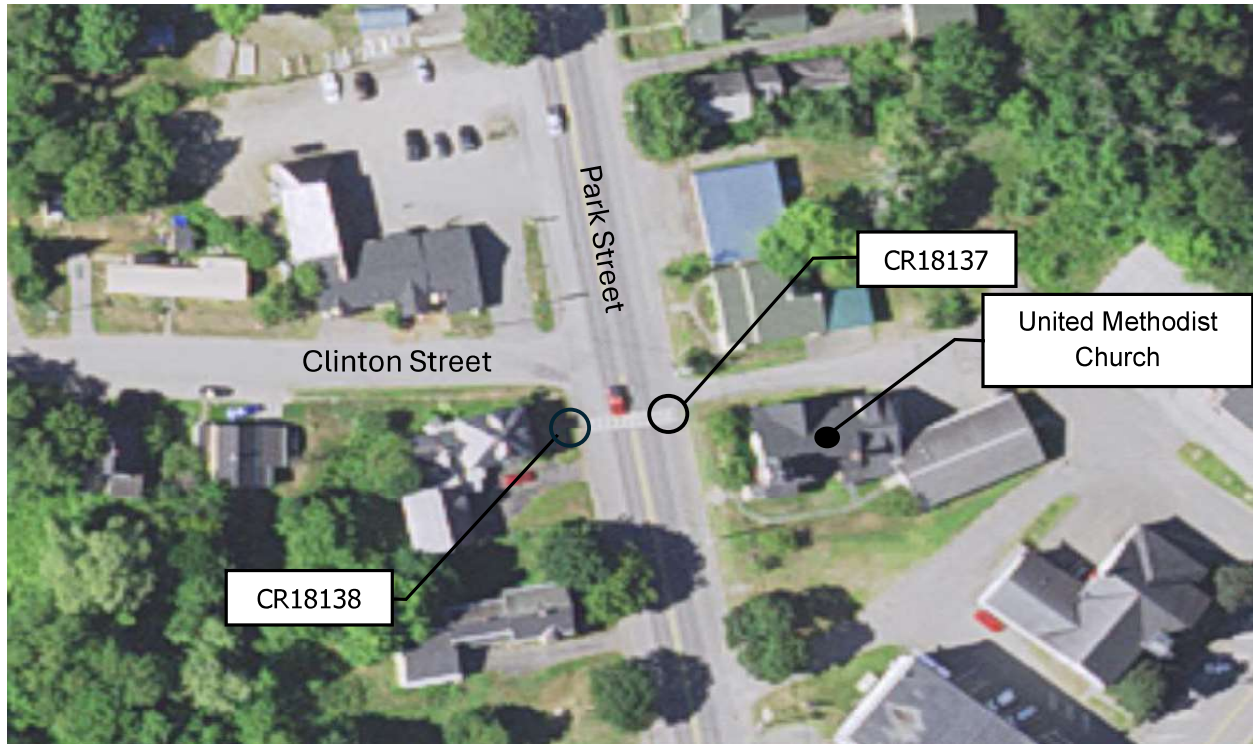
Park Street Across from Clinton Street (CR18137)

Reconstruct Pedestrian Ramp

- Reconstruct similar to Standard Details 801 (27).
- Remove Existing pavement and DWF on sidewalk approx. 10' x 5'.
- Regrade existing sidewalk approx. 10' x 5'.
- Repave existing sidewalk approx. 10' x 5'.
- Install 5' x 2' Detectable warning Fields.
- Install new curb type 3 approx. 10'.
- Paint crosswalk across Park Street Between Asset ID's CR18137 and CR18138.
- Install new Pedestrian Sign

- Reconstruct similar to Standard Details 801 (14).
- Remove Existing pavement and DWF on sidewalk approx. 25' x 5'.
- Regrade existing sidewalk approx. 25' x 5'.
- Repave existing sidewalk approx. 25' x 5'.
- Install 5' x 2' Detectable warning Fields.
- Install new curb type 3 approx. 16'.
- Install new Pedestrian Sign

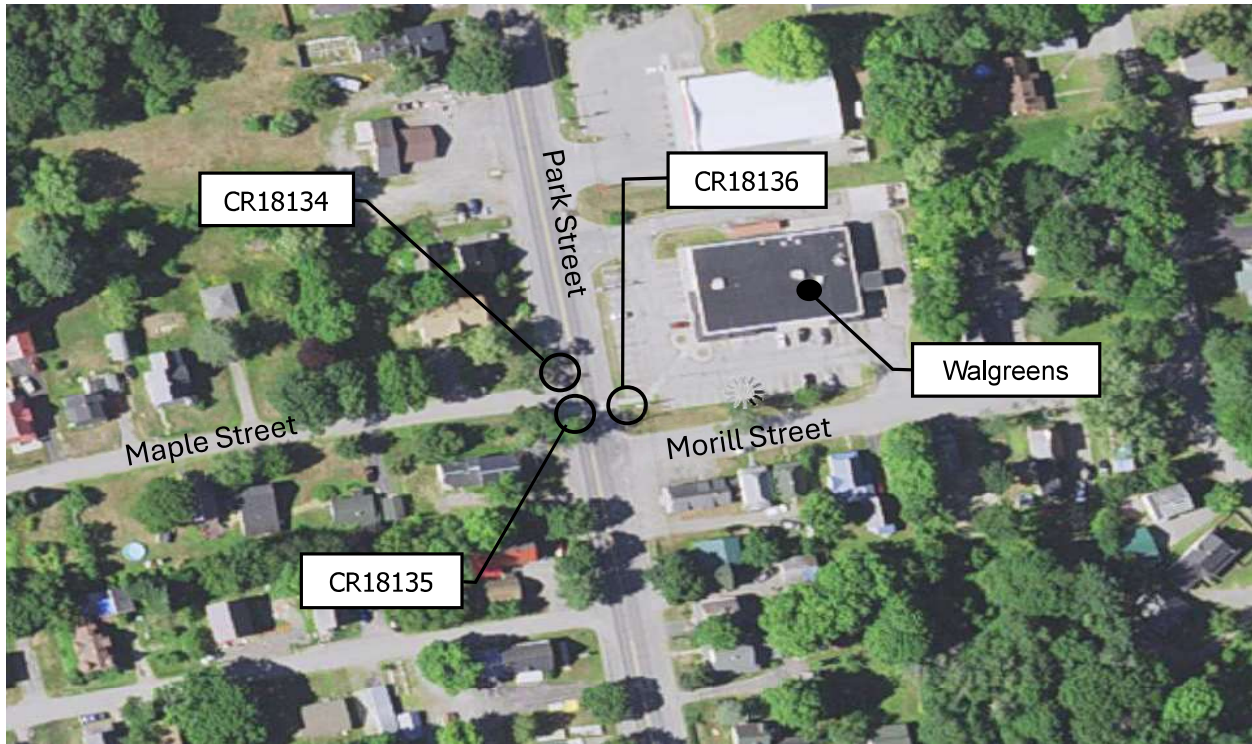
Mid-block from Maple Street on East side of Park Street (CR18136)

Reconstruct Pedestrian Ramp

- Reconstruct similar to Standard Details 801 (14).
- Remove Existing pavement and DWF on sidewalk approx. 25' x 5'.
- Regrade existing sidewalk approx. 25' x 5'.
- Repave existing sidewalk approx. 25' x 5'.
- Install 5' x 2' Detectable warning Fields.
- Install new curb type 3 approx. 16'.
- Paint crosswalk across Park Street Between Asset ID's CR18136 and CR18135.
- Install new Pedestrian Sign

- Reconstruct similar to Standard Details 801 (22).
- Remove Existing pavement and DWF on sidewalk approx. 10' x 5'.
- Regrade existing sidewalk approx. 10' x 5'.
- Repave existing sidewalk approx. 10' x 5'.
- Install 5' x 2' Detectable warning Fields.
- Install new curb type 3 approx. 10'.
- Install new Pedestrian Sign

- Reconstruct similar to Standard Details 801 (22).
- Remove Existing pavement and DWF on sidewalk approx. 10' x 5'.
- Regrade existing sidewalk approx. 10' x 5'.
- Repave existing sidewalk approx. 10' x 5'.
- Install 5' x 2' Detectable warning Fields.
- Install new curb type 3 approx. 10'.
- Paint crosswalk across Maple Street Between Asset ID's CR18135 and CR18134.

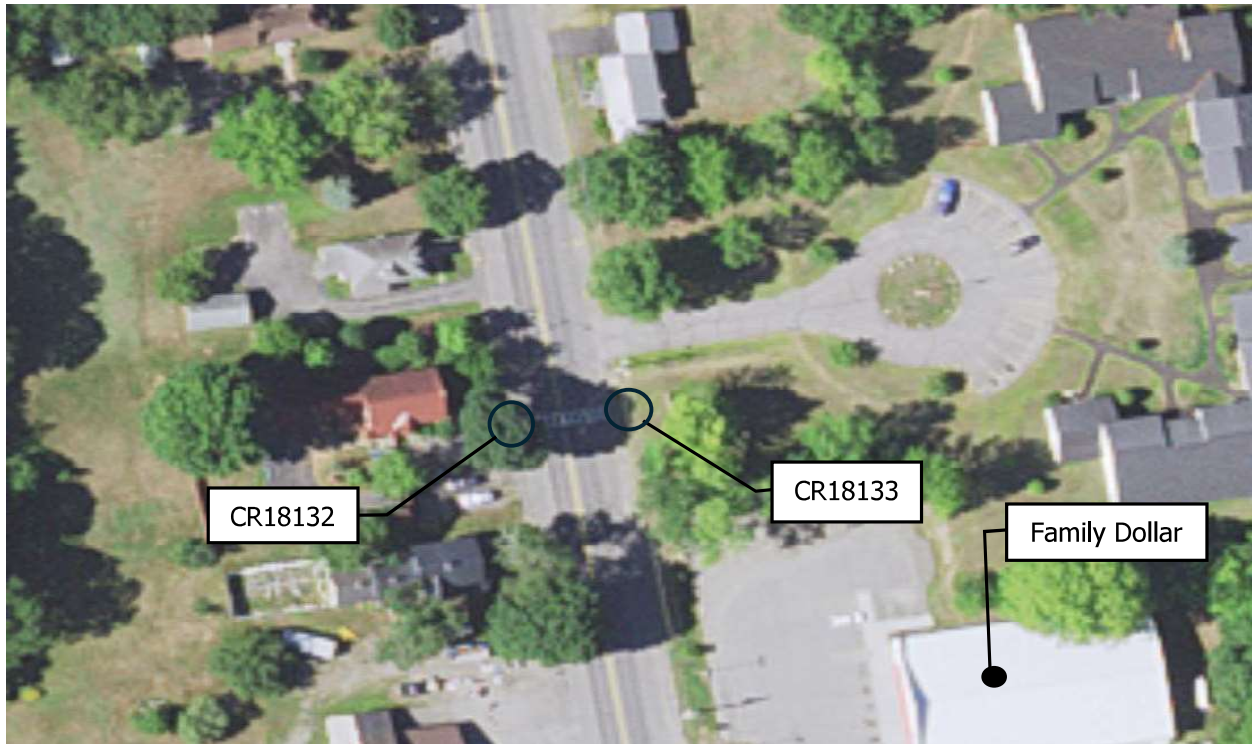
Park Street (CR18133)

Reconstruct Pedestrian Ramp

- Reconstruct similar to Standard Details 801 (14).
- Remove Existing pavement and DWF on sidewalk approx. 25' x 5'.
- Regrade existing sidewalk approx. 25' x 5'.
- Repave existing sidewalk approx. 25' x 5'.
- Install 5' x 2' Detectable warning Fields.
- Install new curb type 3 approx. 16'.
- Paint crosswalk across Park Street Between Asset ID's CR18133 and CR18132.
- Install new Pedestrian Sign

- Relocate ramp back towards house.
- Reconstruct similar to Standard Details 801 (14).
- Remove Existing pavement on sidewalk approx. 25' x 5'.
- Regrade existing sidewalk approx. 25' x 5'.
- Repave existing sidewalk approx. 25' x 5'.
- Install 5' x 2' Detectable warning Fields.
- Install new curb Type 3 approx. 16'.
- Install new Regulatory Pedestrian Sign.

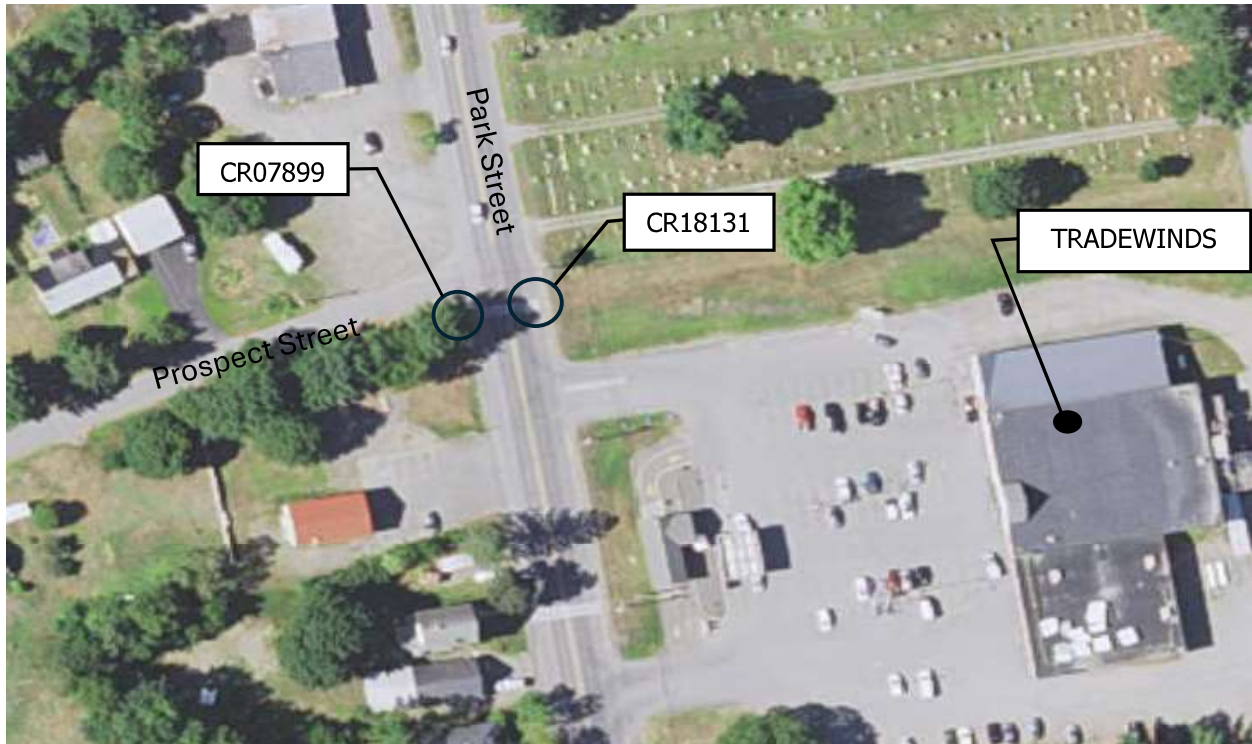
Park Across Prospect Street East side of Park Street (CR18131)

Reconstruct Pedestrian Ramp

- Reconstruct similar to Standard Details 801 (14).
- Remove Existing pavement on sidewalk approx. 25' x 5'.
- Regrade existing sidewalk approx. 25' x 5'
- Repave existing sidewalk approx. 25' x 5'
- Install 5' x 2' Detectable warning Fields.
- Install new curb Type 3 approx. 16'.
- Paint crosswalk across Main Street Between Asset ID's CR18131 and CR08799.
- Install new Regulatory Pedestrian Sign

- Reconstruct similar to Standard Details 801 (22).
- Remove Existing pavement on sidewalk approx. 10' x 5'.
- Regrade existing sidewalk approx. 10' x 5'
- Repave existing sidewalk approx. 10' x 5'
- Install 5' x 2' Detectable warning Fields.
- Install new curb Type 3 approx. 10'.
- Install new Regulatory Pedestrian Sign.

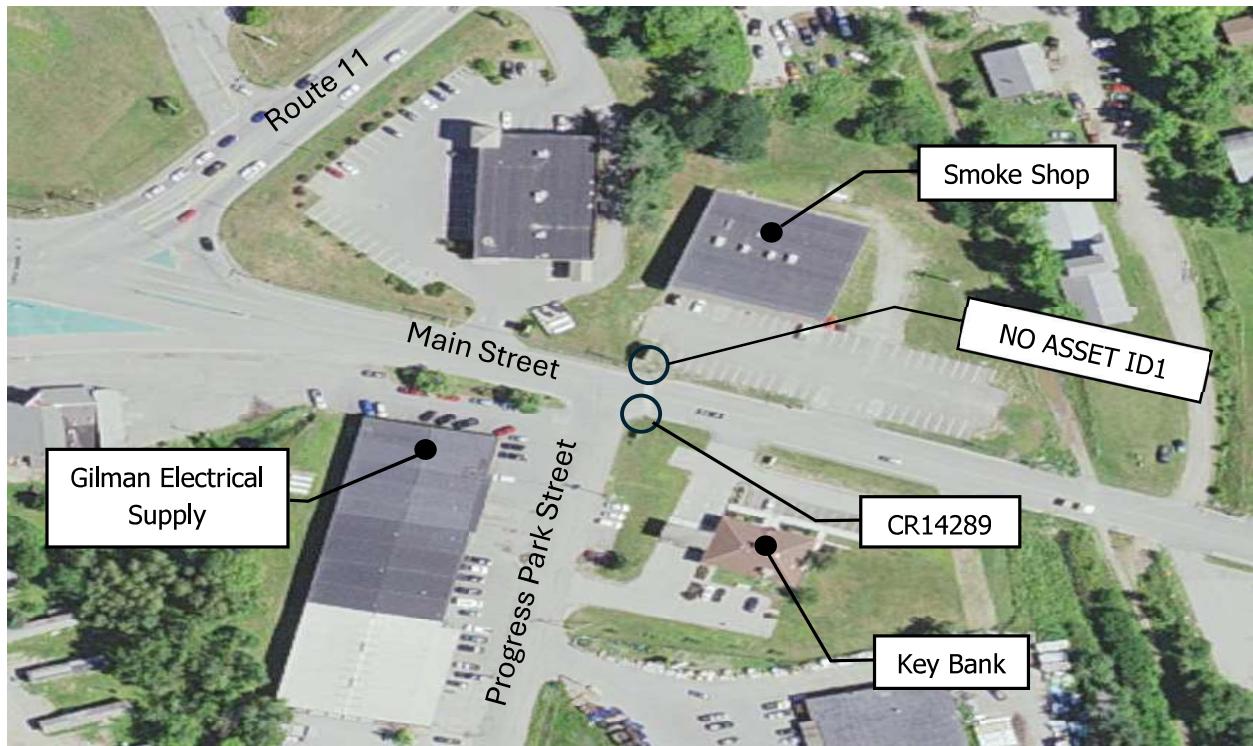
Main Street / Progress Park Street (CR14289)

Reconstruct Pedestrian Ramp

- Reconstruct similar to Standard Details 801 (22).
- Remove Existing pavement on sidewalk approx. 5' x 5'.
- Regrade existing sidewalk approx. 5' x 5'
- Repave existing sidewalk approx. 5' x 5'
- Install 5' x 2' Detectable warning Fields at Skew.
- Repaint crosswalk across Main Street Between Asset ID's CR14289 and No Asset ID1.

- Reconstruct a one-side ramp similar to Standard Details 801 (14).
- Remove Existing pavement on sidewalk approx. 25' x 5'.
- Regrade existing sidewalk approx. 25' x 5'.
- Repave existing sidewalk approx. 25' x 5'.
- Install 5' x 2' Detectable warning Fields.
- Reset 16' curb type 1.

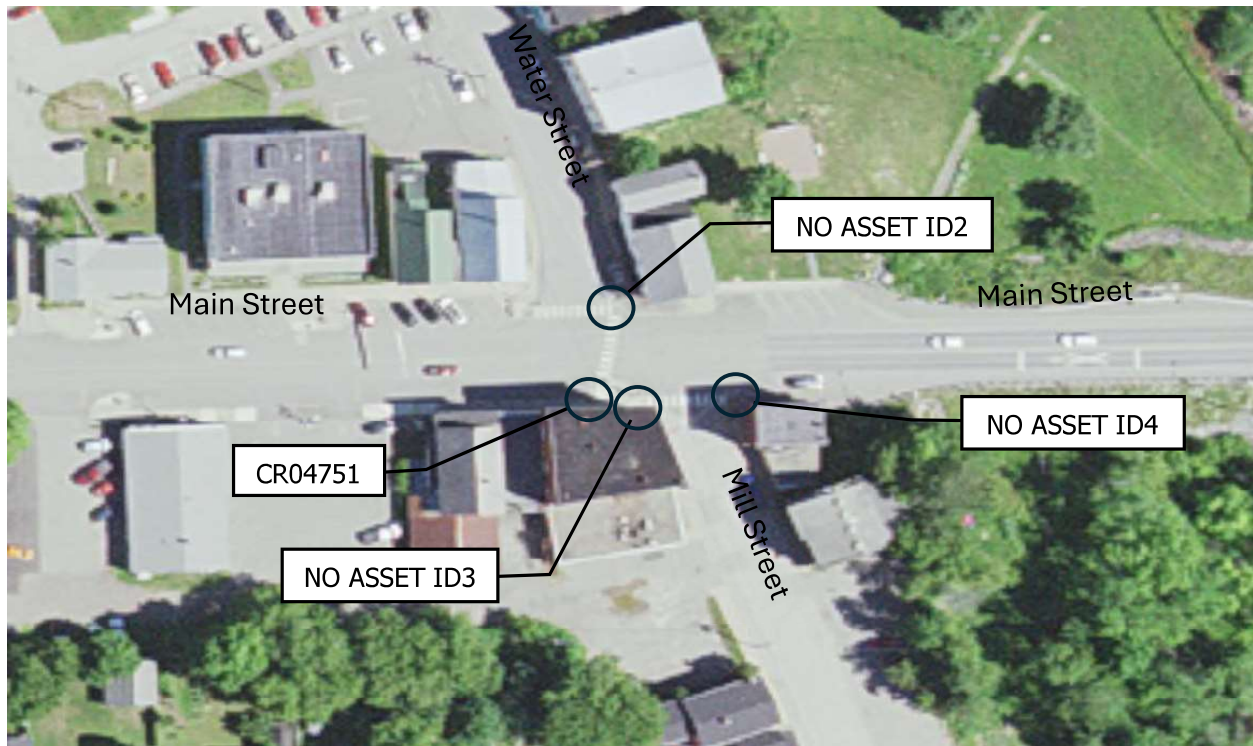
Main Street / Water Street Midblock (CR04751)

Reconstruct Pedestrian Ramp

- Remove existing concrete landing approx. 10' x 10' and detectable warning fields.
- Adjust the affected Water gate.
- Regrade the sidewalk approx. 10' x 10'.
- Replace the concrete landing approx. 10' x 10'.
- Install 5' x 2' Detectable warning Fields.
- Repaint crosswalk across Main Street Between Asset ID's CR14289 and No Asset ID1.

- Remove existing pavement on sidewalk approx. 5' x 5' and 16' x 2' shoulder.
- Regrade existing sidewalk approx. 5' x 5' and approx. 16' x 2' shoulder.
- Repave existing sidewalk approx. 5' x 5' and approx. 16' x 2' shoulder.
- Install 5' x 2' Detectable warning Fields.

- Remove existing concrete landing approx. 16' x 8' and detectable warning fields.
- Regrade the sidewalk approx. 16' x 8'.
- Replace the concrete landing approx. 16' x 8'.
- Install 5' x 2' Detectable warning Fields.
- Repaint crosswalk across Mill Street between Asset ID's No asset ID3 and No Asset ID4.

- Remove existing pavement on sidewalk approx. 25' x 5'.
- Regrade existing sidewalk approx. 25' x 5'.
- Repave existing sidewalk approx. 25' x 5'.
- Install 6' x 2' Detectable warning Fields.
- Install new Regulatory Pedestrian Sign

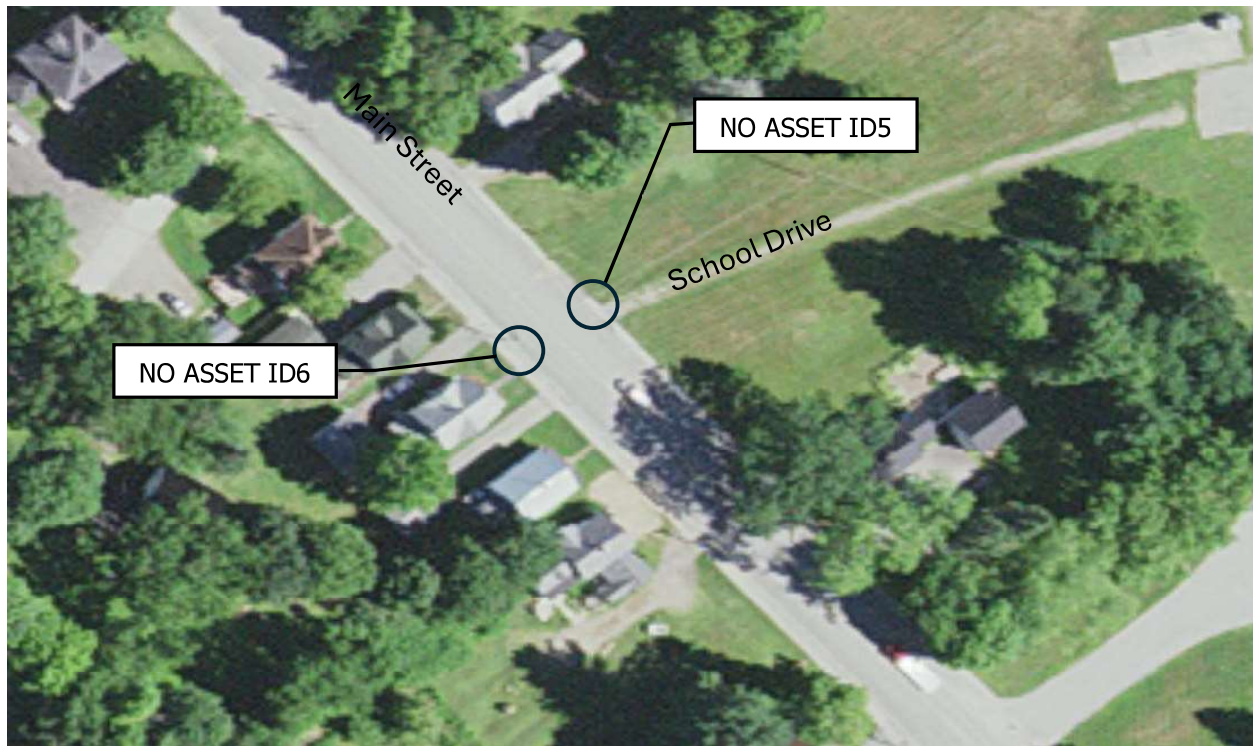
Main Street / School Drive (No Asset 1D5)

Reconstruct Pedestrian Ramp

- Reconstruct similar to Standard Details 801 (14).
- Remove Existing pavement on sidewalk approx. 25' x 5'.
- Regrade existing sidewalk approx. 25' x 5'
- Repave existing sidewalk approx. 25' x 5'
- Install 5' x 2' Detectable warning Fields.
- Install 20' curb type 3.
- Repaint crosswalk across Main Street Between Asset ID's No Asset ID5 and No Asset ID6.
- Install new Regulatory Pedestrian Sign.

- Reconstruct similar to Standard Details 801 (27).
- Remove Existing pavement on sidewalk approx. 10' x 5'.
- Regrade existing sidewalk approx. 10' x 5'
- Repave existing sidewalk approx. 10' x 5'
- Install 5' x 2' Detectable warning Fields.
- Install 10' curb type 3.
- Install new Regulatory Pedestrian Sign.

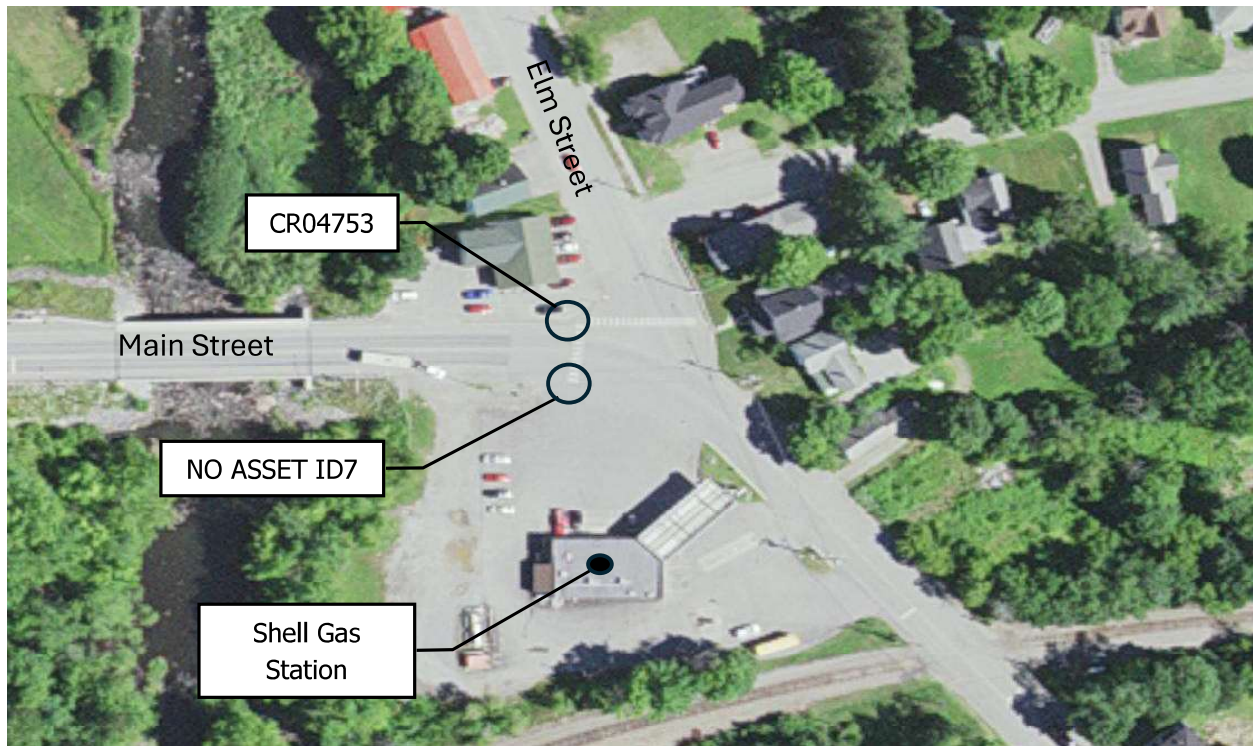
Main Street / Elm Street North Corner (CR04753)

Relocate / Reconstruct Pedestrian Ramp

- Relocate the ramp further down Main street (approx. 44.835316, -69.271325) and remove the existing Crosswalk.
- Reconstruct similar to Standard Details 801 (14).
- Remove Existing pavement on sidewalk approx. 25' x 5' and 16' x 2' shoulder.
- Regrade existing sidewalk approx. 25' x 5' and 16' x 2' shoulder.
- Repave existing sidewalk approx. 25' x 5' and 16' x 2' shoulder.
- Install 5' x 2' Detectable warning Fields.
- Reset 21' curb type 1.
- Paint a new crosswalk across Main Street Between Asset ID CR04753 and No Asset ID7.
- Install new Regulatory Pedestrian Sign.

- Relocate ramp perpendicular to CR04753
- Remove existing pavement on sidewalk approx. 25' x 5'.
- Regrade existing sidewalk approx. 25' x 5'.
- Repave existing sidewalk approx. 25' x 5'.
- Install 5' x 2' Detectable warning Fields.

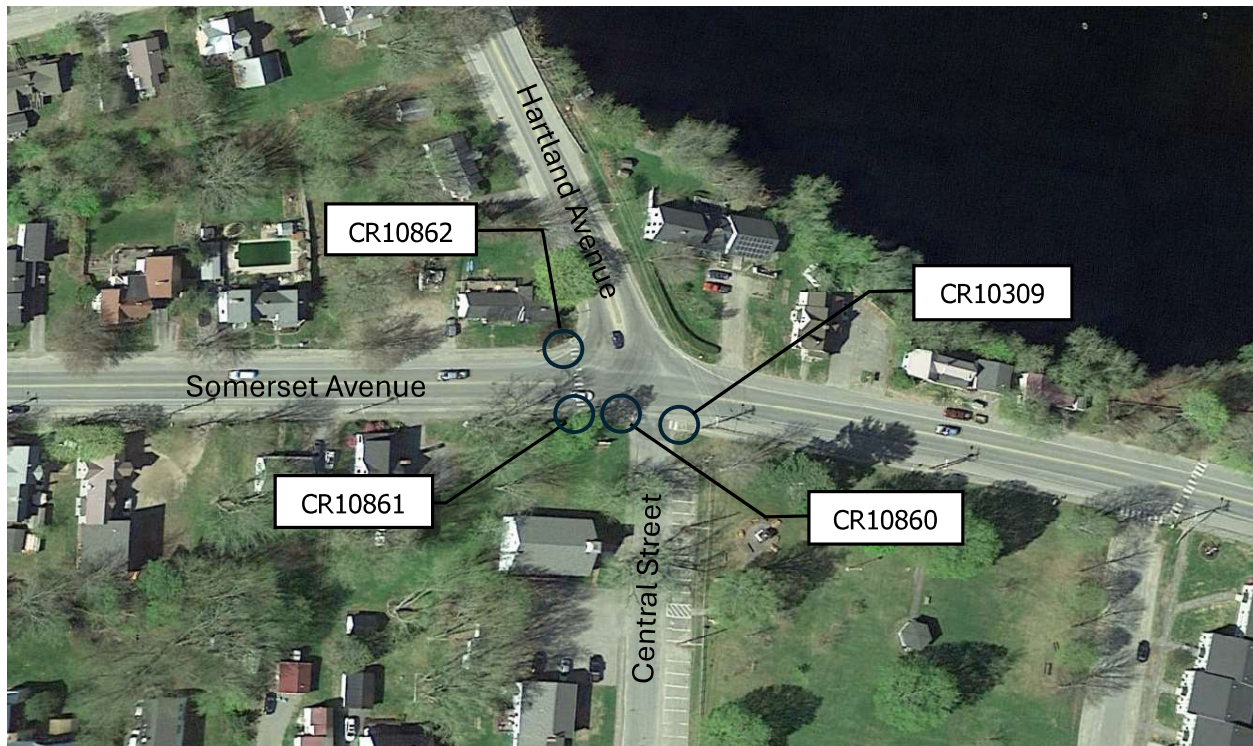
Central Street / Somerset Avenue Southeast (CR10309)

Reconstruct Pedestrian Ramp

- Reconstruct similar to Standard Details 801 (22).
- Remove Existing pavement and DWF on sidewalk approx. 10' x 5'.
- Regrade existing sidewalk approx. 10' x 5' and shoulder approx. 16' x 2'.
- Repave existing sidewalk approx. 10' x 5' and shoulder approx. 16' x 2'.
- Install 5' x 2' Detectable warning Fields.
- Repaint crosswalk across Central Street Between Asset ID's CR10309 and CR10860.

- Reconstruct similar to Standard Details 801 (22).
- Remove Existing pavement and DWF on sidewalk approx. 10' x 5'.
- Regrade existing sidewalk approx. 10' x 5' and shoulder approx. 16' x 2'.
- Repave existing sidewalk approx. 10' x 5' and shoulder approx. 16' x 2'.
- Install 5' x 2' Detectable warning Fields.

- Reconstruct similar to Standard Details 801 (14).
- Remove Existing pavement and DWF on sidewalk approx. 25' x 5'.
- Regrade existing sidewalk approx. 25' x 5' and shoulder approx. 21' x 2'
- Repave existing sidewalk approx. 25' x 5' and shoulder approx. 21' x 2'.
- Reset curb type 3 approx. 21'.
- Install 5' x 2' Detectable warning Fields.
- Repaint crosswalk across Central Street Between Asset ID's CR10861 and CR10862.

- Reconstruct similar to Standard Details 801 (14).
- Remove Existing pavement and DWF on sidewalk approx. 25' x 5'.
- Regrade existing sidewalk approx. 25' x 5' and shoulder approx. 21' x 2'
- Repave existing sidewalk approx. 25' x 5' and shoulder approx. 21' x 2'.
- Install 5' x 2' Detectable warning Fields.

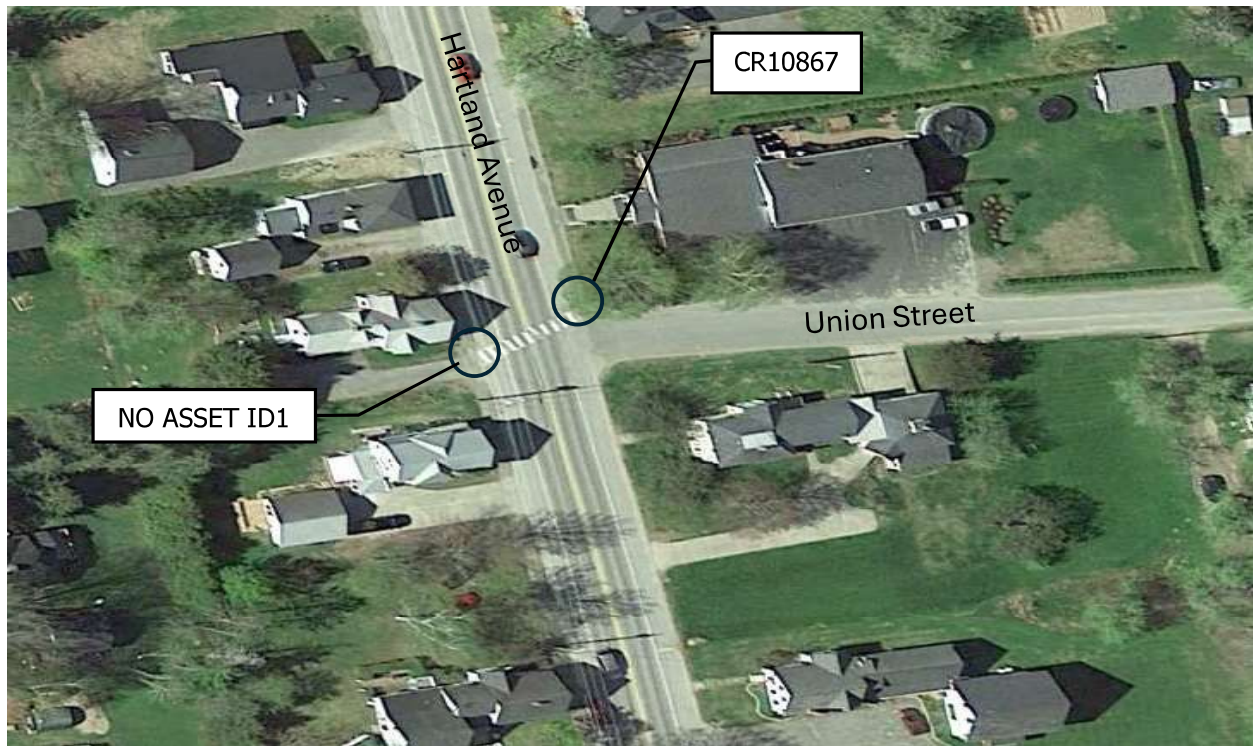
Hartland Avenue / Union Street Southwest (No Asset 1D1)

Relocate/Reconstruct Pedestrian Ramp

- Move away from catch basin. Relocate ramp back towards house.
- Reconstruct similar to Standard Details 801 (14).
- Remove Existing pavement on sidewalk approx. 25' x 5'.
- Regrade existing sidewalk approx. 25' x 5'
- Repave existing sidewalk approx. 25' x 5'
- Install 5' x 2' Detectable warning Fields.
- Install new curb Type 3 approx. 16'.
- Install new Regulatory Pedestrian Sign
- Remove and paint new crosswalk across Hartland Avenue Between Asset ID's No Asset ID1 and CR10867.

- Move away from catch basin. Relocate ramp back towards house.
- Relocate ramp back towards house.
- Reconstruct similar to Standard Details 801 (14).
- Remove Existing pavement on sidewalk approx. 25' x 5'.
- Regrade existing sidewalk approx. 25' x 5'
- Repave existing sidewalk approx. 25' x 5'
- Install 5' x 2' Detectable warning Fields.
- Install new curb Type 3 approx. 16'.
- Install new Regulatory Pedestrian Sign.

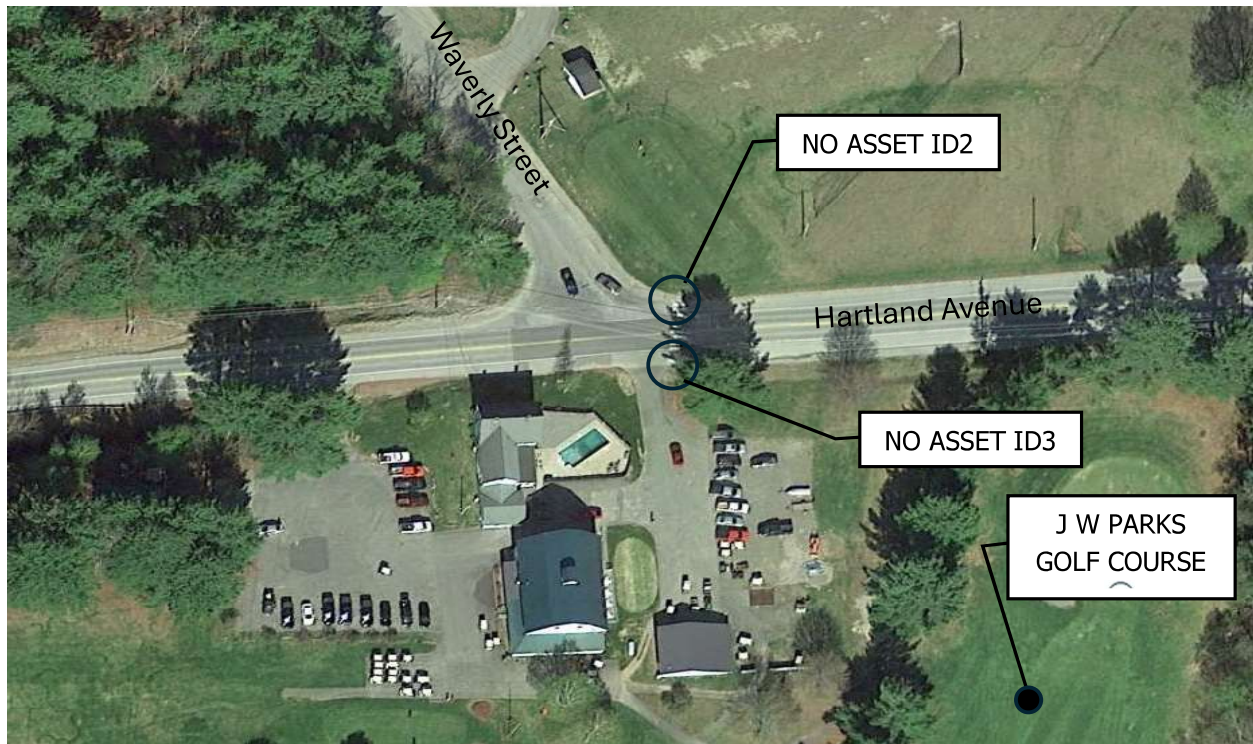
Hartland Avenue /Waverly Street East Ramp (No Asset 1D2)

Relocate/Reconstruct Pedestrian Ramp

Reconstruct Pedestrian Ramp

- Move the ramp back to make it perpendicular to the adjacent landing.
- Reconstruct similar to Standard Details 801 (14).
- Remove Existing pavement on sidewalk approx. 25' x 5'.
- Regrade existing sidewalk approx. 25' x 5'
- Repave existing sidewalk approx. 25' x 5'
- Install 5' x 2' Detectable warning Fields.
- Install 16' curb Type 3.
- Install new Regulatory Pedestrian Sign
- Remove and paint a new crosswalk across Hartland Avenue between Asset ID's No Asset ID2 and No Asset ID3.

- Reconstruct similar to Standard Details 801 (27).
- Remove Existing pavement on sidewalk approx. 10' x 5'.
- Regrade existing sidewalk approx. 10' x 5'
- Repave existing sidewalk approx. 10' x 5'
- Install 5' x 2' Detectable warning Fields.
- Install 10' curb Type 3.
- Install new Regulatory Pedestrian Sign.
