# **Highway Bridge Inspection Report**

**BR# 5196**

## **AUGUSTA MEMORIAL BRIDGE**

**Inspection Date:** 05/12/2021

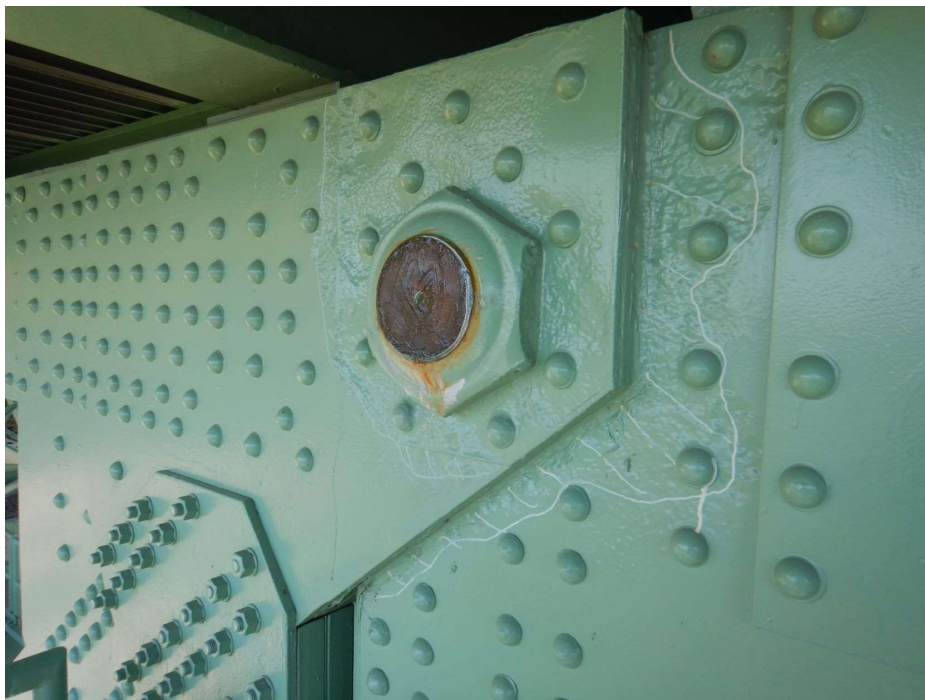
PHOTO 1

Description Downstream end of Pin X3 of Span 2. Note minor pitting (up to 1/8" deep) of connection plates.

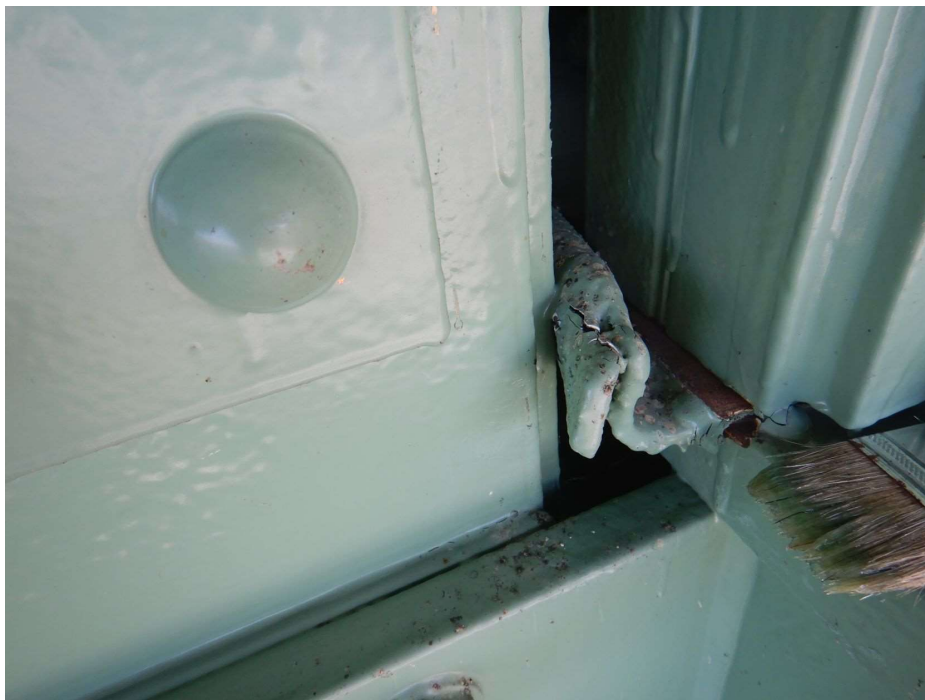
PHOTO 2

Description Upstream end of Pin X3 of Span 2. Note bent and cracked bracket pad due to the movement in the pin connection.

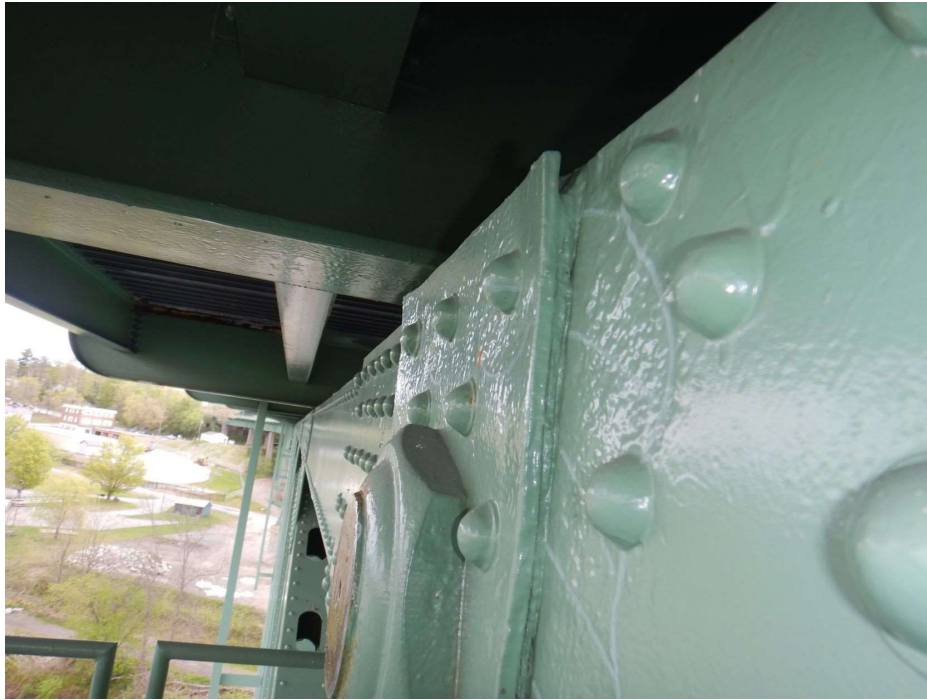
PHOTO 3

Description Upstream end of Pin X7 of Span 4. Note section loss adjacent to the pin connection and warped plates due to significant pitting between the gusset plates.

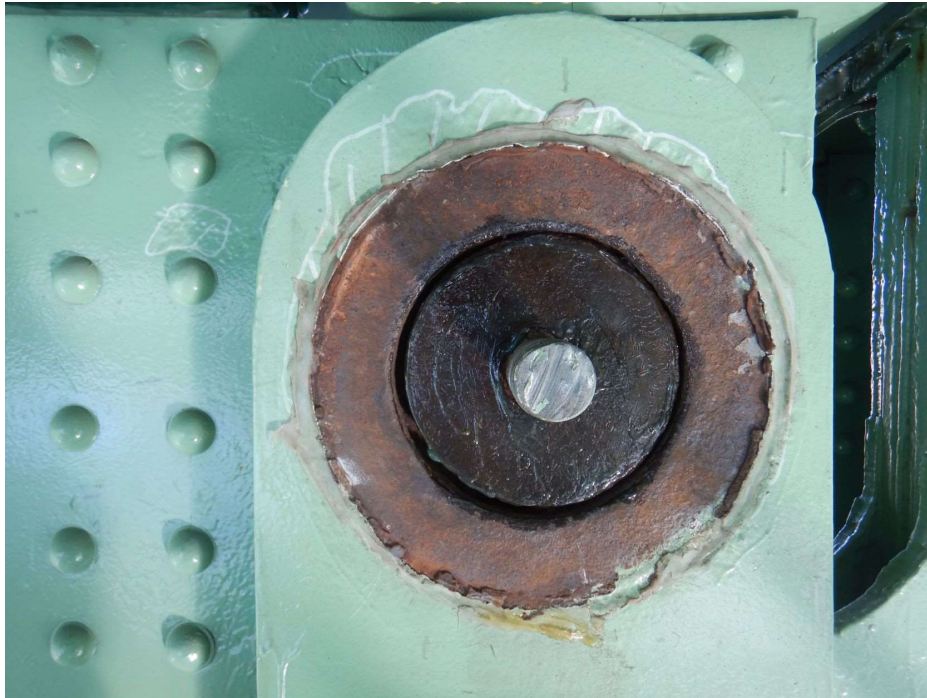
PHOTO 5

Description Downstream end of Pin mg of Span 4. Note the corrosion on the face of pin and link plate. Also note the gap between the pin and link plate.

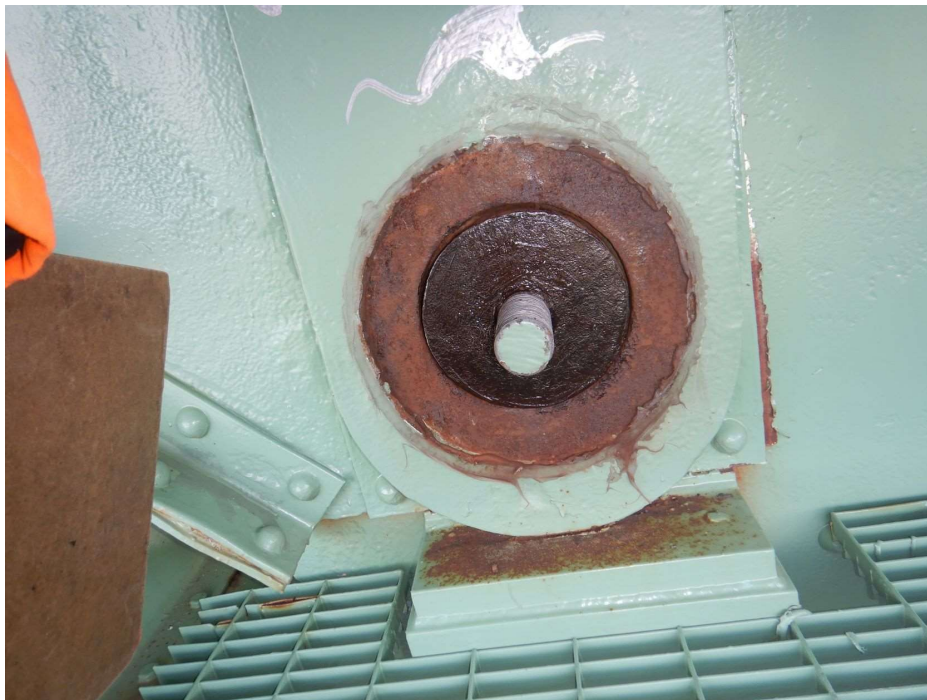
PHOTO 6

Description Upstream end of Pin mg of Span 4. Note the corrosion on the face of pin and link plate, the gap between the pin and link plate, and the link plate resting on the bottom catch plate.

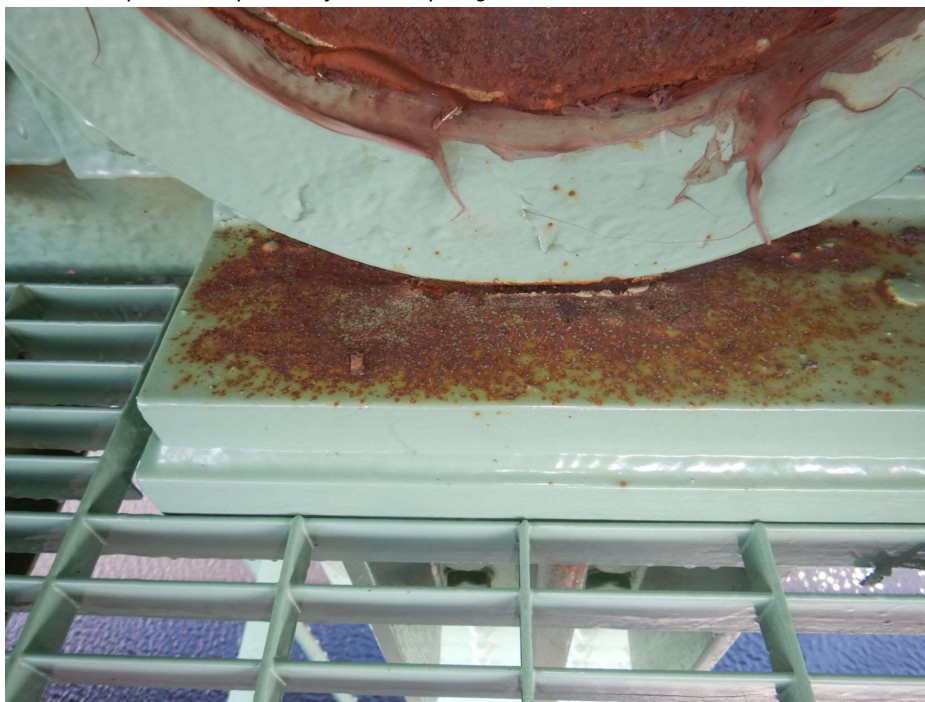
PHOTO 8

Description Upstream end of Pin mg of Span 4. Close up look at the link plate in contact with the bottom catch plate.

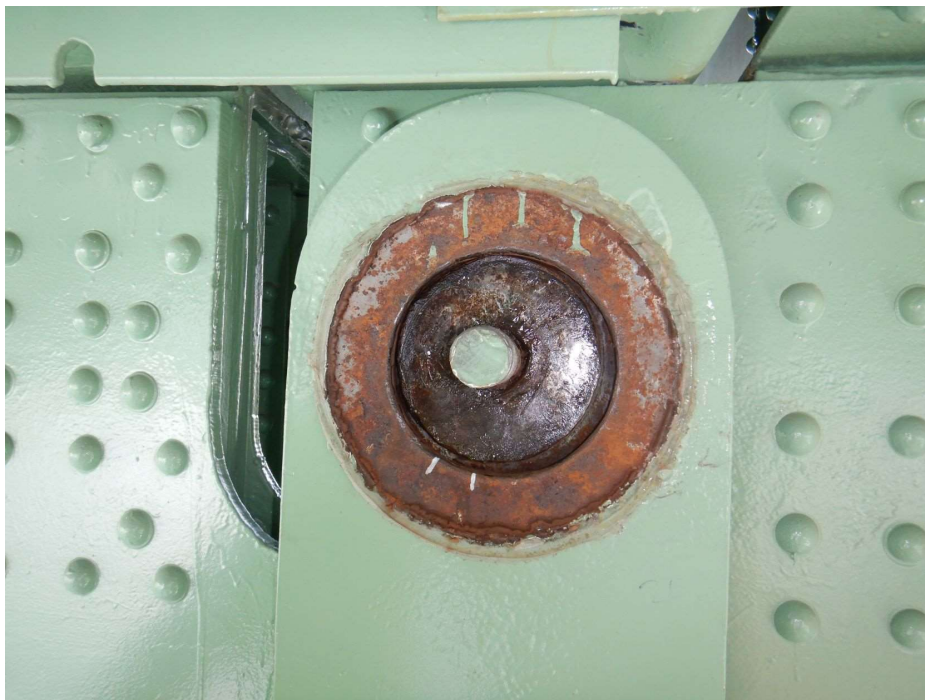
PHOTO 9

Description Upstream end of Pin mg of Span 4. Note the corrosion on the face of pin and link plate and the gap between the pin and link plate.

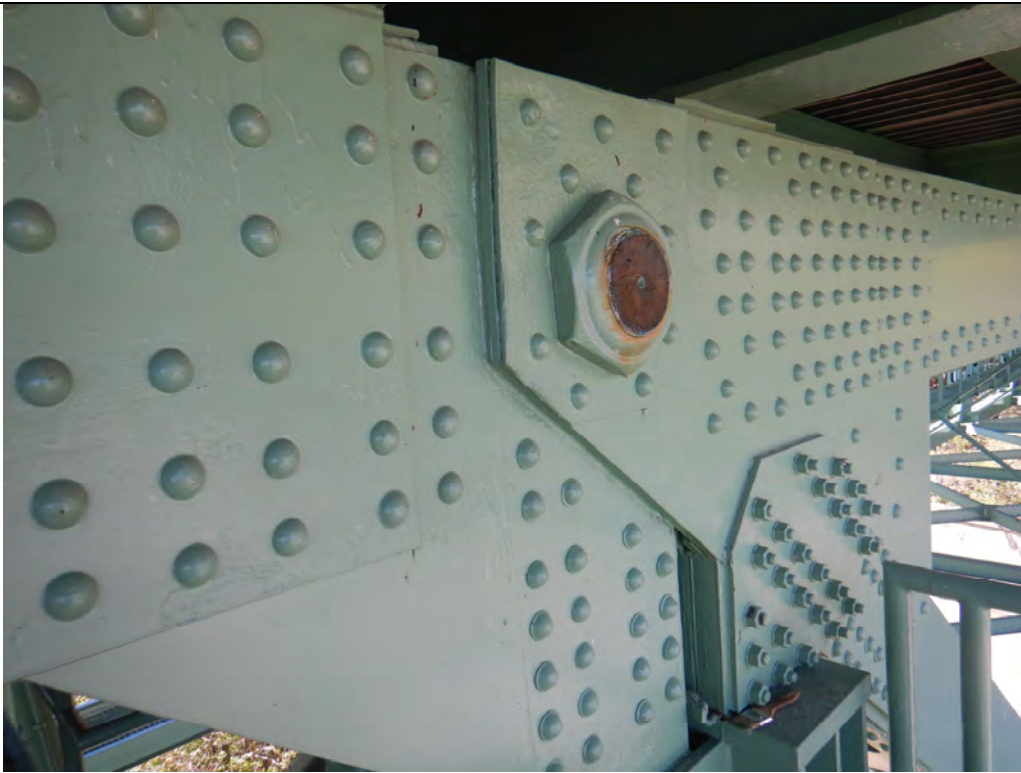
**Location:** *Span No. 2, Pin X3, Upstream*

**Description:** *Upstream end. Note rust stains around the pin.*

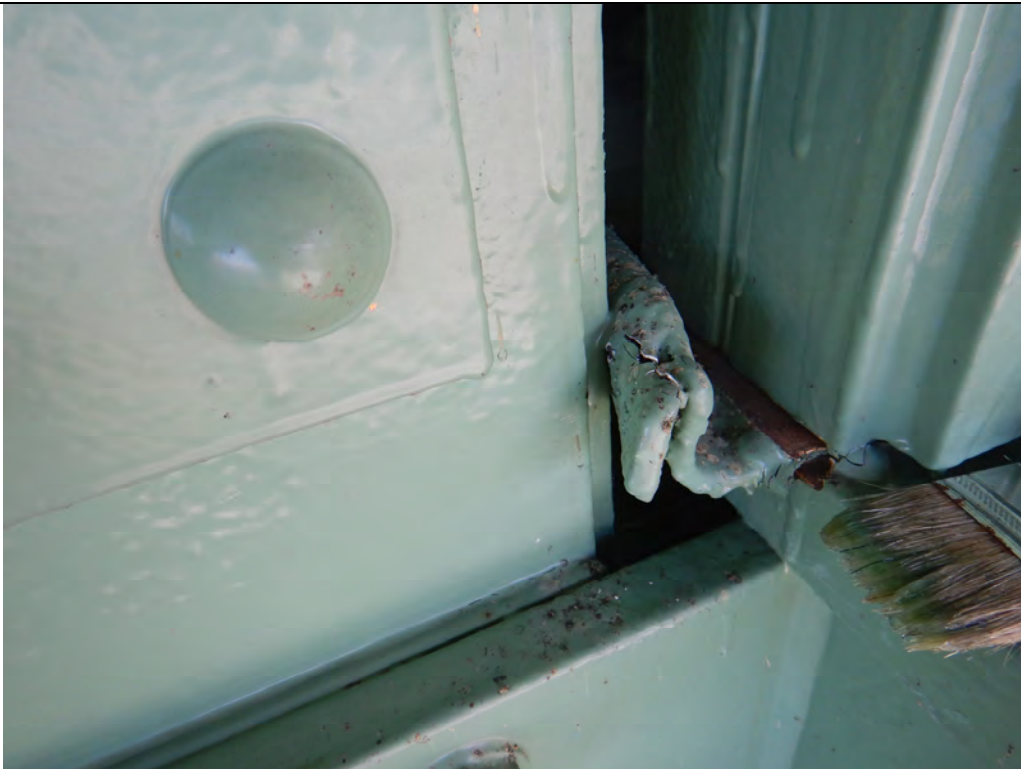
**Location:** *Span No. 2, Pin X3, Upstream*

**Description:** *Upstream end. Note bent and cracked bracket pad due to the movement in the pin connection.*

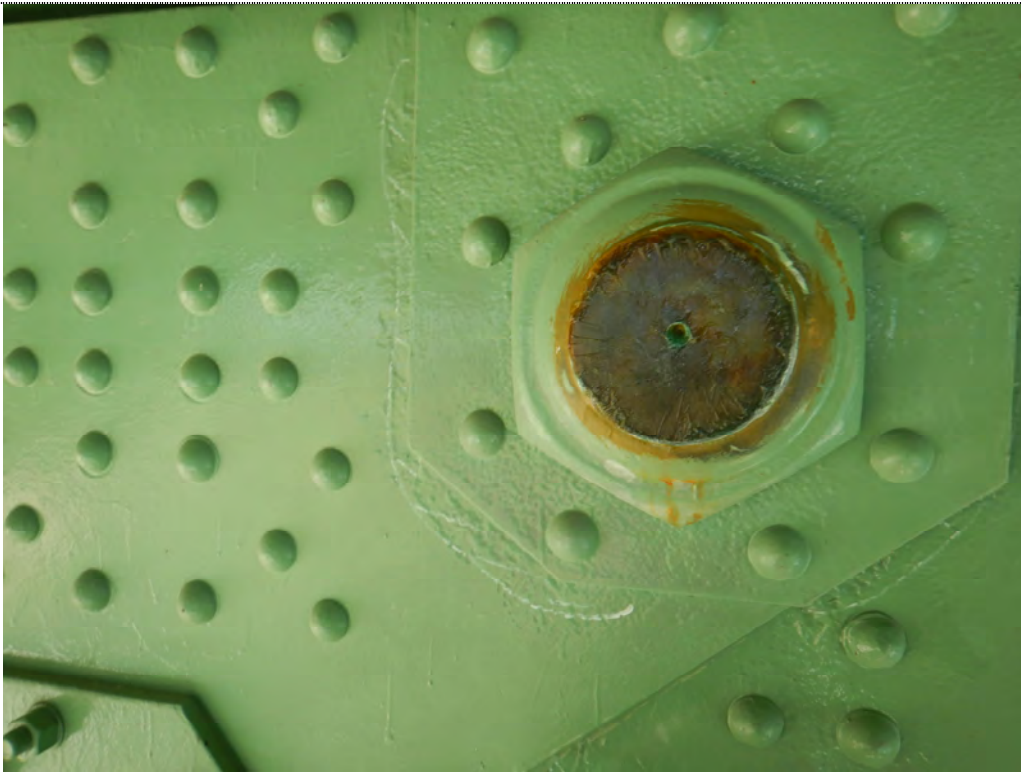
**Location:** Span No. 2, Pin X3, Upstream

**Description:** Downstream end. Note painted over section loss on the exterior gusset plate and rust stains on the pin.

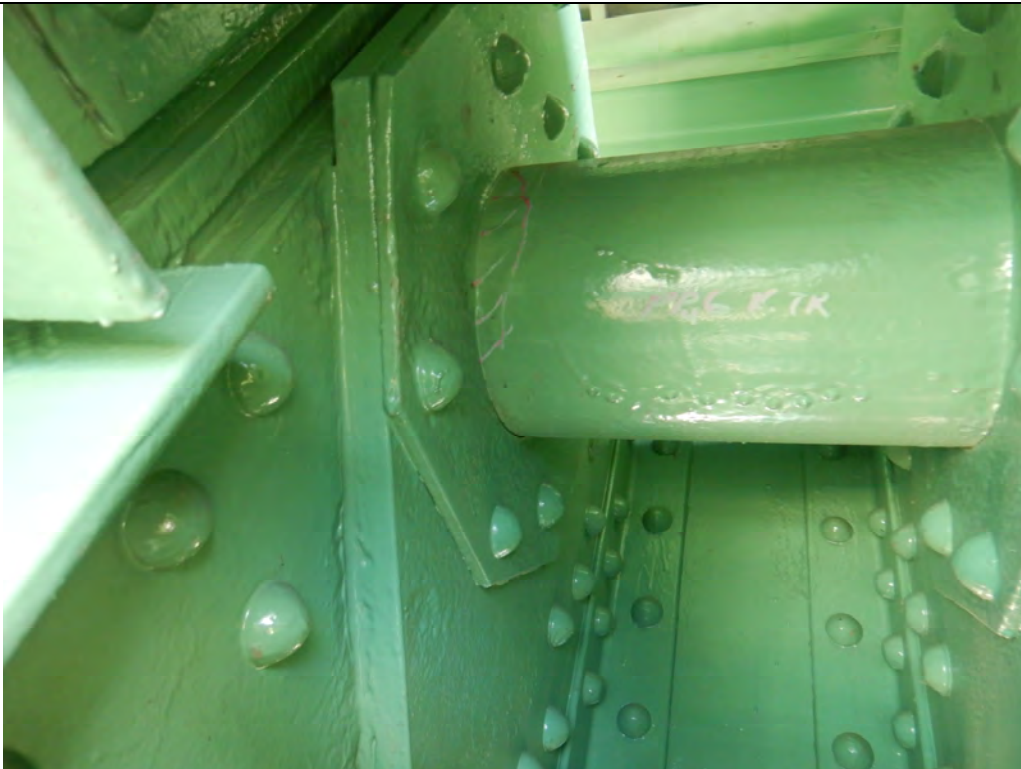
**Location:** Span No. 2, Pin X3, Upstream

**Description:** Top of connection looking down. Note minor pitting on top of pin.

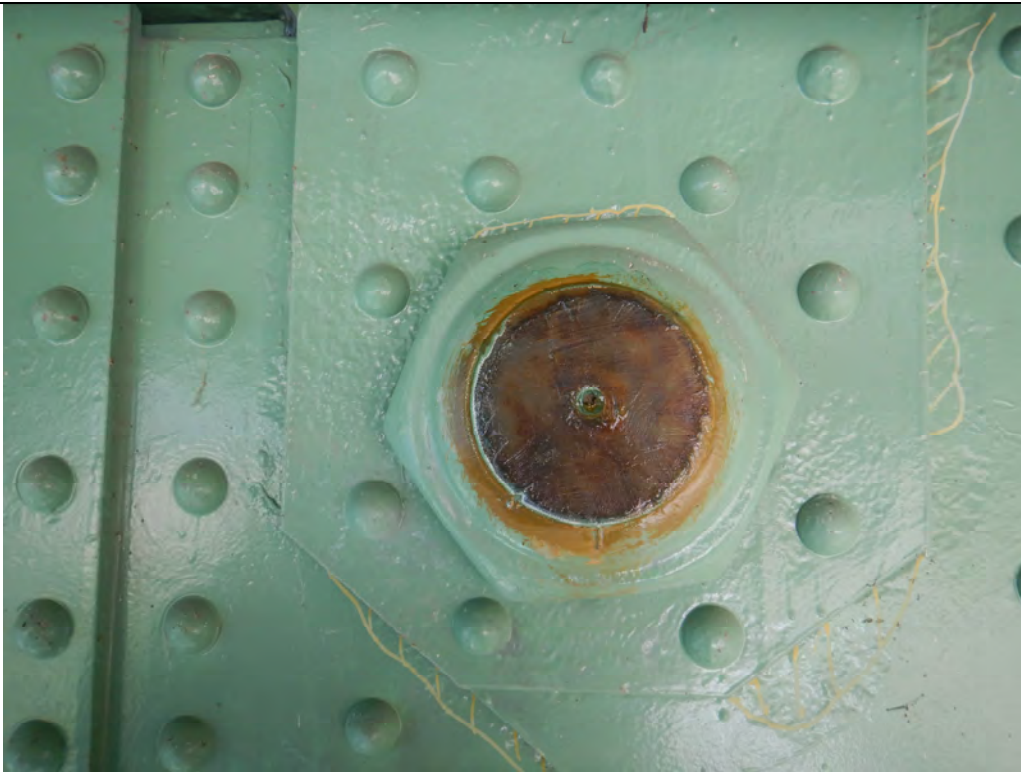
**Location:** *Span No. 2, Pin X3, Downstream*

**Description:** *Upstream end. Note moderate pitting (up to 3/16" deep) of connection plates.*

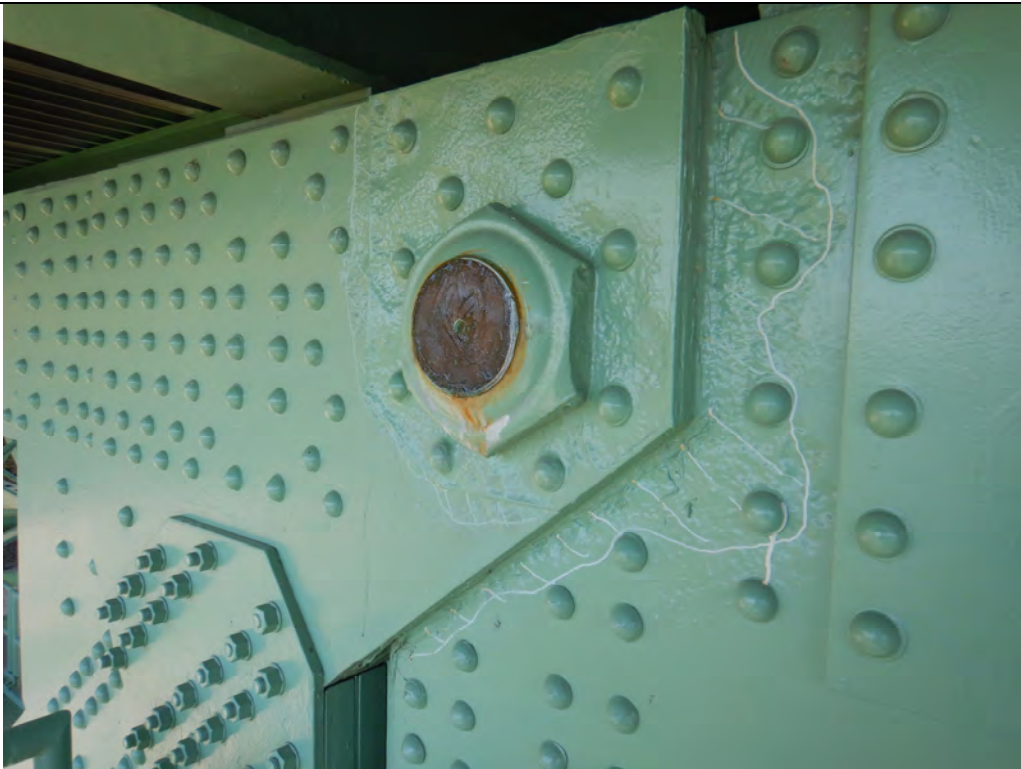
**Location:** *Span No. 2, Pin X3, Downstream*

**Description:** *Downstream end. Note minor pitting (up to 1/8" deep) of connection plates.*

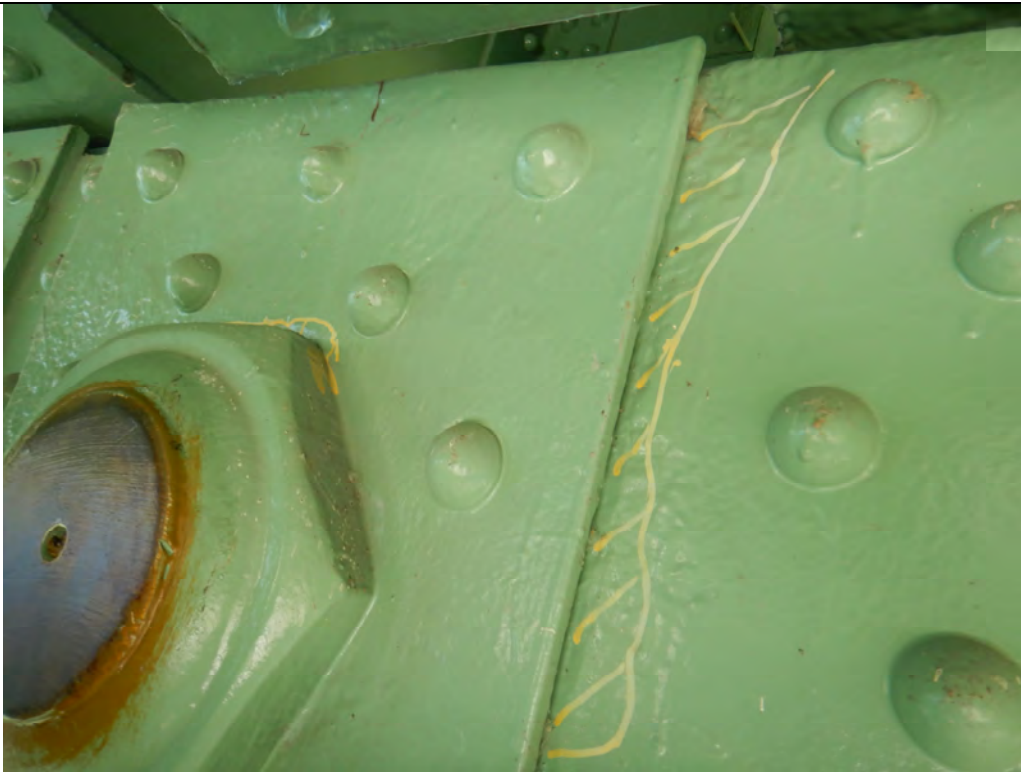
**Location:** Span No. 2, Pin X3, Downstream

**Description:** Upstream end. Close up view of typical 1/8" deep pitting. Note pack rust behind between the steel plate warping the corner edges of the end gusset plate outward.

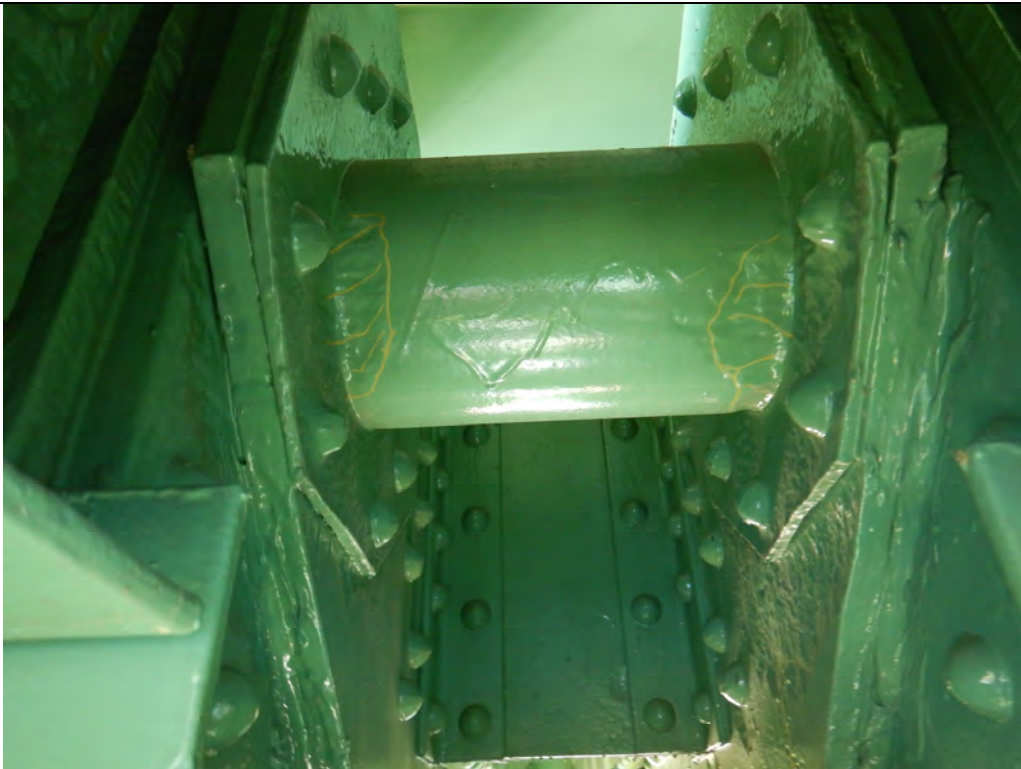
**Location:** Span No. 2, Pin X3, Downstream

**Description:** Bottom of connection looking up. Note minor pitting on the bottom of the pin at both ends and adjacent connection plates.

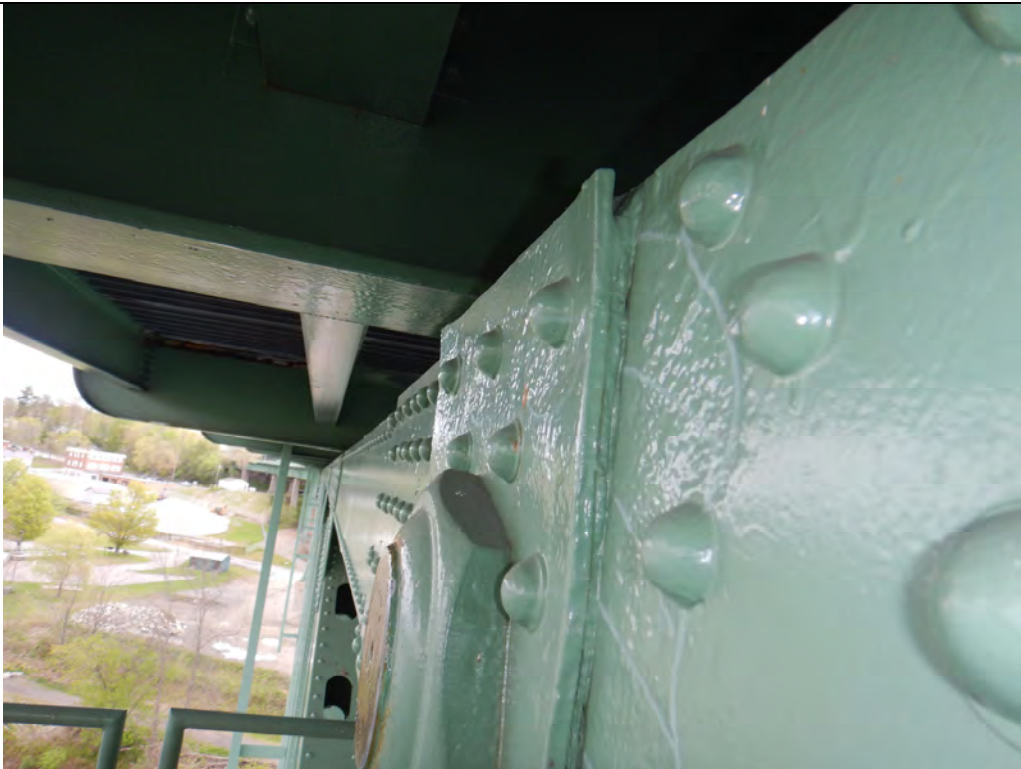
**Location:** Span No. 4, Pin X7, Upstream

**Description:** Upstream end. Note section loss adjacent to the pin connection and warped plates due to significant pitting between the gusset plates.

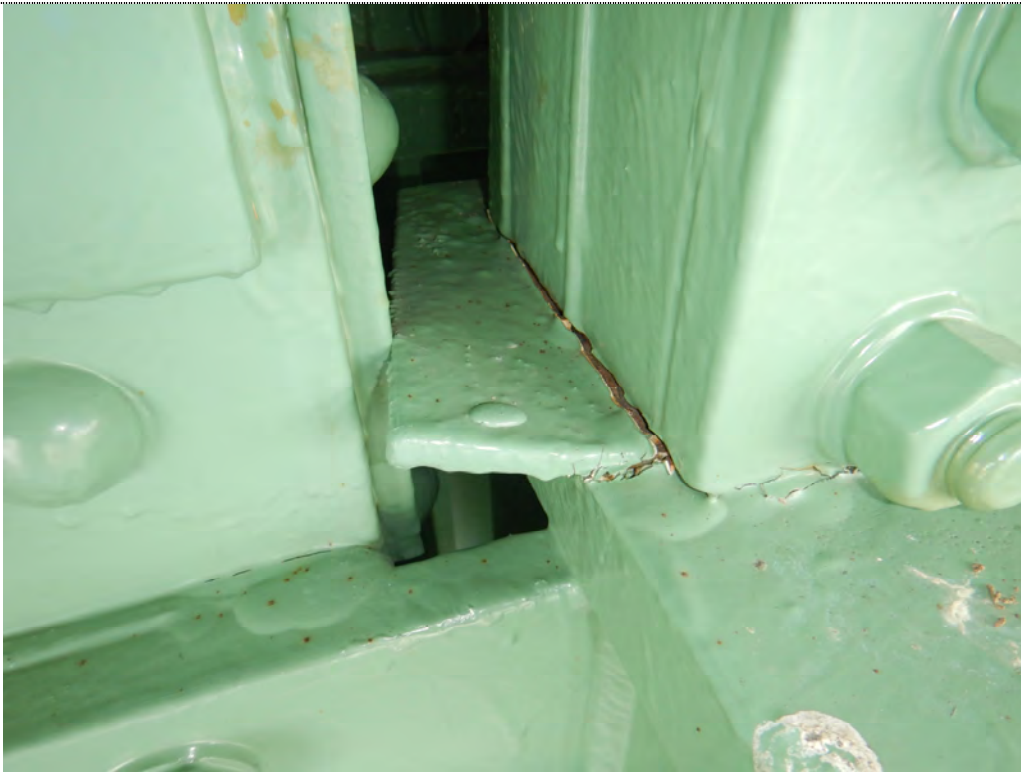
**Location:** Span No. 4, Pin X7, Upstream

**Description:** Upstream end. Note the bracket pad has shifted up to 1/8".

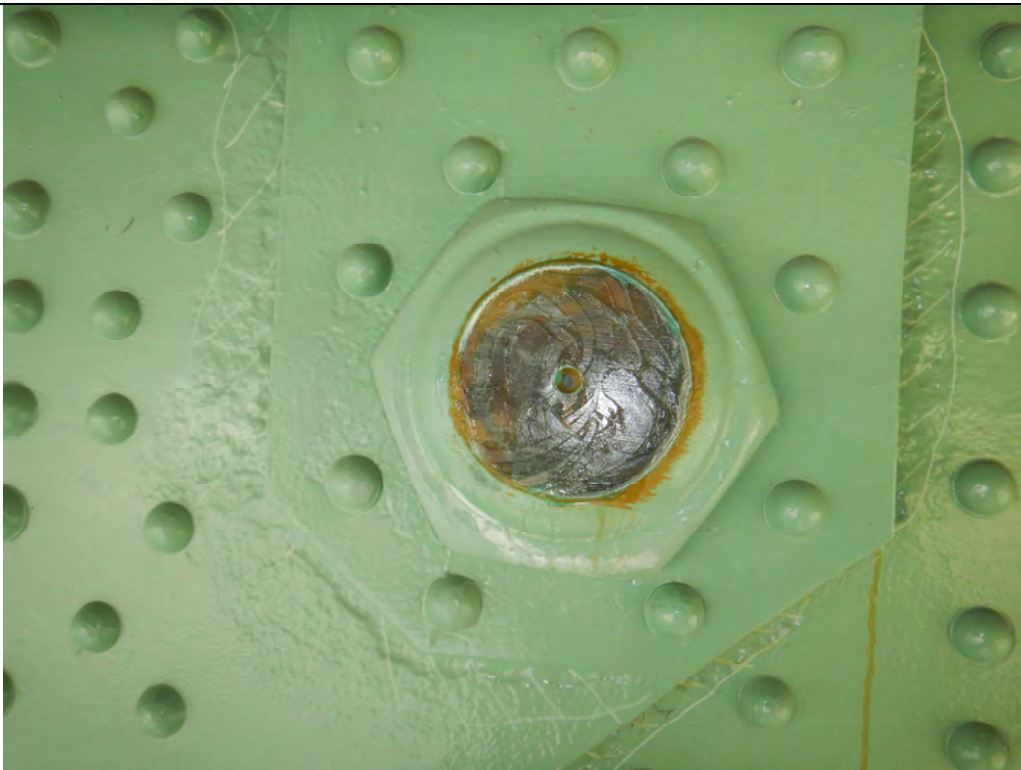
**Location:** Span No. 4, Pin X7, Upstream

**Description:** Downstream end. Note section loss and rust staining adjacent to the pin connection.

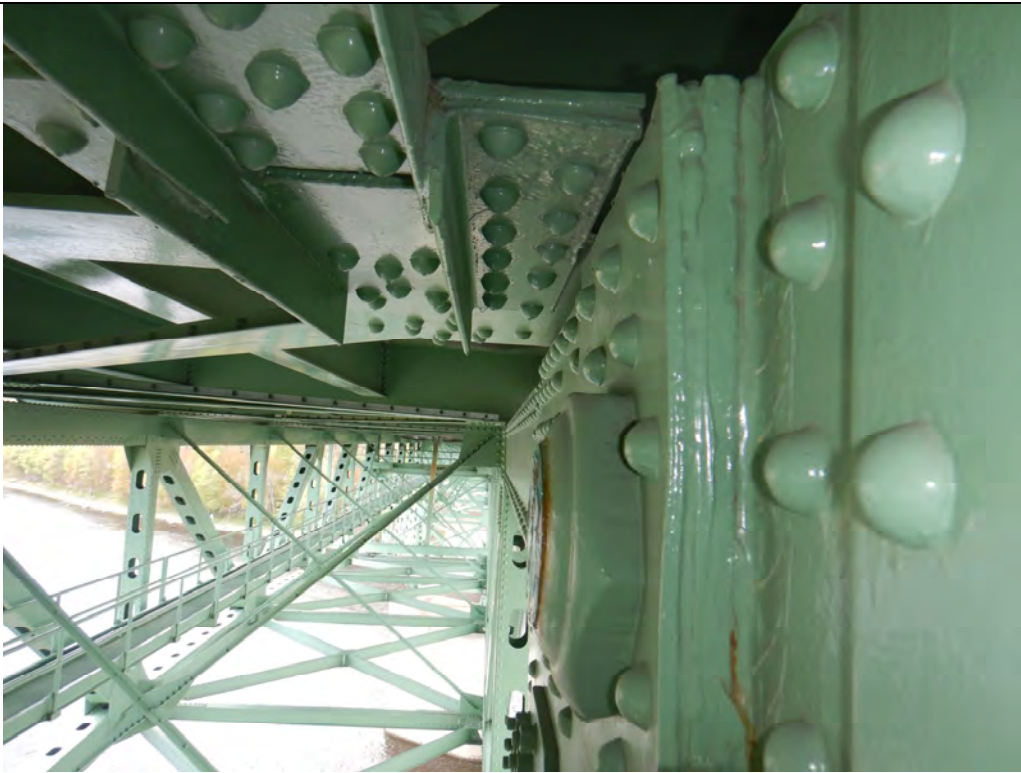
**Location:** Span No. 4, Pin X7, Upstream

**Description:** Downstream end. Close up of the warped plates adjacent to the pin connection.

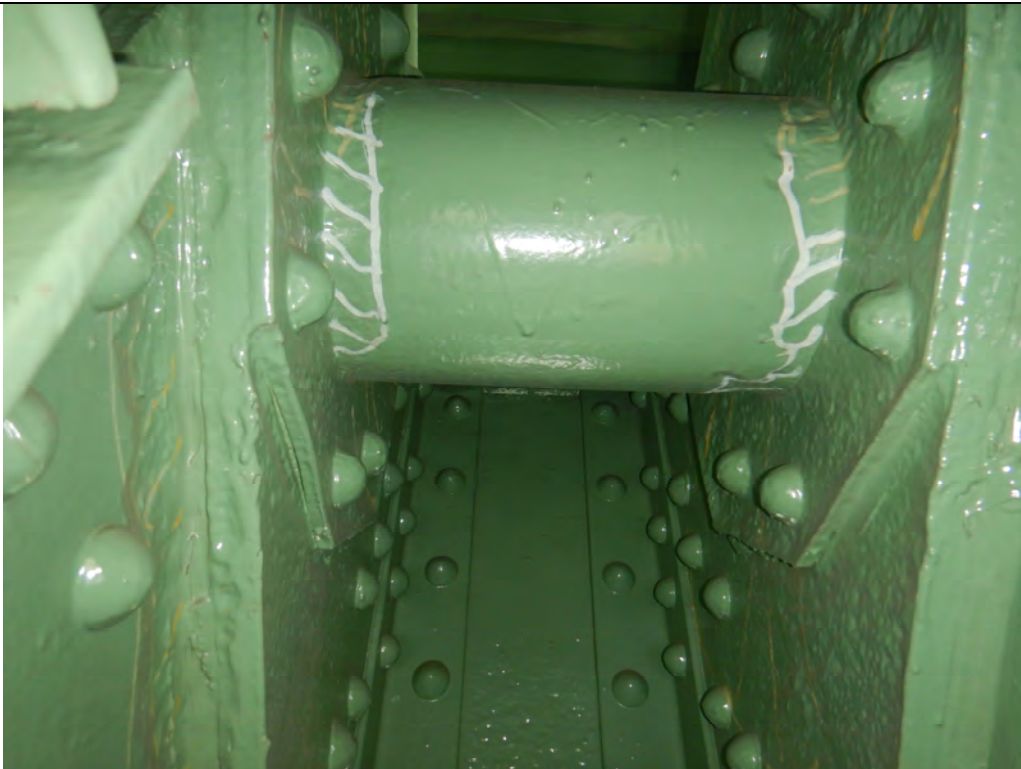
**Location:** Span No. 4, Pin X7, Upstream

**Description:** Top of connection looking down. Note minor pitting on pin and interior plates.

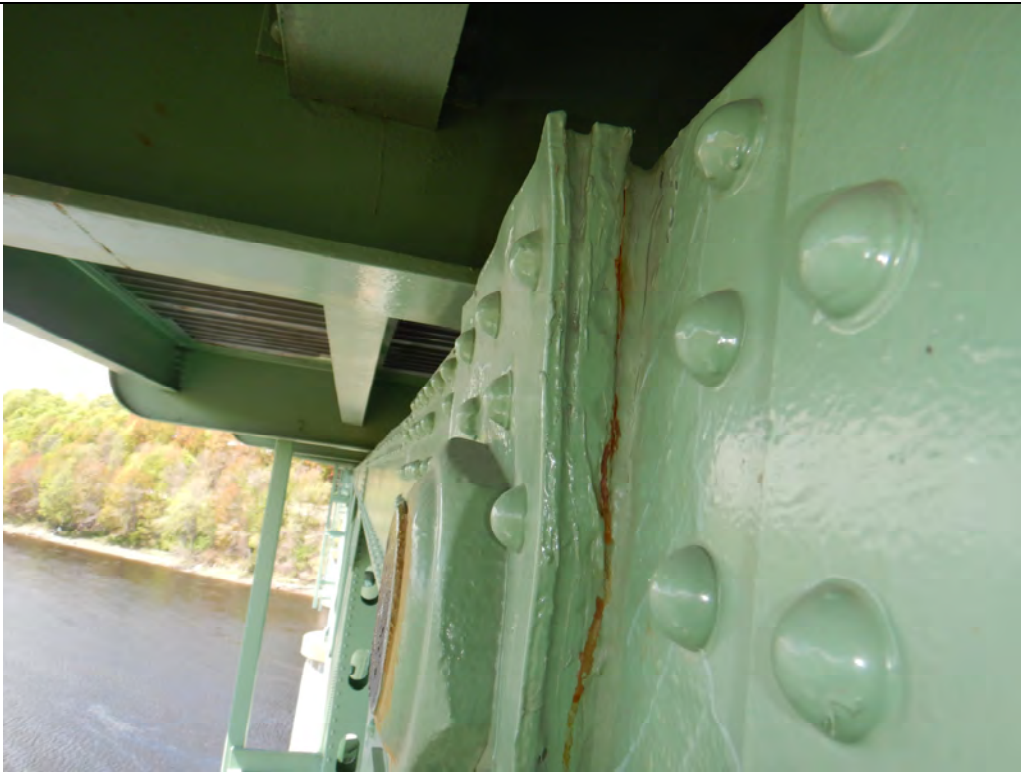
**Location:** *Span No. 4, Pin X7, Downstream*

**Description:** *Downstream end. Note warping of plates. Plates have been sealed and repainted since previous inspection. Rust beginning to form between the plates indicating new corrosion.*

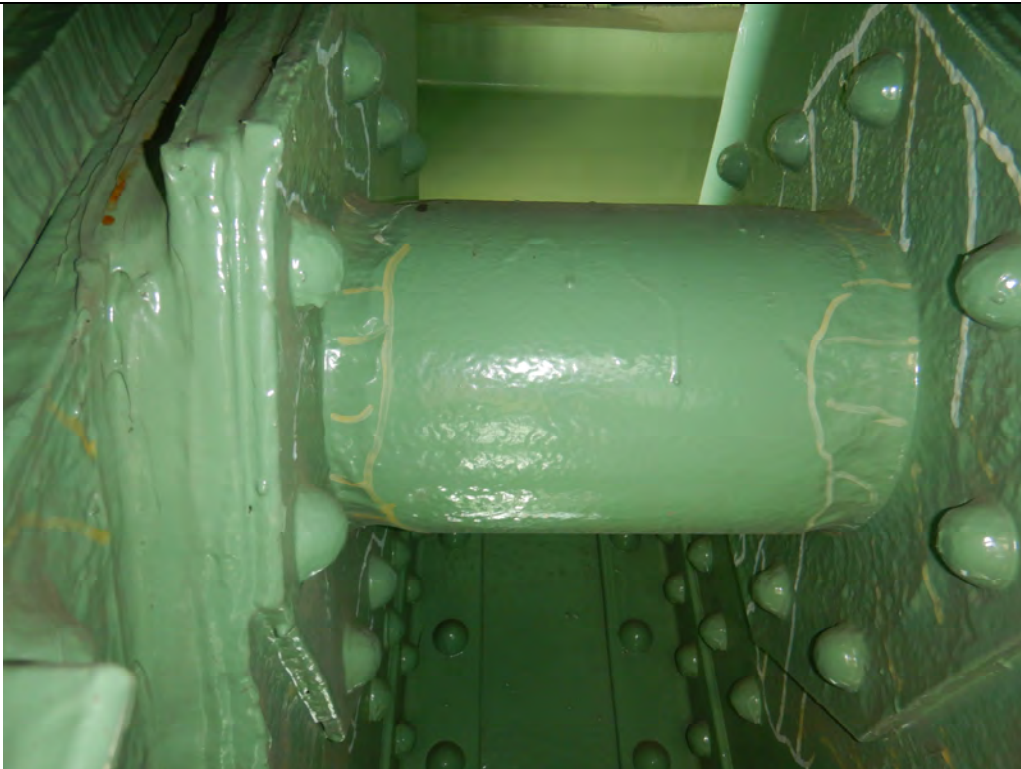
**Location:** *Span No. 4, Pin X7, Downstream*

**Description:** *Top of connection looking down. Note corrosion on pin and interior plates.*

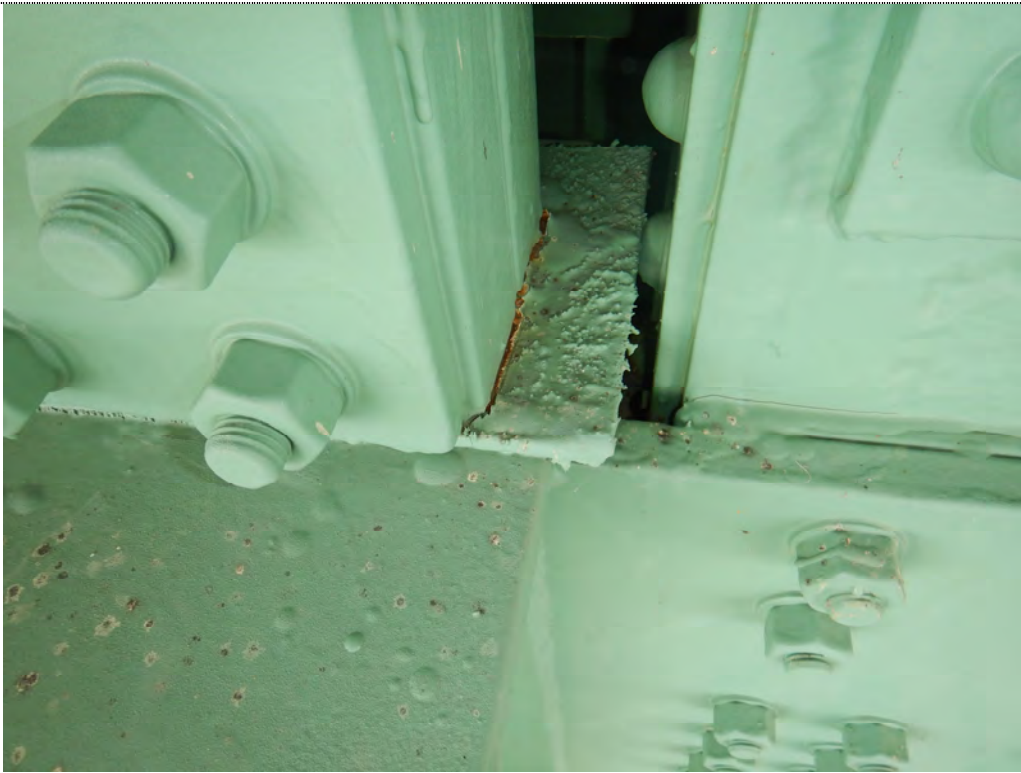
**Location:** Span No. 6, Pin X3, Upstream

**Description:** Upstream end. Note the bracket pad has shifted up to 1/8".

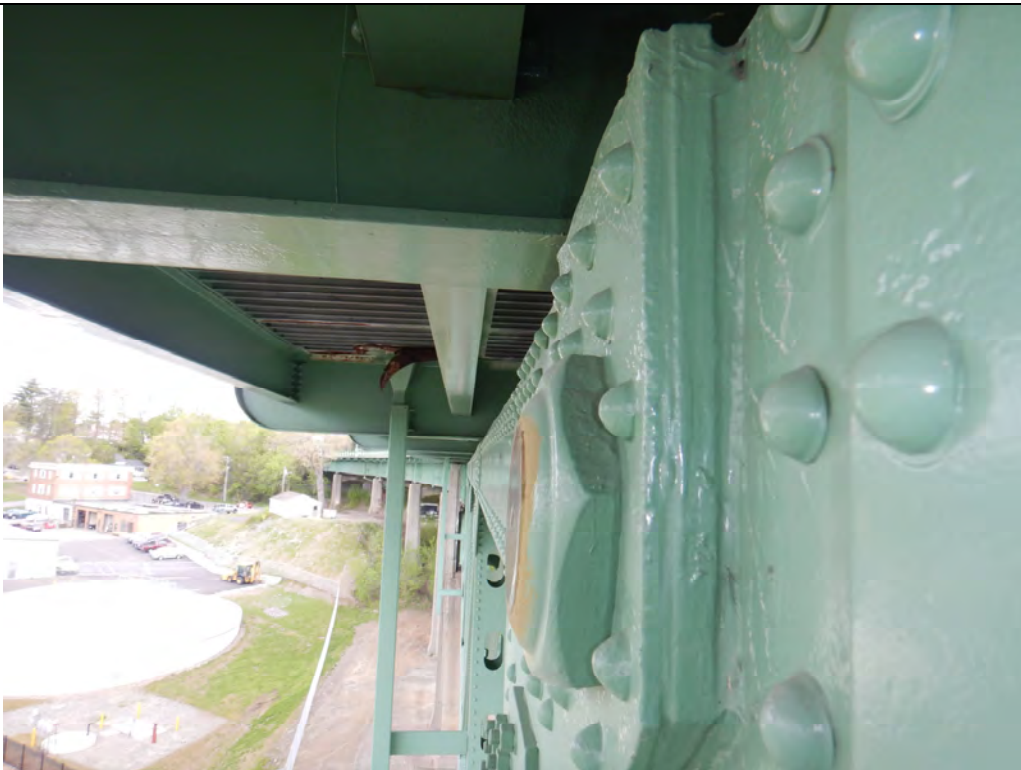
**Location:** Span No. 6, Pin X3, Upstream

**Description:** Upstream end. Note warping of plates. Plates have been sealed and repainted since previous inspection. No seals are broken which indicates the warping has not increased.

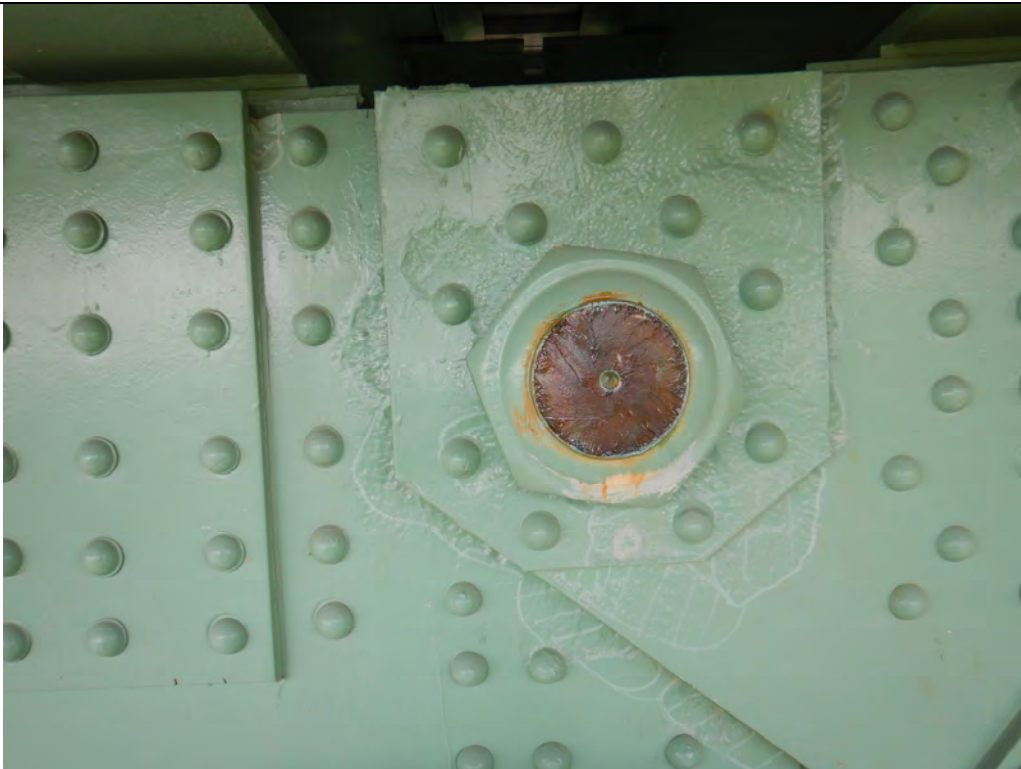
**Location:** *Span No. 6, Pin X3, Downstream*

**Description:** *Downstream end. Note minor corrosion of plates and rust stains around the pin.*

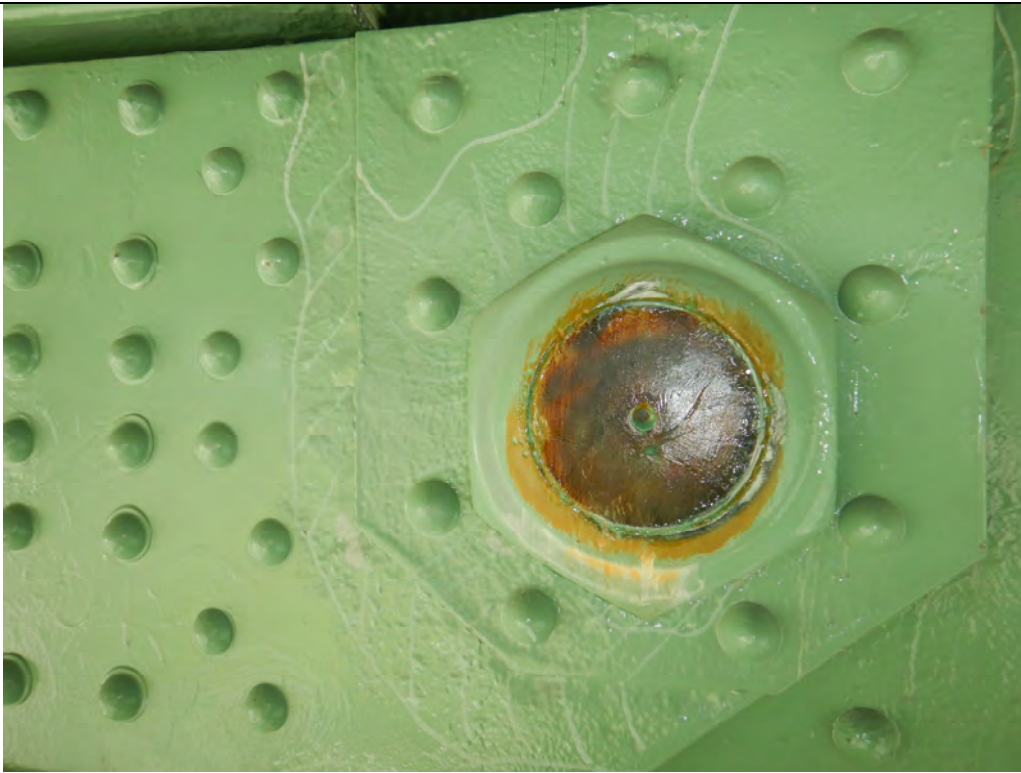
**Location:** *Span No. 6, Pin X3, Downstream*

**Description:** *Upstream end. Note minor corrosion of plates and rust stains around the pin.*

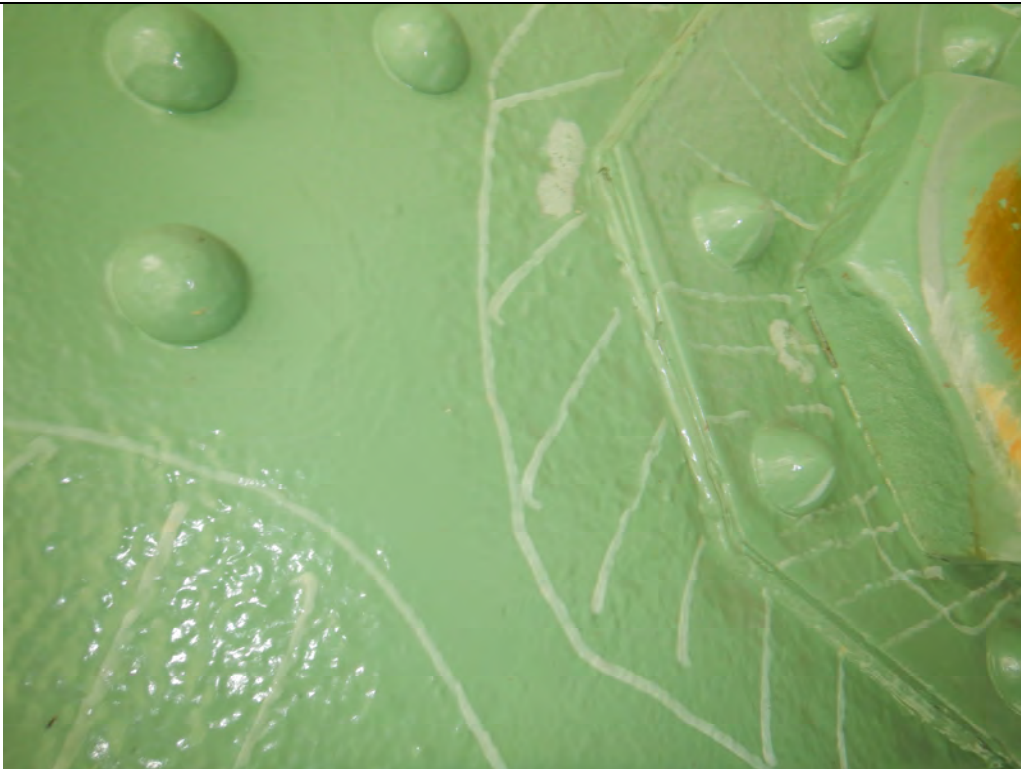
**Location:** *Span No. 6, Pin X3, Downstream*

**Description:** *Upstream end. Close up of pitting of plates.*

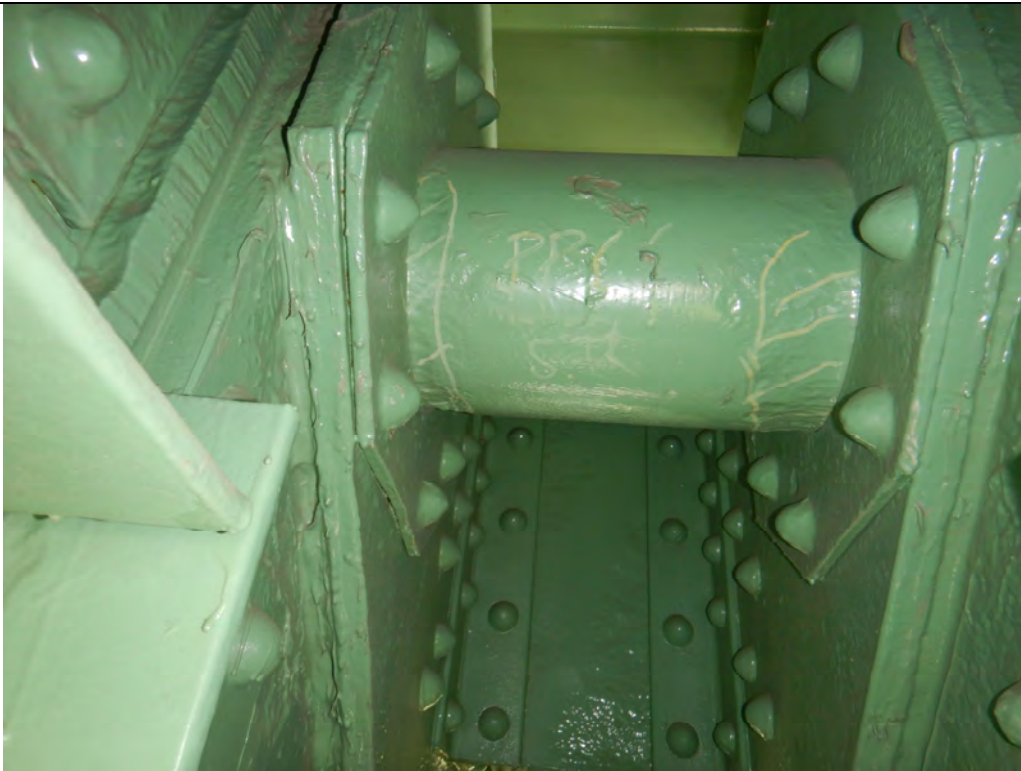
**Location:** Span No. 6, Pin X3, Downstream

**Description:** Top of connection looking down. Note corrosion on pin and interior plates.

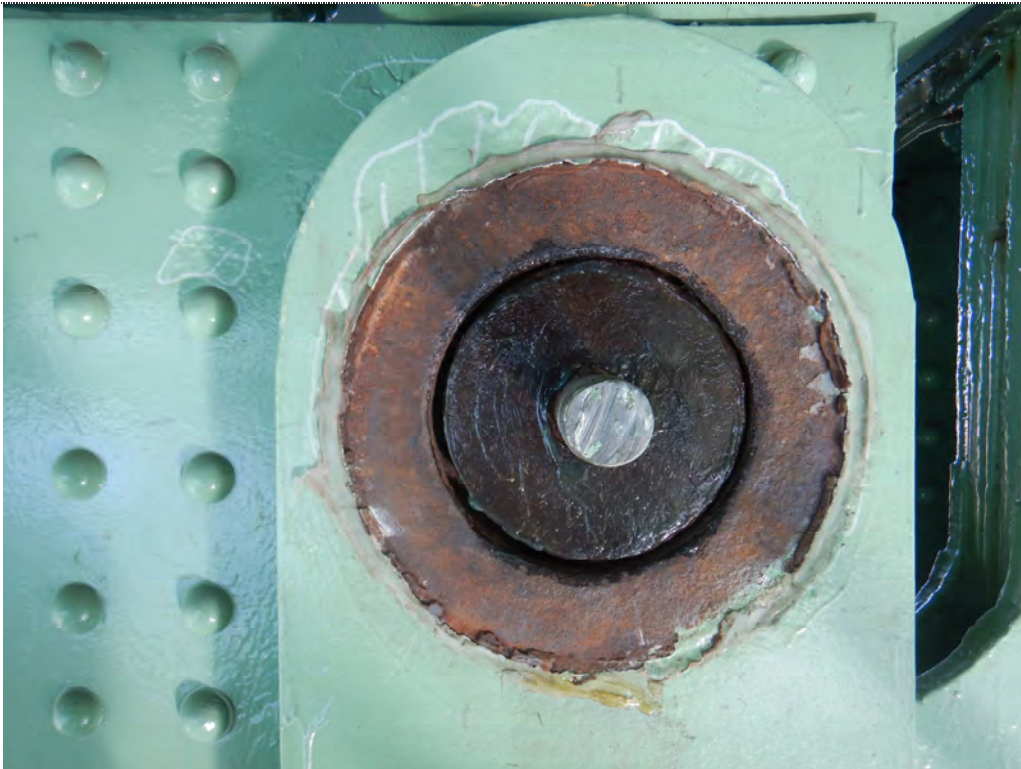
**Location:** Span No. 4, Pin mg, Upstream, Upper

**Description:** Downstream end of pin. Note the corrosion on the face of pin and link plate. Also note the gap between the pin and link plate.
