# **Highway Bridge Inspection Report**

**BR# 5196**

## **AUGUSTA MEMORIAL BRIDGE**

**Inspection Date:** 05/12/2021

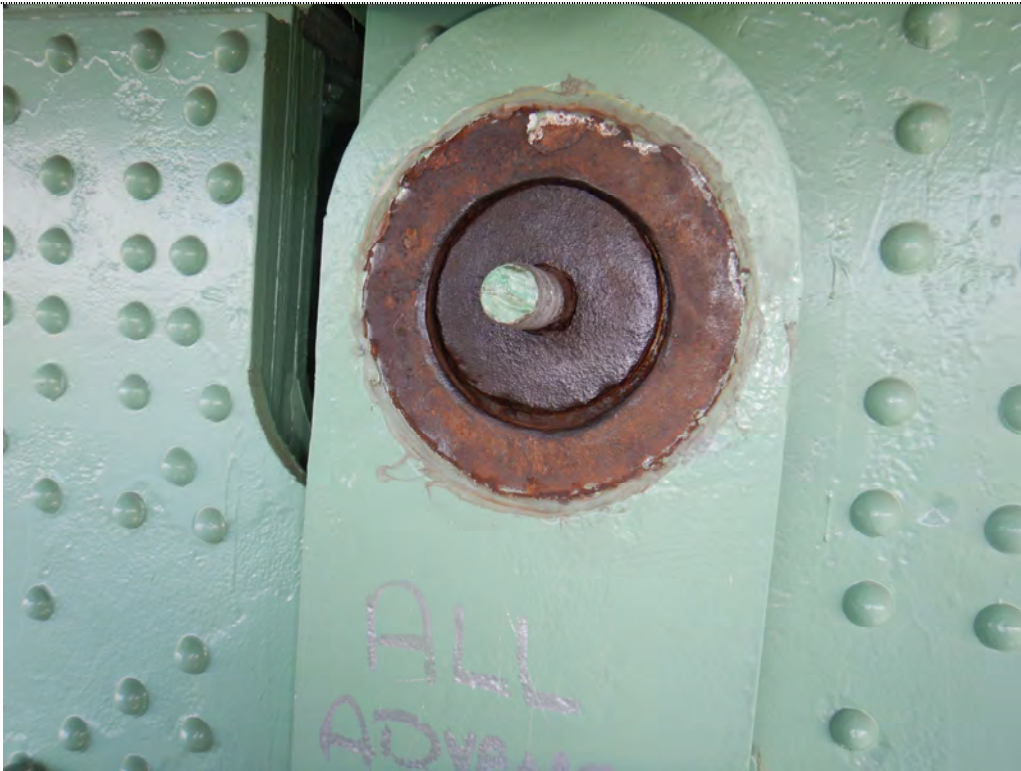
**Location:** Span No. 4, Pin mg, Upstream, Upper

**Description:** Upstream end of pin. Note the corrosion on the face of pin and link plate. Also note the gap between the pin and link plate.

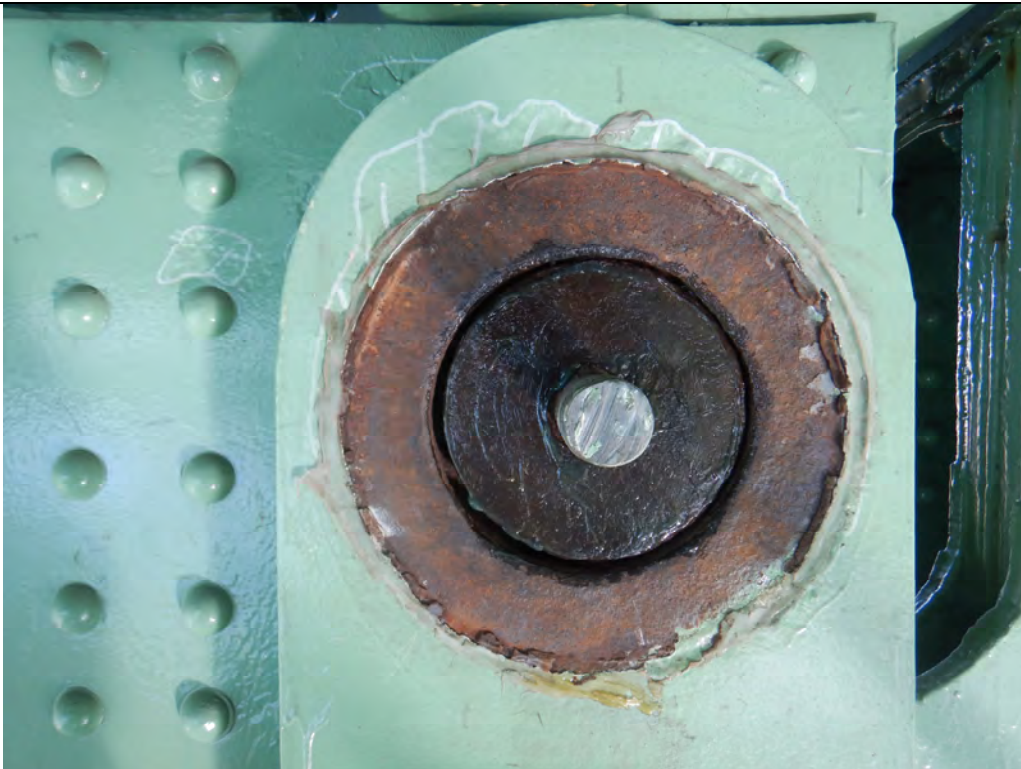
**Location:** Span No. 4, Pin mg, Upstream, Upper

**Description:** Downstream end. Note the pitting of the exterior link plate and connection plate.

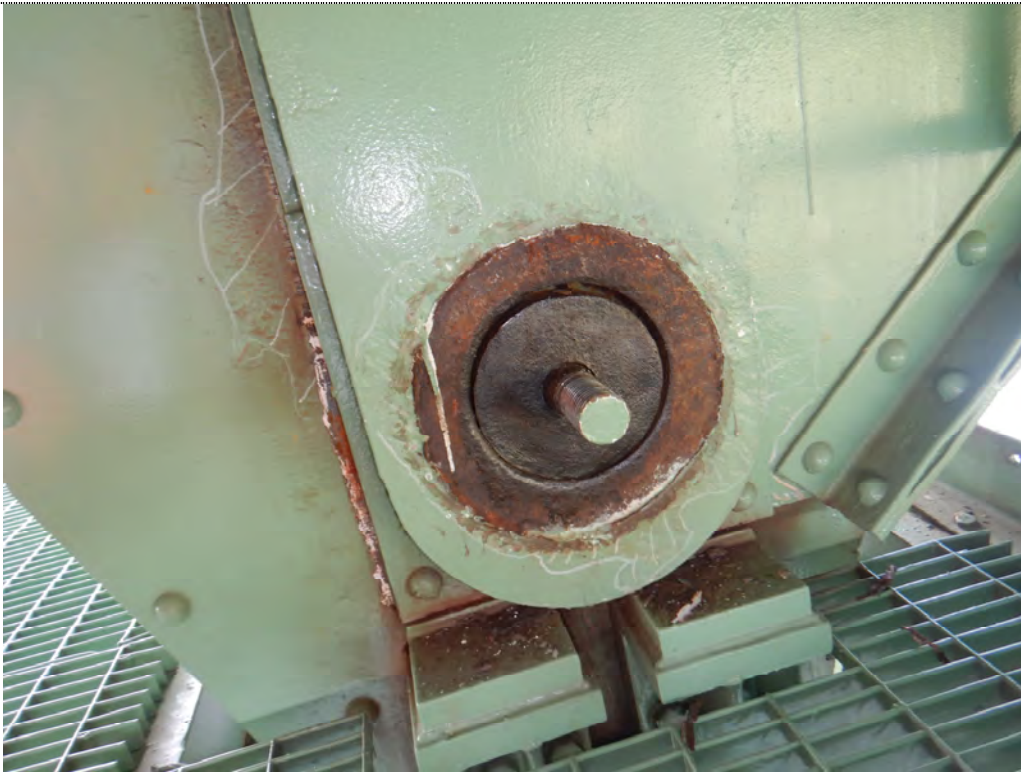
**Location:** Span No. 4, Pin mg, Upstream, Lower

**Description:** Downstream end of pin. Note the corrosion on the face of pin, link plate and cap plate. Note pitting of the exterior link plate. Also note the gap between the pin and link plate.

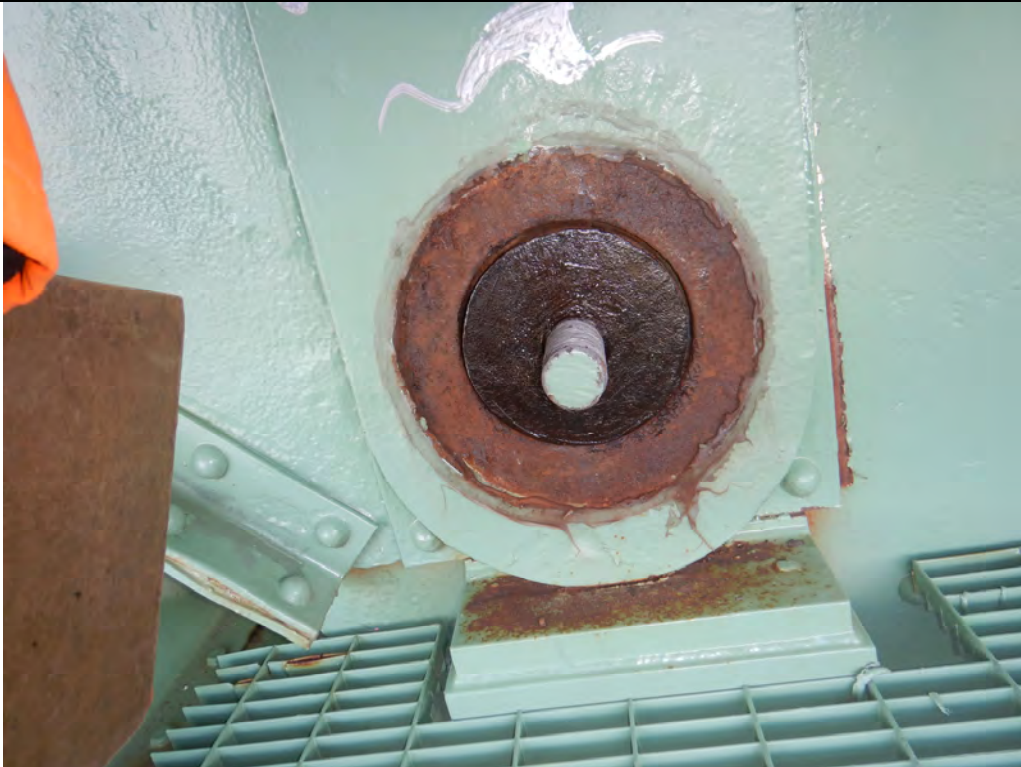
**Location:** Span No. 4, Pin mg, Upstream, Lower

**Description:** Upstream end of pin. Note the corrosion on the face of pin and link plate, the gap between the pin and link plate, and the link plate resting on the bottom catch plate.

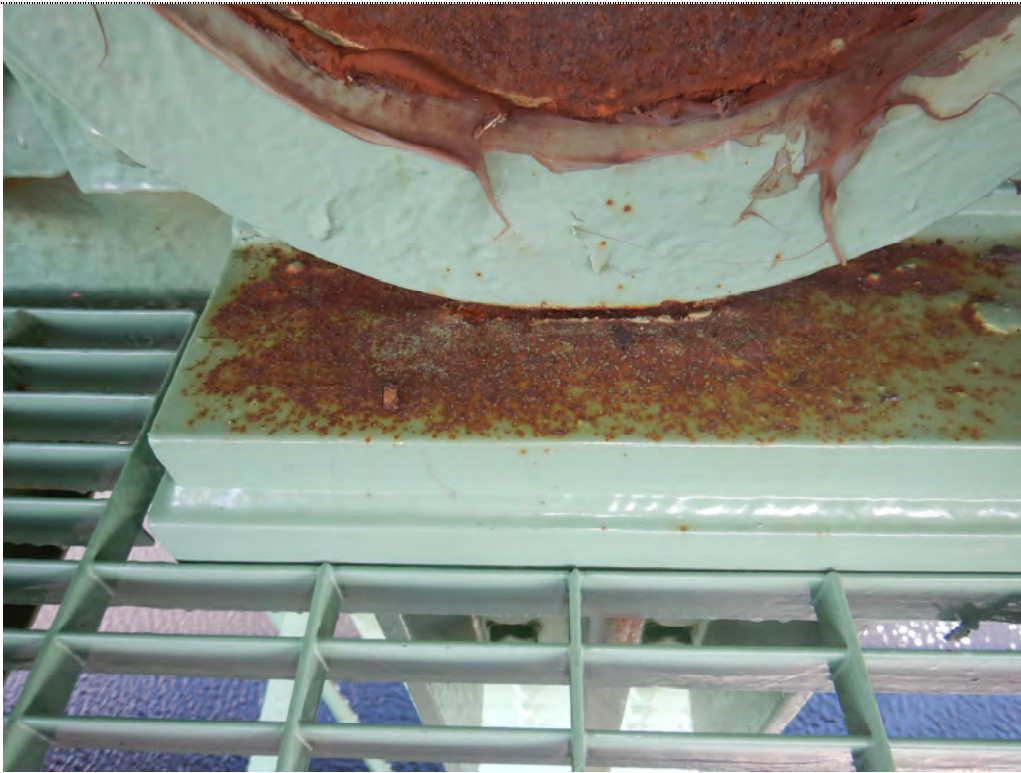
**Location:** Span No. 4, Pin mg, Upstream, Lower

**Description:** Upstream end of pin. Close up look at the link plate in contact with the bottom catch plate.

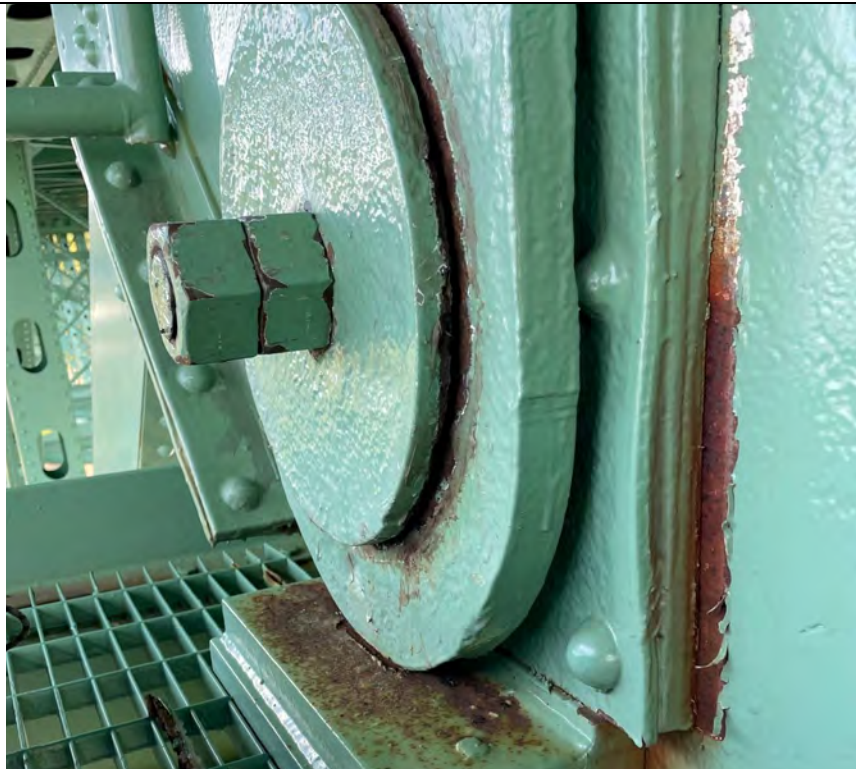
**Location:** Span No. 4, Pin mg, Upstream, Lower

**Description:** Upstream. Note plates have shifted approximately 9/16". The plates have also warped due to previously arrested pitting.

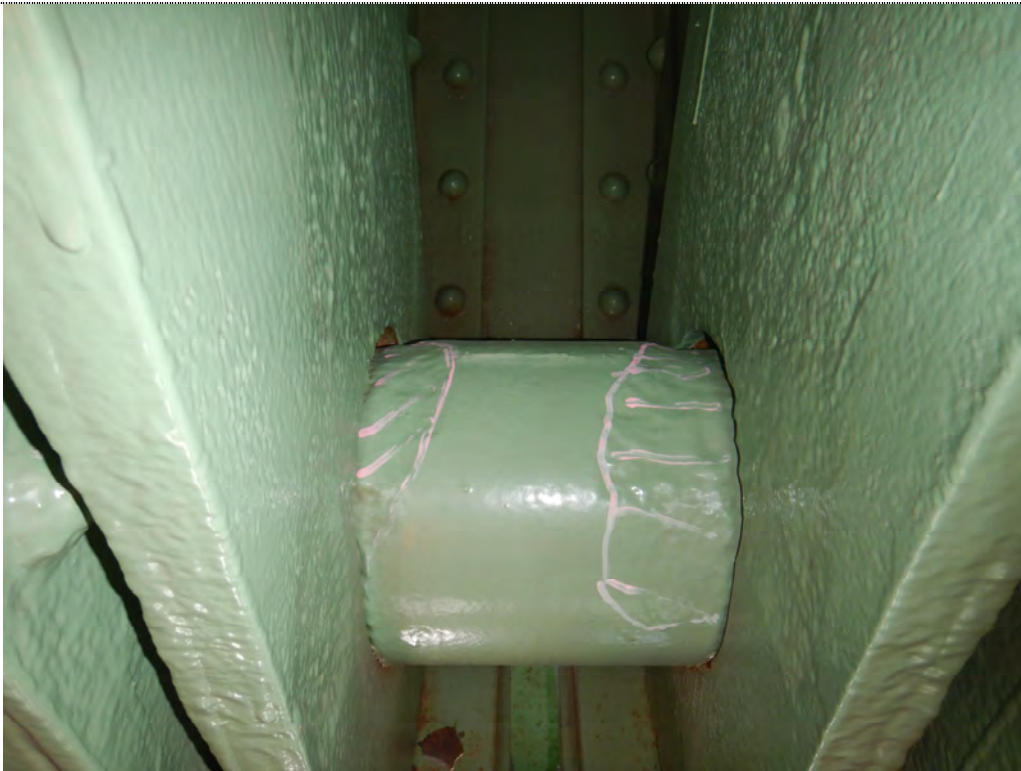
**Location:** Span No. 4, Pin mg, Upstream, Lower

**Description:** Interior link plates and pin. Note the corrosion and minor section loss at the pin and link plate. Also note the gap between the top of the pin and the hole in the link plate.

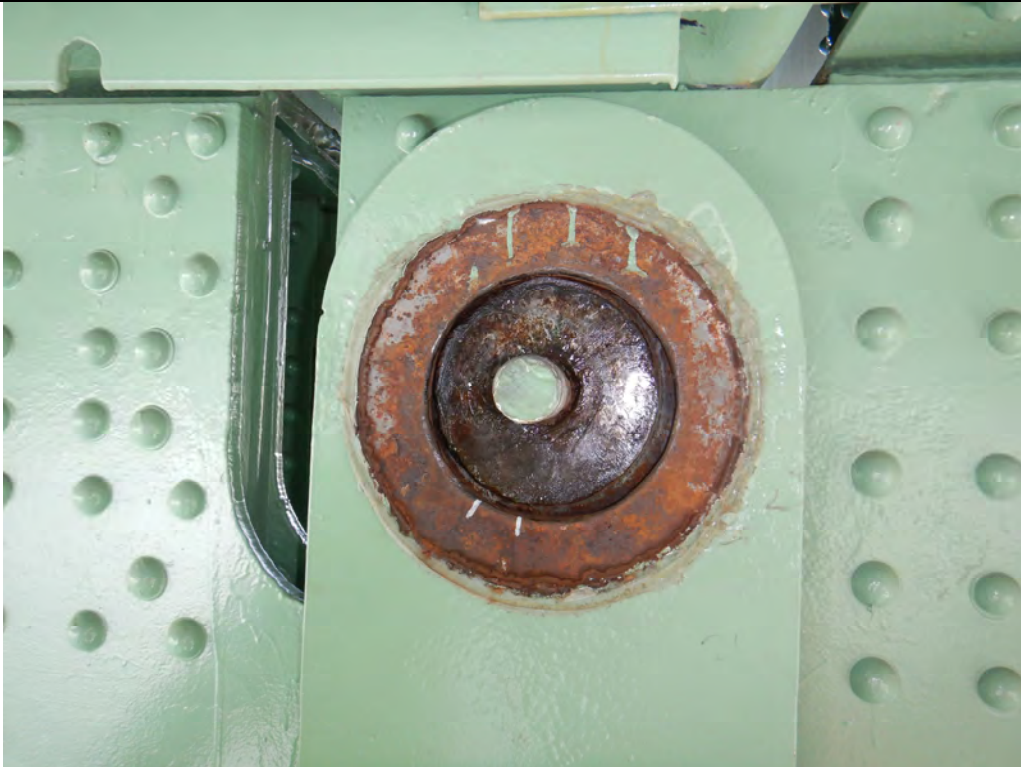
**Location:** Span No. 4, Pin mg, Downstream, Upper

**Description:** Upstream end. Note the corrosion on the face of pin and link plate and the gap between the pin and link plate.

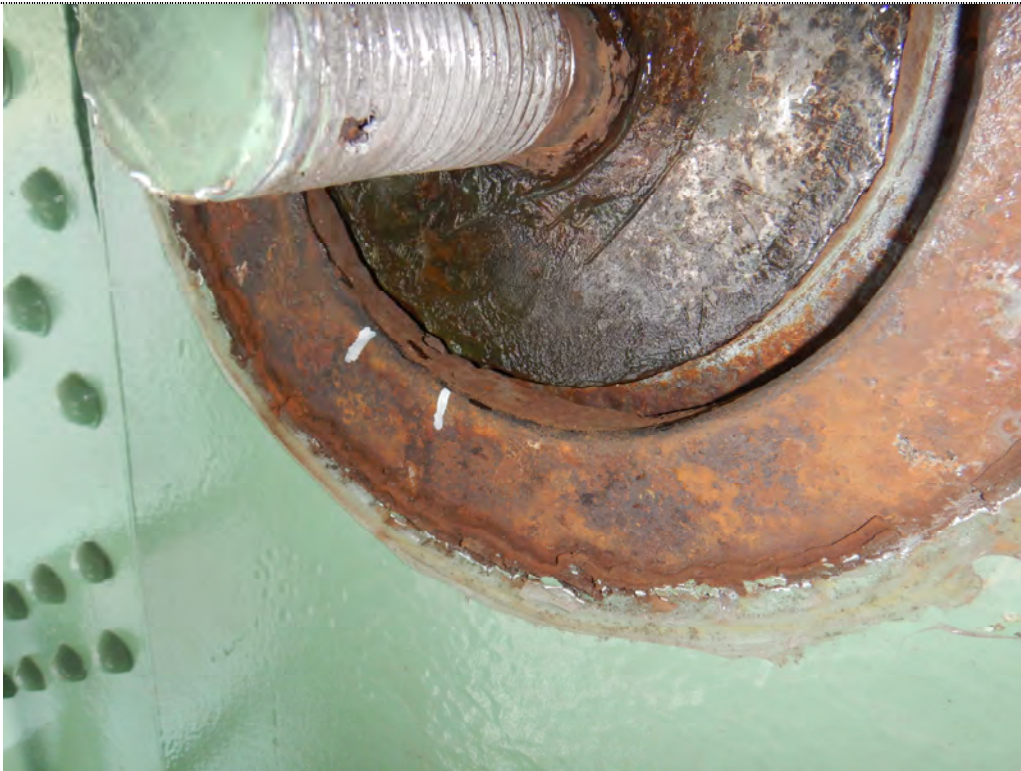
**Location:** Span No. 4, Pin mg, Downstream, Upper

**Description:** Upstream end of pin. Note the corrosion on the face of pin and link plate and that the face of link plate is out from the end of the pin by approximately 3/8".

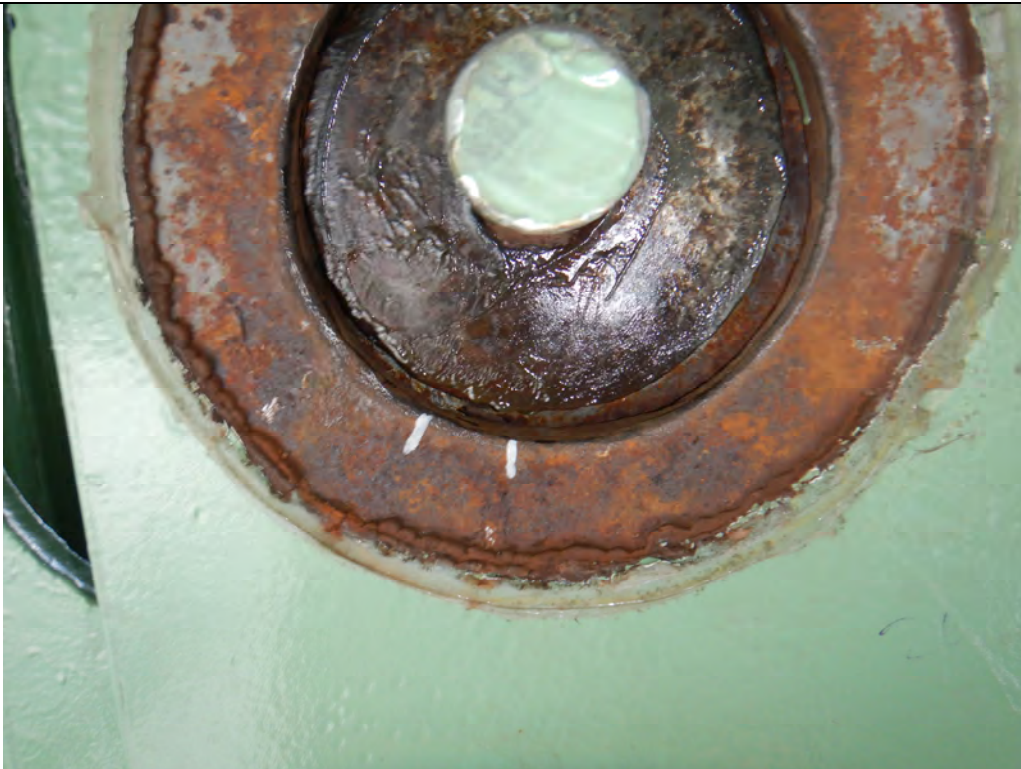
**Location:** Span No. 4, Pin mg, Downstream, Upper

**Description:** Upstream end. Close up view of gap between pin and link plate. Maximum gap is approximately 5/8".

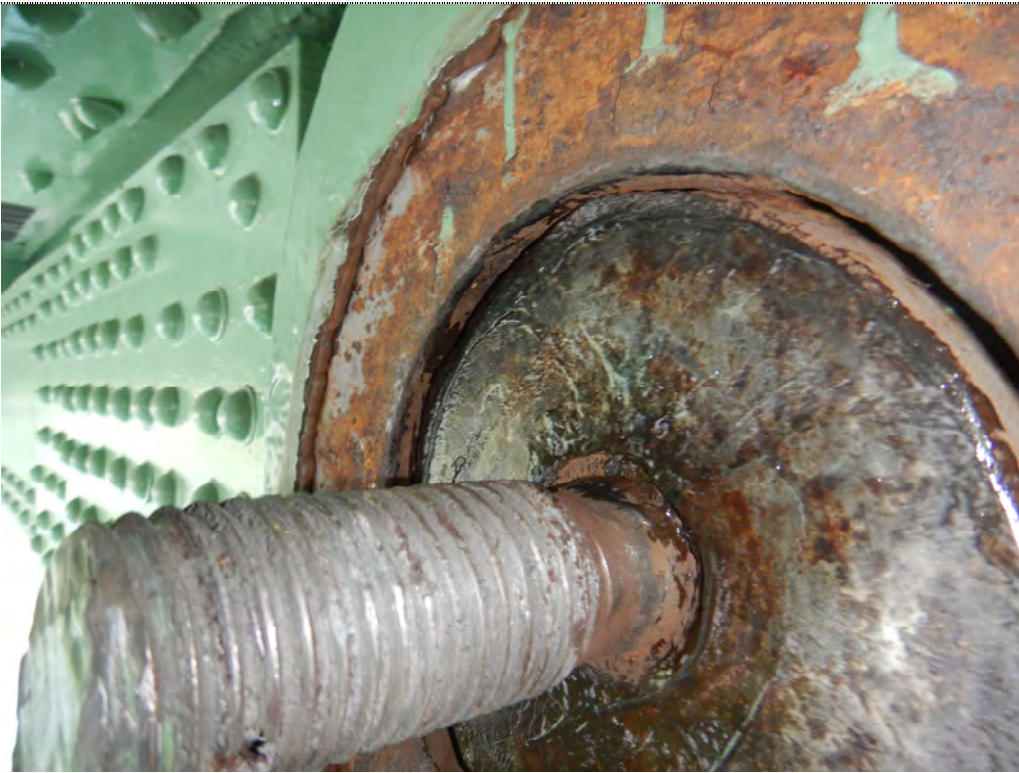
**Location:** Span No. 4, Pin mg, Downstream, Upper

- The faces of the exterior link plates were between 1/32" and 9/16" out from the ends of the pins.
- The bolt through the center of the upper pin at Pin mg on the downstream truss was found to be necked down on the upstream side of the link plate.
- The gap between the edge of the pin hole in the link plates and the circumference of the pin ranged from 1/4" to 11/16".

**Description:** Upstream end. Note the necking in the through bolt likely caused by the bending of the link plate.

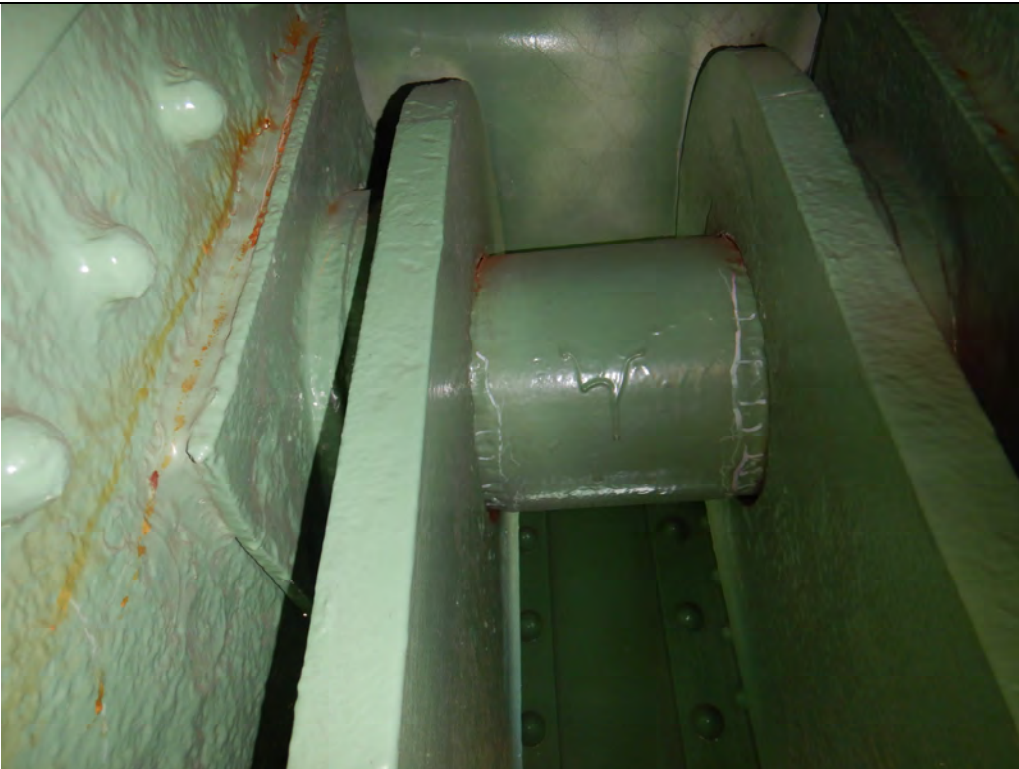
**Location:** Span No. 4, Pin mg, Downstream, Upper

**Description:** Interior link plates. Note the pitting around the link plate/pin connection area.

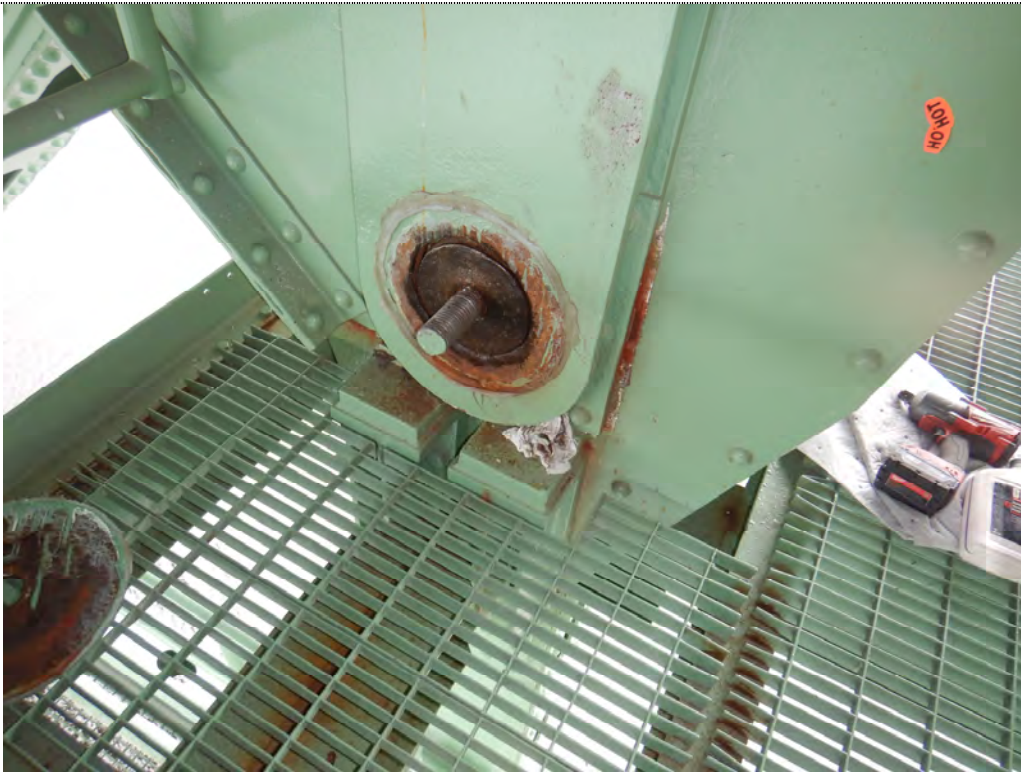
**Location:** Span No. 4, Pin mg, Downstream, Lower

**Description:** Upstream end of pin. Note the corrosion on the face of pin and link plate and that the plates have shifted approximately 1". The plates have also warped due to previously arrested pitting.

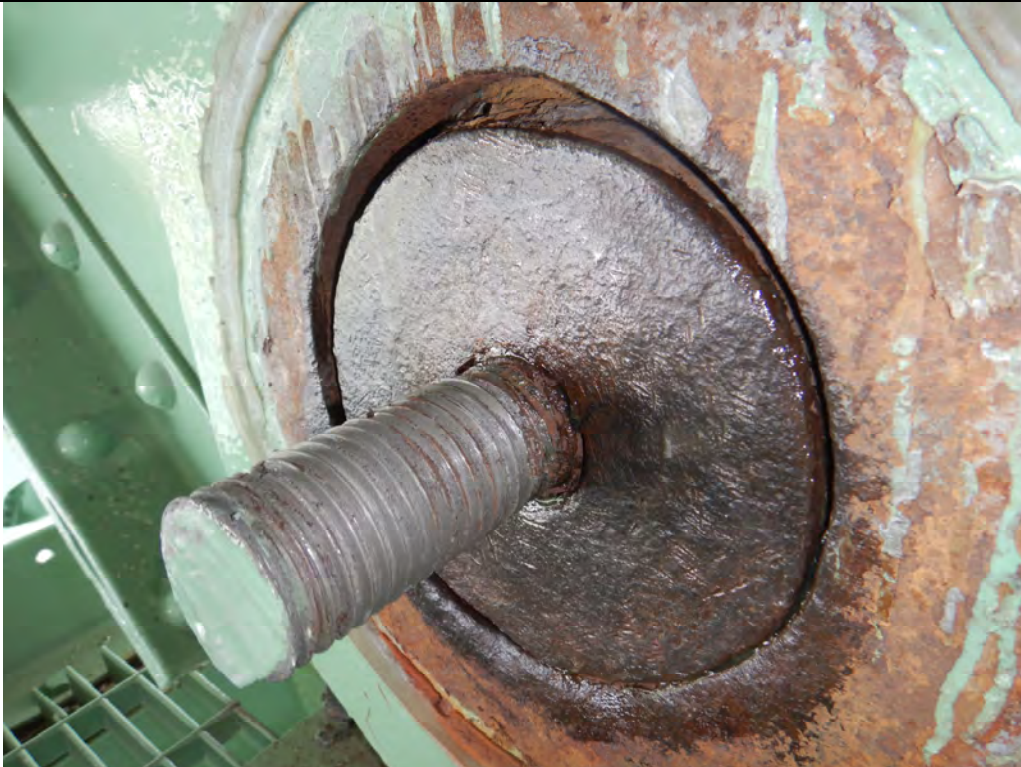
**Location:** Span No. 4, Pin mg, Downstream, Lower

**Description:** Upstream end. Close up view of gap between pin and link plate. Maximum gap is approximately 5/8".

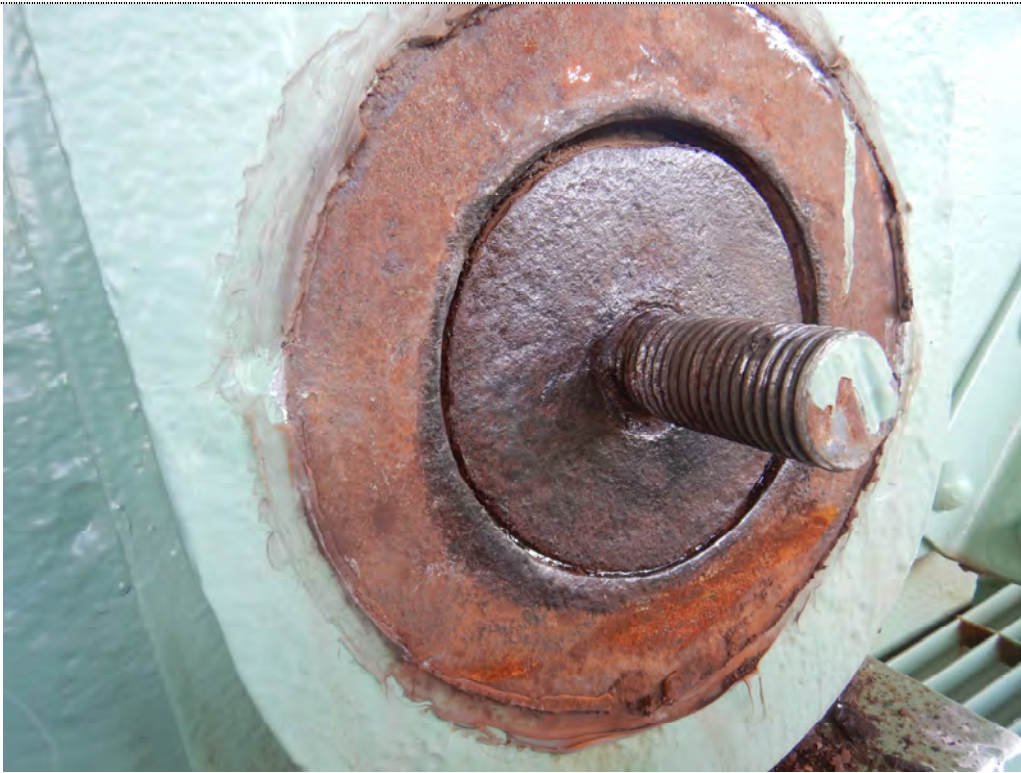
**Location:** Span No. 4, Pin mg, Downstream, Lower

**Description:** Downstream end of pin. Note the corrosion on the face of pin and link plate and pitting of the link plate. Also note the gap between the pin and link plate.

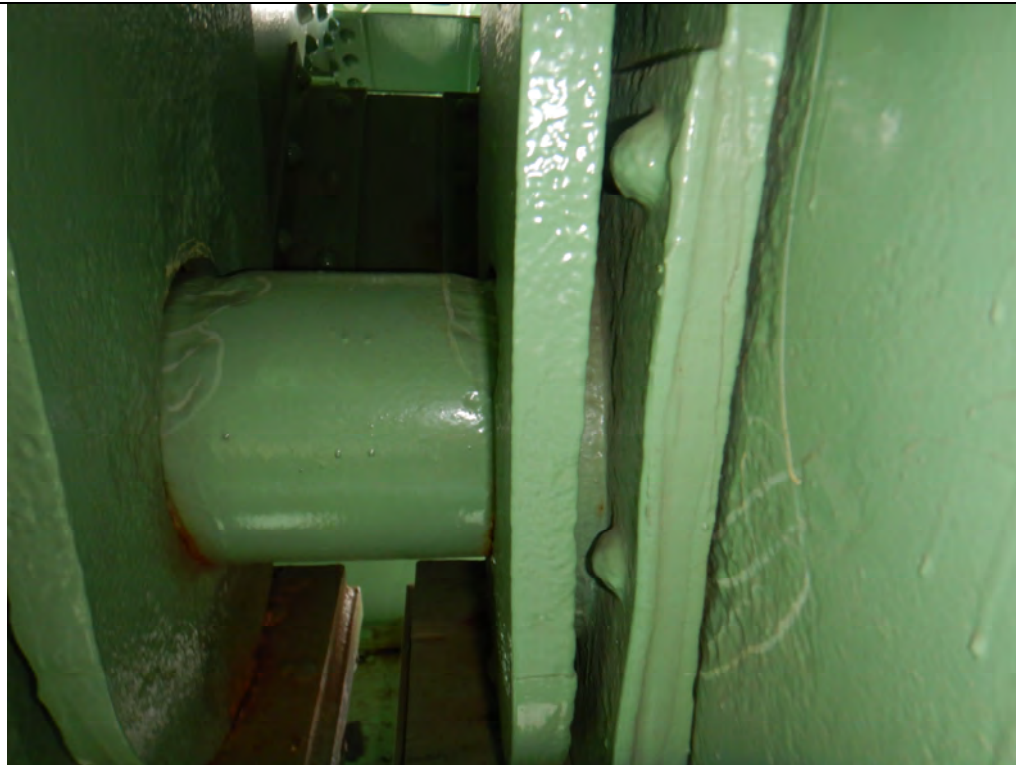
**Location:** Span No. 4, Pin mg, Downstream, Lower

**Description:** Interior link plates. Note the corrosion and minor section loss at the pin and link plate. Also note the gap between the top of the pin and the hole in the link plate.

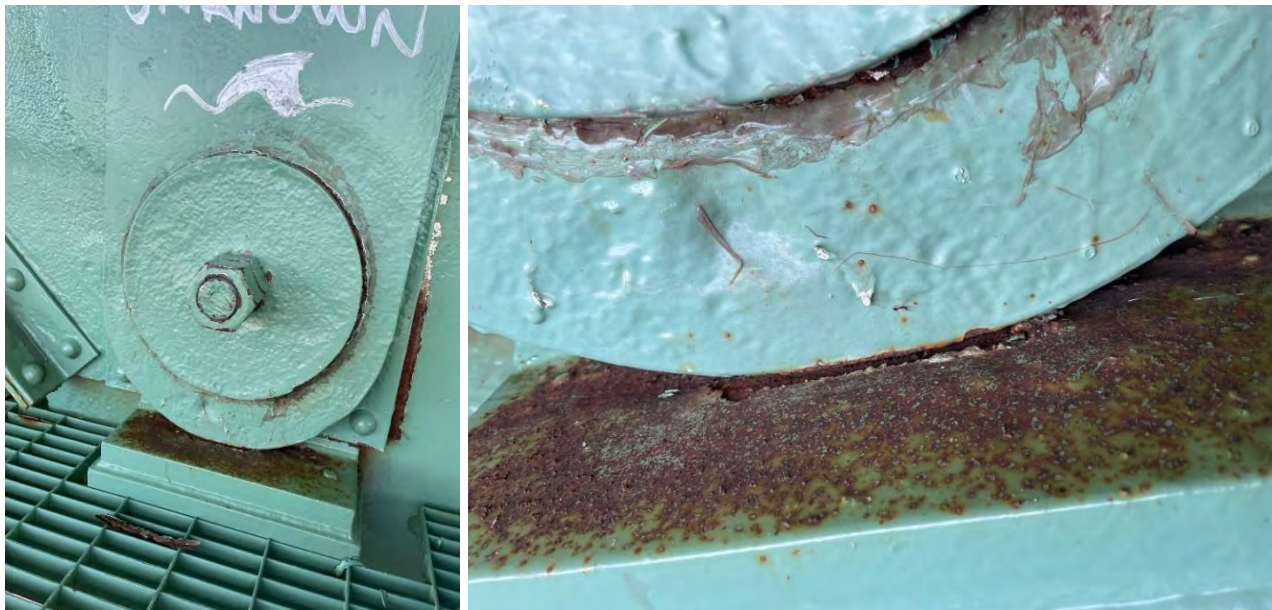
During the inspection, VHB observed that the upstream exterior link plate on the North (upstream) Truss was resting on and wearing into the top of the suspended span retainer below, as shown in the photos below. The 2017 Fracture Critical Report also noted this contact between the bottom of the upstream exterior link plate. The paint in the contact area between the suspended span retainer and the gusset plate is worn off and wearing in.

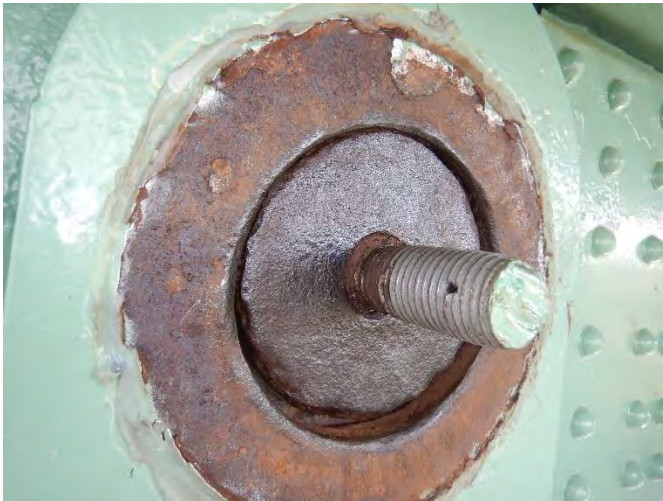
Top Pin

The ultrasonic testing required the removal of the nuts and cap plates at the pin and link connections. In general, the tops of the pins are worn at the contact points at the top center of the top pins. At the upstream end of the top pin at the North (upstream) Truss, the bottom gap between the edge of the pin hole in the link plate and the circumference of the pin has decreased slightly from  $1\frac{1}{16}$ " to  $\frac{1}{2}$ " since the last inspection in 2016, indicating that this link plate may be lifting off the pin because the bottom of it is in contact with the suspended span retainer.

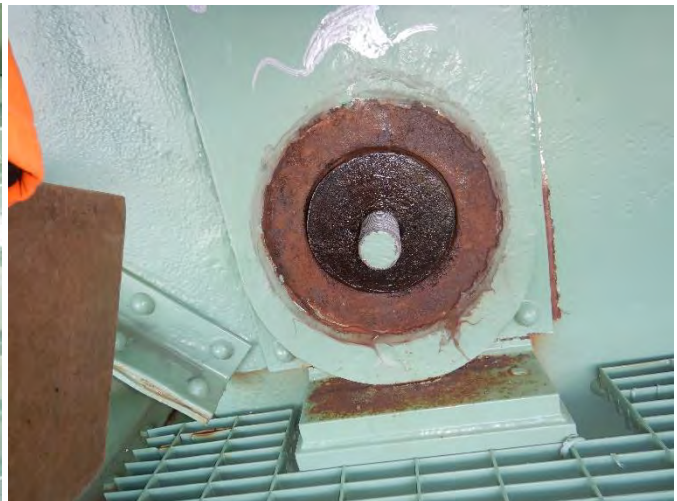
Bottom Pin

After the bottom pin cap plate was removed to perform the ultrasonic testing, VHB noticed evidence of movement of the upstream exterior link plate at the North Truss under live load. The team then tapped the upstream exterior link plate with a two-pound hammer. Based on the tonal differences between this upstream exterior link plate and the other three link plates at this pin and link connection, it appears that some load sharing may be occurring between the suspended span retainer below and the upstream exterior link plate. The suspended span retainer is designed to support the suspended span in the event of a pin or link plate failure so the noted contact between the upstream exterior link plate and the suspended span retainer is not an immediate structural concern. However, having the suspended span retainer partially support the suspended span for the long term is not recommended because it limits the free movement of the pin and link connection.
