Soils Report 78-17  
Brooklin/Sedgwick - Hancock County  
Benjamin River Bridge  
No. 3216  
March, 1978

SURFACE AND SUBSURFACE INVESTIGATION  
FOR THE PROPOSED RECONSTRUCTION OF THE  
BENJAMIN RIVER BRIDGE BETWEEN THE  
TOWNS OF BROOKLIN AND SEDGWICK

Bridge No. 3216

Soils Report 78-17

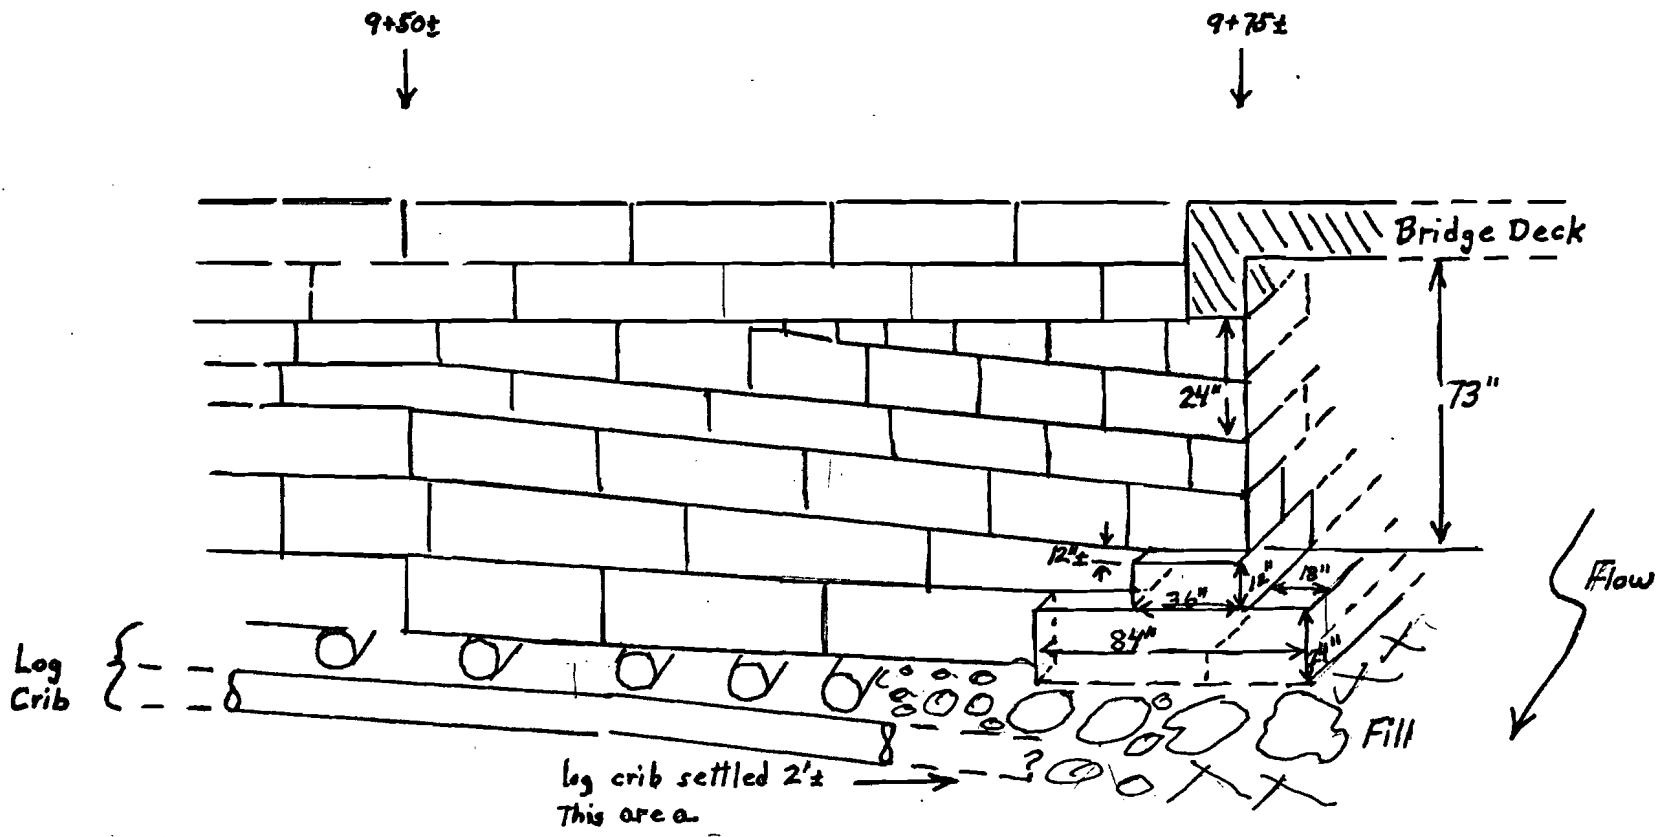
South side (right) of West Abutment  
Abut #1

Abutment on spread footing constructed with granite slabs. (Sheets 3 and 4)

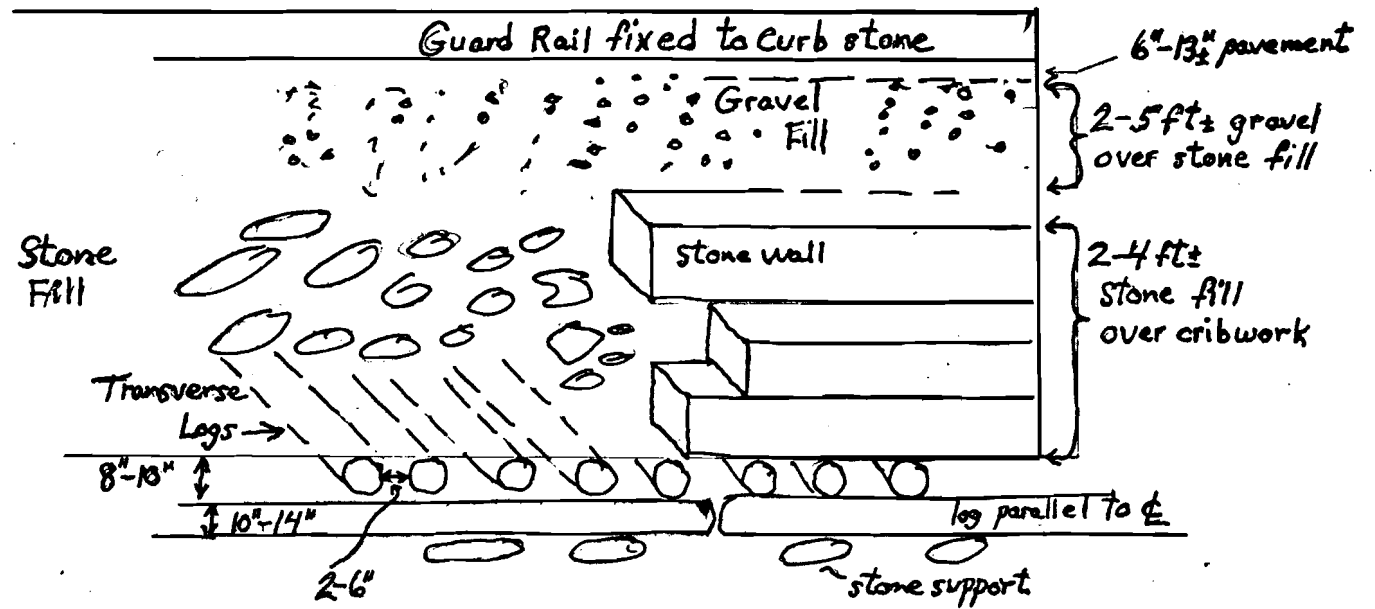
Typical Section Causeway

Causeway constructed with 2 - 6 feet of gravel over 2 - 4 feet of stone fill. (Sheet 6)

NOTE: No logs visible  
stations 10+00-12+00

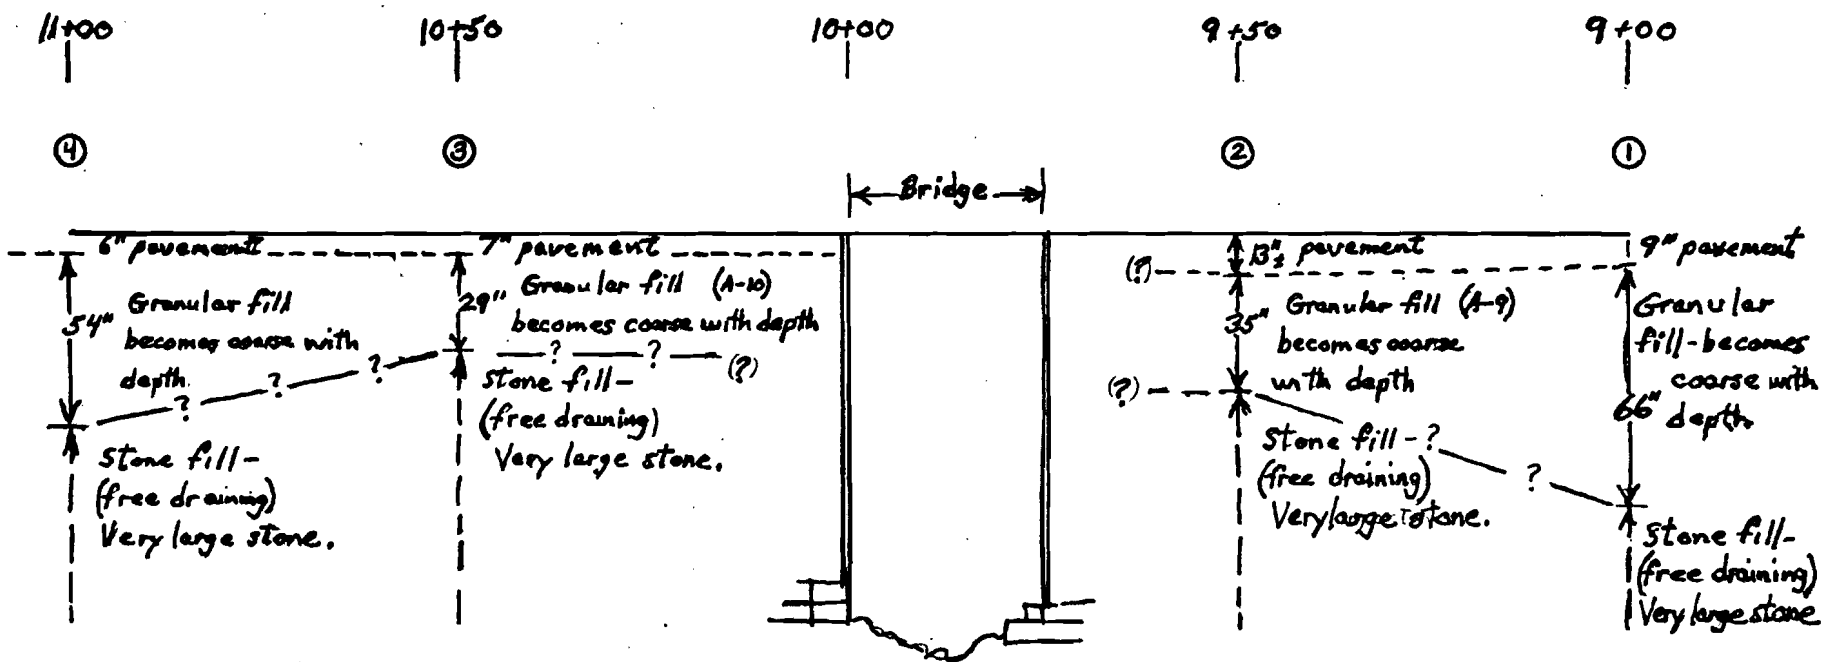
Causeway fill - Quarry Bit Explorations

It is believed from these borings that the finer granular base material is being washed away from underneath the road as a result of the continual flow of tidal water through the causeway. Initially, this free flow of water was unknown, and thus a filter system was proposed beneath the riprap along the roadway slopes to prevent the base material washout. However, from the results of the four borings made through the road, and on-site observations, this natural tidal flow was found all through the stones and log crib work in the causeway. It is believed that placing the filter behind the riprap as originally proposed would not completely stop the loss of material from the road base. It is recommended that this natural flow be left unimpeded, and a filter fabric be used at subgrade beneath the reconstructed road surface along the causeway. This would effectively stop the loss of fines in the roadway base without impeding the free flow of tidal water through the causeway.

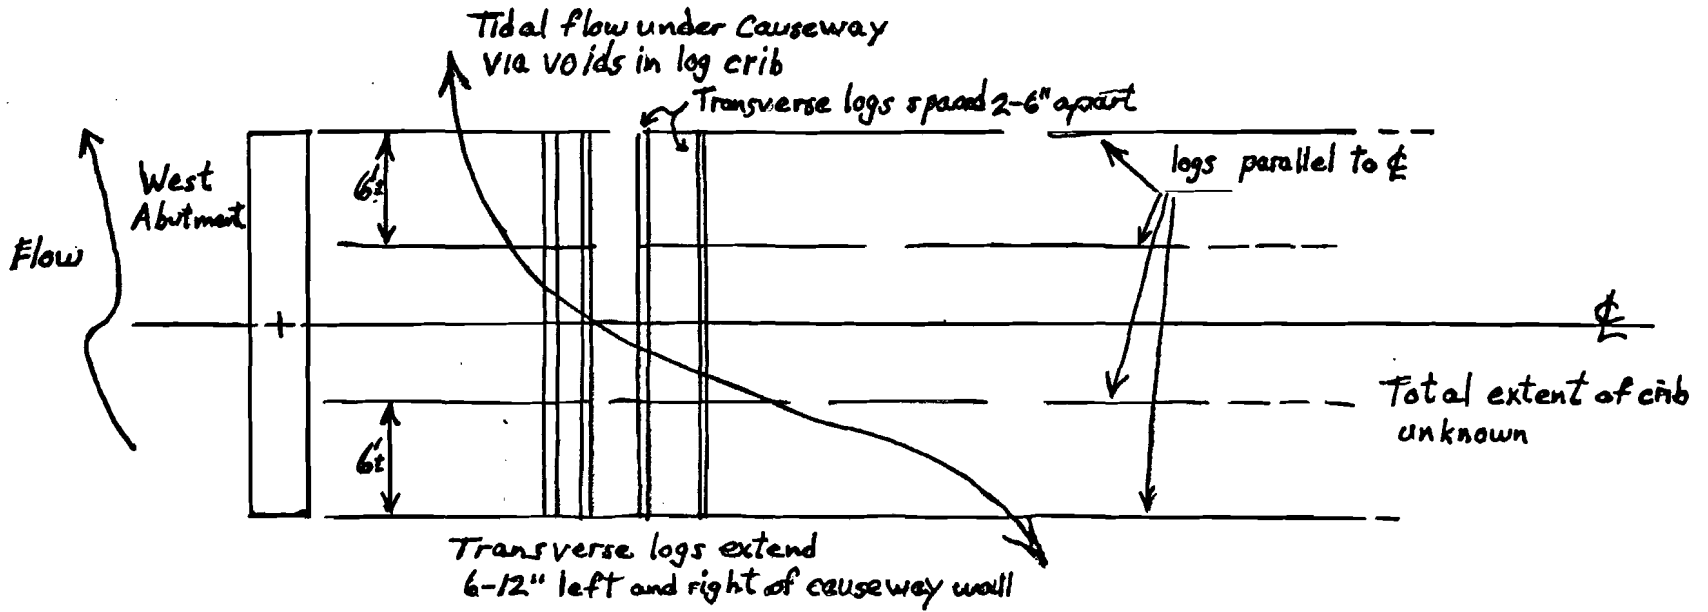
Log Crib Causeway Foundation

Causeway constructed on log crib work. Tidal flow through the crib between Stations 9+25 - 9+60+. (Sheets 5 and 7)

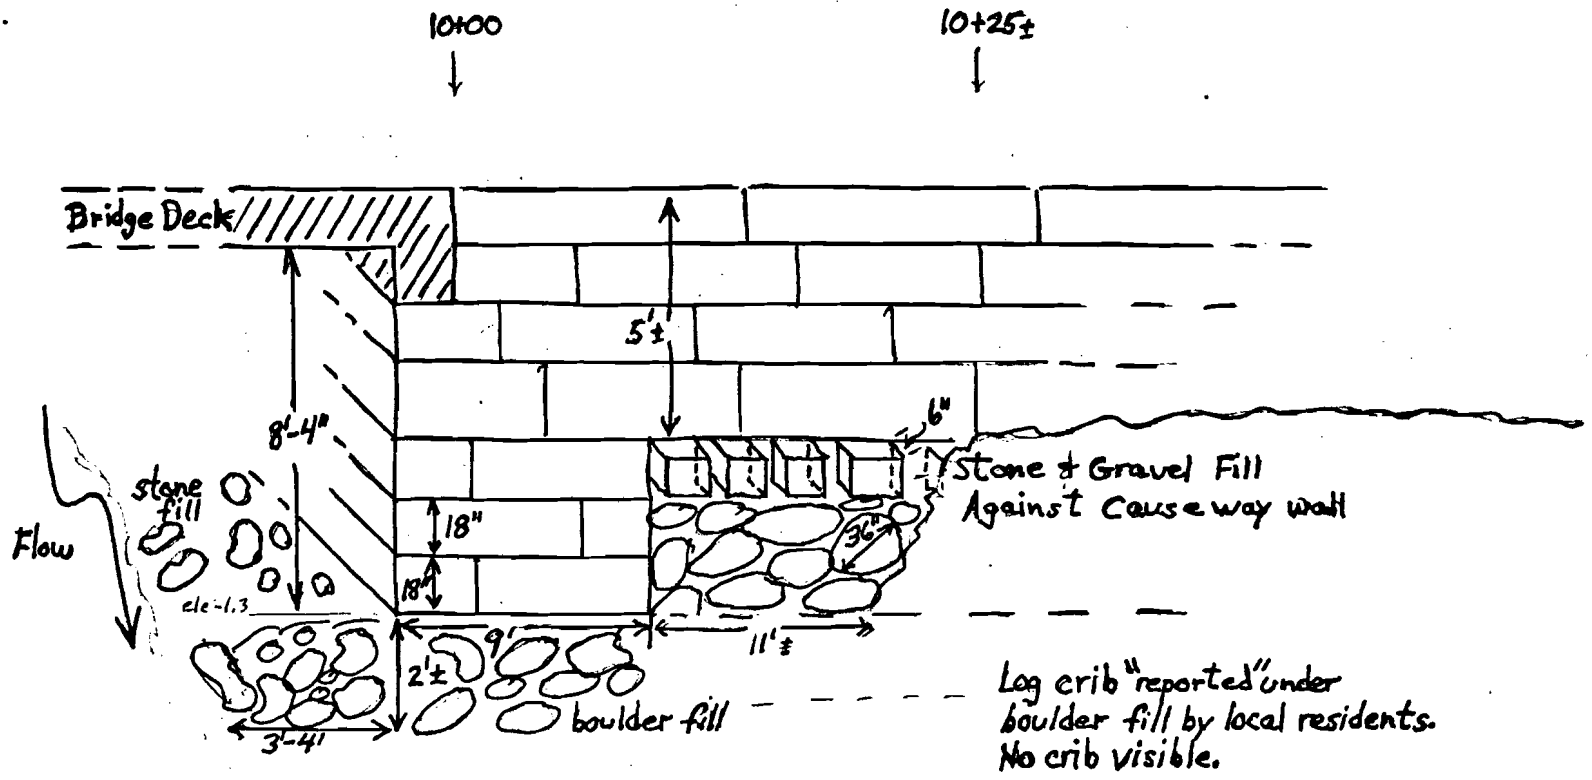
South side (right) of East Abutment

Abutment constructed with large blocks (18") for footing and lower two courses of stone. (Sheets 8 and 9)
