# Highway Bridge Inspection Report

BR# 1427

I-95 SOUTHBOUND  
Over  
STILLWATER AVENUE

Town:  
Bangor

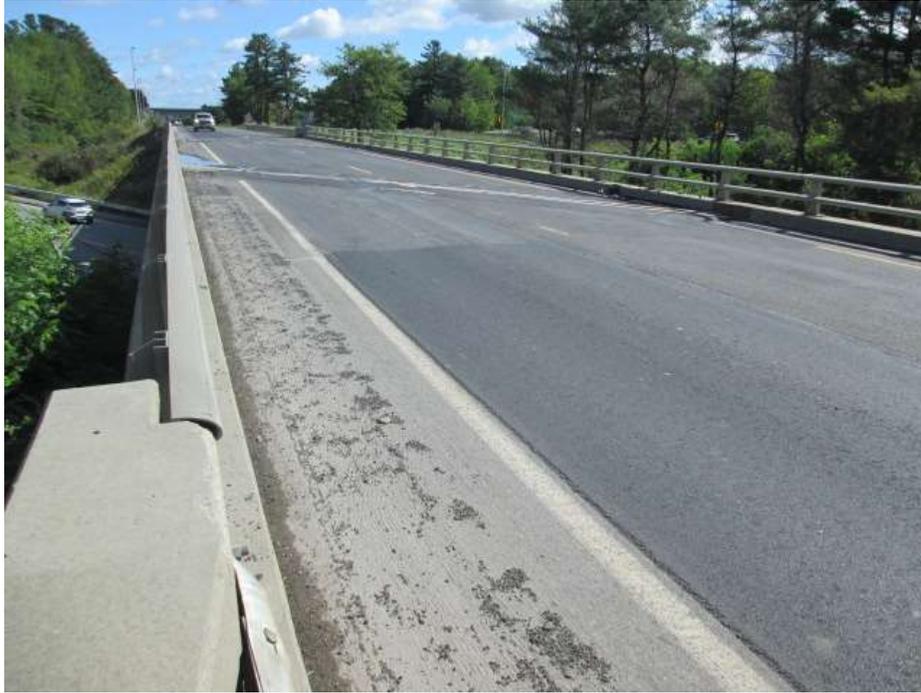
PHOTO 1

Description Roadway looking east

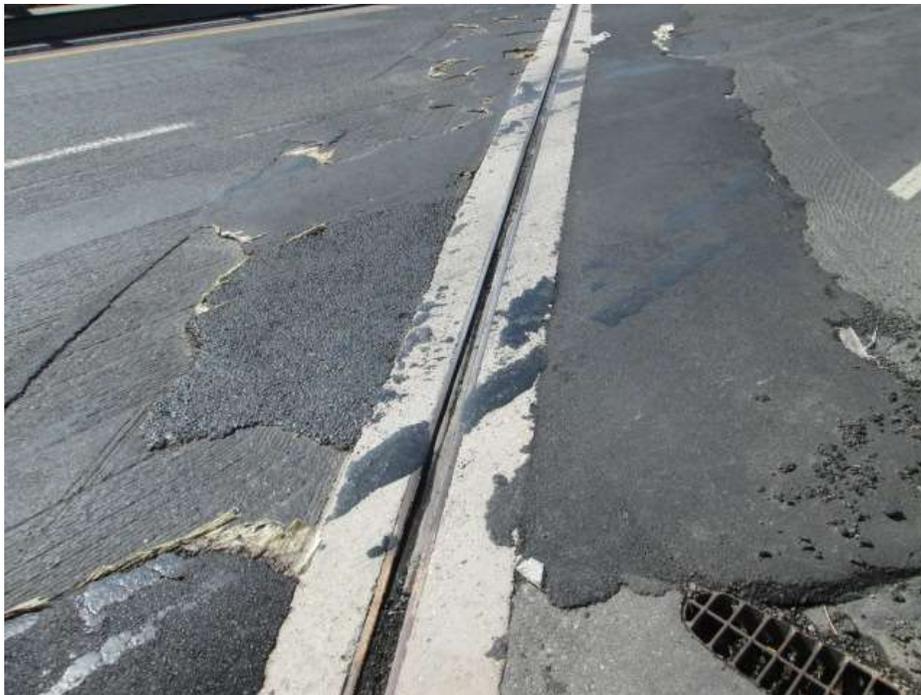
PHOTO 2

Description west joint

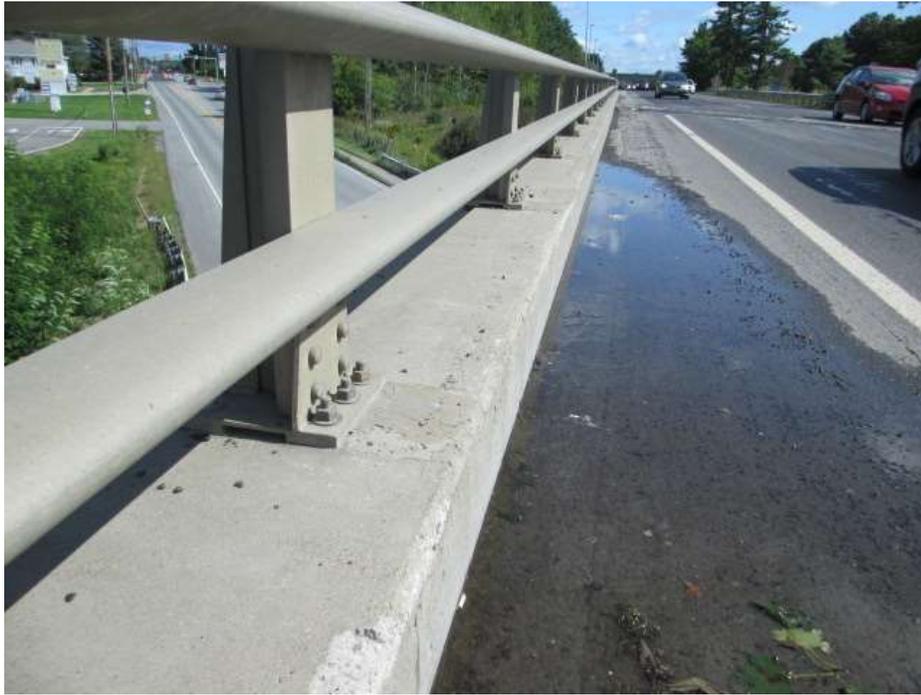
PHOTO 3

Description north rail

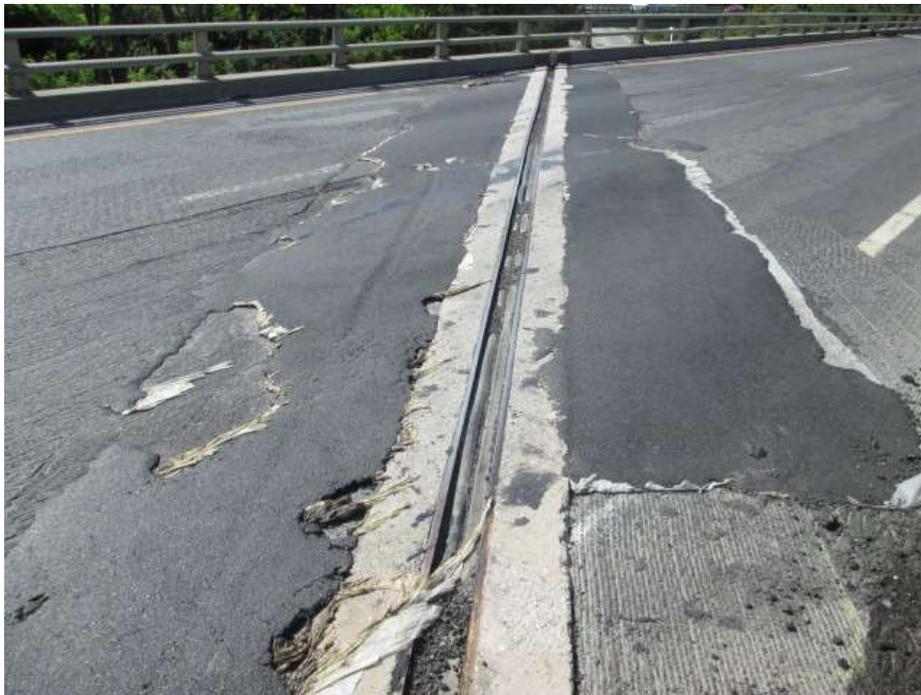
PHOTO 4

Description Pier joint

Type	Work Item	Priority	Notes
Maintenance	Rehab Substructure		Rehab abutments and piers.
Capital	Paint		Clean and paint all steel.
Maintenance	Repair Erosion		Repair shoulder erosion at road below adjacent to pier column.
Preservation	Other		Apply Silane
Maintenance	Repair Joint		Rehab east pier joint that has missing seal, install header
Preservation	Coat Beam Ends		
Preservation	Repair Wearing Surface		mill and fill

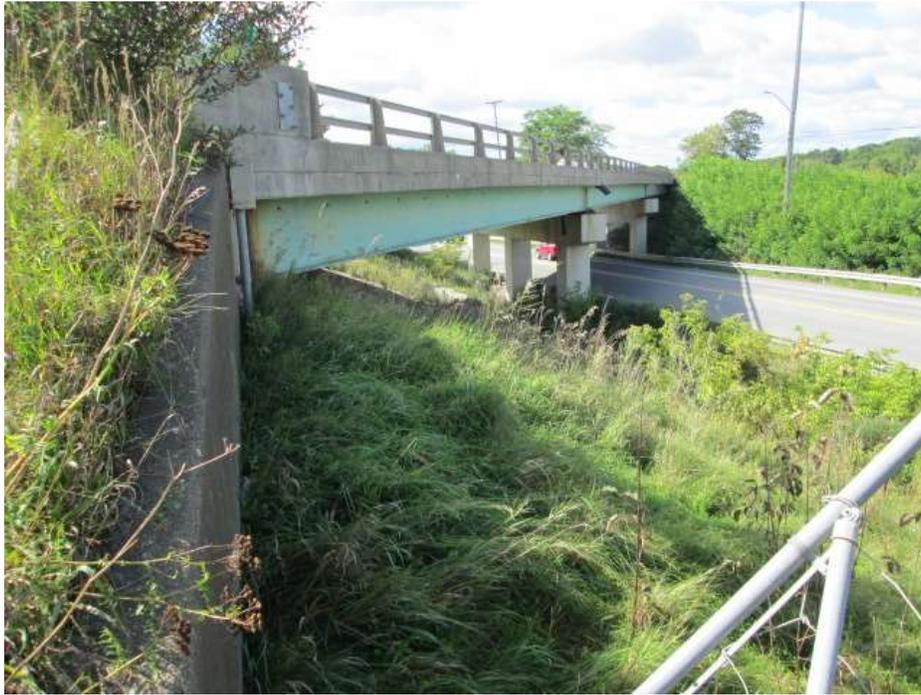
PHOTO 5

Description North side view

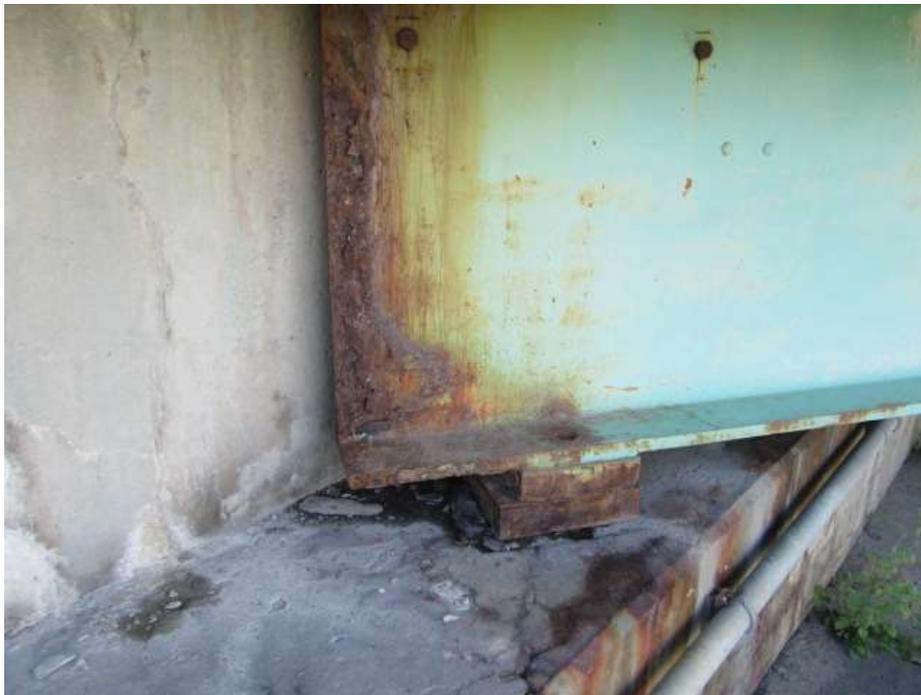
PHOTO 6

Description Abutment beam end

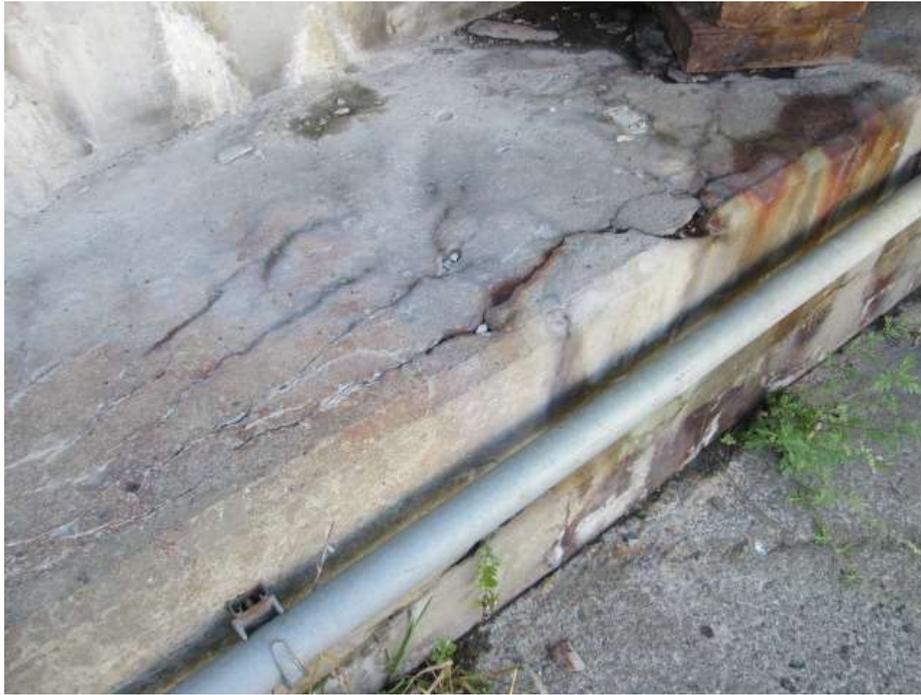
PHOTO 7

Description east abutment

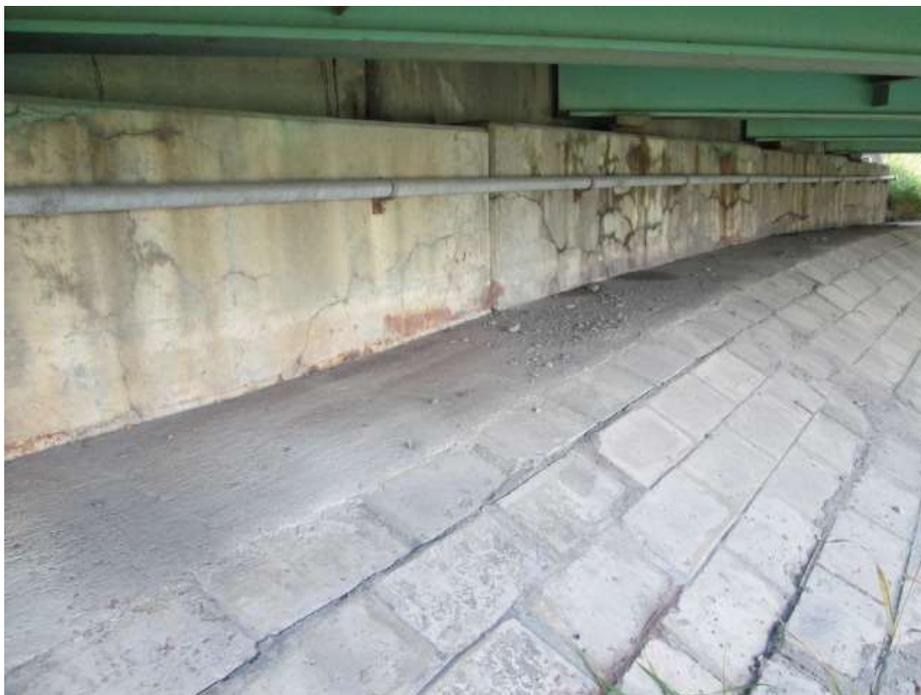
PHOTO 8

Abutments have extensive map cracking up to 1/8" wide with dark staining. Isolated areas of spalling with exposed rebar at SW corner of south abutment. Wings have scattered minor dark map cracking. Pier columns have scattered minor map cracking with isolated delams. Pier caps have scattered moderate/ isolated heavy cracking with isolated areas of spalling/large delamination.

Description Cracking east abutment

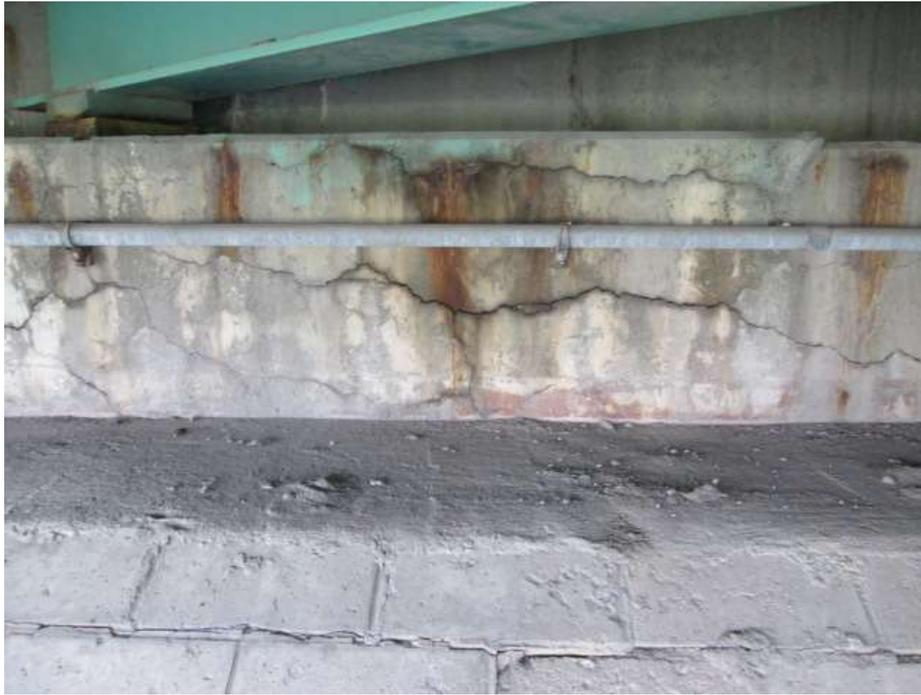
PHOTO 9

Description east abutment

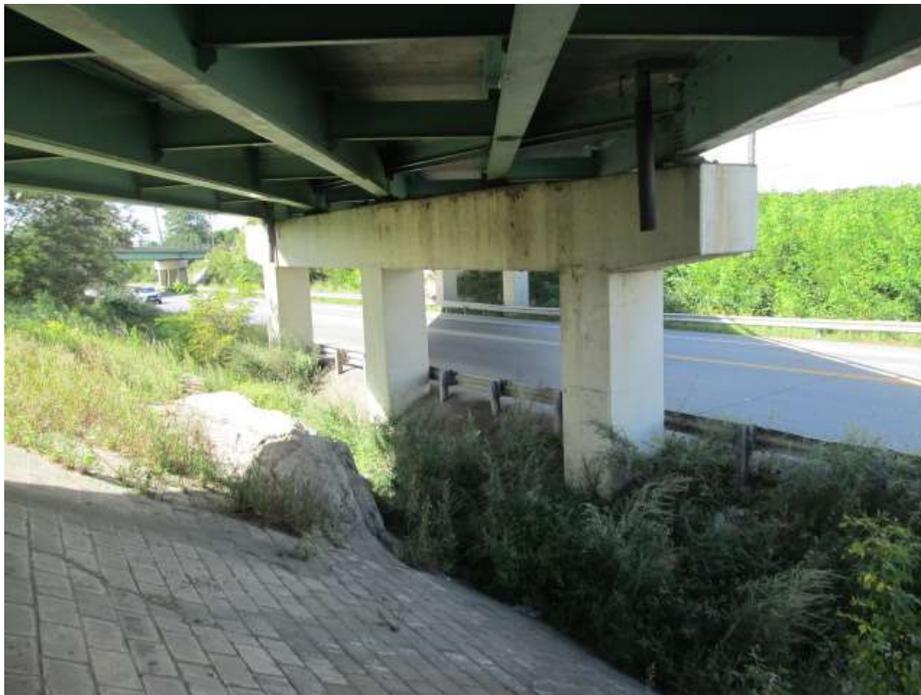
PHOTO 10

Description east pier east face

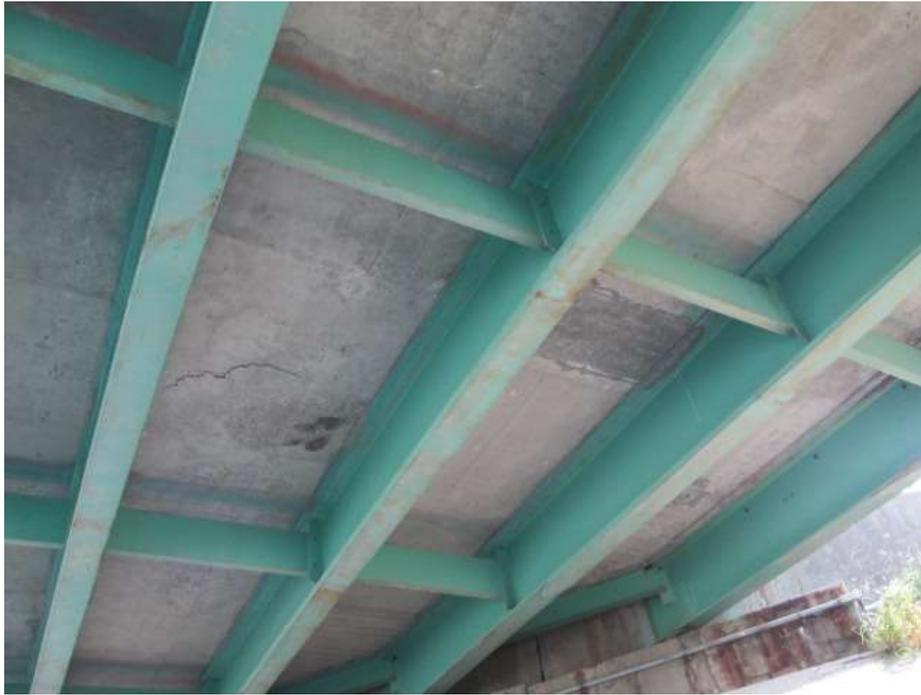
PHOTO 11

Description east span

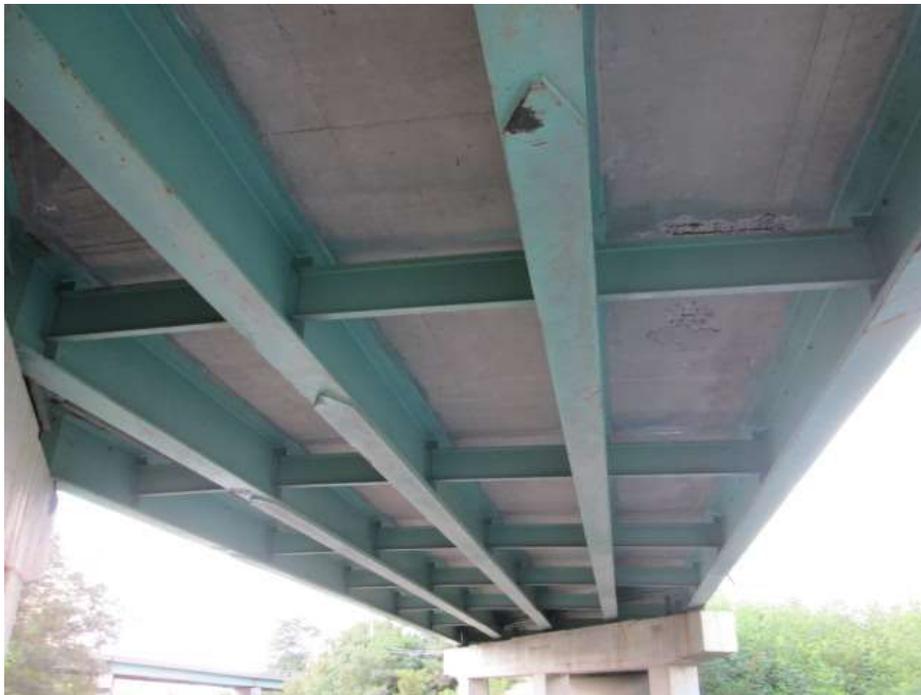
PHOTO 12

Description center span

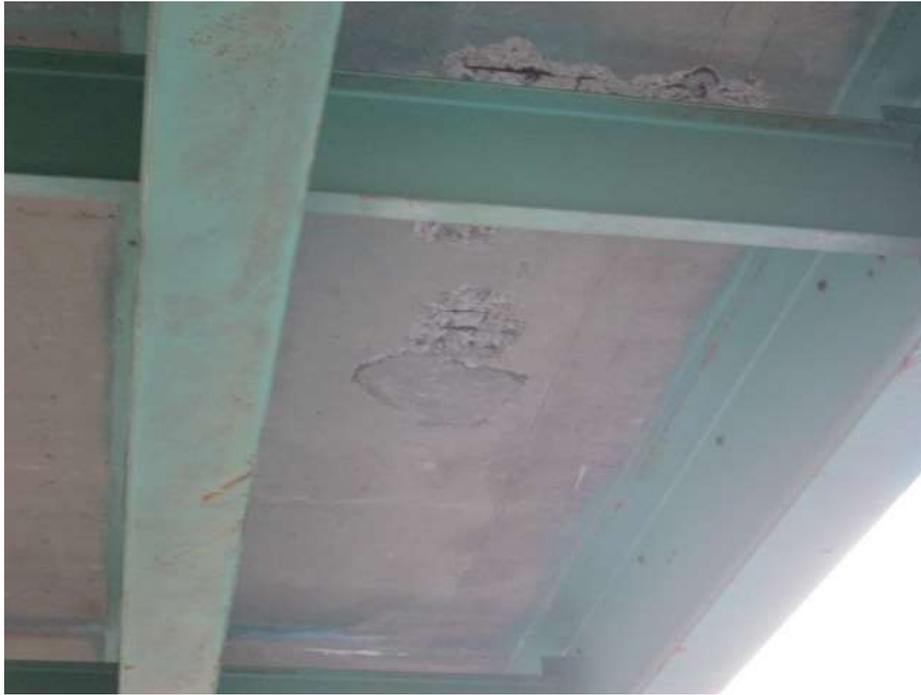
PHOTO 13

Deck underside has scattered minor cracking, patches and minor spalls with exposed rebar. large areas of wet staining interior bays. Bridge rail has scattered areas of plow scrapes and minor damage.

Description Spall bottom of deck center span

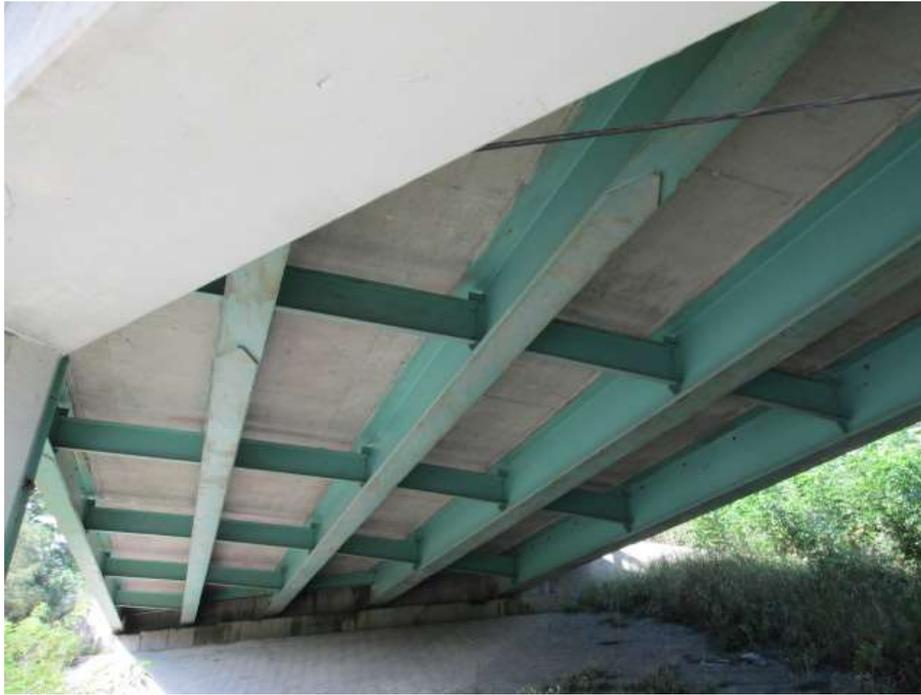
PHOTO 15

Description west span/ abutment

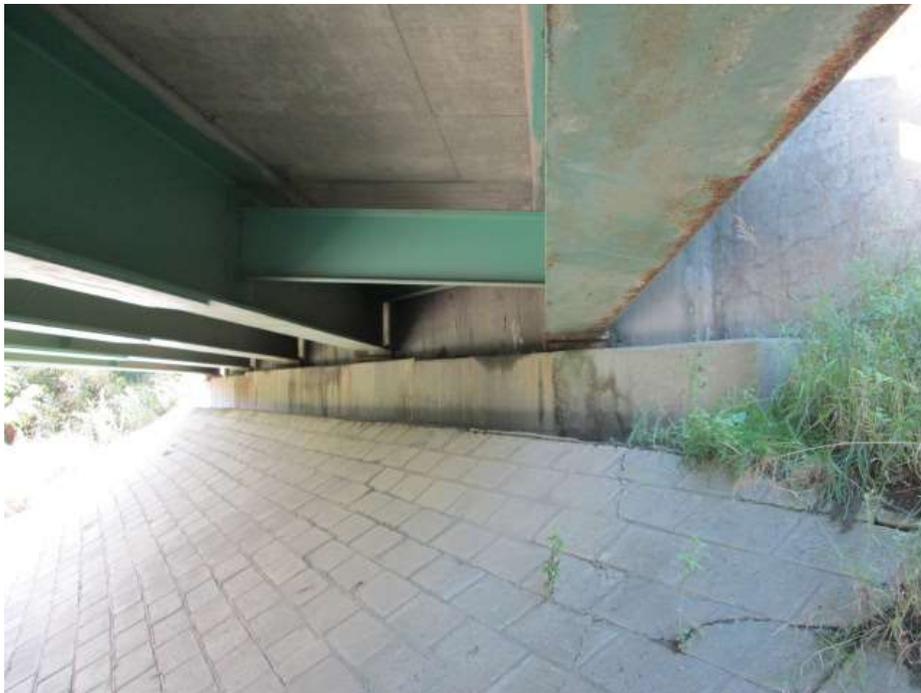
PHOTO 16

Description west abutment

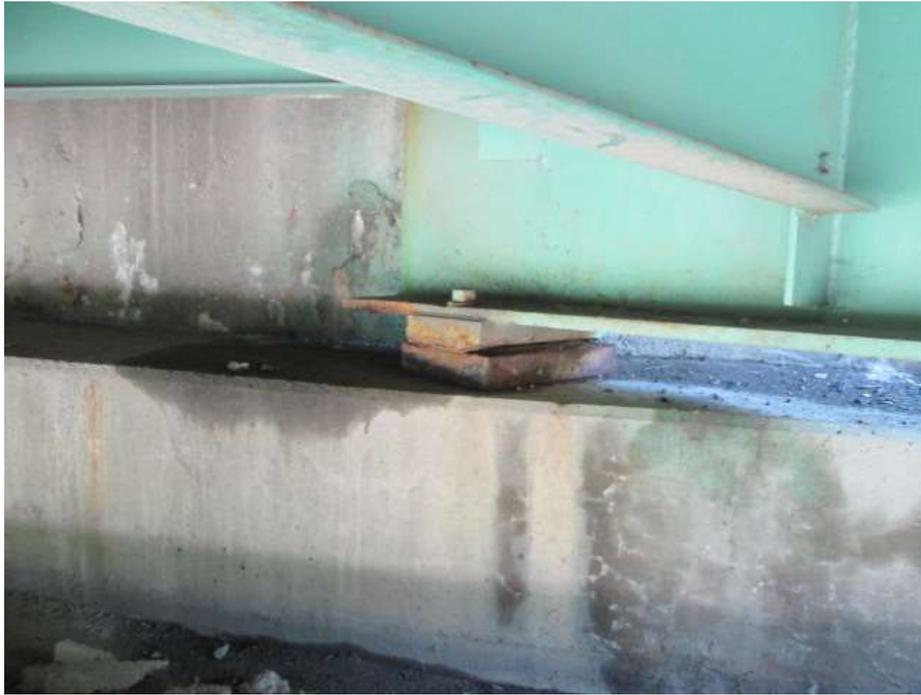
PHOTO 17

Description west abutment interior bearing

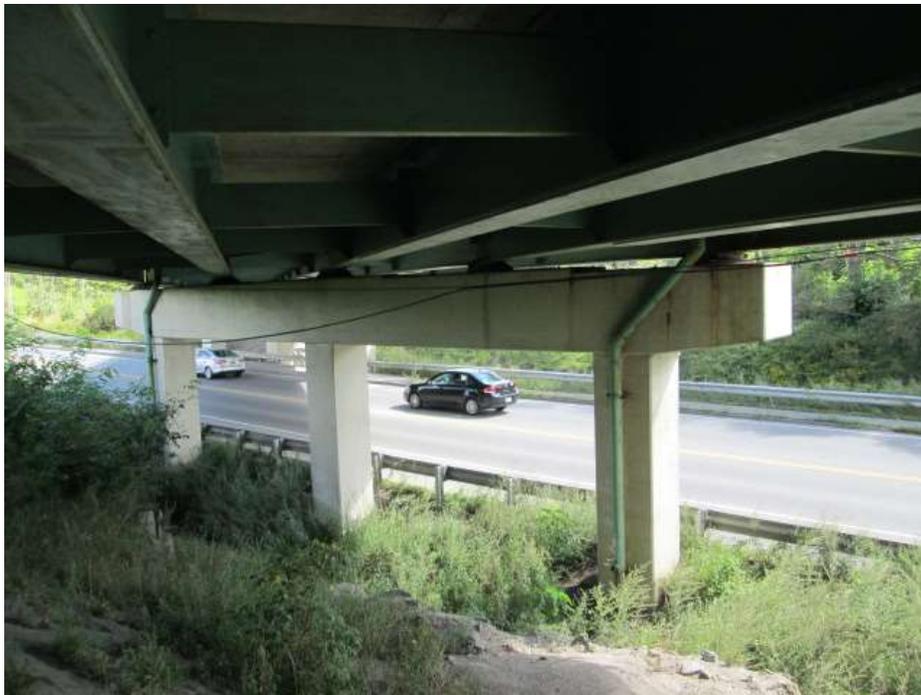
PHOTO 18

Description west pier west face
