**Structure Number:** 5782  
**Facility Carried:** DINSMORE RD

**Highway Bridge Inspection Report**

**Bridge Name:** DINSMORE ROAD / I-95

**Town:** Sidney

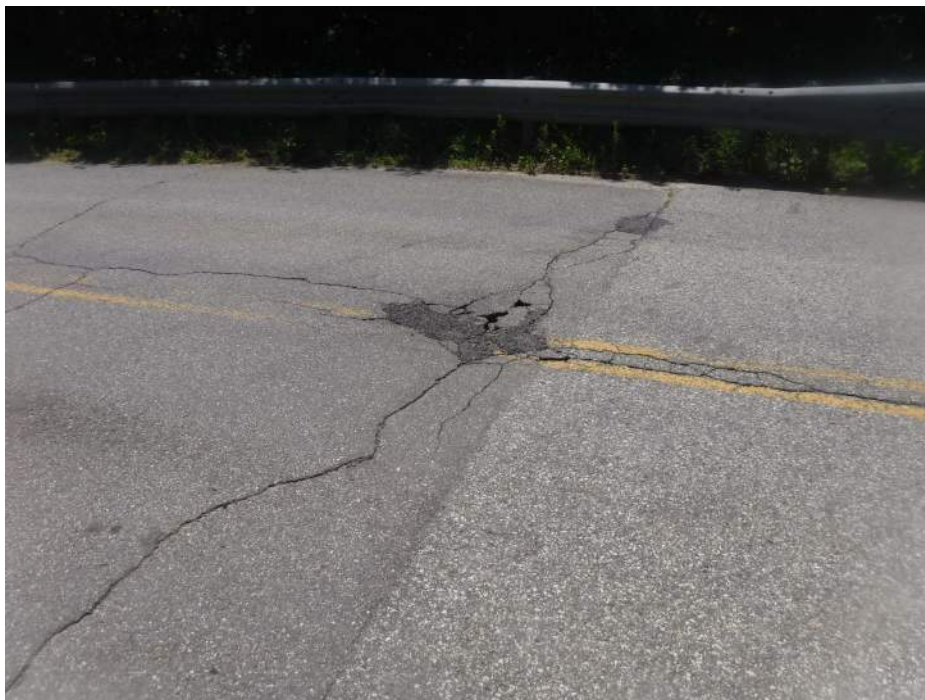
PHOTO 6

2024 - Transverse cracking was found over abutments. Heavy cracking/failure of wearing surface over approach slabs. Transverse cracking was found over center span pier.

Description View of transverse cracking over eastern abutment

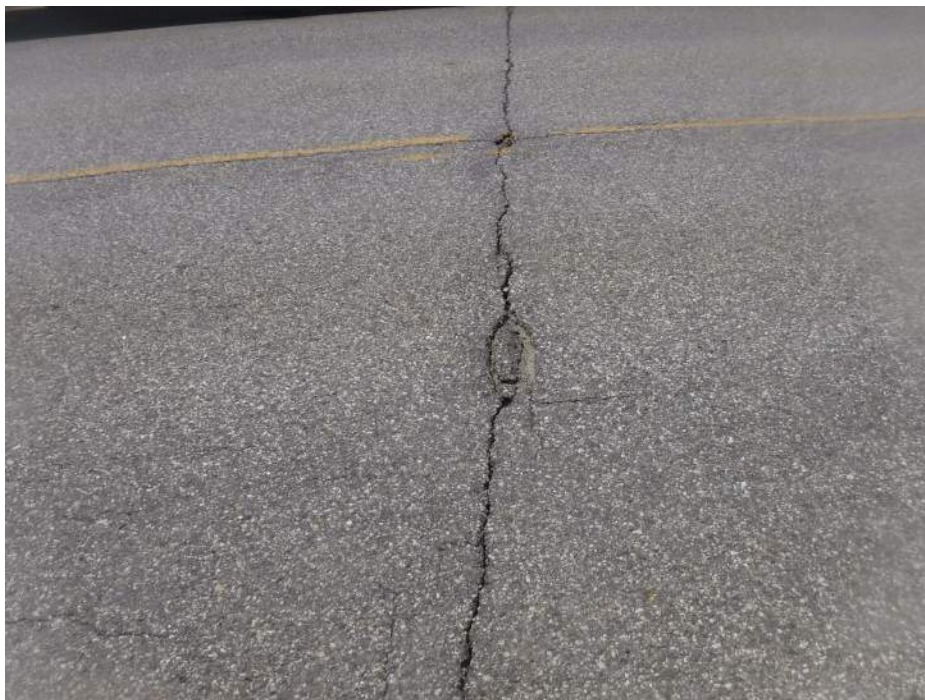
PHOTO 7

Description View of cracking over center span pier

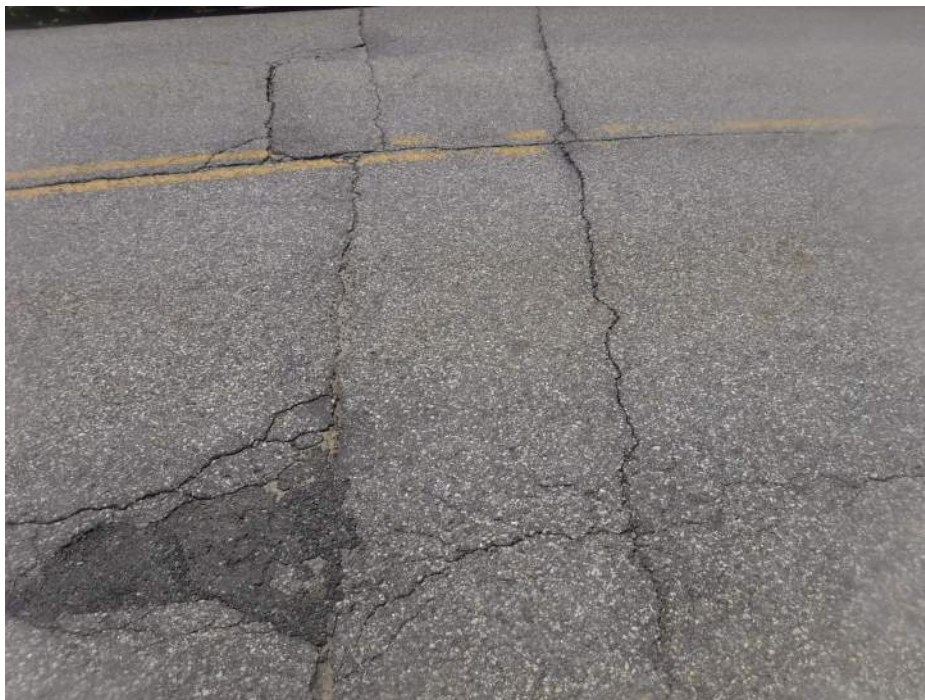
PHOTO 8

Description View of transverse cracking over western abutment

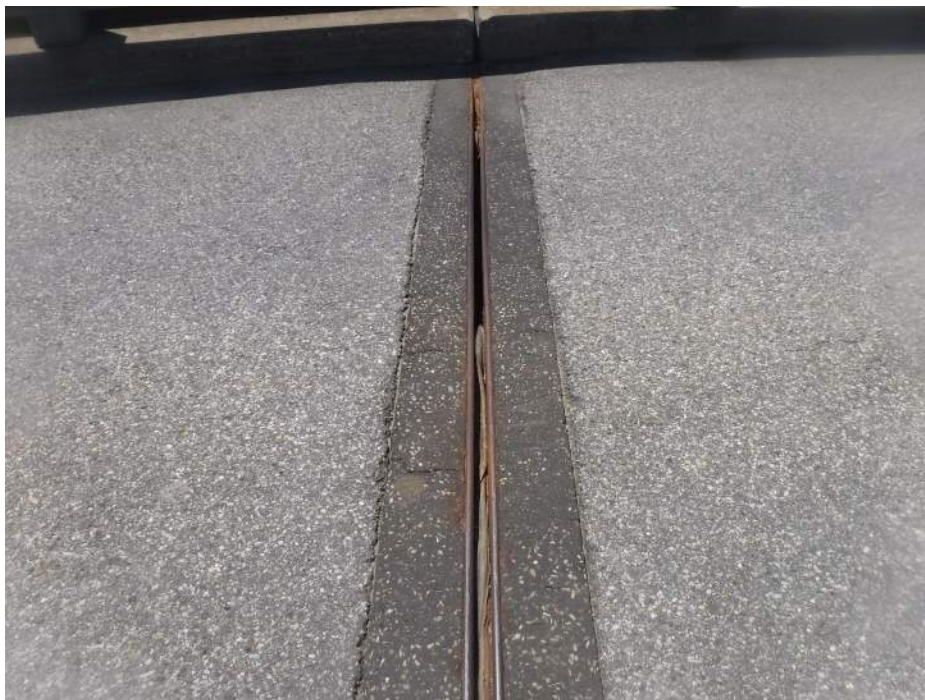
PHOTO 9

2024 - The eastern joint seal is falling through joint. The western joint seal is ripping. Two small spalls were found on fascia over the northern side of the south bound lane. Delaminations with exposed rebar found all over the most eastern span. Three spalls with exposed rebar found under deck over south bound lane.

Description View of eastern joint

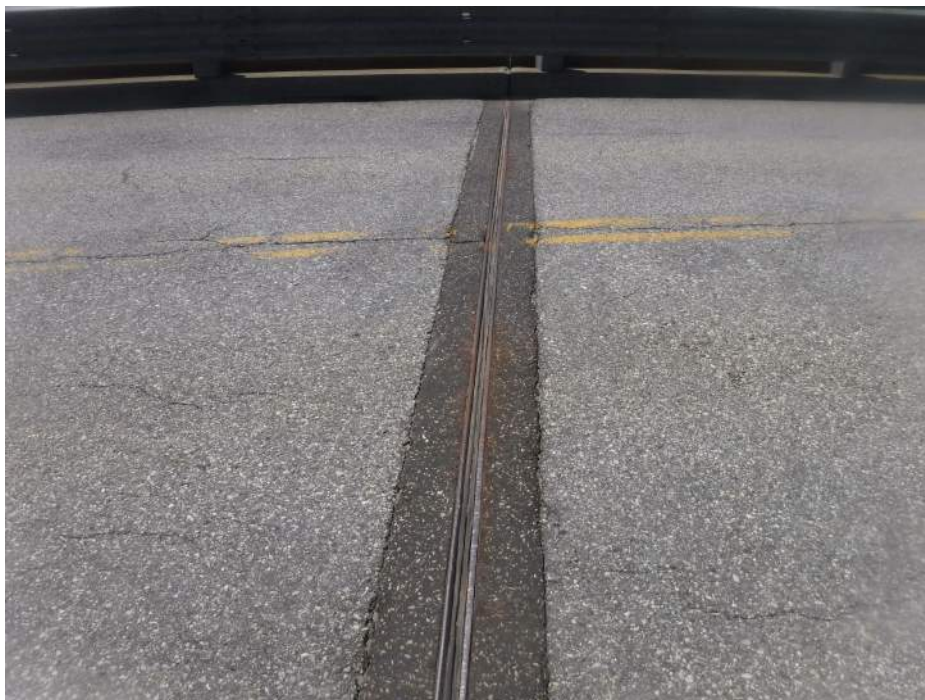
PHOTO 10

Description View of western joint

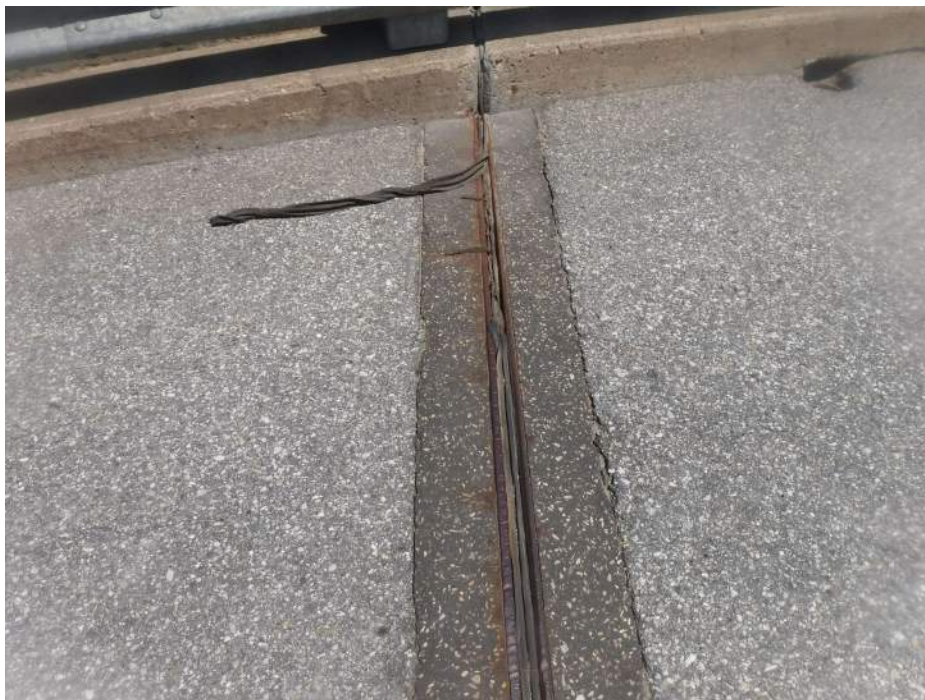
PHOTO 11

Description View of the ripping occurring on the western joint

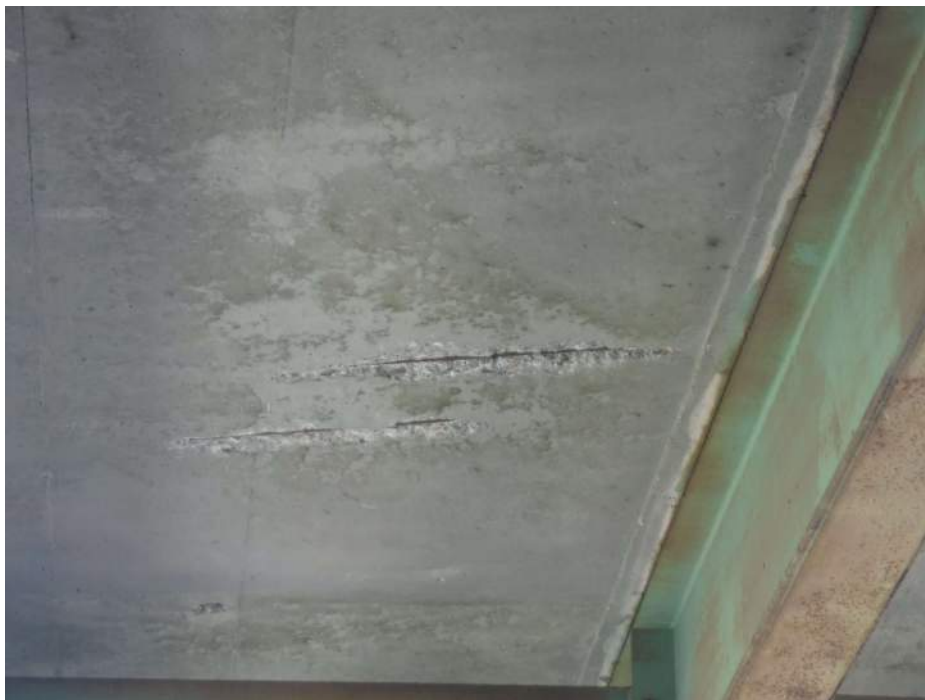
PHOTO 14

Description View of spalls over southbound lane

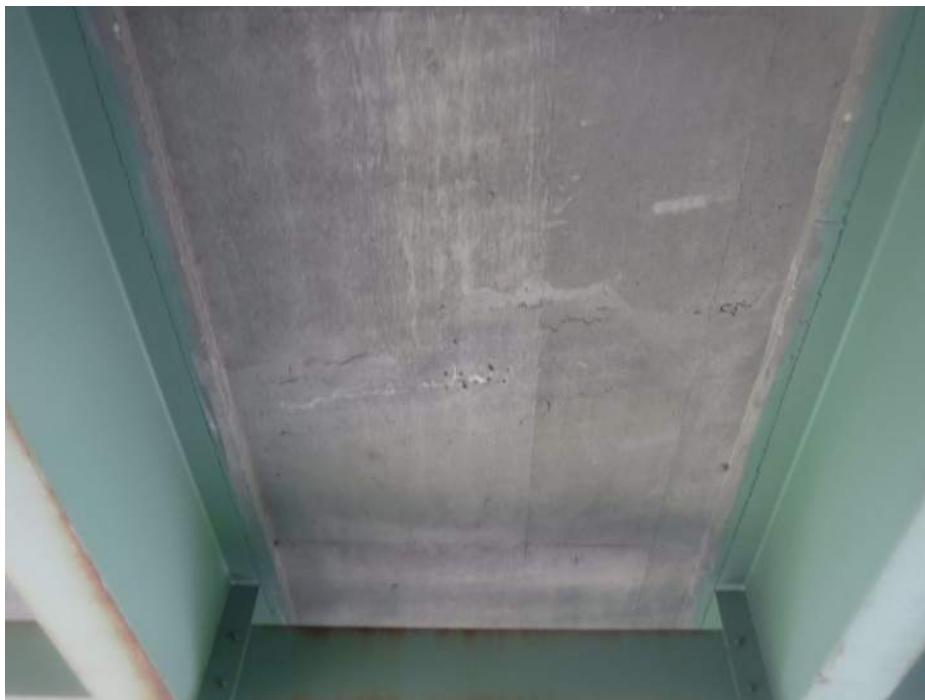
PHOTO 15

Description View of delamination area on underside of deck on eastern span

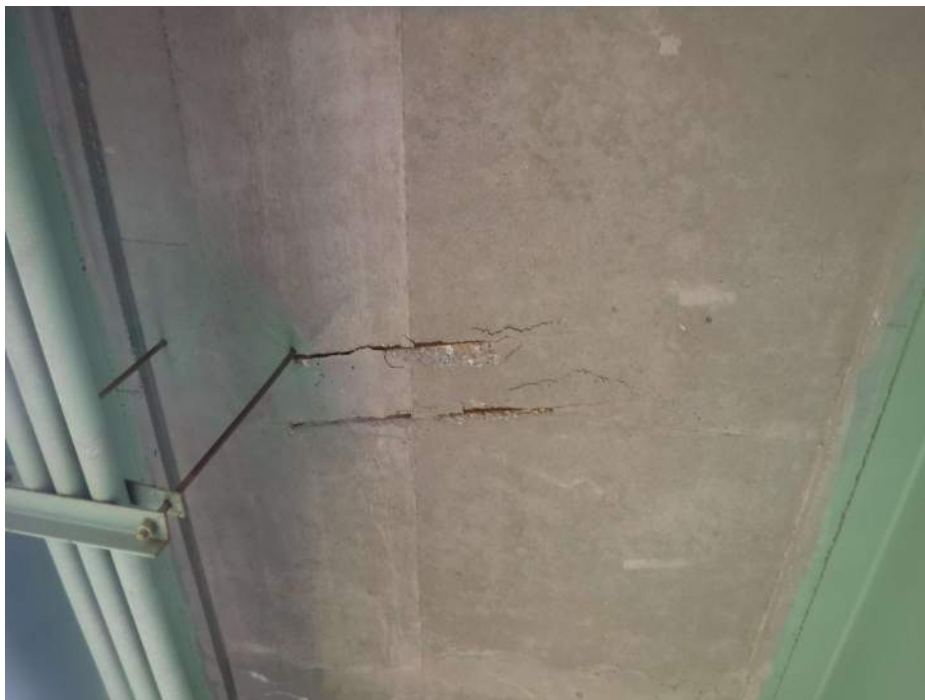
PHOTO 16

Description View of spalls with exposed rebar on underside of deck on eastern span

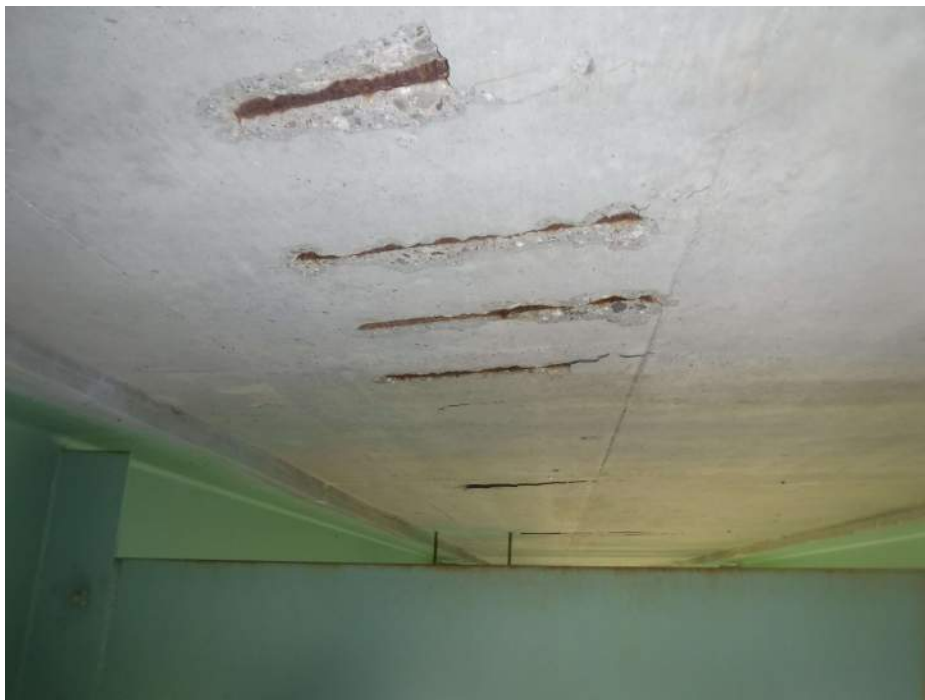
PHOTO 17

Description View of spalls with exposed rebar on underside of deck on eastern span

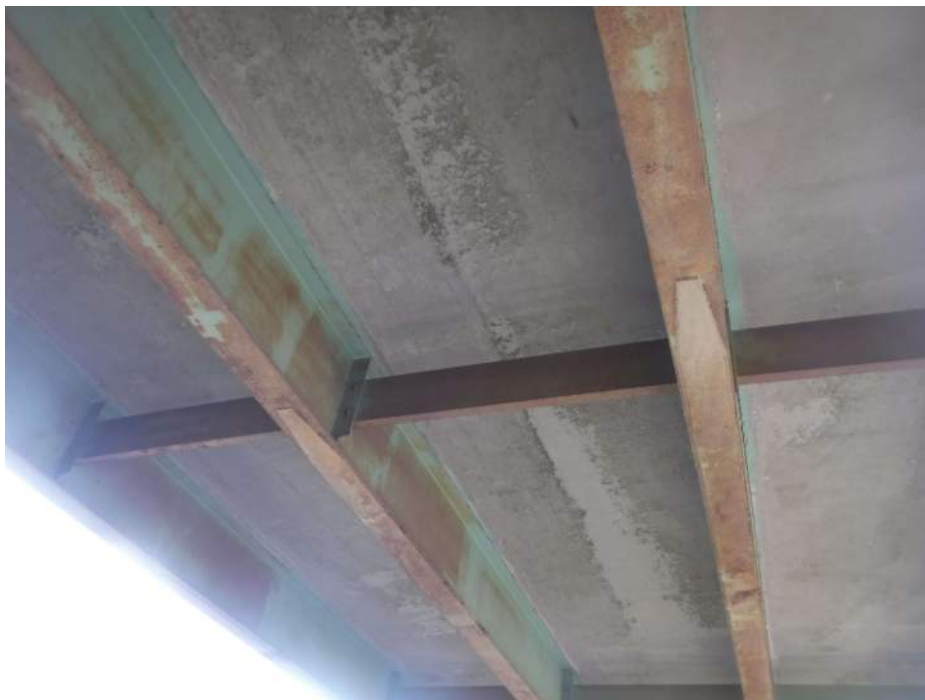
PHOTO 19

2024 - Speckled/flaking rust and minor sections loss on beams and diaphragms above most westerly pier and center pier. Joint leakage is the suspected cause of this. Heavy speckled rust over travel lanes.

Description View of freckled rust and paint failure over southbound lane

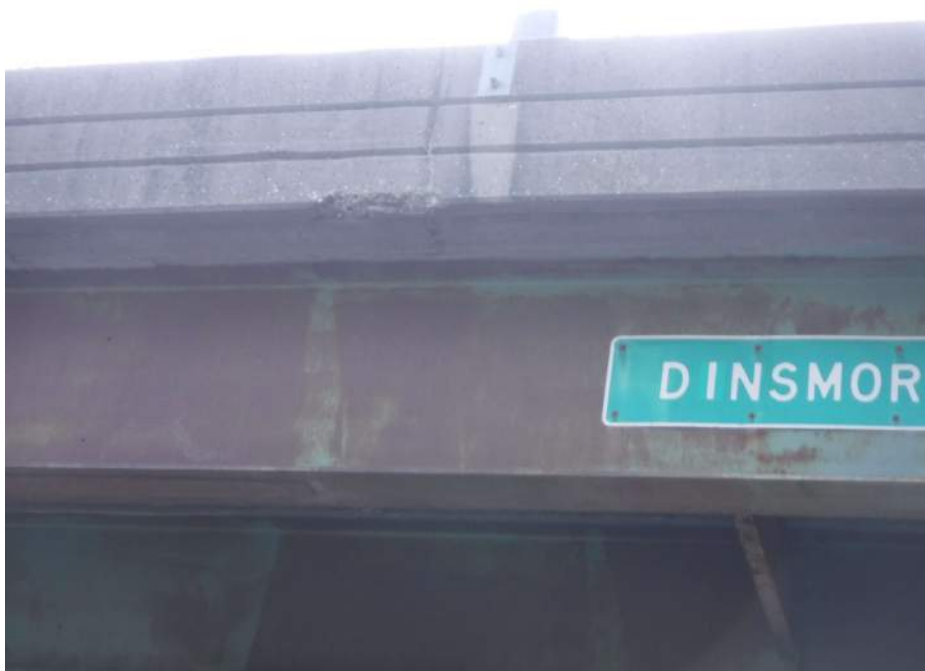
PHOTO 21

Description View of paint failure on northern beam over southbound lane

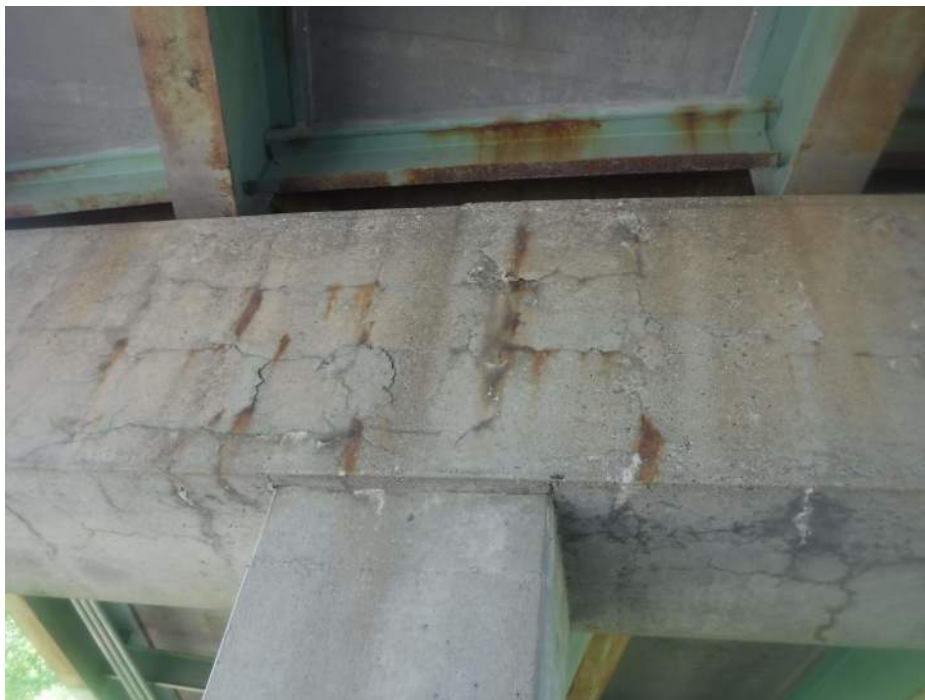
PHOTO 23

2024 - The west pier cap has extensive map cracking, staining and efflorescence. Three spalls with exposed rebar found on 2nd most easterly pier cap. Easterly abutment has minor cracking.

Description View of cracking and delamination on western most pier

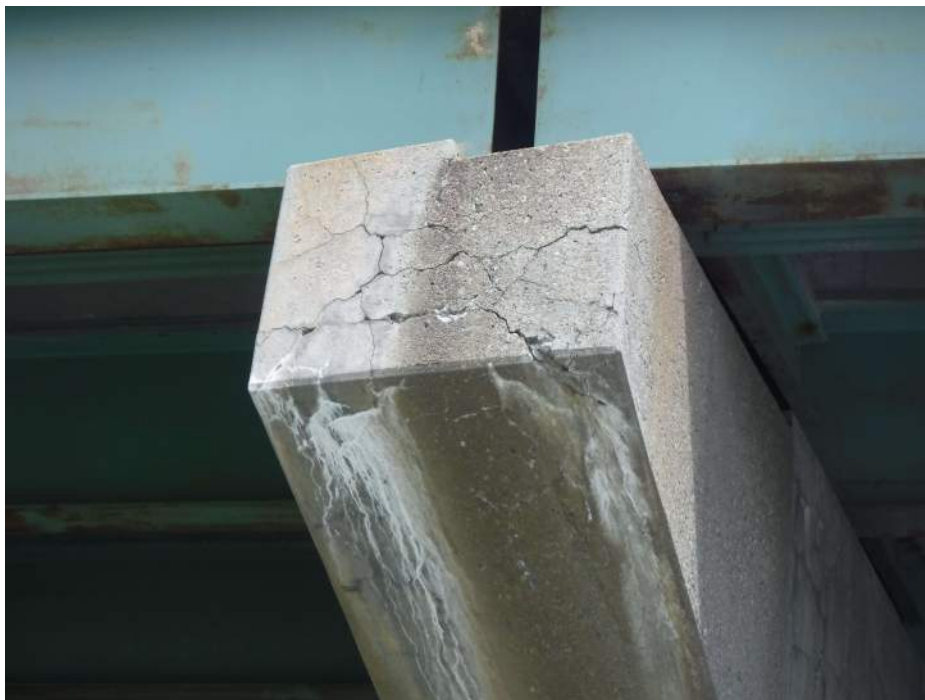
PHOTO 24

Description View of cracking and efflorescence on southern corner of western pier

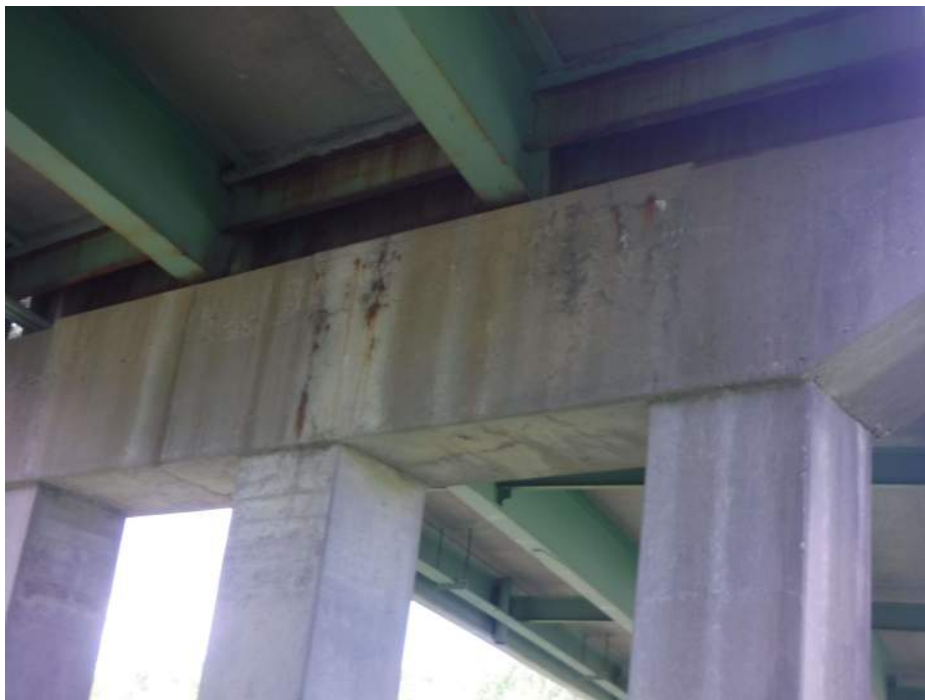
PHOTO 27

Description View of cracking on pier 3 cap

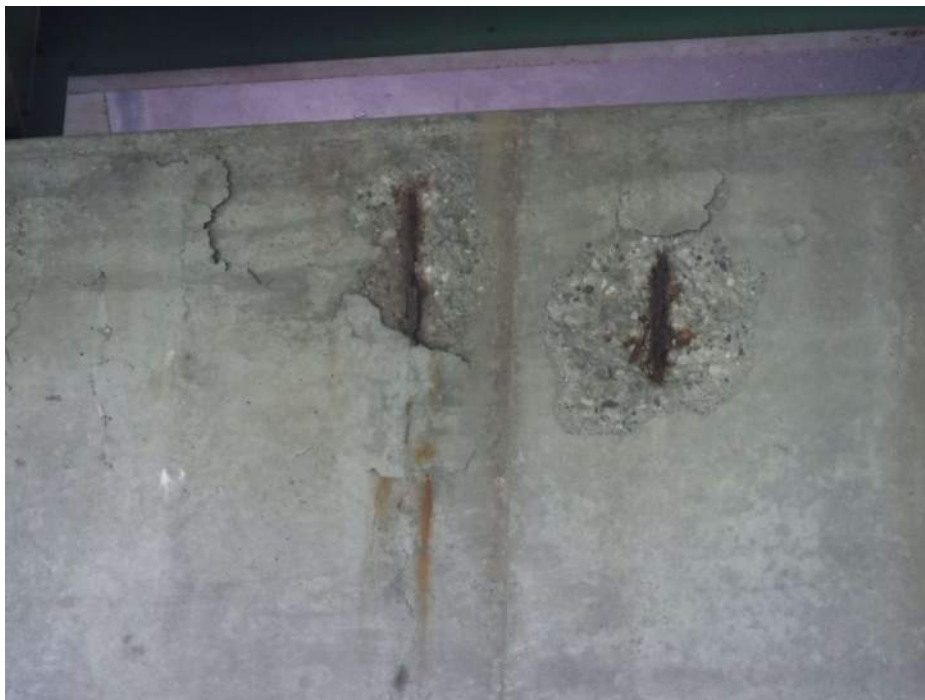
PHOTO 29

Description View of spalls with exposed rebar on pier 4 cap

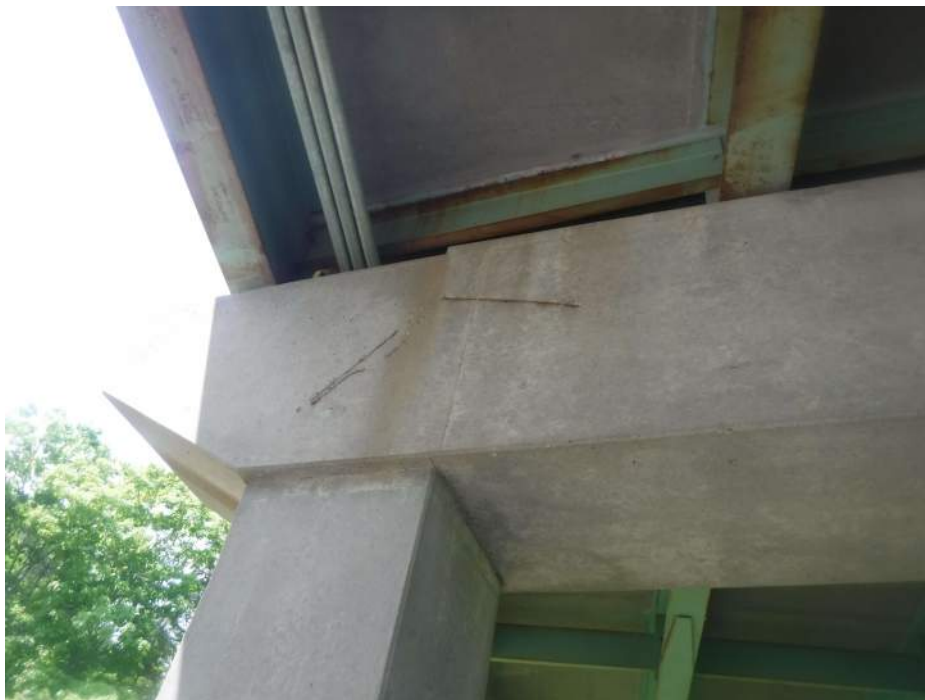
PHOTO 30

Description View of exposed metal on the eastern side of pier 4

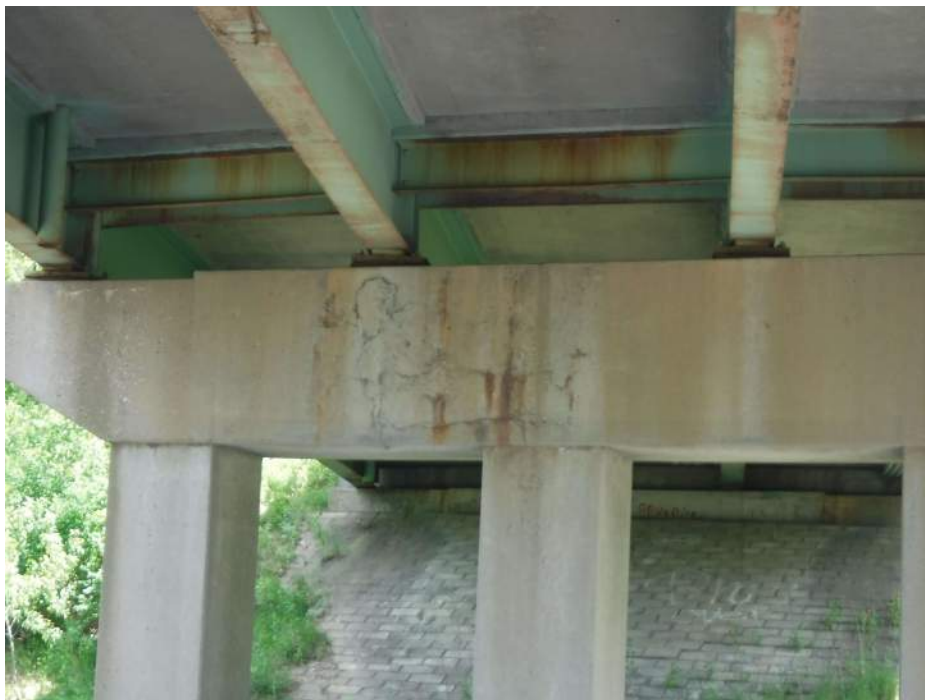
PHOTO 31

Description View of heavy cracking and delamination on the most easterly pier (#5)

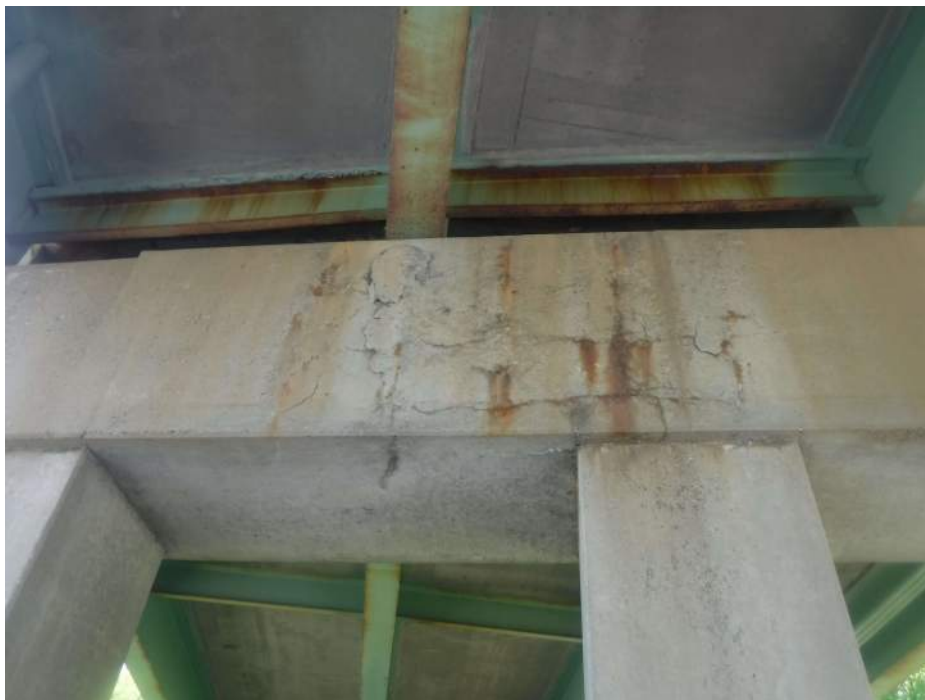
PHOTO 32

Description Closer view of heavy cracking and delamination on pier 1

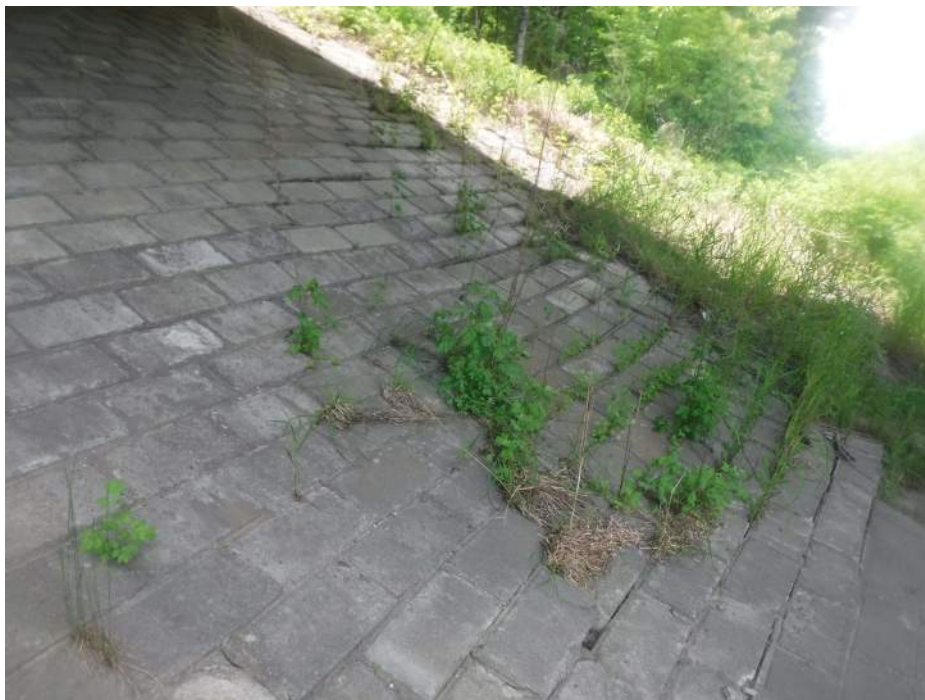
PHOTO 34

2024 - Excessive winter sand build up on approach rails. Eastern slope protection cracking and starting to fail.

Description View of settling of slope protection on eastern side of bridge

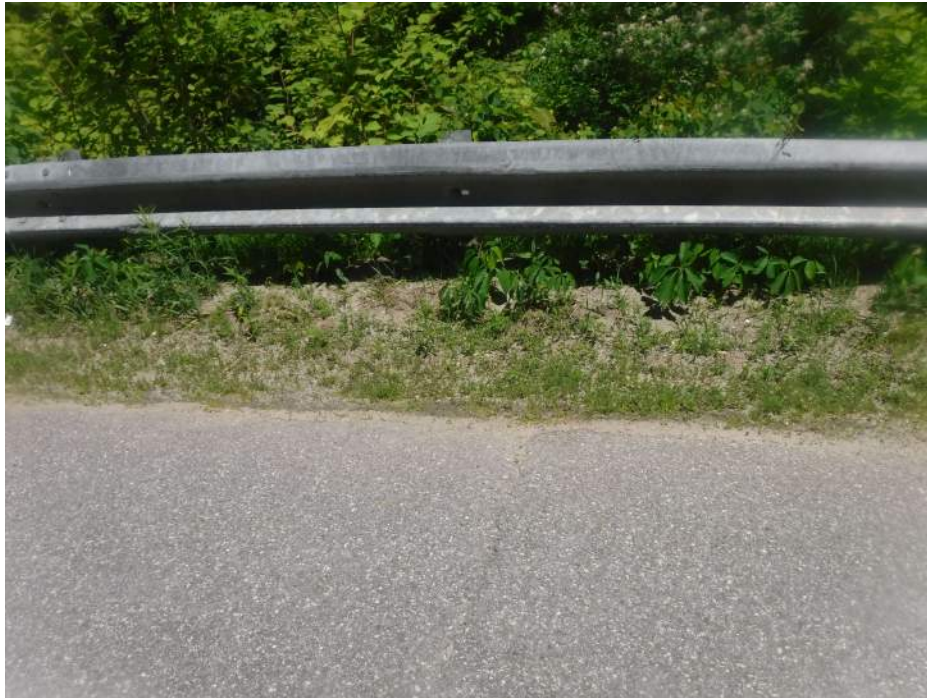
PHOTO 35

Description View of winter sand build up
