Structure Number: 1560
Facility Carried: ROBERTSON BLVD

Highway Bridge Inspection Report

Bridge Name: INDUSTRIAL PARK RD / I395

Town: Brewer

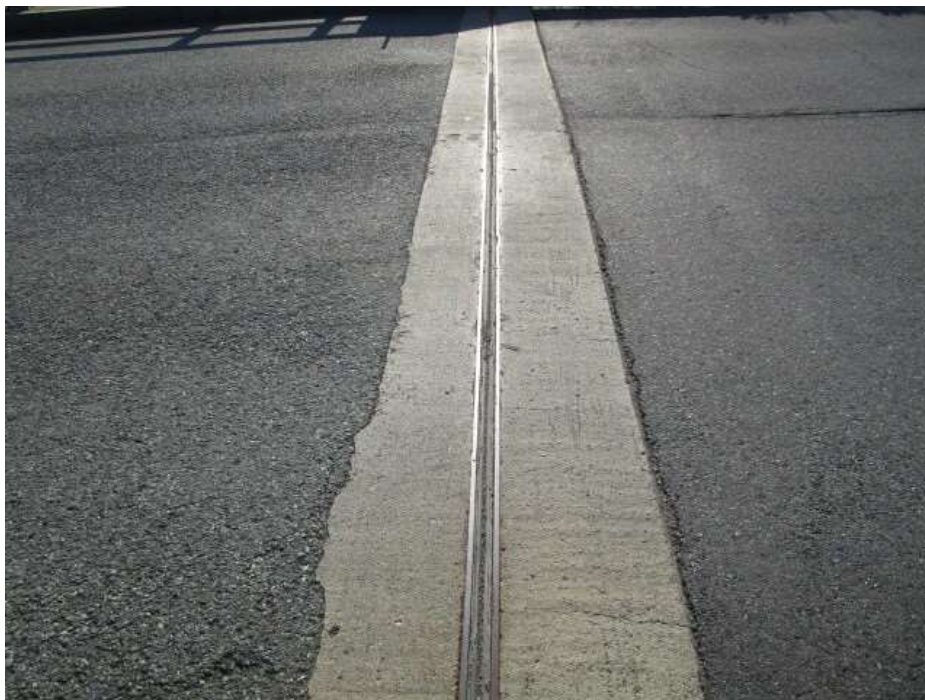
PHOTO 2

Description south end joint

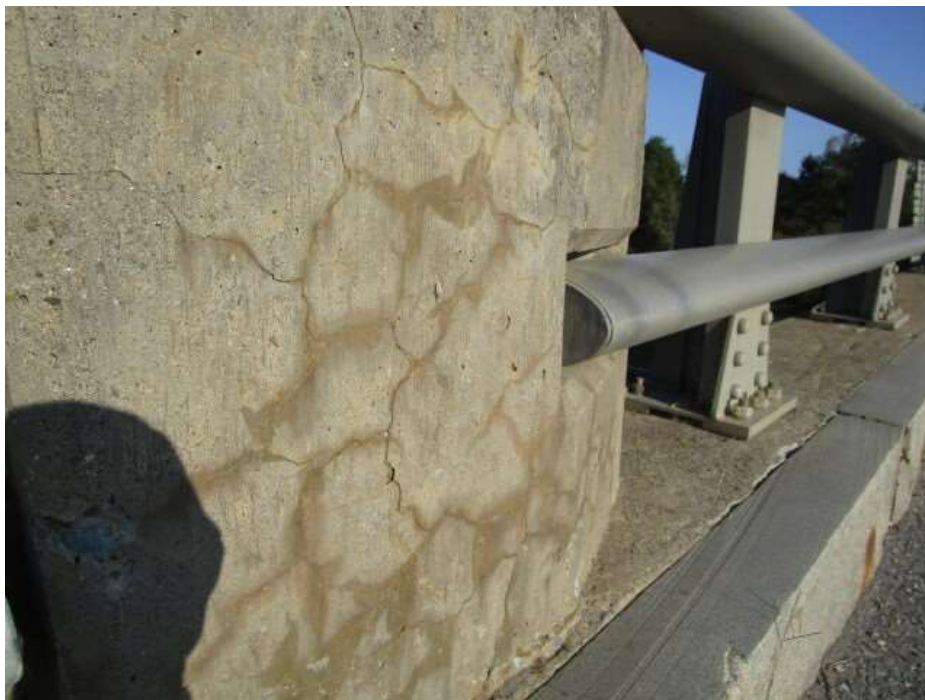
PHOTO 4

Description typical map cracking of end posts

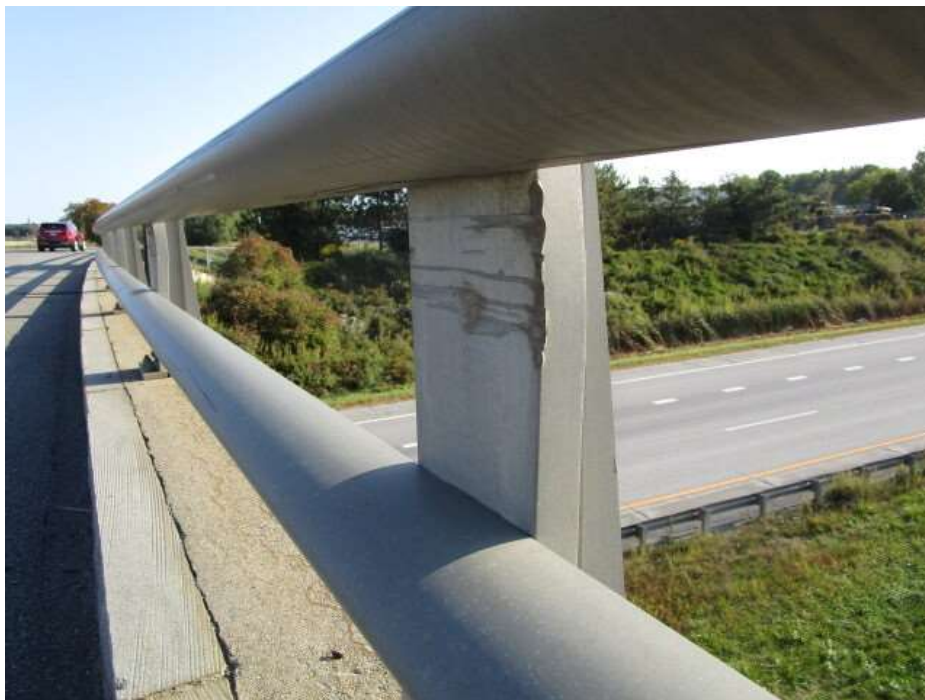
PHOTO 7

overall satisfactory condition with moderate cracking, efflo staining and spalling at joint fascia areas. Main bays have minor cracking only. Joint seals are in seals appear good. Concrete joint headers have been rehabbed and are in good condition. Transverse cracking and efflo every 6'-10' on the fascia's. East side bridge rail has minor damage to rail post/ no cracking.

Description minor damage to east side rail posts

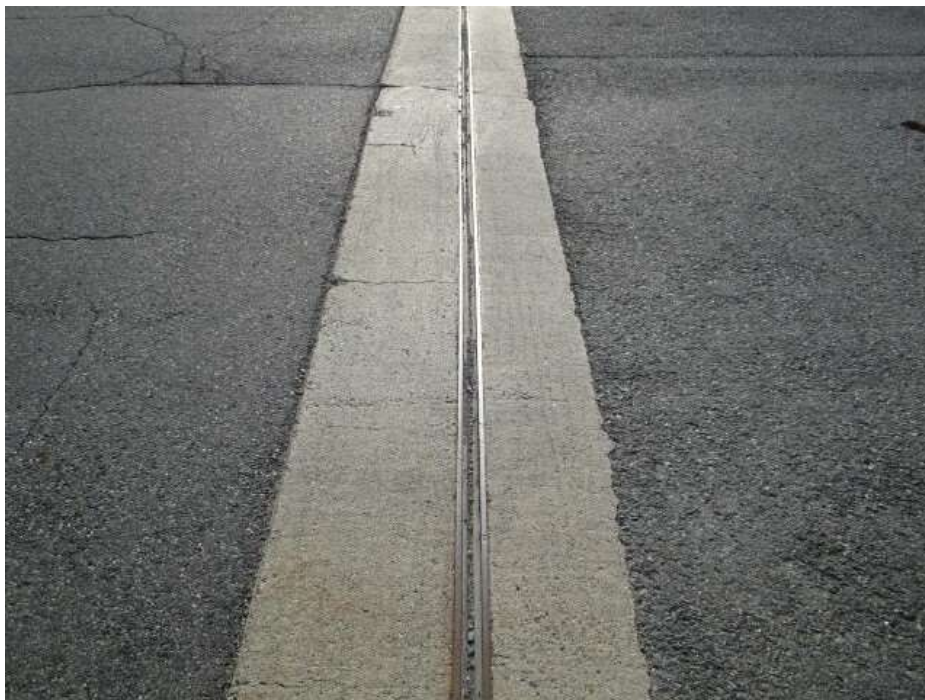
PHOTO 9

Description north end joint

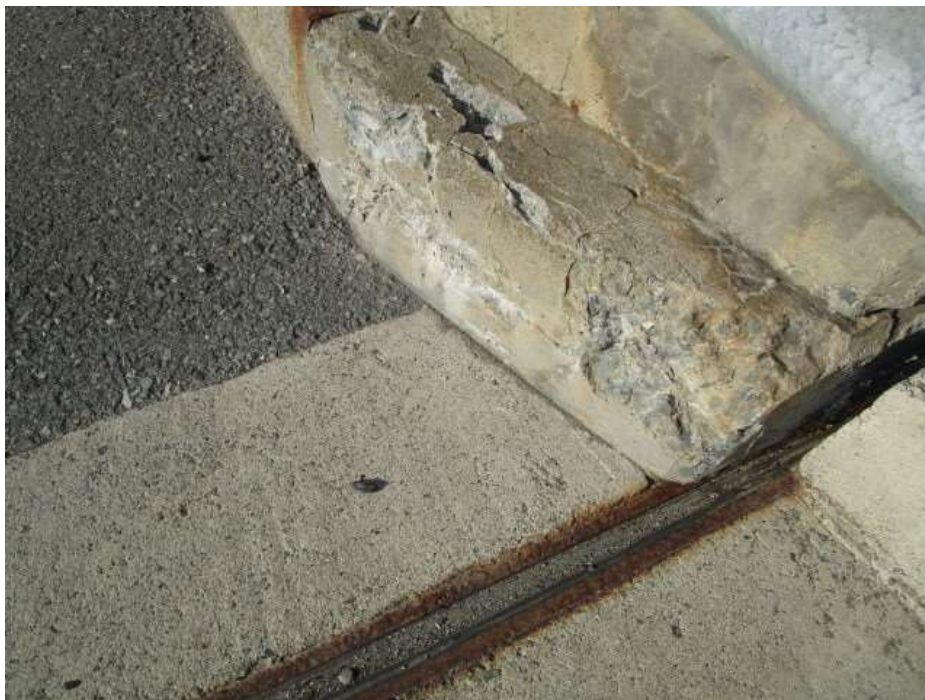
PHOTO 10

Description deteriorated curb at NW end post area

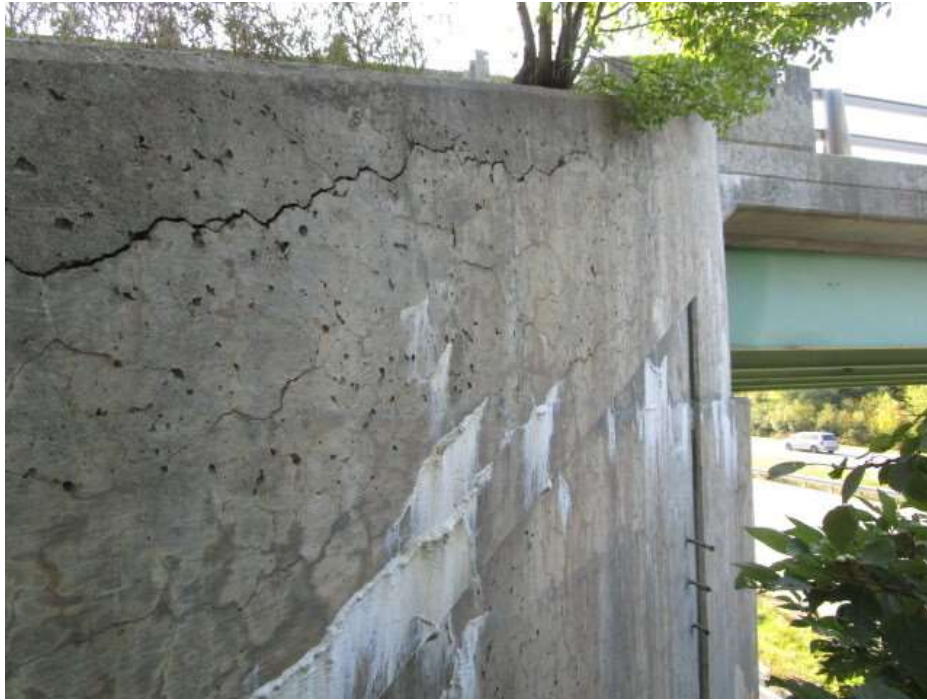
PHOTO 11

Overall fair condition with extensive cracking and active efflo due to ASR concrete. Wings have moderate to heavy cracking at the tops & cracking/ stained breast walls. NE abutment bridge seat has large, scaled area with exposed re-steel. Both abutments have full height cracks up to 1/8" wide. Pier has isolated minor map cracking at the ends but far less ASR than the abutments. Both of the concrete slope protection s is slumping, 2.5" as measured at the abutment with slight buckling in lower panels.

Description Cracking at NW wing top

Type	Work Item	Priority	Notes
Capital	Rehab Substructure		Rehab/repair wings and abutments.
Capital	Paint		
Capital	Seal Joint		Seal replacement
Capital	Other		Apply Silane
Capital	Rehab Substructure		repair bridge seat, NE wing turn

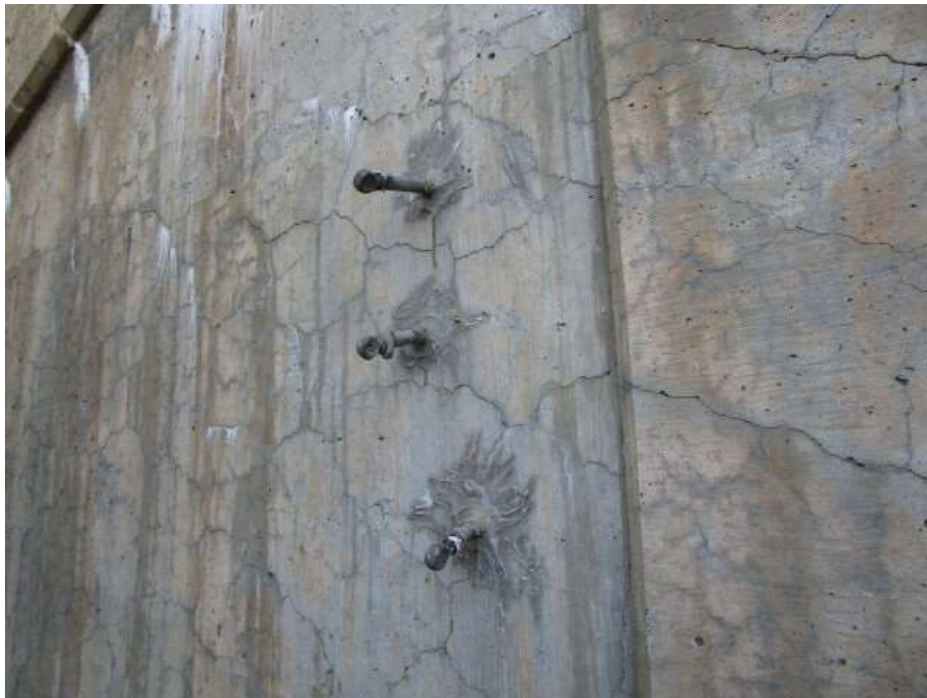
PHOTO 12

Description some kind of epoxy injection tubes

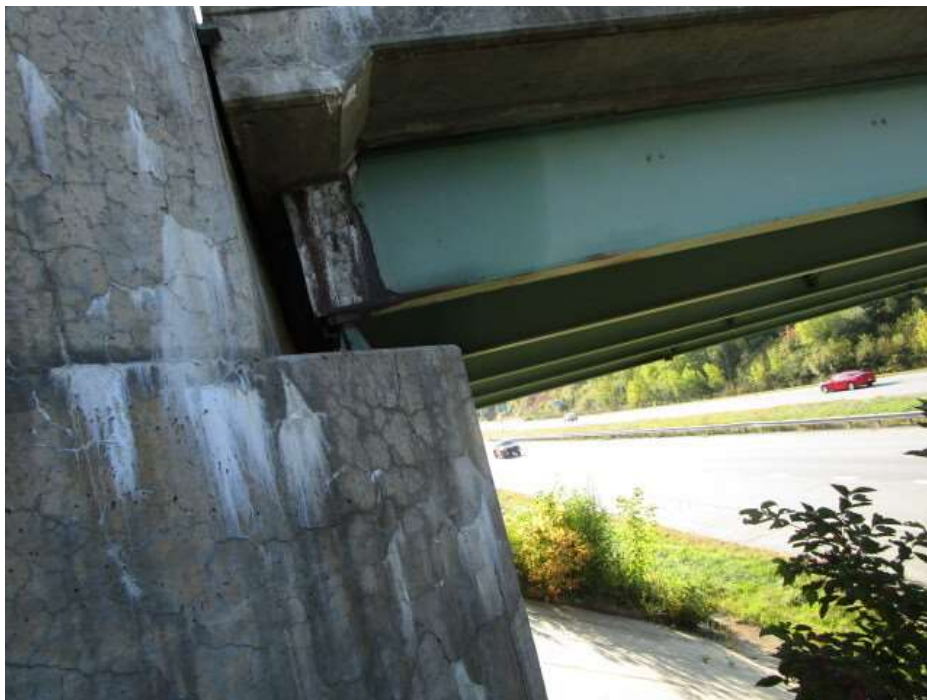
PHOTO 13

Girders have complete paint chalking with paint loss and rust scaling at beam ends. The NE exterior beam end has heavy scaling. The NE exterior bearing is tipped to limit with ambient air temperature of 60 degrees.

Description NW beam end

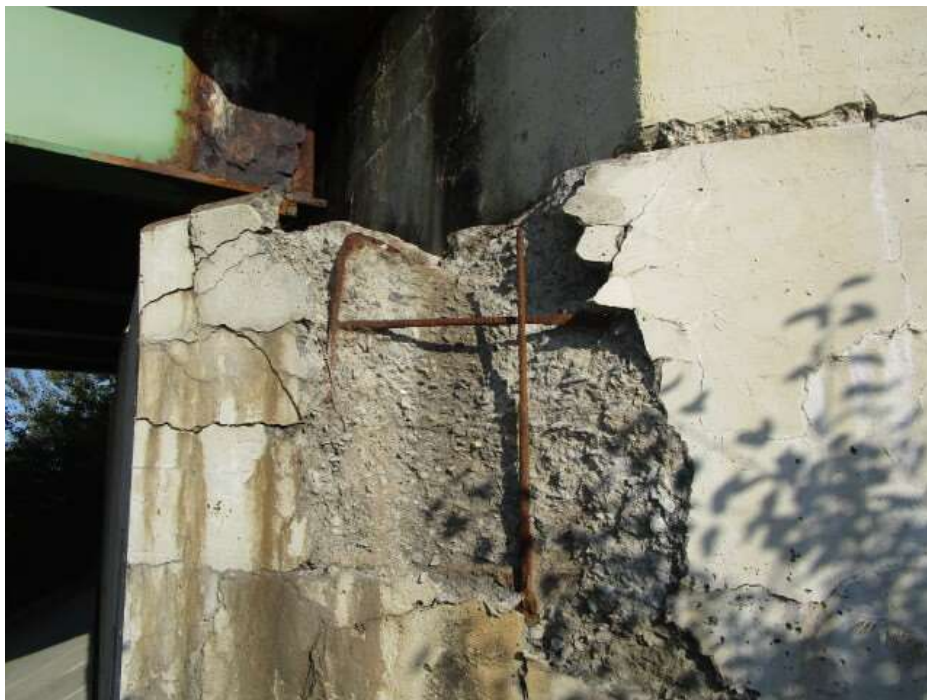
PHOTO 17

Description heavy deterioration at NE abutment wing turn area

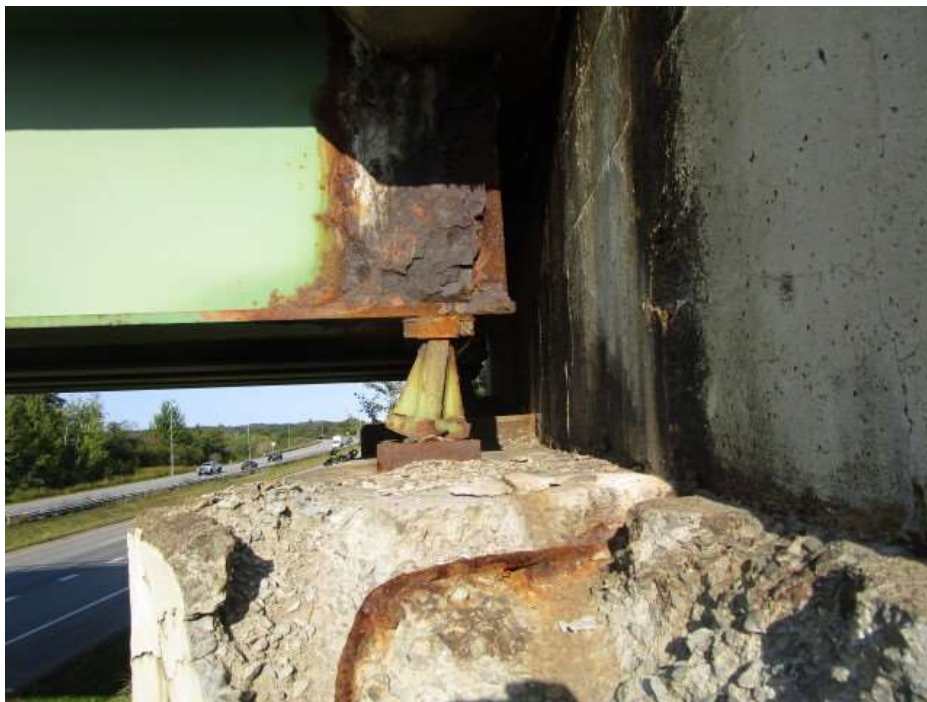
PHOTO 18

Description bearing at limits NE abutment

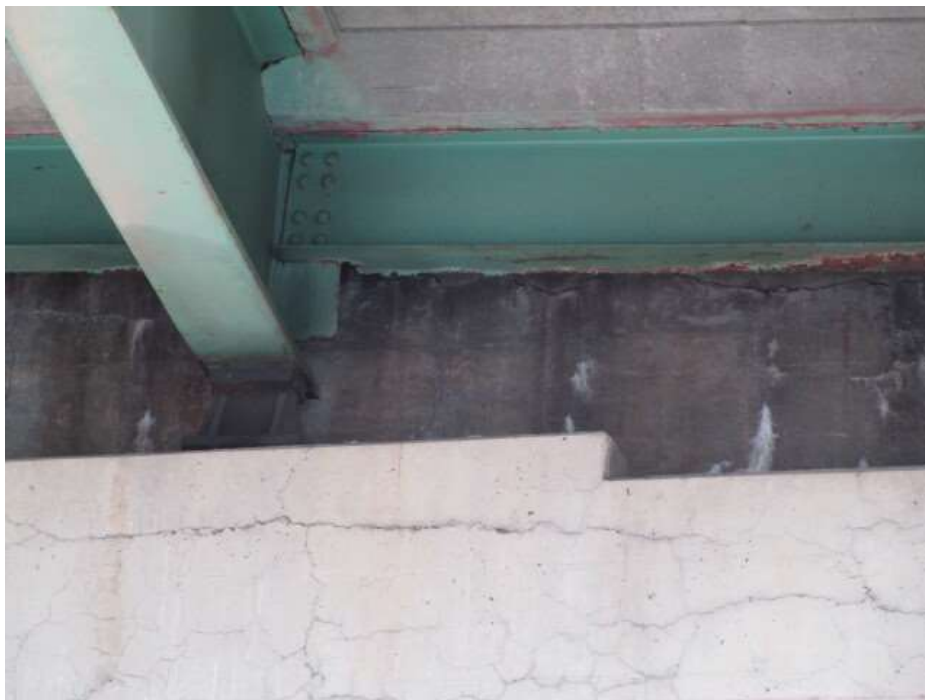
PHOTO 21

Description north abutment cracking & staining

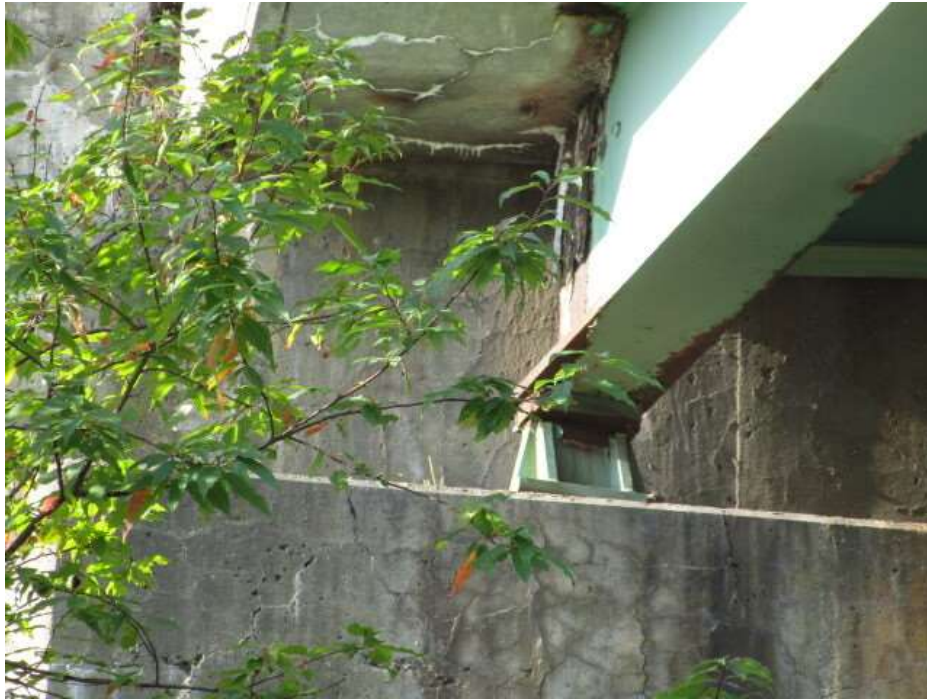
PHOTO 23

Description south abutment beam end
