Structure Number: 1463
Facility Carried: LYONS ROAD

Highway Bridge Inspection Report

Inspection Type(s): Routine

Bridge Name: LYONS ROAD / I95 SB

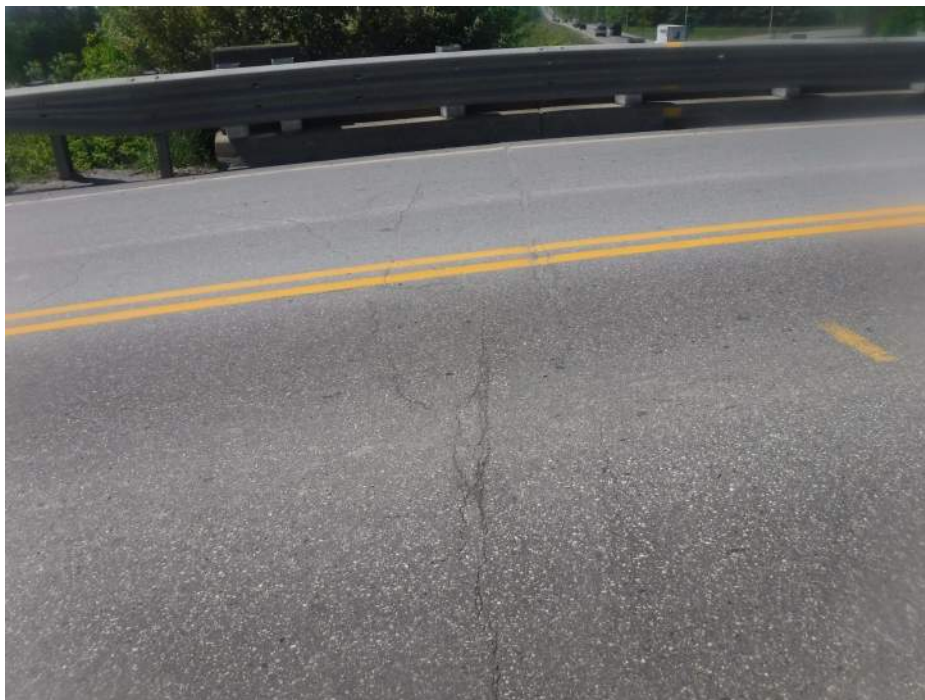
PHOTO 6

2024 - Transverse cracking over abutments. Small area of longitudinal cracking and spalling on northwest curb.

Description Transverse cracking over eastern abutment

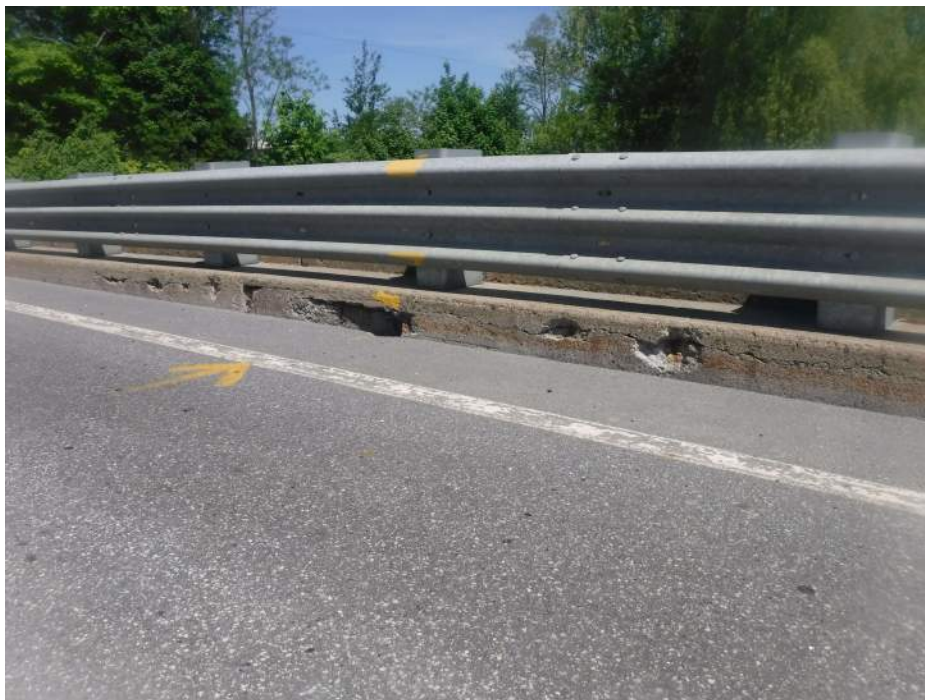
PHOTO 7

Description View of spalling and cracking on northern curb

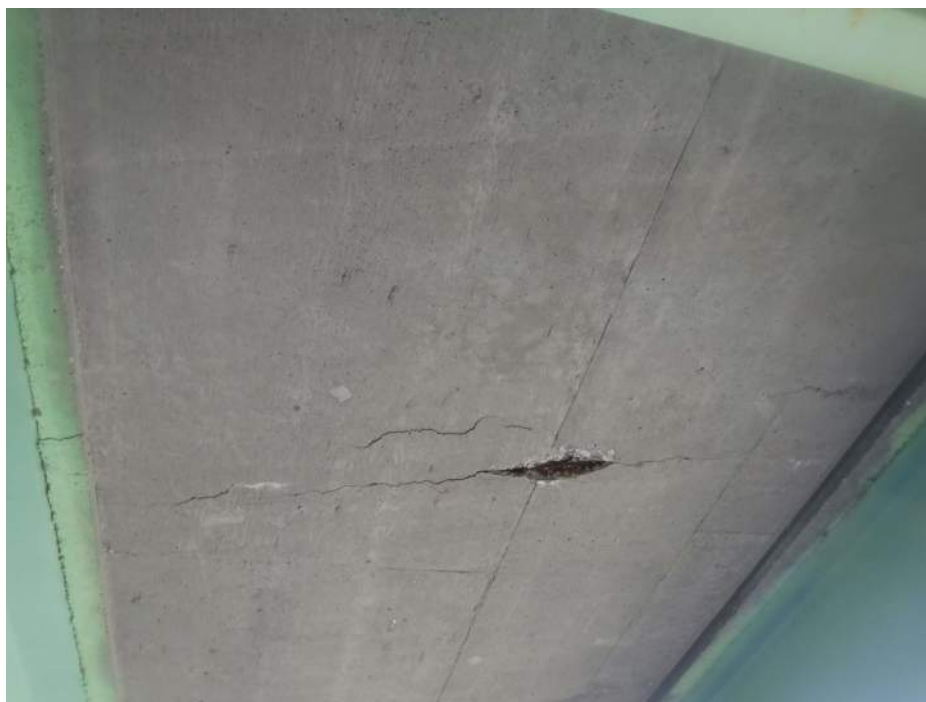
PHOTO 10

2024 - Underside of westerly span has 5% delaminations and spalling.

Description View of spall with exposed rebar and delamination area on western side of deck

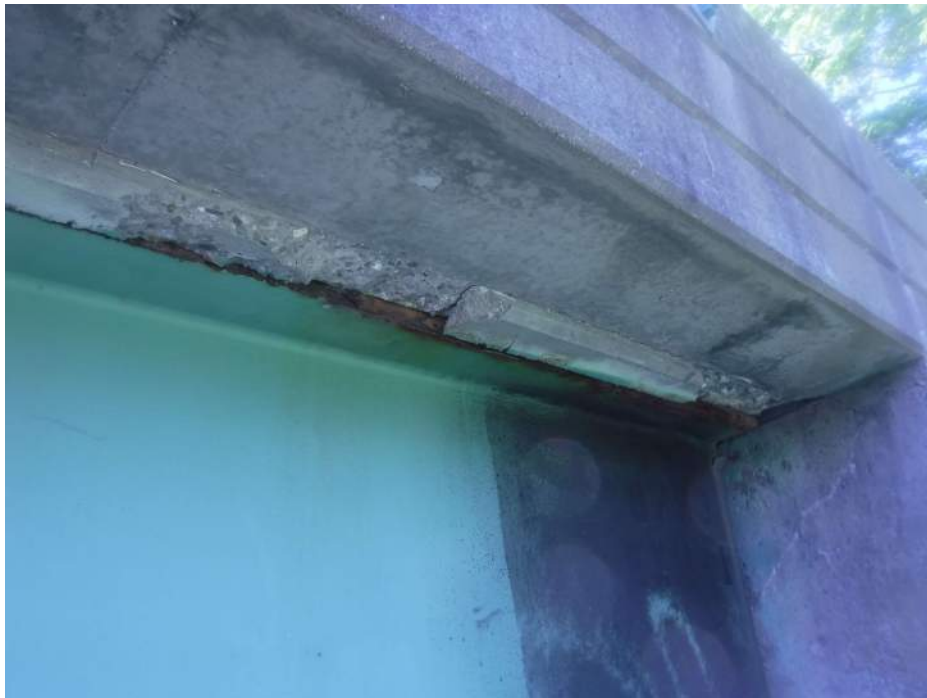
PHOTO 12

Description View of spall with exposed rebar on northwestern side of bridge

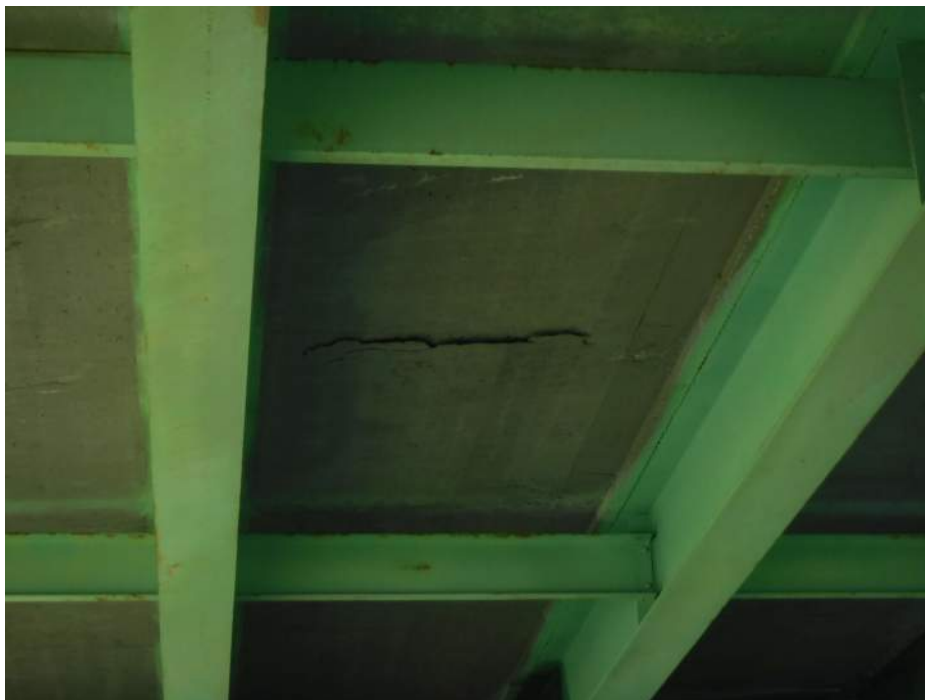
PHOTO 14

Description View of delamination forming on western deck

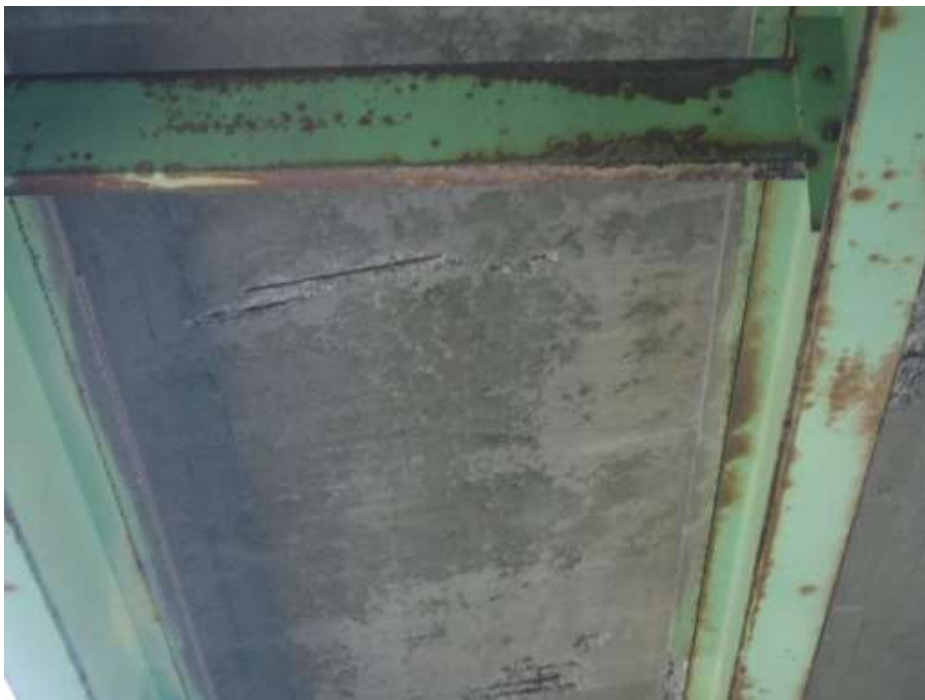
PHOTO 15

Description View of small spall with exposed rebar over roadway

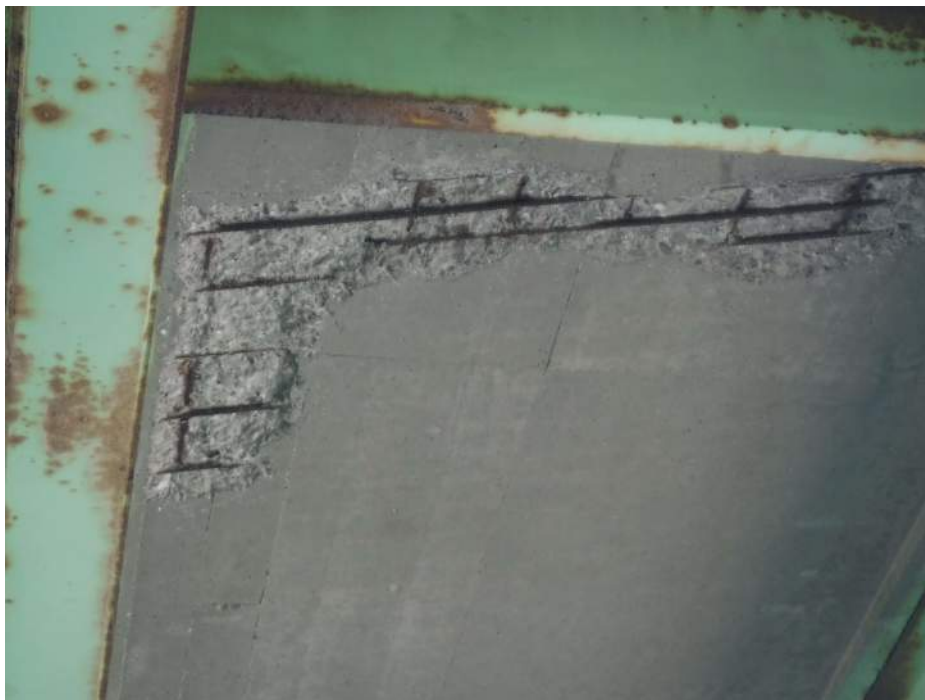
PHOTO 16

Description Large spall with exposed rebar found above roadway

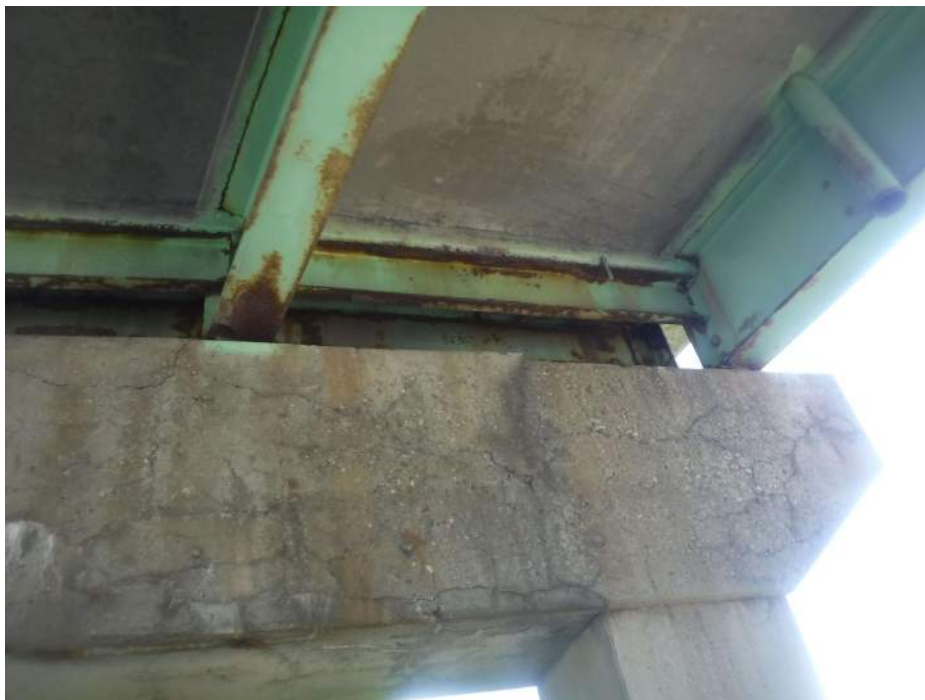
PHOTO 20

2024 - Minor section loss found on diaphragms and beams over eastern abutment.

Description View of heavy pack rust and section loss forming on diaphragms above eastern pier

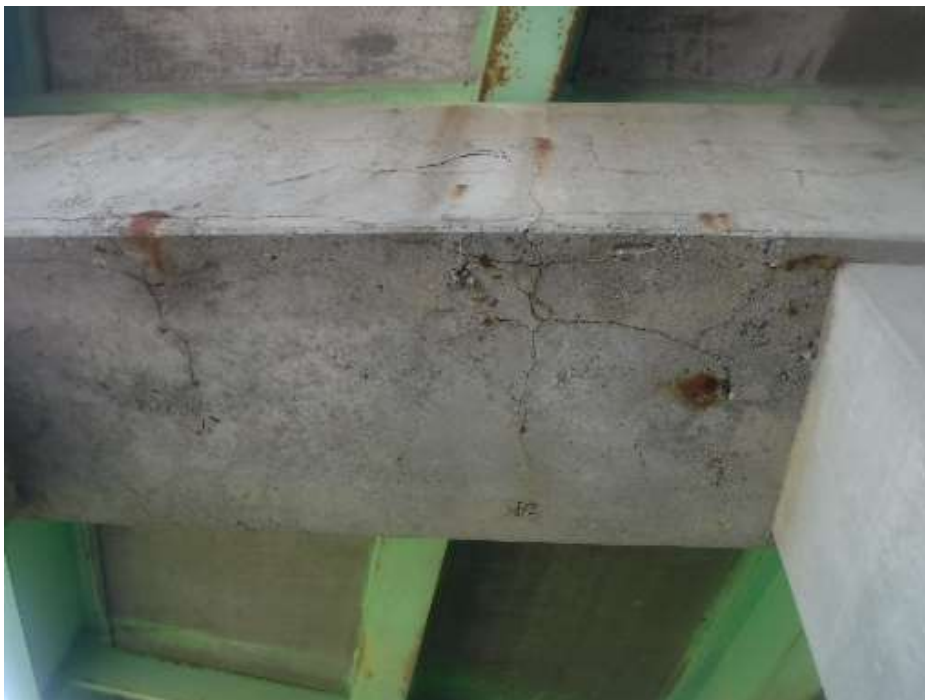
PHOTO 24

Description View of cracking on western pier

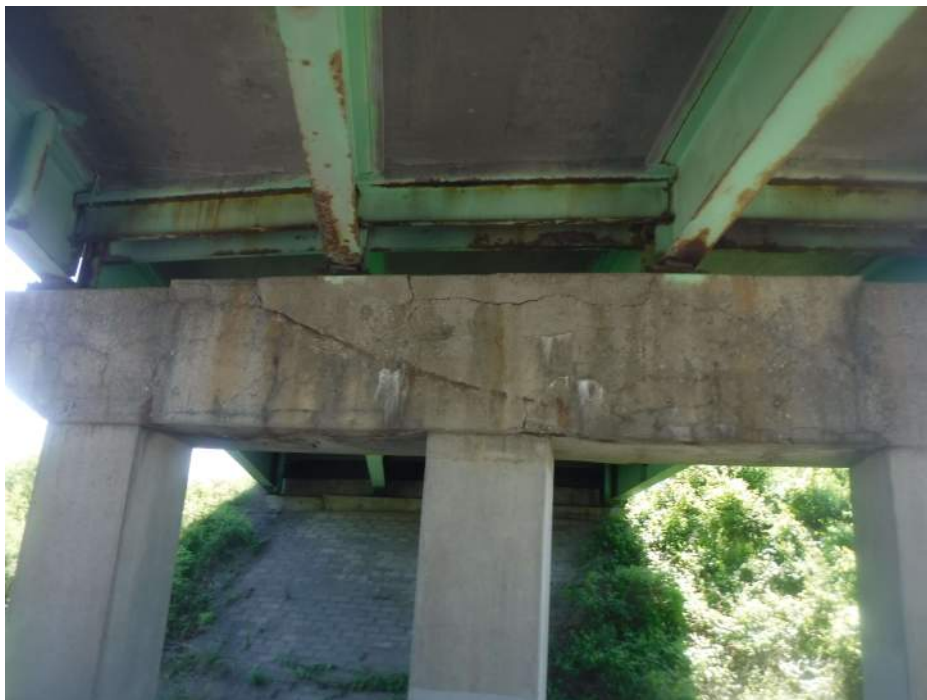
PHOTO 26

2024 - The eastern piers caps/columns has heavy cracking, major delaminations and spalling. Large crack on pier 2 cap, westerly face, has turned into a large delamination/spall. The delamination/spall is offset from face by 2 inches.

Description View of large, heavy cracking/delamination on western face of eastern pier cap

Type	Work Item	Priority	Notes
Maintenance	Rehab Substructure		Pier caps
Preservation	Seal Joint		
Maintenance	Cut Brush		
Maintenance	Other		Repair slope protection
Capital	Paint		Paint

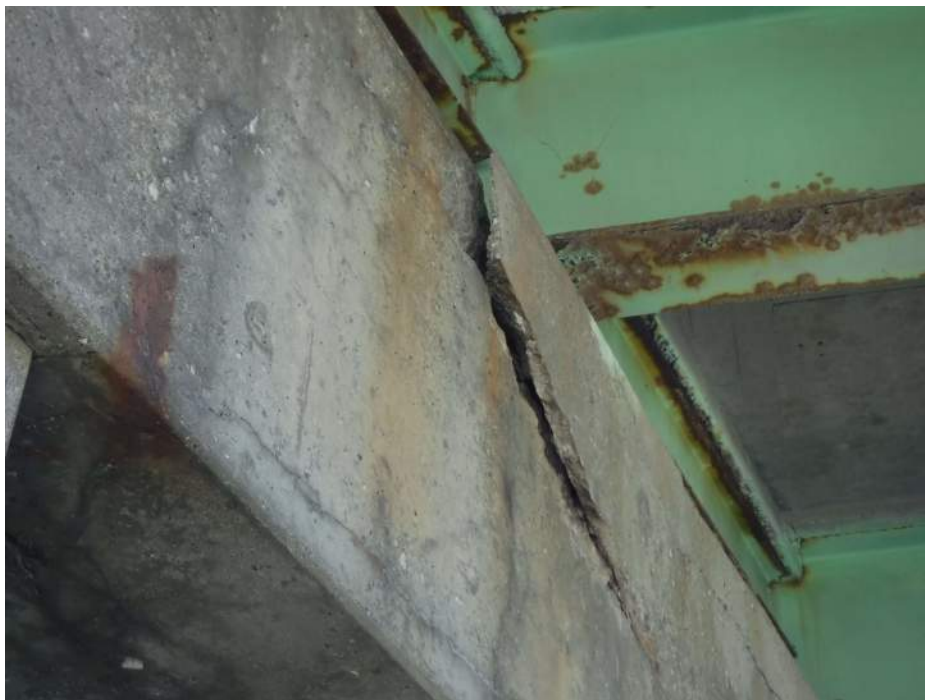
PHOTO 27

Description Side view of heavy cracking/delamination on the eastern pier caps western face

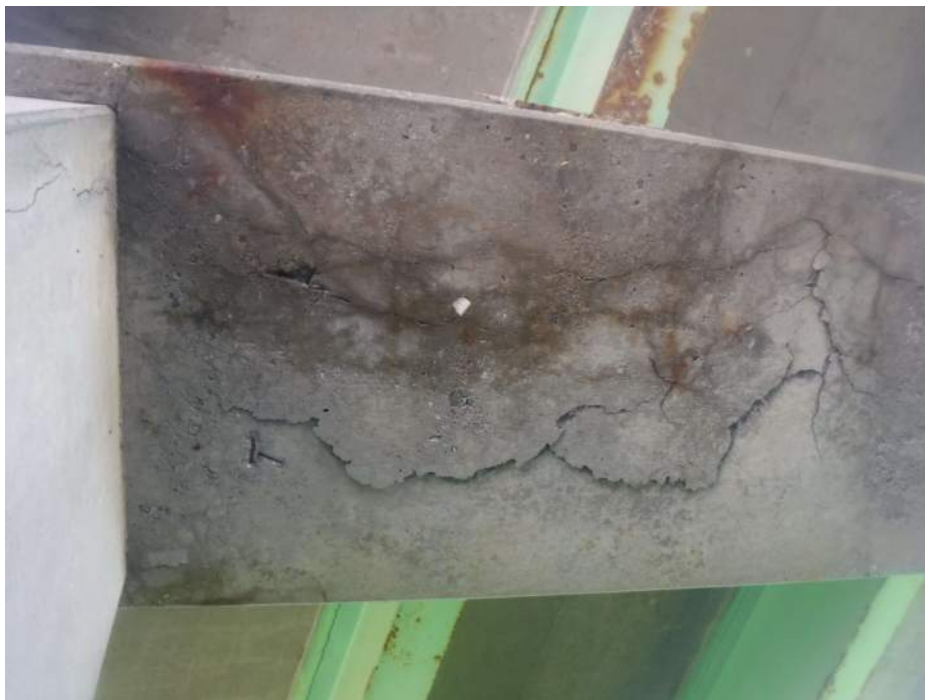
PHOTO 28

Description View of large delamination/heavy cracking on bottom of eastern pier cap

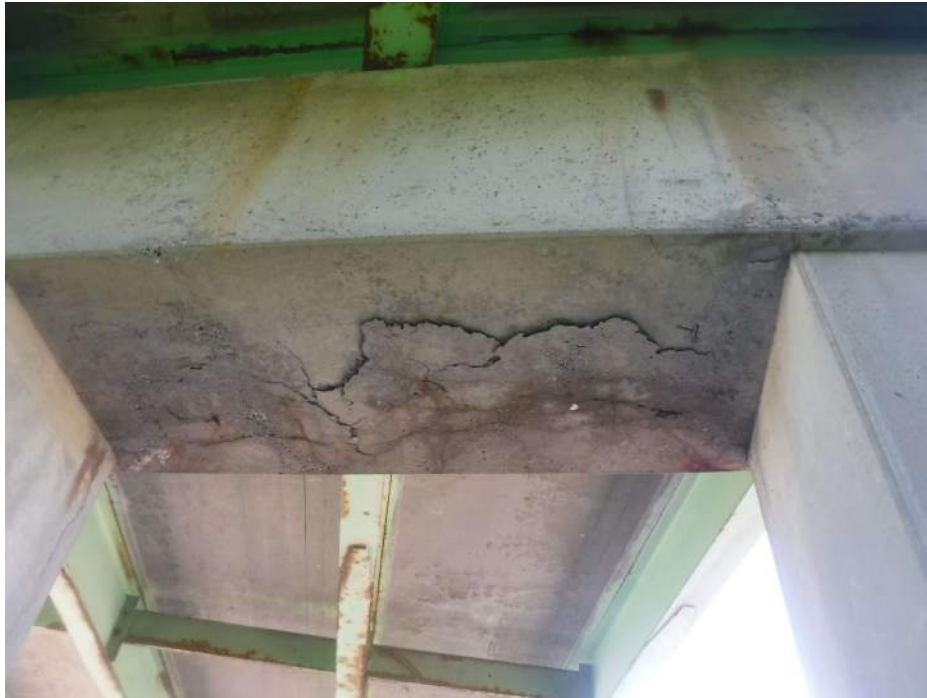
PHOTO 29

Description Side view of large delamination/heavy cracking on bottom of eastern pier cap
