Structure Number: 5783
Facility Carried: LYONS ROAD

Highway Bridge Inspection Report

Bridge Name: LYONS RD / I-95 NB

Town: Sidney

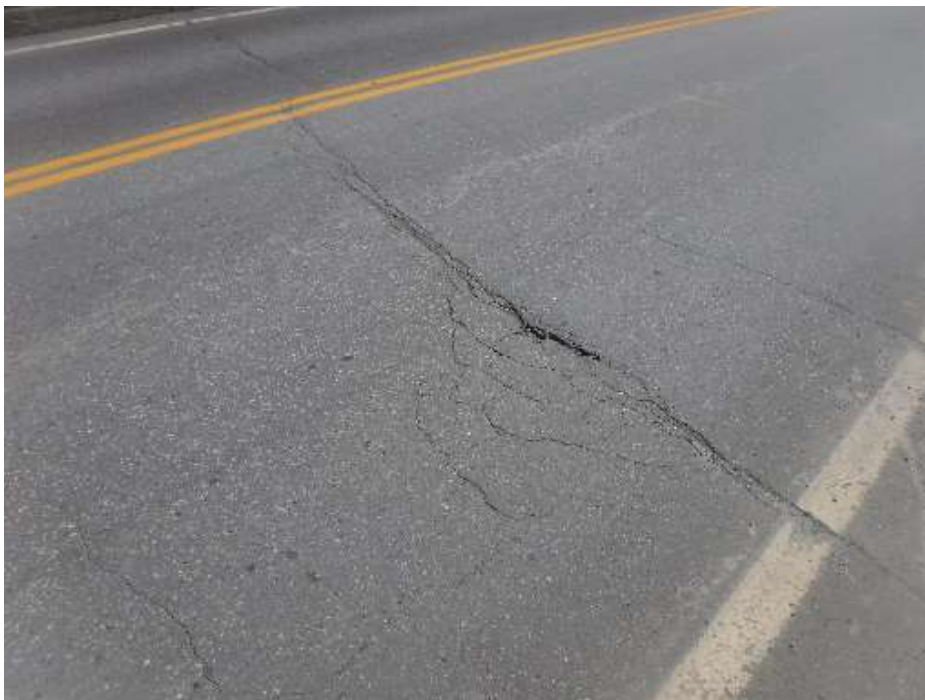
PHOTO 4

2024 Transverse cracking over both abutments.

Description Transverse cracking and settlement over western abutment

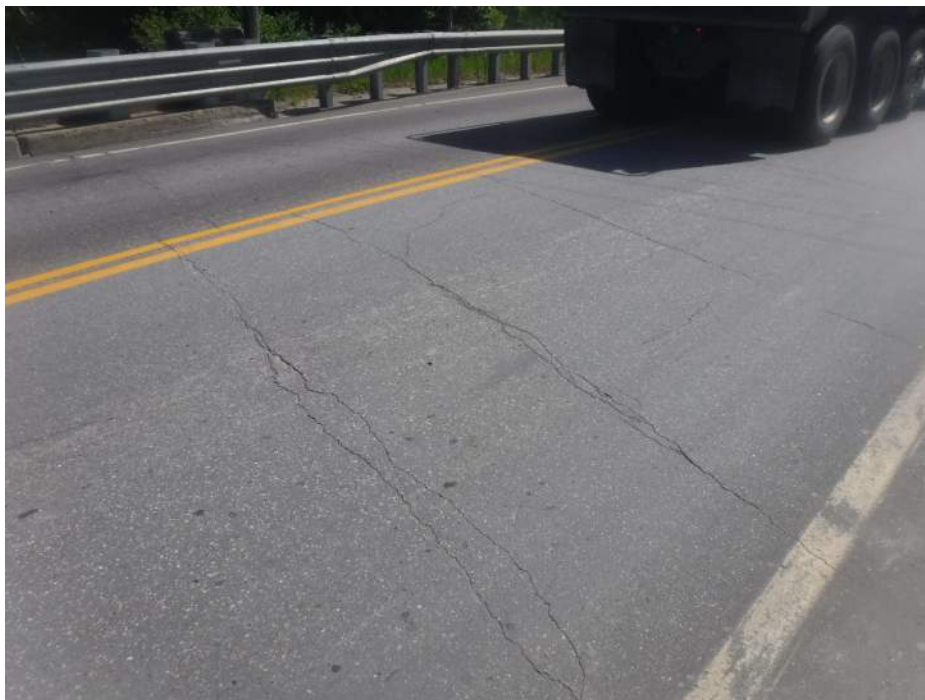
PHOTO 5

Description View of transverse cracking over eastern abutment

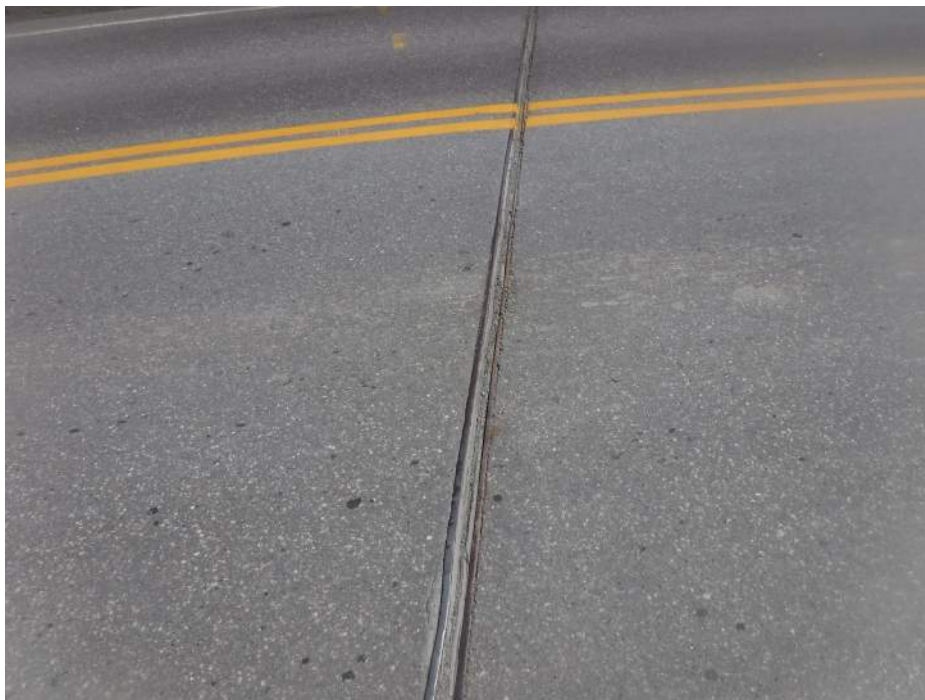
PHOTO 6

Description Typical view of bridge joints

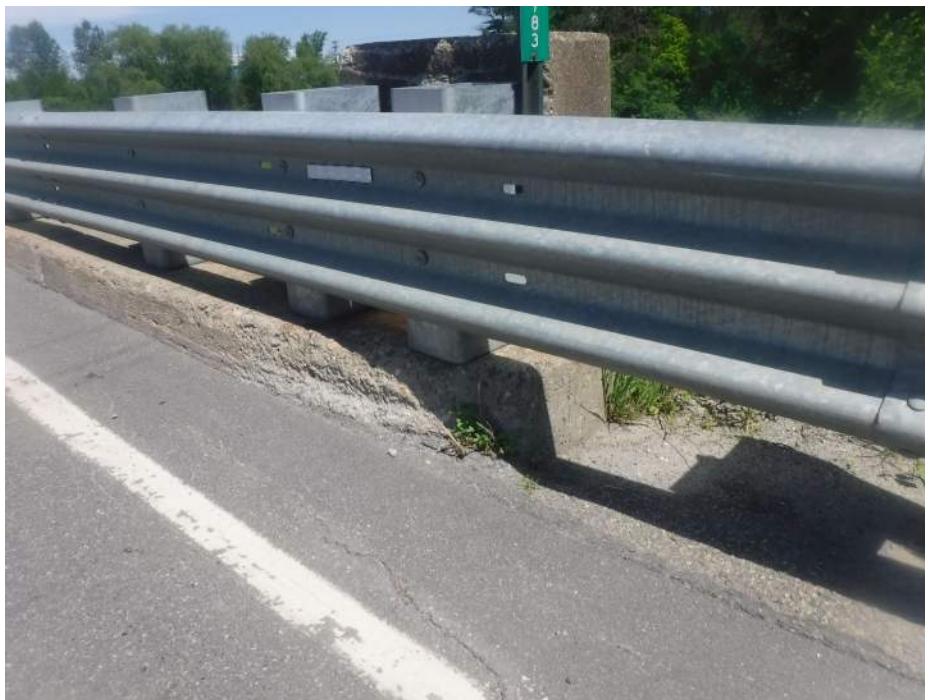
PHOTO 7

Description View of impact damage on northern eastern curb

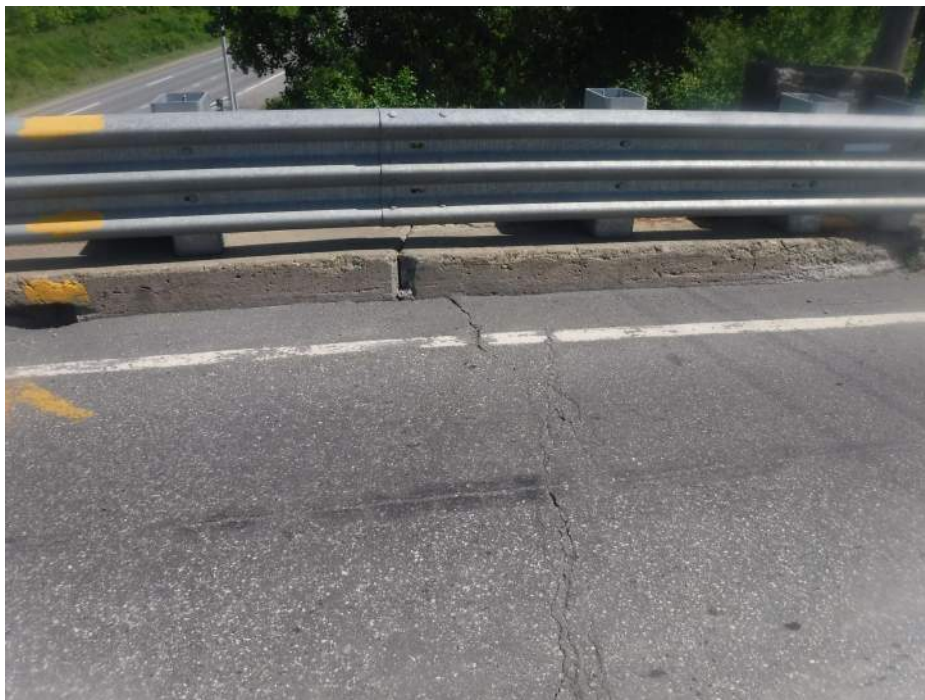
PHOTO 8

Description Typical view of northern curb

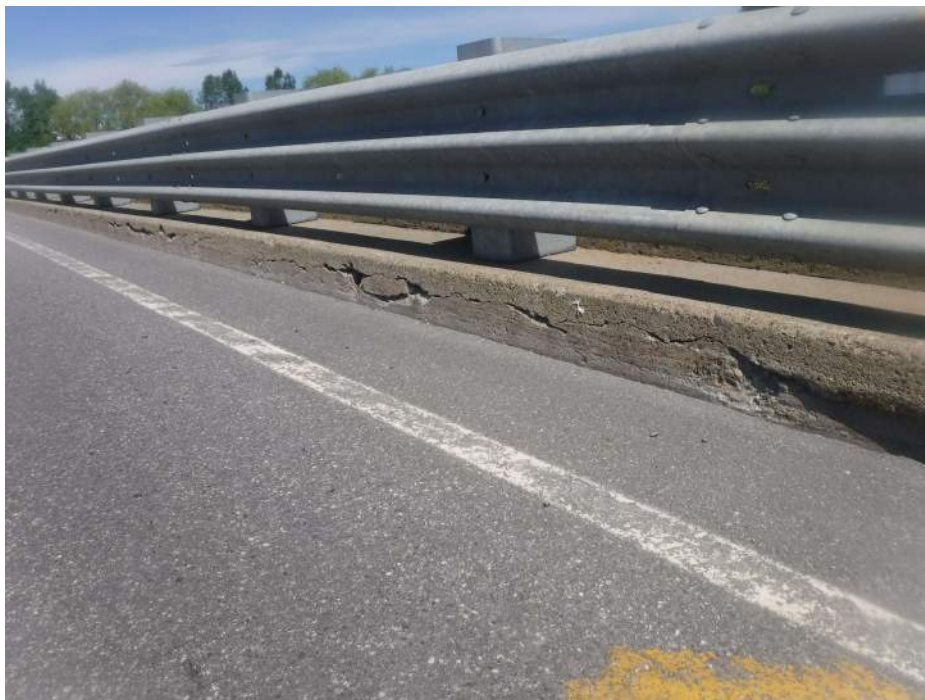
PHOTO 10

2024 North curb has major longitudinal cracking along 3/4 of face. Large spalls and delaminations on westerly end of underside of deck.
Small spalls and delaminations on easterly end of underside of deck. Several areas of spalling with exposed rebar on underside of southern and northern fascia beams.

Description View of cracking along northern curb

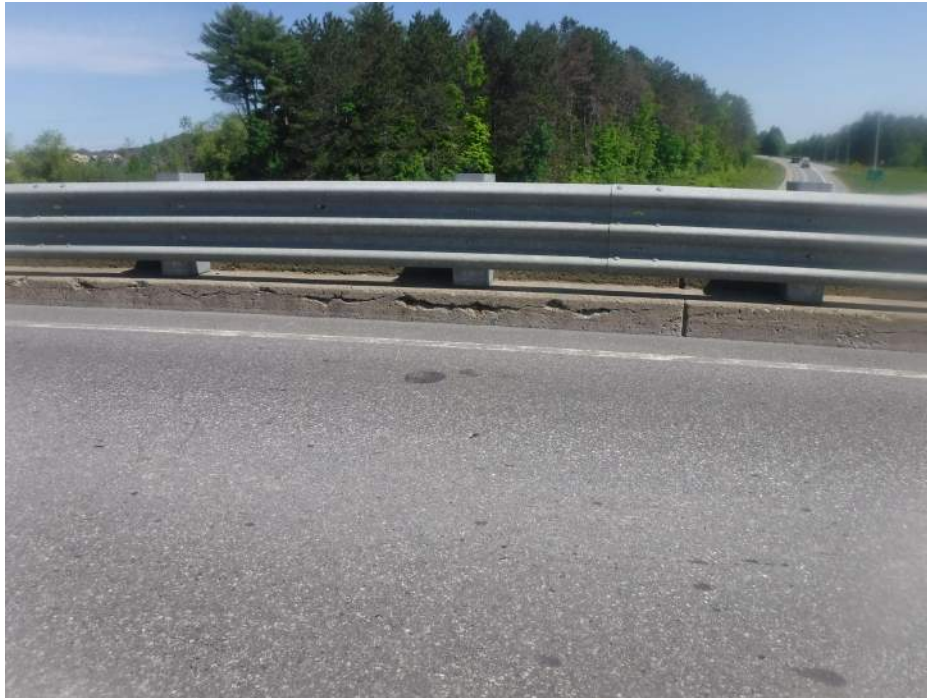
PHOTO 11

Description Another view of cracking along northern curb

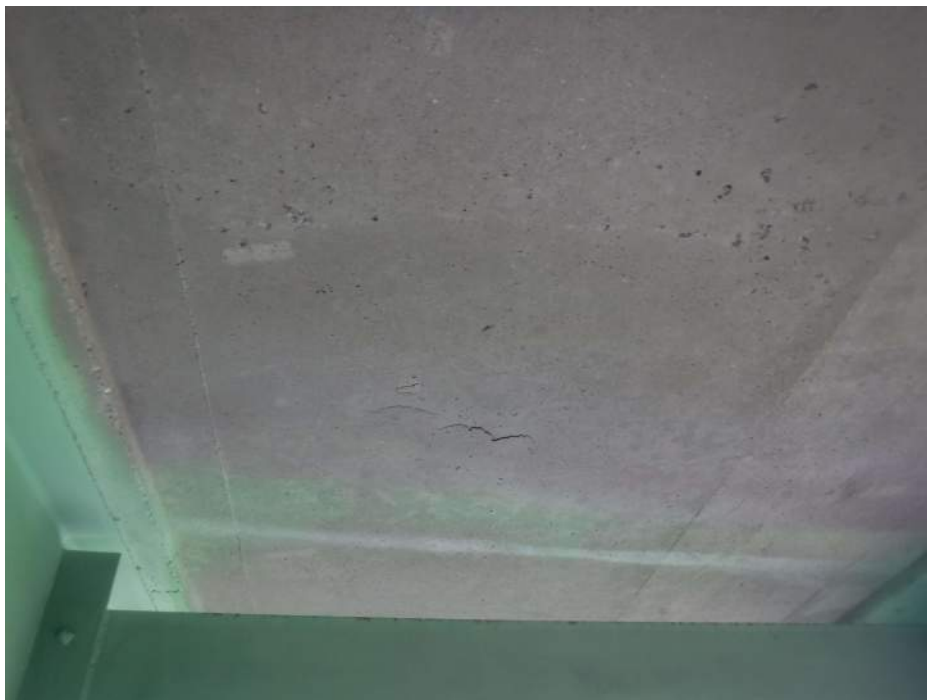
PHOTO 12

Description Typical view of western underside of deck. Small delamination can be seen in photo

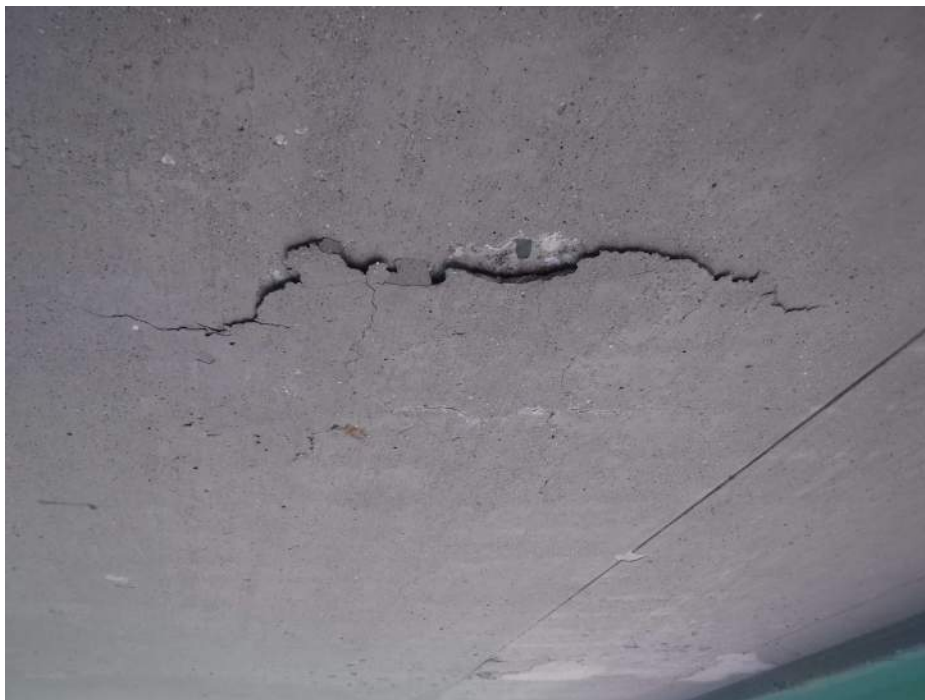
PHOTO 13

Description View of large delamination under western end of deck

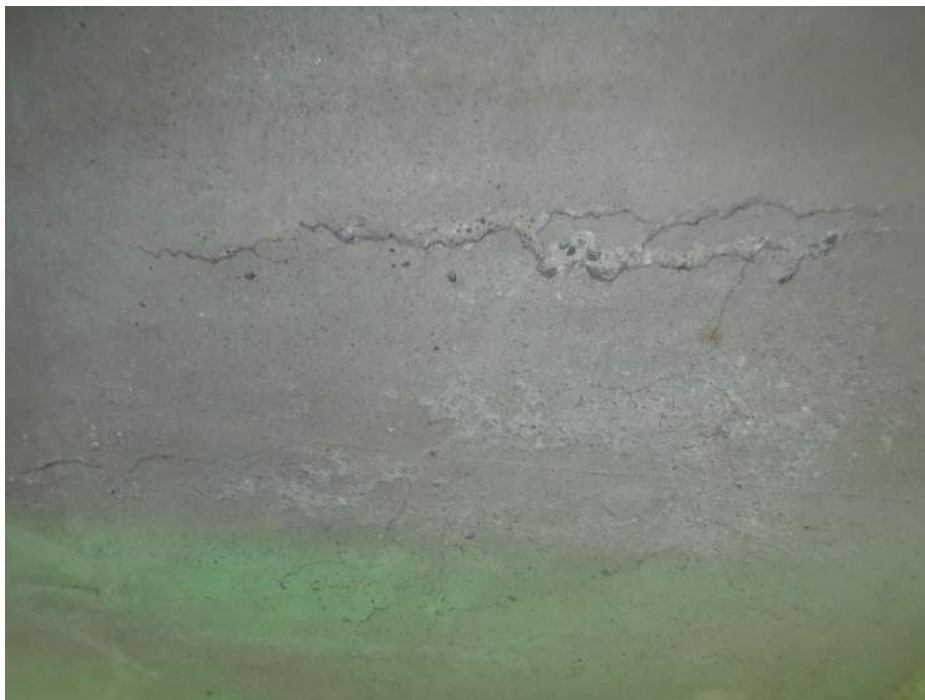
PHOTO 14

Description View of delamination area on western side of deck

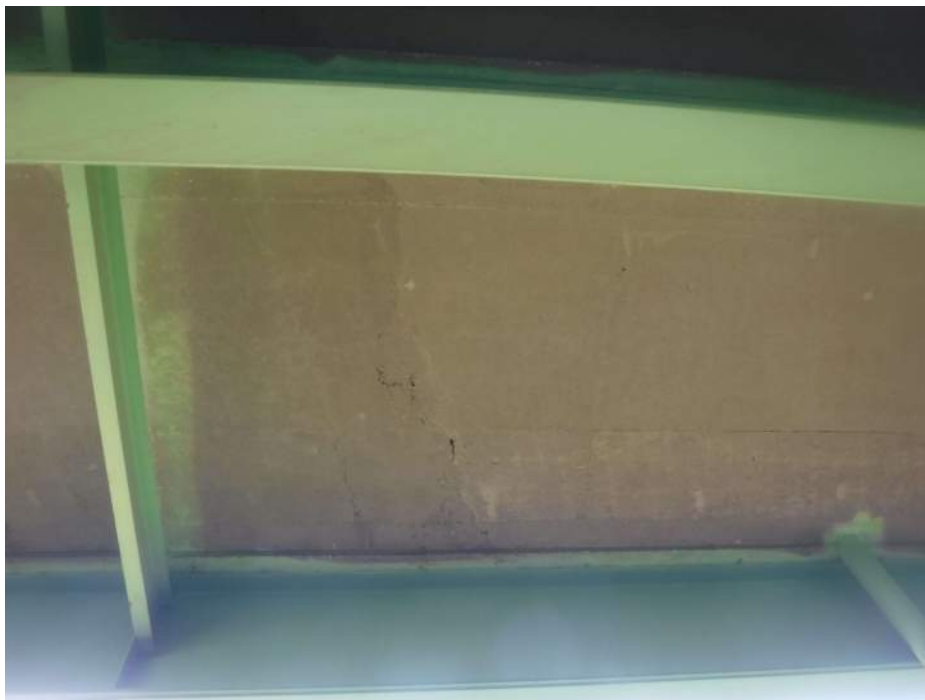
PHOTO 15

Description View of delamination found on underside of western part of deck

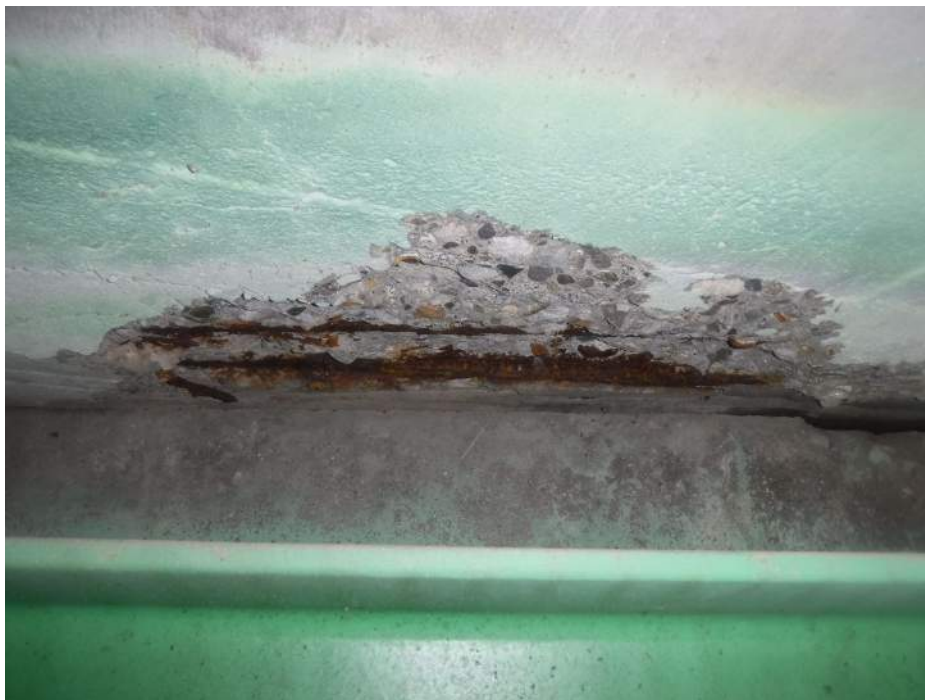
PHOTO 16

Description Large spall found over western abutment

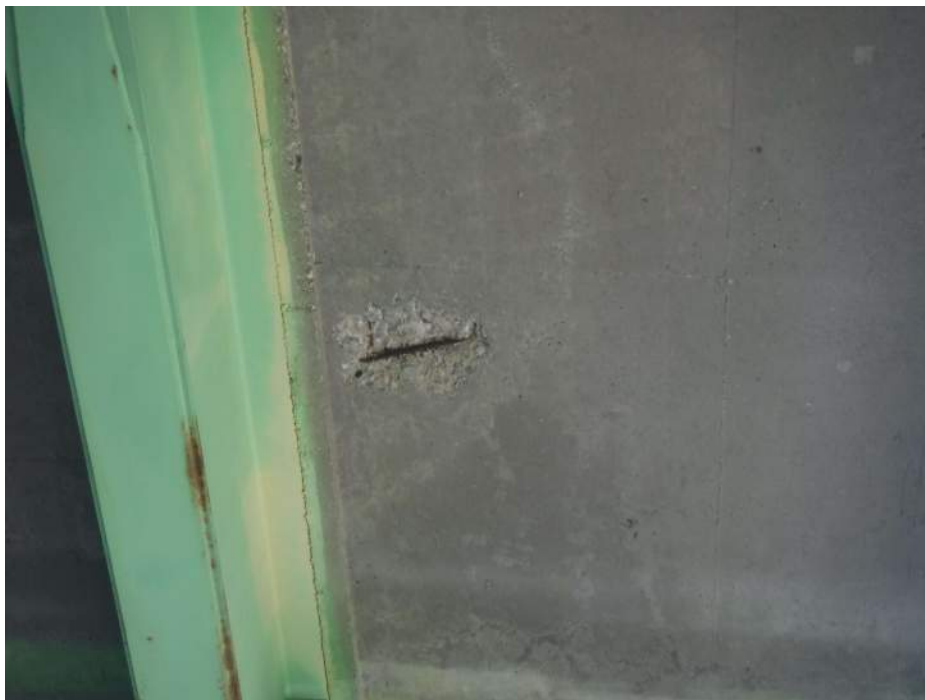
PHOTO 17

Description View of small spall with exposed rebar over travel lane

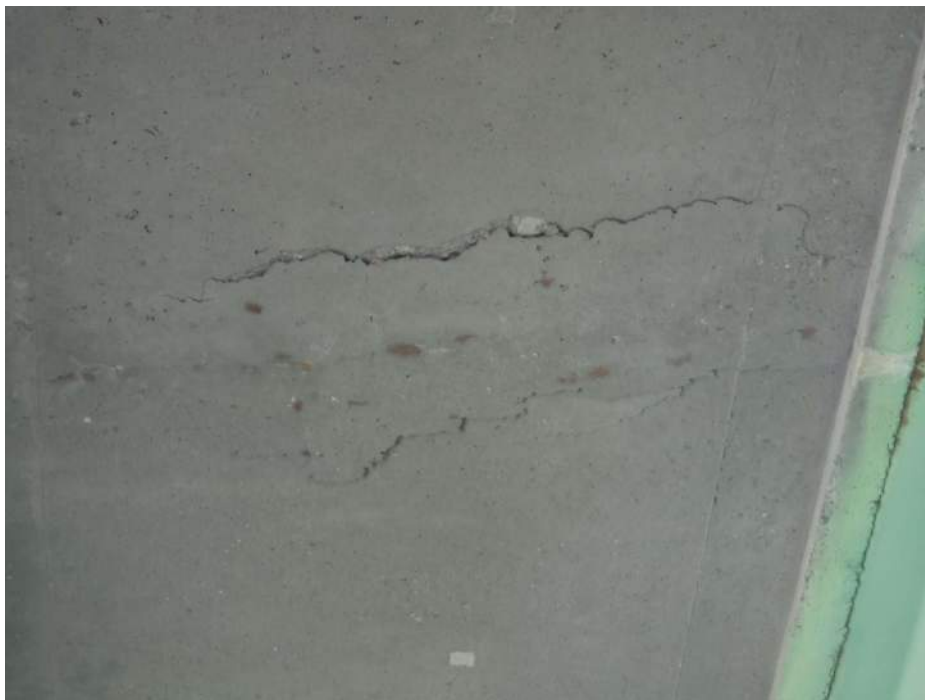
PHOTO 18

Description View of delamination on eastern side of deck

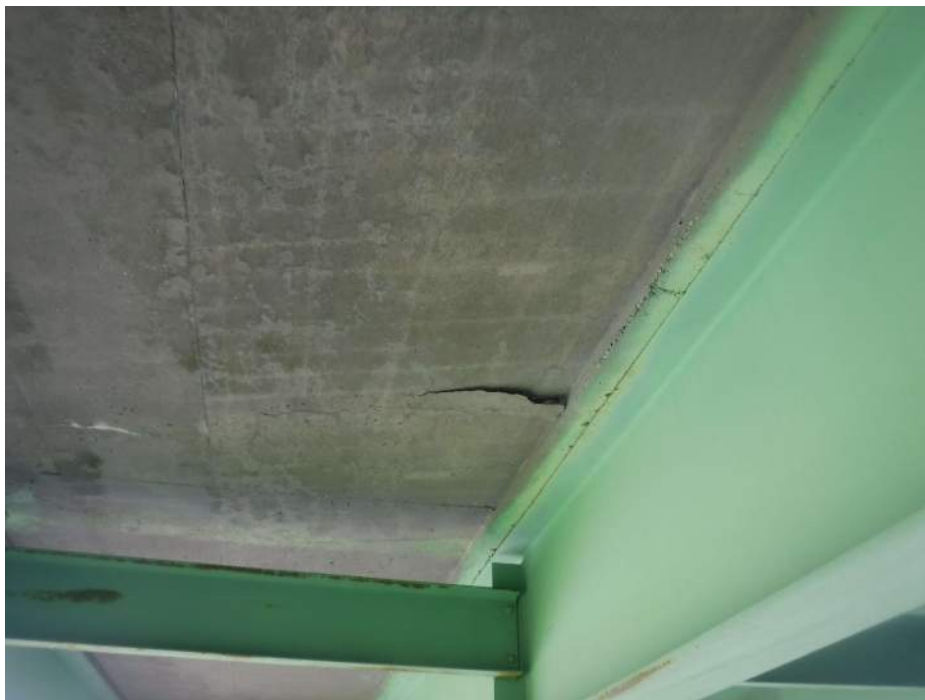
PHOTO 19

Description View of small delamination on eastern side of deck

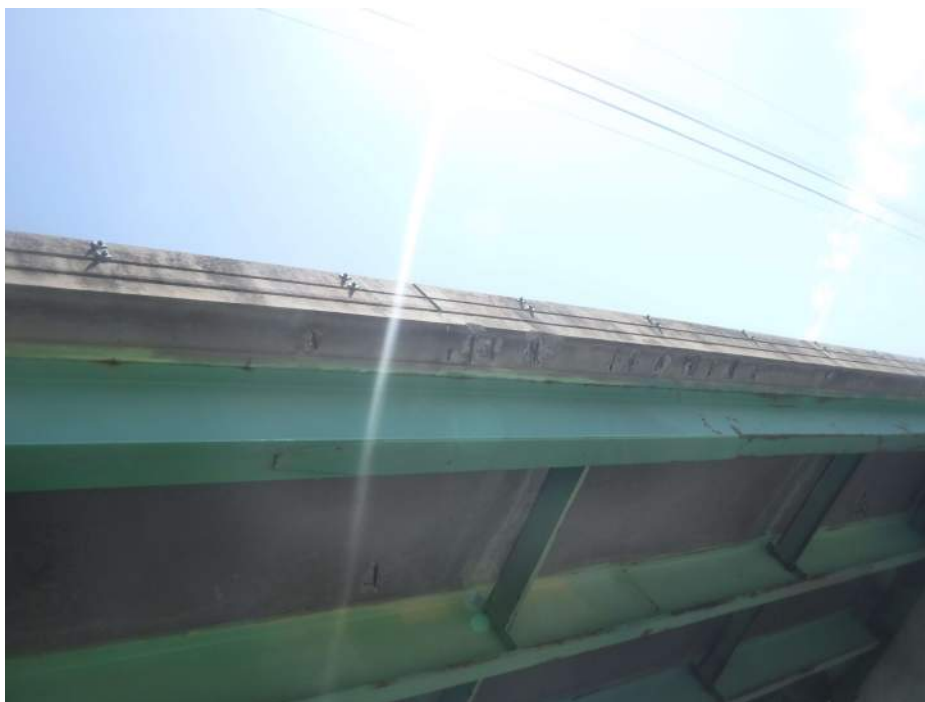
PHOTO 20

Description View of underside of southern fascia beam. Note spalls with exposed rebar

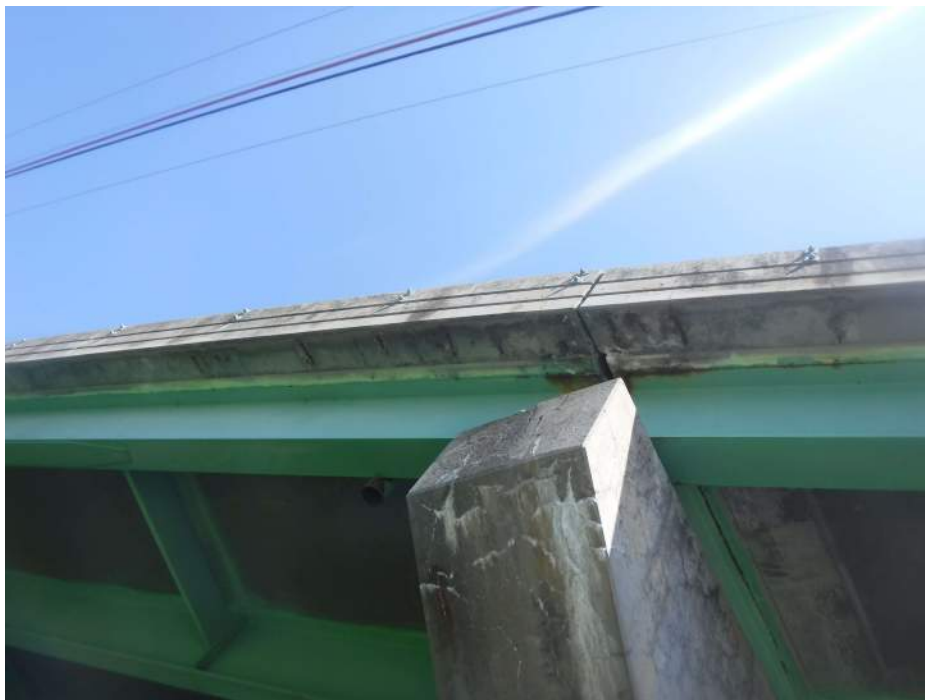
PHOTO 21

Description View of underside of northern fascia beam. Note spalls with exposed rebar

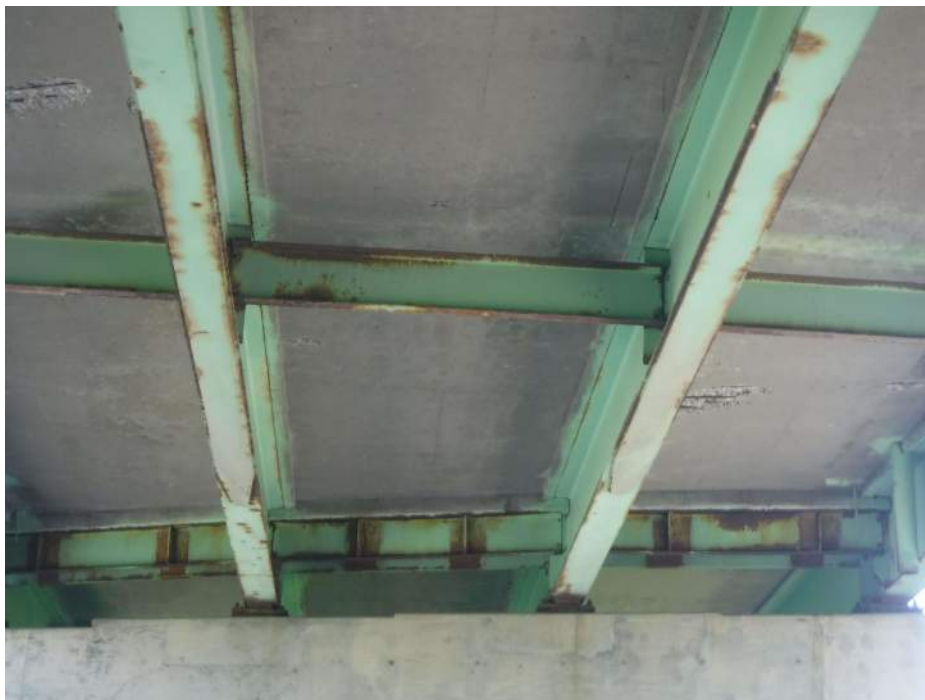
PHOTO 22

Description Typical view of deck over roadway. Note spalls with exposed rebar

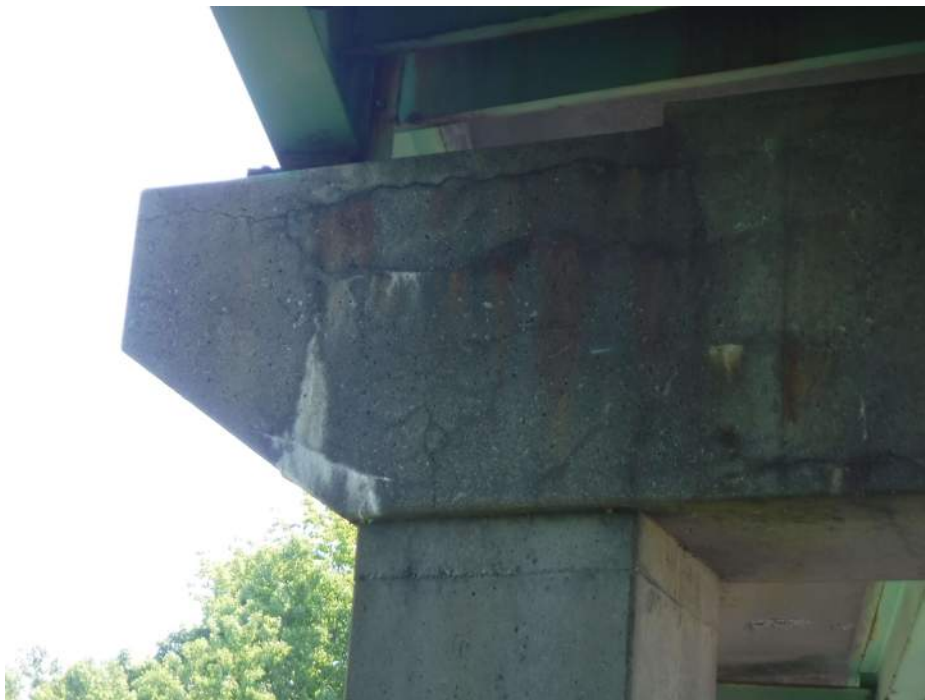
PHOTO 29

The East Pier has been rehabbed
The West pier cap has minor to moderate fine cracking with staining and moderate cracking at the end of the hammerhead.
Both abutments are in satisfactory condition with minor cracking only.
Slope protection has minor to moderate slumping at each of the top and bottom.

Description View of cracking and efflorescence on northern side of western pier

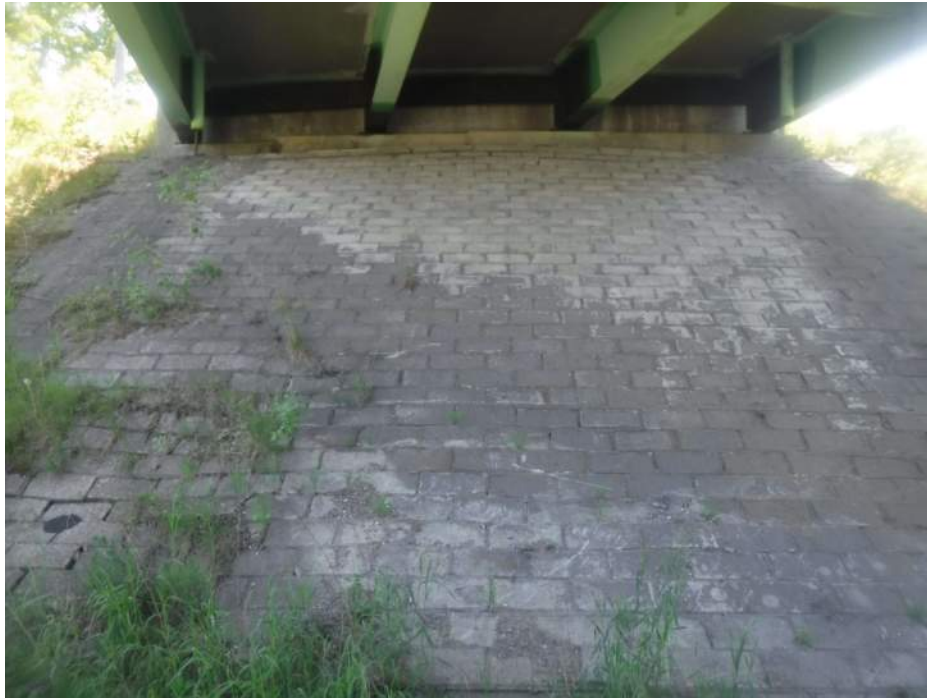
PHOTO 31

Description Typical view of slope protection
