Inspector: TYLIN, TYLIN
Inspection Date: 09/06/2024

Structure Number: 5784
Facility Carried: DRUMMOND RD

Highway Bridge Inspection Report

Bridge Name: DRUMMOND ROAD / I-95

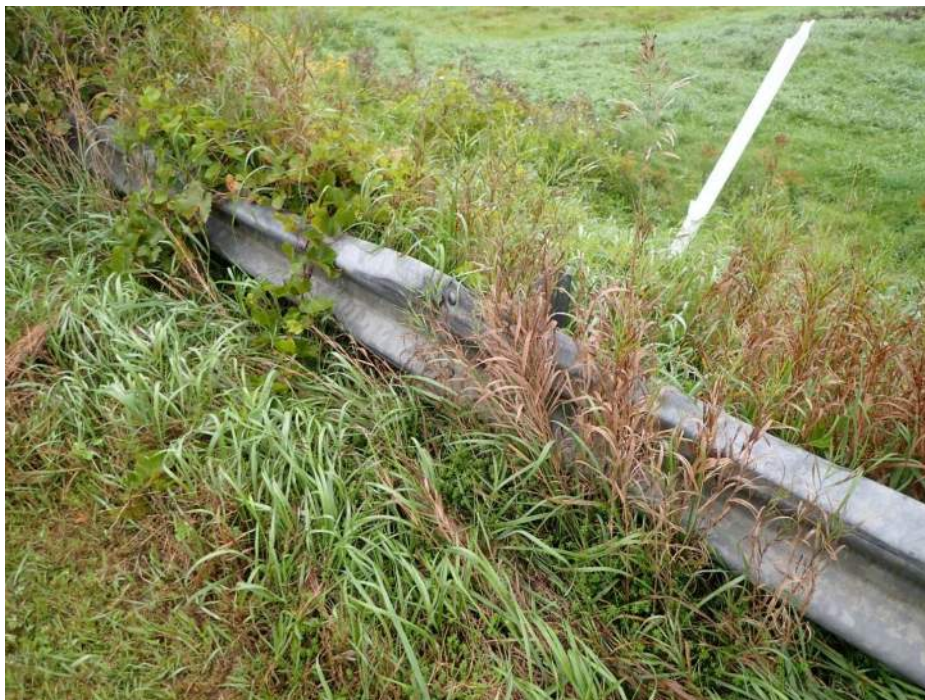
PHOTO 6 Condition

Description West Approach - South guardrail, impact deformation

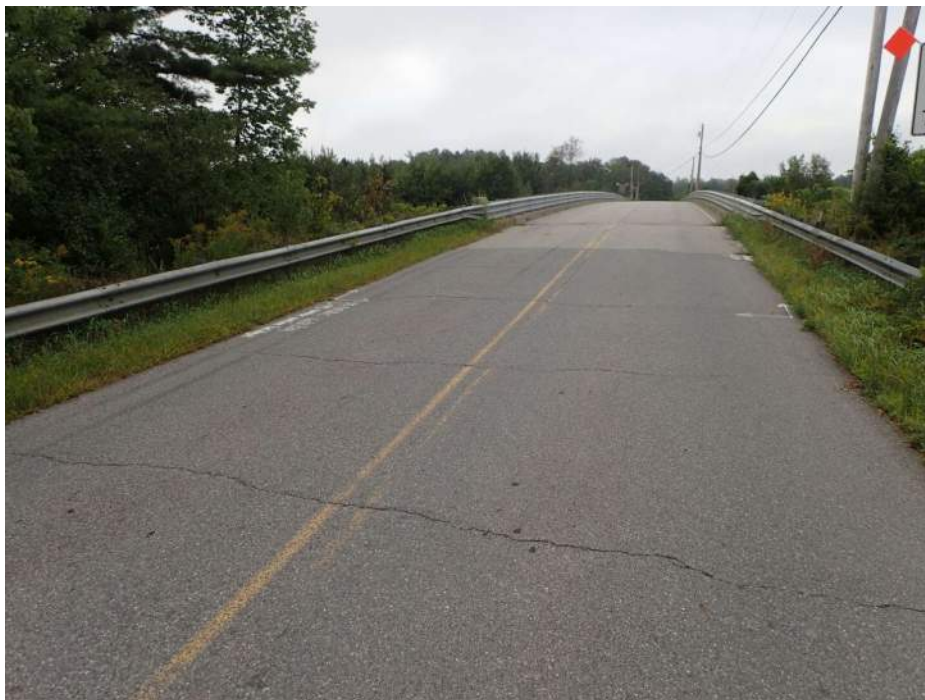
PHOTO 7 Condition

Description West Approach - Large transverse cracks & some longitudinal cracking

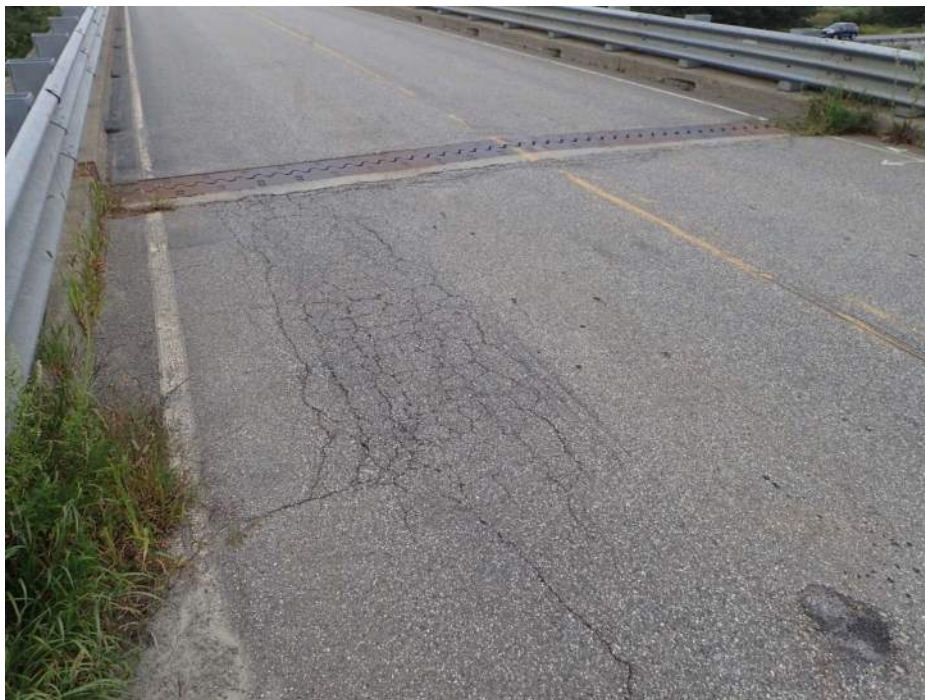
PHOTO 9 Condition

Description West Approach - Westbound lane, heavy map cracking & settlement

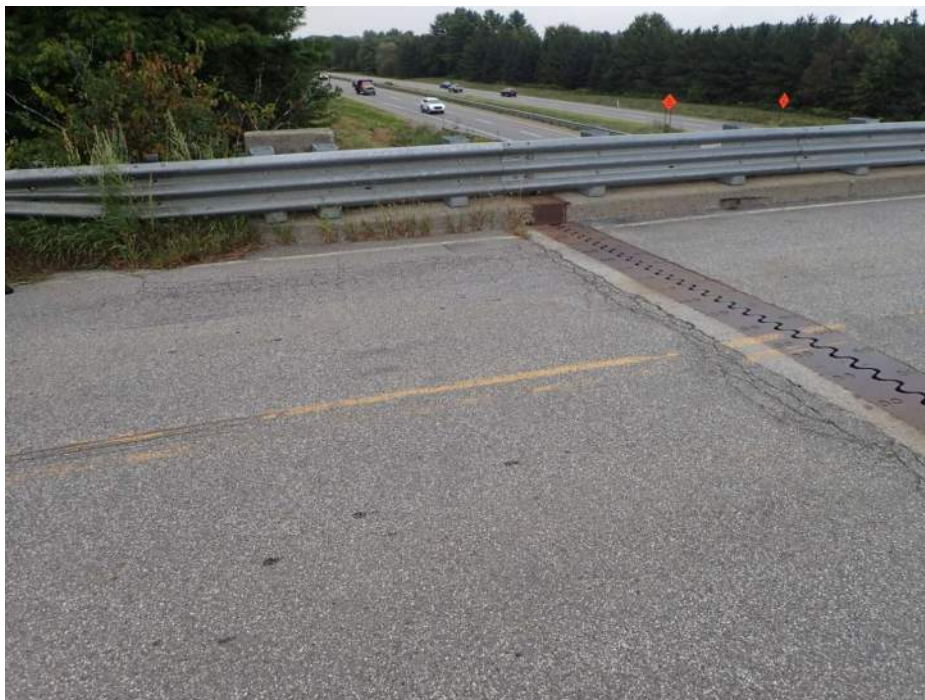
PHOTO 10 Condition

Description West Approach - North guardrail transition, map cracking & settlement prior to Abutment 1 backwall

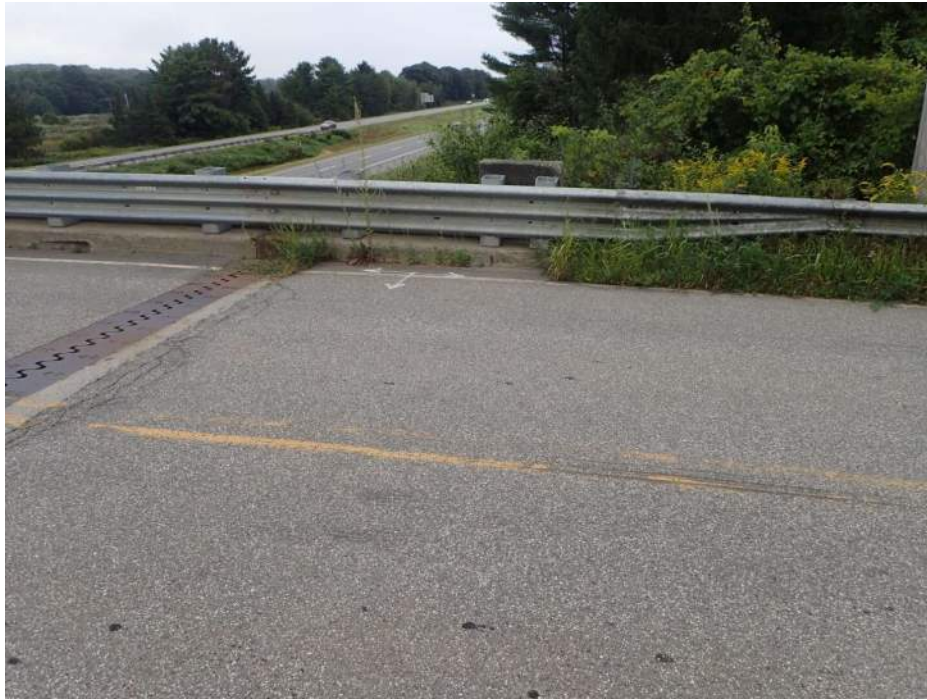
PHOTO 11 Condition

Description West Approach - South guardrail transition, map cracking & settlement prior to Abutment 1 backwall

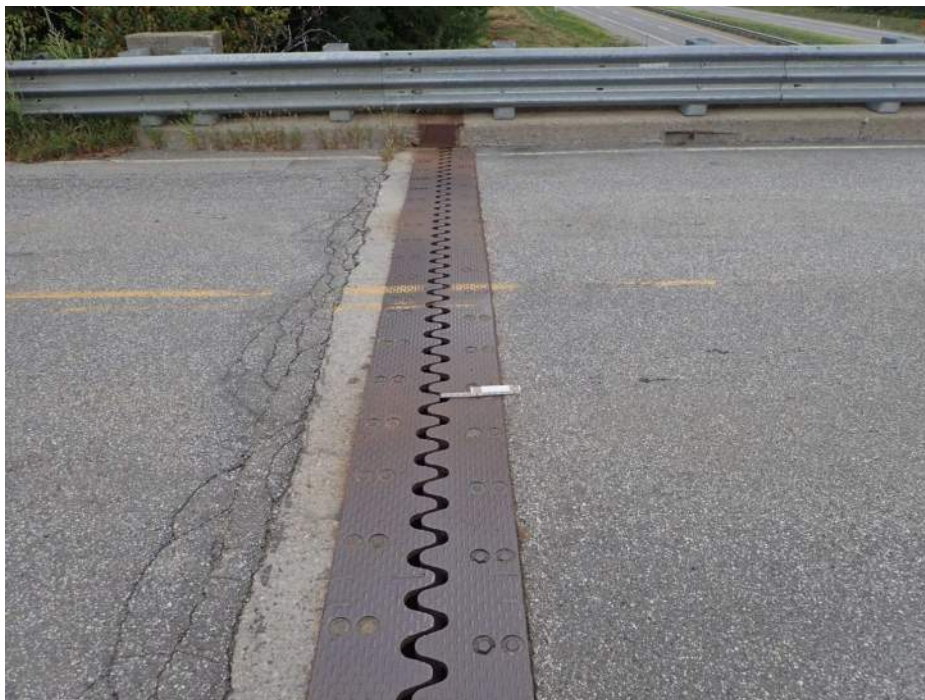
PHOTO 13 Condition

Description Finger Joint over Abutment 1 - Looking North, 53 deg F, 1 3/4" opening

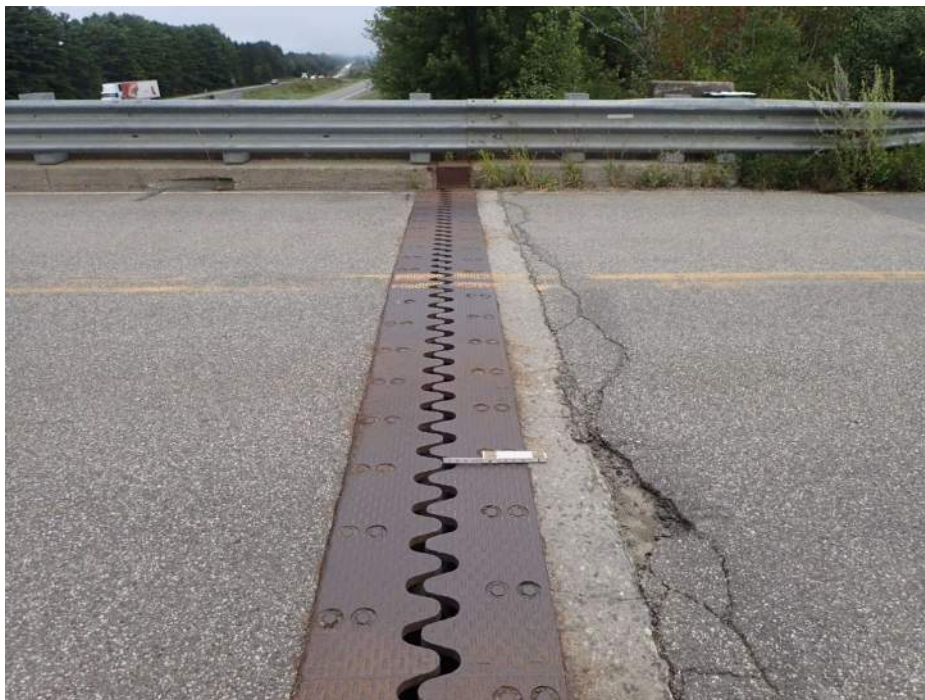
PHOTO 18 Condition

Description Finger Joint over Abutment 2 - Looking North, 53 deg F, 1 3/4" opening, map cracking and spalling of pavement on approach side at backwall

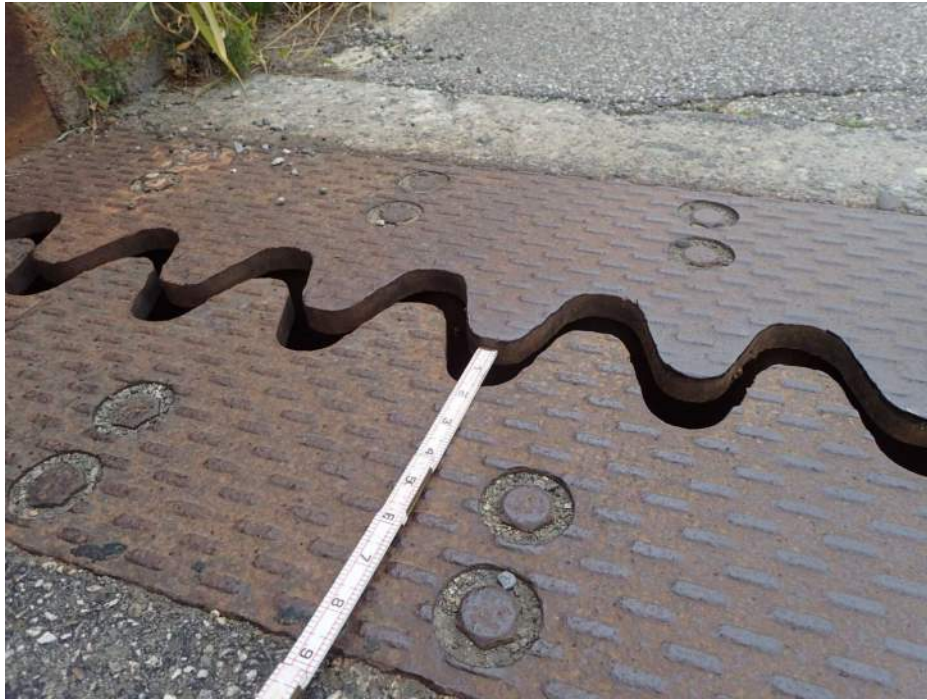
PHOTO 19 Condition

Description Finger Joint over Abutment 2 - North gutterline, 53 deg F, +/- 1 1/2" opening, Fingers on Abutment side are +/- 1/4" higher than bridge side.

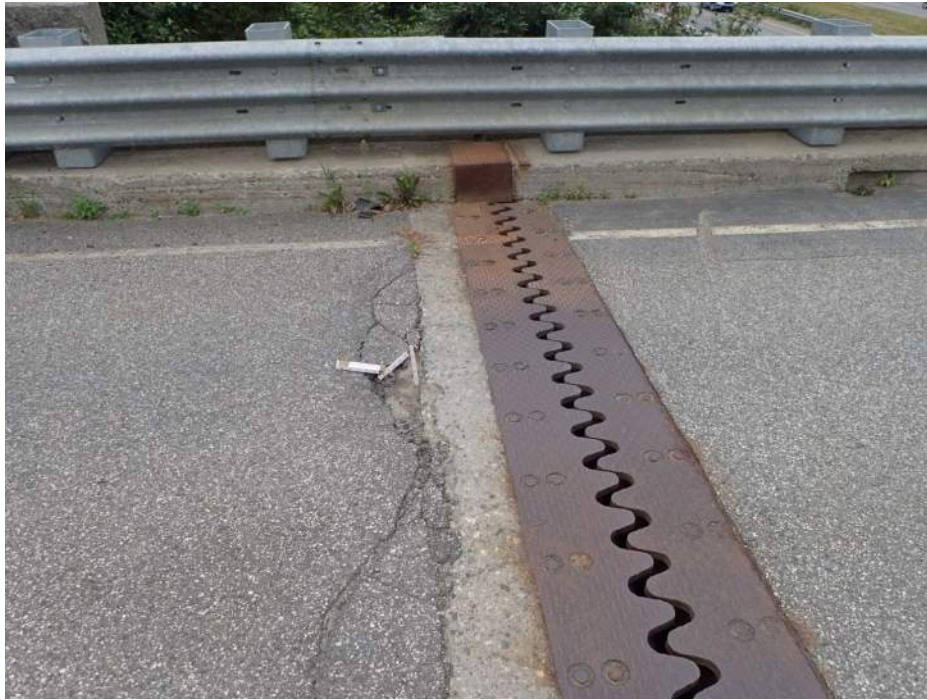
PHOTO 21 Condition

Description Finger Joint over Abutment 2 - Looking South, map cracking and spalling of pavement on approach side at backwall

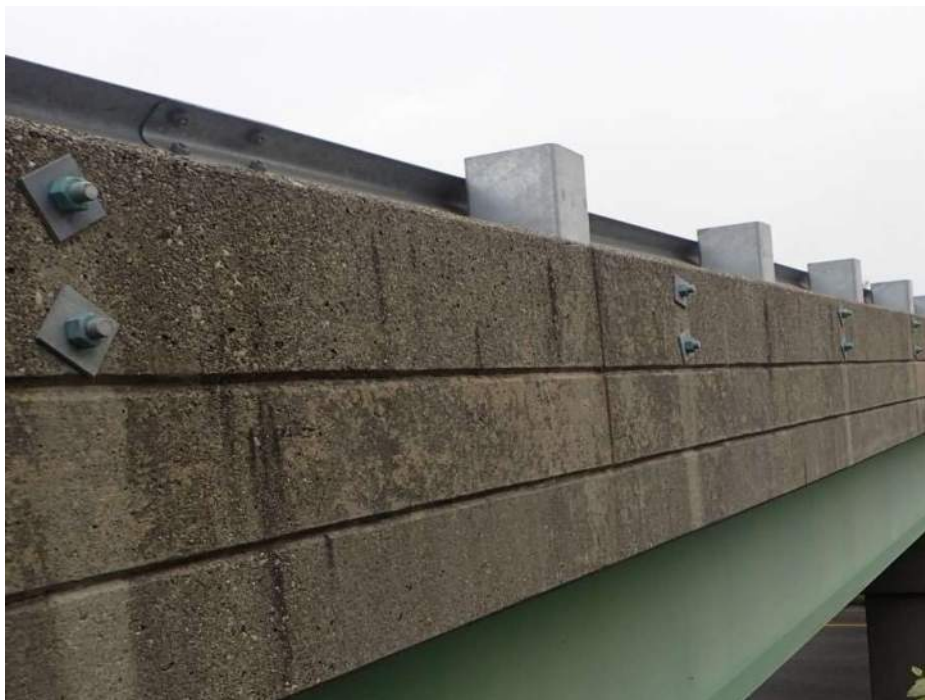
PHOTO 28 Condition

Description Retrofitted bridge railing, posts secure by bolting posts to existing railing - typical

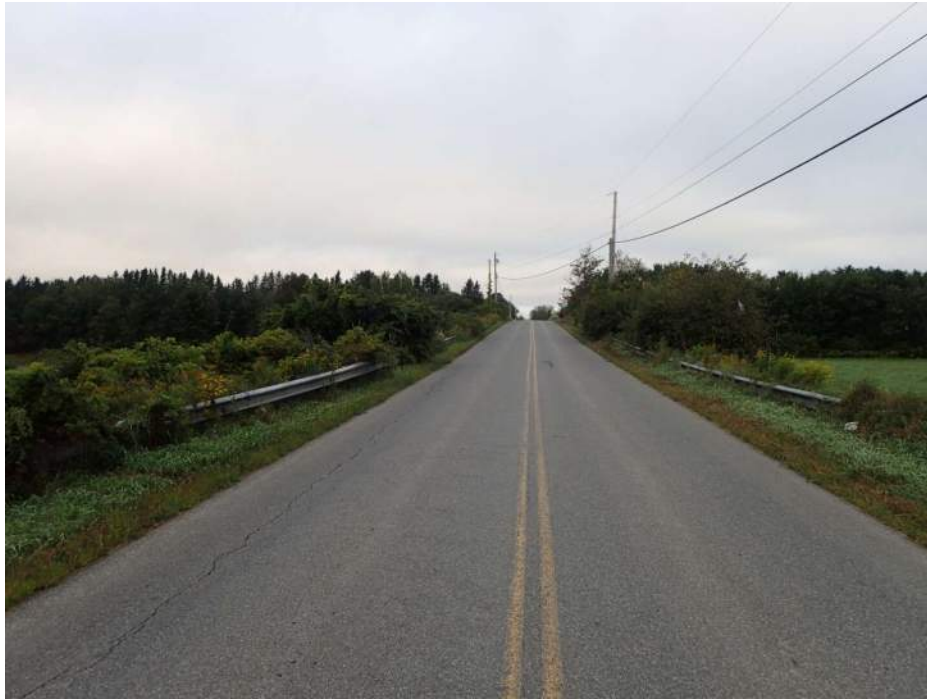
PHOTO 31 Condition

Description East Approach - Longitudinal wide cracking & settling in outer wheel path of Eastbound lane, full length of approach roadway. Photo 1 of 3

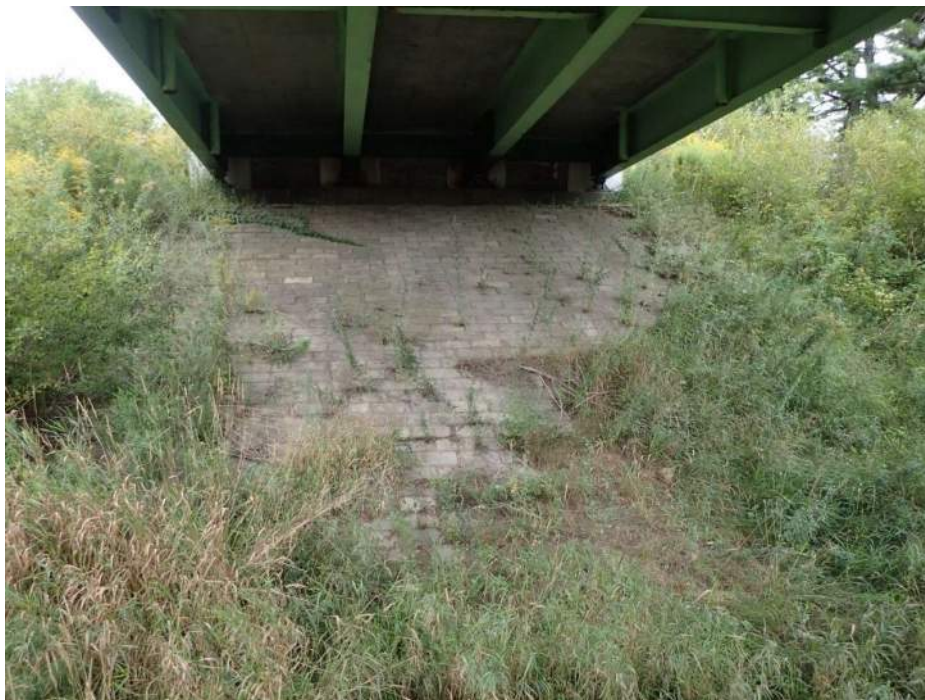
PHOTO 38 Condition

Description Abutment 1 bank protection - intact but with heavy vegetation & cracking of joints.

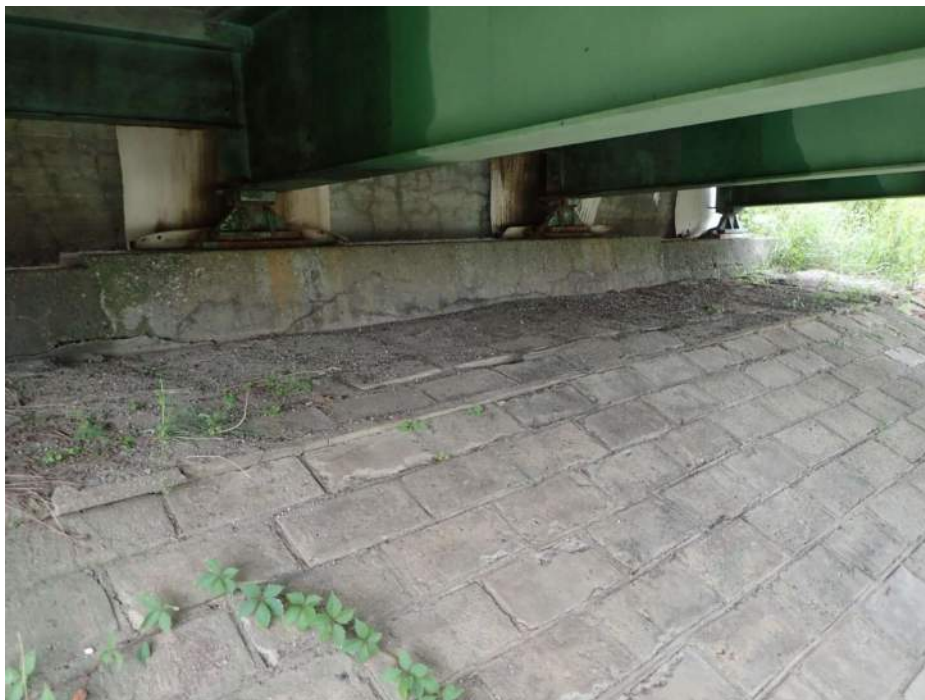
PHOTO 39 Condition

Description Abutment 1 bank protection - intact but with heavy vegetation & cracking of joints.

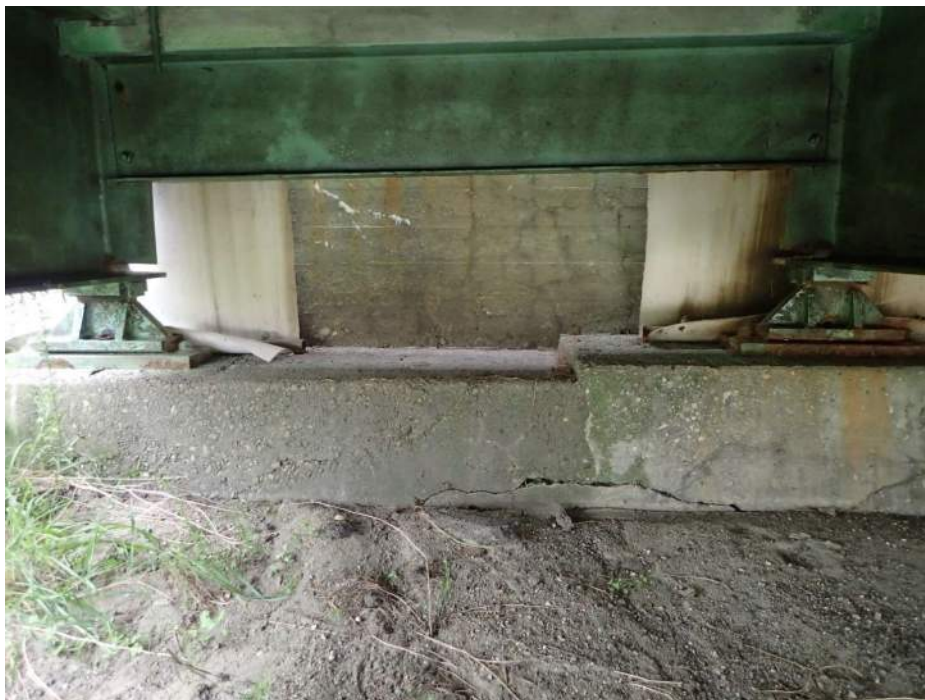
PHOTO 41 Condition

Description Abutment 1 - Bay 3, Gdr 4 bearing, Gdr 3 bearing, map cracking on backwall & large crack on breastwall

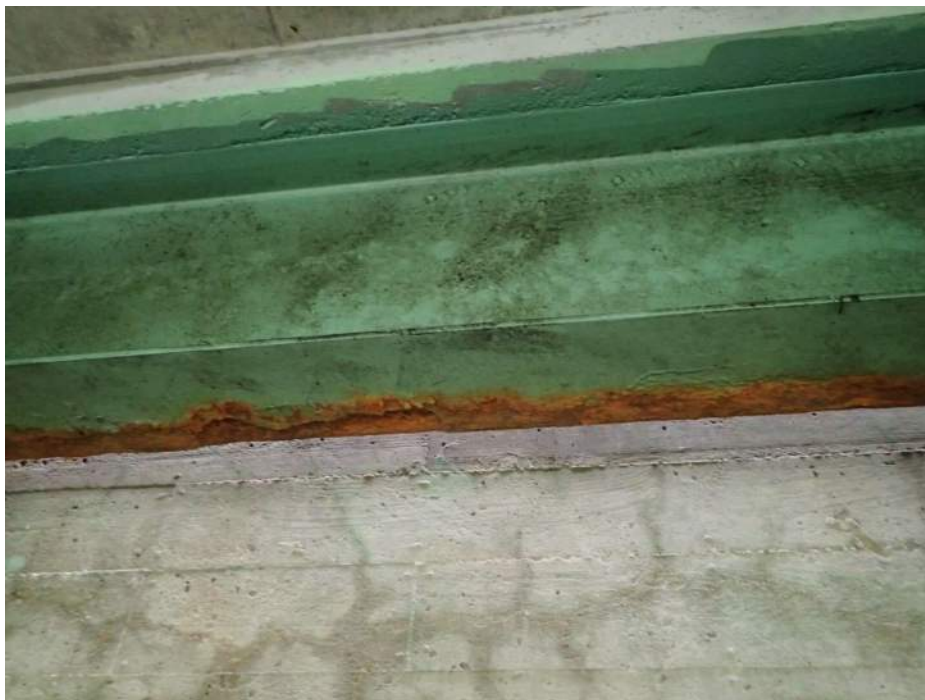
PHOTO 43 Condition

Description Abutment 1 - diaphragm at end of deck, rust on joint side, typical

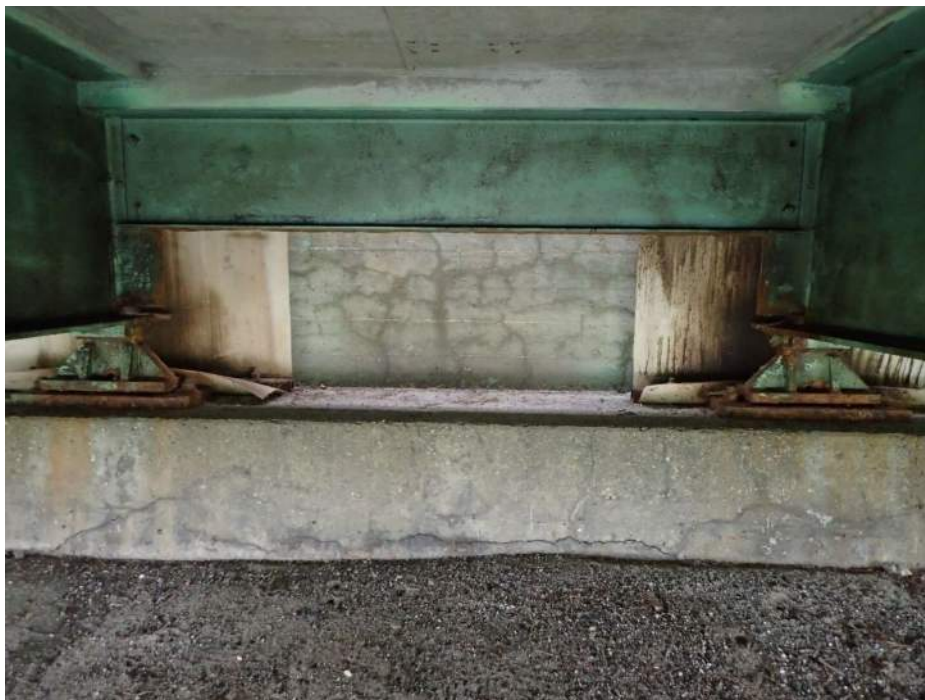
PHOTO 44 Condition

Description Abutment 1 - Bay 2, Gdr 3 bearing, Gdr 2 bearing, map cracking on backwall & large crack on breastwall

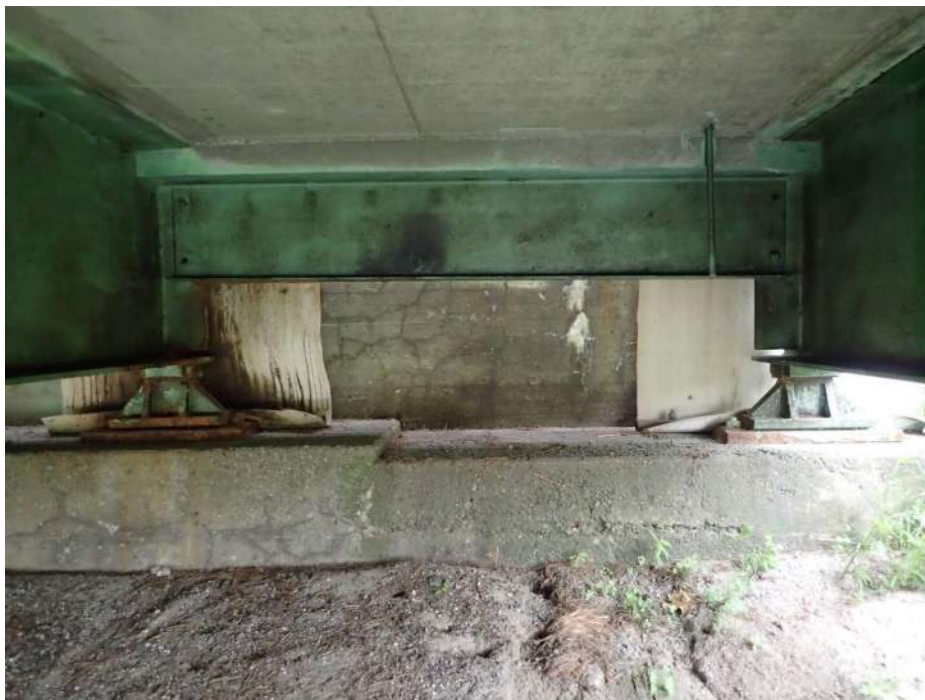
PHOTO 46 Condition

Description Abutment 1 - Bay 1, Gdr 2 bearing, Gdr 1 bearing, map cracking & efflorescence on backwall

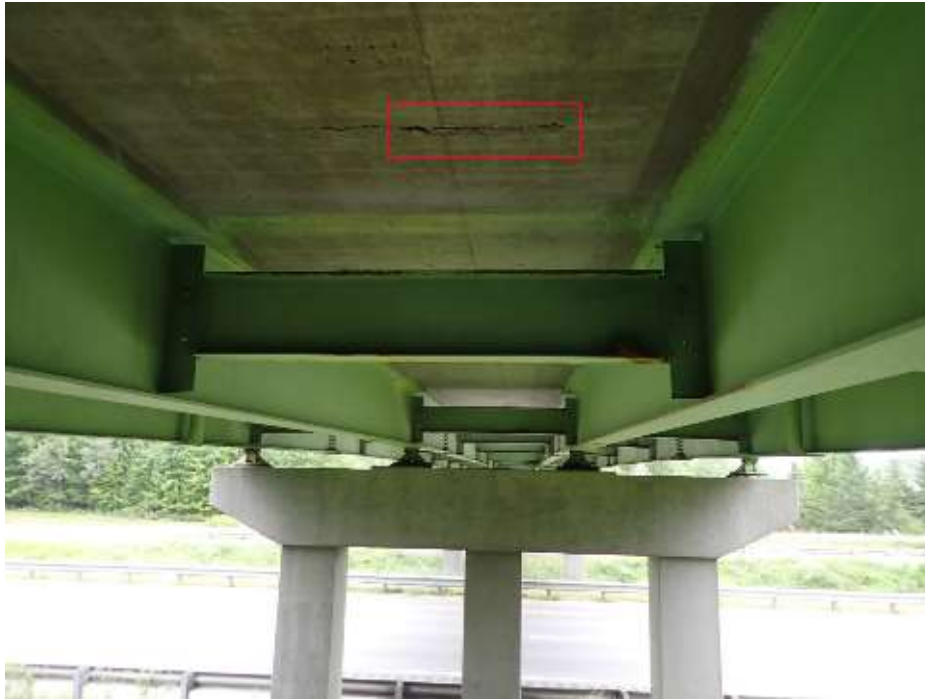
PHOTO 49 Condition

Description Span 1 - Underside of deck & steel framing, looking towards Pier 1, note spall with Exposed Corroded Steel Reinforcement (ECSR) - See next Photo for closeup.

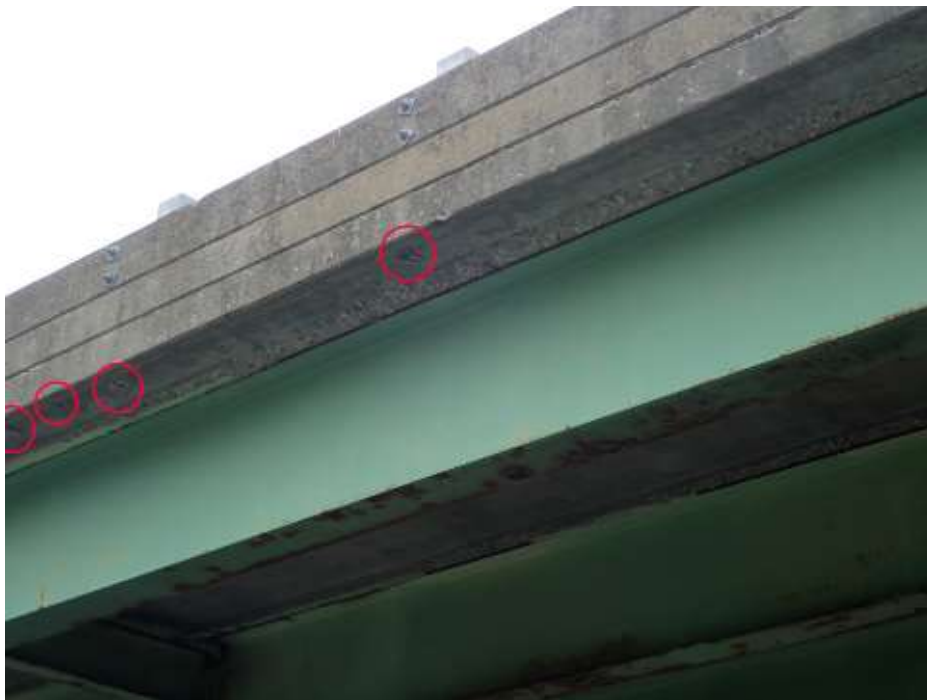
PHOTO 60 Condition

Description Span 2 over I95 SB - South fascia & overhang, small spalls with ECSR

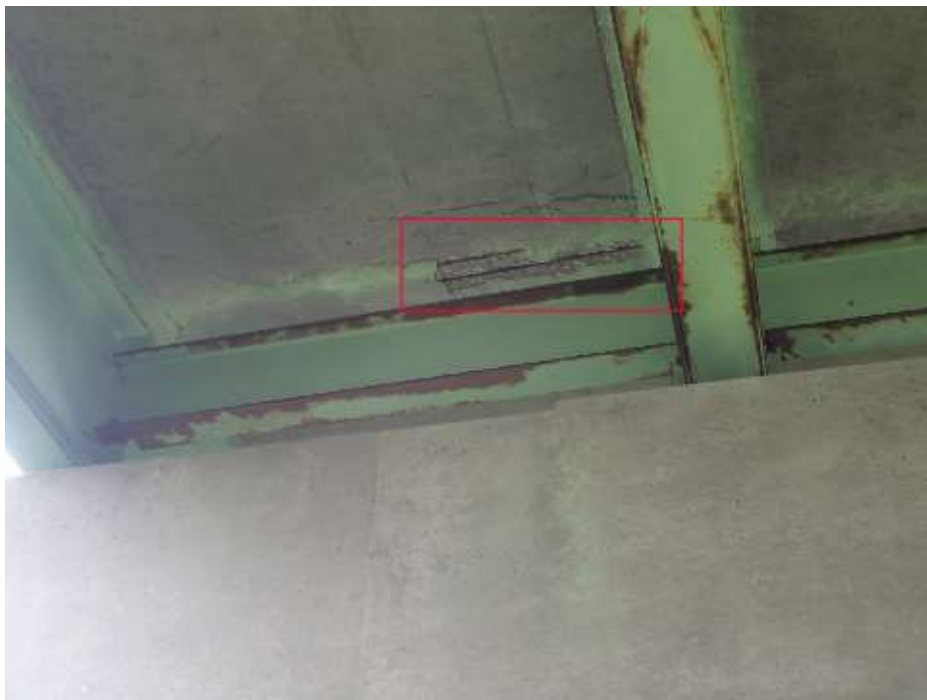
PHOTO 62 Condition

Description Span 2 over I95 SB - Bay 1 over Pier 1, spall with ECSR

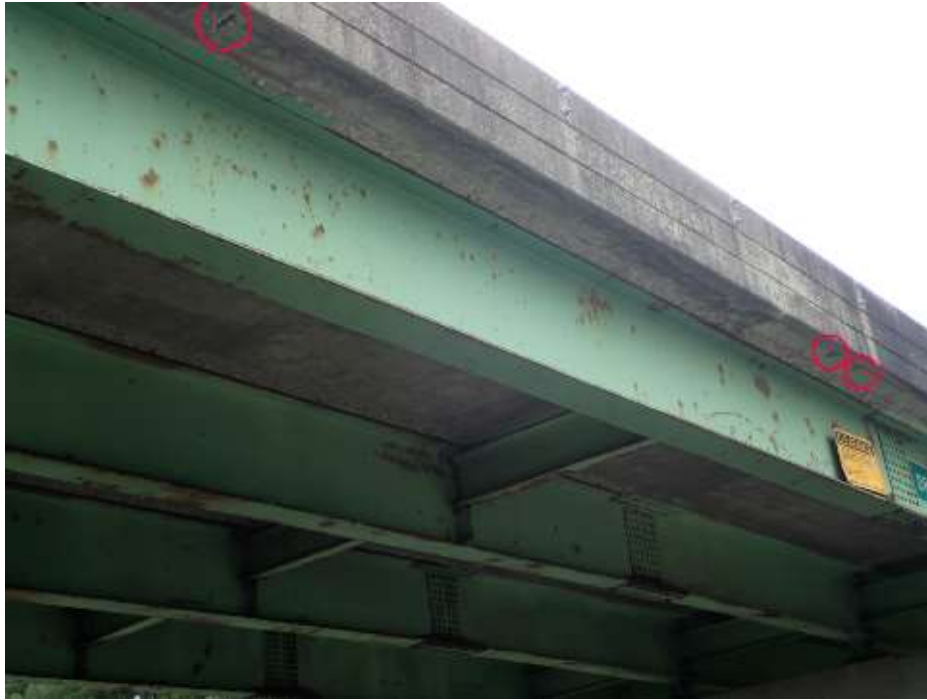
PHOTO 63 Condition

Description Span 2 over I95 SB - North fascia, note paint condition, also small spalls with ECSR

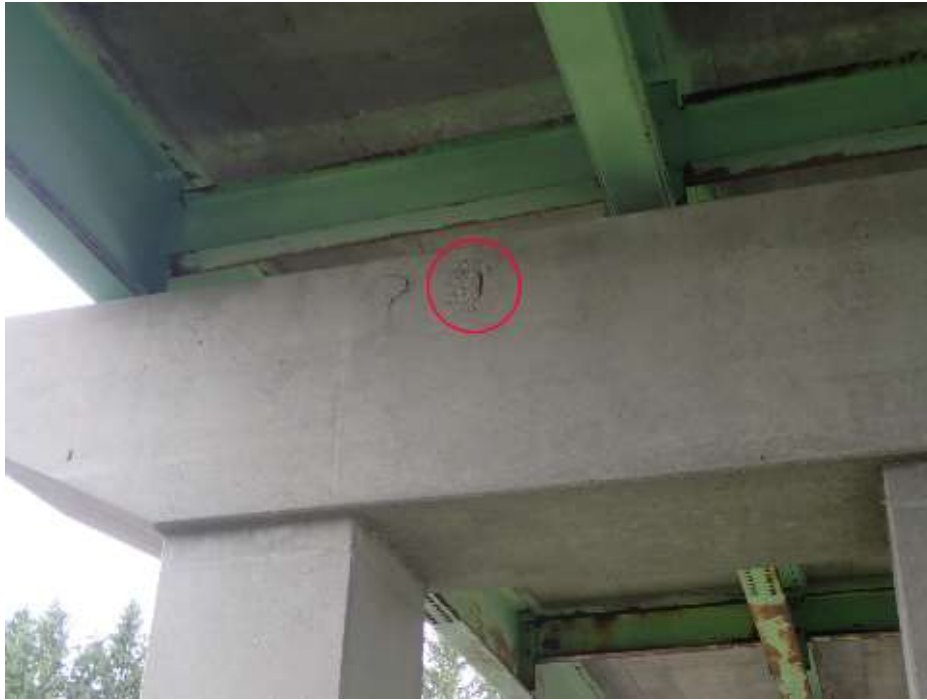
PHOTO 65 Condition

Description Pier 2 - West Elevation, spall with ECSR

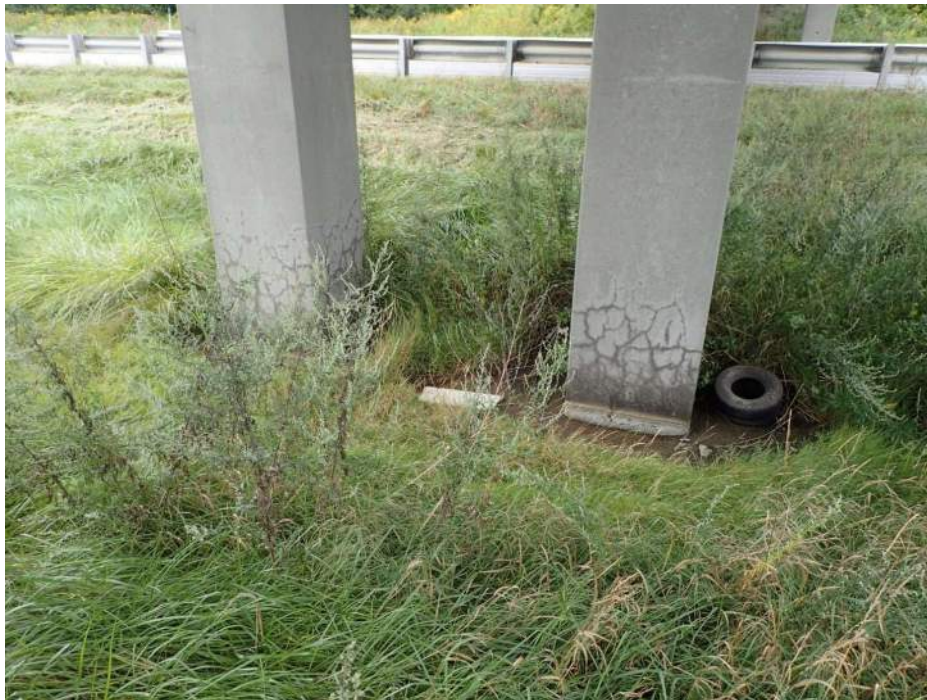
PHOTO 66 Condition

Description Pier 2 - West Elevation, map cracking from ground up approximately 3' - 4'

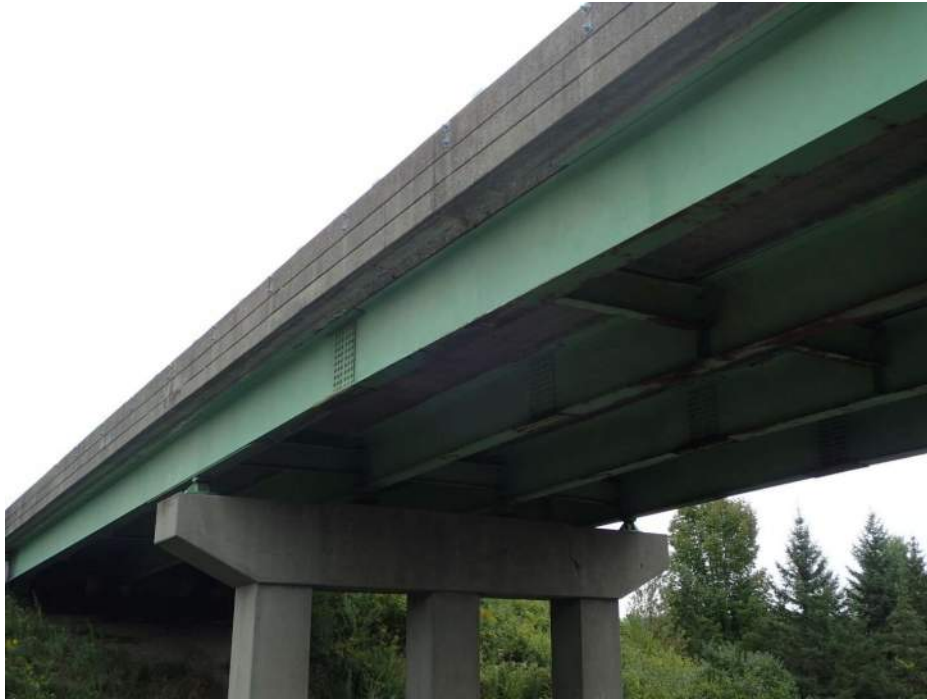
PHOTO 71 Condition

The existing haunches extend past the girder flange tips by 4" on each side. Span 2 is over the southbound lanes of I95 and Span 3 is over the northbound lanes of I95. The haunches in spans 2 and 3 have widespread spalling. During the inspection, pieces of concrete haunch were found in left shoulder of the NB barrel of I-95, there is concern that additional pieces of the concrete haunch may break loose potentially over the traffic lanes on I-95. Additional segments of these haunch extensions remain over the live traffic lanes, however it is not possible to sound these segments or investigate in more detail without a lift or snooper and traffic restrictions on I-95.

Description Span 3 over I95 NB - North fascia, much of haunch has spalled but there are several areas where the haunch is still intact (typical)

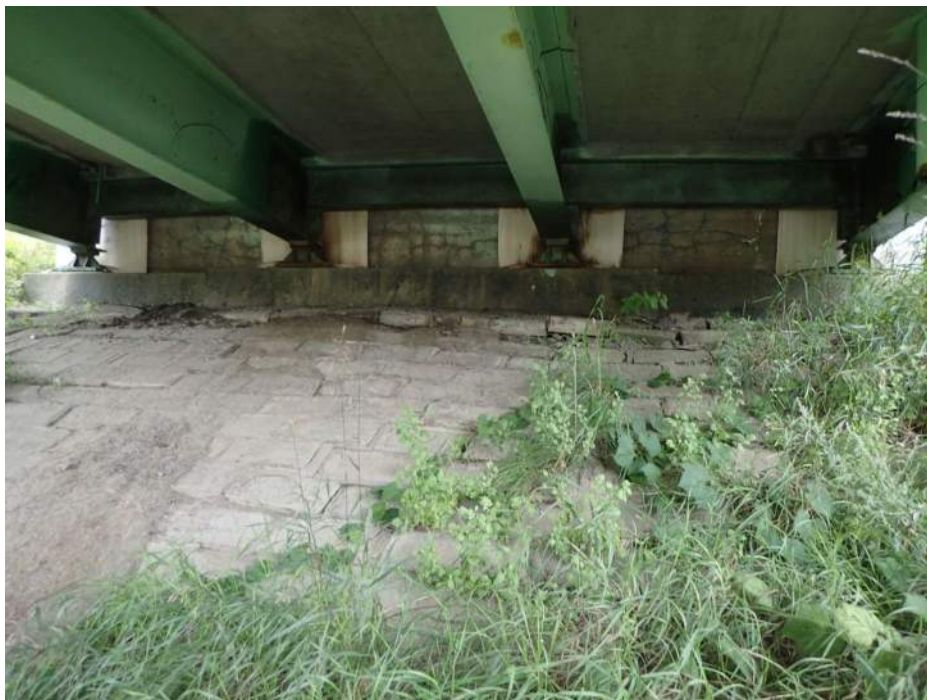
PHOTO 88 Condition

Description Abutment 2 bank protection - intact but with heavy vegetation, heaving & cracking of joints.

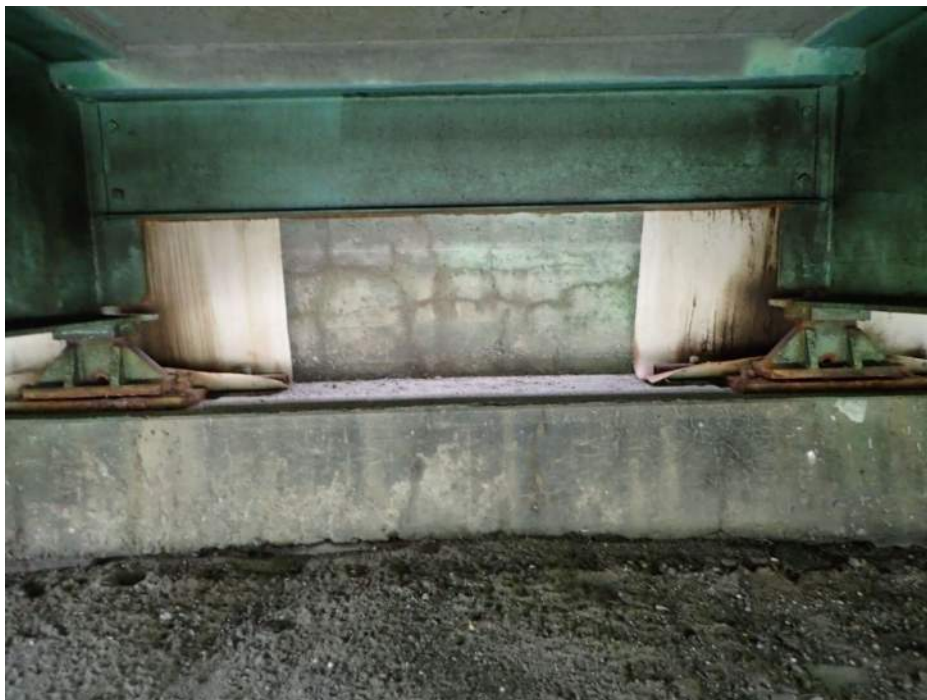
PHOTO 93 Condition

Description Abutment 2 - - Bay , Girder 2 & 3, light map cracking on backwall

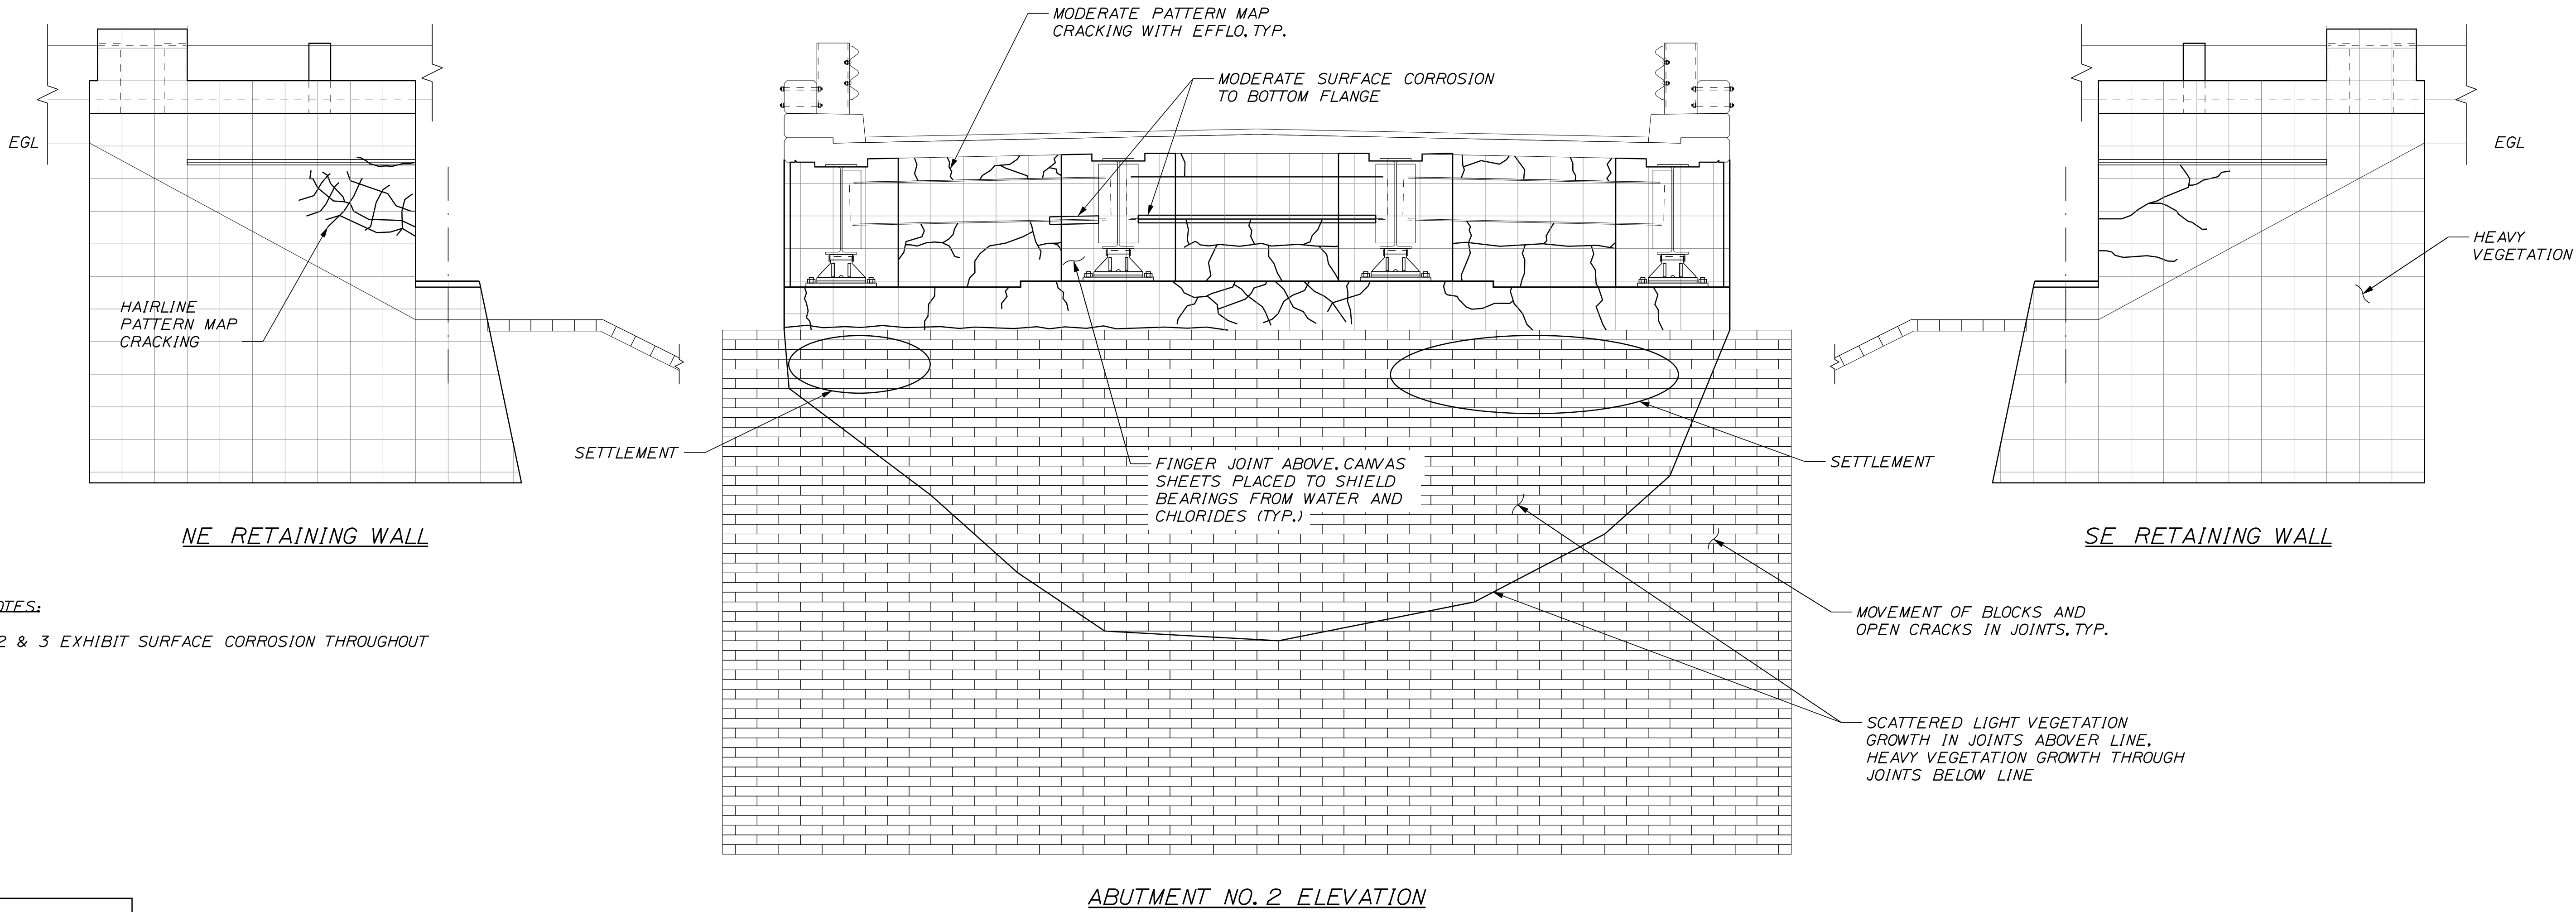
BEARING NOTES:
BEARINGS 2 & 3 EXHIBIT SURFACE CORROSION THROUGHOUT
