Inspector: TYLIN, TYLIN
Inspection Date: 09/06/2024

Structure Number: 5784
Facility Carried: DRUMMOND RD

Highway Bridge Inspection Report

Bridge Name: DRUMMOND ROAD / I-95

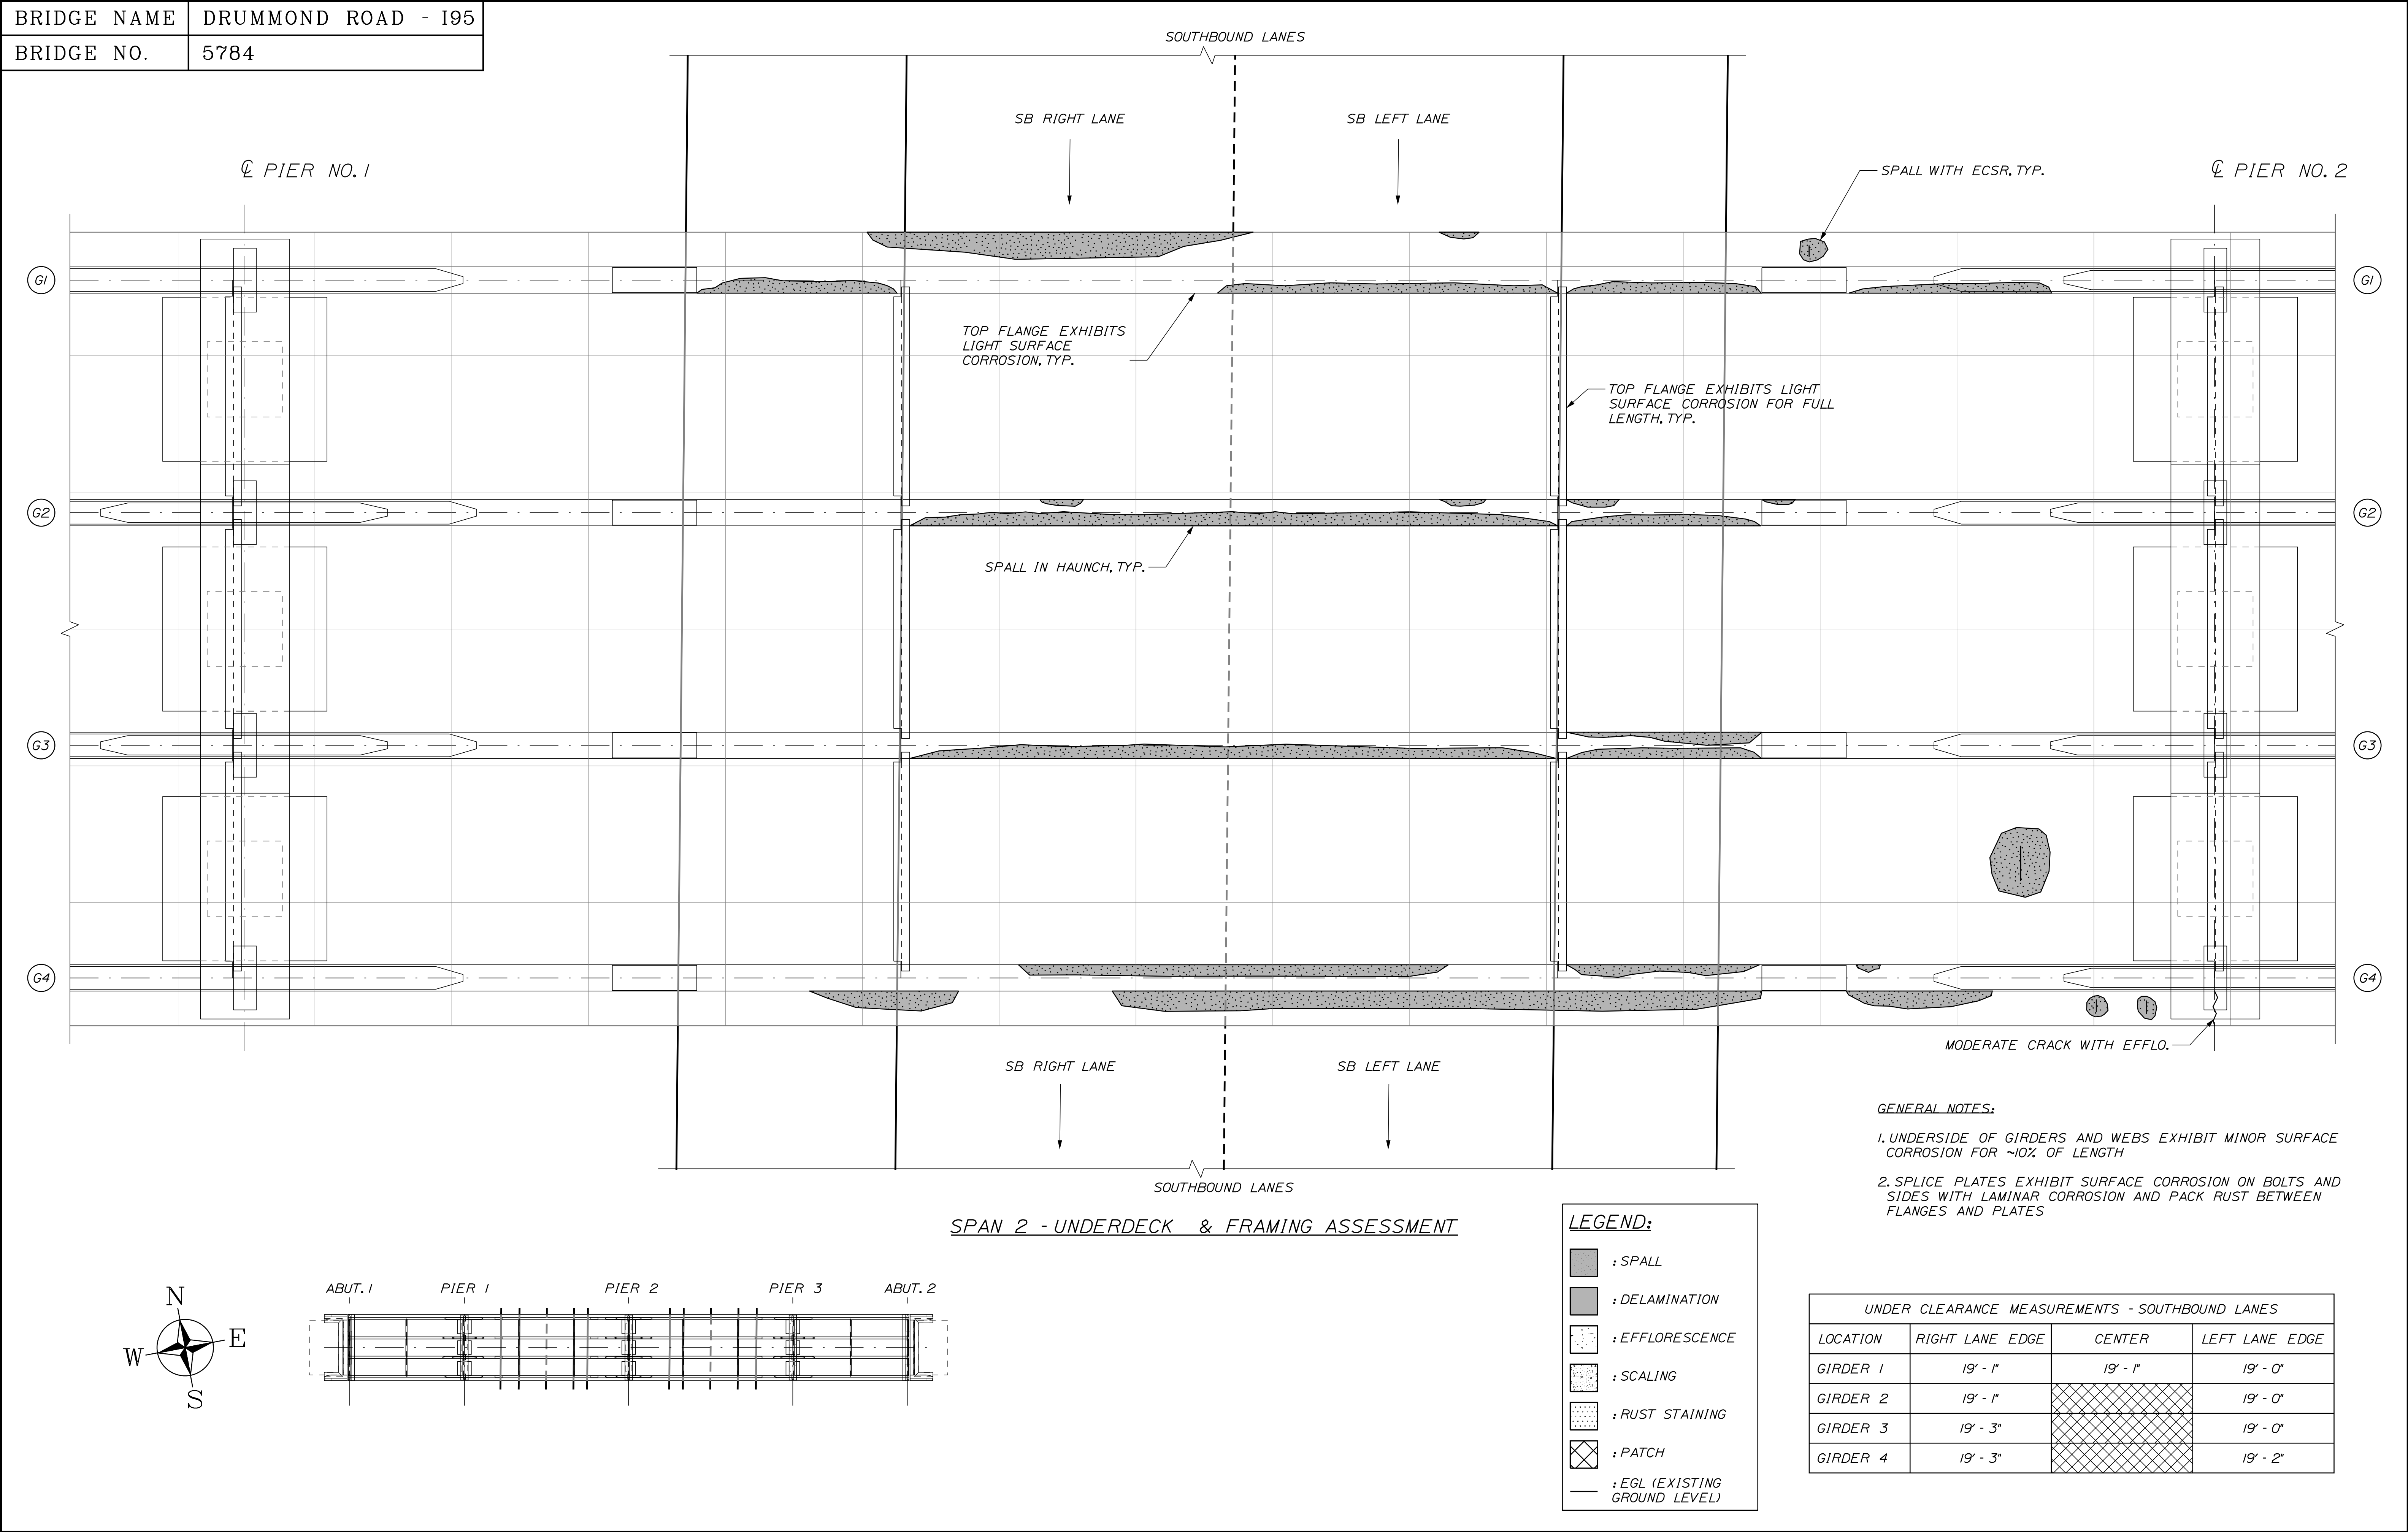
1. UNDERSIDE OF GIRDERS AND WEBS EXHIBIT MINOR SURFACE CORROSION FOR ~10% OF LENGTH

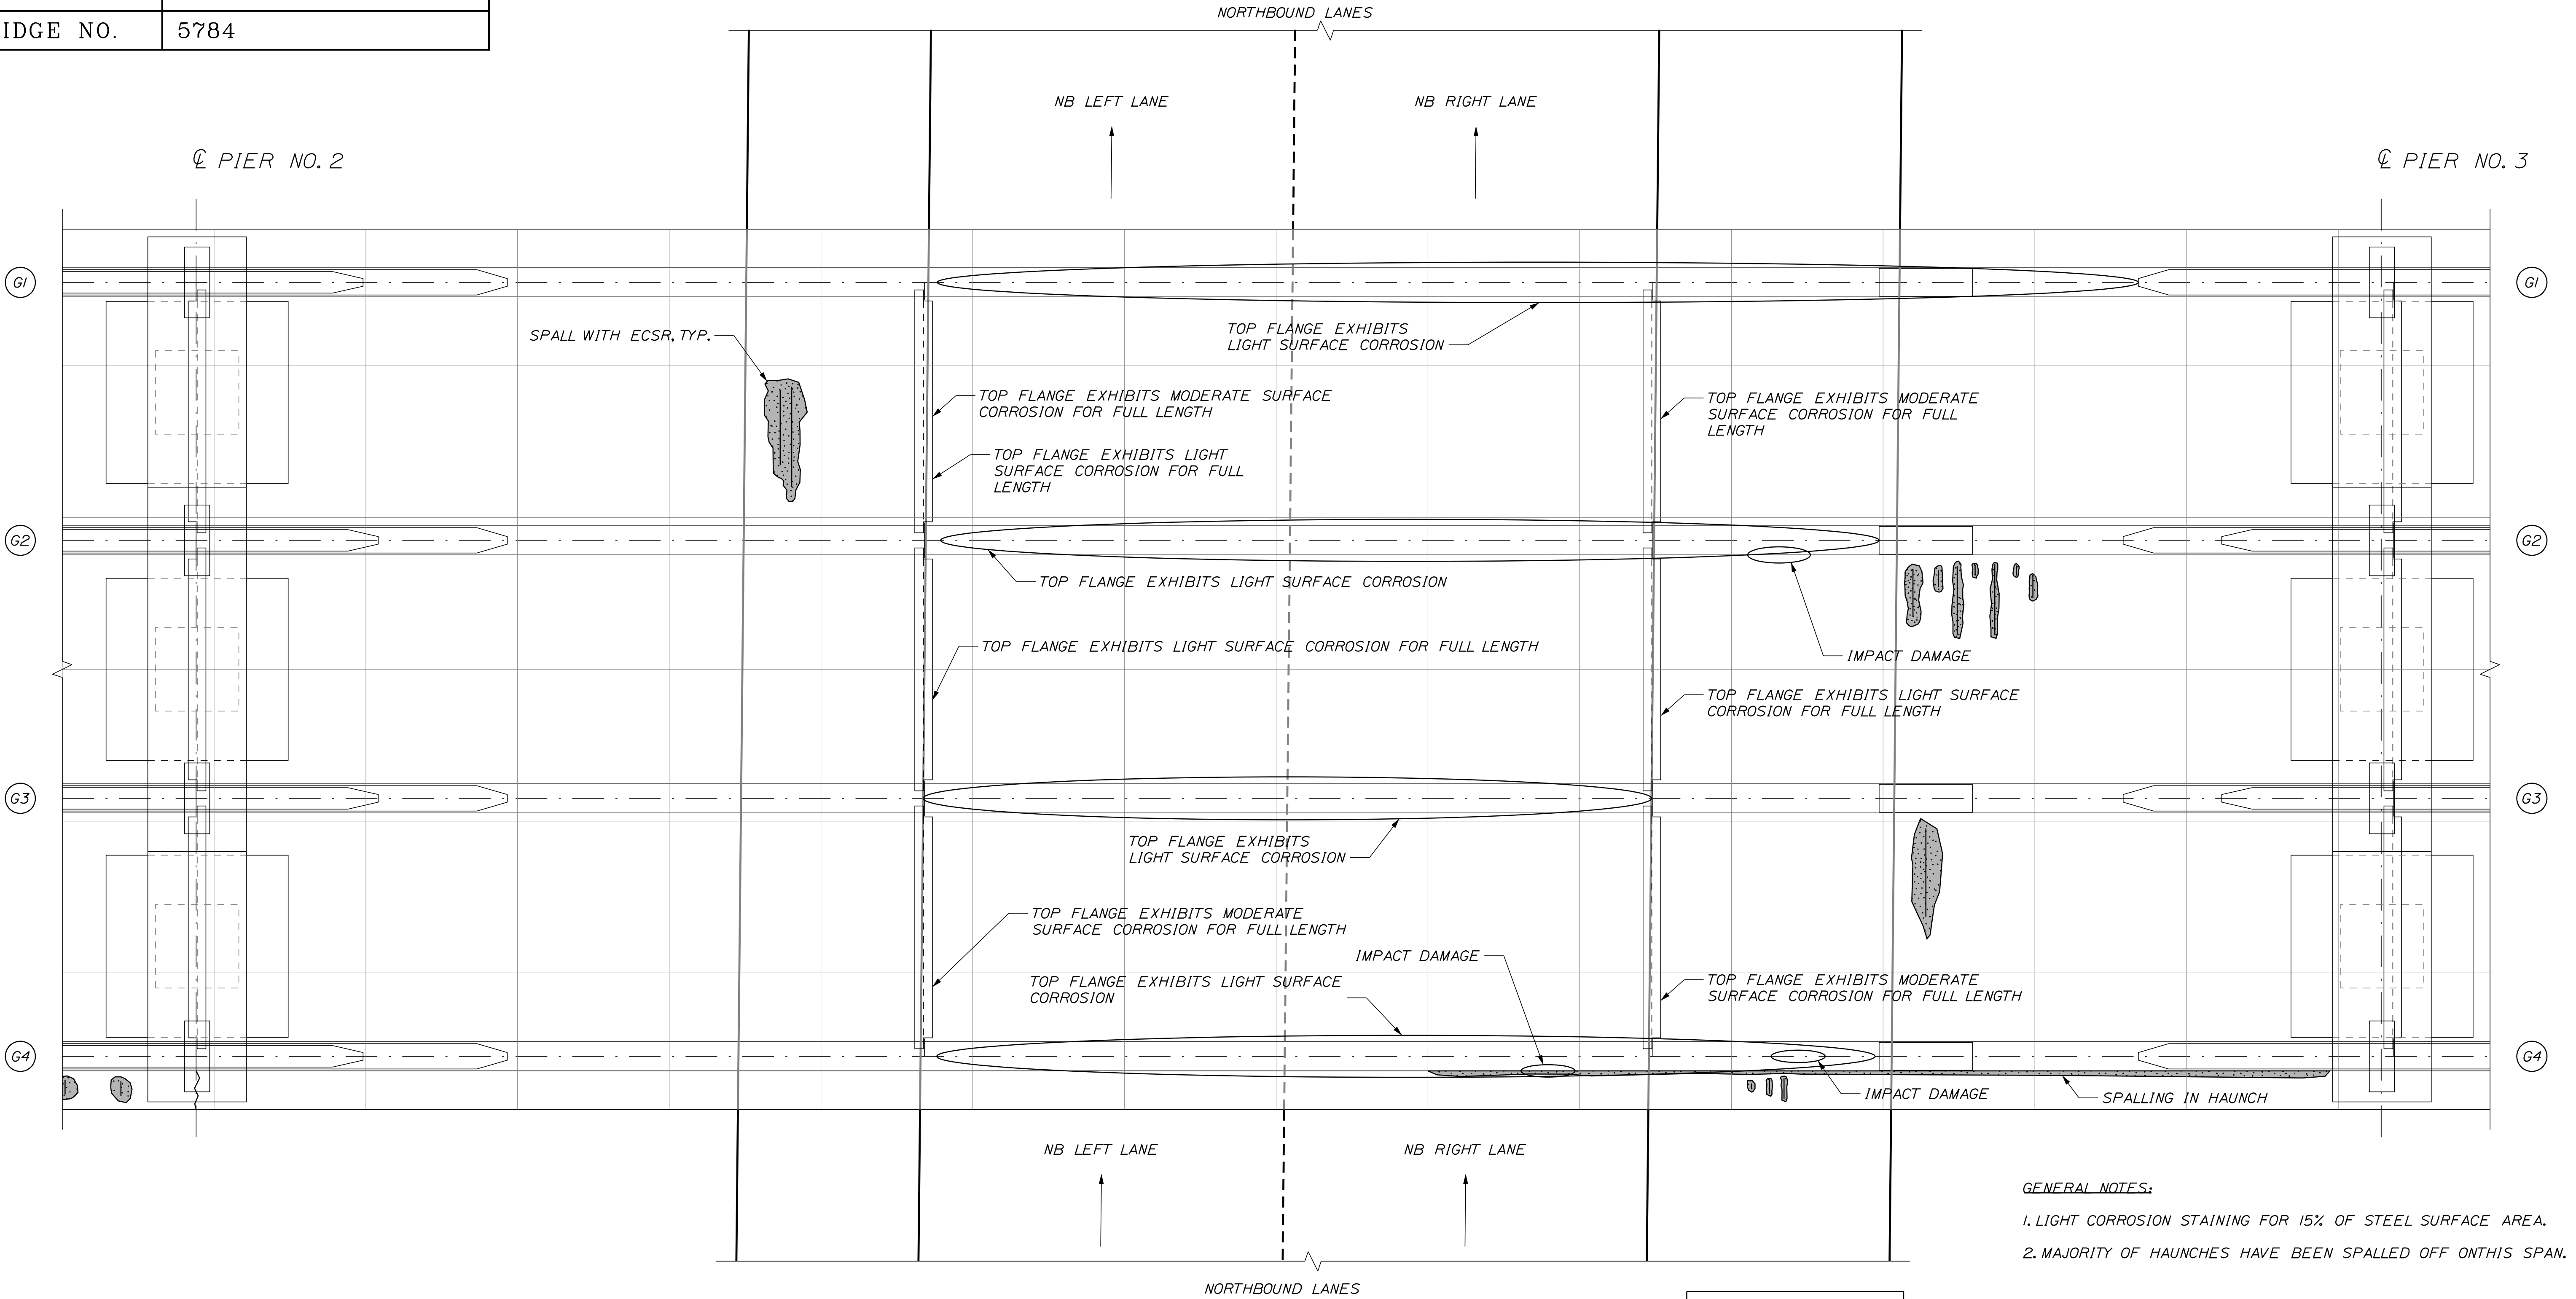
1. LIGHT CORROSION STAINING FOR 15% OF STEEL SURFACE AREA.

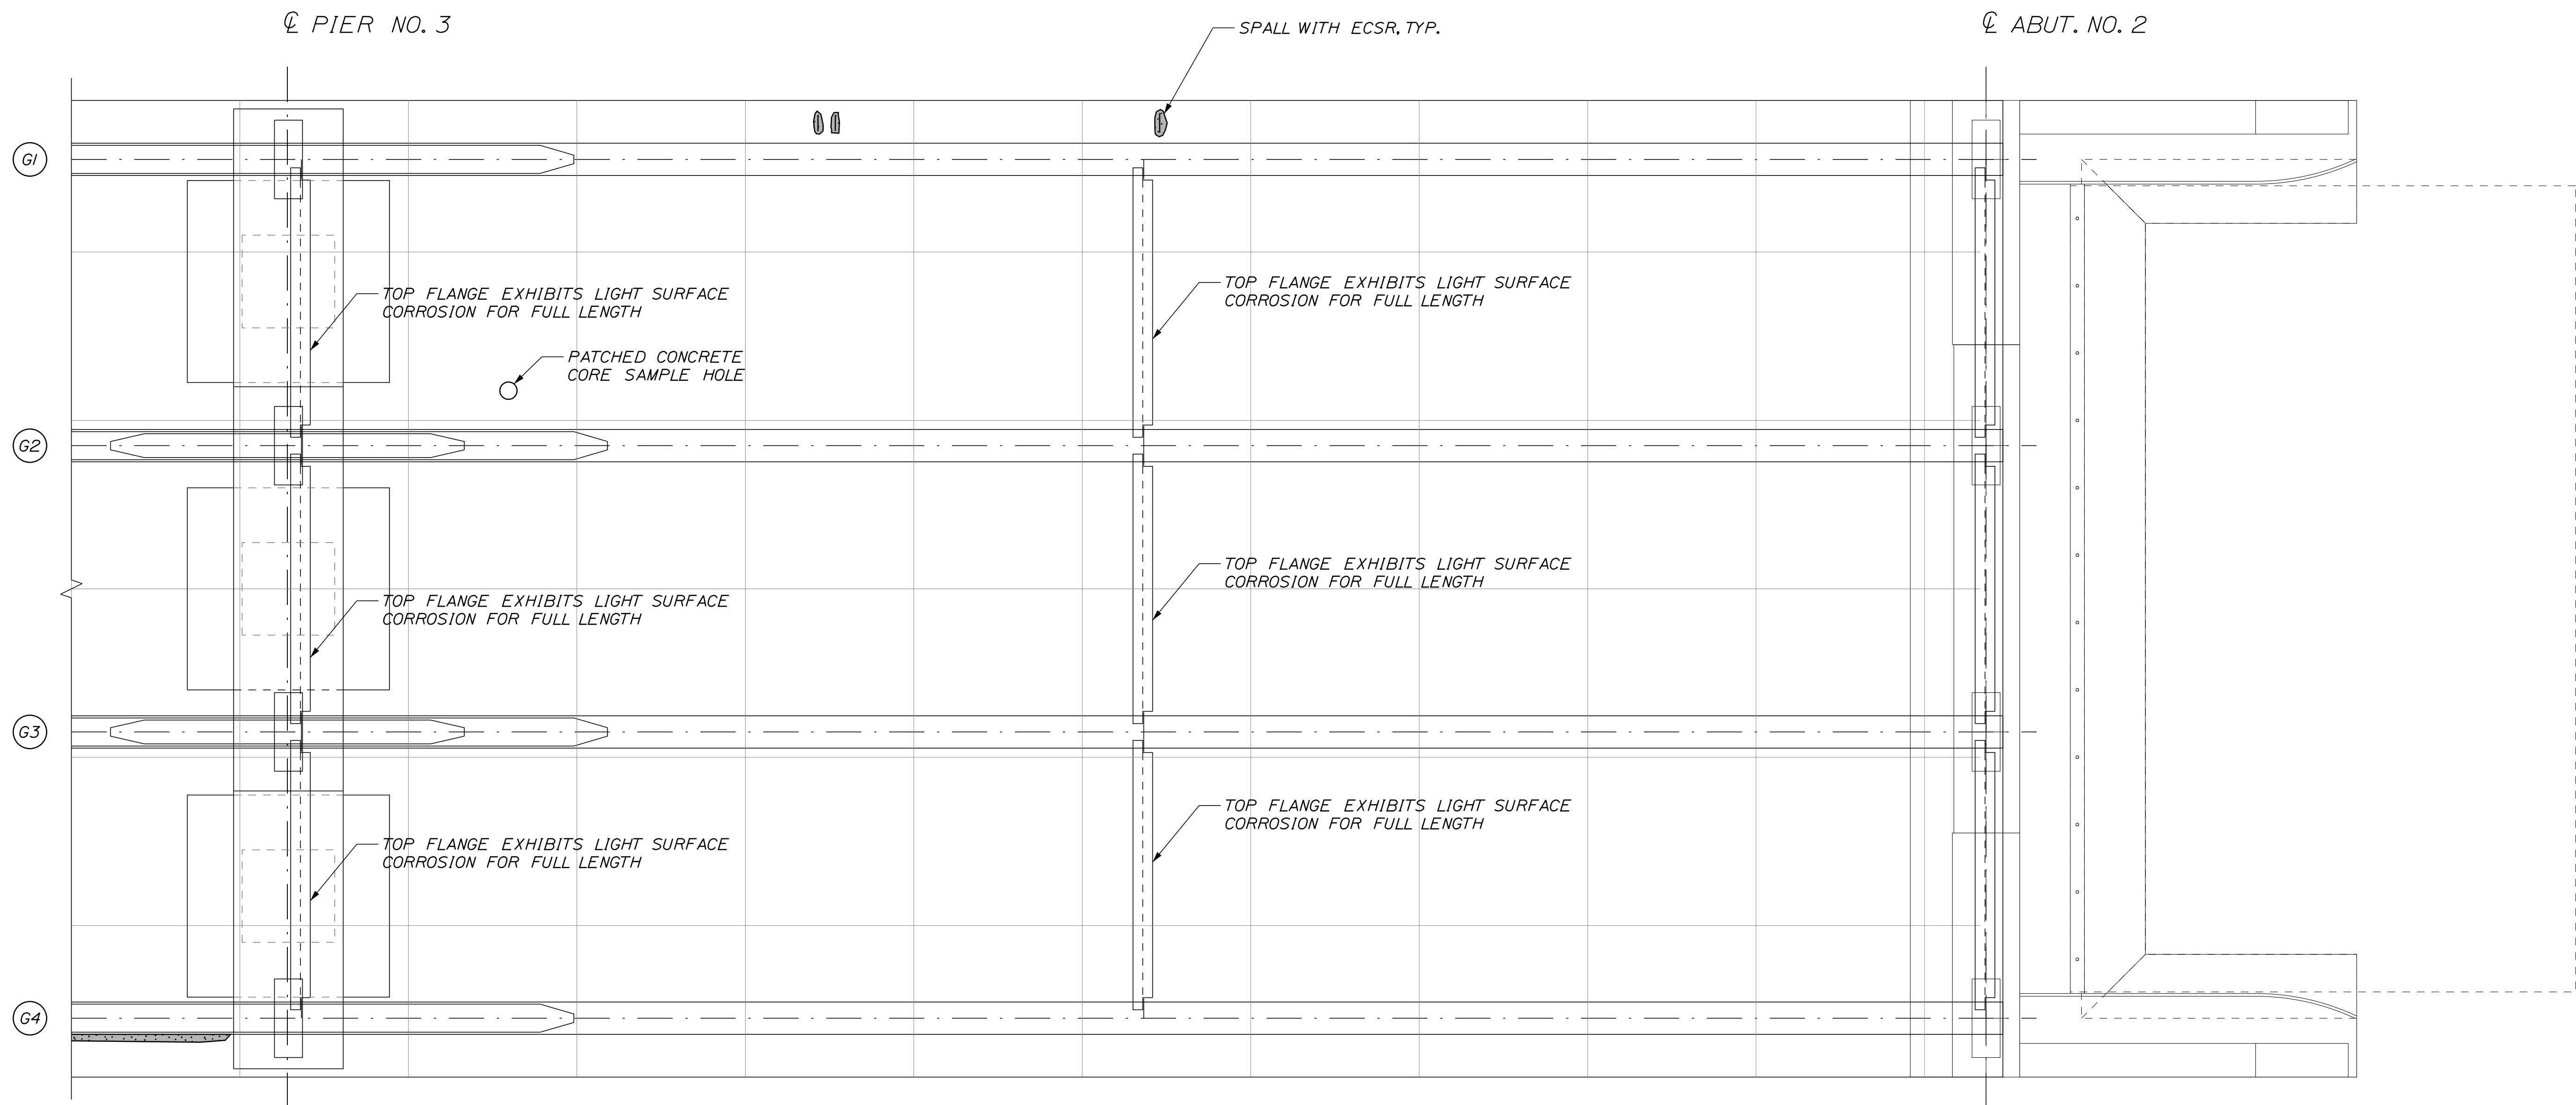
SPAN 4 - UNDERDECK & FRAMING ASSESSMENT

GENERAL NOTES:
1. LIGHT CORROSION STAINING FOR 5% OF STEEL SURFACE AREA.

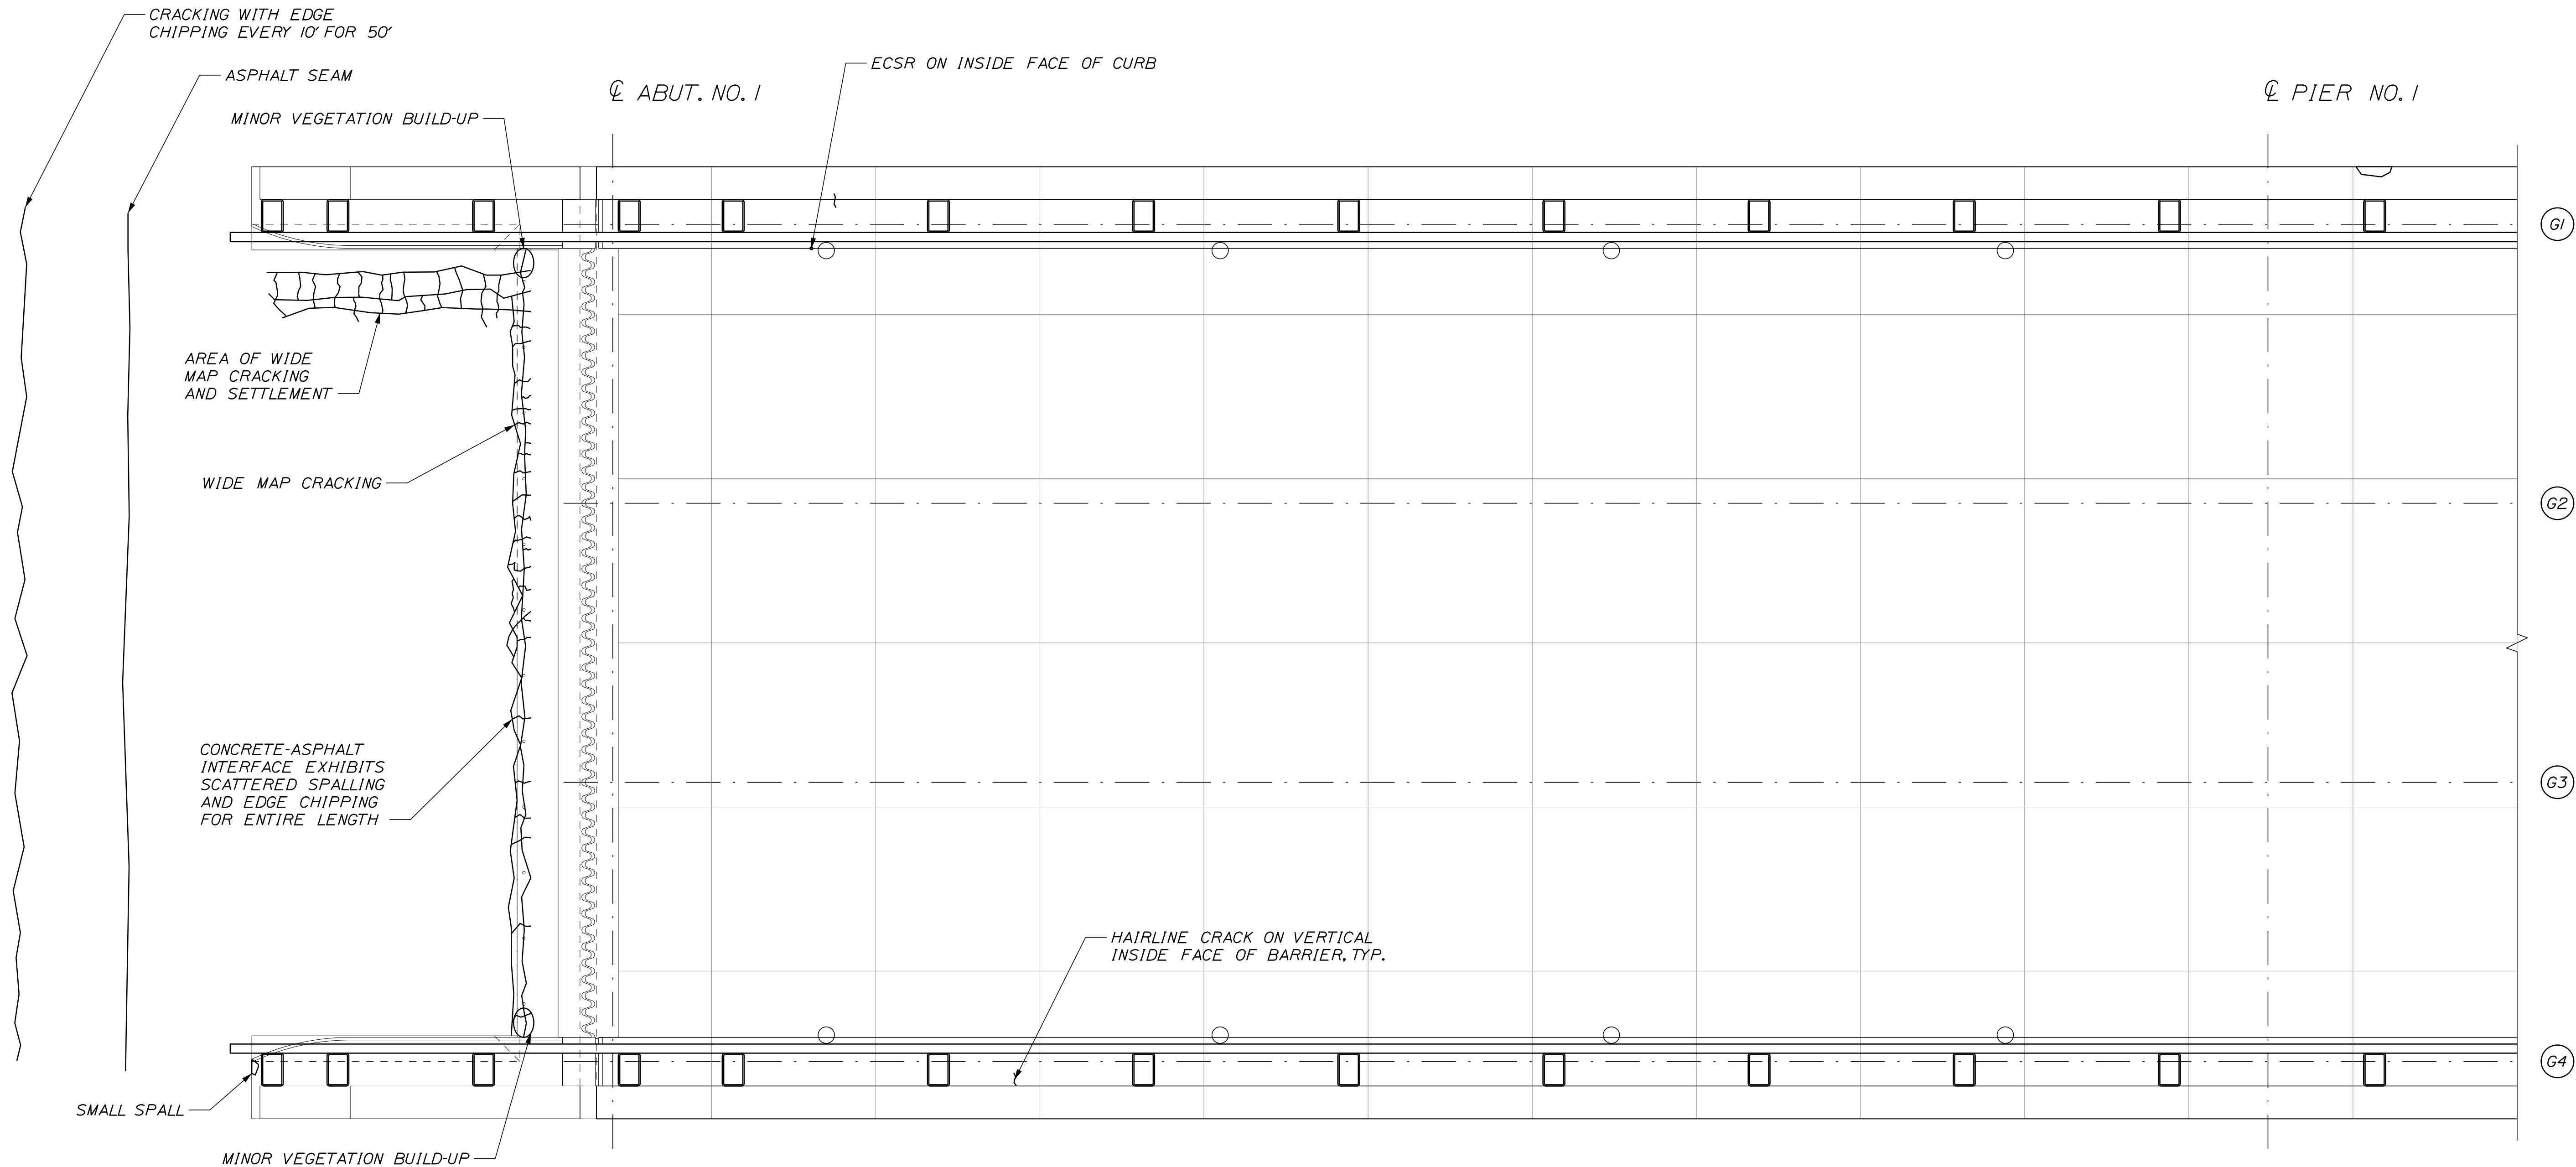
1. GUARDRAIL DAMAGED/ BENT FOR 3' AT 3RD POST FROM END.
