**Inspector:** Calderwood,Engineering  
**Inspection Date:** 10/29/2024

**Structure Number:** 5799  
**Facility Carried:** I 395 EB

**Highway Bridge Inspection Report**

**Bridge Name:** I395 / MAIN STREET

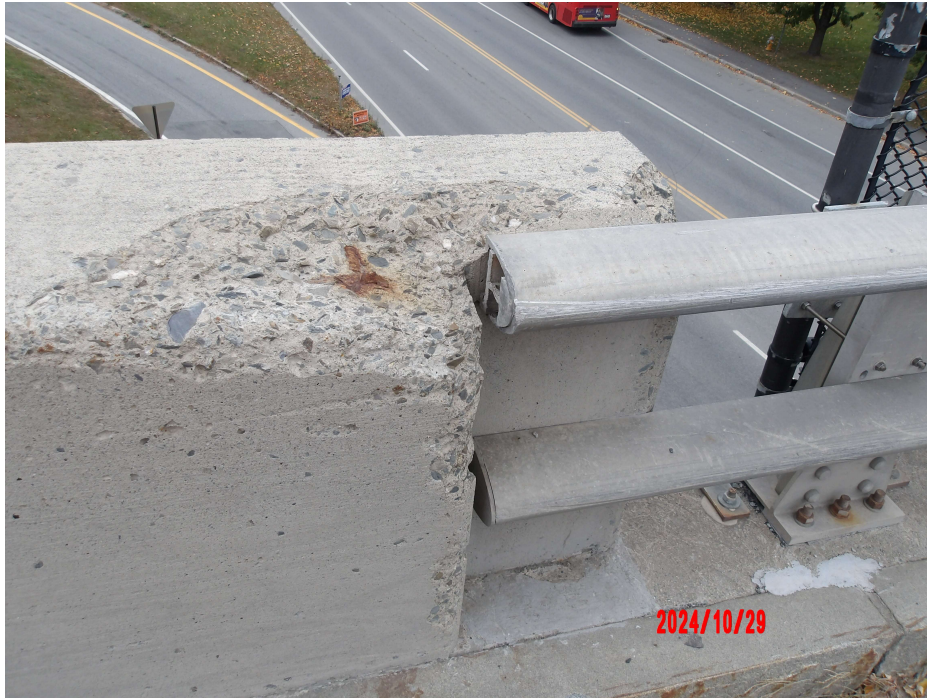
PHOTO 1

Description spalled end post top

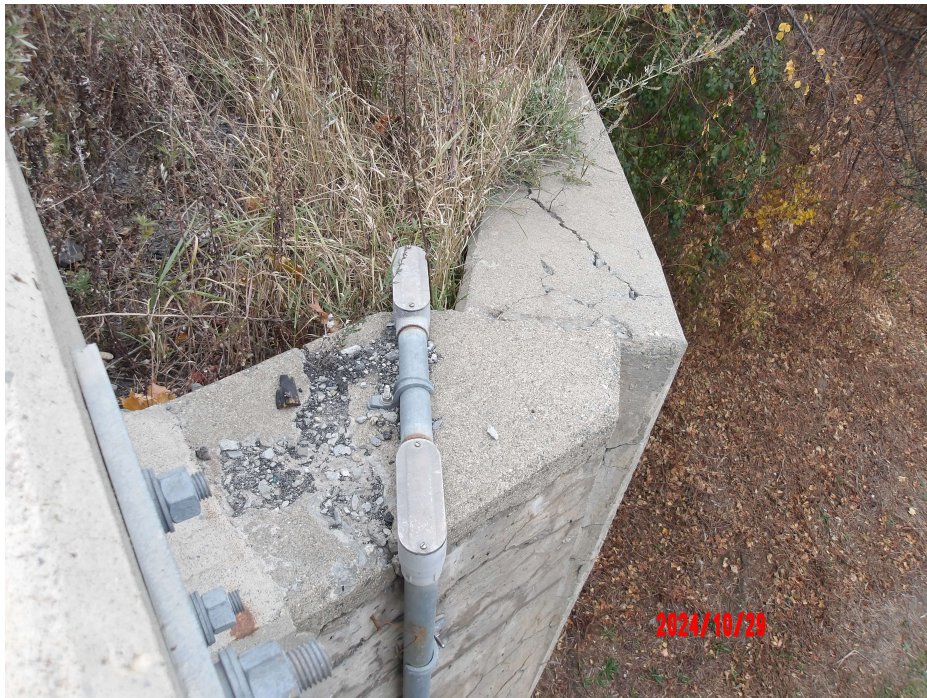
PHOTO 2

Southeasterly breastwall, s'ly corner appears to have moved away from wingwall and rest of abutment at first construction joint.

Notable movement of all 4.

Description top of southeasterly wing - note crack down wing top

Type	Work Item	Priority	Notes
Preservation	Other		Apply Silane
Safety	Other		Repair/replace damaged sign supports and install new anchor bolts.
Preservation	Coat Beam Ends		
Maintenance	Rehab Substructure		anchor wings to abutments
Maintenance	Cut Brush		
Maintenance	Remove Overfill

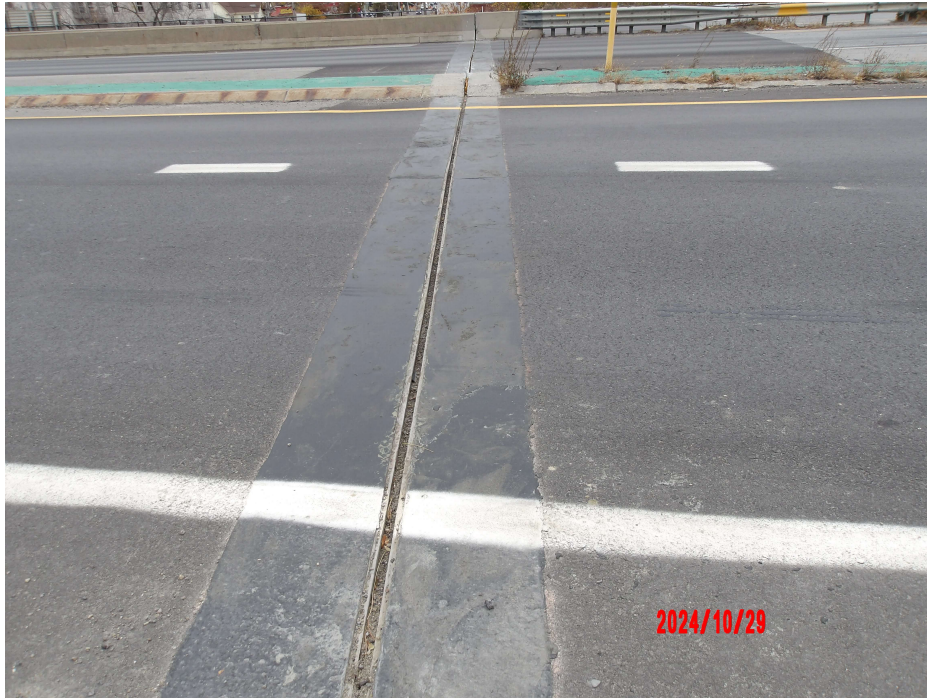
PHOTO 3

Joints appear to be functioning and intact.

Description Easterly joint

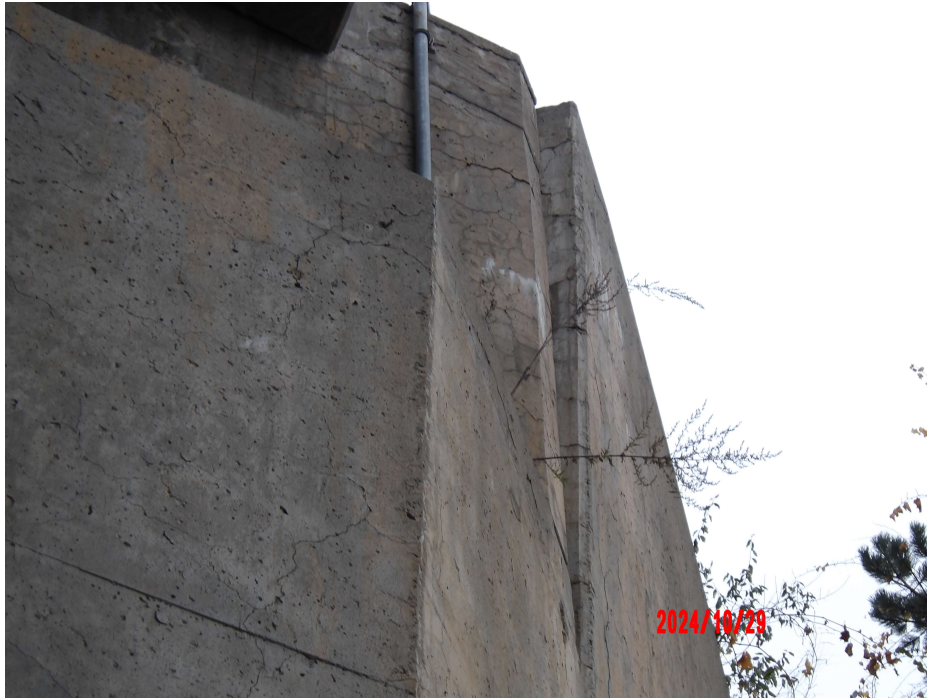
PHOTO 5

12/30/2009: Southeast Wingwall - 7/8" in from abutment @ 5' up (abutment appears to have moved out), 4" rotation out @ 3' down from top of backwall

Description upper portion of southeast wing

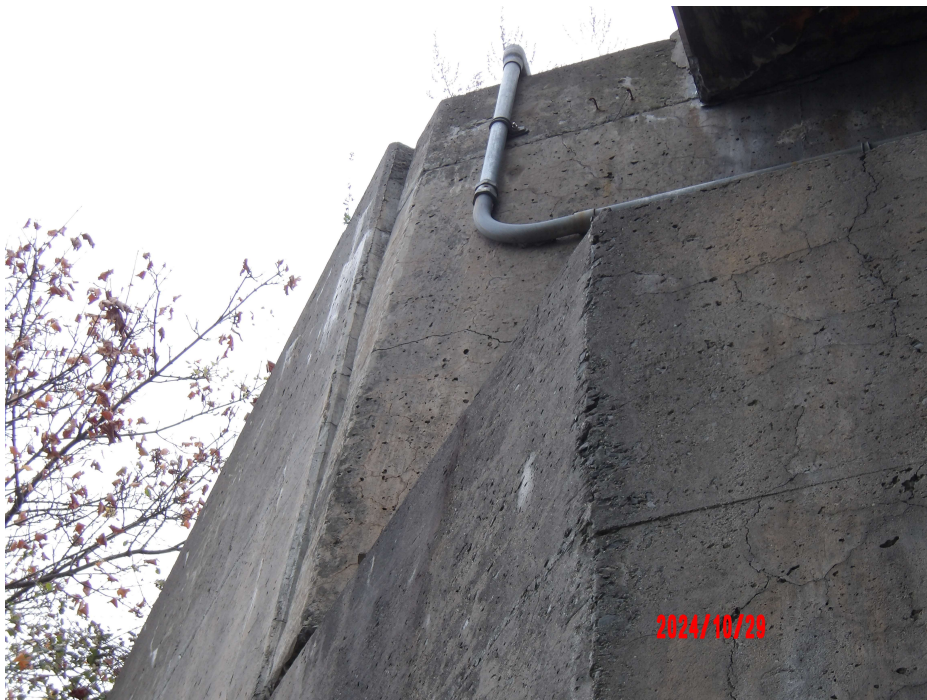
PHOTO 6

12/30/2009: Northeast Wingwall - 1/2" out from abutment @ 5' up, 1 5/8" rotation out @ 3' down from top of backwall

Description upper portion of northeast wing

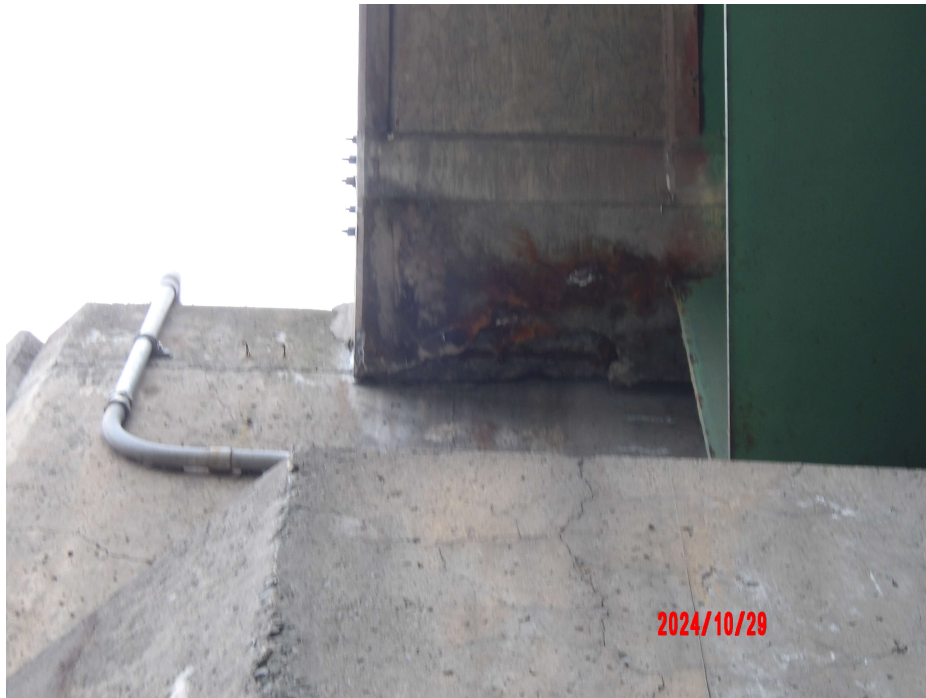
PHOTO 7

Minor spalls, cracking and corrosion in isolated areas, mostly under center joint of deck and deck overhangs. Concrete patching evident of fascias.

Description spalled underside of northeast deck soffit

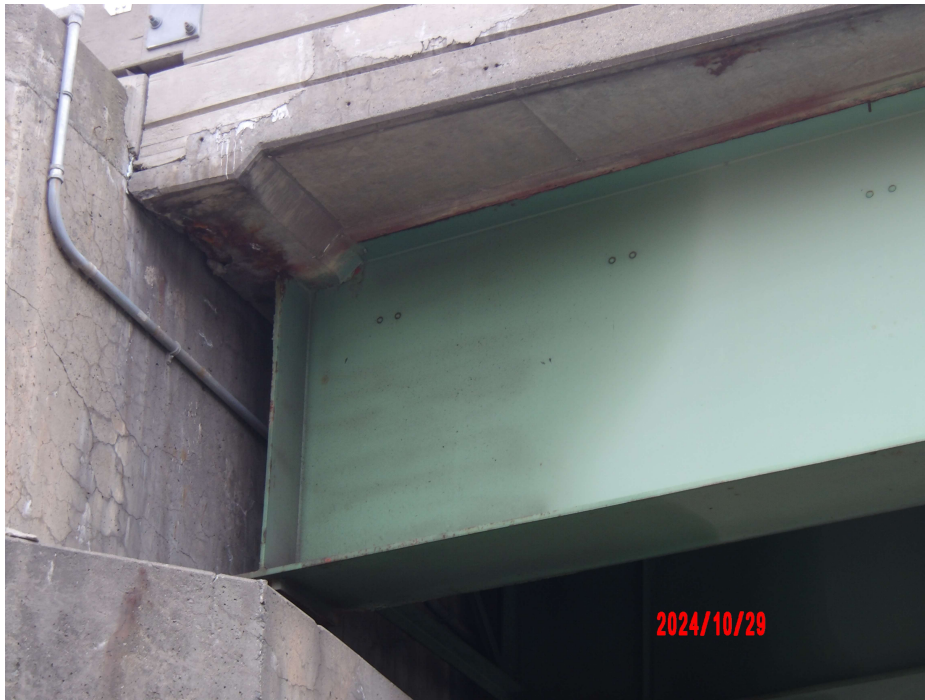
PHOTO 9

Evidence of some past fluid film on beam ends.

Description Northeastly beam end - note fascia patching in deck fascia, perhaps some fluid film

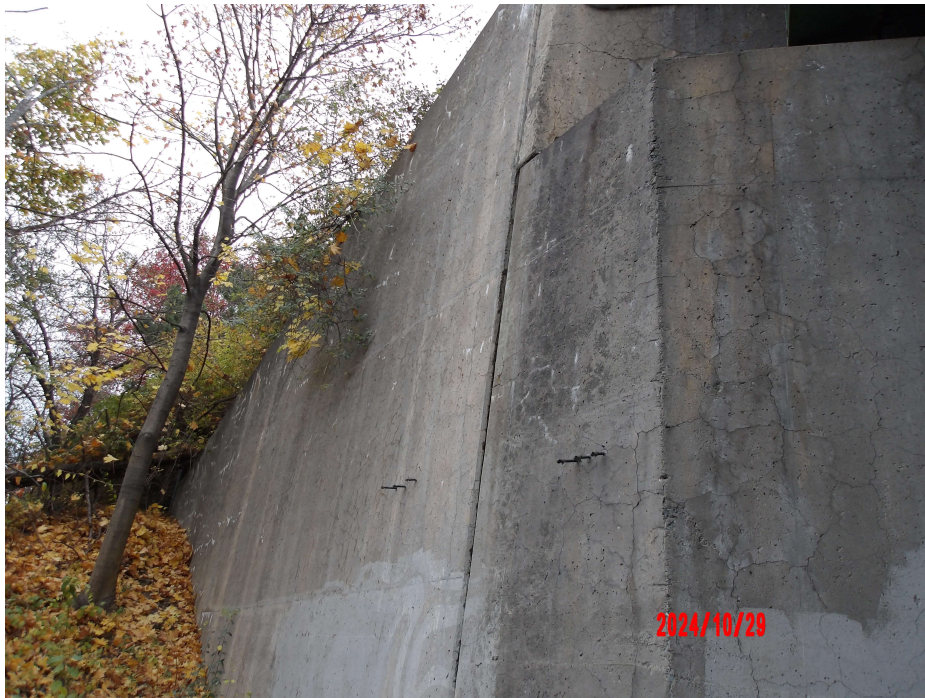
PHOTO 10

Description Northeast wing

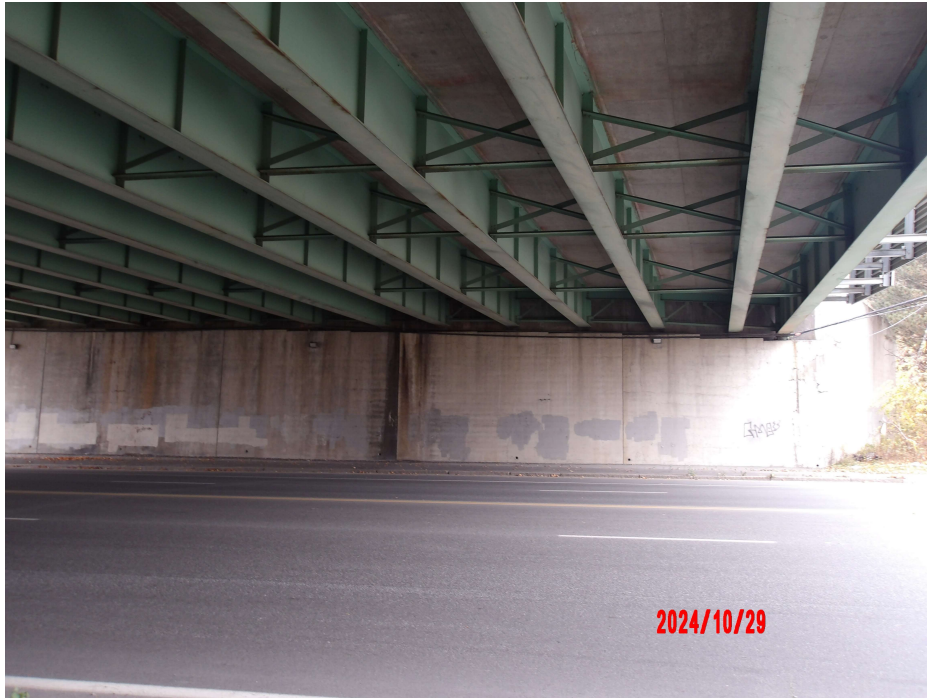
PHOTO 11

Description Westerly abutment

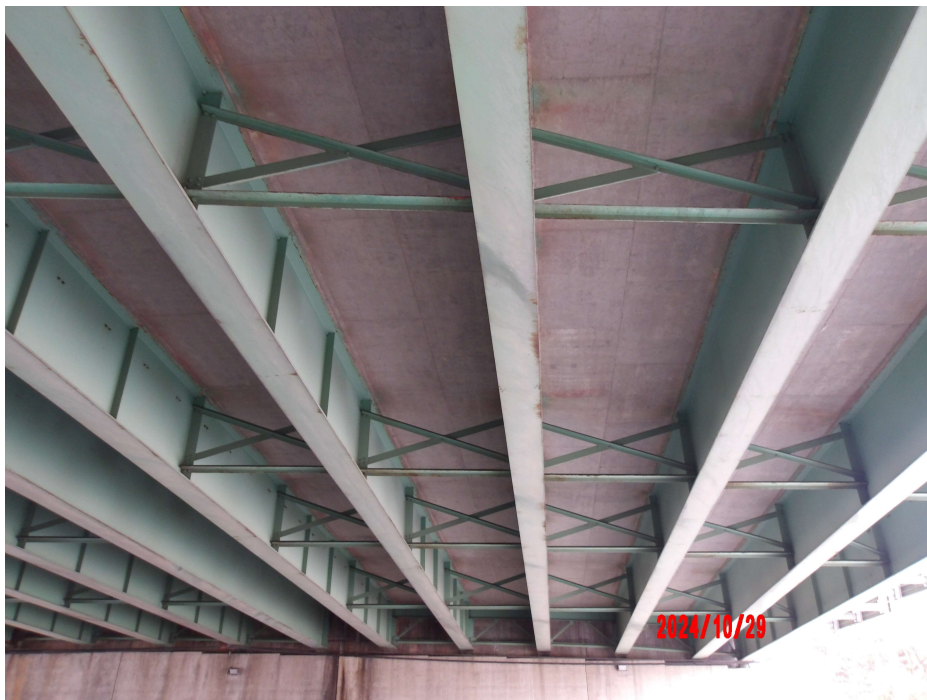
PHOTO 12

Minor paint failure/freckling, mostly bottom flanges.

Webs have chalking paint.

Description Girders, soffit (typ)

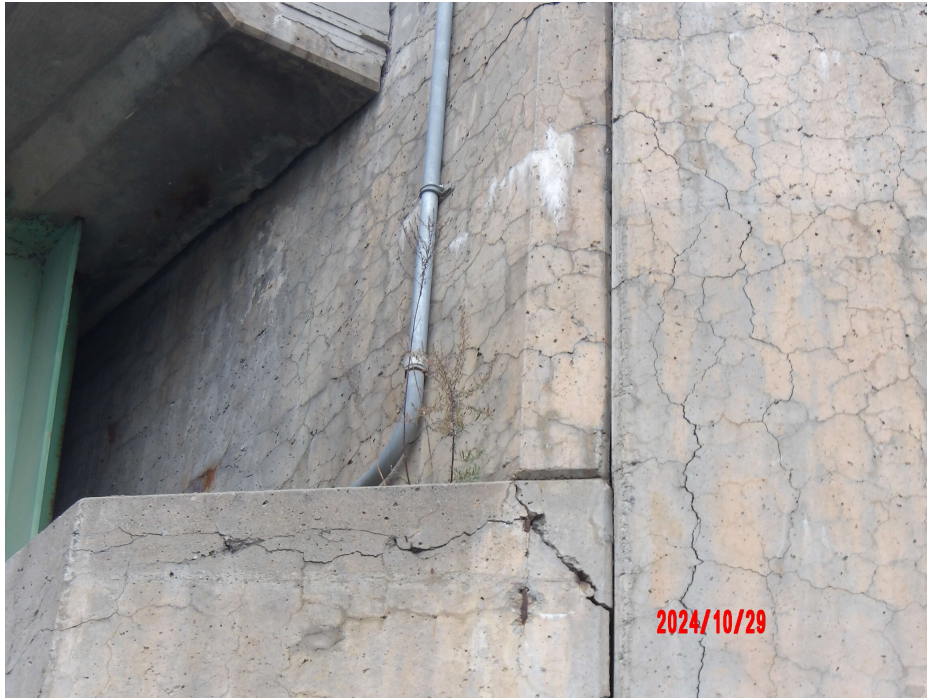
PHOTO 13

Description Cracked bridge seat - southeast corner

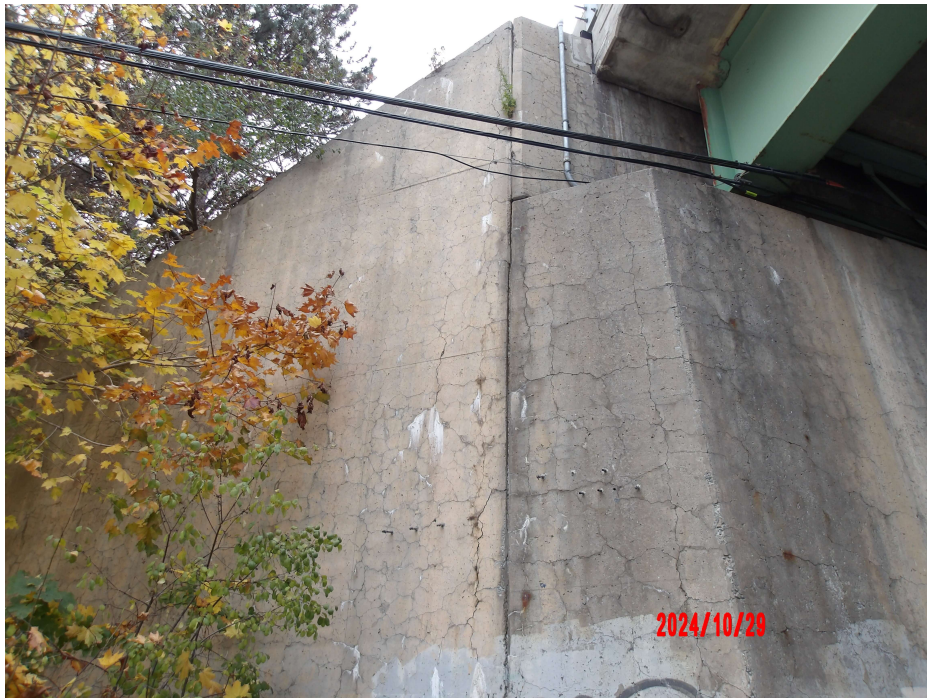
PHOTO 14

12/30/2009: Southwest Wingwall - No apparent change or offset noted at ground or top of wingwall

Description Southwest wingwall

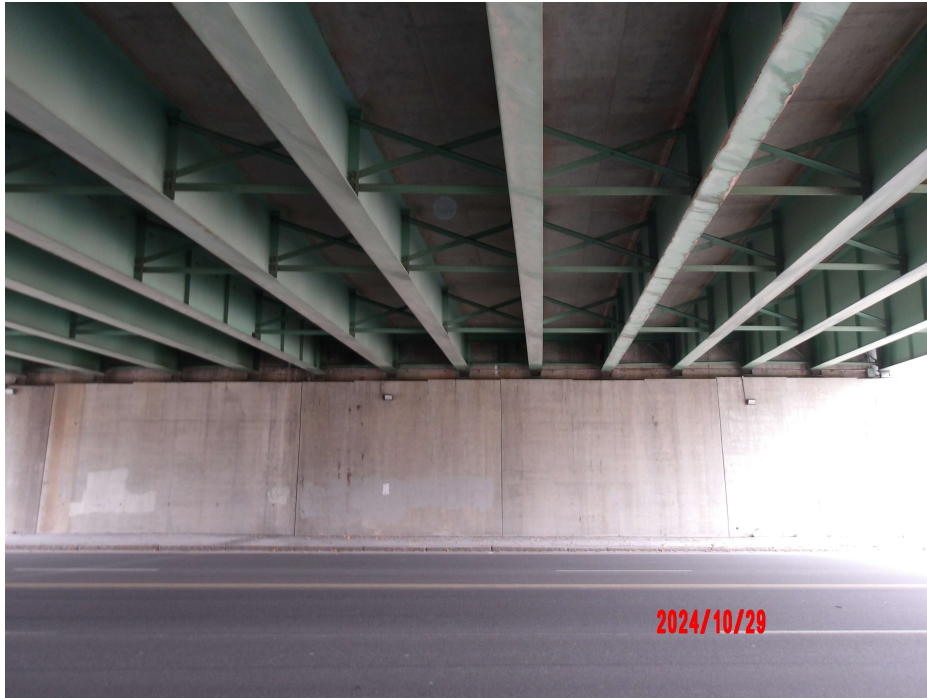
PHOTO 15

Description Easterly abutment

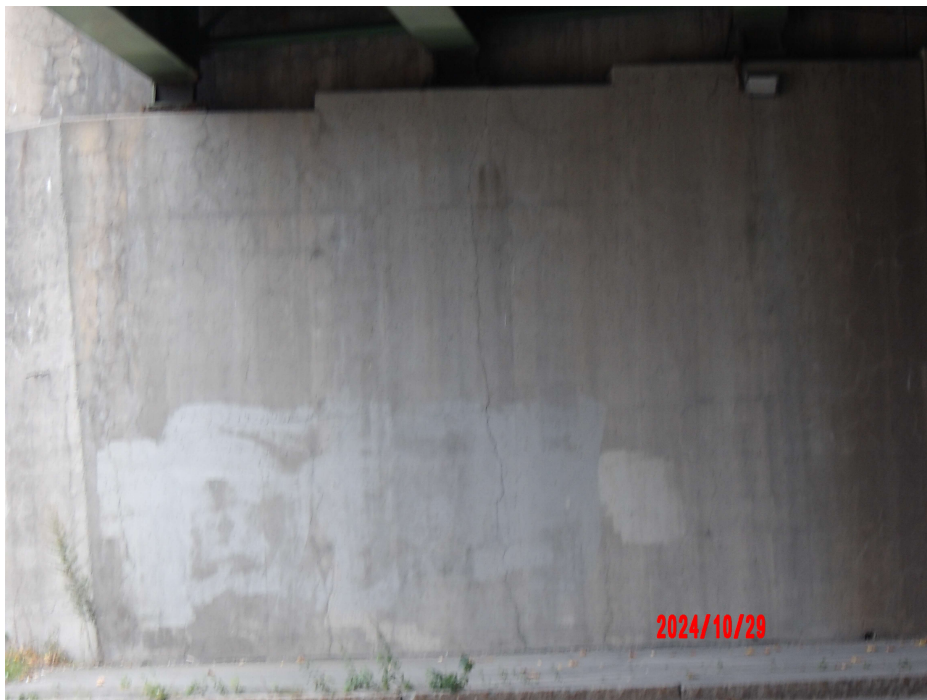
PHOTO 16

Breastwalls generally good condition however, some large vertical cracks and scattered map cracking throughout.

Description Vertical crack in easterly abutment

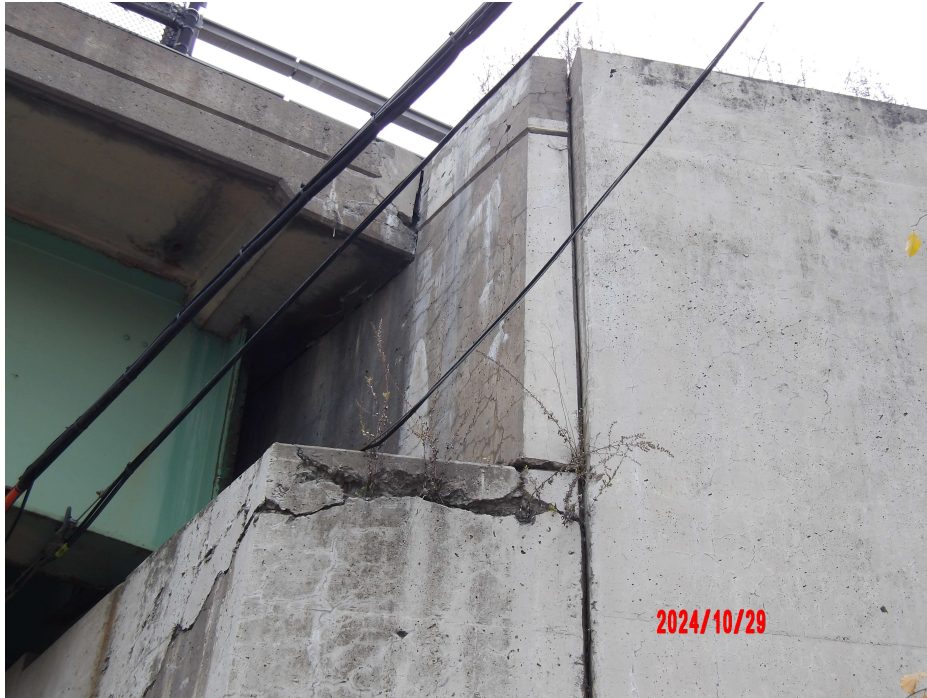
PHOTO 17

Description top of northwesterly abutment seat/wing

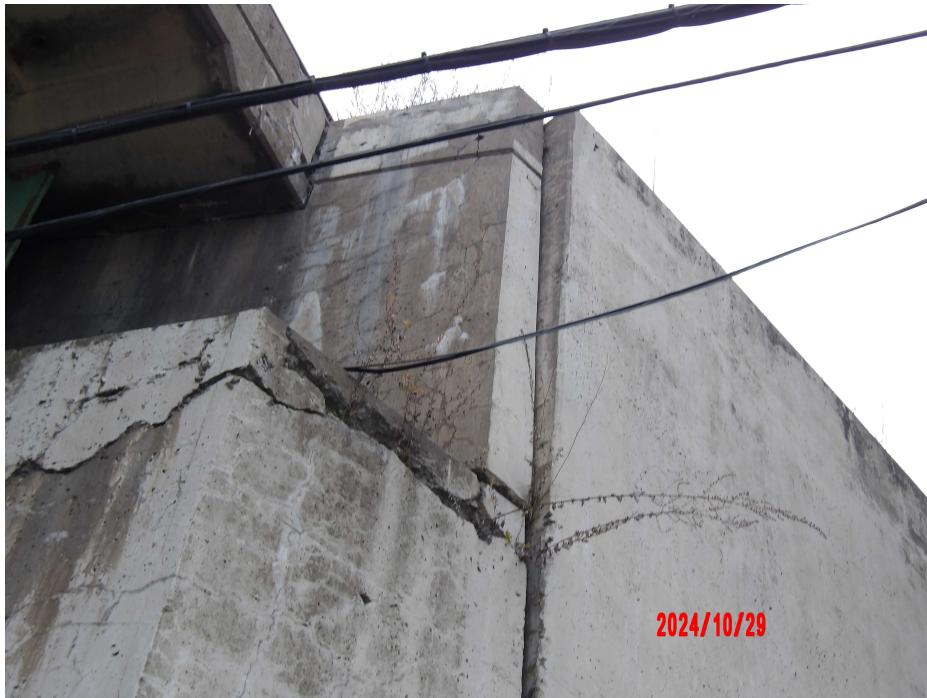
PHOTO 18

2018: All measurements taken. No change except for the NW wall dropped to 3" from 2.5".

Description Top of northwesterly wing/parapet

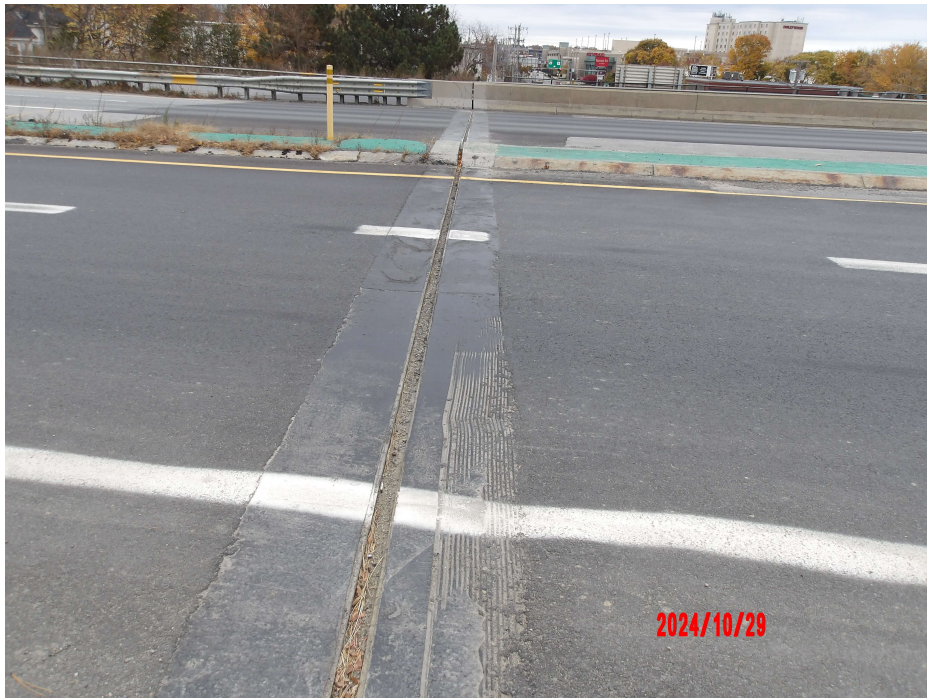
PHOTO 20

Description Westerly joint
