Highway Bridge Inspection Report

BR# 5798

KENDUSKEAG AVENUE / I95

Inspection Date: 06/08/2021

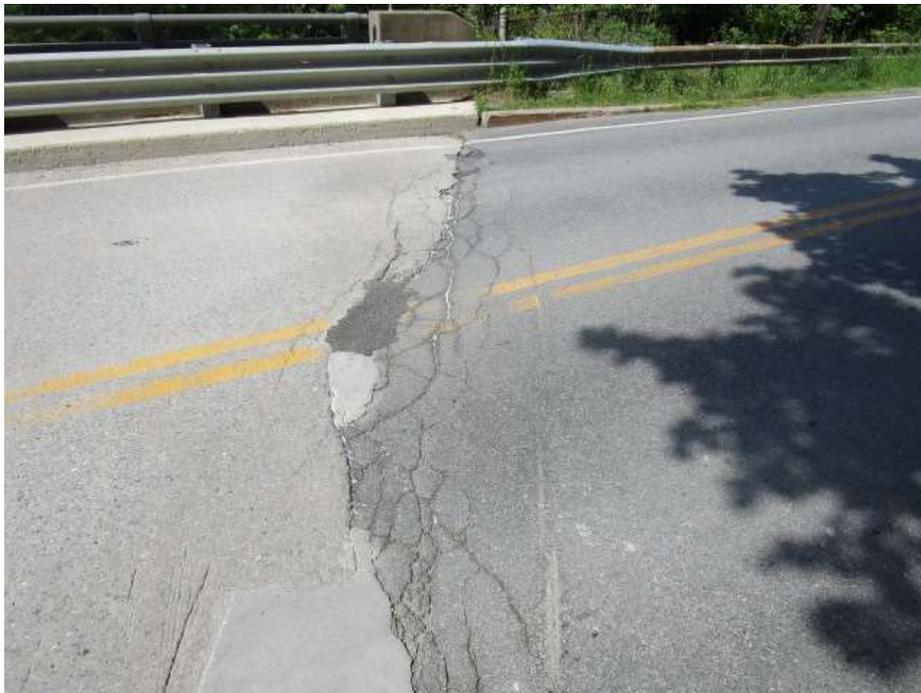
PHOTO 2

Description Cracking bituminous over west abutment

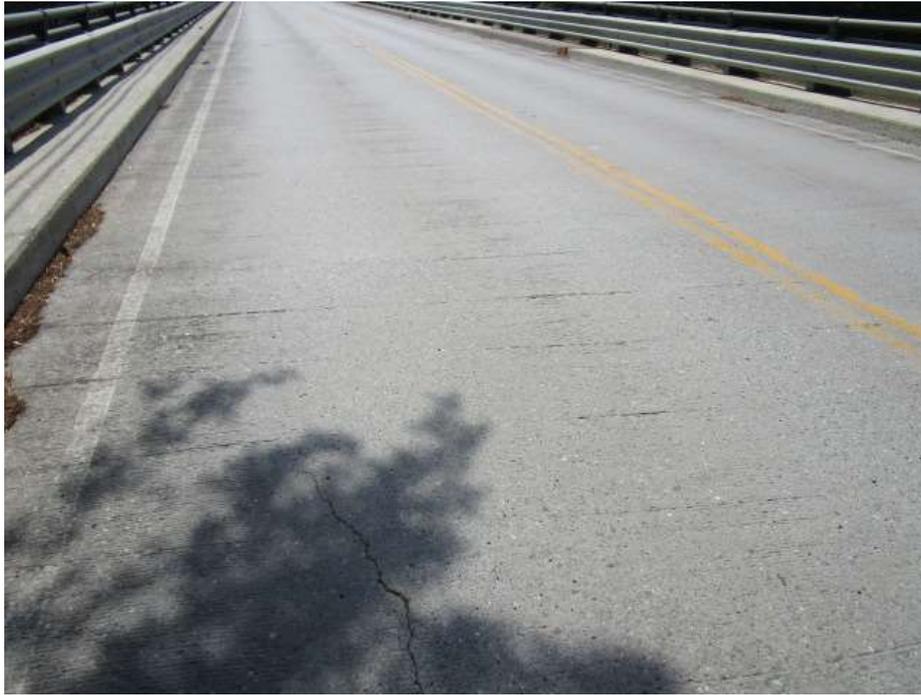
PHOTO 3

Chained entire concrete wearing surface and found approximately 10% minor/ isolated moderate cracking with small areas of delamination. Concrete at ends have been partially patched. Bituminous in this area is poor.

Description wearing surface condition

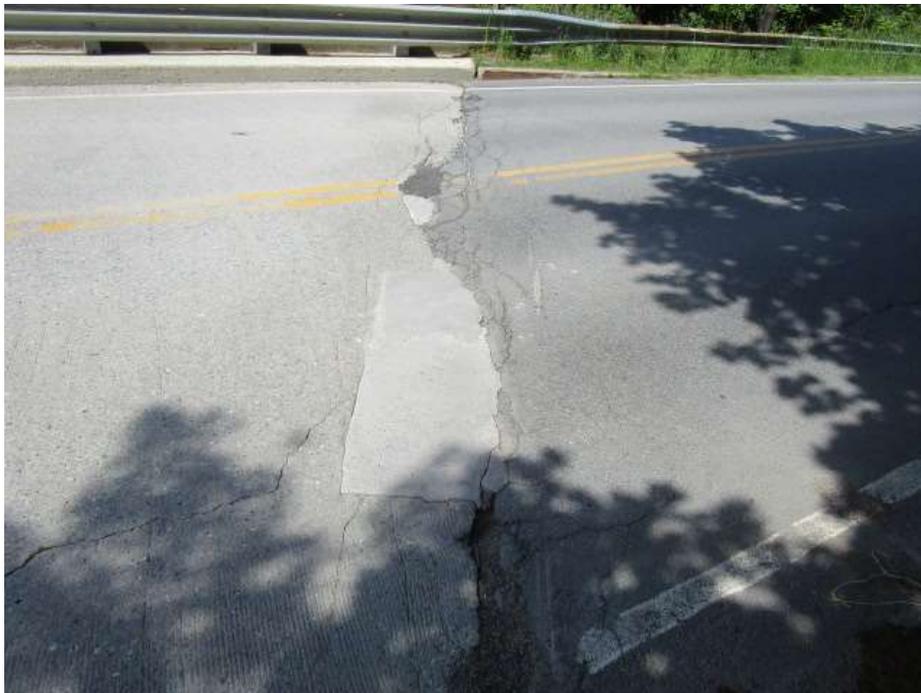
PHOTO 4

Description pavement cracking over west abutment

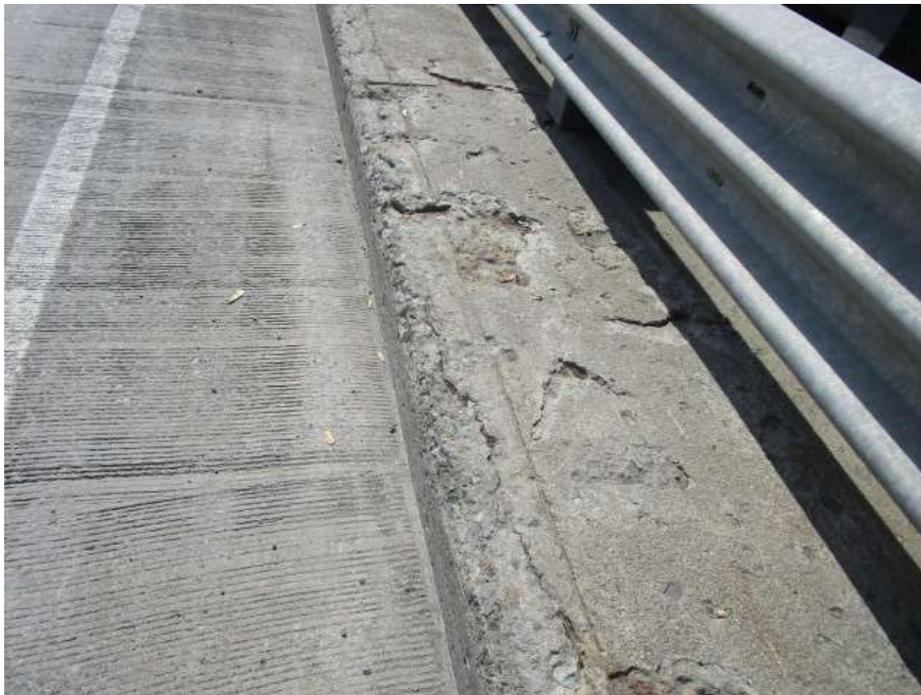
PHOTO 10

Overall fair condition with light scaling of curb lines & fascia's. Scattered staining with isolated spalls and full depth patches. The North safety walk/curbs have been rehabbed. The South safety walk/curbs have sections of rehab. Scattered spalls exposing anchor bolts on the concrete portion of the bridge rail.

Description curb top scaling

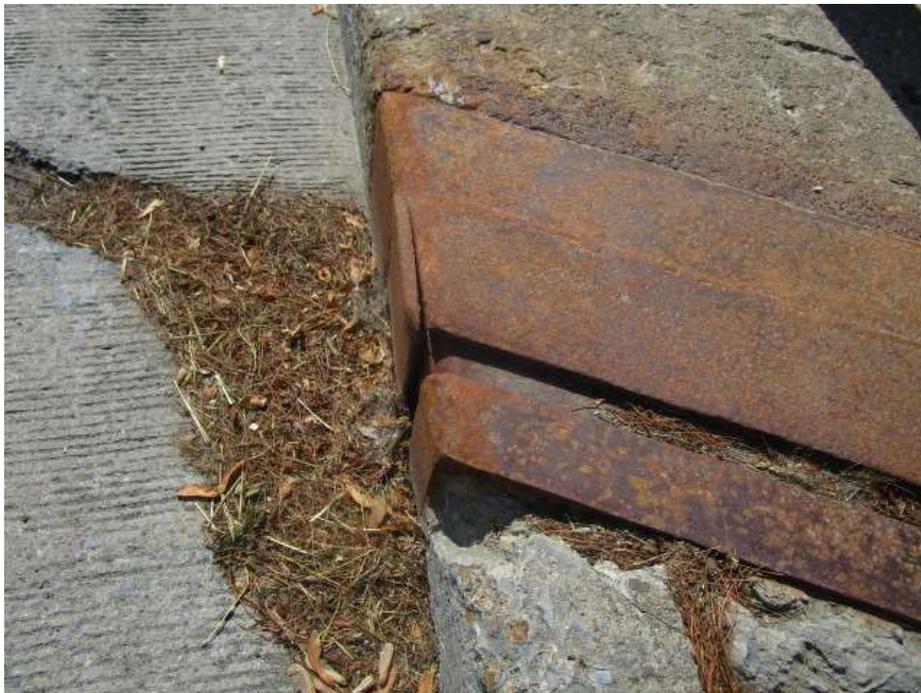
PHOTO 12

Description crack SW joint armor curb plate

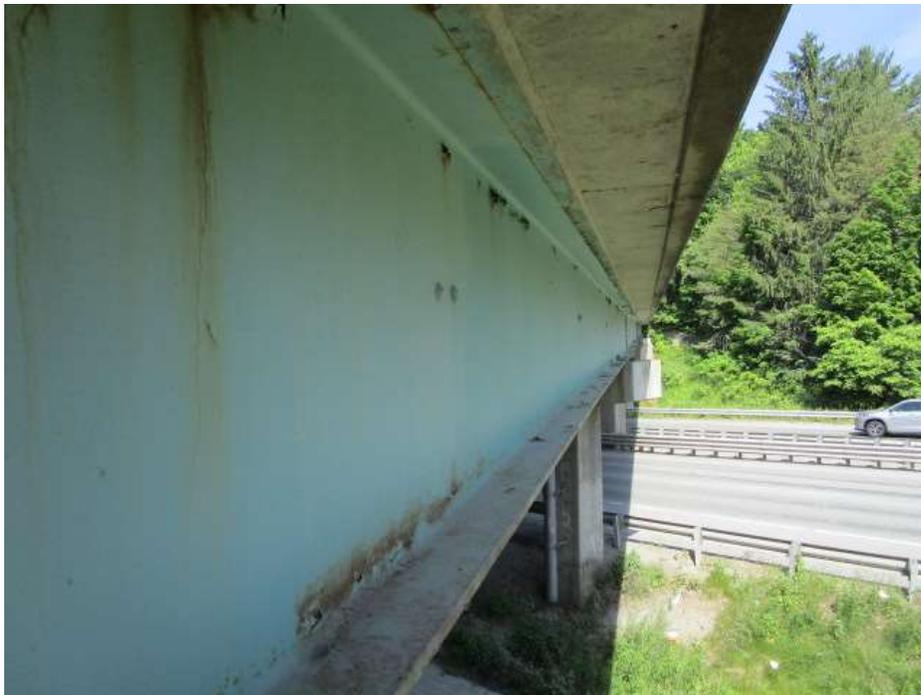
PHOTO 16

Overall satisfactory condition with 30% paint system distress and minor rusting of flanges & lower web areas. Bearings at the abutments have been fluid filmed but not the beam ends.

Description paint system failures north girder

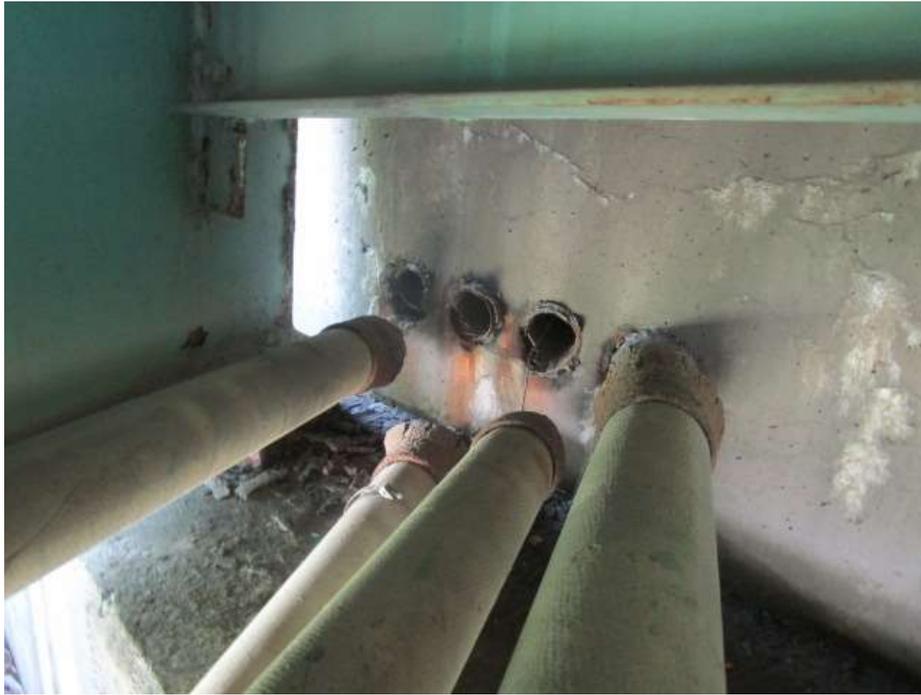
PHOTO 19

Description Rotted out utility conduit east abutment

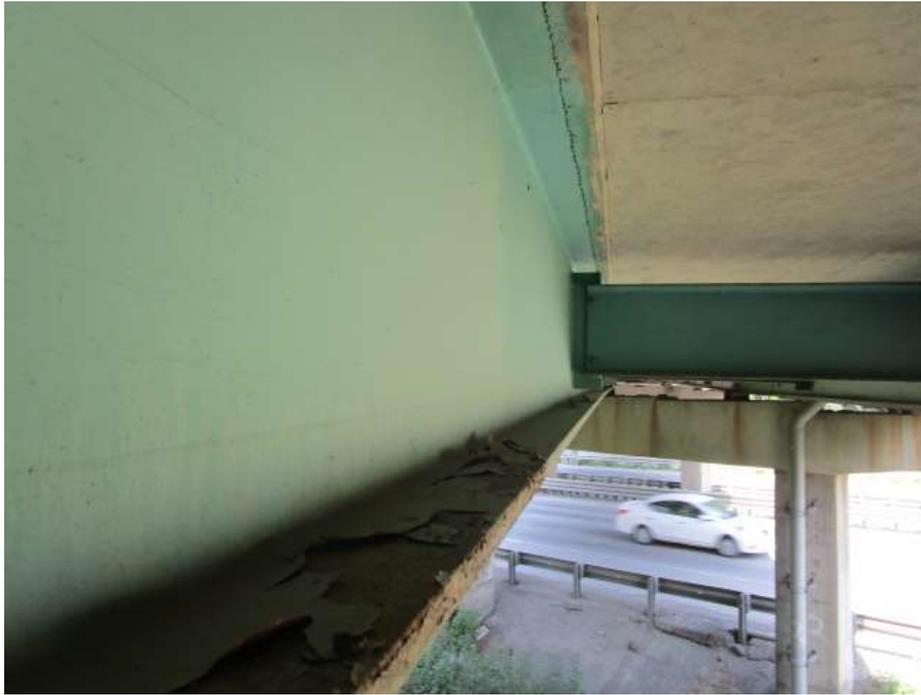
PHOTO 21

Description typical of paint distress

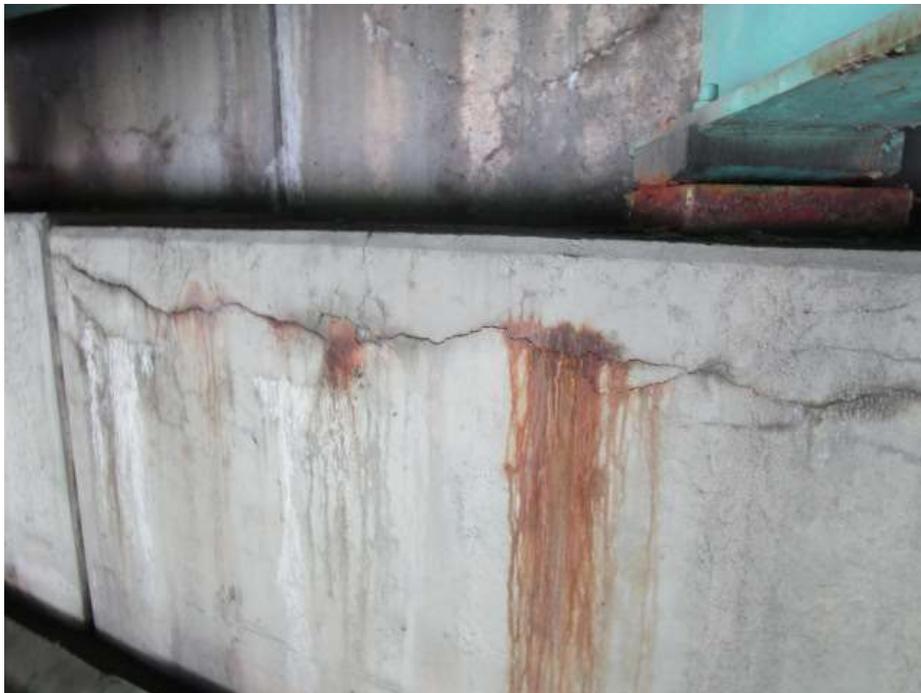
PHOTO 22

Abutments have scattered moderate cracking, staining, and delamination adjacent to bearing areas. bridge seats. Piers have been rehabbed.

Description east abutment bridge seat delaminating at bearing area

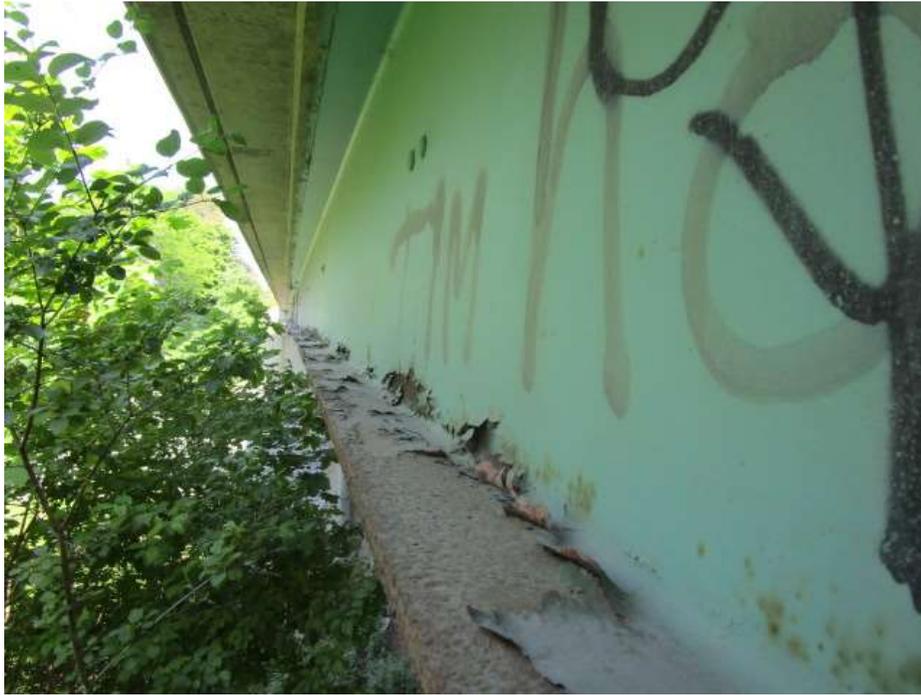
PHOTO 23

Description heavy paint system distress south girder

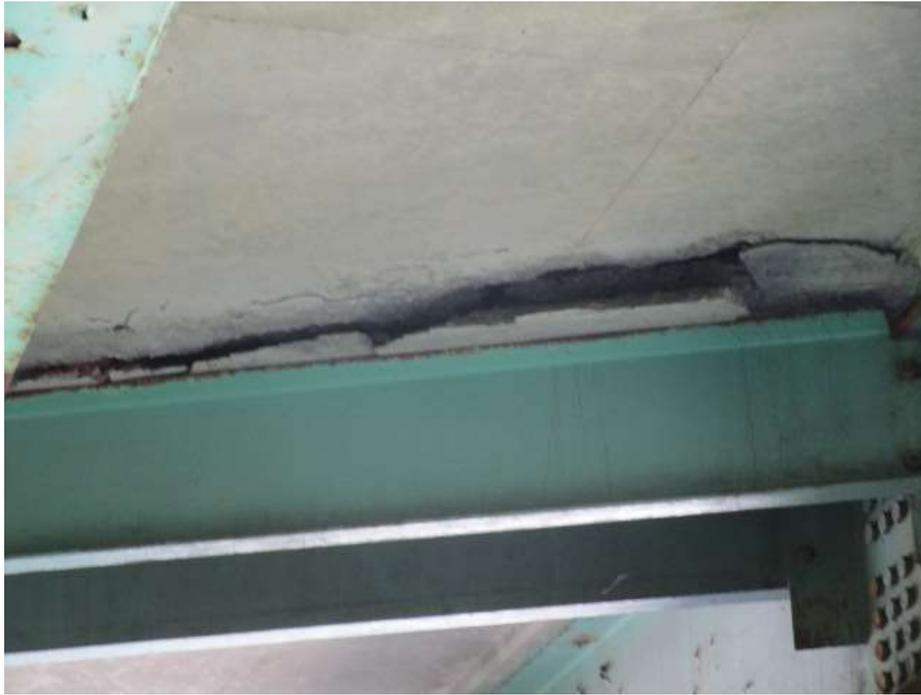
PHOTO 25

Description Large deck delam over east pier cap

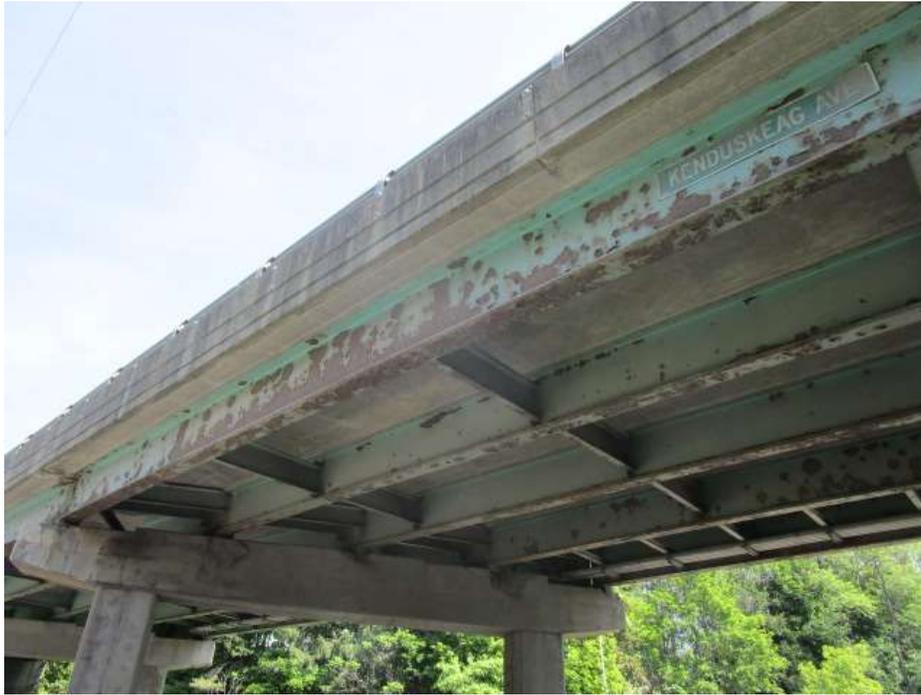
PHOTO 29

Description Heavy paint distress I-95 NB span

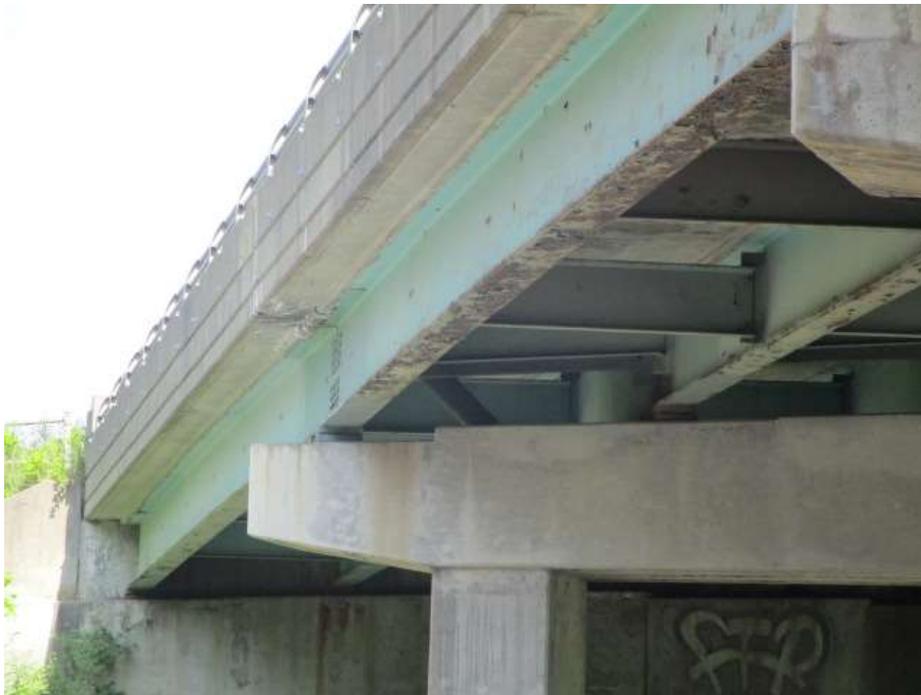
PHOTO 30

Description paint system distress

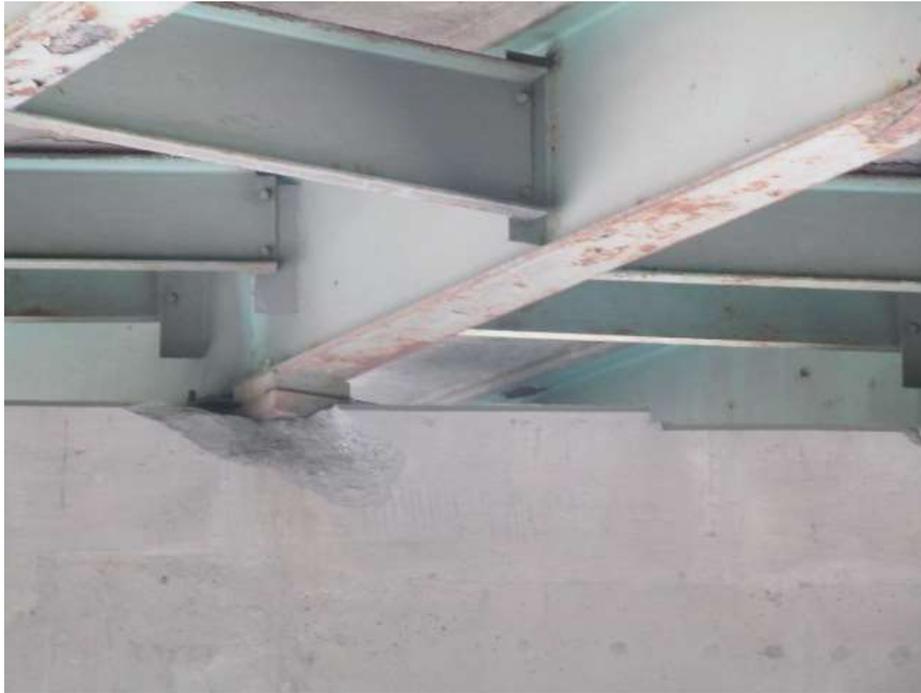
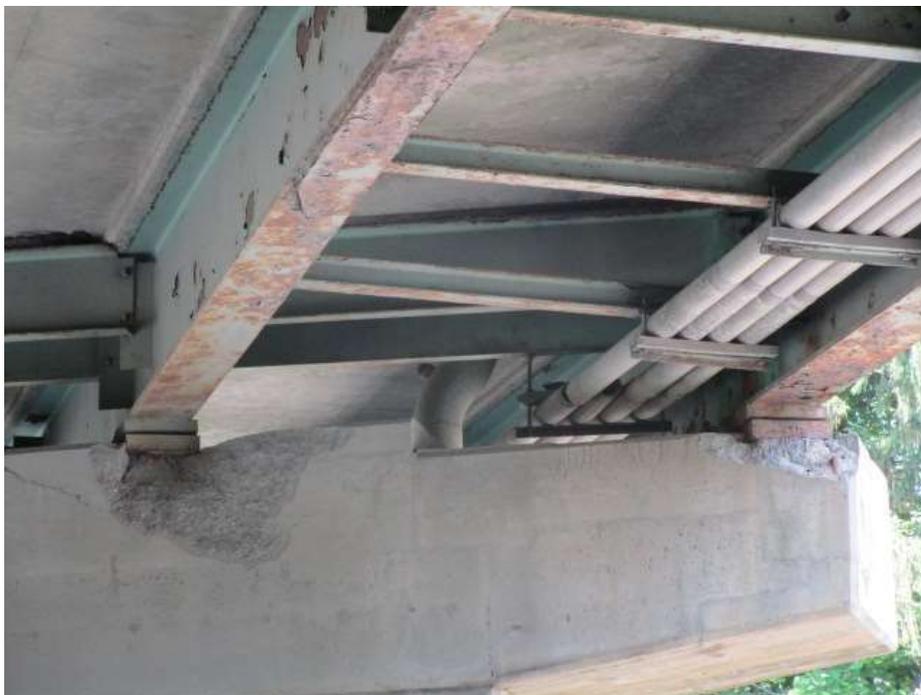
Description Center pier bridge seat spalling at bearing area

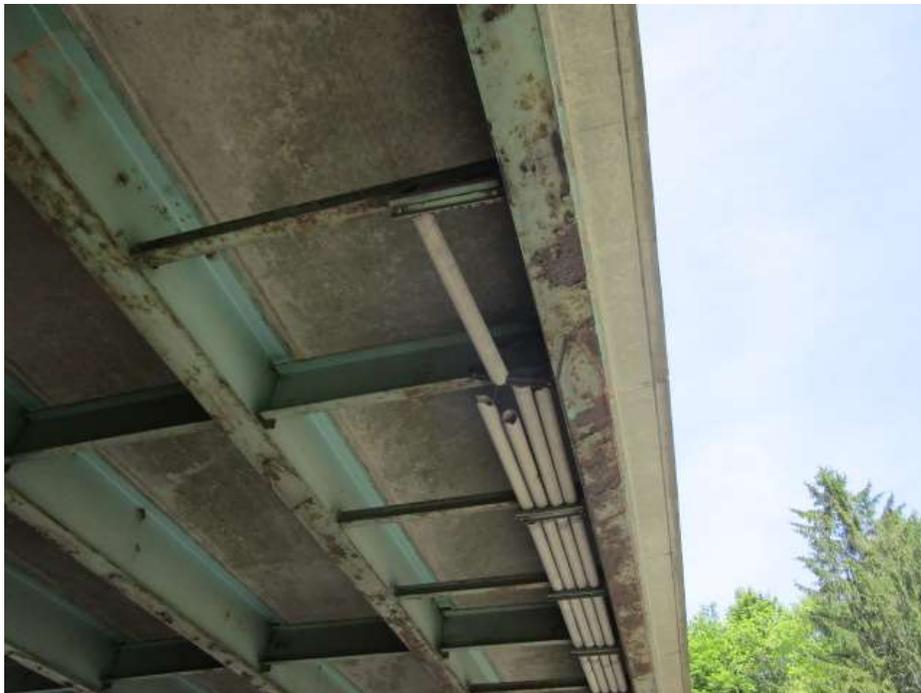
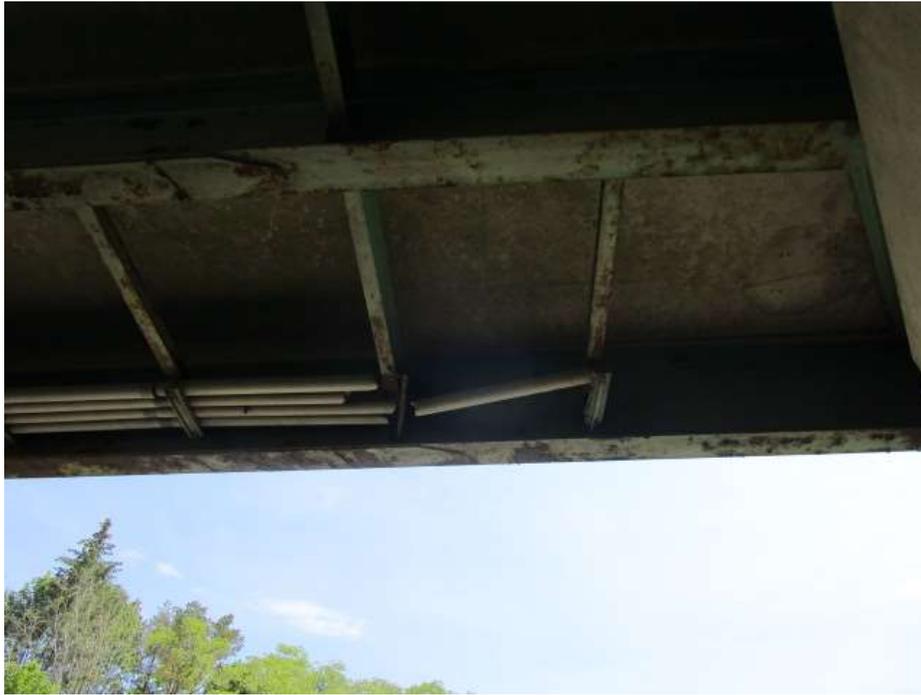
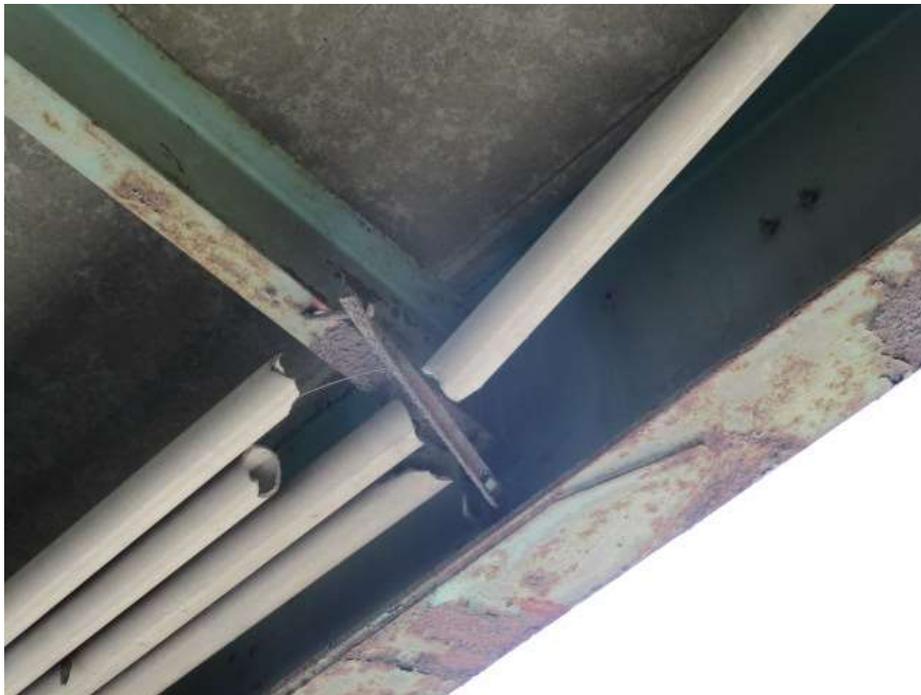
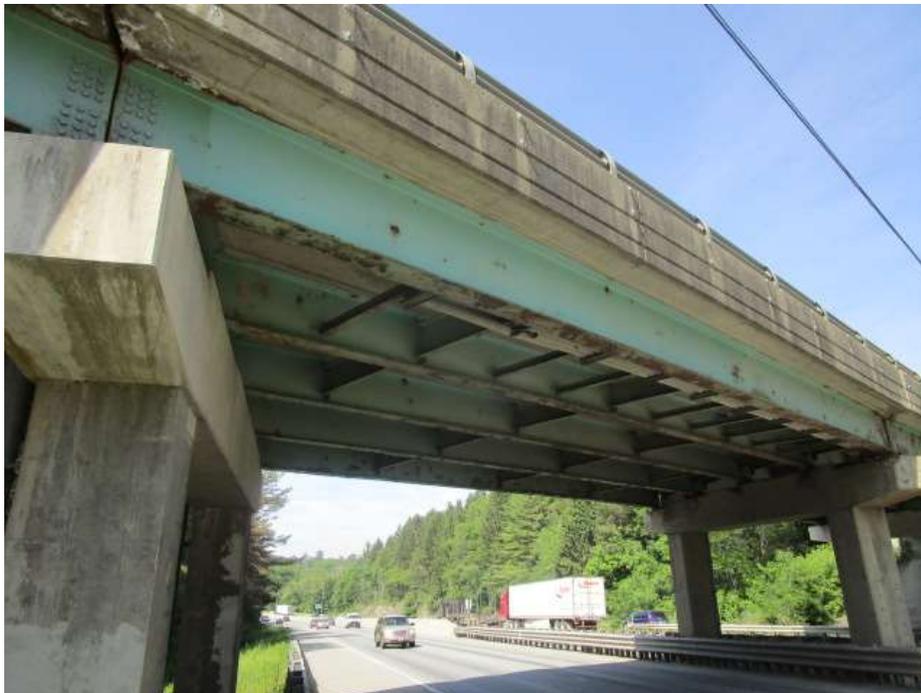
Broken & hanging fiberglass utility conduit adjacent to I-95 NB travel/ shoulder area. Another section of conduit has separated over the SB travel lanes.
Slope protection has minor slumping near the tops. Heavy slope erosion in front of the NW pier. Approach guardrail has end damage.

Description Loose fiberglass utility conduit adjacent to NB travel lanes/ shoulder area

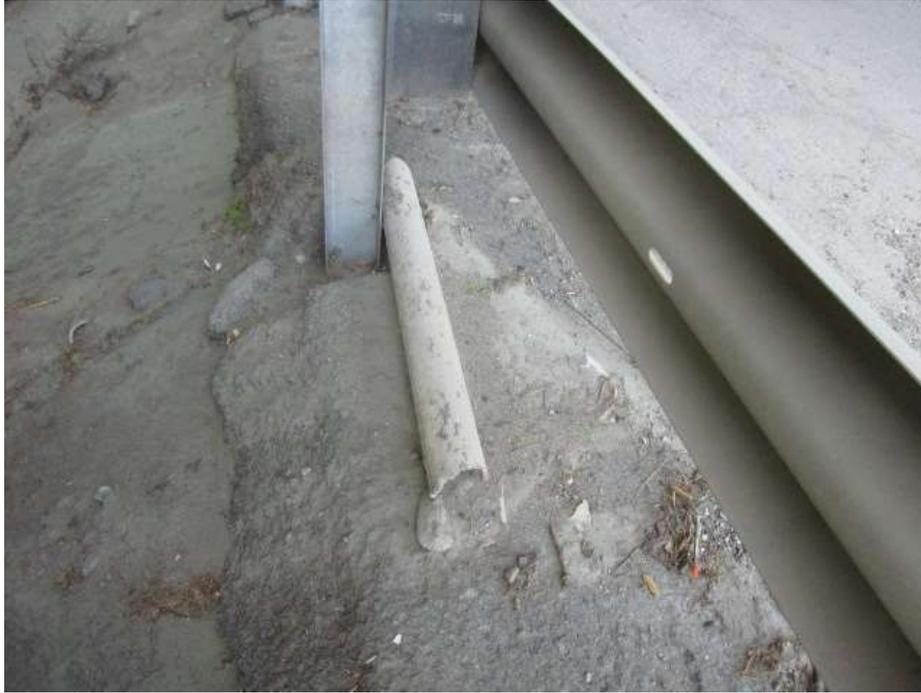
PHOTO 37

Description Fallen fiberglass utility conduit adjacent to NB travel lanes/ shoulder area

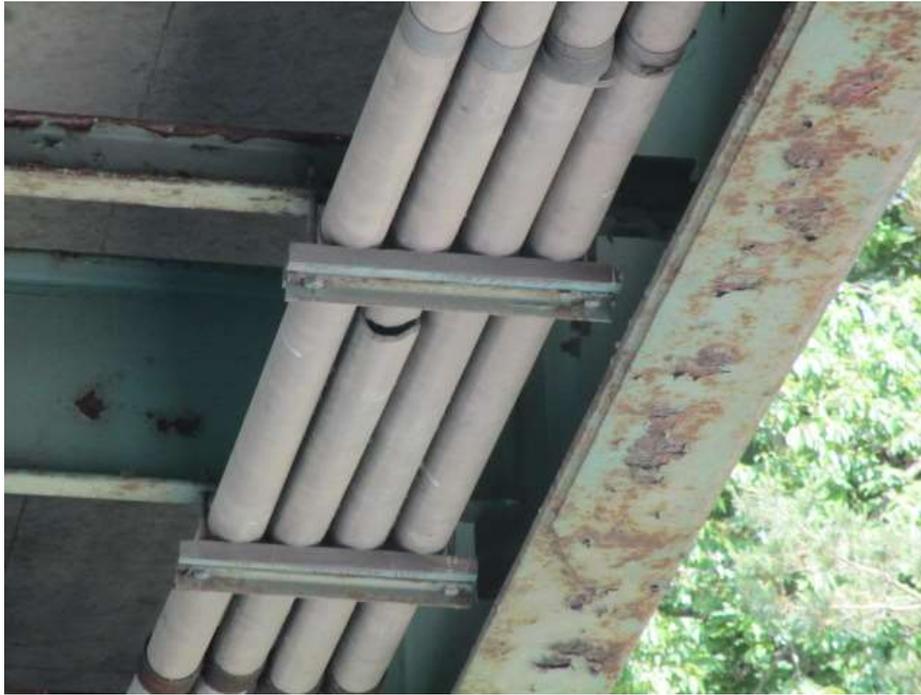
PHOTO 39

Description split fiberglass utility conduit adjacent to SB travel lanes

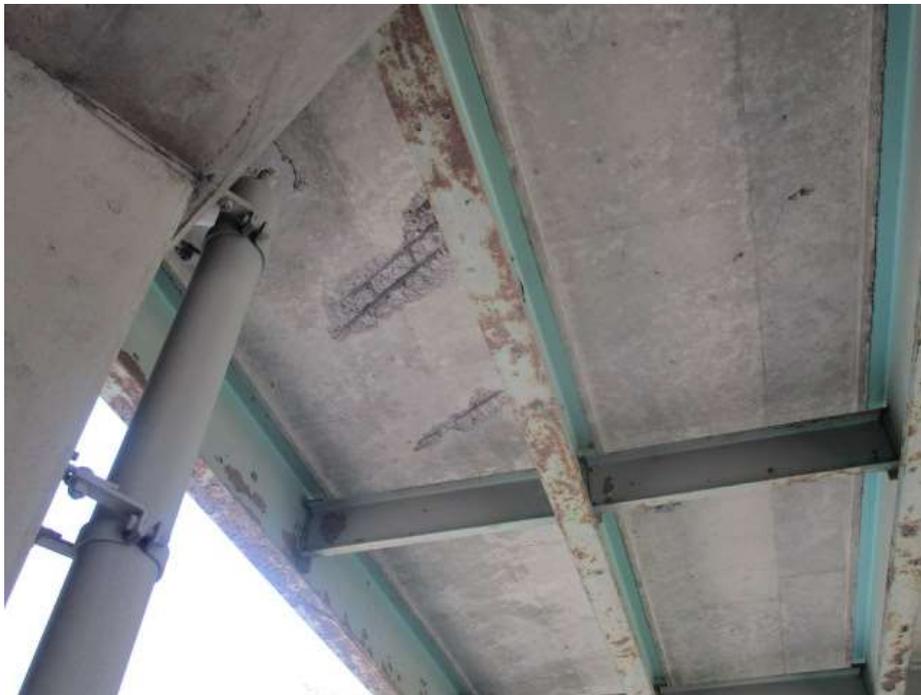
PHOTO 42

Description chipped out delams I-95 SB span

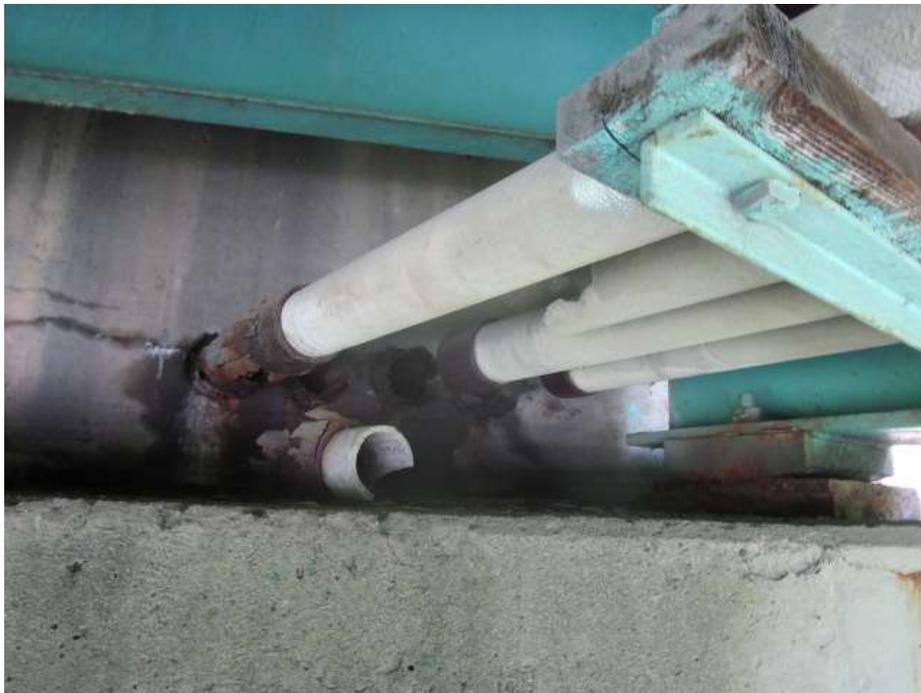
PHOTO 50

Description Deteriorated utility conduit at west abutment

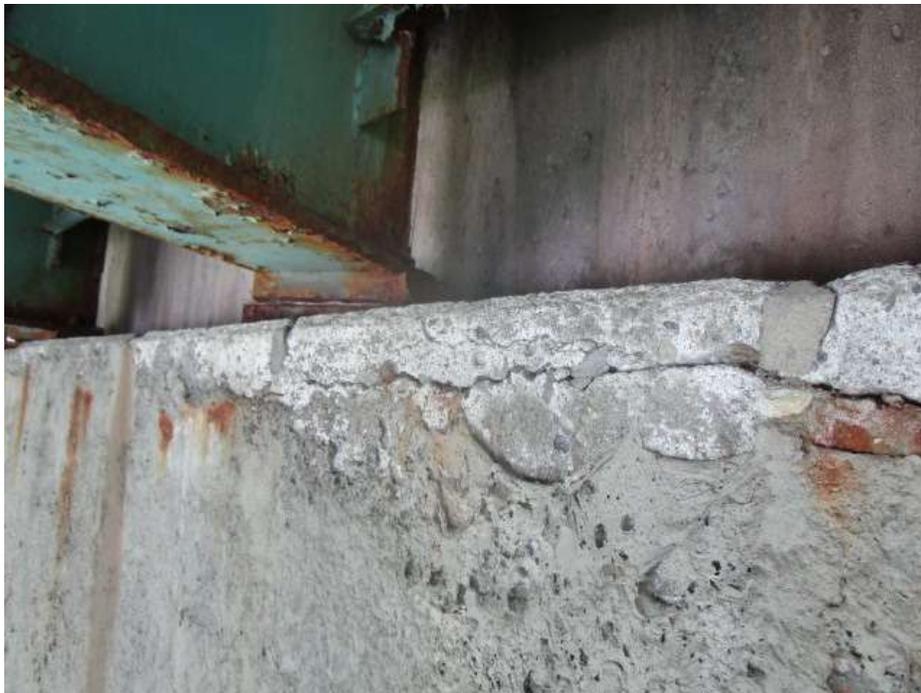
PHOTO 52

Description delaminated west abutment bridge seat

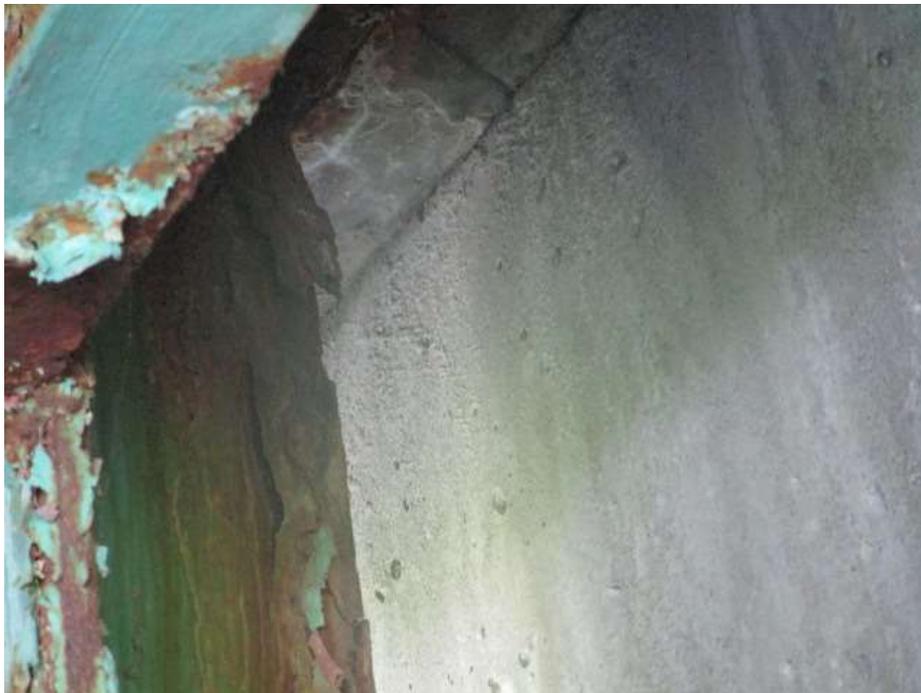
PHOTO 54

Description rusting west abutment beam end

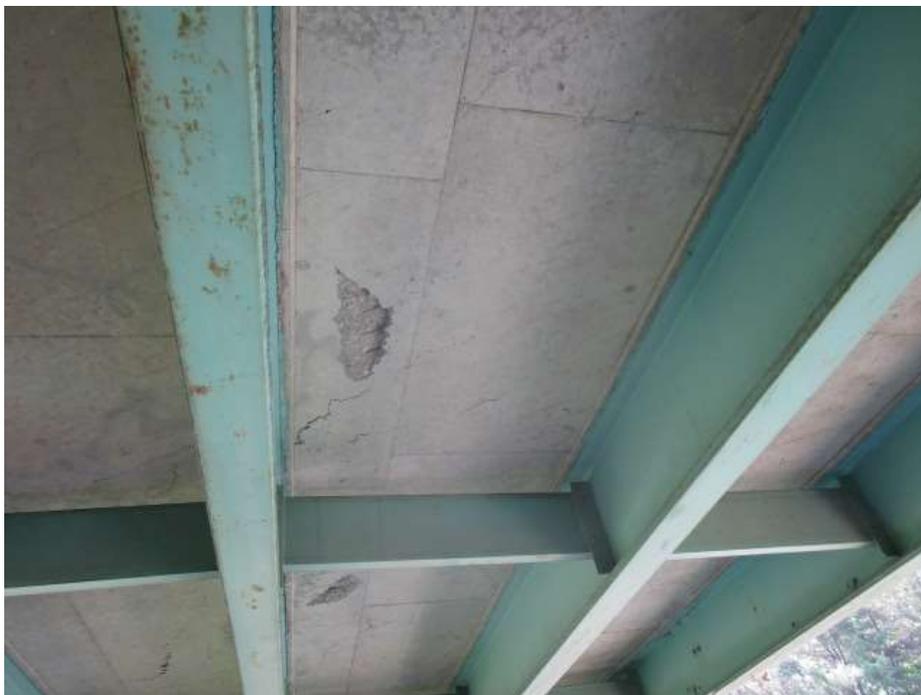
PHOTO 56

Description spall spall west span bottom of deck
