Inspector: Harris, Scott
Inspection Date: 12/14/2022

Structure Number: 5798
Facility Carried: KENDUSKEAG AVENUE

Highway Bridge Inspection Report

Bridge Name: KENDUSKEAG AVENUE / I95

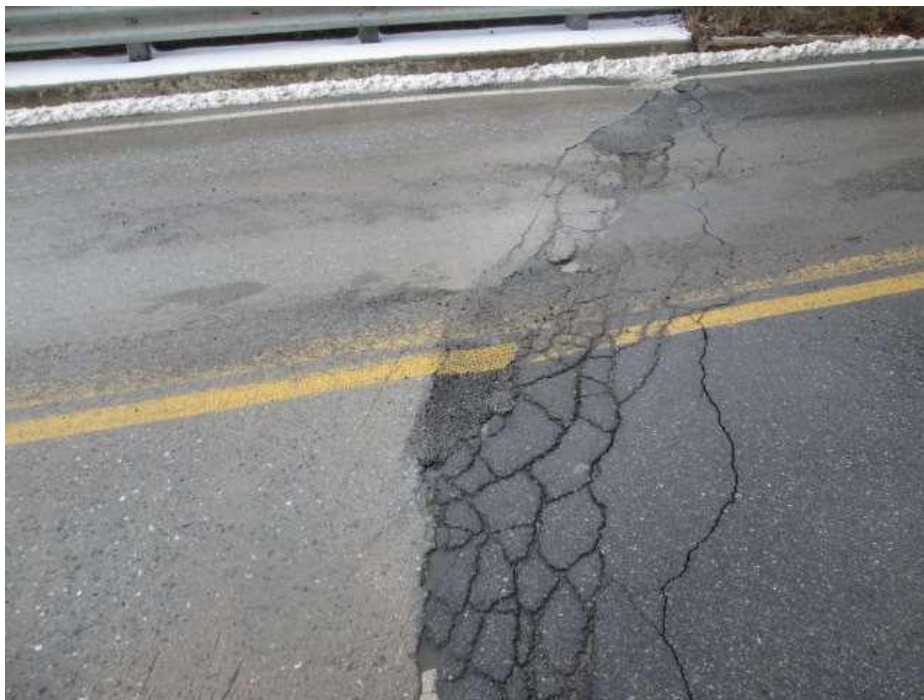
PHOTO 2

Did not chain this inspection due to freezing conditions. previous report indicated: Chained entire concrete wearing surface and found approximately 10% minor/ isolated moderate cracking with small areas of delamination. Concrete at ends have been partially patched/ crumbled. Bituminous in this area is poor.

Description west end crumbling wearing surface

Type	Work Item	Priority	Notes
Capital	Other		Apply Silane
Maintenance	Repair Wearing Surface		repair wearing surface near ends
Capital	Rehab Substructure		Center pier cap at bearing areas
Maintenance	Repair Deck		Repair curbs
Maintenance	Repair Erosion		Repair slope erosion.
Preservation	Remove Debris		Clean drains.
Preservation	Coat Beam Ends		
Capital	Paint		
Capital			Rehab abutments

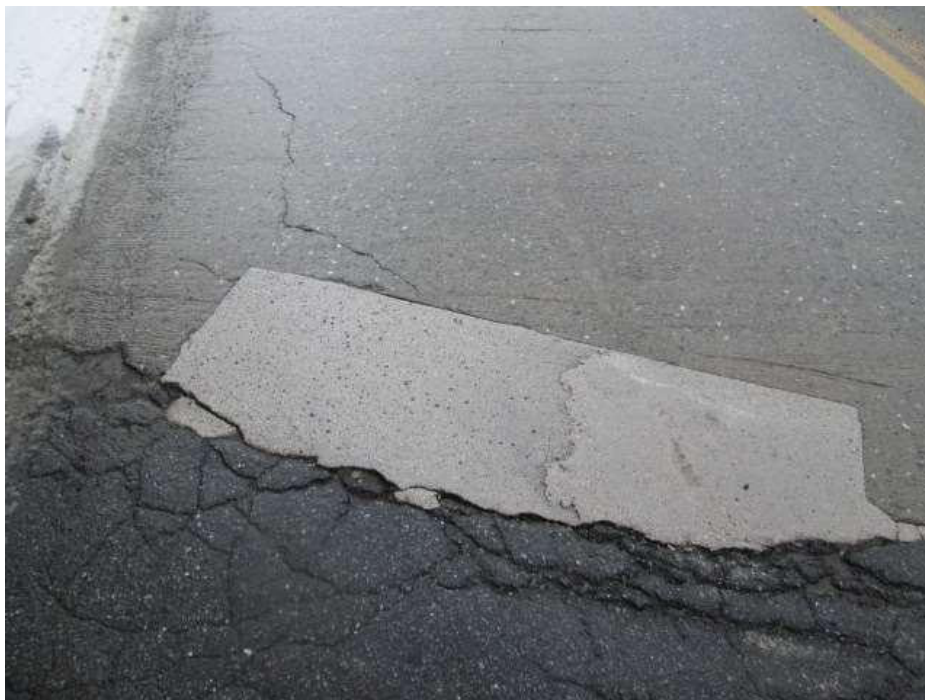
PHOTO 3

Description west end wearing surface pothole

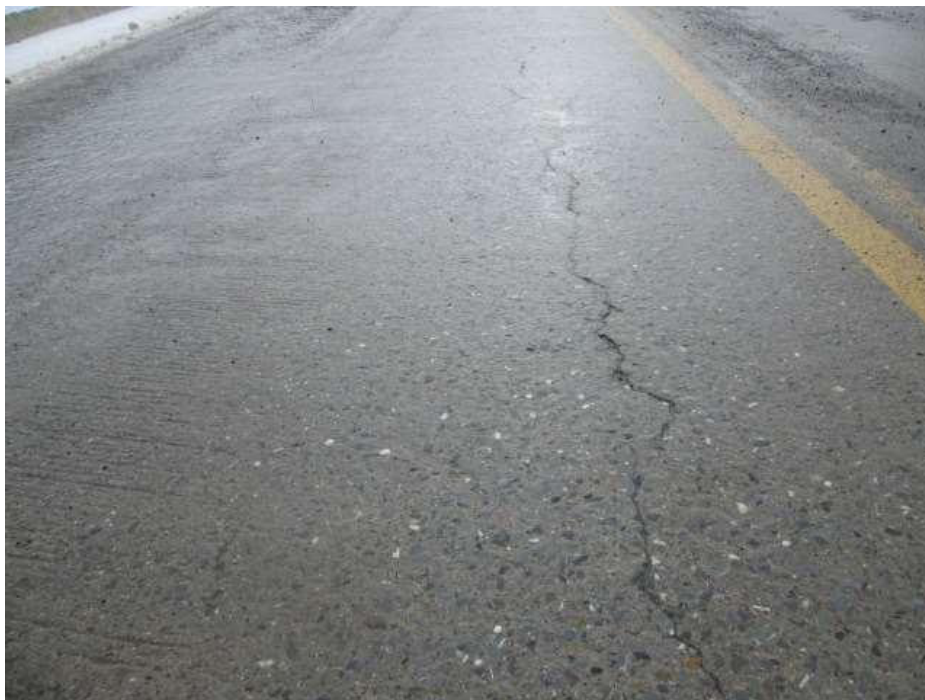
PHOTO 6

Description longitudinal cracking concrete wearing surface

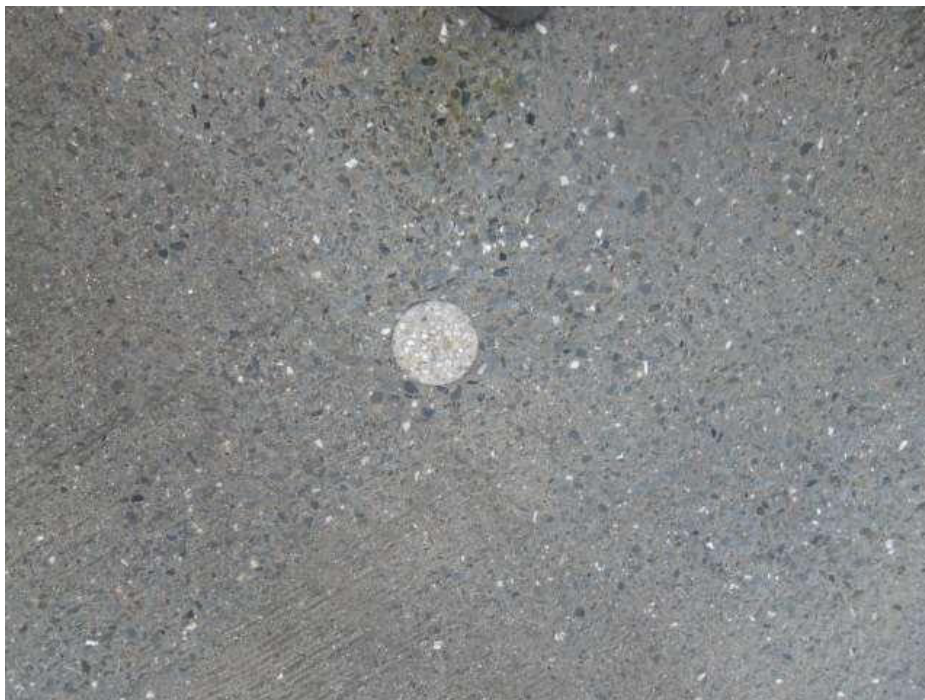
PHOTO 8

Description core hole patch

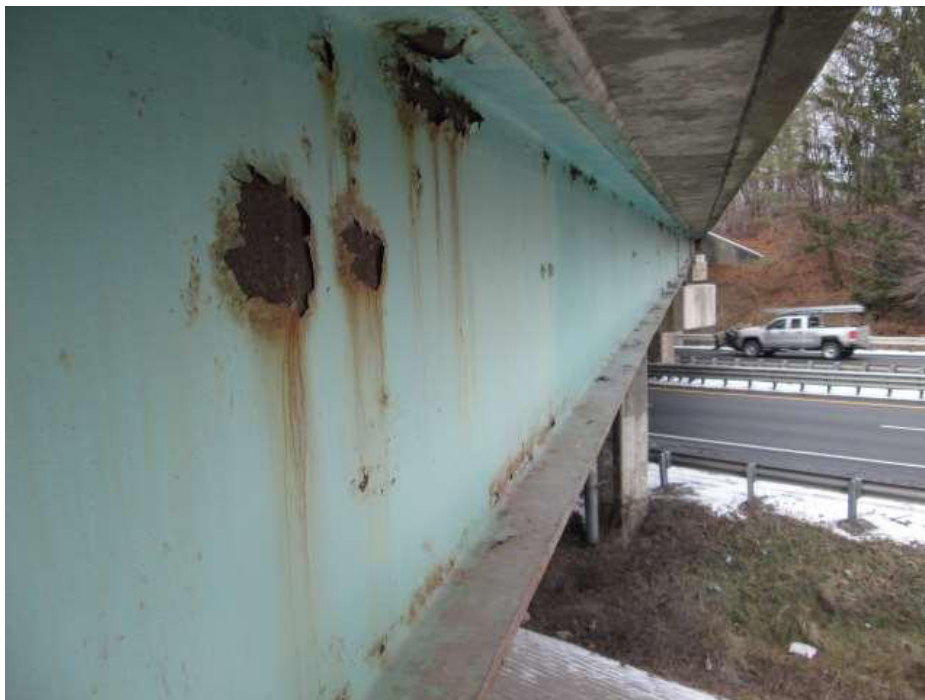
PHOTO 15

Overall fair condition with 60% paint system distress and minor/ isolated moderate rusting of flanges & lower web areas. Bearings at the abutments have been fluid filmed but not the beam ends.

Description failing paint north exterior girder

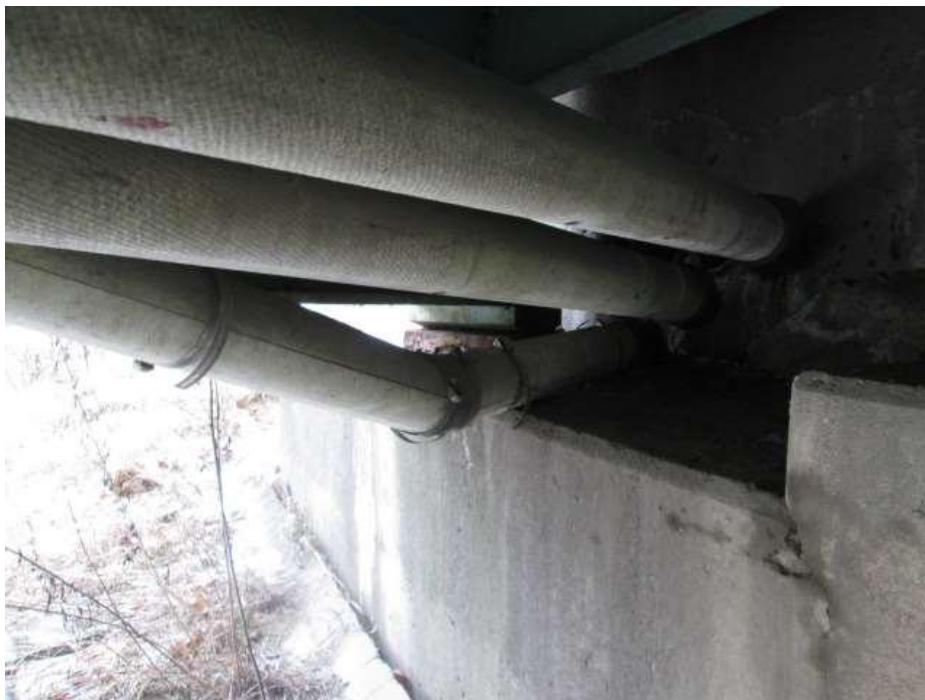
PHOTO 18

Description rusted out utility conduit lines

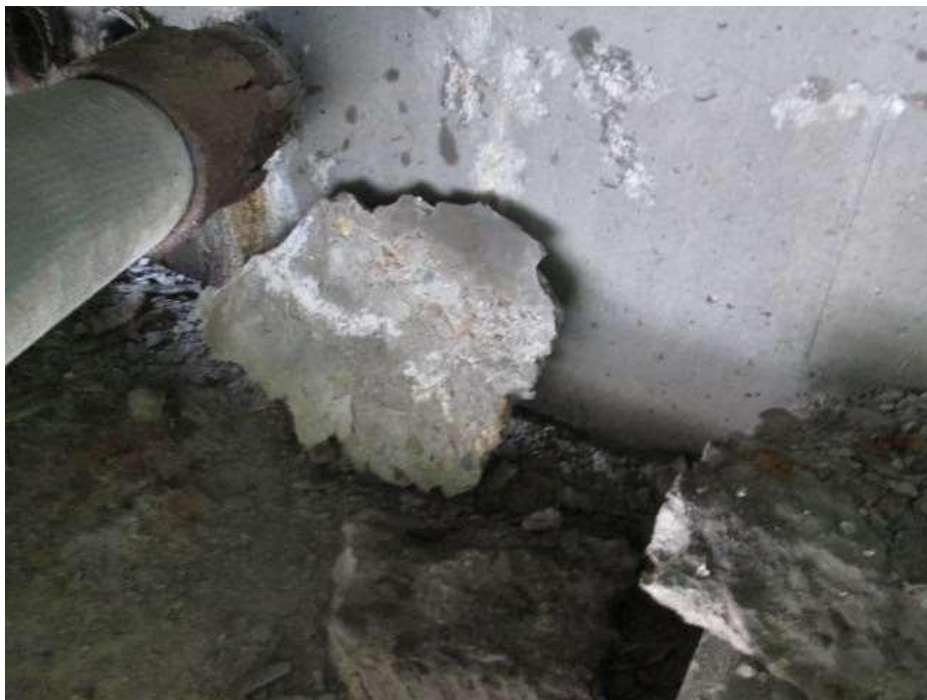
PHOTO 19

Abutments have scattered moderate cracking, staining, and delamination adjacent to bearing areas. bridge seats. Piers have been rehabbed. center pier east face has large spalls at 3 of 5 bearing areas.

Description spalled concrete on east abutment bridge seat

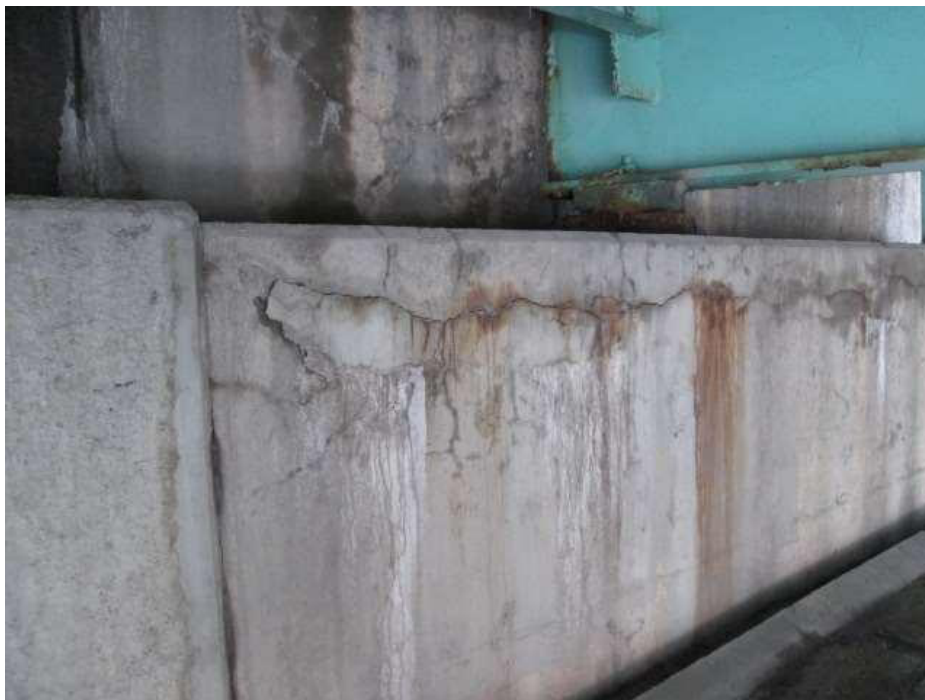
PHOTO 21

Description cracking & delaminated east abutment bridge seat

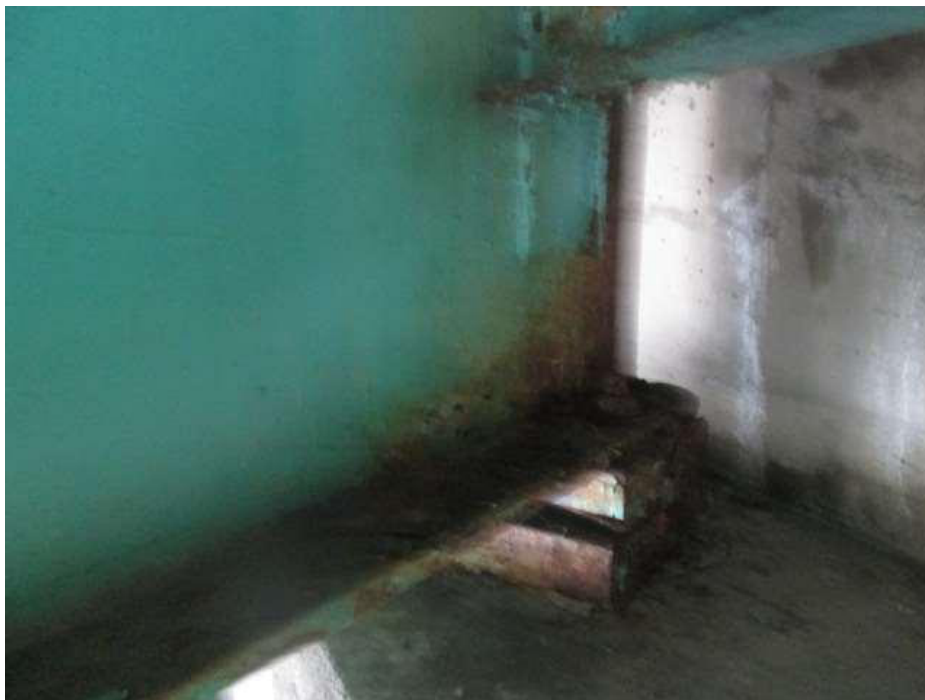
PHOTO 22

Description Typical paint failure & rusting of east abutment interior beam ends

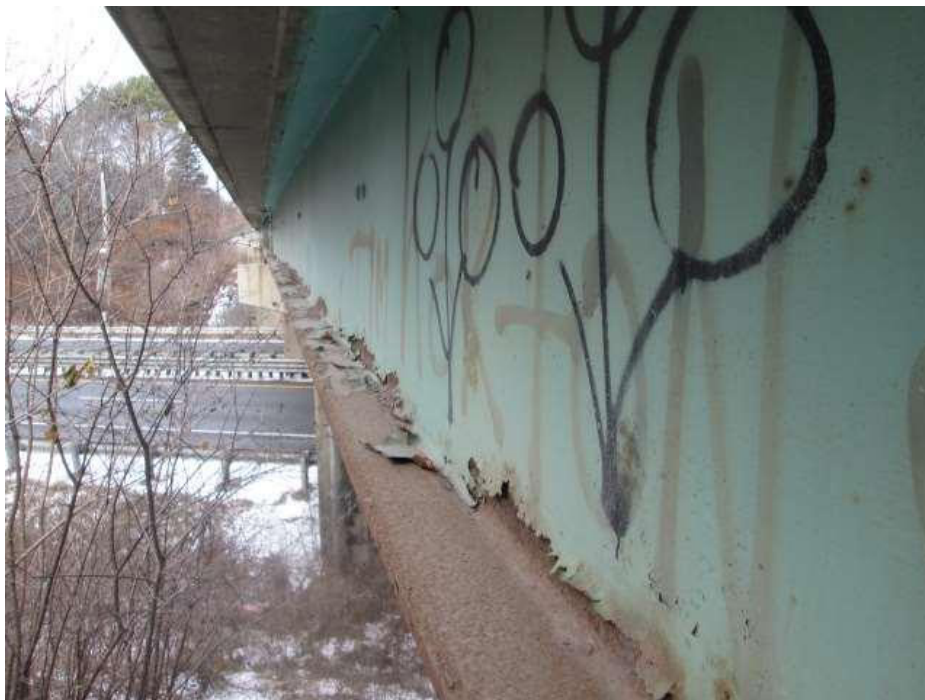
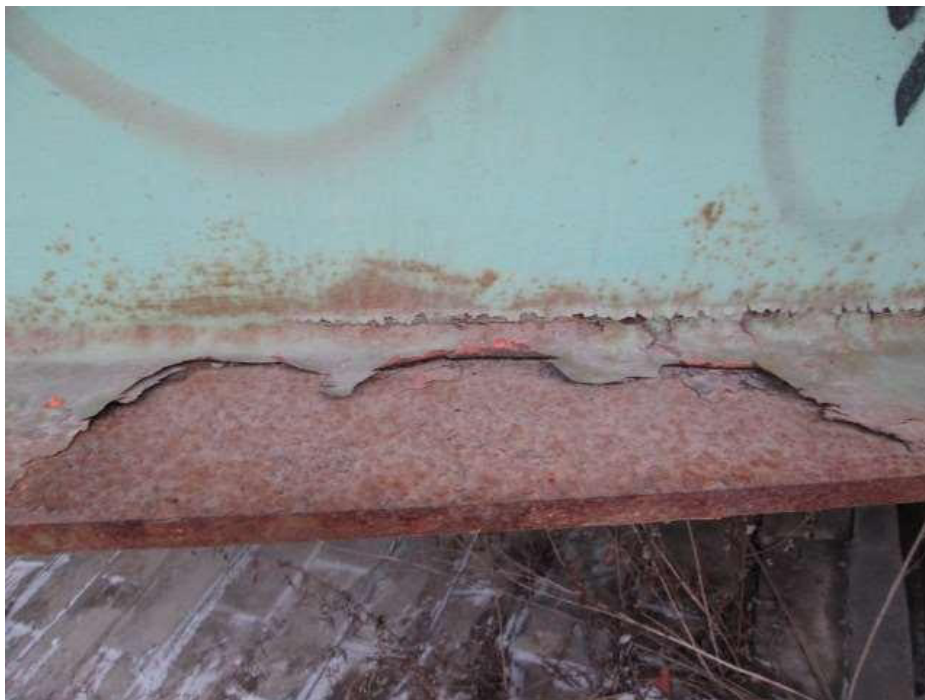
Description Failed paint exterior south girder

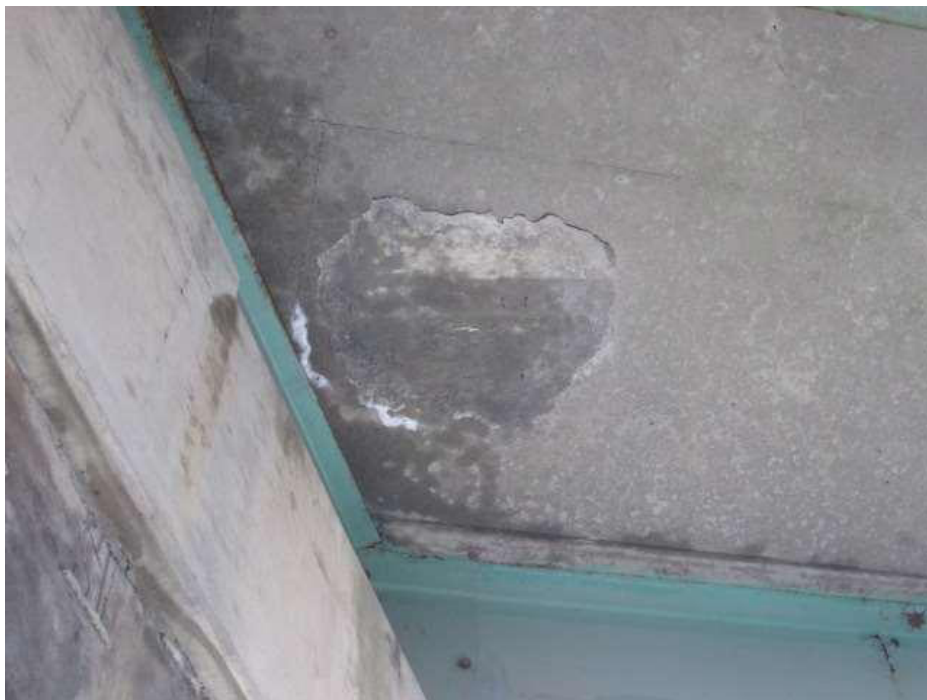
PHOTO 30

Description patched spall bottom of deck I95 NB span

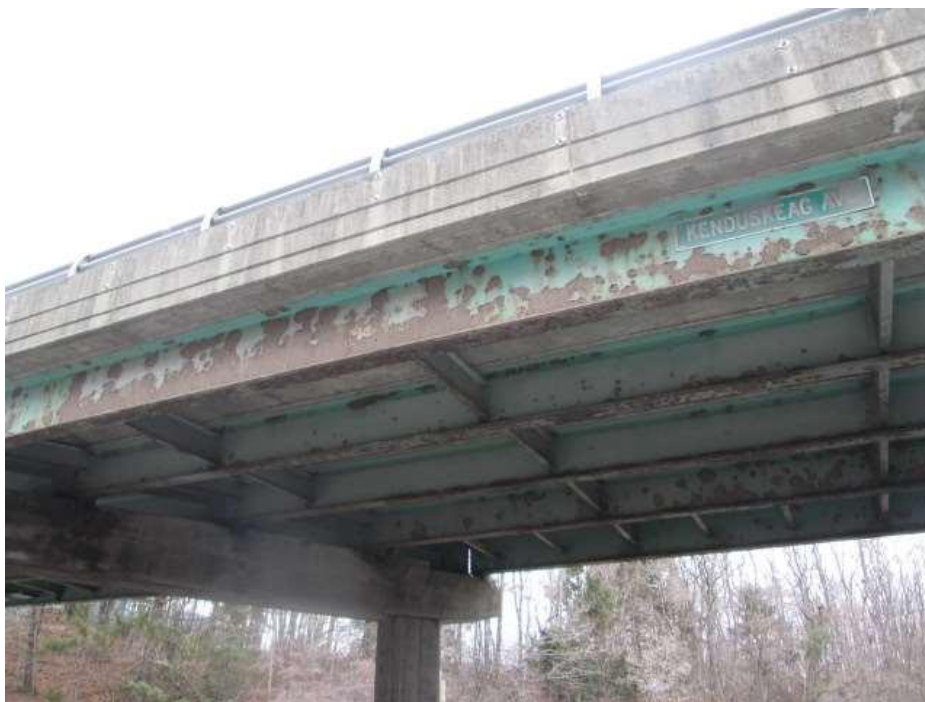
PHOTO 32

Description I95 NB span paint failures

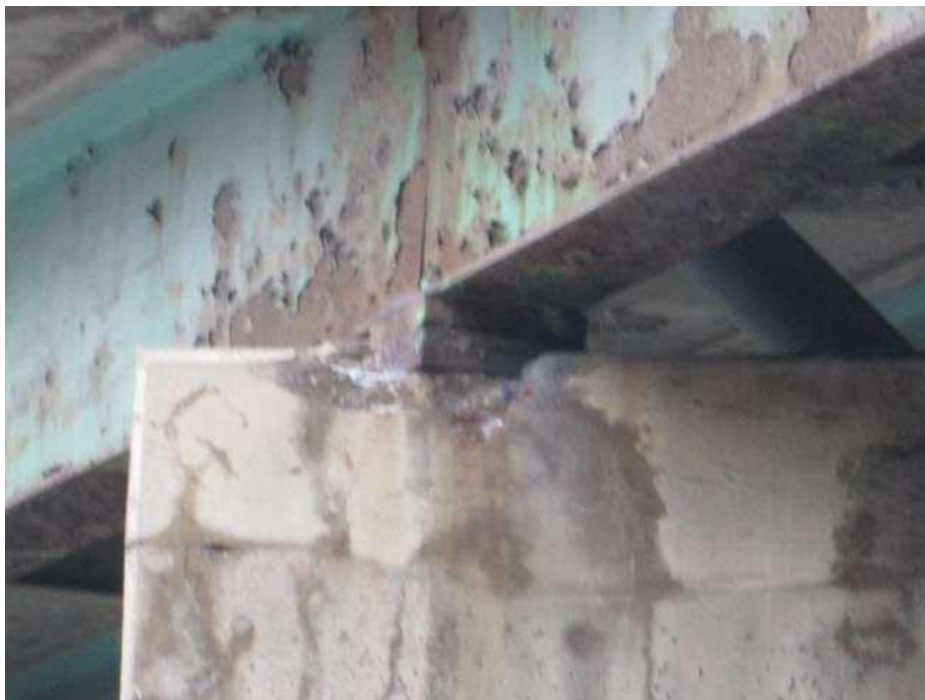
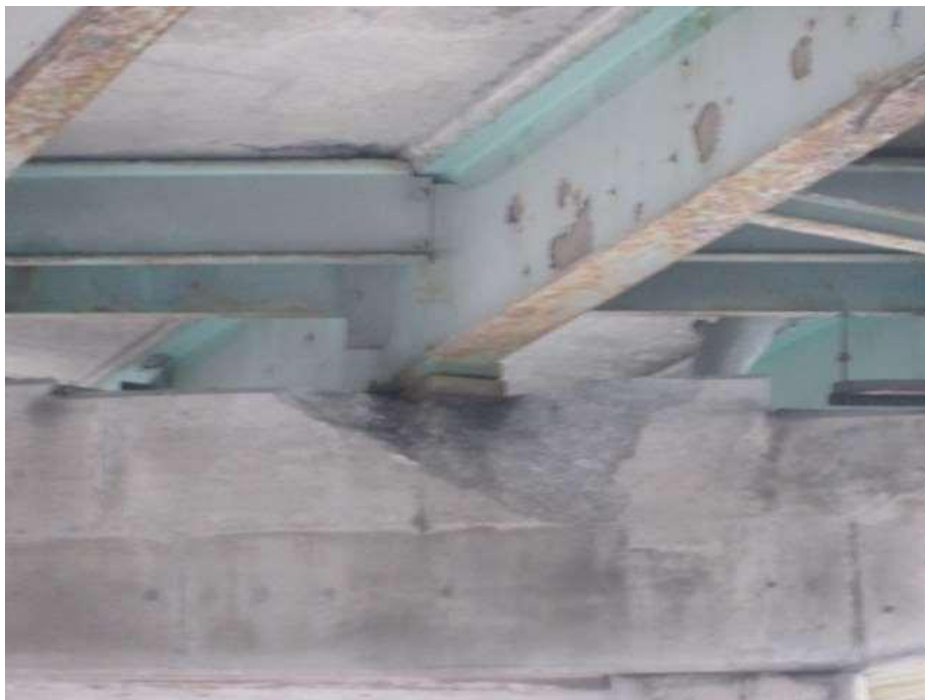
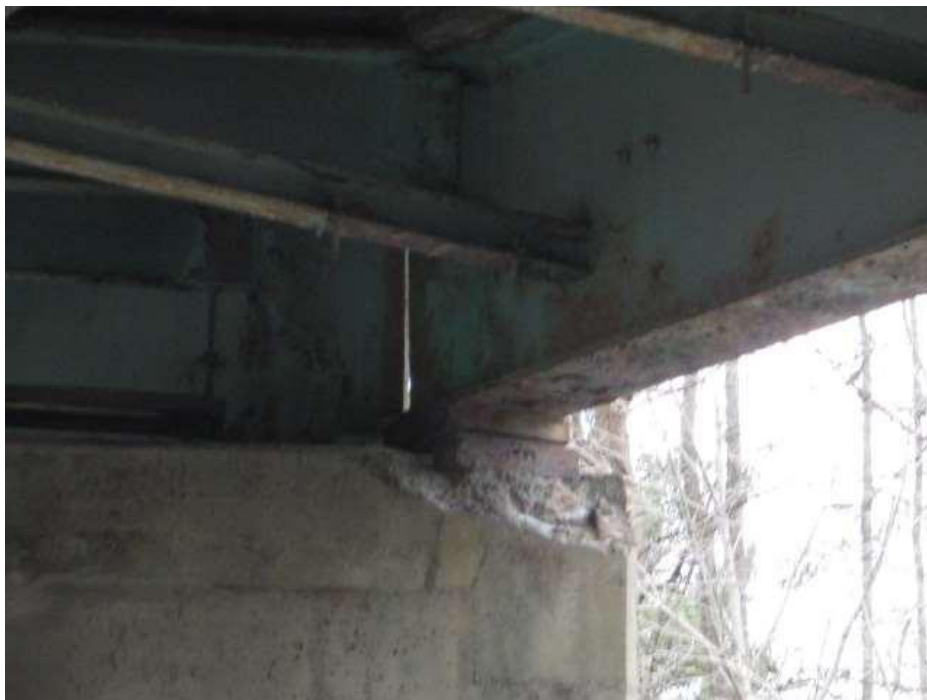
Description center pier east side bridge seat spall at bearing

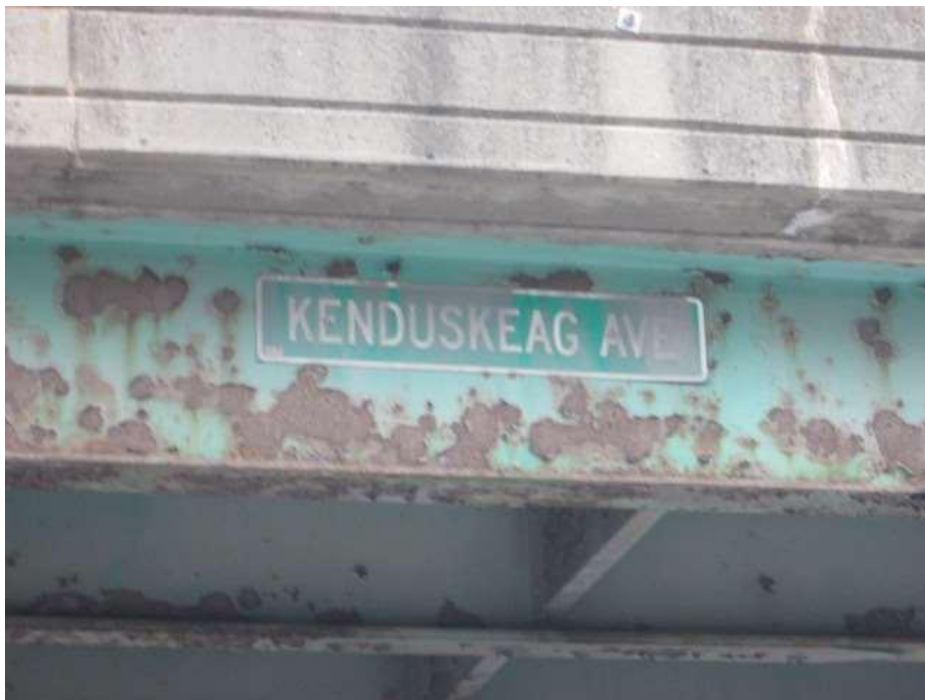
PHOTO 37

Description failing paint exterior south girder

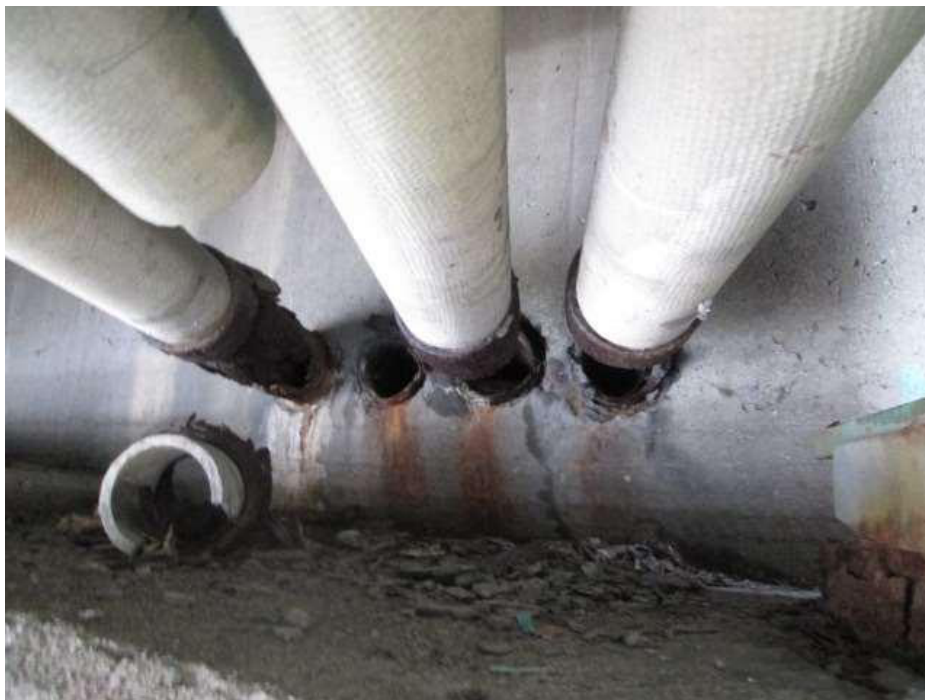
PHOTO 42

Description Rotted out utility conduit west abutment

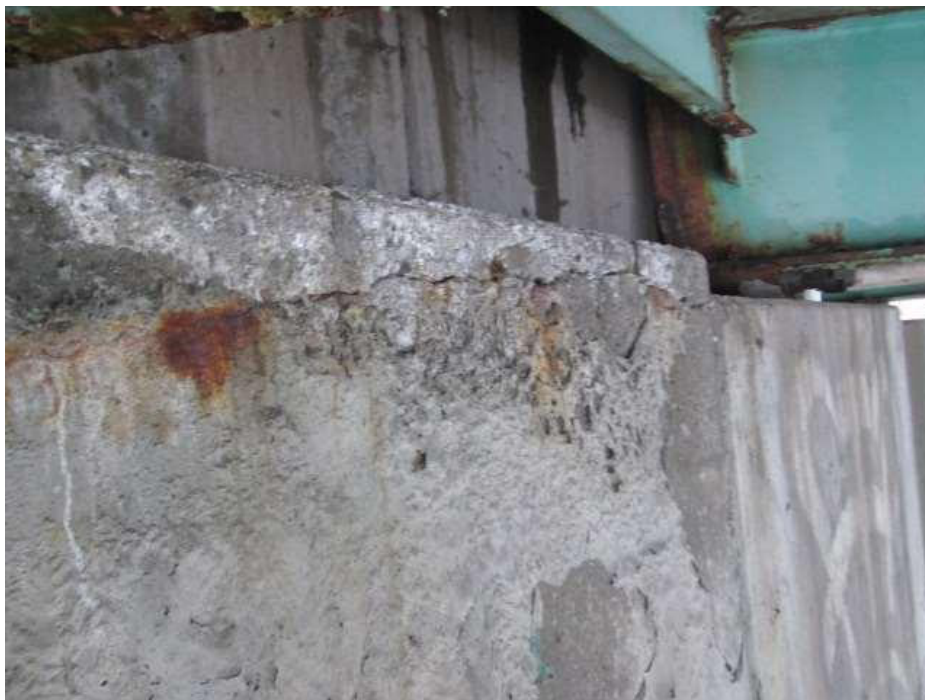
PHOTO 44

Description west abutment delaminated bridge seat area

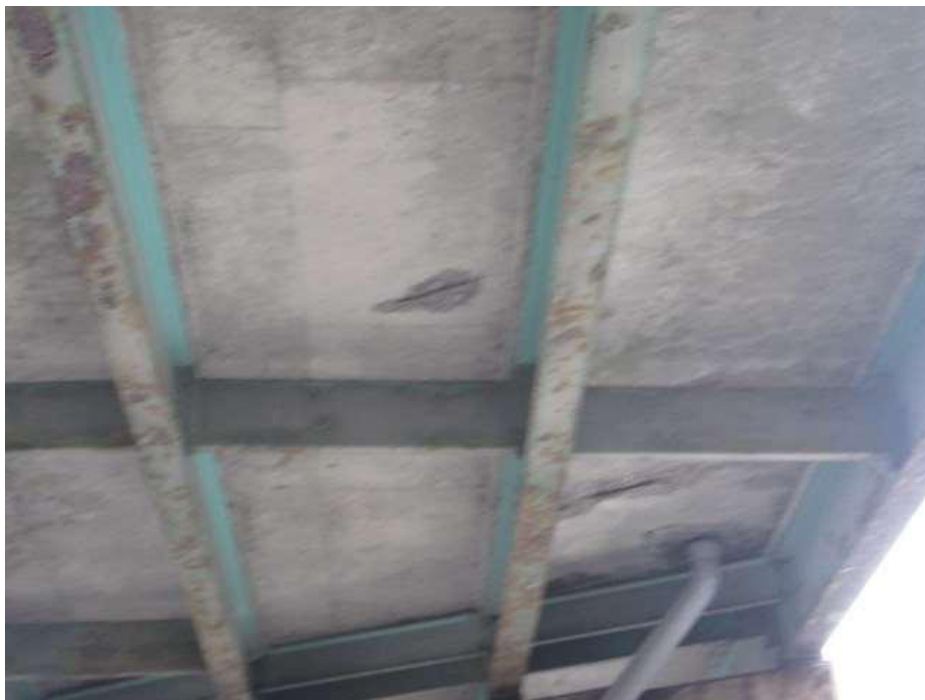
PHOTO 55

Description deck spalls I95 SB span (Not over roadway)

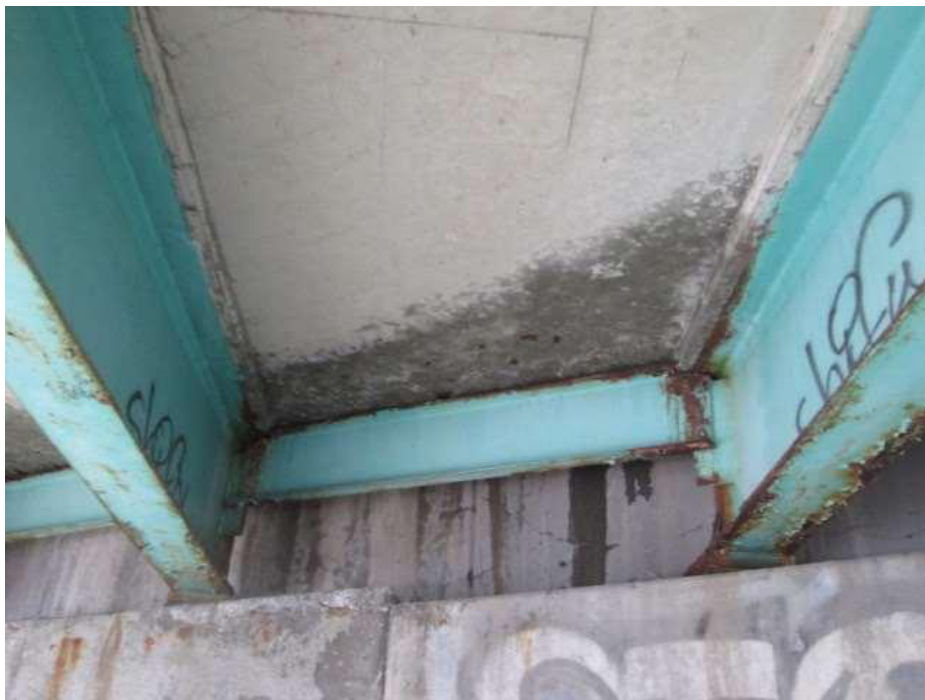
PHOTO 57

Description wet bottom of deck west end
