Highway Bridge Inspection Report

BR# 5800

I-95 NB / STILLWATER AVE

Town:
Bangor

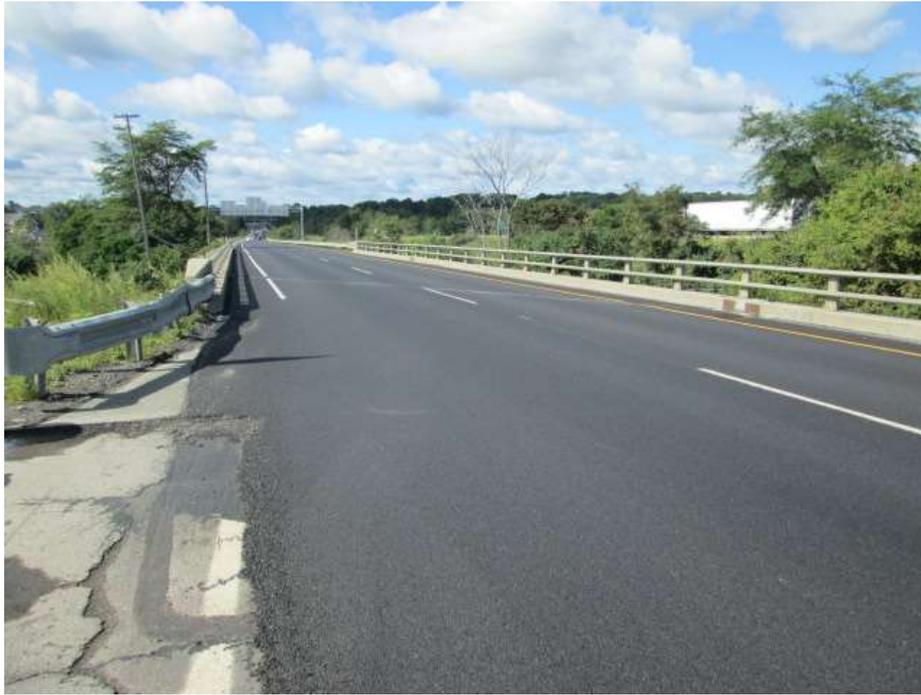
PHOTO 1

Description Roadway condition

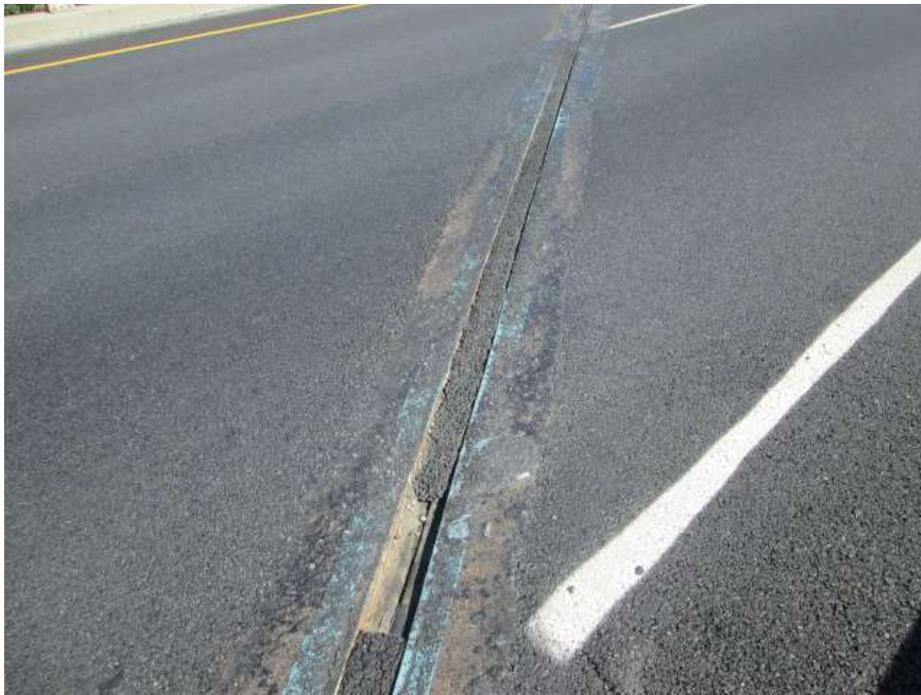
PHOTO 2

Description east joint

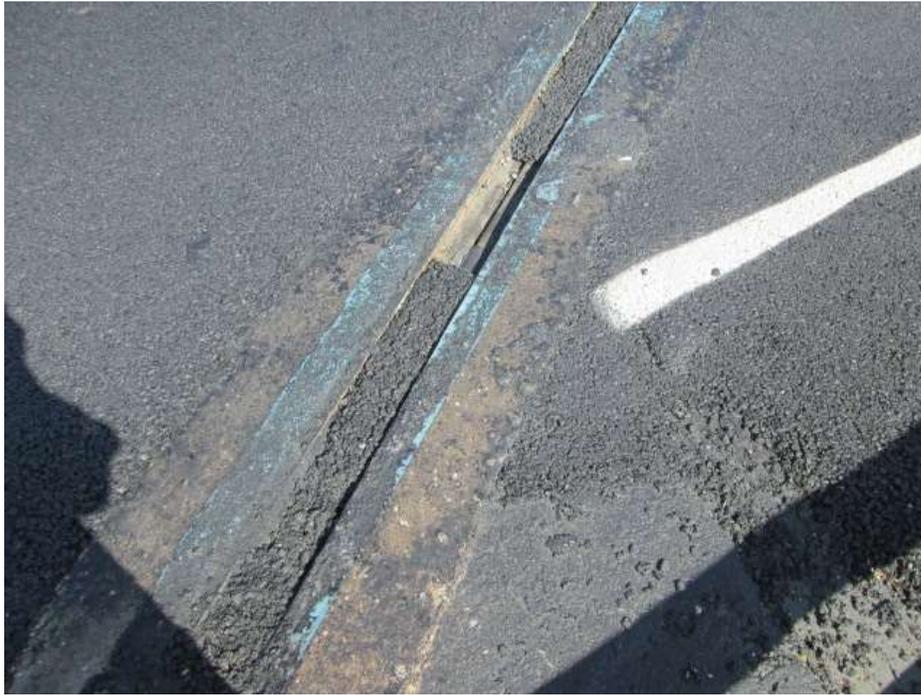
PHOTO 3

Description east joint

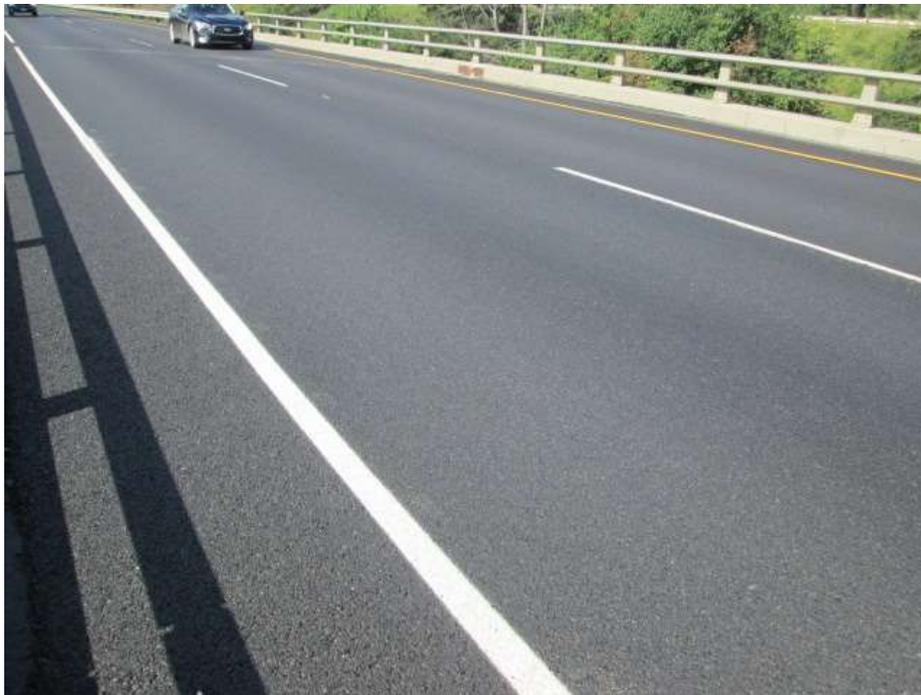
PHOTO 4

New bituminous overlay

Description new wearing surface

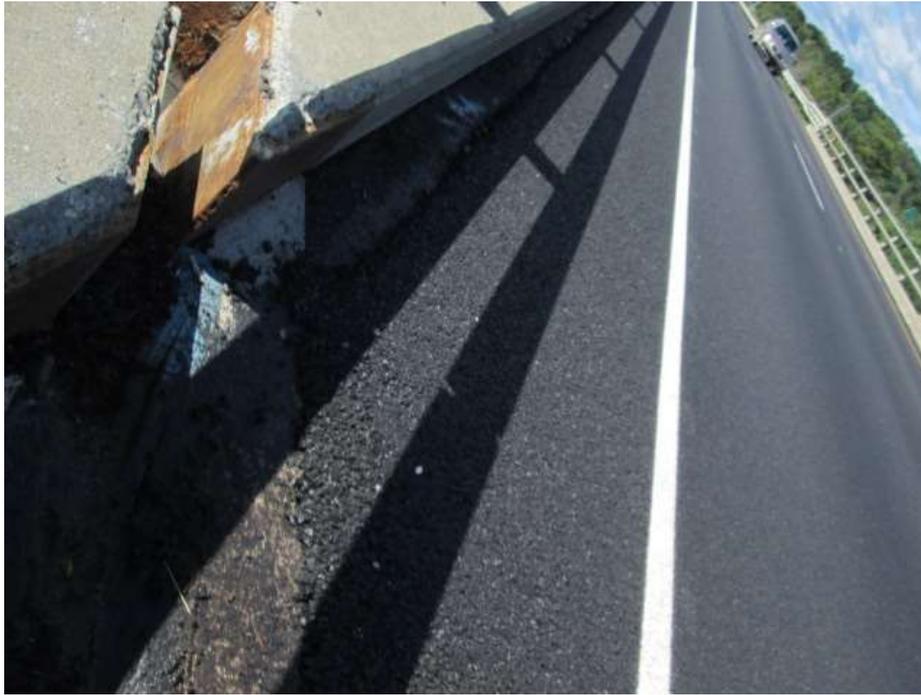
PHOTO 5

Description wearing surface

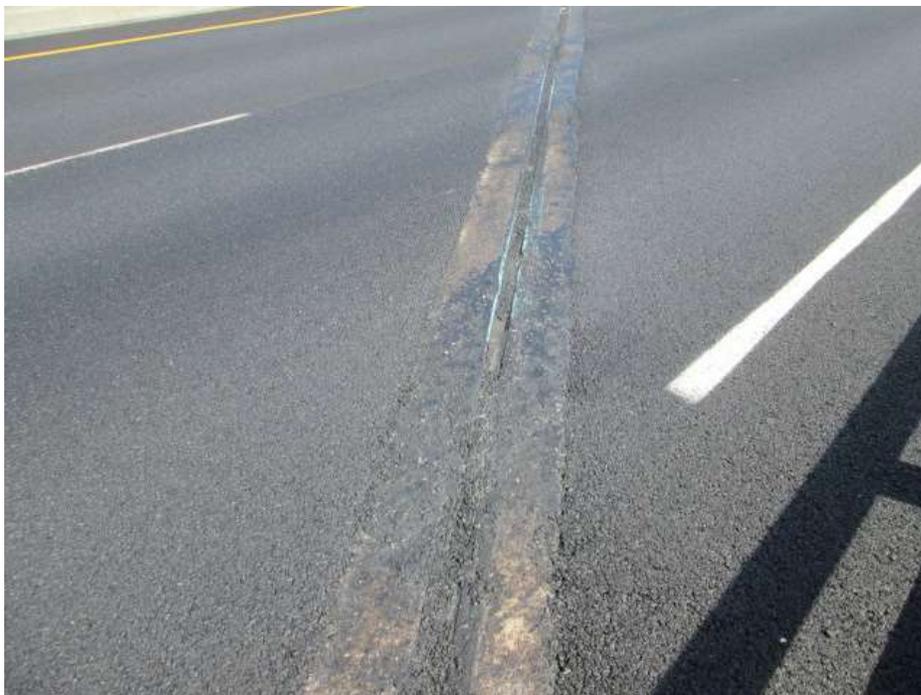
PHOTO 6

Description east pier joint

Type	Work Item	Priority	Notes
Maintenance	Rehab Substructure		Repair abutment and pier heavy spalling.
Preservation	Coat Beam Ends		
Preservation	Seal Joint		
Preservation	Other		Apply Silane
Maintenance	Repair Joint		Repair loose joint armor at east pier, install header
Safety	Repair Bridge Rail

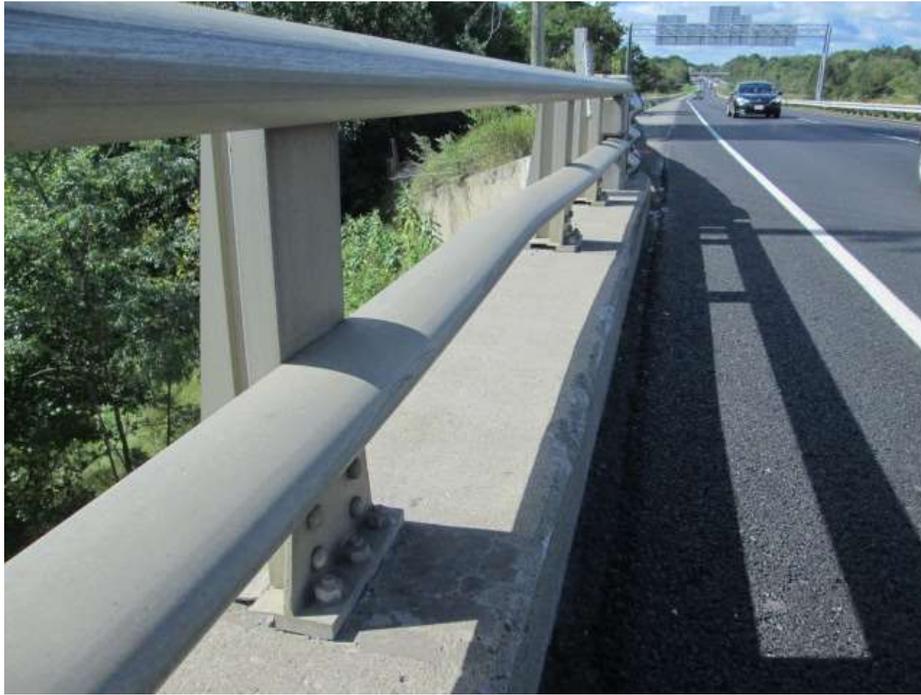
PHOTO 7

Description rail type

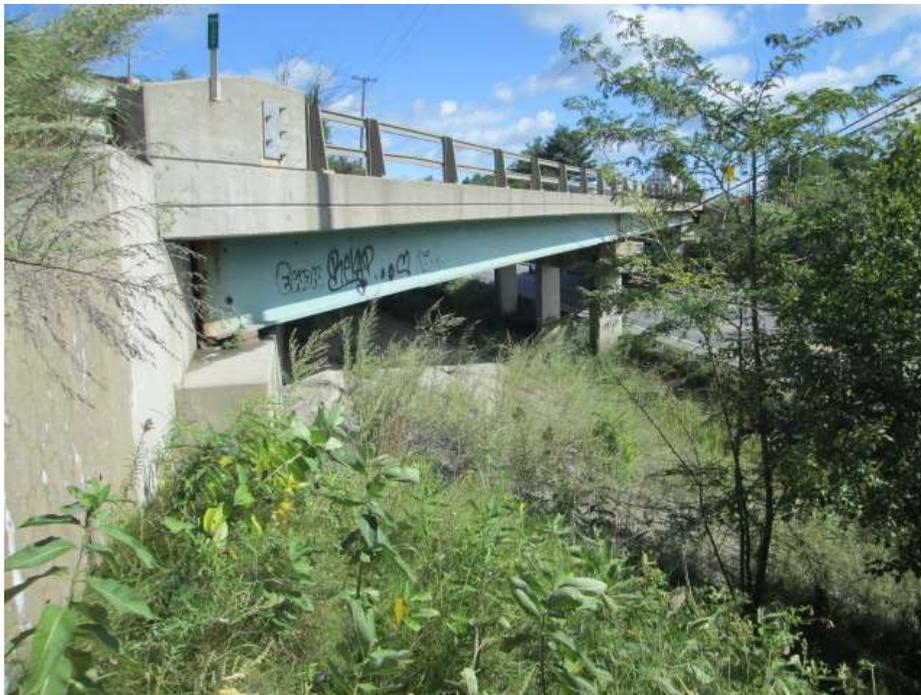
PHOTO 8

Description South side view

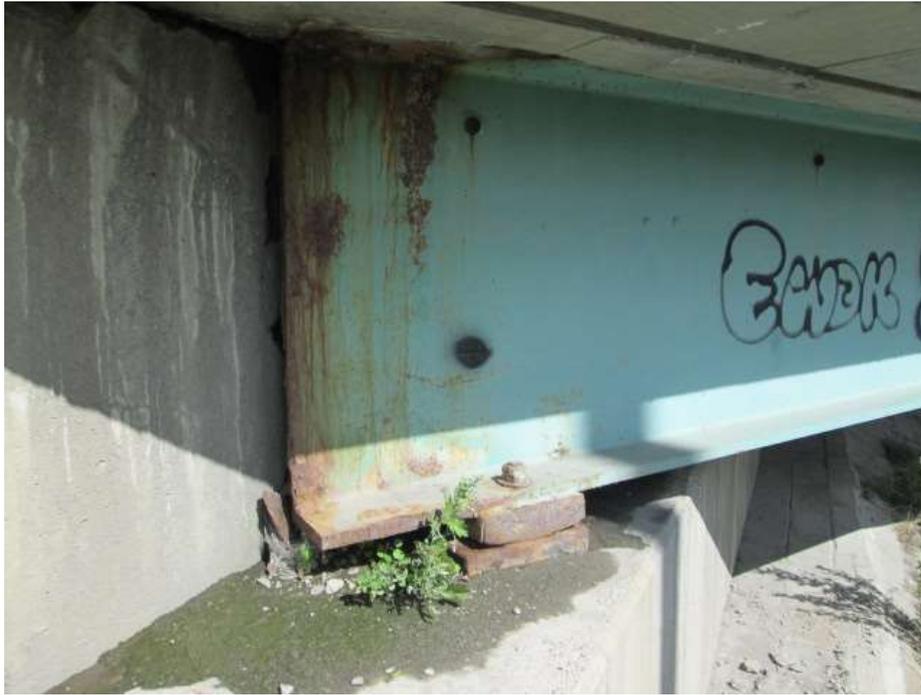
PHOTO 9

Description SW beam end

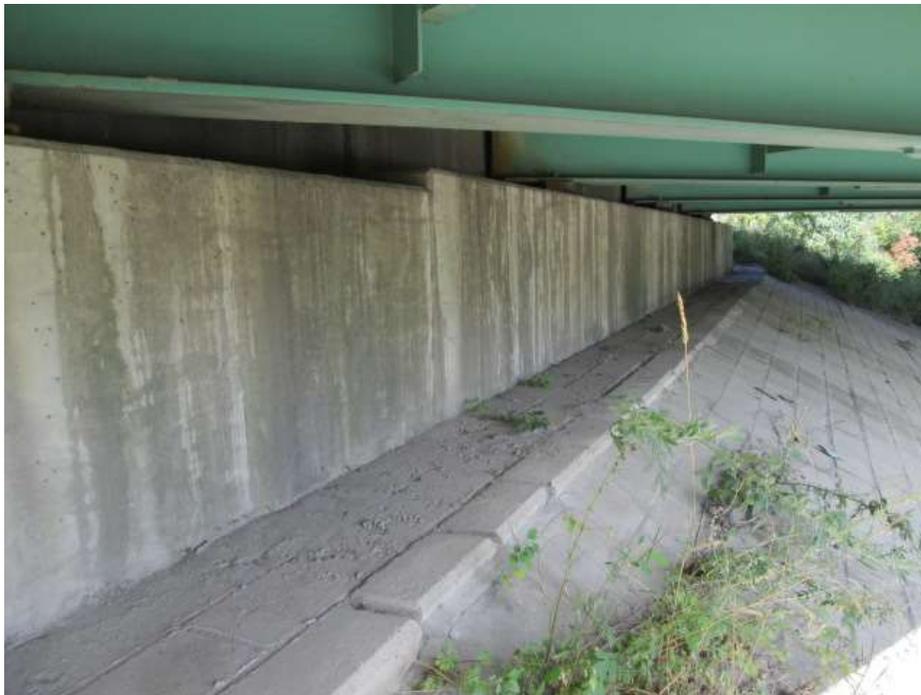
PHOTO 10

Description west abutment

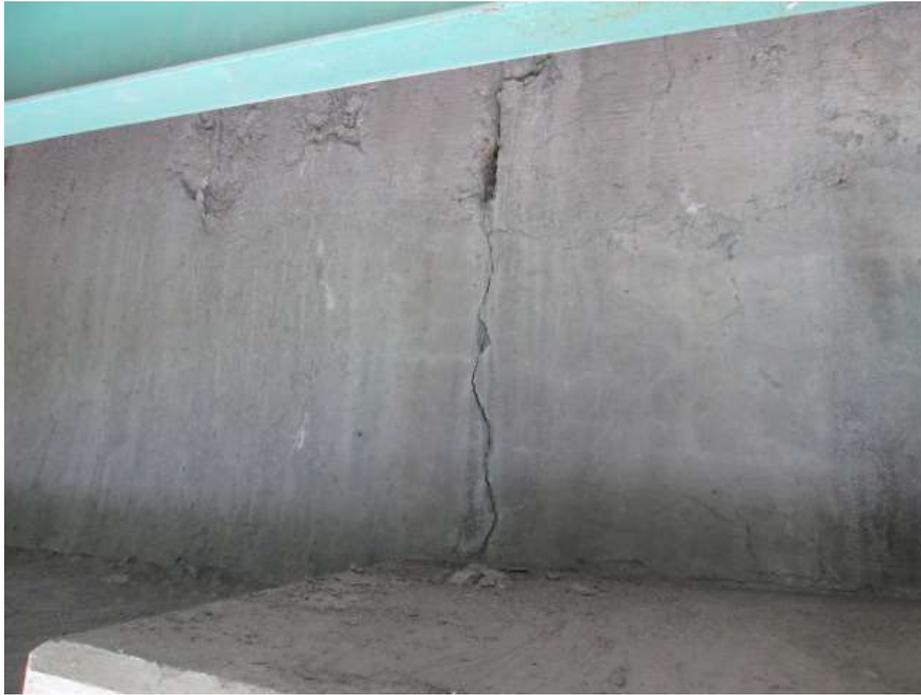
PHOTO 11

Description Backwall cracking west abutment

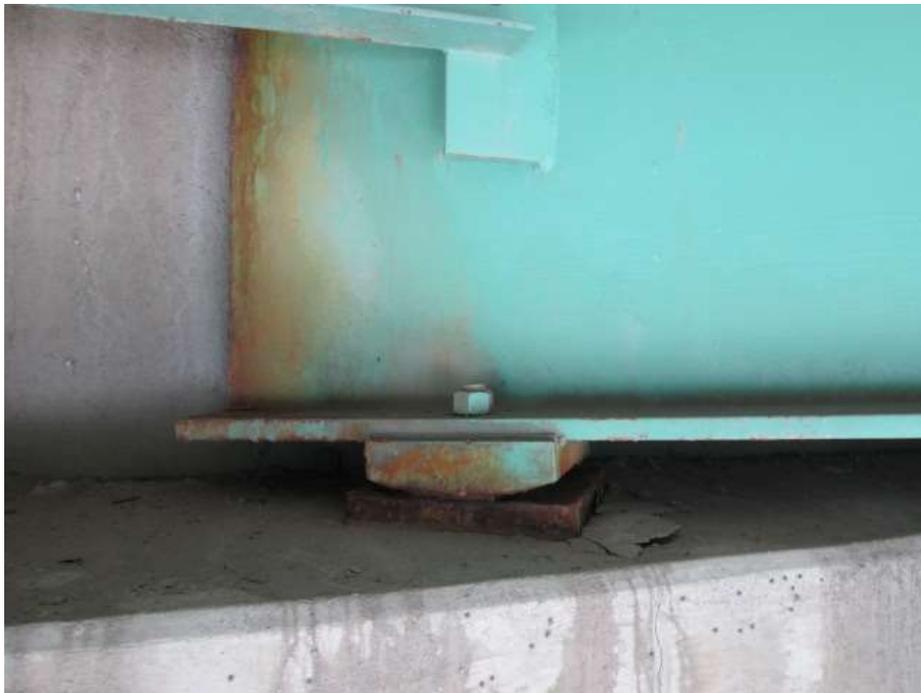
PHOTO 12

Description Typical west abutment interior beam end

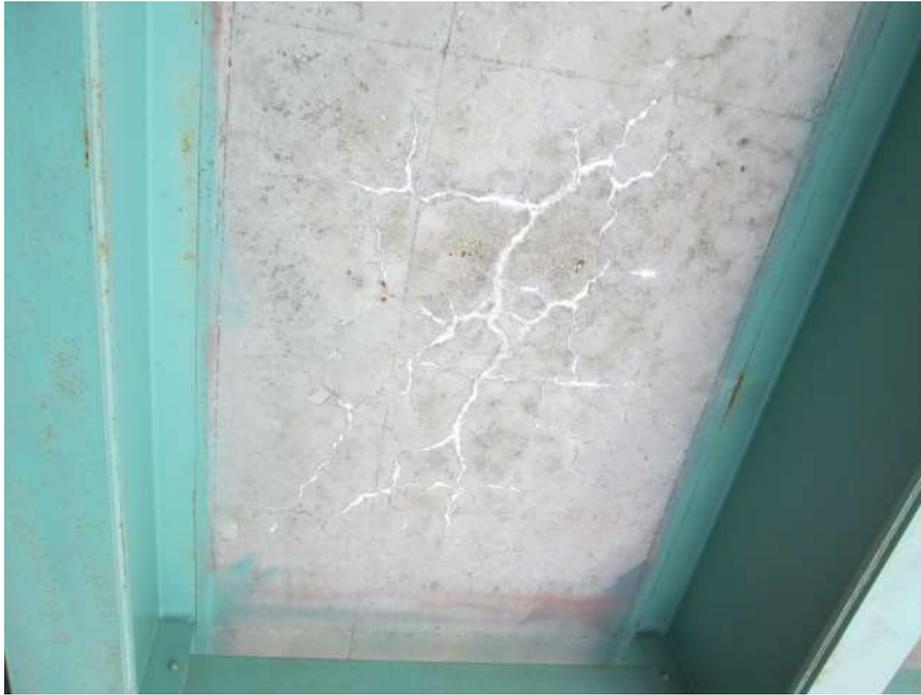
PHOTO 13

Description Area of heavy staining west span deck

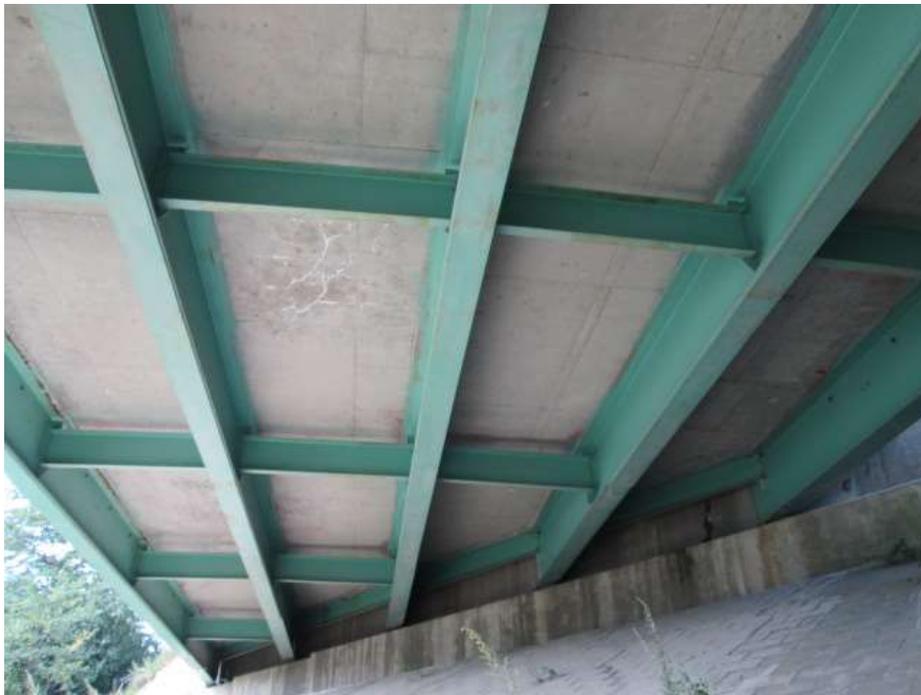
PHOTO 14

Description west span/ abutment

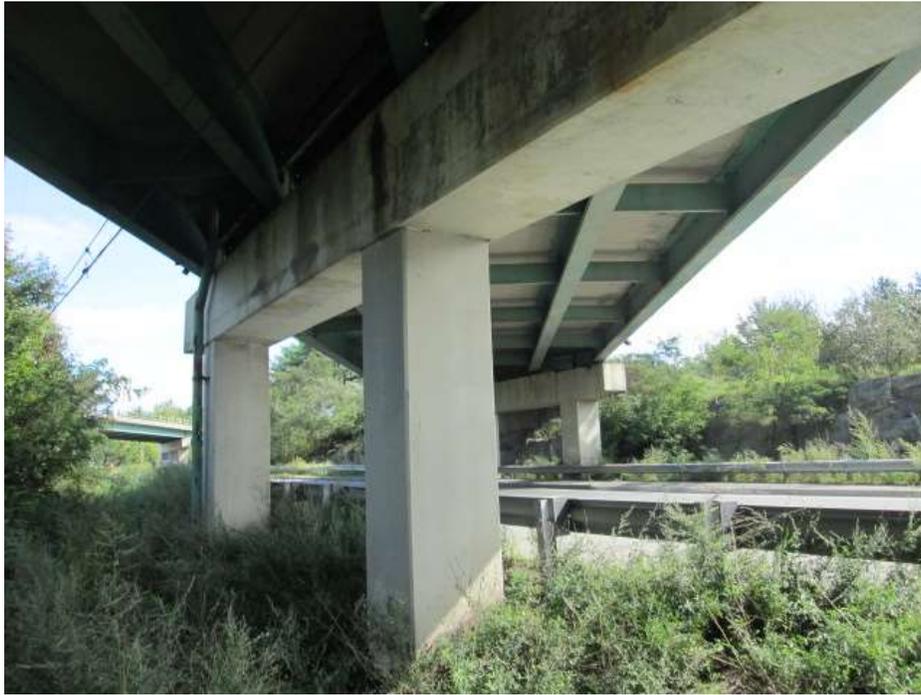
PHOTO 15

Description west pier west face

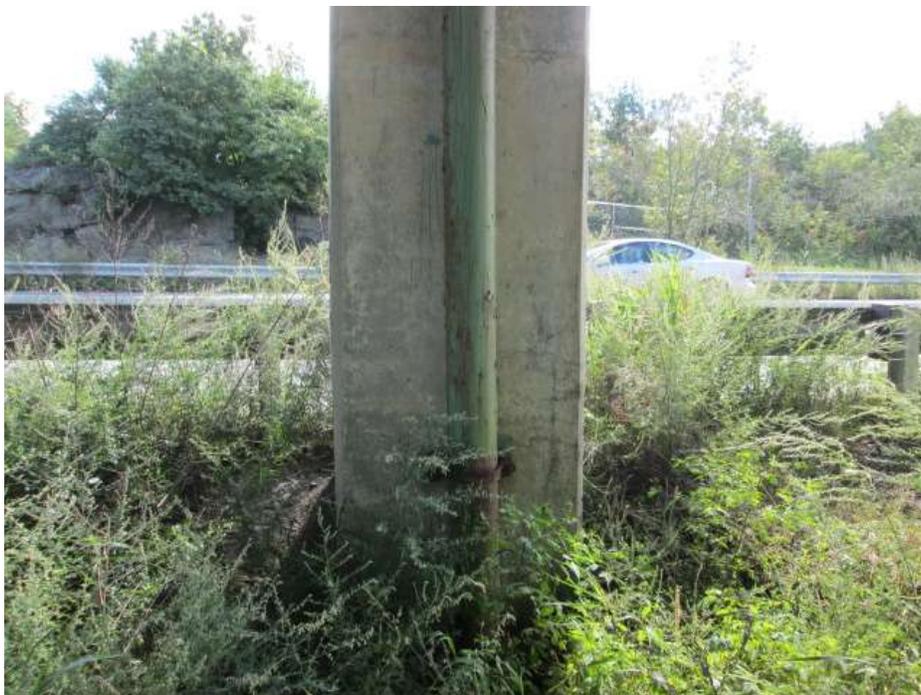
PHOTO 16

Description rusting drain outlet at west pier

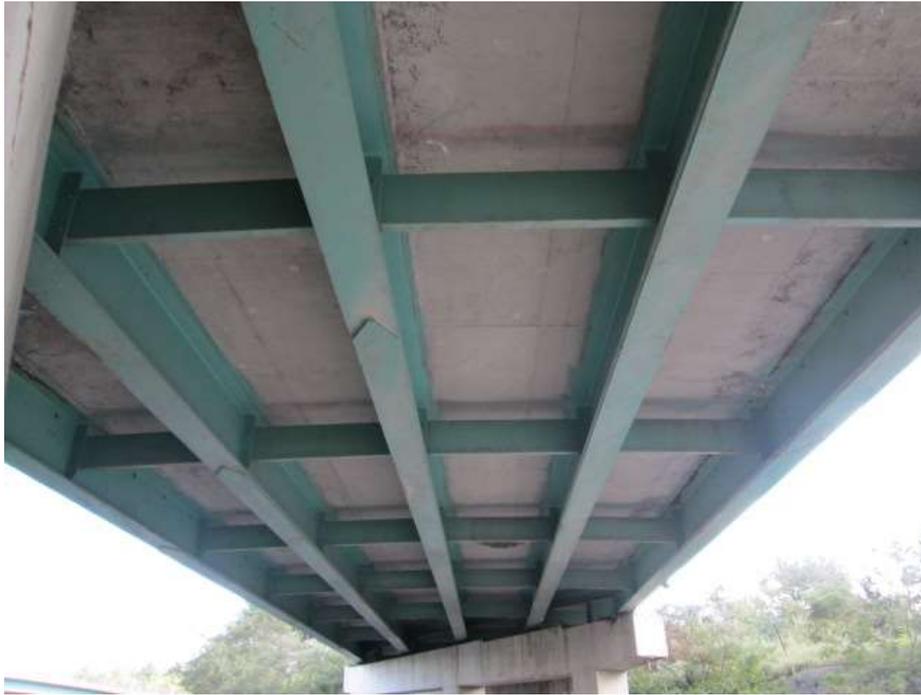
PHOTO 17

Description center span view

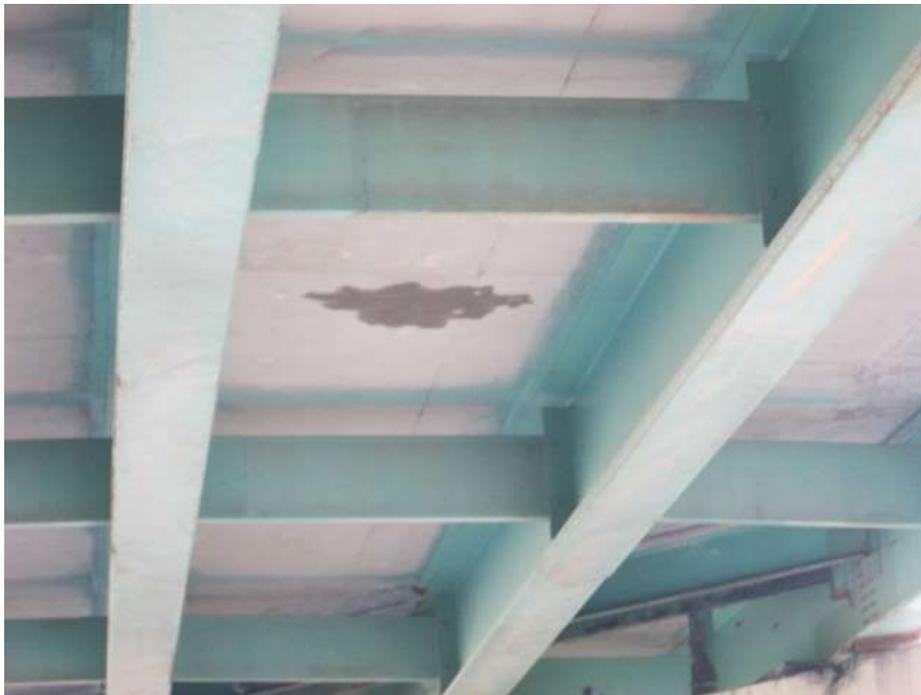
PHOTO 18

Description wet stained area center span interior bay

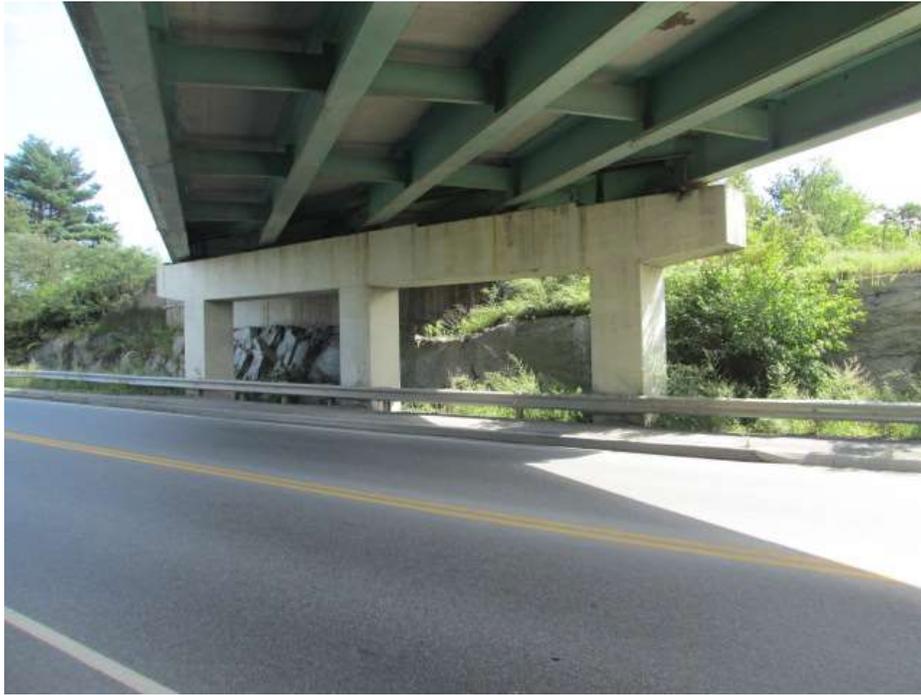
PHOTO 19

Description east pier west face

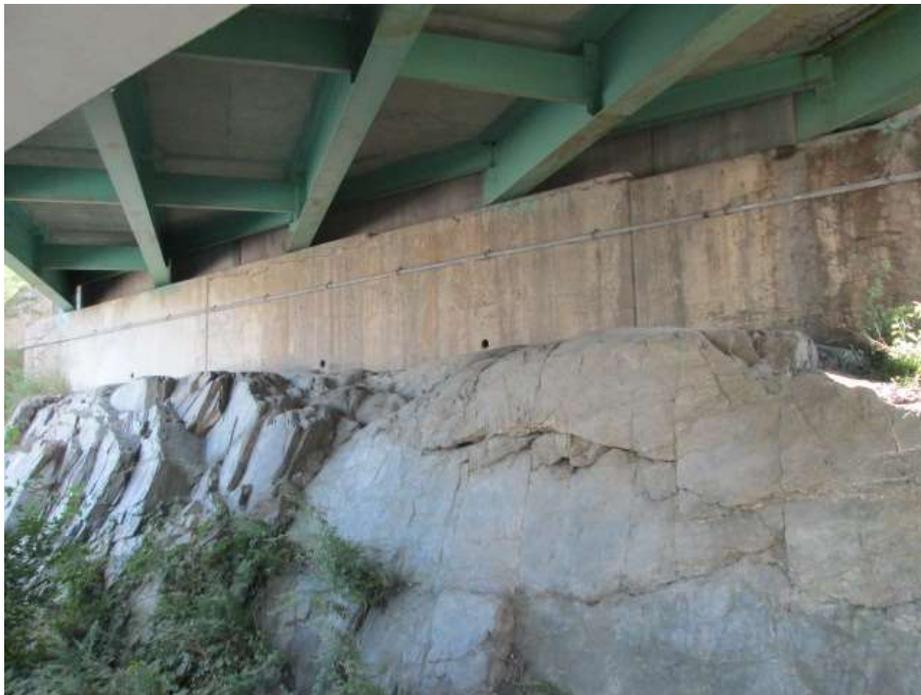
PHOTO 20

Description east abutment

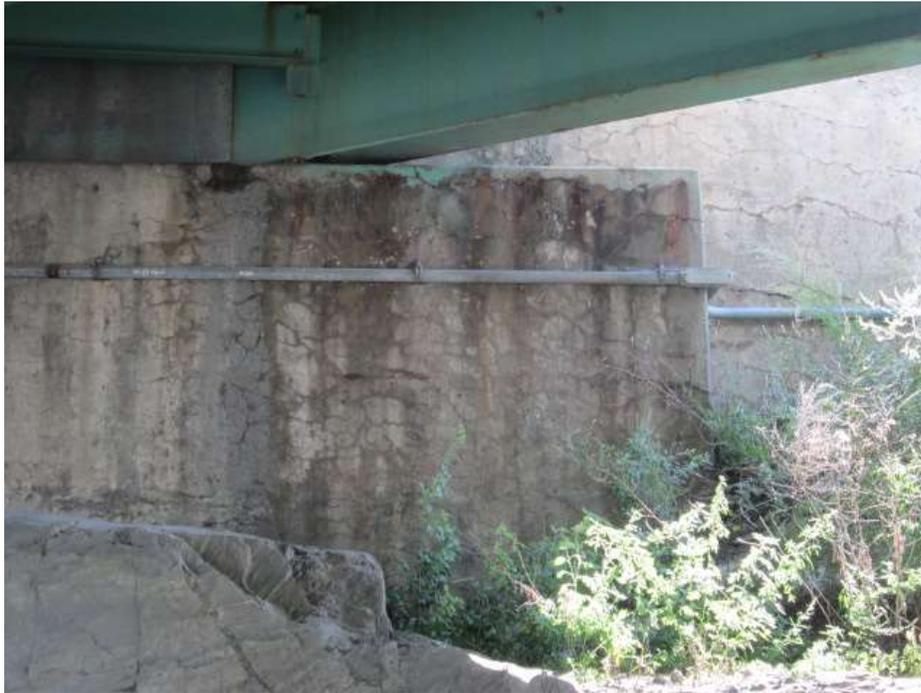
PHOTO 21

Description Heavy cracking east abutment

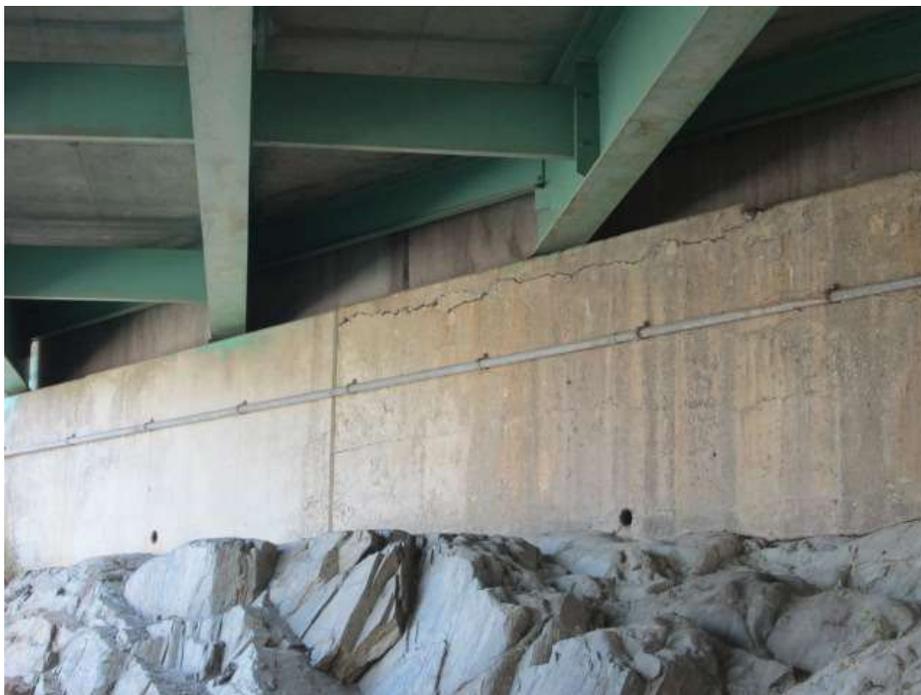
PHOTO 22

Description e3ast abutment

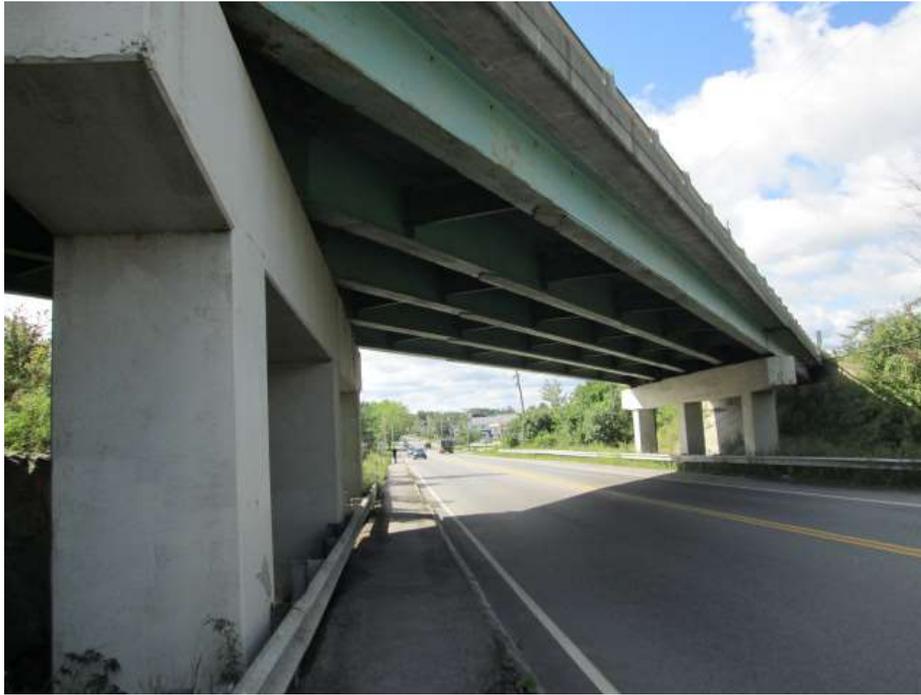
PHOTO 23

Description north side view
