**Inspector:** Harris, Scott  
**Inspection Date:** 09/12/2023

**Structure Number:** 5812  
**Facility Carried:** TRAFTON RD

**Highway Bridge Inspection Report**

**Bridge Name:** TRAFTON ROAD / I 95

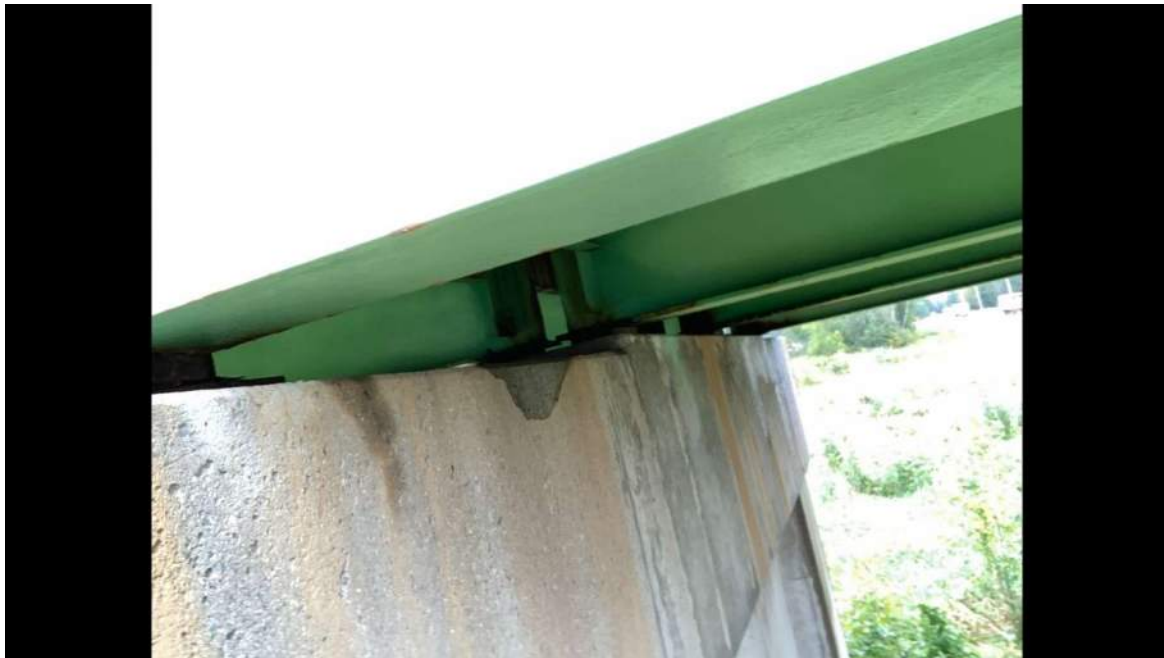
PHOTO 1

Description Pier bearings

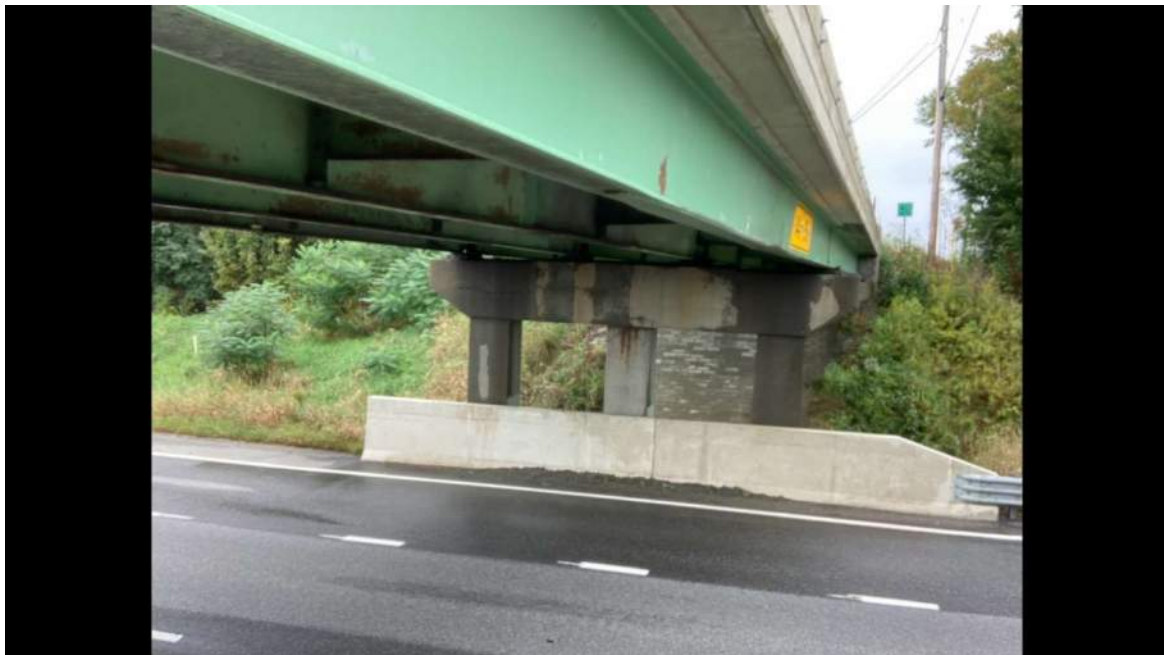
PHOTO 2

Existing collision damage to the North beam over the SB travel lanes was unchanged.  
Paint on the beams over the travel lanes has speckle rust and edge failure.  
Bearings on the piers have minor paint deterioration.  
Paint loss on bearings and beam ends at the abutments.  
Beam ends at each of the abutments have had preventative treatments.  
All joint seals above each of the piers are intact but appear to be leaking.

Collision damage unchanged - 2020,2021

Description SB span north end collision damage

Type	Work Item	Priority	Notes
Preservation	Seal Joint		
Capital	Coat Beam Ends		
Capital	Paint		
Maintenance	Remove Delams Over Traffic		Monitor for deck spalls over traffic
Capital	Rehab Superstructure		Repair collision damage SB

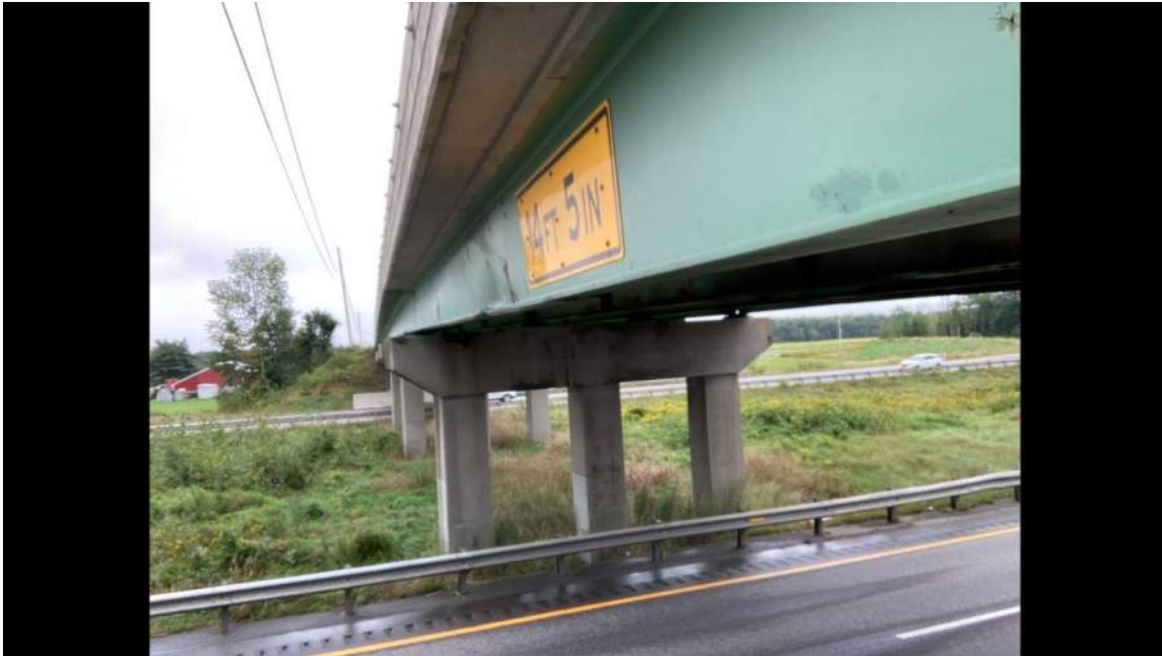
PHOTO 3

Description SB span north end collision damage

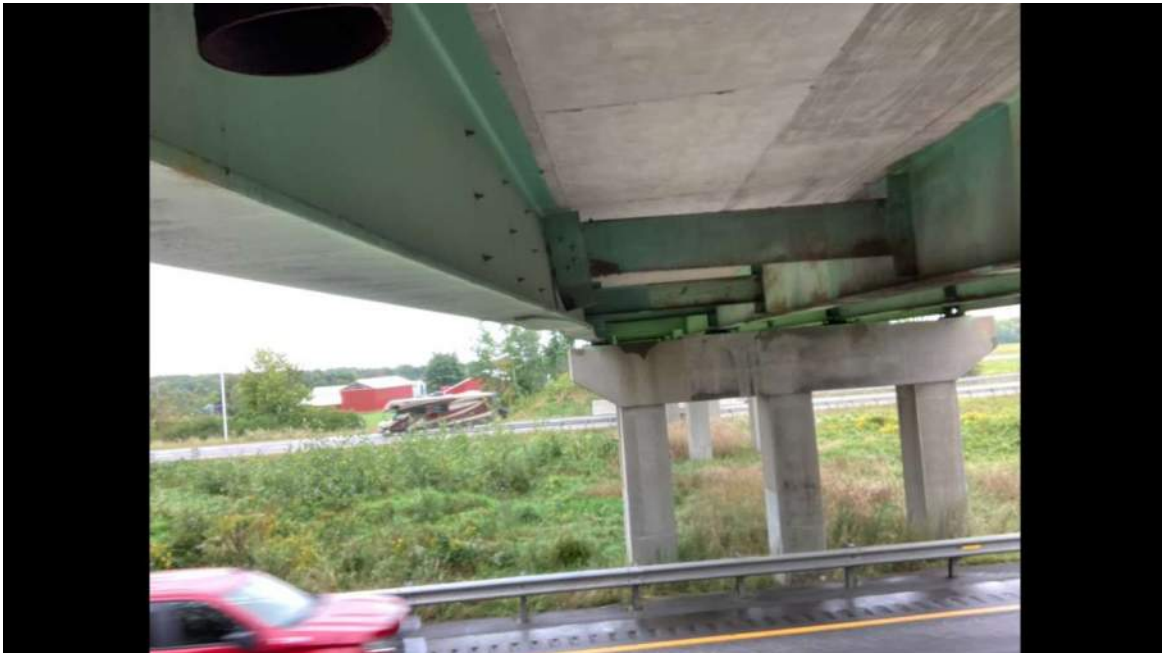
PHOTO 4

Description SB span north end collision damage diaphragm

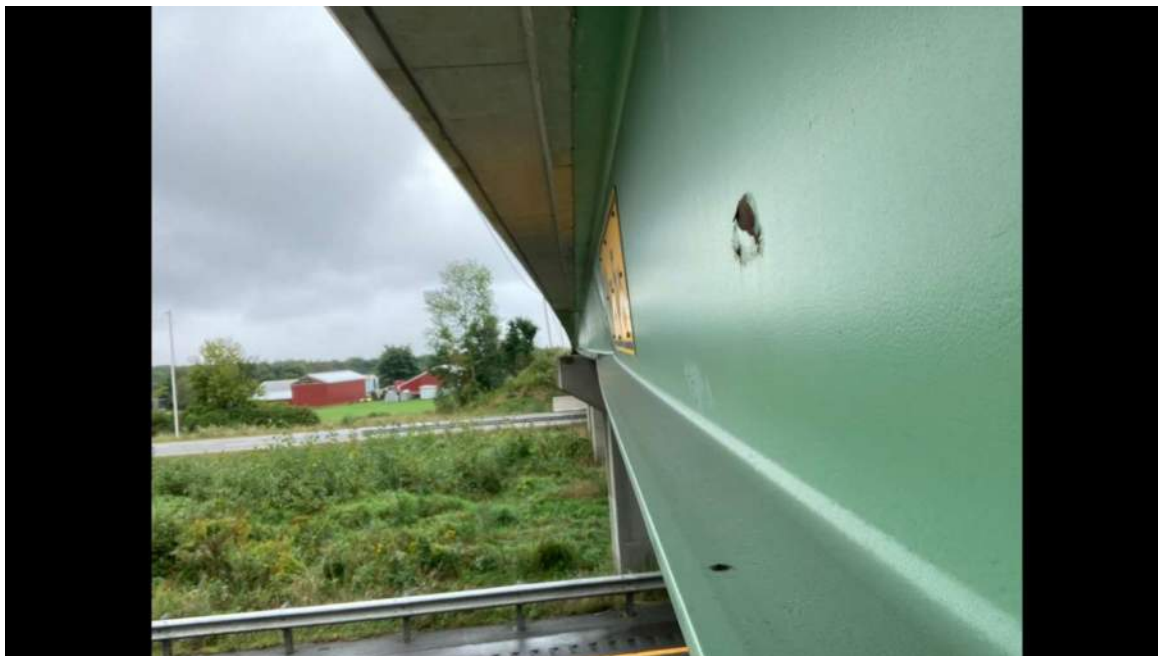
PHOTO 5

Description SB span north end collision damage

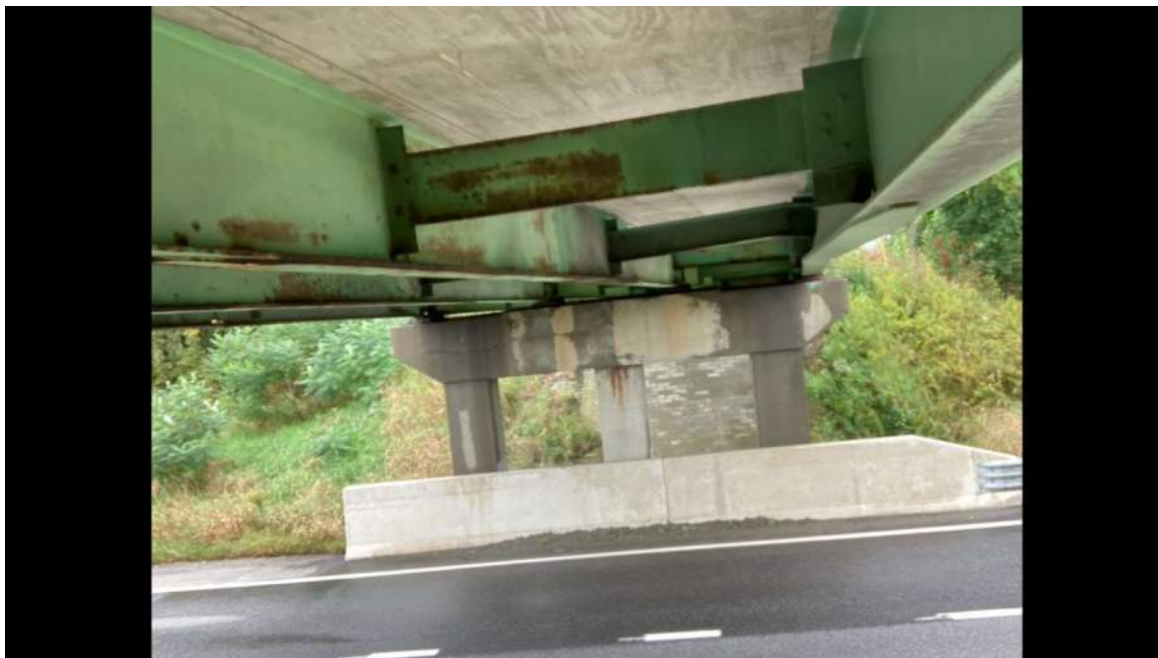
PHOTO 9

Description SB span north end collision damage looking west

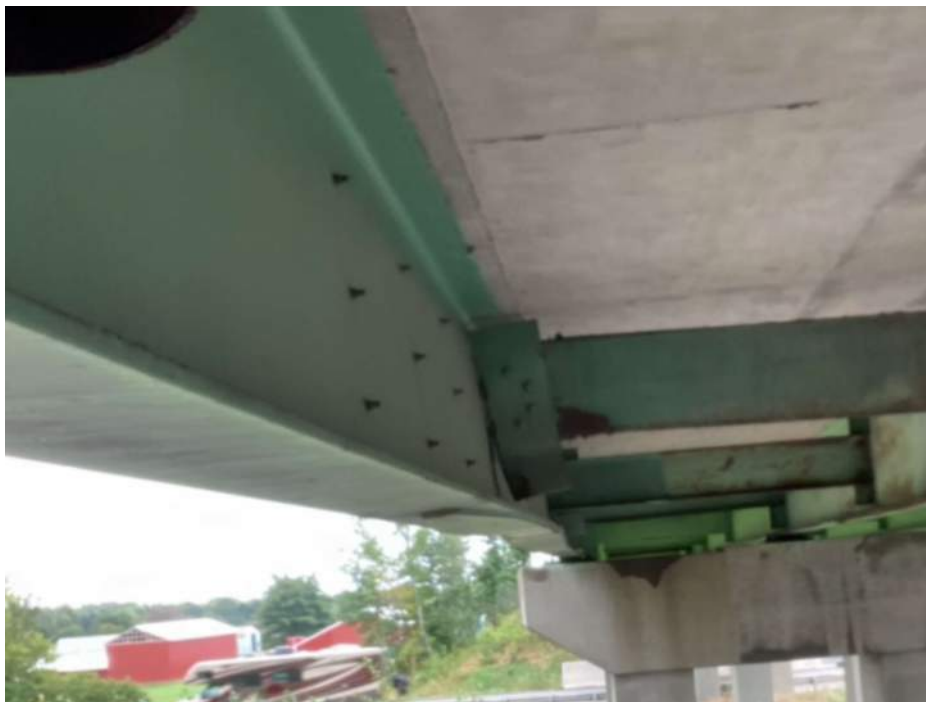
PHOTO 10

Description North girder inside diaphragm damaged

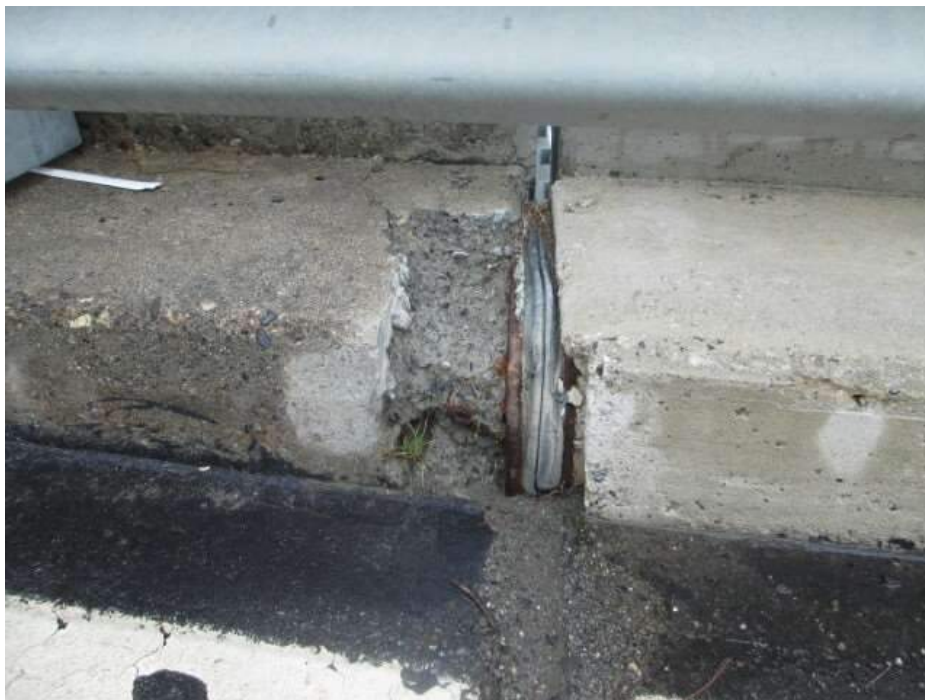
PHOTO 16

Description spalling at north joint curb area

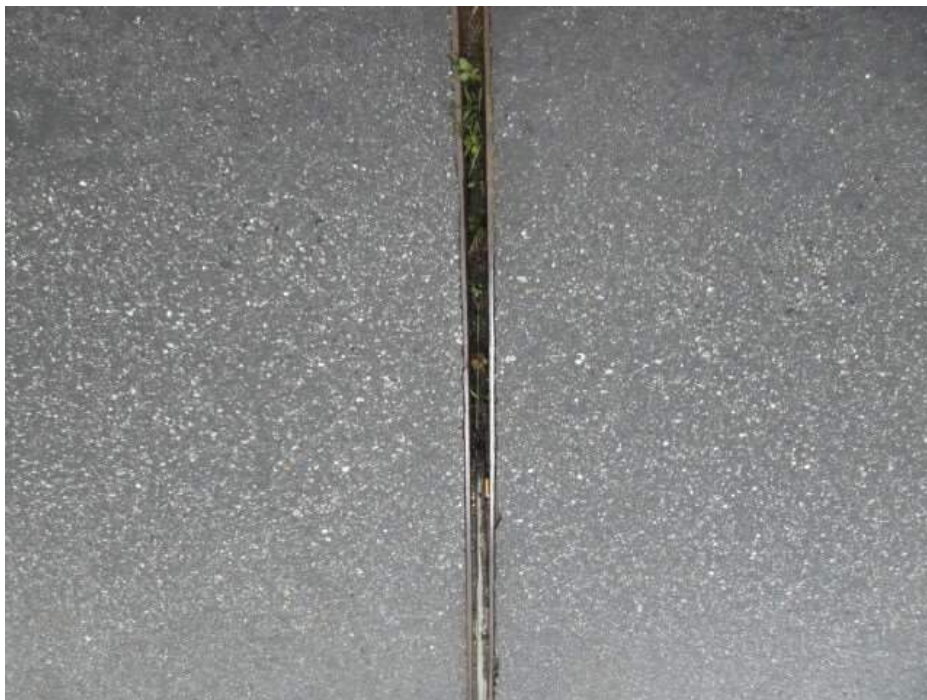
PHOTO 18

Description pushed down pier joint seal

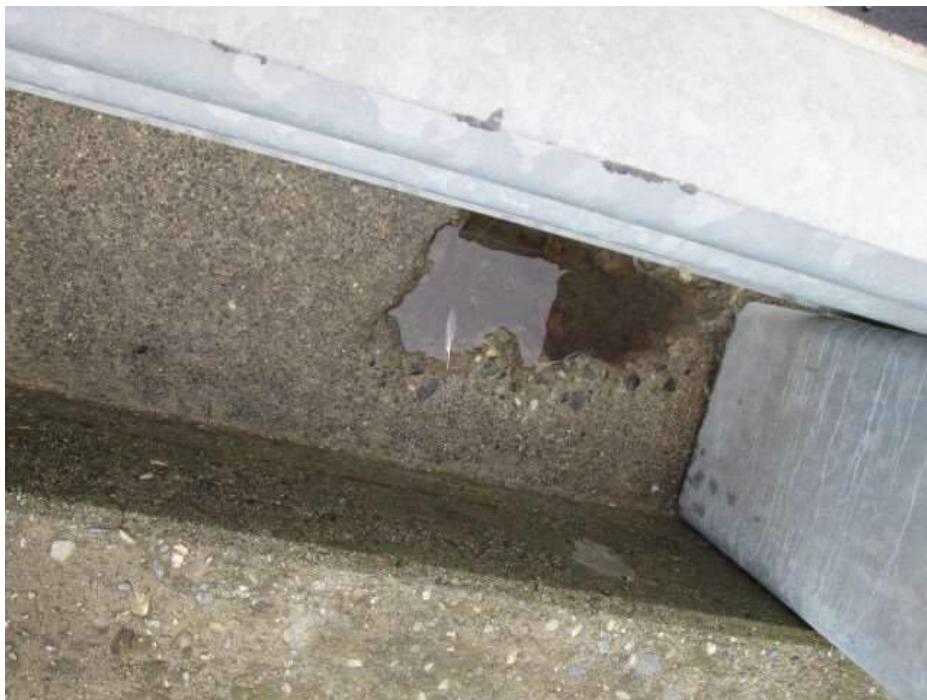
PHOTO 20

Description curb spall

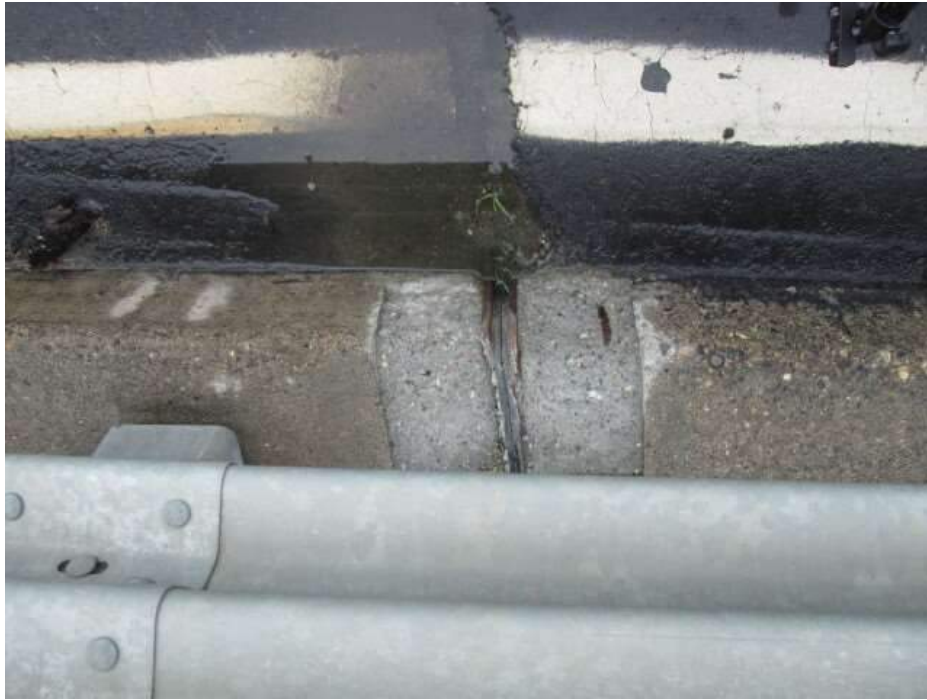
PHOTO 21

Description spalling at curb joint armor

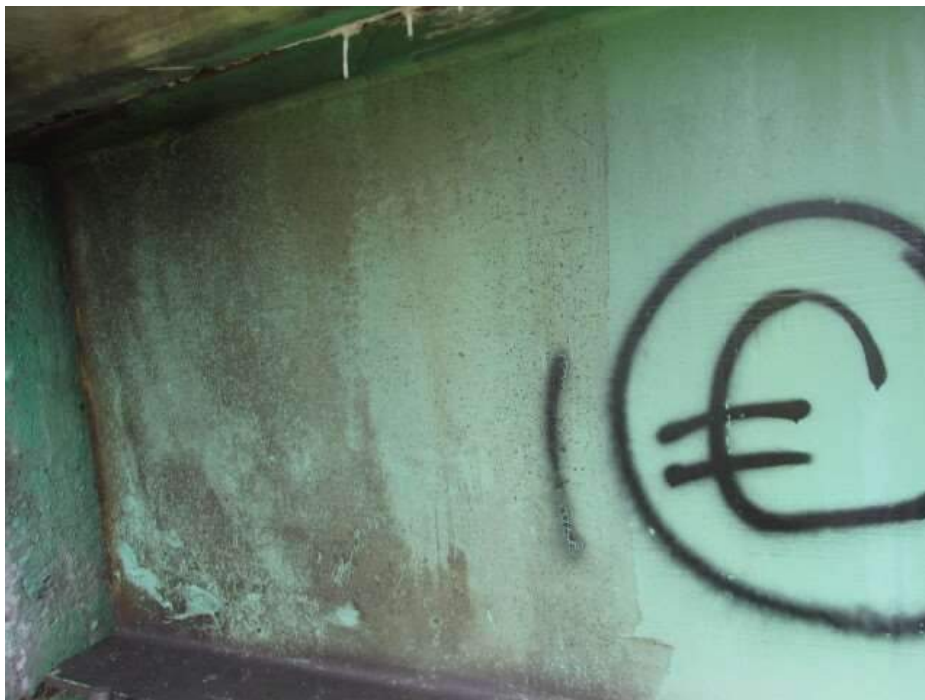
PHOTO 23

Description east beam end oil treatment

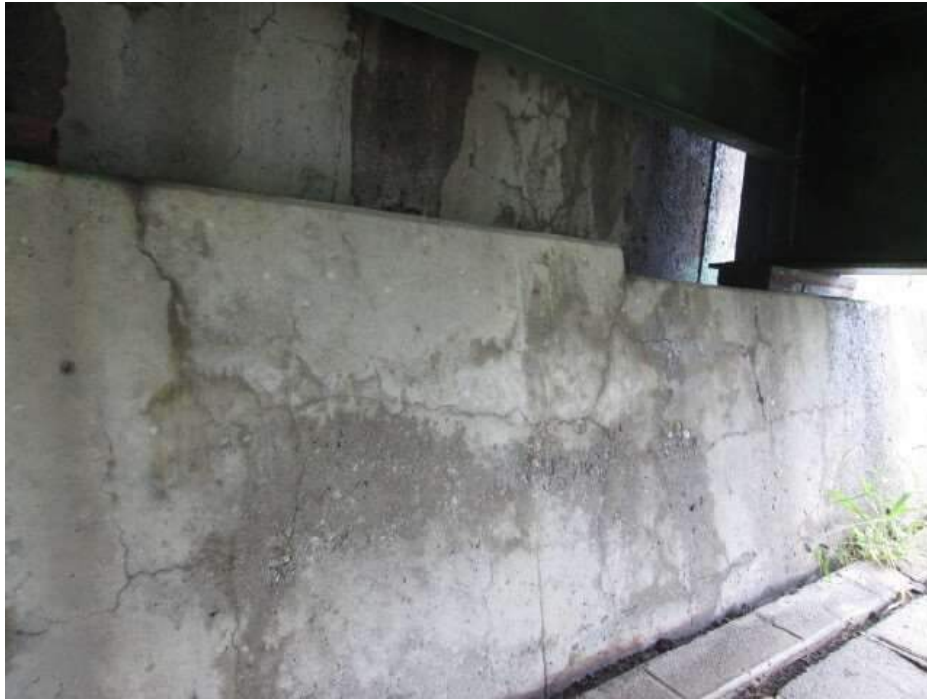
PHOTO 25

Description cracking east abutment

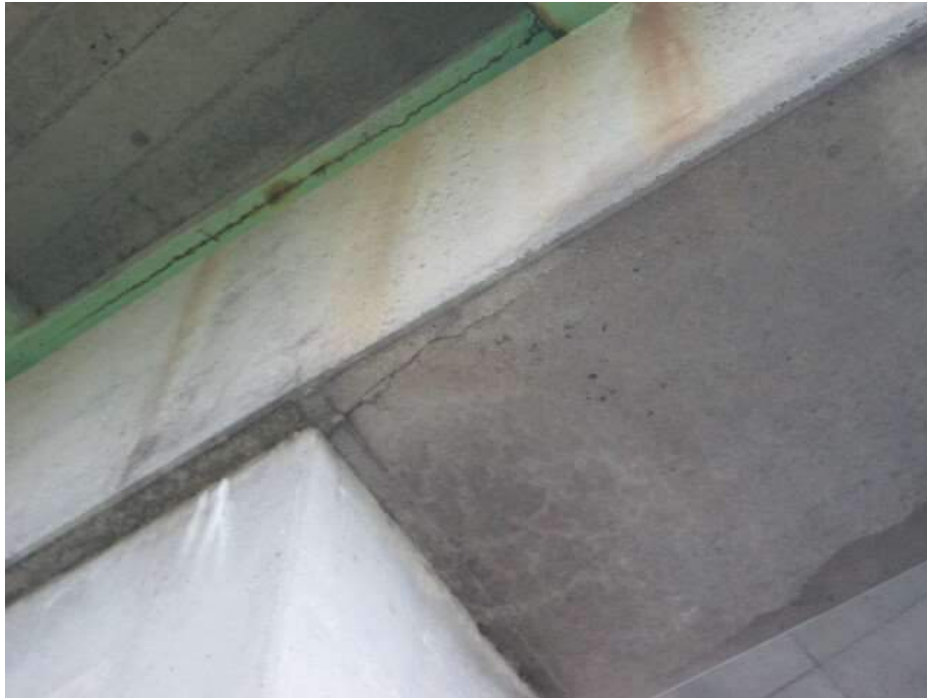
PHOTO 33

Description cracking at pier cap

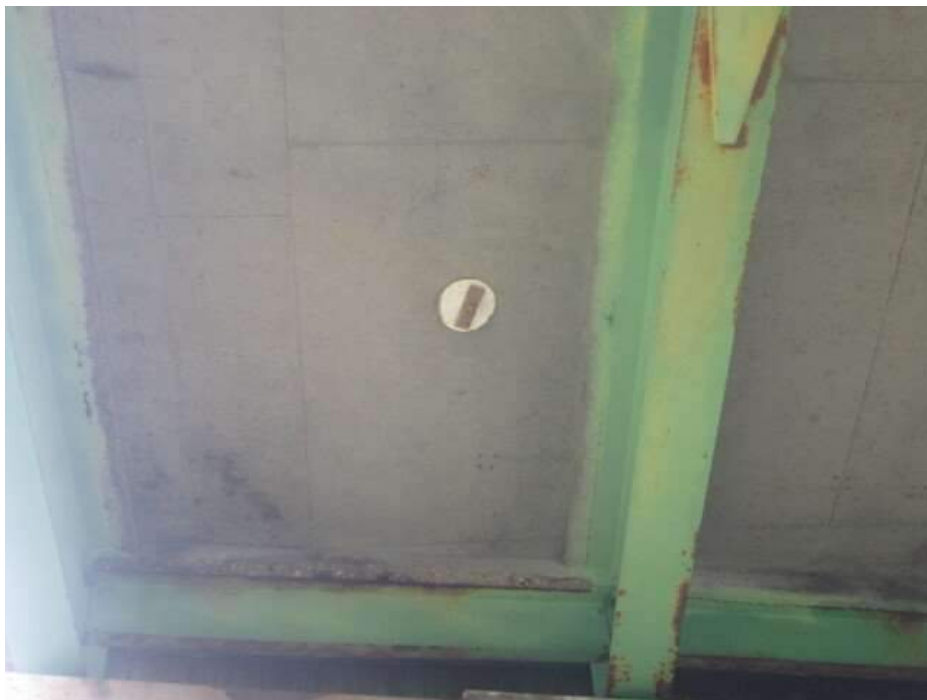
PHOTO 34

Description weird patched area

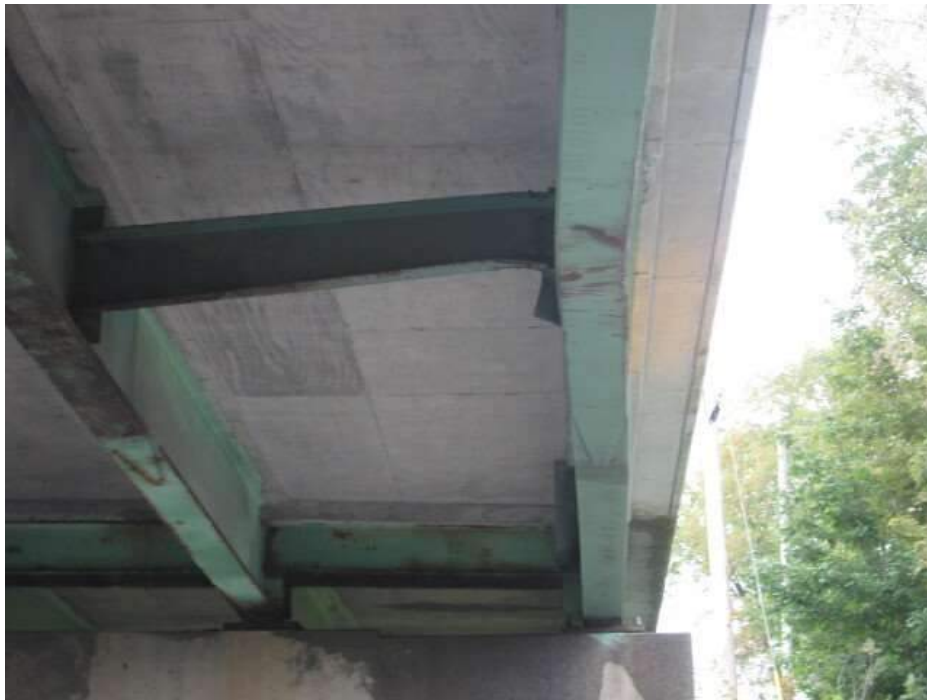
PHOTO 39

Description Collision sweep I-95 SB north girder

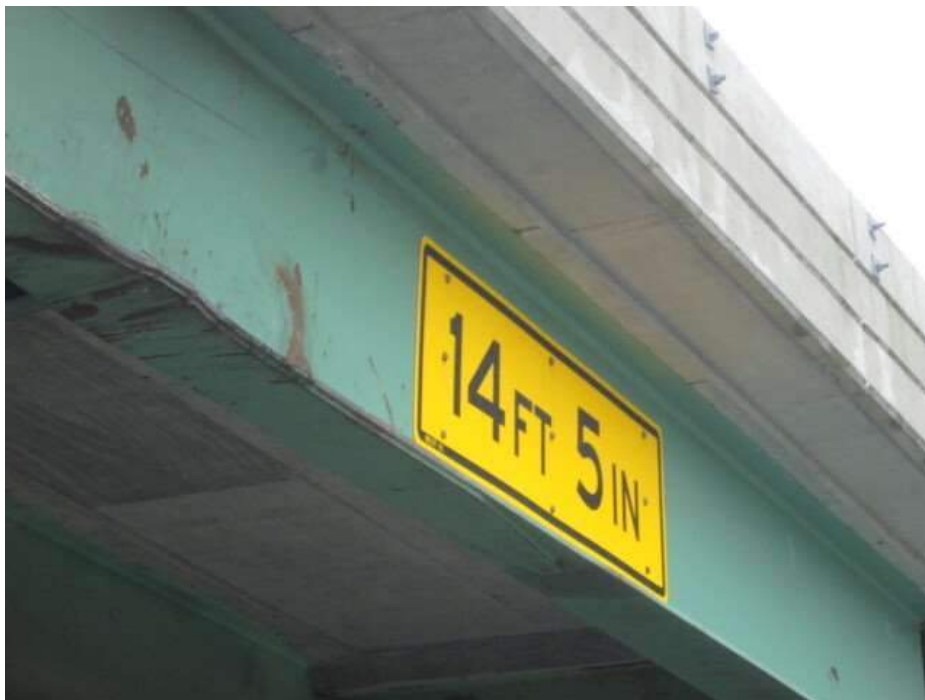
PHOTO 42

Description clearance posted north girder

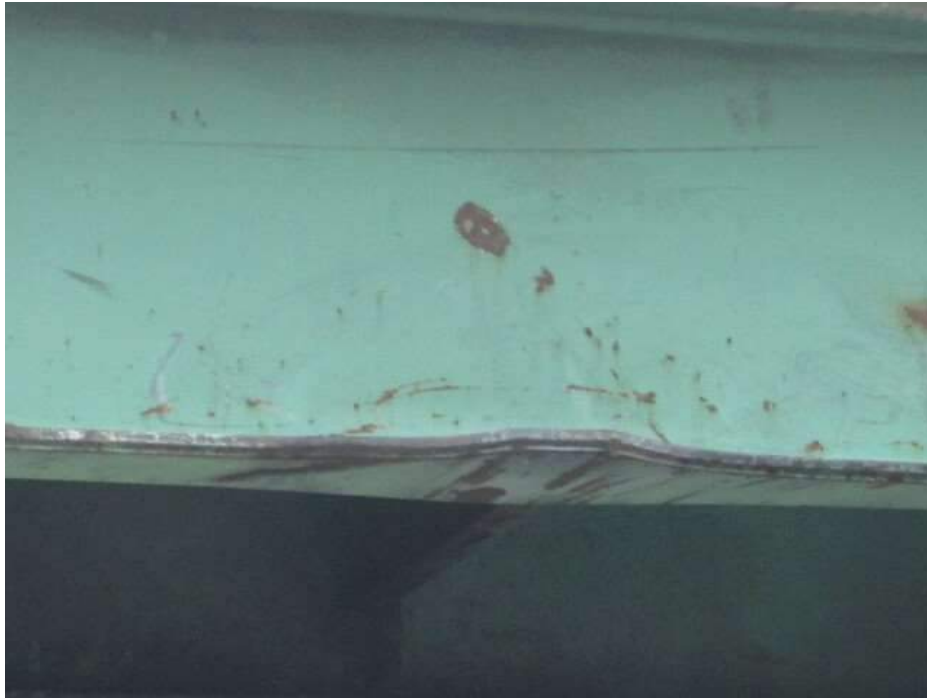
PHOTO 43

Description north girder I-95 BSD span impact damage
