**Structure Number:** 1562  
**Facility Carried:** PARKWAY S

**Highway Bridge Inspection Report**

**Bridge Name:** PARKWAY SOUTH / I395

**Town:** Brewer

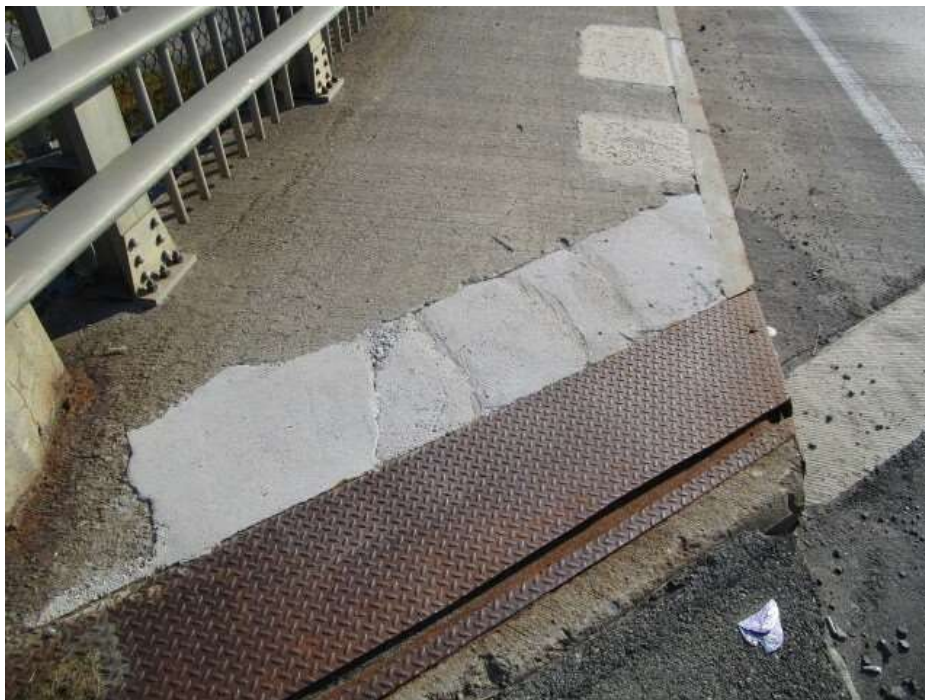
PHOTO 2

Description patched south end of west sidewalk

Type	Work Item	Priority	Notes
Capital	Replace Wearing Surface		
Capital	Repair Joint		south joint armor/ header
Capital	Repair Deck		Repair sidewalk surface
Capital	Other		Apply Silane
Capital	Paint		
Capital	Rehab Substructure

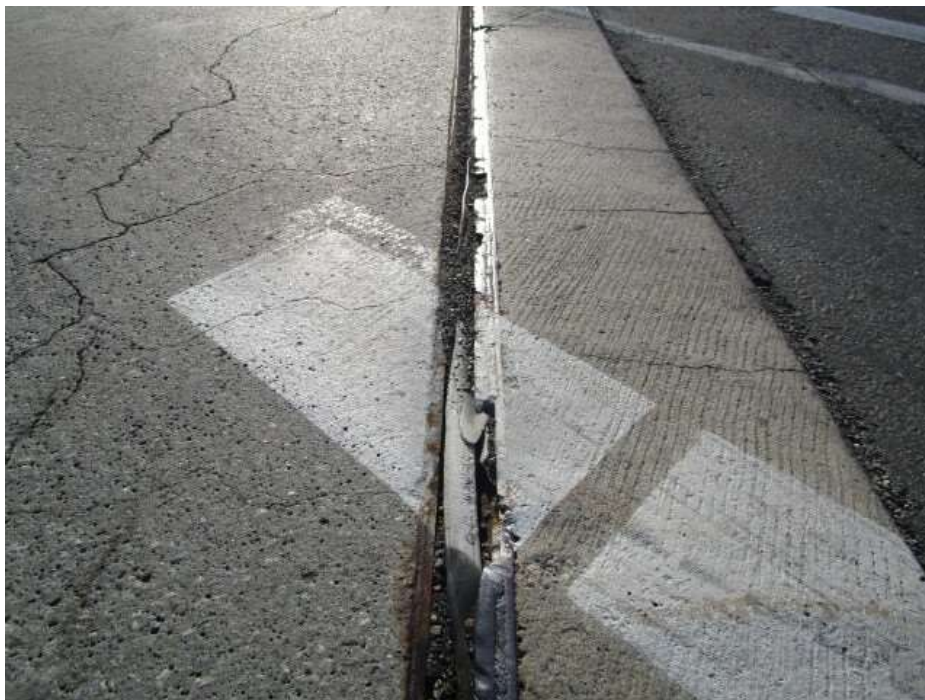
PHOTO 4

Description minor armor damage to south end joint

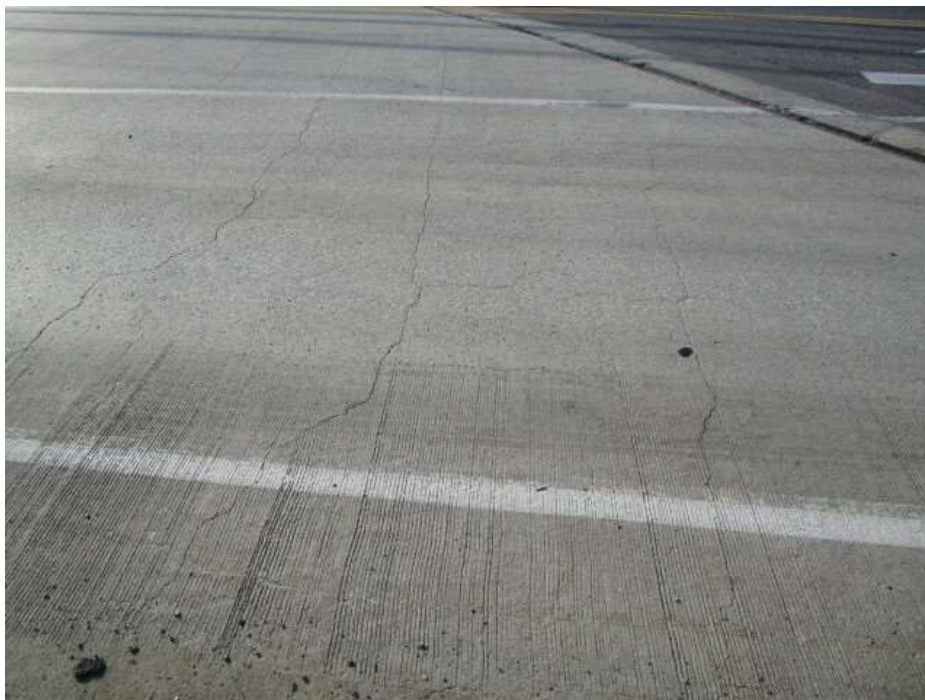
PHOTO 6

Did not chain concrete wearing surface at this time due to heavy traffic. Observed moderate cracking with delaminated area at north joint headers. Areas of large cracking in WB lane & moderate cracking 30% of surface area. No major spalling noted at this time

Description wearing surface transverse cracking

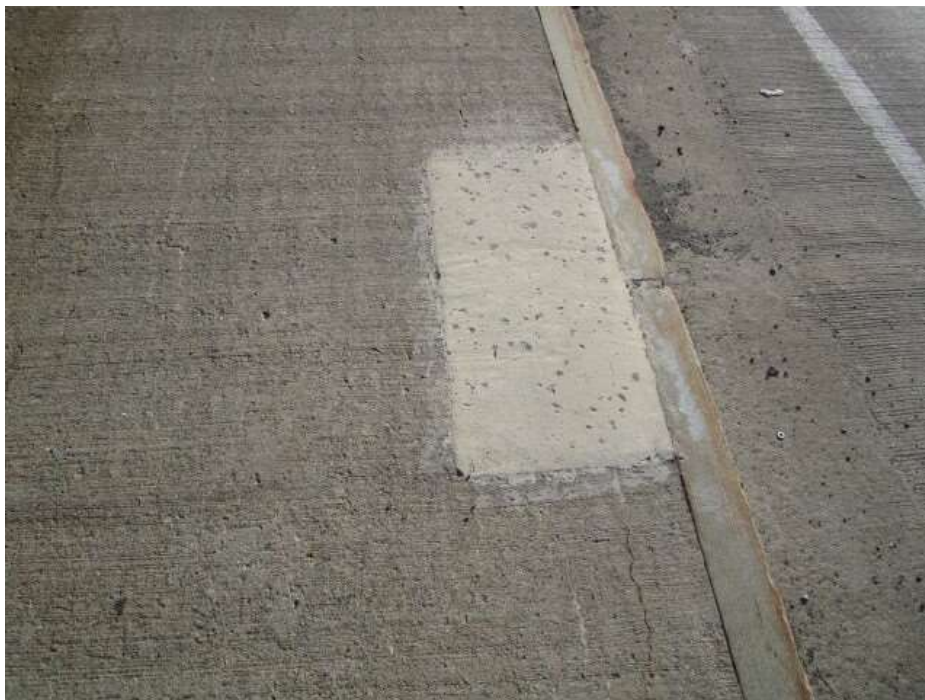
PHOTO 8

Description west sidewalk patch

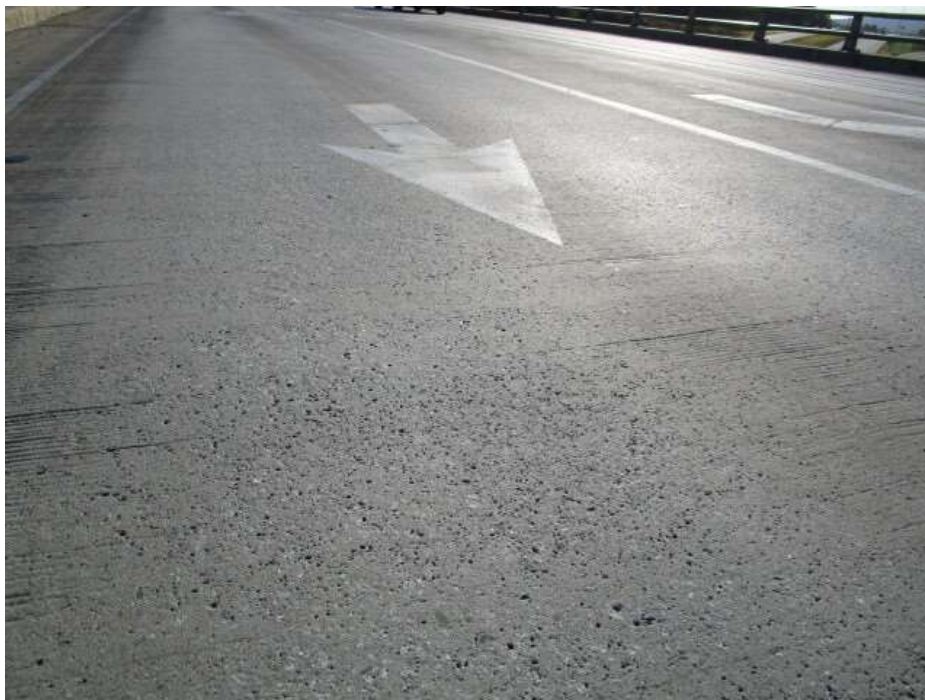
PHOTO 9

Description typical of wearing surface wear

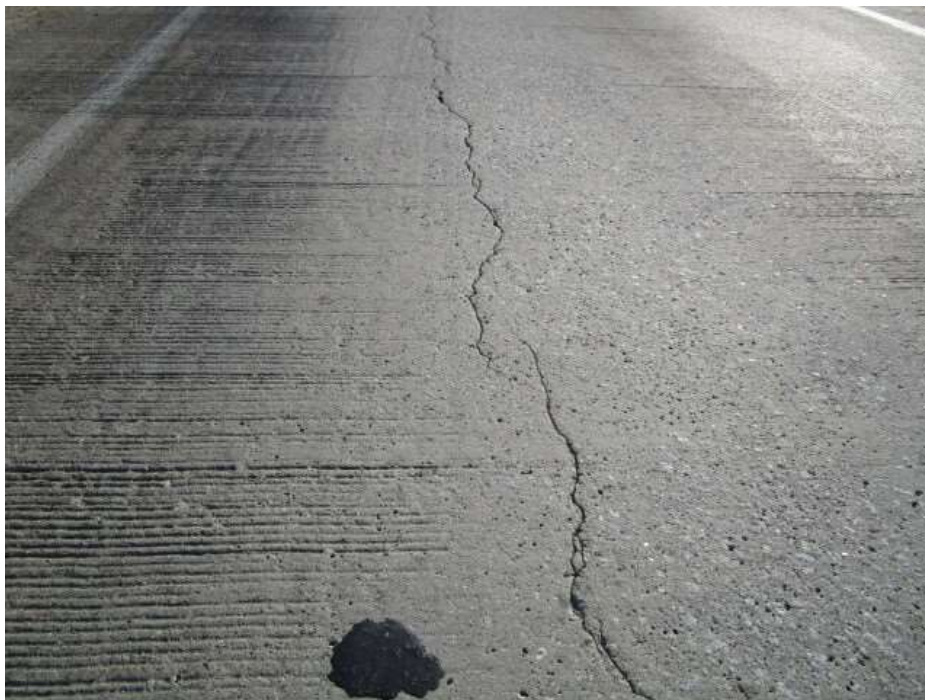
PHOTO 10

Description large longitudinal crack in SB travel lane

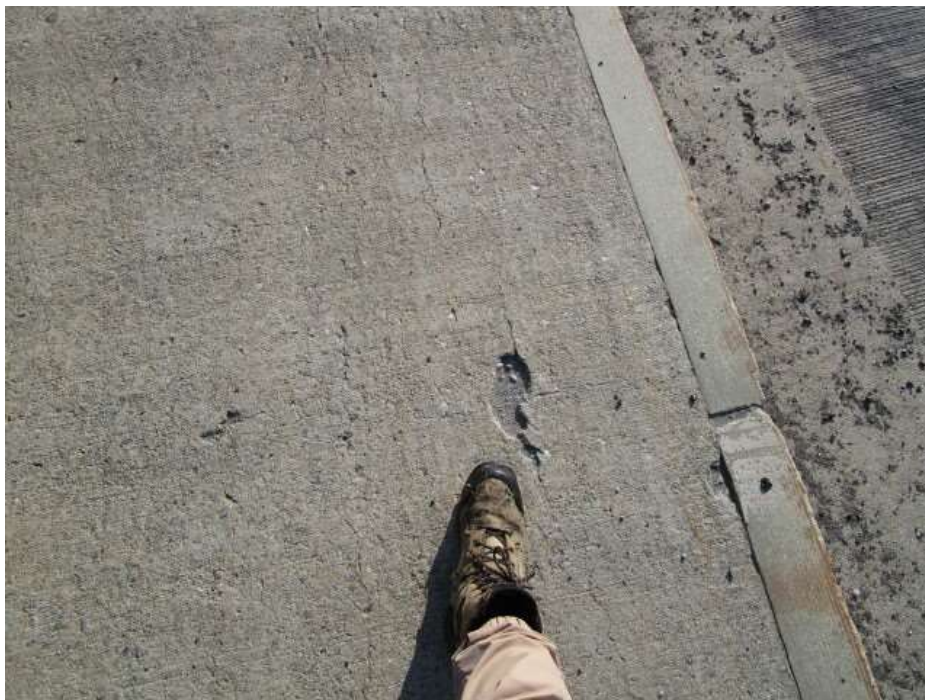
PHOTO 11

Description mini pothole west sidewalk

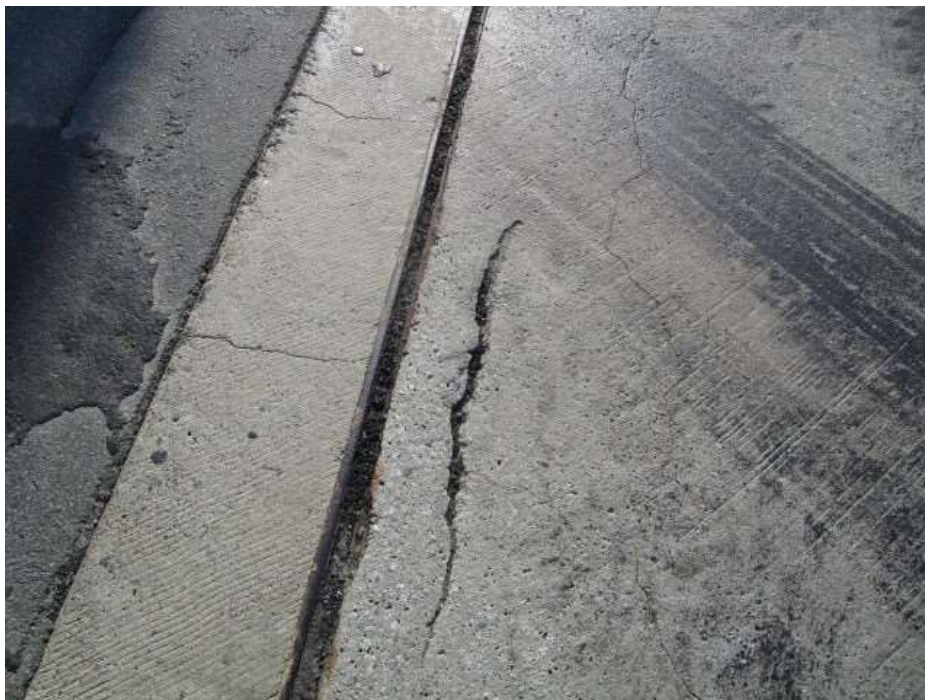
PHOTO 13

Description delaminated area at north joint SB lane (deck side)

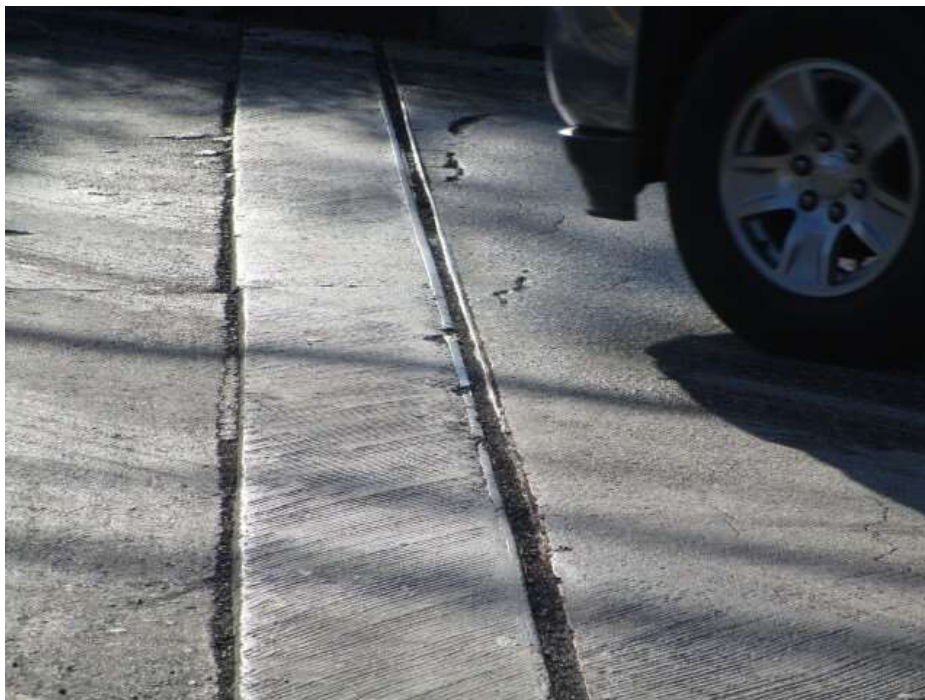
PHOTO 14

Description minor damage to armor north end joint

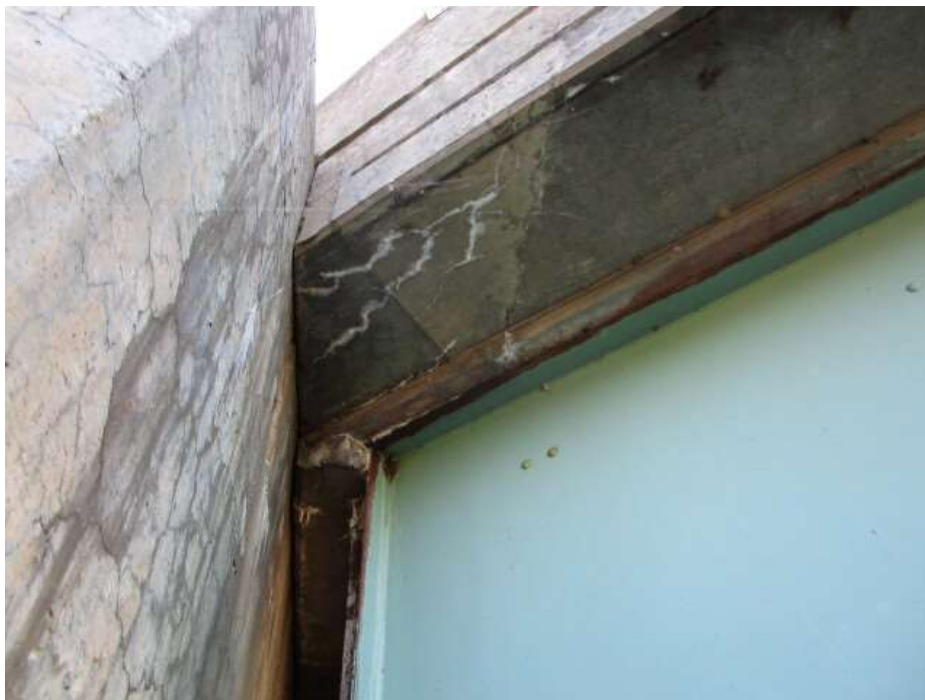
PHOTO 17

Overall fair condition with moderate cracking & staining of exterior bays. Interior bays have minor cracking & staining only. Curb tops have moderate scaling areas. Exterior bays/ fascia has scattered efflo & rust stained areas. South joint armor has minor plow damage. North joint has minor armor damage & spall deck side SB travel lane. Bridge rail & snow fence in overall satisfactory condition with minor post impacts only.

Description cracking & staining NW end of deck

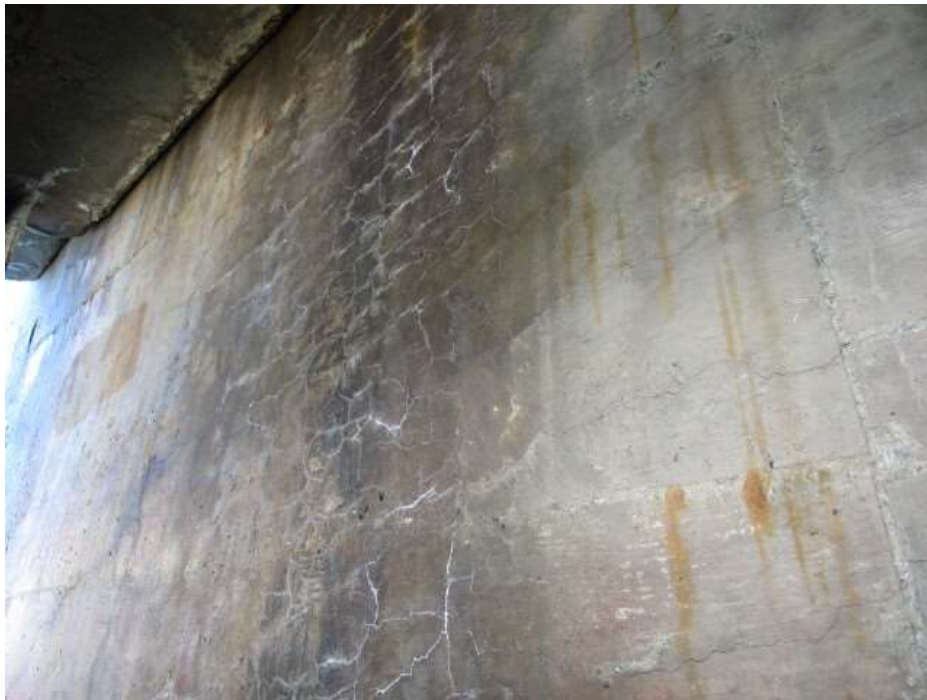
PHOTO 19

Overall poor condition with widespread moderate cracking an isolated areas of heavy cracking/ staining with stains. The abutments, back-walls and wing walls suffer from ASR map cracking. The NE corner of the North abutment has moderate/ heavy scaling of bridge seat/ upper breastwall area. Pier columns have fine vertical cracks and scattered map cracking. The East end column is coated with woven fiberglass

Description cracking & efflo staining at north abutment backwall

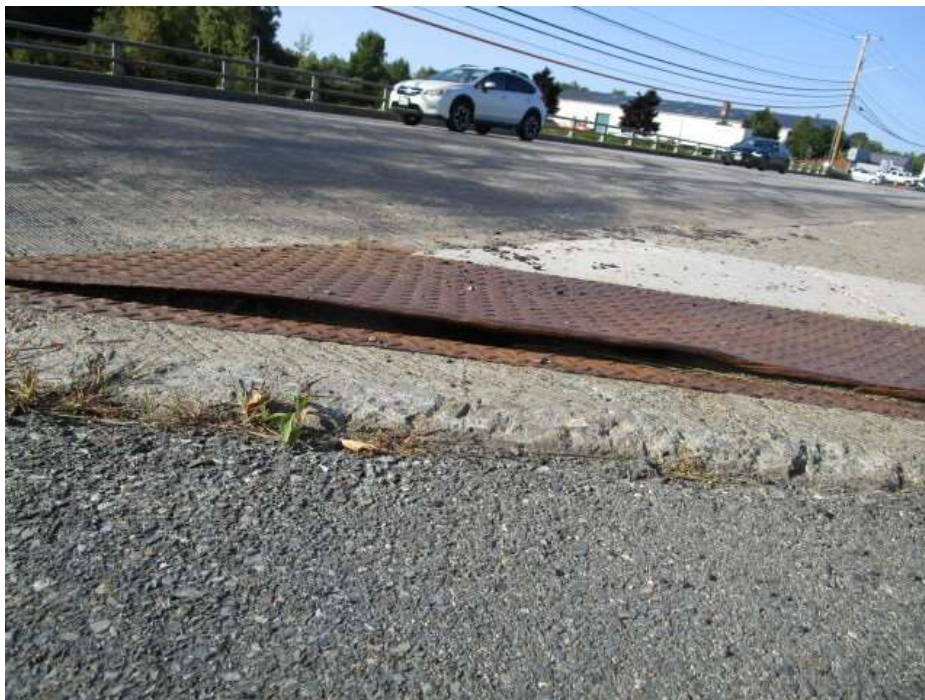
PHOTO 26

Description north end of west sidewalk joint plates offset

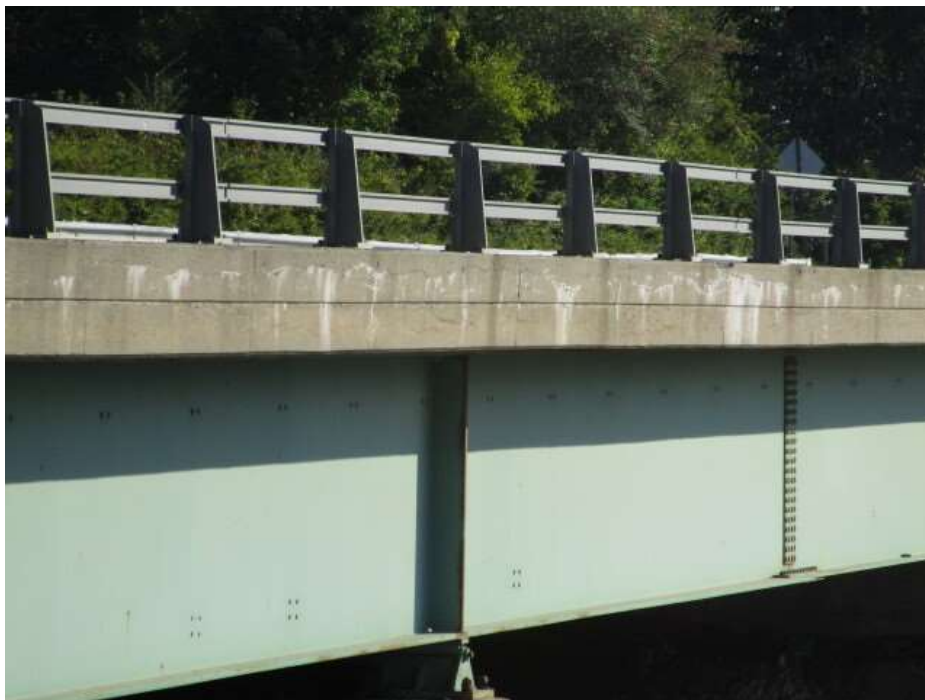
PHOTO 27

Description typical of efflo staining east fascia

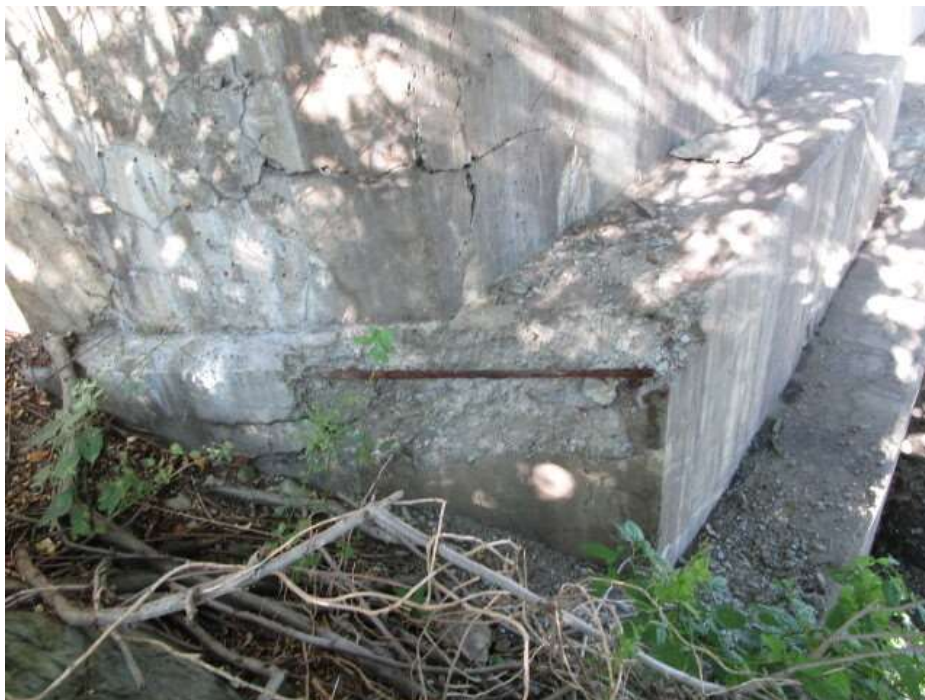
PHOTO 28

Description heavy scaling concrete at SE abutment footing

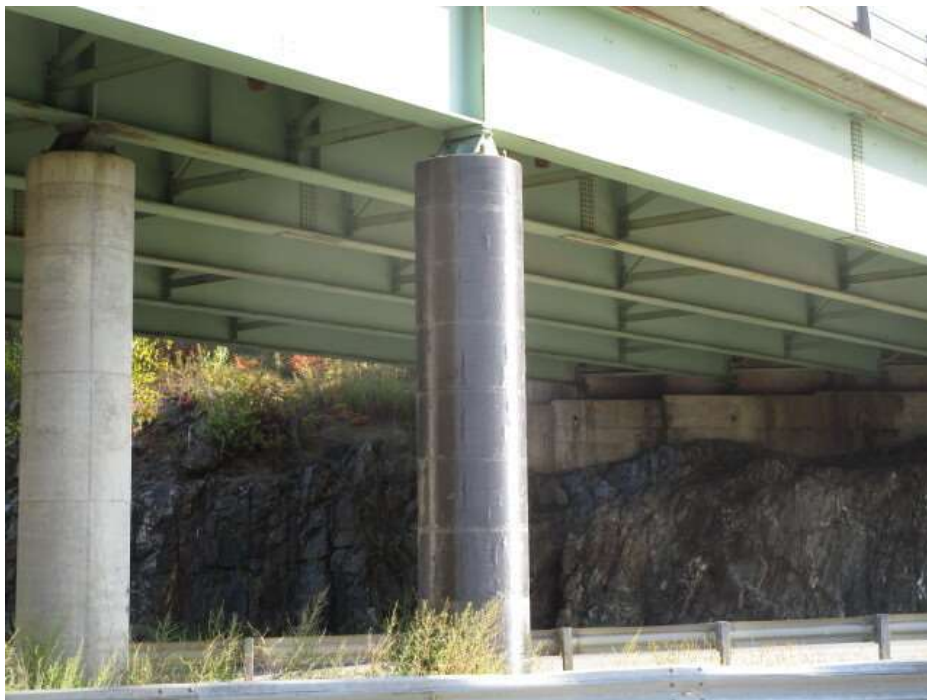
PHOTO 32

Description Wrapped east pier pile

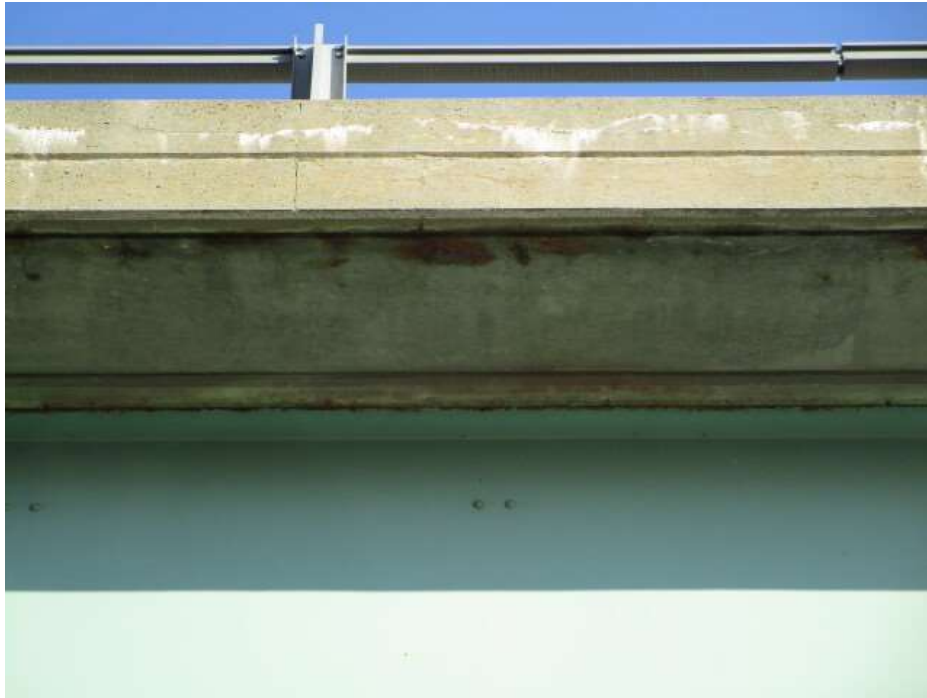
PHOTO 33

Description fascia cracking & staining

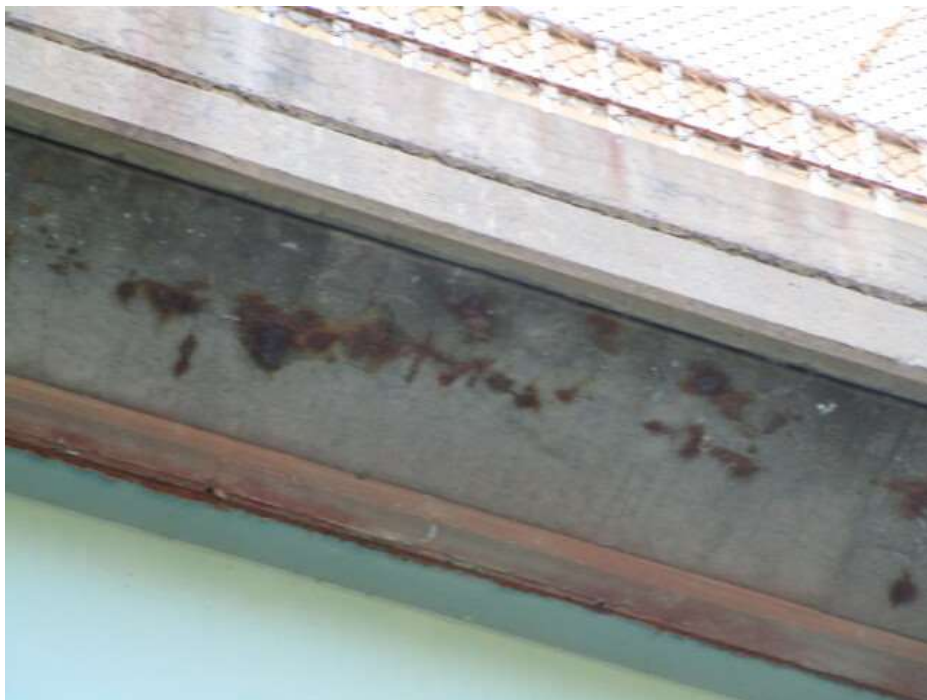
PHOTO 36

Description rust staining exterior bay west side
